0-6963: Planning the Next Generation of Seal Coat Equipment

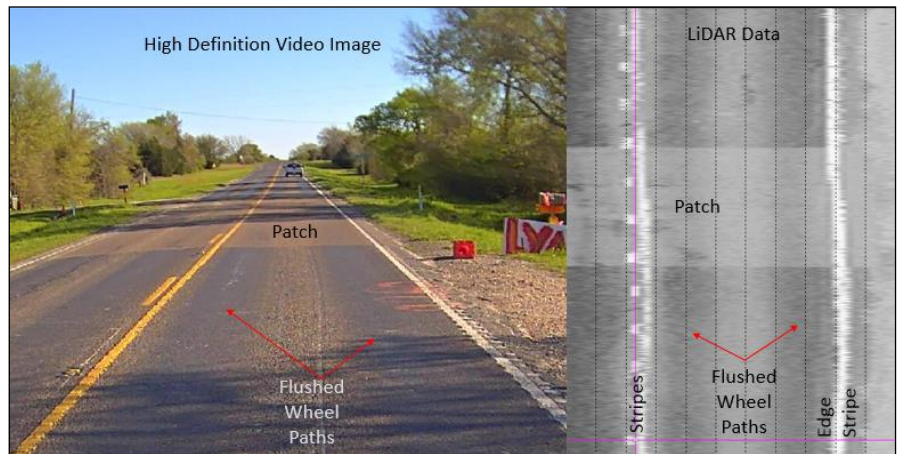
Figure 1. High-Definition Video Image and LiDAR Data.

- The HDV system is an excellent tool for documenting the surface condition and is ready for implementation.

- The LiDAR system shows much promise to remove a significant amount of subjectivity when determining variations in surface conditions. Additional work is needed so that this technology can be automated to identify surface conditions and suggest rate changes, thus reducing labor hours and improving efficiency. With automation, the methods developed using mobile LiDAR can be deployed shortly before actual construction, making decisions more real time. More real-time decisions will ultimately lead to better performance.

Figure 1 shows examples of these systems.
