MASH TEST 3-11 EVALUATION OF TXDOT W-BEAM GUARDRAIL WITH 7½-INCH DIAMETER ROUND WOOD POSTS IN CONCRETE MOW STRIP

Test Report 0-6968-R2

Cooperative Research Program

TEXAS A&M TRANSPORTATION INSTITUTE

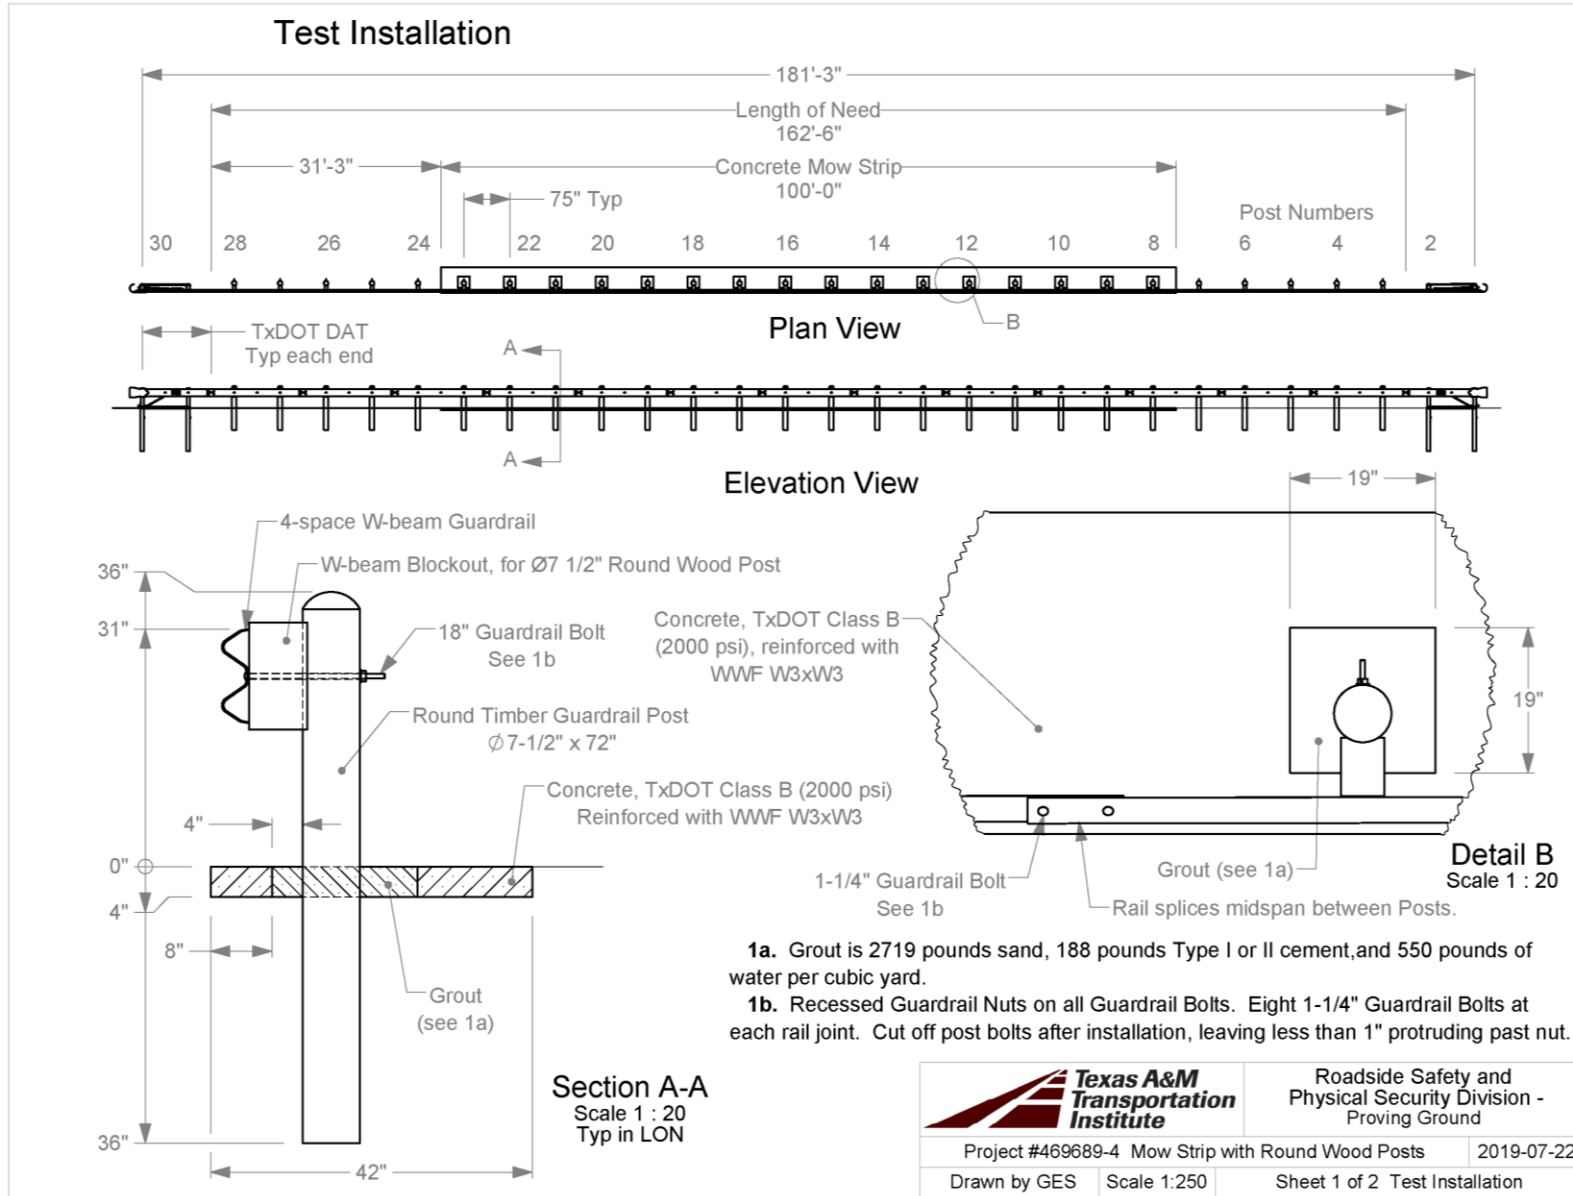
Figure 2.1. Overall Details of TxDOT W-Beam Guardrail with 7 1/2-Inch Diameter Round Wood Posts in Concrete Mow Strip.

The TxDOT W-beam guardrail with 7½-inch diameter round wood posts in concrete mow strip had a total length of 181 ft-3 inches. This consisted of 162 ft-6 inches of 12-gauge W-beam guardrail attached to 7½ inch diameter wood posts with a TxDOT downstream anchor terminal (DAT) [GF (31) DAT-14] on each end. The top of the rail was located 31 inches above grade, the posts were spaced 75 inches center-to-center, and the guardrail splices were located mid-span between every other post. Standard 12-gauge W-beam guardrail (type RWM04a) was used in the system. Each TxDOT GF (31) DAT-14 terminal was 9 ft-4½ inches long as measured from their anchor posts to the W-beam splice between posts 2 and 3 and posts 28 and 29, respectively.

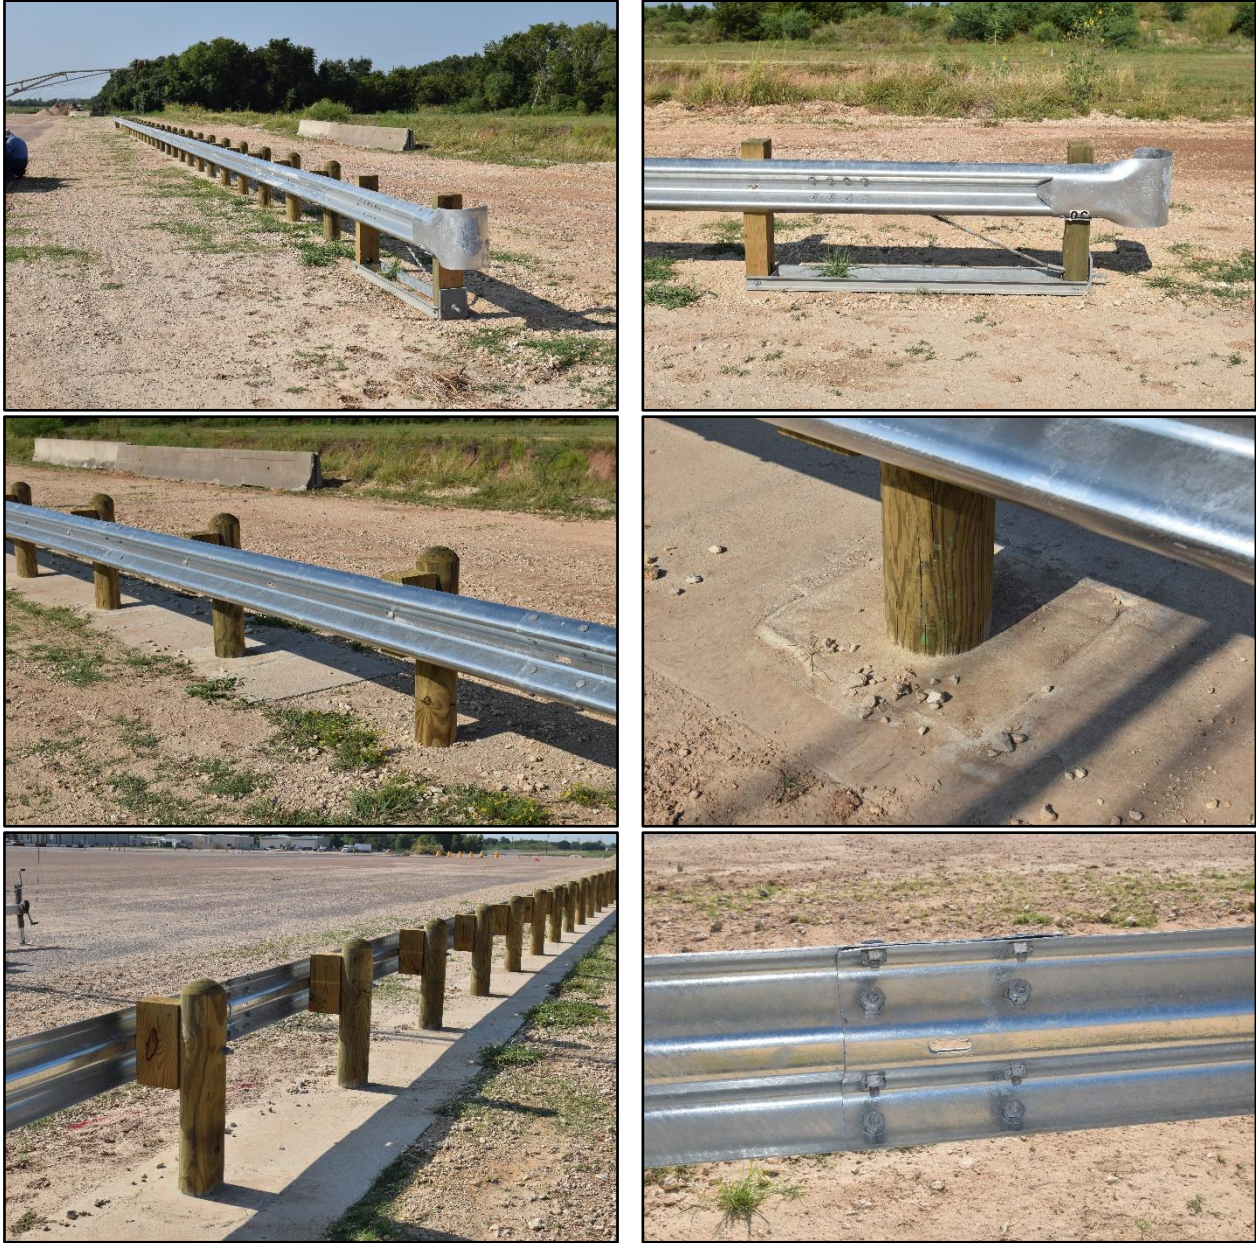
Figure 2.2. TxDOT W-Beam Guardrail with 7½-inch Diameter Round Wood Posts in Concrete Mow Strip prior to Testing.

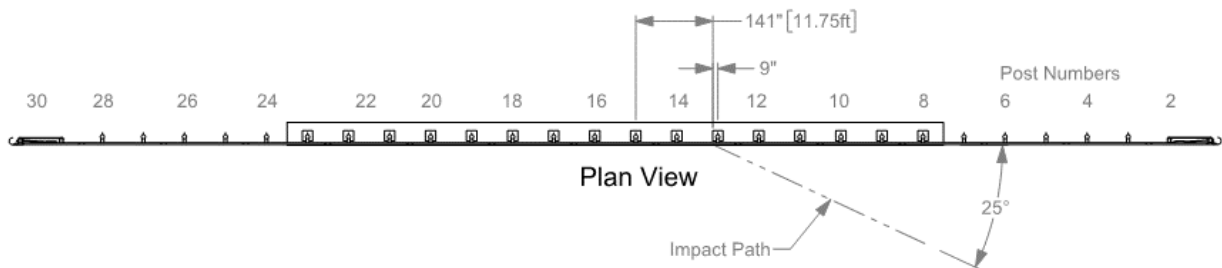
Figure 3.1. Target CIP for *MASH* Test 3-11 on the TxDOT W-Beam Guardrail with 7½-inch Diameter Round Wood Posts in Concrete Mow Strip.

Table 3.1 shows the test conditions and evaluation criteria for *MASH* TL-3 for longitudinal barriers. *MASH* Test 3-11 involves a 2270P vehicle weighing 5000 lb \pm 110 lb and impacting the critical impact point (CIP) of the TxDOT W-beam guardrail with 7½-inch diameter round wood posts in concrete mow strip at an impact speed of 62 mi/h \pm 2.5 mi/h and an angle of 25° \pm 1.5°. The target CIP, shown in Figure 3.1, was determined using the information provided in *MASH* Section 2.2.1, Section 2.3.2, and Figure 2-1. The target CIP was 11.75 ft upstream of the center of post 15 (equivalent to 9 inches downstream of the center of post 13).

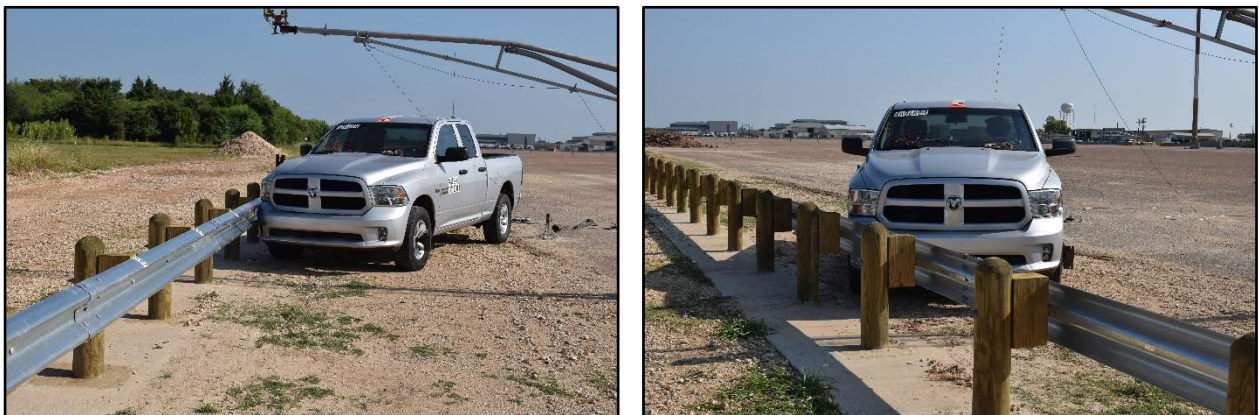
Figure 5.1. Test Installation/Test Vehicle Geometrics for Test No. 469689-4-1.

Figures 5.1 and 5.2 show the 2013 RAM 1500 pickup truck used for the crash test. The vehicle's test inertia weight was 5017 lb, and its gross static weight was 5017 lb. The height to the lower edge of the vehicle bumper was 11.75 inches, and height to the upper edge of the bumper was 27.0 inches. The height to the vehicle's center of gravity was 28.0 inches. Tables D.1 and D.2 in Appendix D1 give additional dimensions and information on the vehicle. It was directed into the installation using the cable reverse tow and guidance system, and was released to be freewheeling and unrestrained just prior to impact.

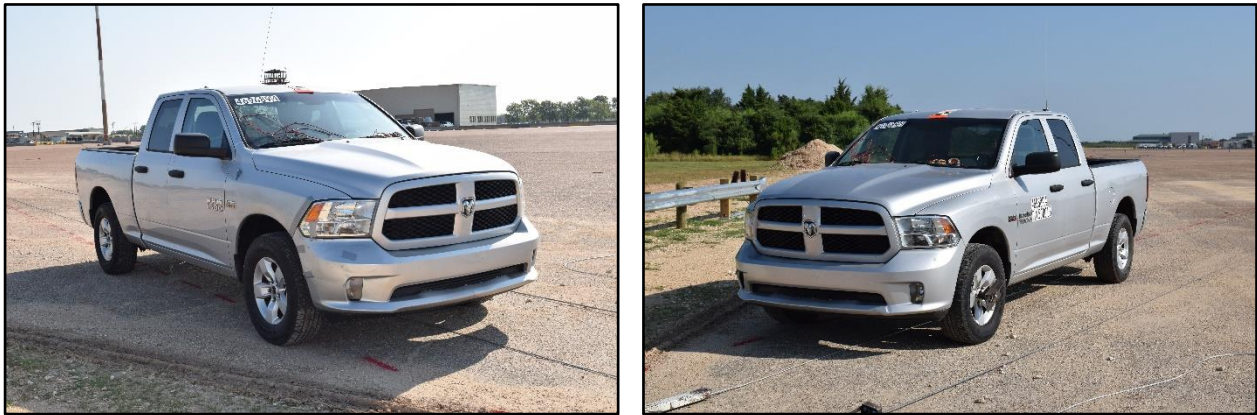
Figure 5.2. Test Vehicle before Test No. 469689-4-1.

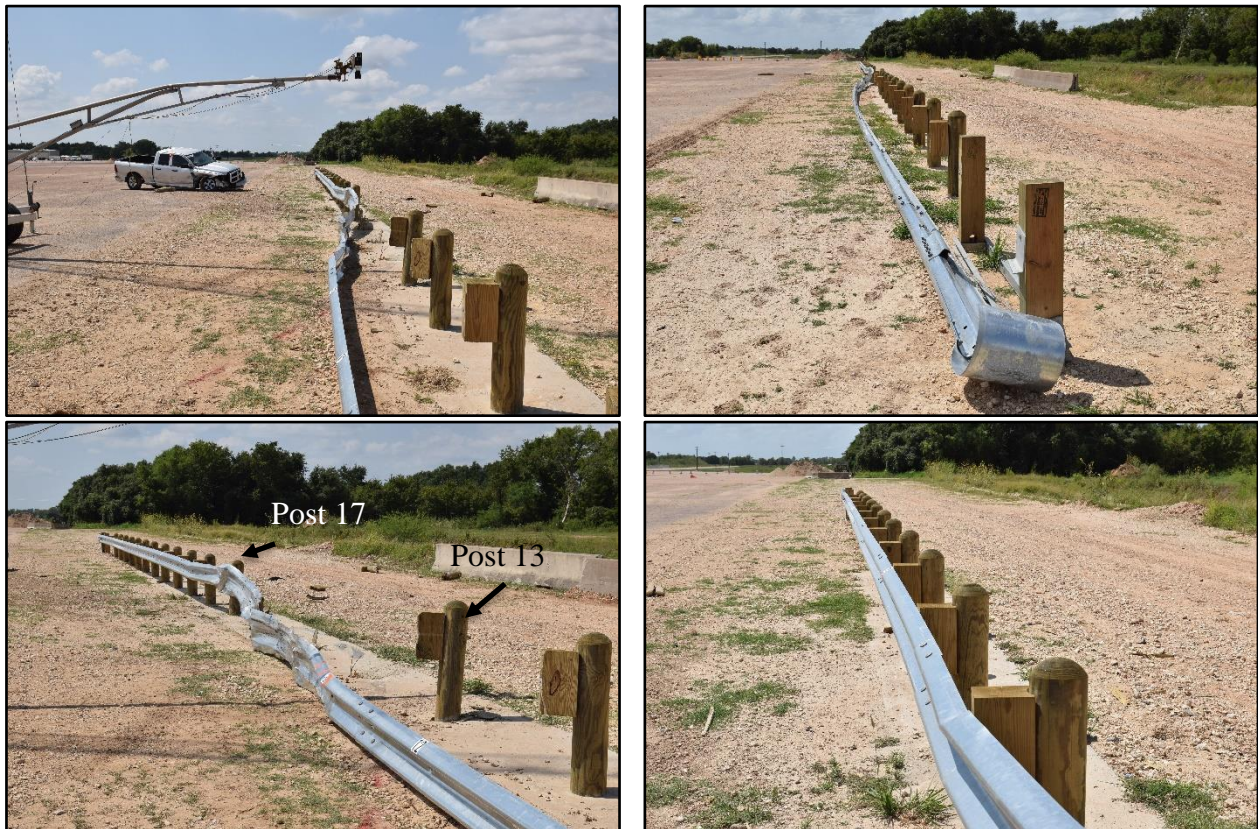
Figure 5.3. TxDOT W-Beam Guardrail with 7½-inch Diameter Round Wood Posts in Concrete Mow Strip after Test No. 469689-4-1.

Figures 5.3 and 5.4 show the damage to the TxDOT W-beam guardrail with 7½-inch diameter round wood posts in concrete mow strip. The rail released from posts 1 through 16, and 18. There was a ¾-inch gap in the soil on the upstream side of post 1, and ½-inch gaps on the downstream side of posts 1 and 2. The blockouts rotated clockwise at posts 3 through 11. The blockout rotated clockwise and cracked at post 12. Post 13 had 1½-inch gaps in the grout on the traffic side and ½-inch on the field side, and it was leaning toward the field side at 86°. Post 14 broke off at grade, and the grout cracked near the post. Post 15 also broke off at grade, and had a 2½-inch gap in the grout on the traffic and field sides. Post 16 fractured and broke off at 6 inches above grade, and had a 2-inch gap in the grout on the traffic side and a 4-inch gap on the field side. There was a 1-inch gap in the grout on the traffic side and a 2-inch gap on the field side of post 17, it was leaning back at 83°, and the blockout was broken and detached. There was no apparent damage or post movement from posts 19 through 30. Working width* was 50.9 inches, and height of working width was 54.4 inches. Maximum dynamic deflection during the test was 43.4 inches.

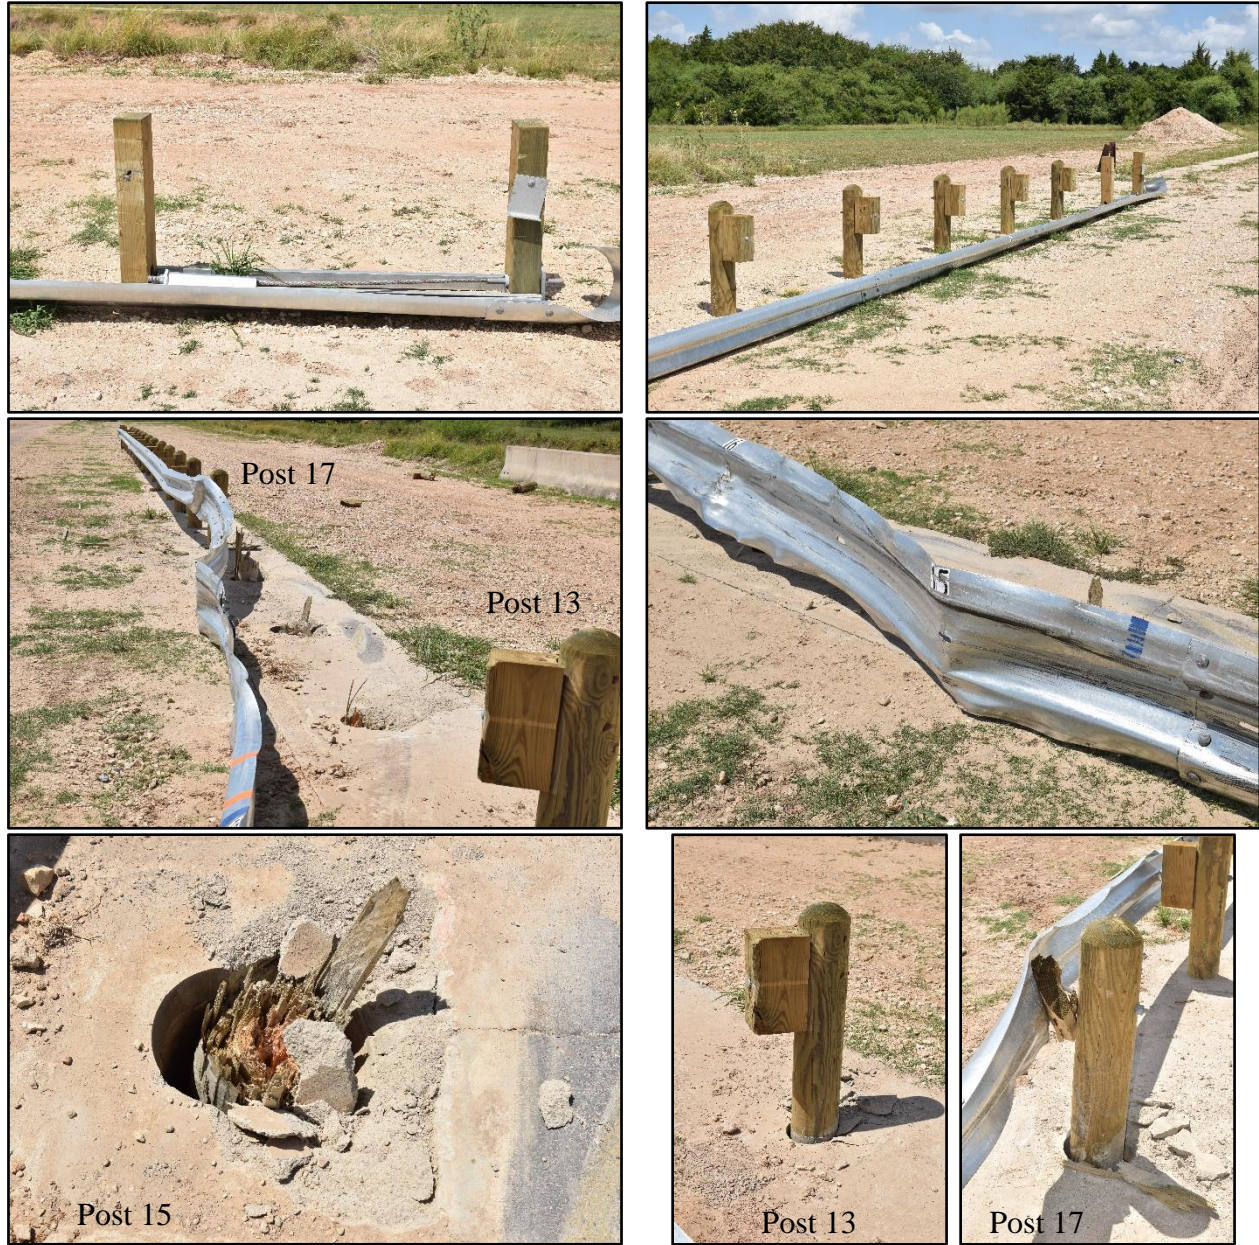
Figure 5.4. Damage to Installation after Test No. 469689-4-1.

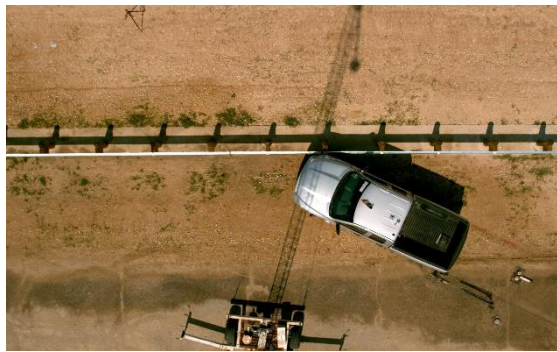
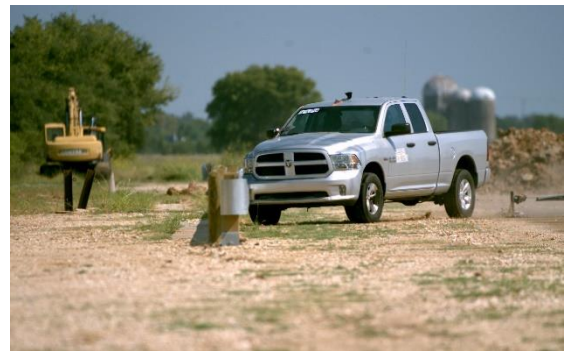
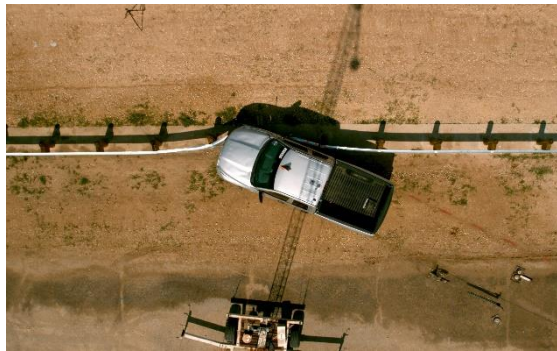
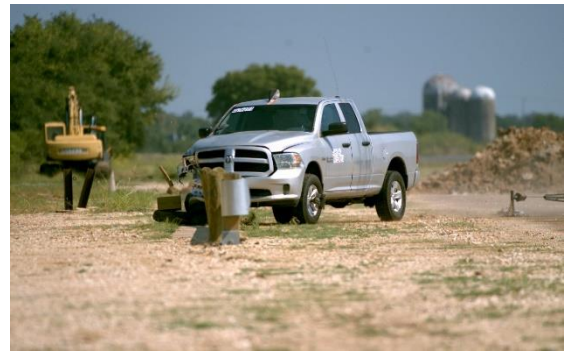
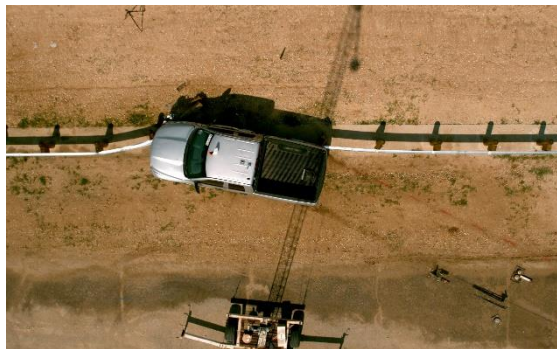
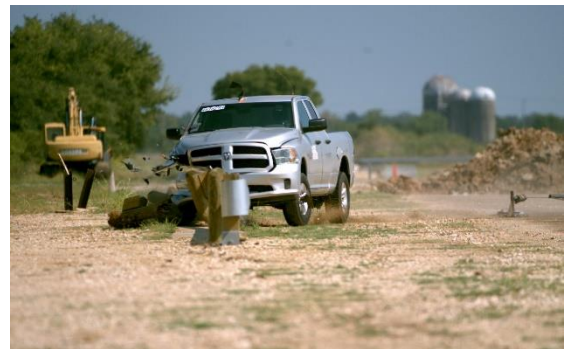
Figure D.1. Sequential Photographs for Test No. 469689-4-1 (Overhead and Frontal Views).

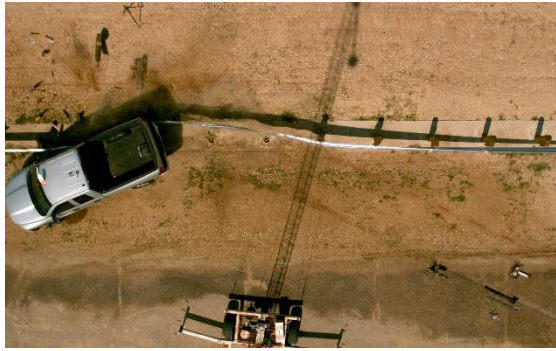
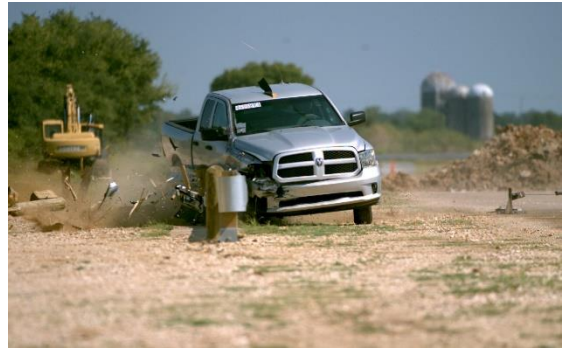
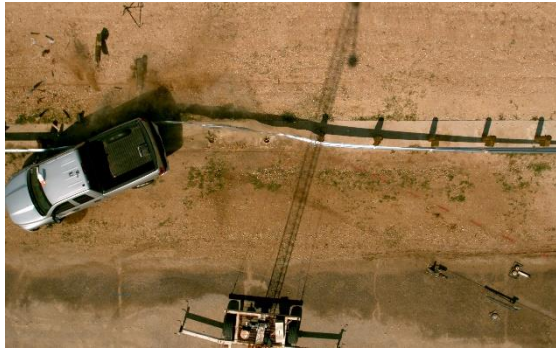
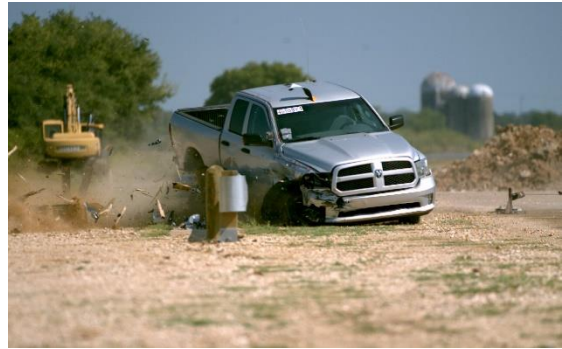
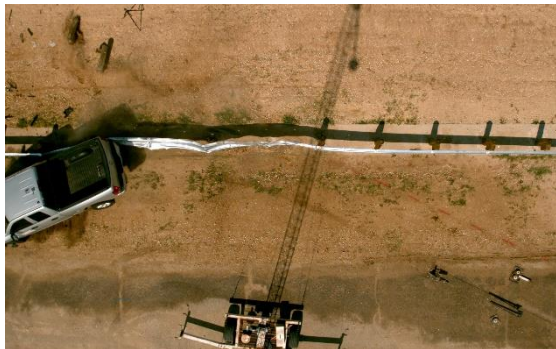
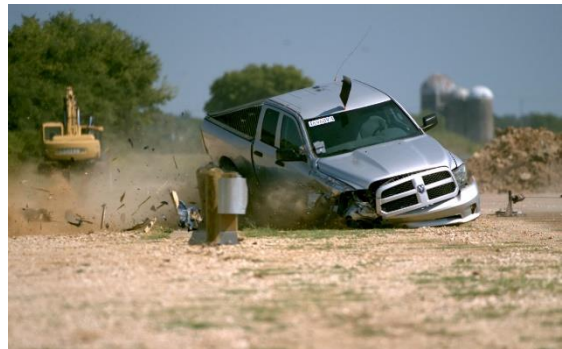
Figure D.1. Sequential Photographs for Test No. 469689-4-1 (Overhead and Frontal Views) (Continued).

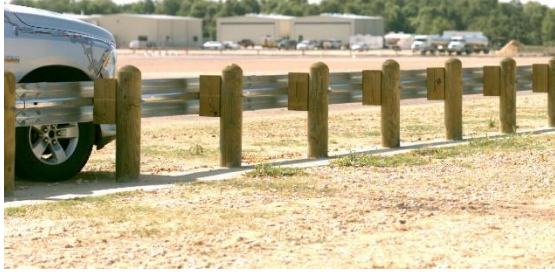
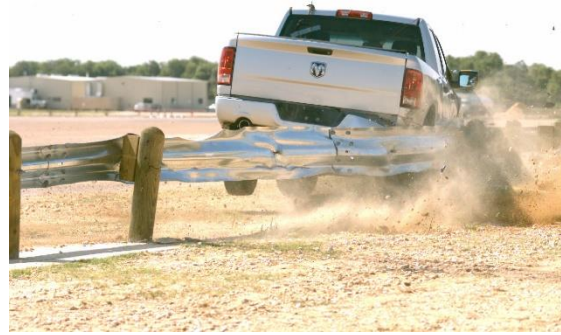
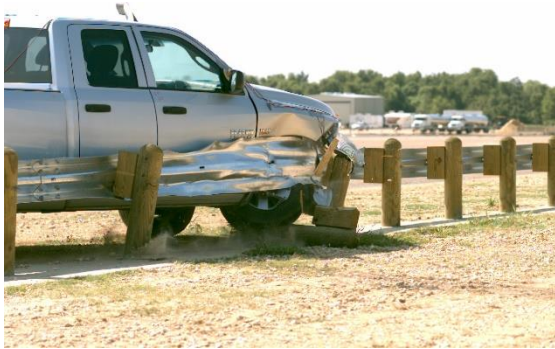
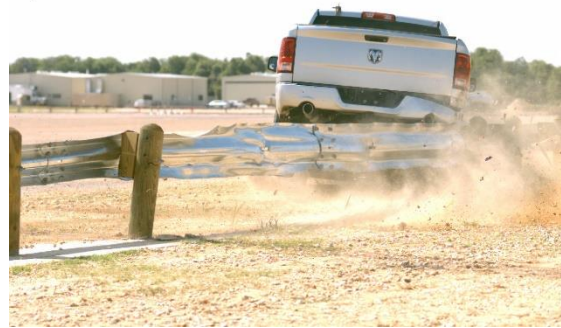
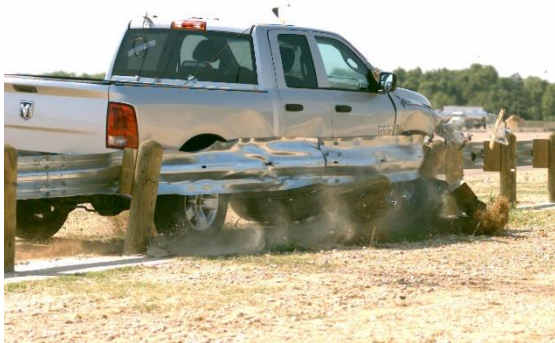
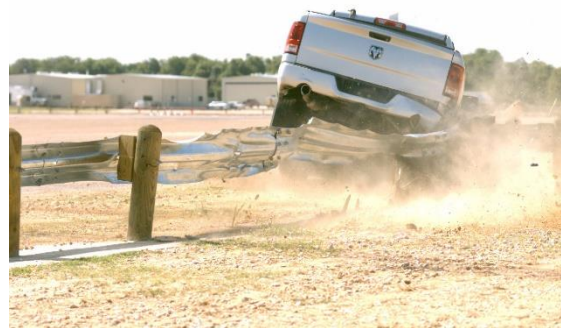
Figure D.2. Sequential Photographs for Test No. 469689-4-1 (Rear View).

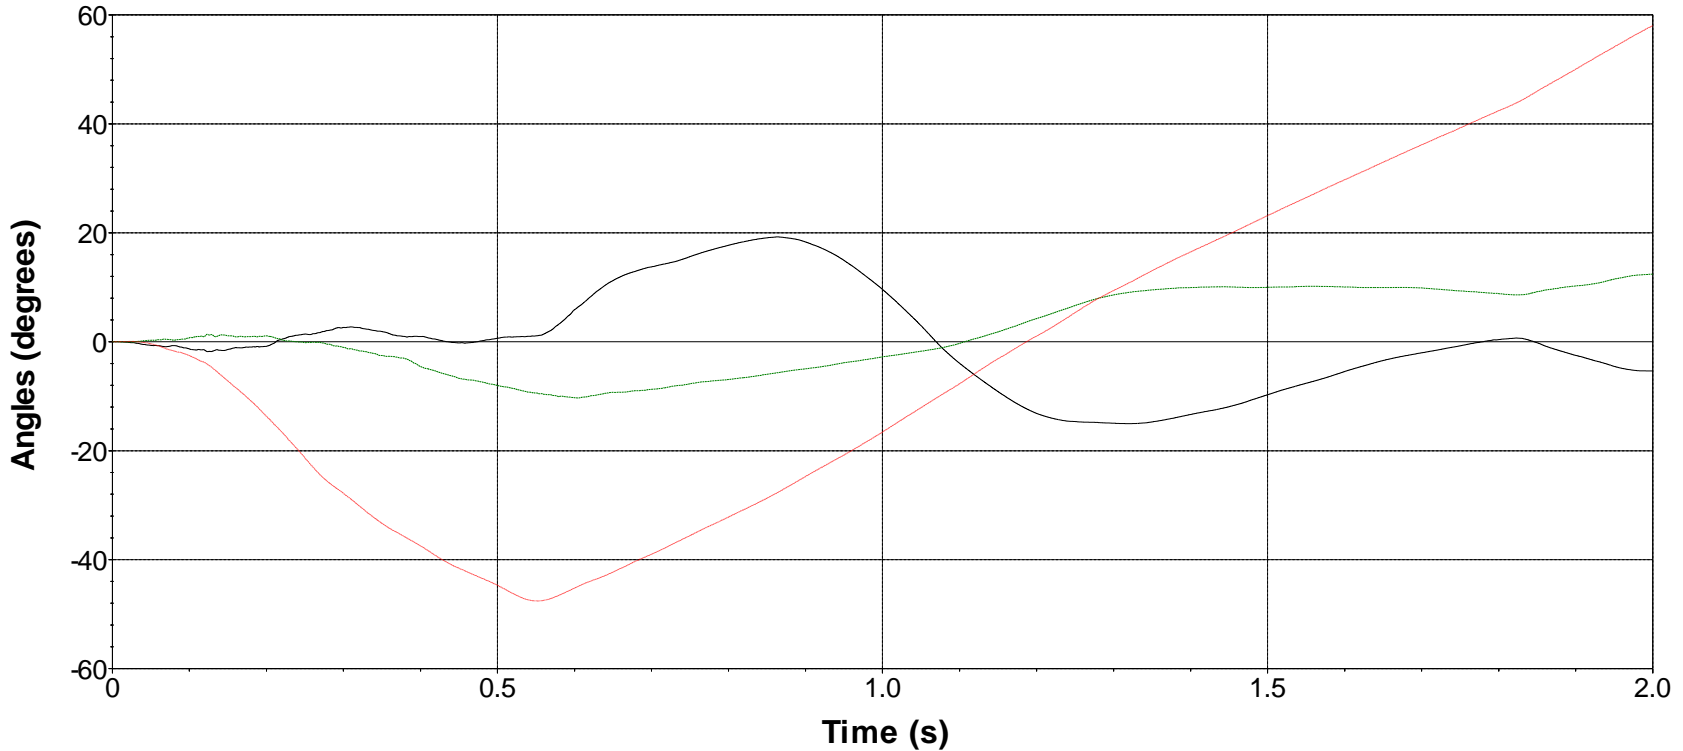
Roll, Pitch, and Yaw Angles

- Sequence for determining orientation:
1. Yaw.
 2. Pitch.
 3. Roll.

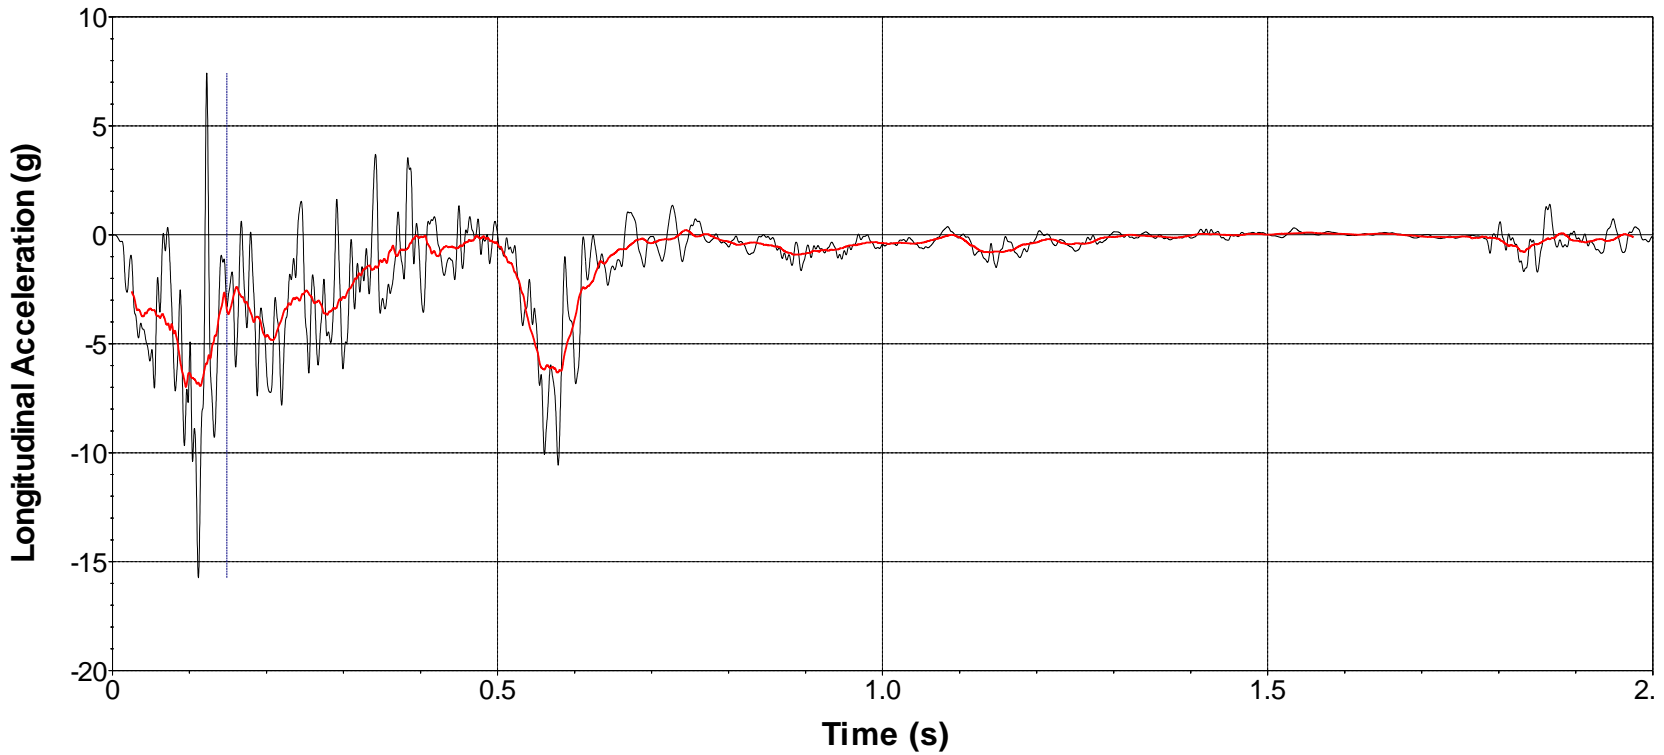
— Time of OIV (0.1485 sec) — SAE Class 60 Filter — 50-msec average

**Figure D.4. Vehicle Longitudinal Accelerometer Trace for Test No. 469689-4-1
(Accelerometer Located at Center of Gravity).**

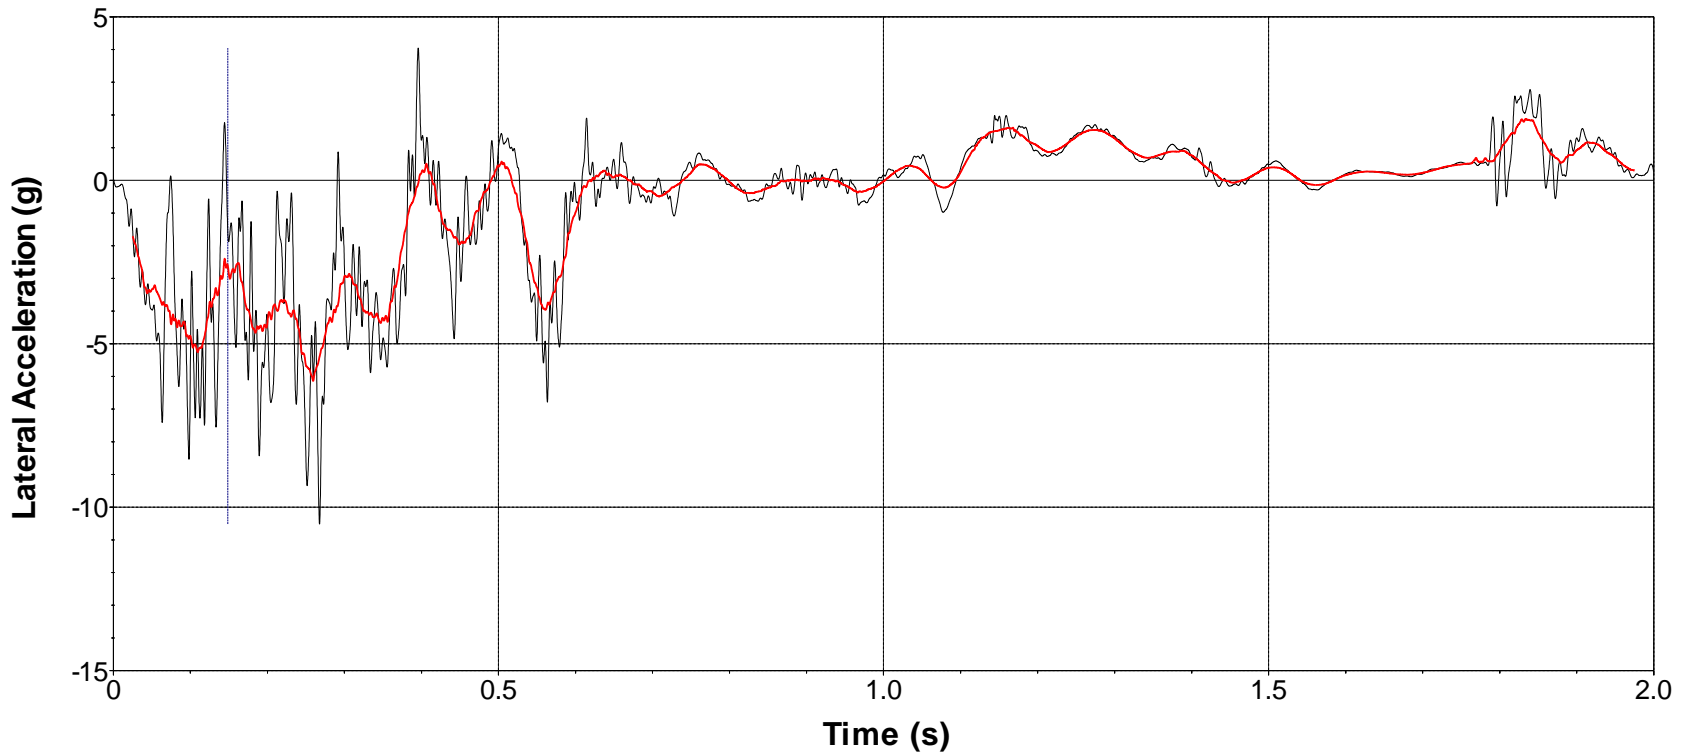
Time of OIV (0.1485 sec) SAE Class 60 Filter 50-msec average

Figure D.5. Vehicle Lateral Accelerometer Trace for Test No. 469689-4-1 (Accelerometer Located at Center of Gravity).

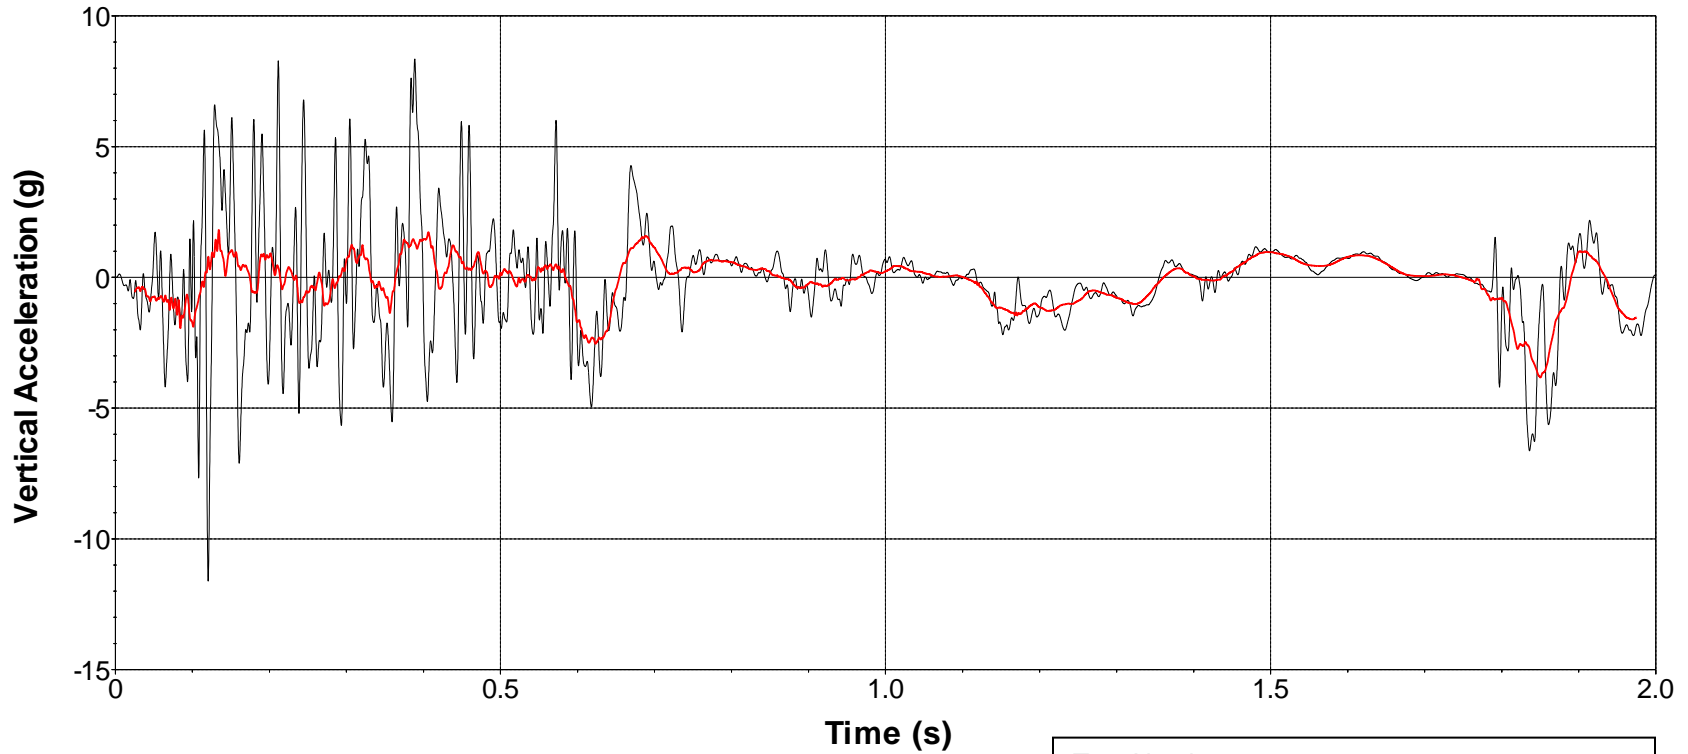
Z Acceleration at CG

— SAE Class 60 Filter — 50-msec average
