DEVELOPMENT OF *MASH* TL-3 TRANSITIONS FOR CAST IN PLACE CONCRETE BARRIERS

Test Report 0-6968-R8

TEXAS A&M TRANSPORTATION INSTITUTE

TEXAS DEPARTMENT OF TRANSPORTATION

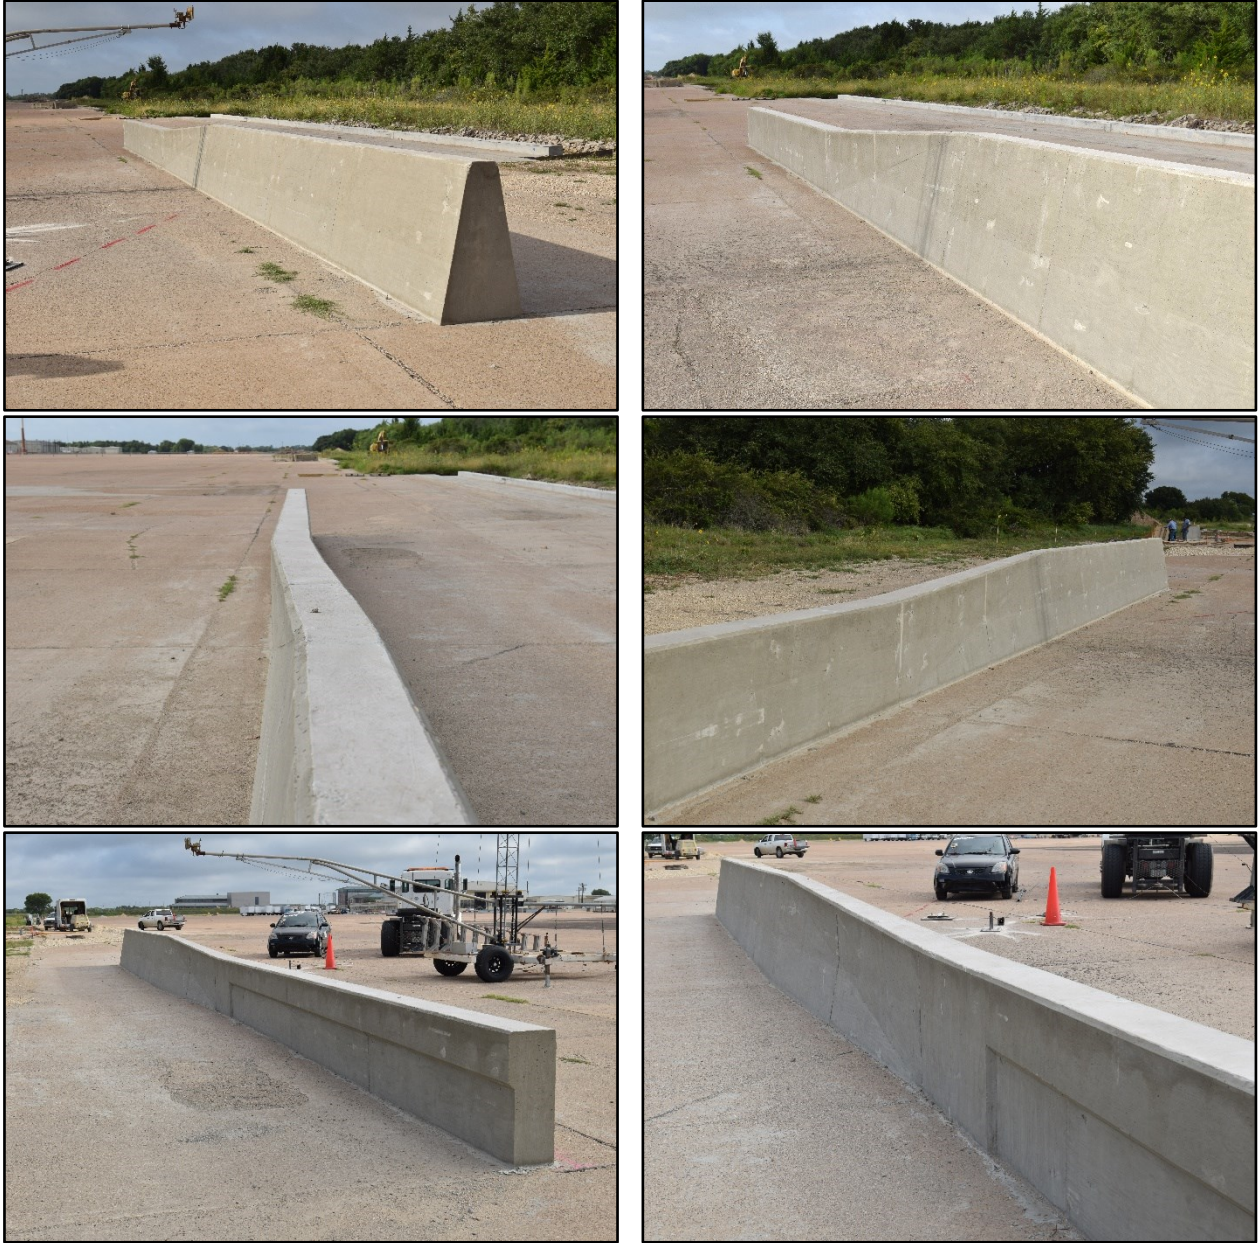
Figure 3.2. T221 Vertical Wall to SSCB Transition Prior to Testing.

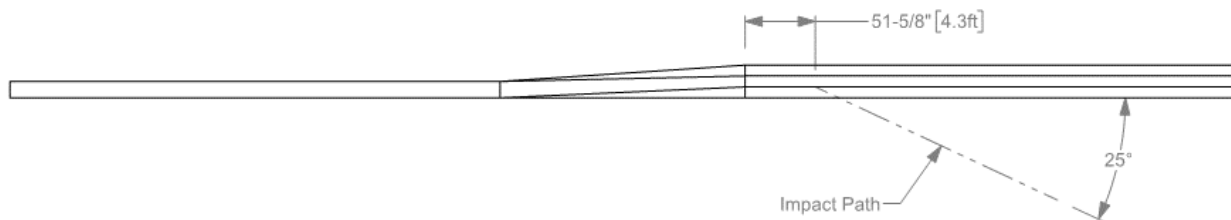
Figure 4.2. Target CIP for *MASH* Test 3-21 on the T221 Vertical Wall to SSCB Transition.

Table 4.1 shows the test conditions and evaluation criteria for *MASH* TL-3 for transitions. The critical impact point (CIP) for each test was determined using the information provided in *MASH* Section 2.3.2 and *MASH* Figure 2-1. Figures 4.1 and 4.2 show the target CIPs for each test. The crash tests and data analysis procedures were in accordance with guidelines presented in *MASH*. Chapter 5 presents brief descriptions of these procedures.

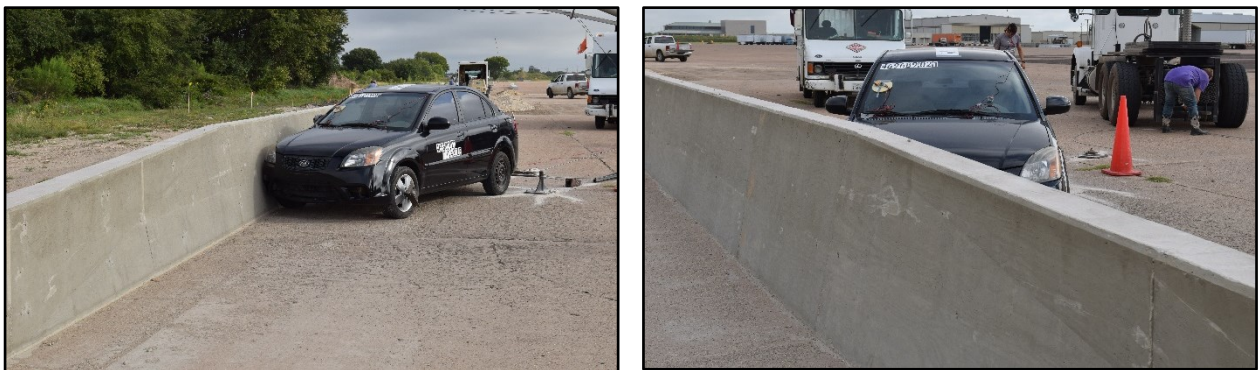
Figure 6.1. Transition and Test Vehicle Geometrics for Test No. 469689-2-1.

Figures 6.1 and 6.2 show the 2011 Kia Rio used for the crash test. The vehicle's test inertia weight was 2416 lb, and its gross static weight was 2581 lb. The height to the lower edge of the vehicle bumper was 7.75 inches, and height to the upper edge of the bumper was 21.5 inches. Table C.1 and in Appendix C.1 gives additional dimensions and information on the vehicle. The vehicle was directed into the installation using a cable reverse tow and guidance system, and was released to be freewheeling and unrestrained just prior to impact.

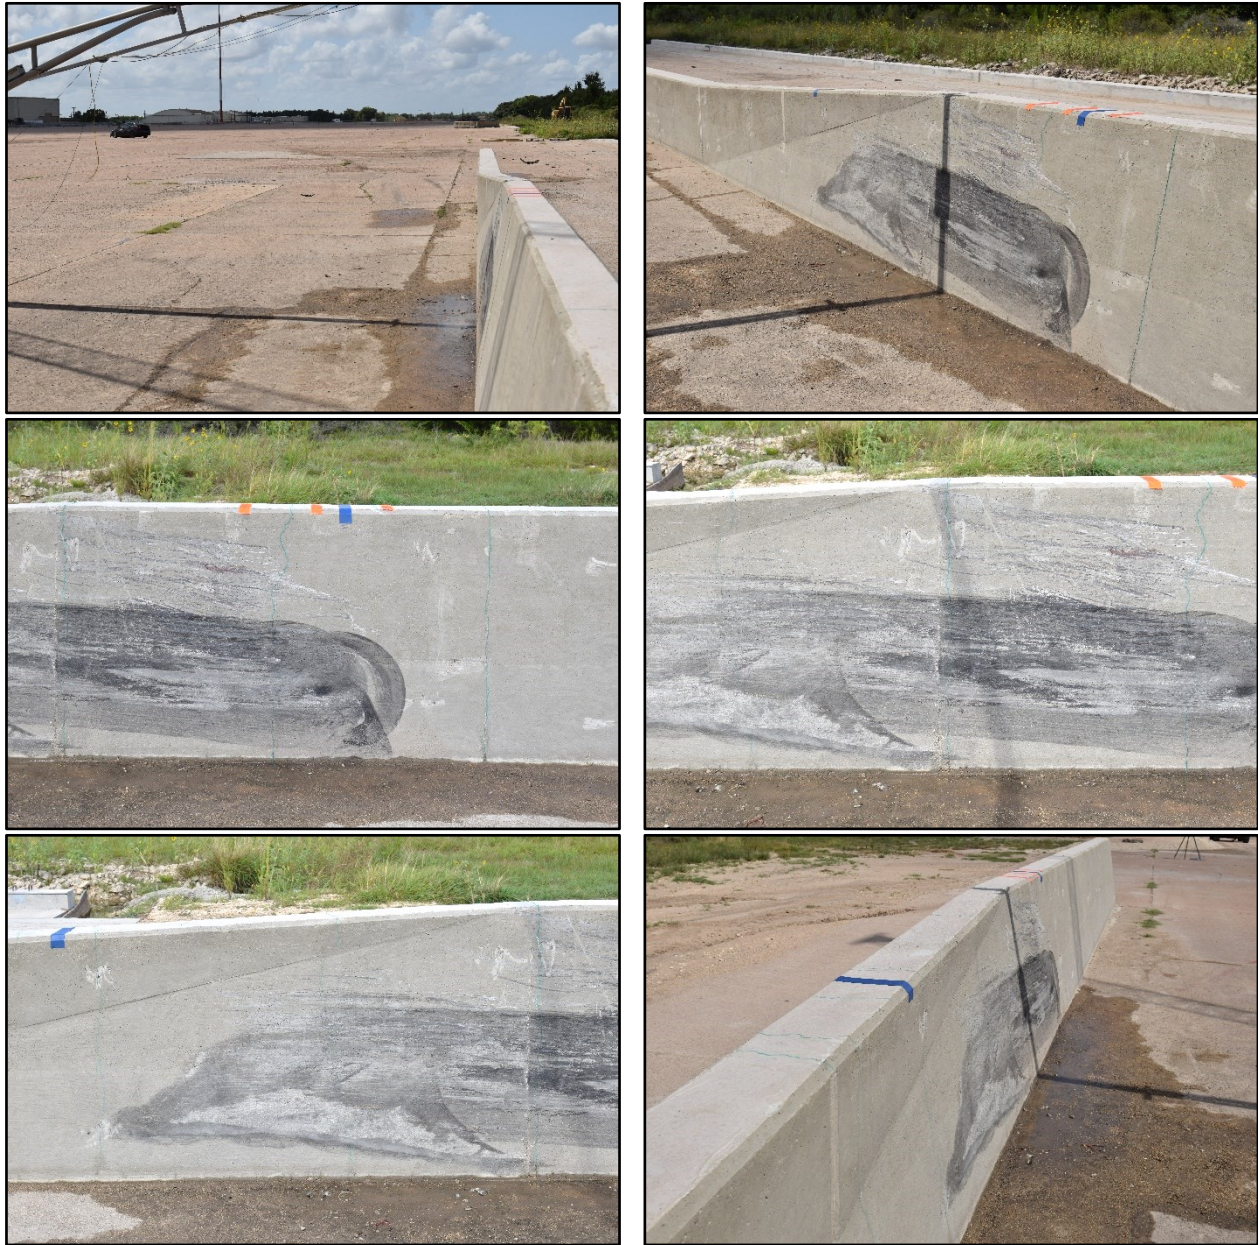
Figure 6.3 shows the damage to the T221 vertical wall to SSCB transition. The SSCB barrier and the transition sustained cosmetic damage only. Working width* was 24.0 inches. The height of the working width was 0.0 inch. No dynamic deflection or permanent deformation of the barrier or the transition were observed.

Figure 6.3. T221 vertical wall to SSCB transition after Test No. 469689-2-1.

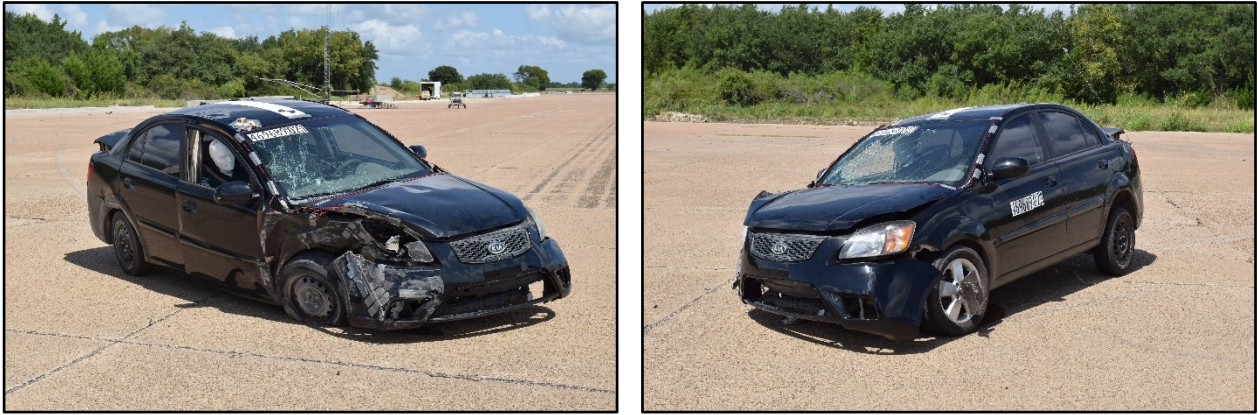
Figure 6.4 shows the damage sustained by the vehicle. The front bumper, hood, right front fender, right strut and tower, right front tire and rim, right front door and window glass, right rear door right rear rim, right rear exterior bed, and rear bumper were damaged. The windshield sustained stress cracks radiating up and out from the right A-post. Maximum exterior crush to the vehicle was 8.0 inches in the front and side planes at the right front corner at bumper height. Maximum occupant compartment deformation was 3.5 inches in the right front floor pan. Figure 6.5 shows the interior of the vehicle. Tables C.2 and C.3 in Appendix C.1 provide exterior crush and occupant compartment measurements.

Figure 6.4. Test Vehicle after Test No. 469689-2-1.

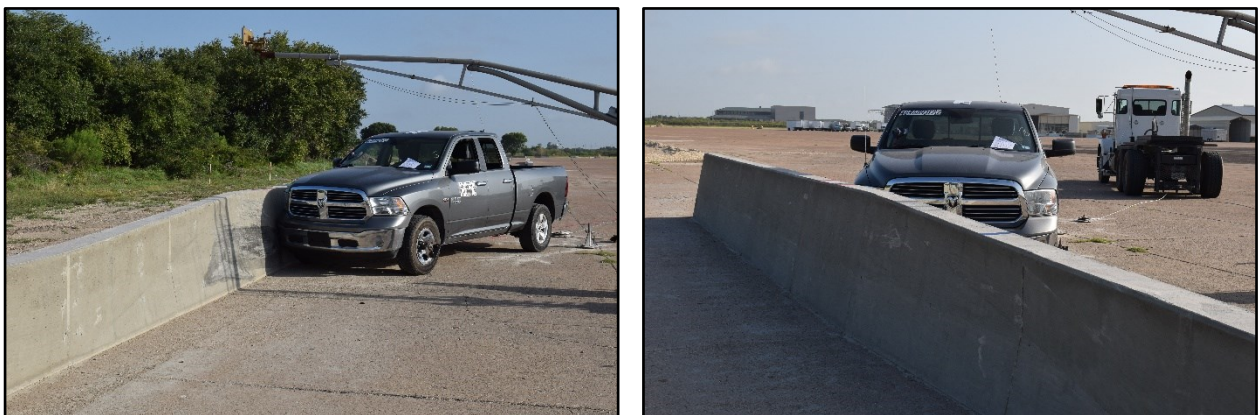
Figure 7.1. Transition and Test Vehicle Geometries for Test No. 469689-2-2.

Figures 7.1 and 7.2 show the 2013 Dodge RAM 1500 pickup truck used for the crash test. The vehicle's test inertia weight was 5035 lb and its gross static weight was 5035 lb. The height to the lower edge of the vehicle bumper was 11.75 inches, and the height to the upper edge of the bumper was 27.0 inches. The height to the vehicle's center of gravity was 28.4 inches. Tables D.1 and D.2 in Appendix D.1 give additional dimensions and information on the vehicle. The vehicle was directed into the installation using the cable reverse tow and guidance system, and was released to be freewheeling and unrestrained just prior to impact.

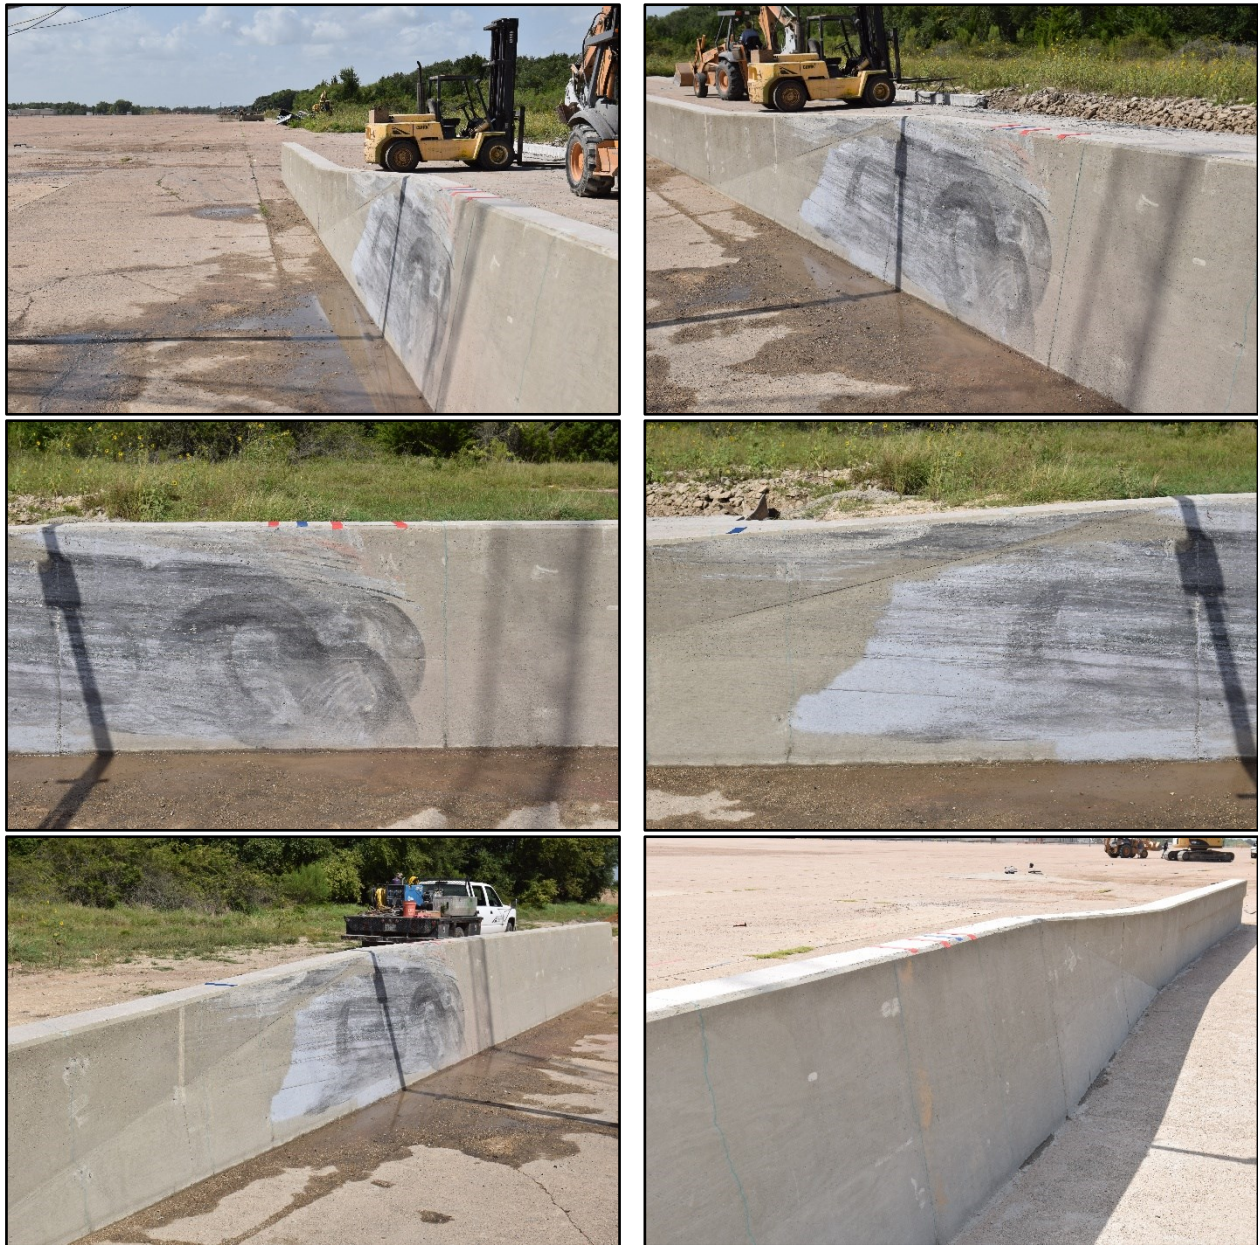
Figure 7.3 shows the damage to the T221 vertical wall to SSCB transition. The barrier sustained cosmetic damage only. Working width* was 24.0 inches. The height of the working width was 0.0 inch. No dynamic deflection or permanent deformation were observed.

Figure 7.3. Transition after Test No. 469689-2-2.
