Traffic Control Device Analysis, Testing, and Evaluation Program: FY2019 Activities

Technical Report 0-6969-R2

TEXAS A&M TRANSPORTATION INSTITUTE
COLLEGE STATION, TEXAS

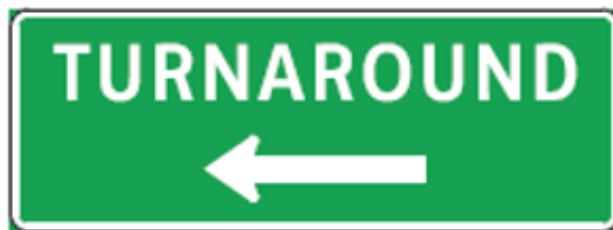
Figure 5. TURNAROUND Sign.

D13-1TL-(R)¶

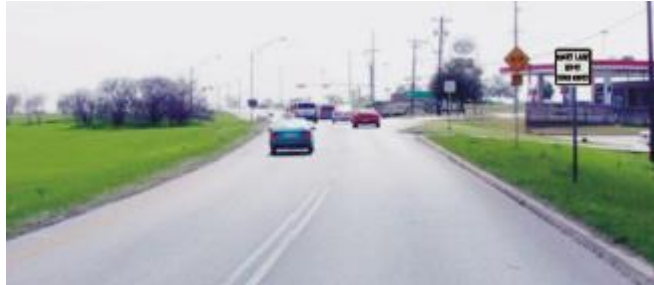
<p style="text-align: center;">Scenario 1</p>	<p>Scenario 1—RIGHT LANES MUST TURN RIGHT sign post-mounted on the right side of the road.</p>

For Scenario 1, most participants thought there would be two lanes at the intersection. For those that thought more than two lanes would be at the intersection, most assumed a right-turn lane would be added. After more discussion, all of the participants agreed that with the information provided, there was no way of knowing how many lanes were at the intersection.

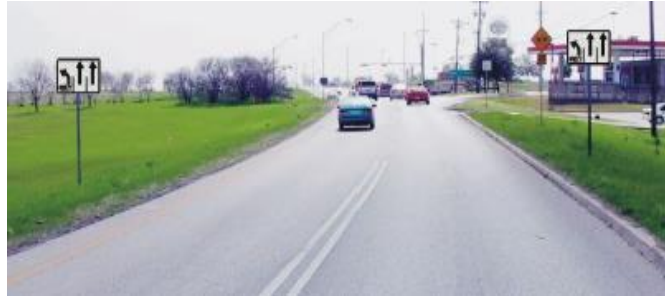
<p style="text-align: center;">Scenario 2</p>	<p>Scenario 2—Symbol (arrow) R3-8 signs with vertical line separators and ONLY post-mounted on both sides of the road.</p>

For Scenario 2, all of the participants thought there would be three lanes at the intersection, although there was some discrepancy about whether the lane would be added to the left or right. Participants preferred signs on both sides of the roadway. Many participants also commented on the benefits of the small vertical separator lines.

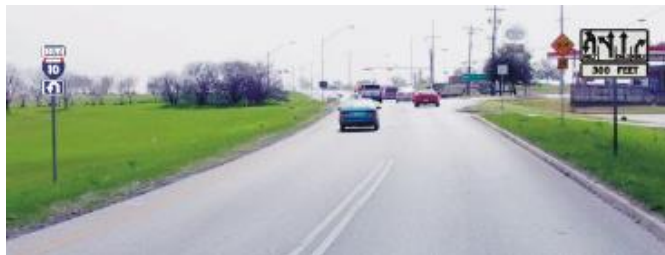
<p style="text-align: center;">Scenario 3</p>	<p>Scenario 3—Symbol (arrow) R3-8 sign with vertical line separators, ONLY, and supplemental distance plaque post-mounted on the right side of the road and route sign with supplemental U-turn arrow (M5-3T) post-mounted on the left side of the road.</p>

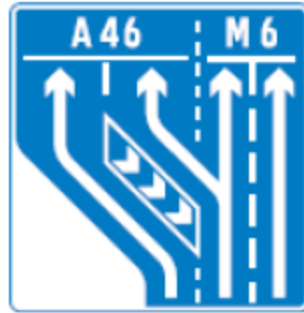
Figure 11. International Lane Assignment Signs for Flared Approaches (12).

In 2010, TTI completed a research project that investigated how best to sign approaches to diamond interchanges (12). Researchers identified international practices of lane assignment with signs and pavement markings from Australia, New Zealand, the United Kingdom, and Germany. Researchers found a common theme among several of the countries of using trap lane signs, which use arrows to illustrate through, shared, and turn-only movements for flared approaches. Figure 11 contains examples of international lane assignment signs.

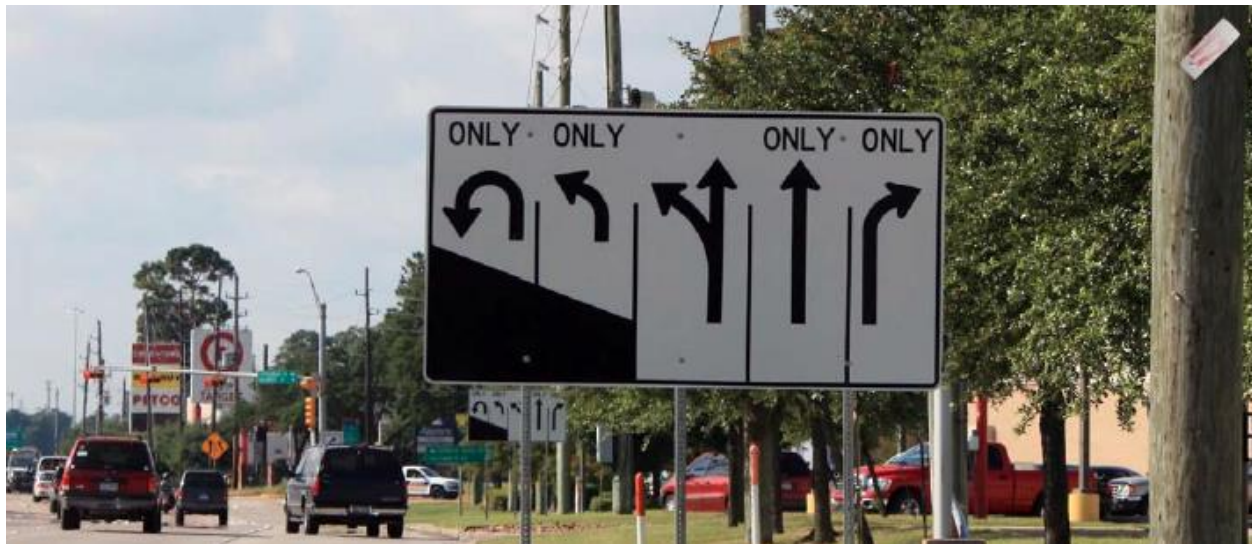
Figure 12. Close-Up of Alternative Advance Intersection Lane Control Sign (12).

Based on international practices and the results of the surveys and focus groups, researchers developed an alternative advance intersection lane assignment sign (see Figure 12). This sign was installed and evaluated on a frontage road approach to a signalized intersection where the frontage road flared out to include additional lanes at the intersection (see Figure 13). The alternative advance intersection lane control signs included lane addition tapers (black area on sign in Figure 12). One set of alternative advance intersection lane control signs was installed approximately 635 ft prior to the stop line at the intersection (i.e., point where the three-lane roadway widened to four lanes). A third alternative advance intersection lane control sign was installed on the right side of the roadway approximately 1135 ft prior to the stop line (i.e., in the three-lane roadway section).

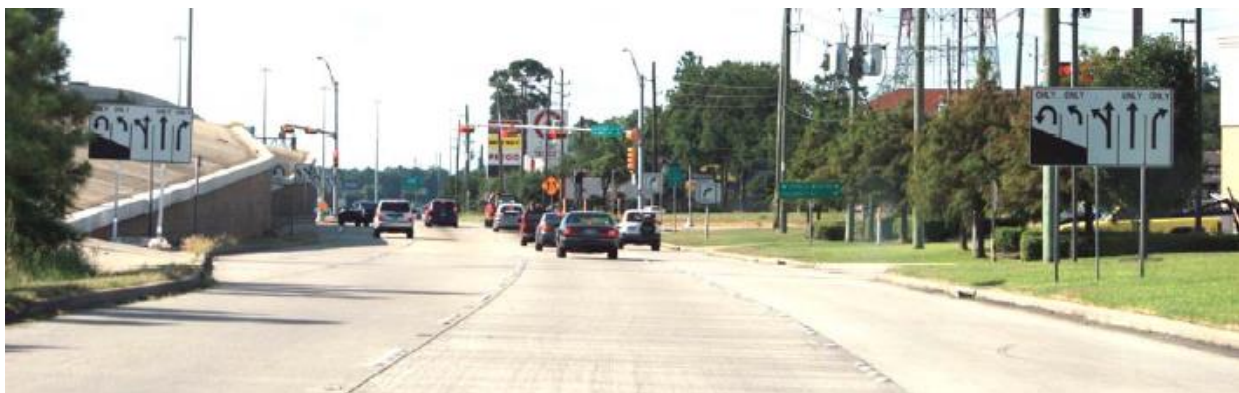
Figure 13. Set of Alternative Advanced Intersection Lane Control Signs at IH-45 Southbound at Cypresswood Drive in Houston (12).

Field study findings revealed only a slight reduction in the number of illegal movements at the intersection. In addition, the number of lane changes nearest the intersection remained relatively the same. However, the total number of lane changes in the entire area of interest (from the stop line at the intersection to 1635 ft upstream of the stop line) decreased, leading researchers to assume that drivers were making lane changes farther upstream (outside of the data collection area).

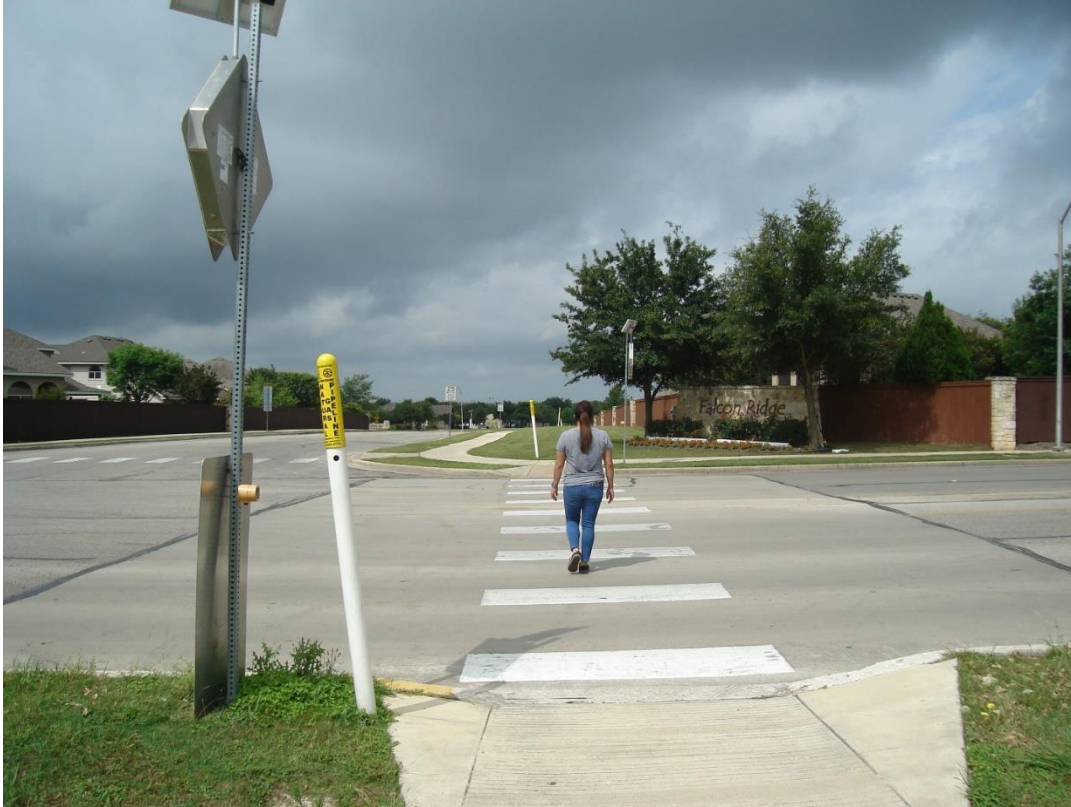
Figure 18. View from the Camera Position at a Site in Cibolo, Texas.

The researchers recorded the activity at each pedestrian crossing site utilizing video camcorders and pole-mounting hardware. The cameras were arranged to capture the crosswalk markings, the pedestrian crossings, and the LED-Em signs. Figure 18 shows an example of the camera positioning at a study site. Video data were not available for one of the sites in San Antonio (SA-01).

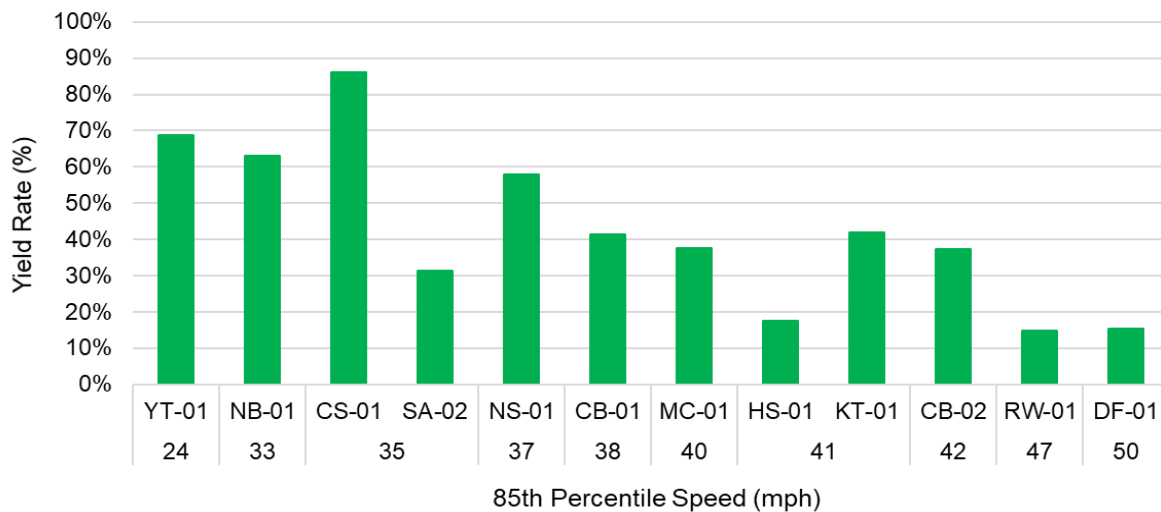
Figure 19. Driver Yield Rates by 85th Percentile Speed for Staged Crossings.

The graphs illustrate an inverse relationship between the yield rate percentage and speed. The main finding from this exploration is that seemingly, with higher operating speeds, the yield rates for the LED-Em signs decrease. Five of the sites had an active speed limit of 30 mph with a range of driver yielding between 86 and 31 percent, which implies that aside from speed, there are other factors contributing to the yield rate differences among sites.

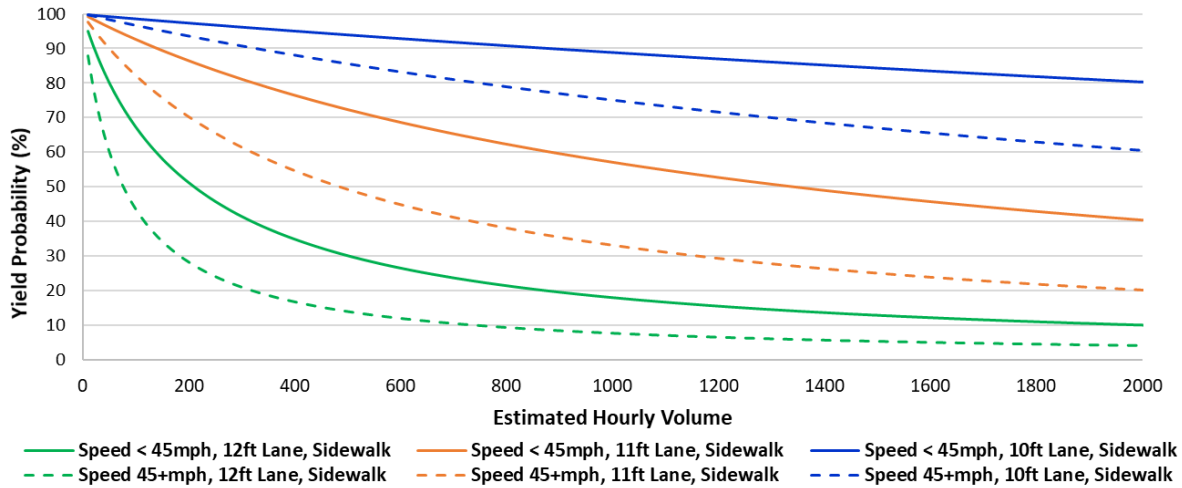
Figure 21. Yield Probability for Driver Yielding Based on Hourly Volume, Operational (85th Percentile) Speed, Lane Width, and Sidewalk Presence.

starts to level out for volumes of greater than 600 vehicles per hour, especially in the case of a combination of no sidewalks, 12-ft lanes, and 85th percentile speeds of 45 mph or greater.

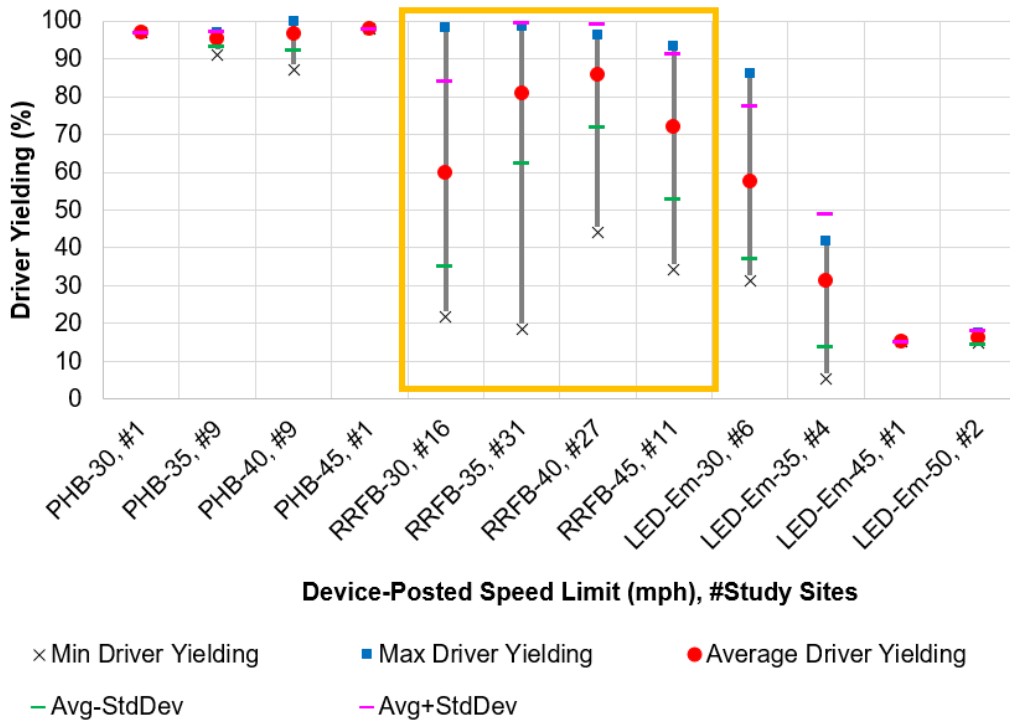
- A direct comparison is not possible for posted speed limits of 40 mph and 50 mph due to the lack of LED-Em sign sites with a posted speed limit of 40 mph and the lack of PHB and RRFB sites with a posted speed limit of 50 mph (see Figure 22b).

(a) Driver Yielding Statistics, Grouped by Type of Device

(b) Driver Yielding Statistics, Grouped by Posted Speed Limit

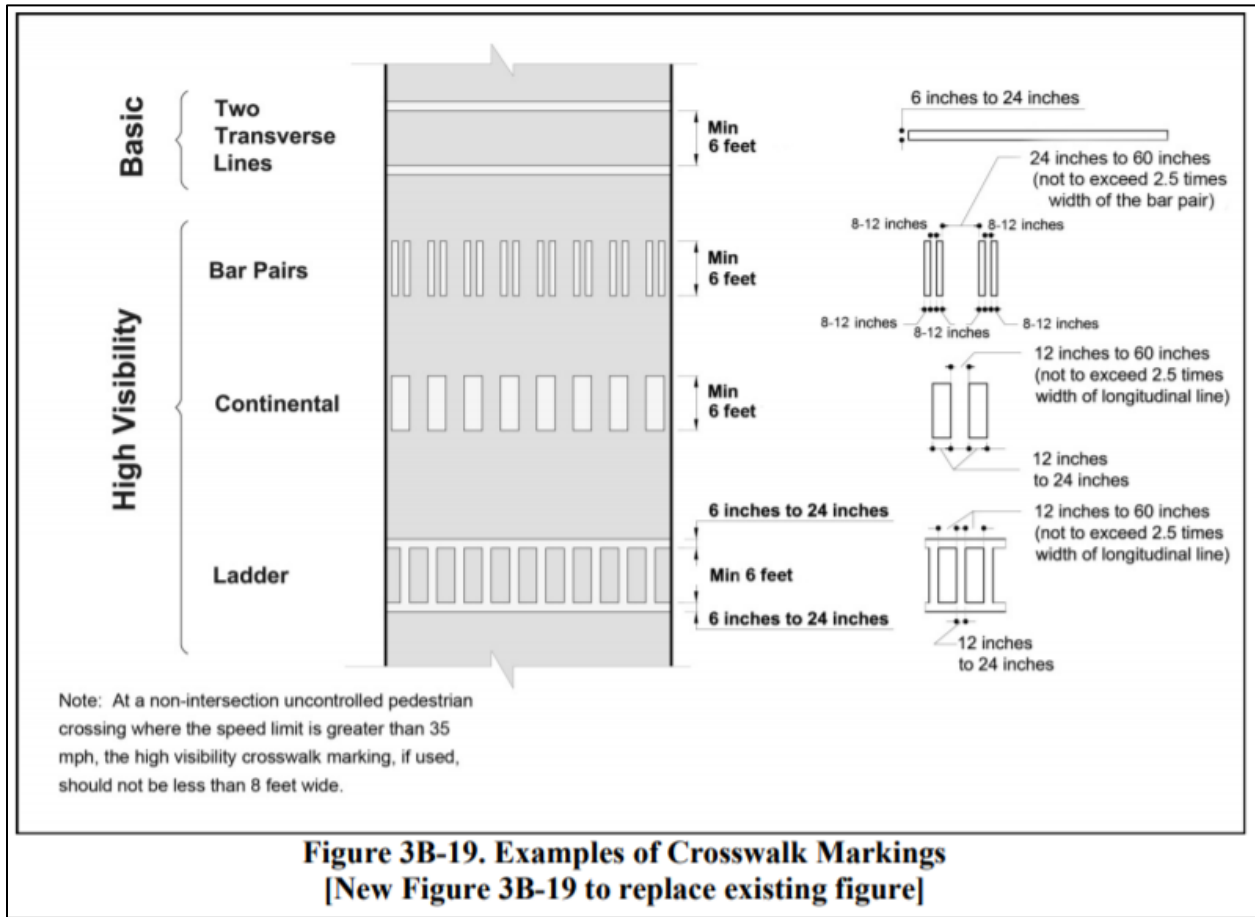
Figure 25. Proposed Figure for Next Edition of the MUTCD (50).

available on the NCUTCD website. A new proposed figure provides greater details on crosswalk marking types (see Figure 25).

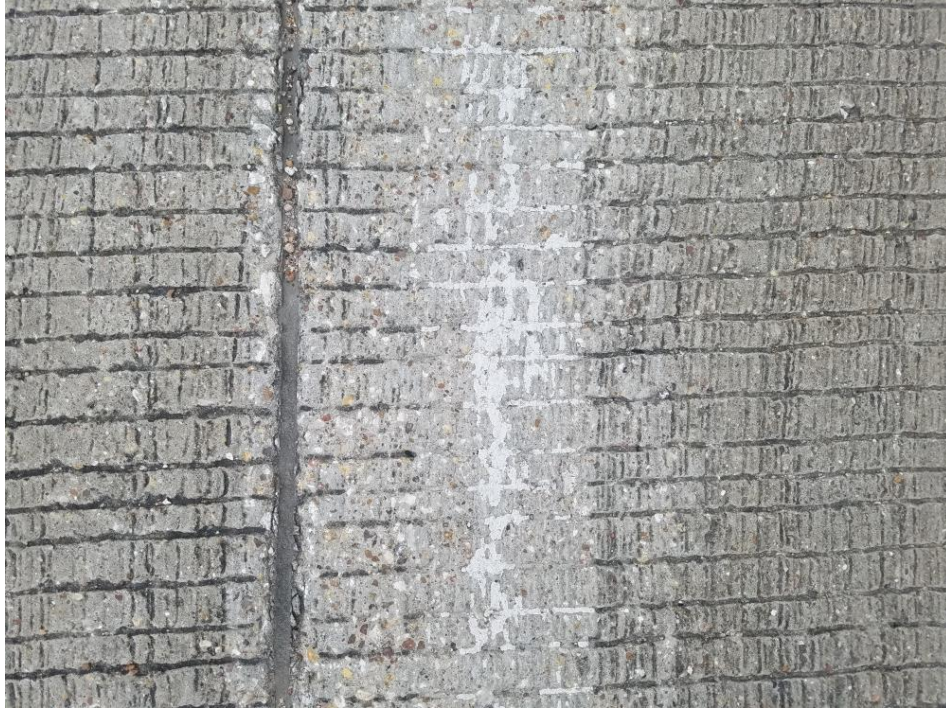
Figure 37. Flailing Removal on Grooved Concrete—Marking Remnants in Grooves.

Figure 37 shows an example of the marking remnants that were left in the groove and area below the top surface of the concrete pavement. A blasting technique would effectively remove these remaining pieces of marking with minimal road surface damage if full removal were needed. If the flailing technique were used to completely remove the marking, the pavement surface would have been damaged, and the color difference would have been more noticeable during the day.

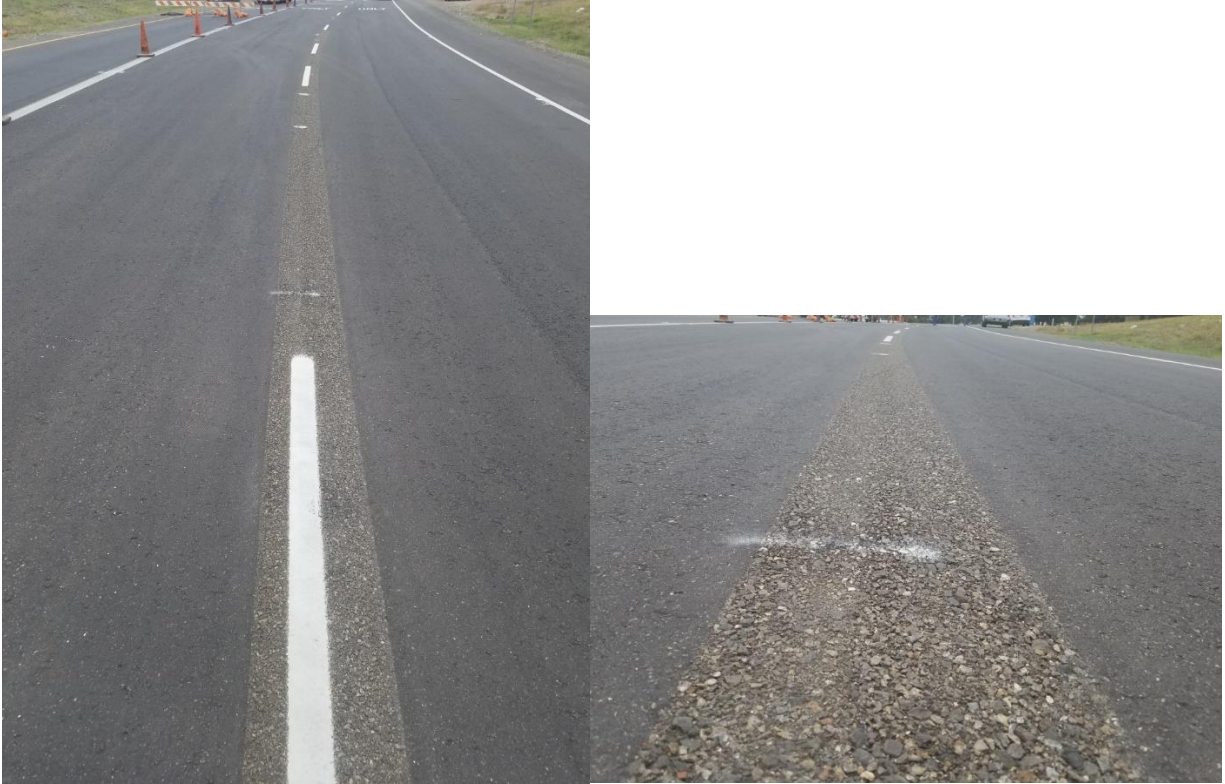
Figure 38. High-Pressure Water Blasting on Asphalt.

Removal on asphalt is typically more difficult than on concrete due to the variety in types and porosity of asphalt and how asphalt materials change as they age. Figure 38 provides daytime images of high-pressure water blasting results on a new asphalt surface. This removal was conducted to make a minor change in the striping configuration on the newly constructed asphalt. The removal resulted in 100 percent removal of the marking but did cause some removal of the surface asphalt binder and small aggregate. This resulted in a minor color change and texture change that can be seen in the closer photo. Due to the minor change in the striping, the color and texture changes will not result in confusion to the driver in this situation. Corrective actions could be considered if in another situation the pavement marking pattern were more dramatically changed, or if pavement durability concerns were present due to the loss of the surface asphalt binder. These corrective actions could include a fog seal or the like to replenish some of the asphalt and help blend the color back to the darker asphalt color.

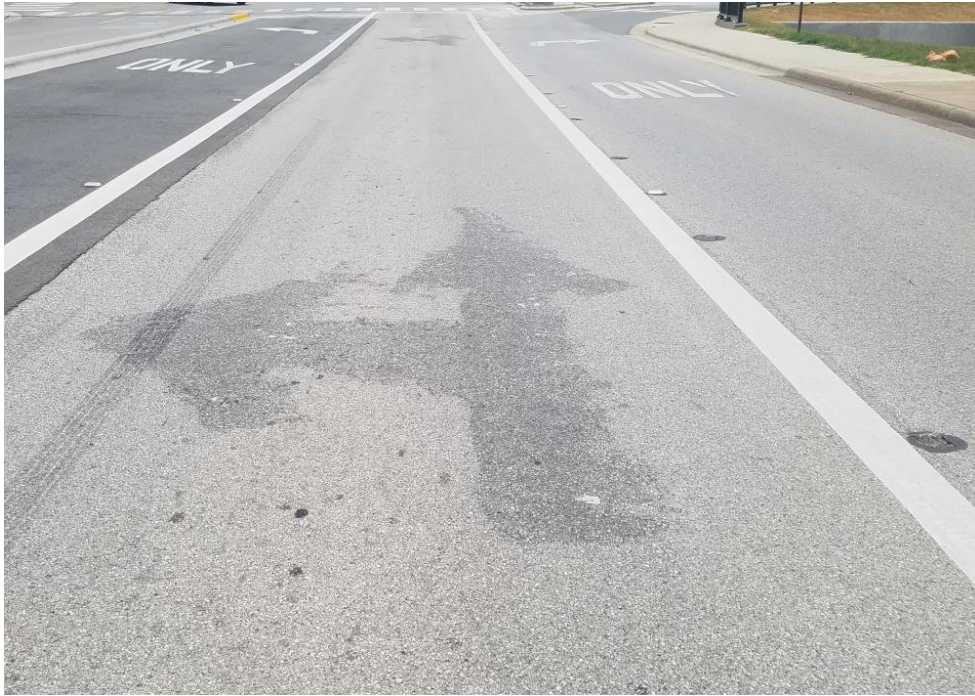
Figure 39. Hand-Operated Flailing Removal on Asphalt.

hole if the hole in the asphalt pavement is of concern for water intrusion and possible premature pavement failure.

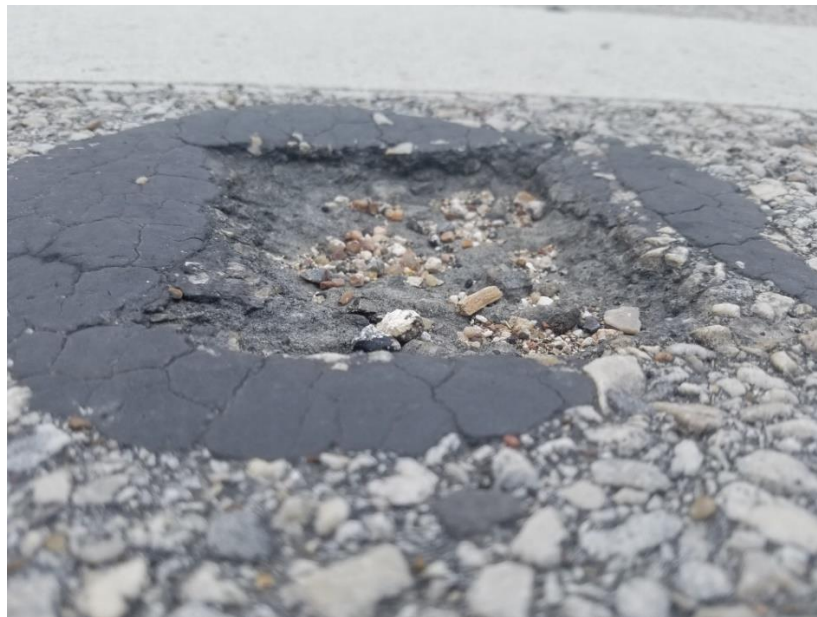
Figure 40. Marker Removal on Asphalt.

Figure 40 shows the results of a marker that had previously been removed. The researchers did not witness the removal or know what removal type was used to remove the marker. The results show that the removal of the marker resulted in loss of some of the asphalt road surface under the marker. It is possible that another removal method would have resulted in less damage to the asphalt road surface. Some asphalt binder could be used to seal or patch the
