# Design and *MASH* TL-3 Evaluation of Surface Mounted Median Guardrail

Technical Report 0-7052-R1

**Test Report No. 440522-01**  
**Test Report Date: January 2022**  
**Published: April 2022**

**Contract No.: 0-7052**  
**Test No.: 440522-01-1/440522-01-2**  
**Test Date: 2021-09-27/2021-10-06**

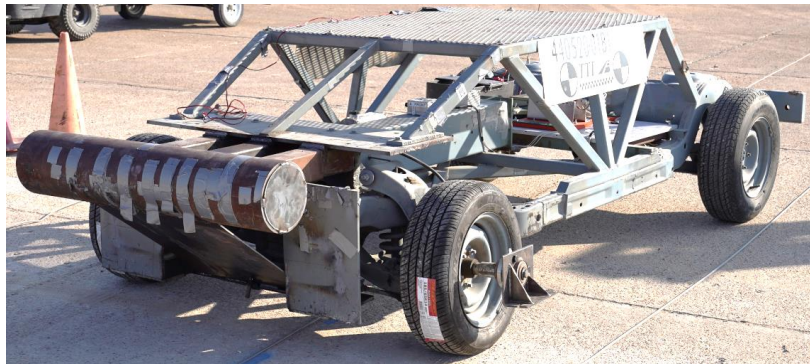
**Figure 2.4. Test Bogie Vehicle with Rigidized Pipe Nose.**

In all tests, the impacting bogie vehicle weighed 2,130 lb and had a rigidized pipe nose (Figure 2.4). Presented next are details of the test articles and results of the component-level testing.

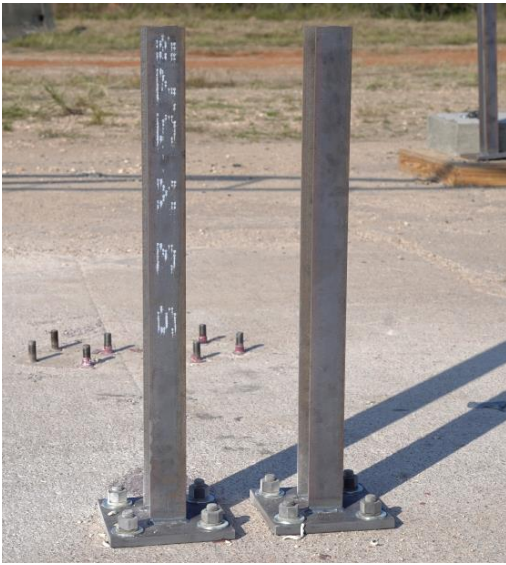
**Figure 2.6. Post Setup for Test 440521-01-B1.**

For test 440521-01-B1, the posts were mounted to the concrete slab such that the interior anchor bolts were spaced 5 inches apart (Figure 2.6). For test 440521-01-B2, the posts were rotated so that the flanges of the posts were at a 26.6-degree angle from the impact path (Figure 2.7). The interior field side bolt holes were spaced 5 inches apart, and the exterior field side bolt holes were 14<sup>3</sup>/<sub>4</sub> inches apart.

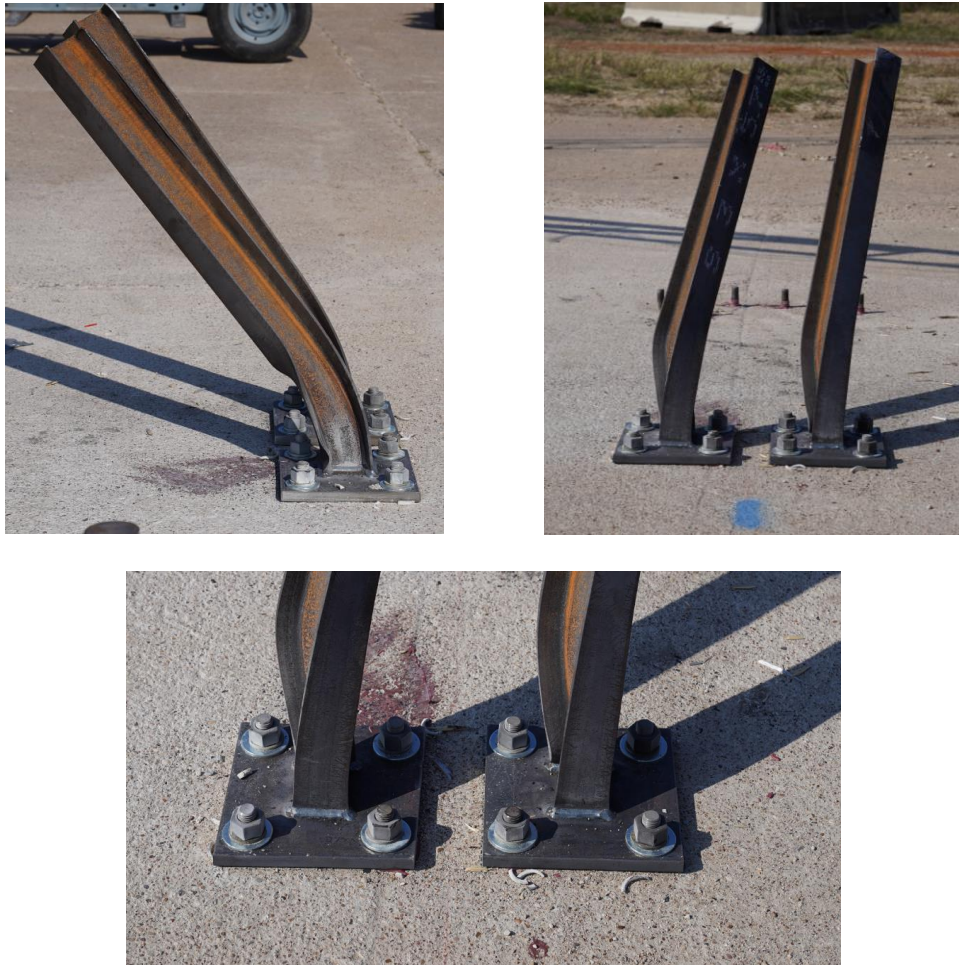
**Figure 2.10. Posts after Test 440521-01-B1.**

In this test, the bogie vehicle impacted at the centerline of the post pair at an impact speed of 18.9 mi/h. The impact occurred at a height of 24.5 inches from grade. Figure 2.10 shows the post installation after the test. The left post was leaning 35.5 degrees back from vertical and 30.0 degrees to the right from vertical. The right post was leaning 36.5 degrees back from vertical and 5.5 degrees to the right. Both posts were deformed at the base, but no damage to the

welds or the concrete pavement was noted. Figure 2.11 shows the forward displacement of the top of the posts as a function of time.

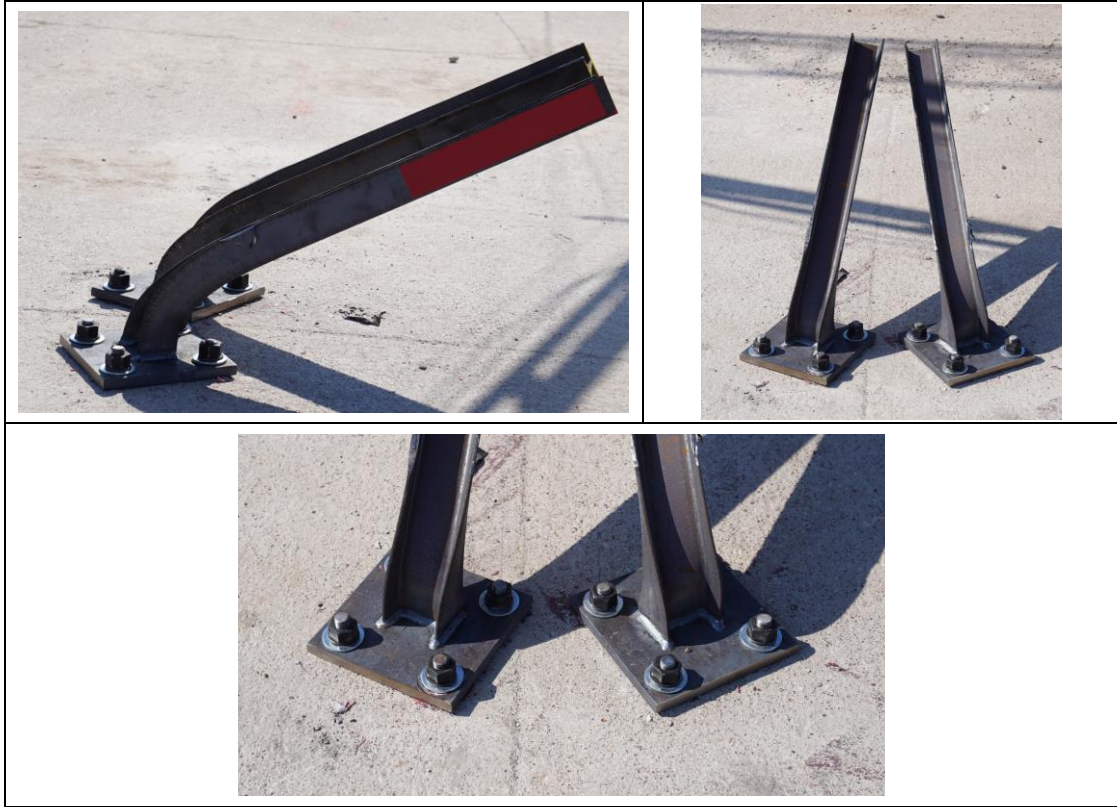
**Figure 2.12. Posts after Test 440521-01-B2.**

In this test, the bogie vehicle impacted at the centerline of the post pair at an impact speed of 20.8 mi/h. The impact occurred at a height of 22.5 inches from grade. Figure 2.12 shows the post installation after the test. The left post was leaning 59.9 degrees back from vertical and 8.5 degrees to the right. The right post was leaning 61.0 degrees back from vertical and 9.5 degrees to the left. Both posts were deformed at the base, but no damage to the welds or the concrete pavement was noted. Figure 2.13 shows the forward displacement of the top of the posts as a function of time.

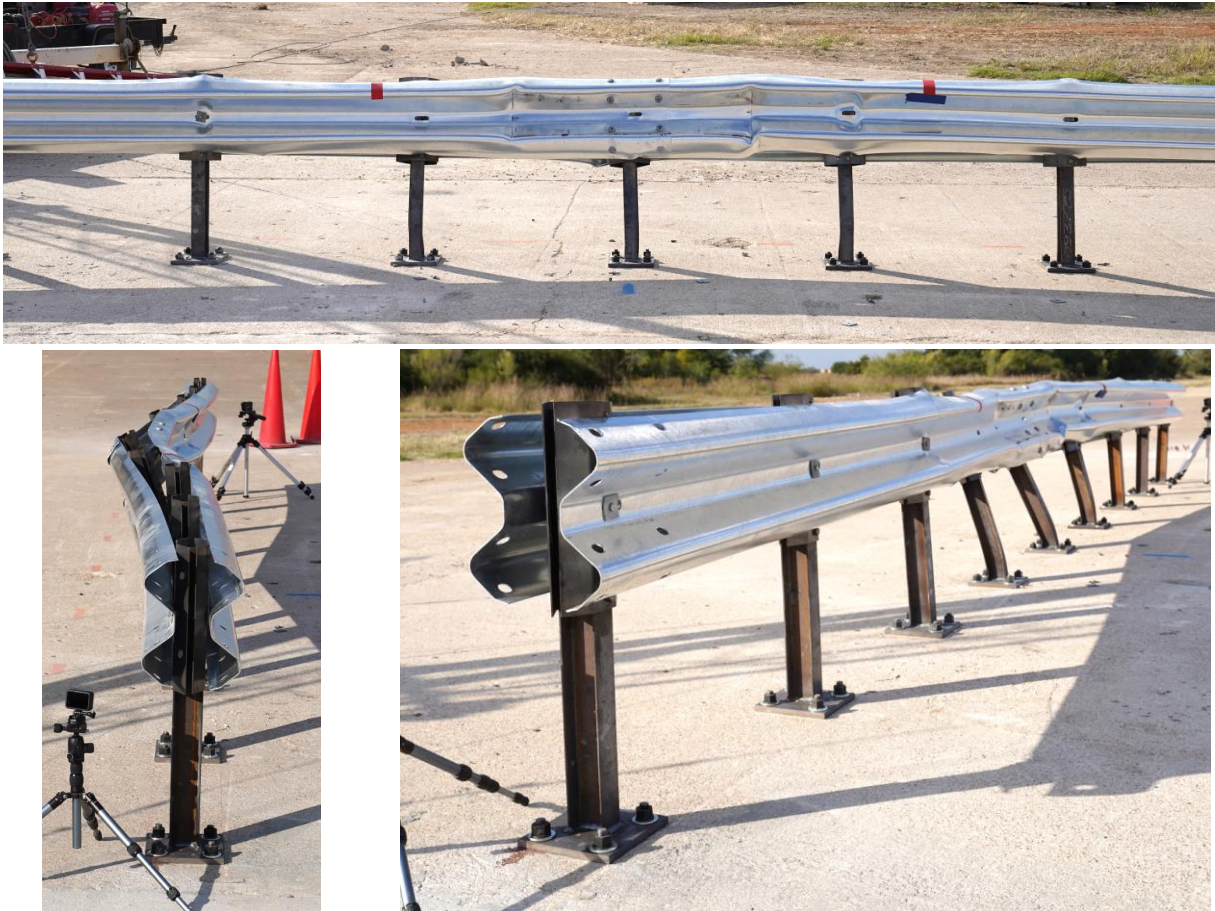
**Figure 2.14. Installation after Test 440521-01-B3.**

22.6 inches from grade. Figure 2.14 shows the damage to the installation. The traffic-side rail released from posts 4 through 8, and the field-side rail released from post 3.

The bogie vehicle came to a stop after impact and then rebounded. The welds of the posts at the baseplate did not fail. There was also no damage to the concrete pavement at the baseplate locations. Figure 2.15 shows the forward displacement versus time response of the field-side splice at the impact post.

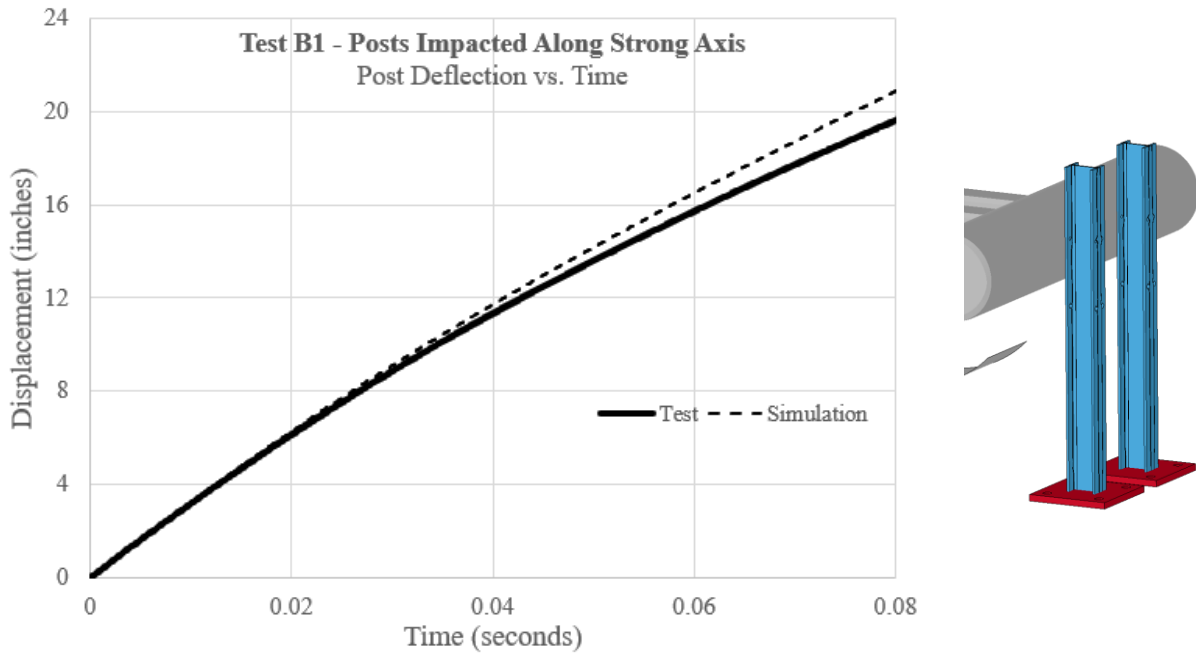
**Figure 2.16. Simulation and Test Post Deflection for Posts Impacted along the Strong Axis.**

The researchers first developed an FE model of the post and baseplate and performed simulations of the component-level bogie impact test described earlier. The goal of these simulations was to verify that the post and baseplate model adequately captures the post deflection response observed in the bogie impact tests. Figure 2.16 and Figure 2.17 show the post and baseplate model and comparison of the simulation results of the post pair deflection versus time. Figure 2.16 shows the comparison of the post deflection versus time response for Test 440521-01-B1, in which the posts were impacted along the strong axis of the posts.

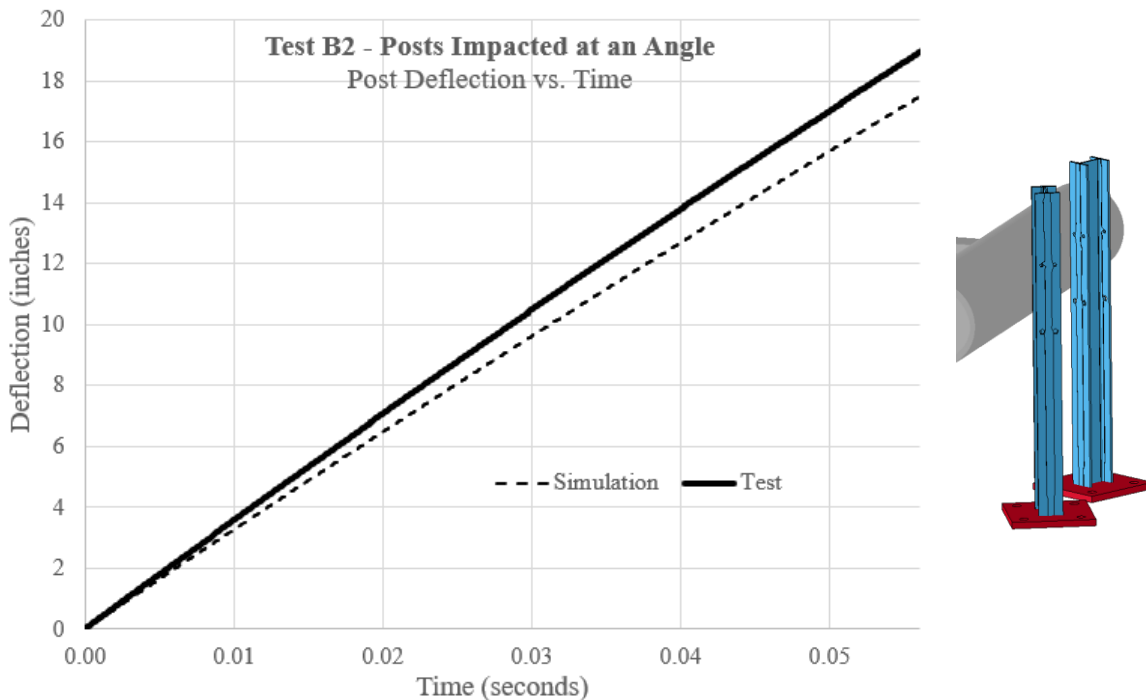
**Figure 2.17. Simulation and Test Post Deflection for Posts Impacted at an Angle.**

Figure 2.17 shows the comparison of the post deflection versus time response for Test 440521-01-B2, in which the posts were impacted at an angle. The post and baseplate model adequately captured the post deflection response observed in both tests.

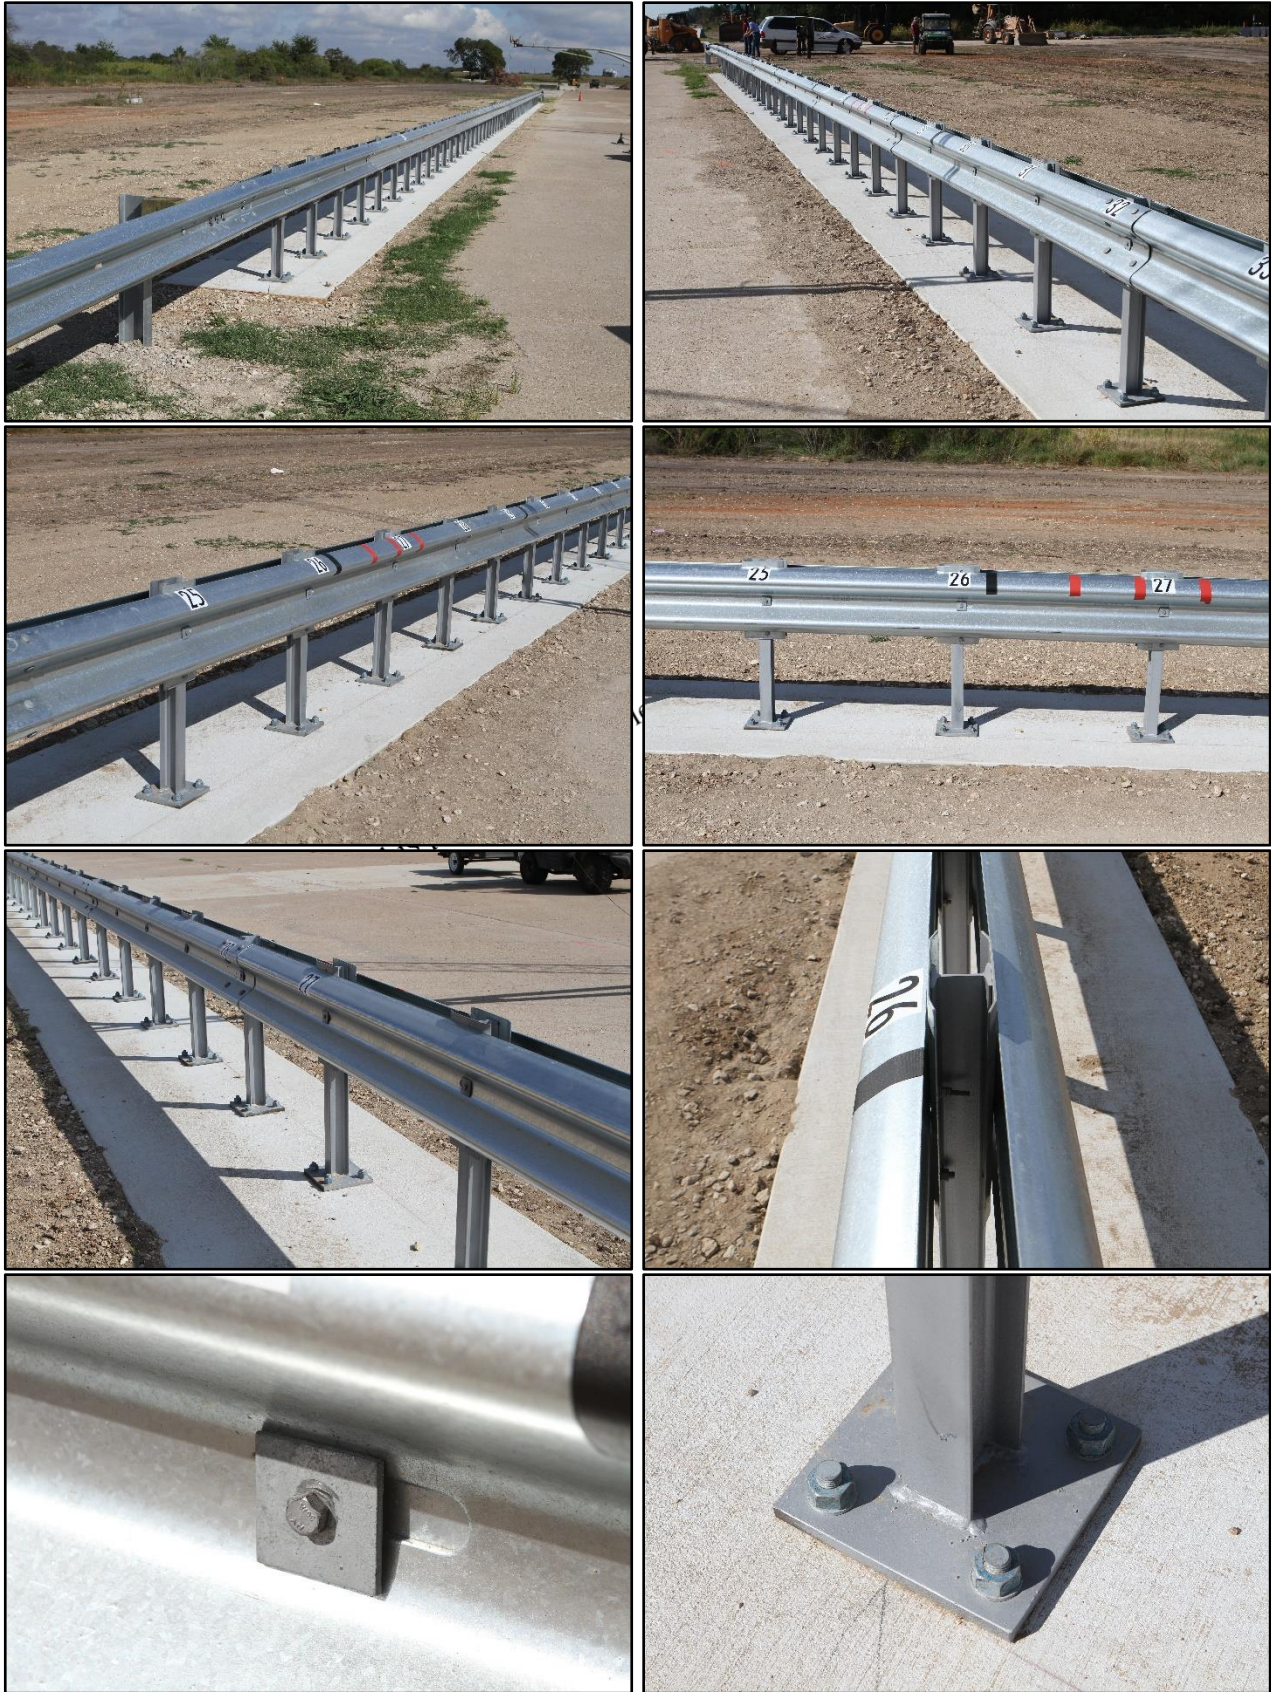
**Figure 3.2. Surface- Mounted Median Guardrail prior to Testing.**

Figure 3.1 presents the overall information of the surface mounted median guardrail, and Figure 3-2 provides photographs of the installation. Appendix A provides further details of the test installation. Drawings were provided by the Texas A&M Transportation Institute (TTI) Proving Ground, and construction was performed by MBC Management and TTI Proving Ground personnel.

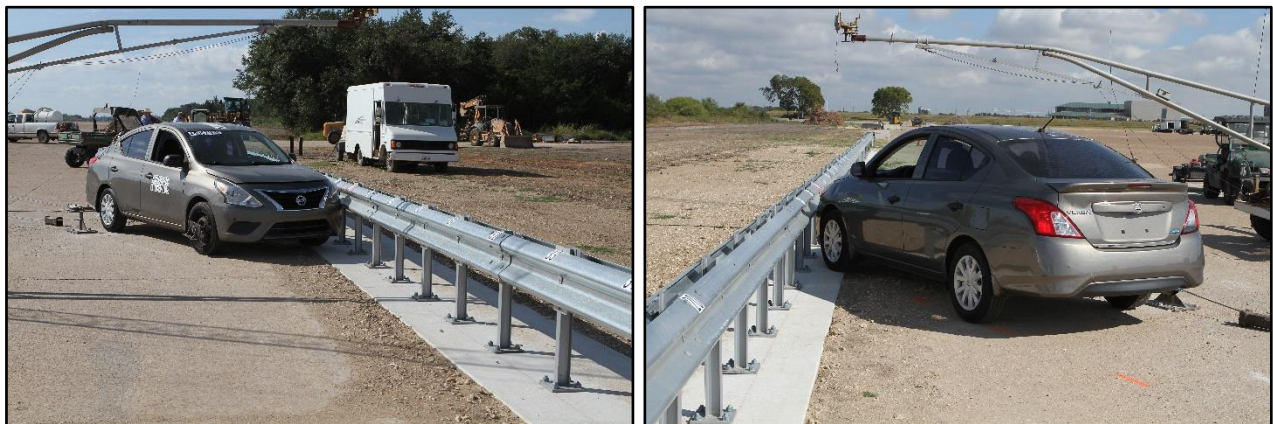
**Figure 6.1. Surface-Mounted Median Guardrail/Test Vehicle Geometrics for Test 440522-01-01.**

See Table 6.1 for details on the *MASH* impact conditions for this test. The CIP for *MASH* Test 3-10 on the surface-mounted median guardrail was 3.5 ft ± 1 ft upstream of the centerline of post 28. Figure 6.1 depicts the target impact setup.

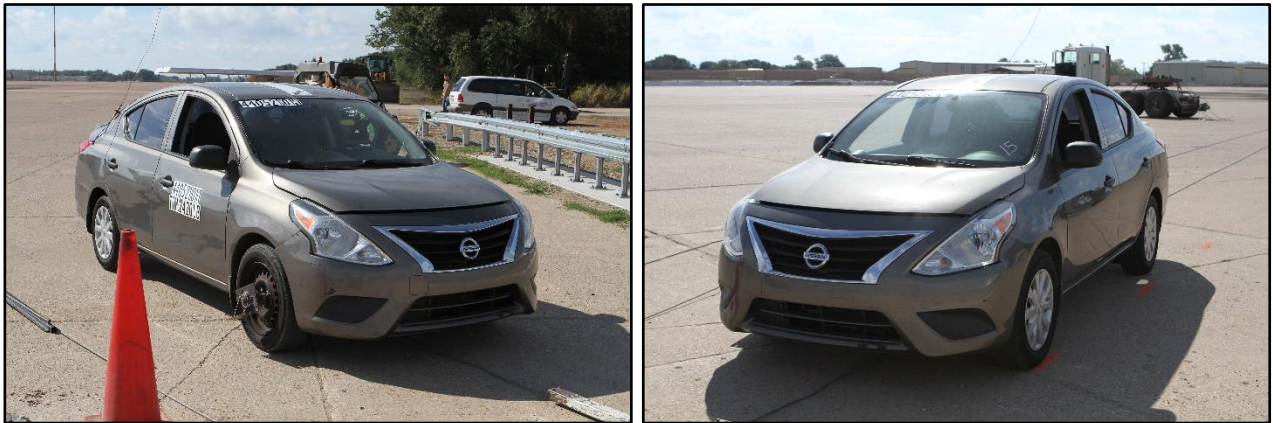
**Figure 6.2. Vehicle before Test 440522-01-01.**

Figure 6.2 shows the 2015 Nissan Versa used for the crash test. Table 6.3 shows the vehicle measurements. Table C.1 in Appendix C.1 gives additional dimensions and information on the vehicle.

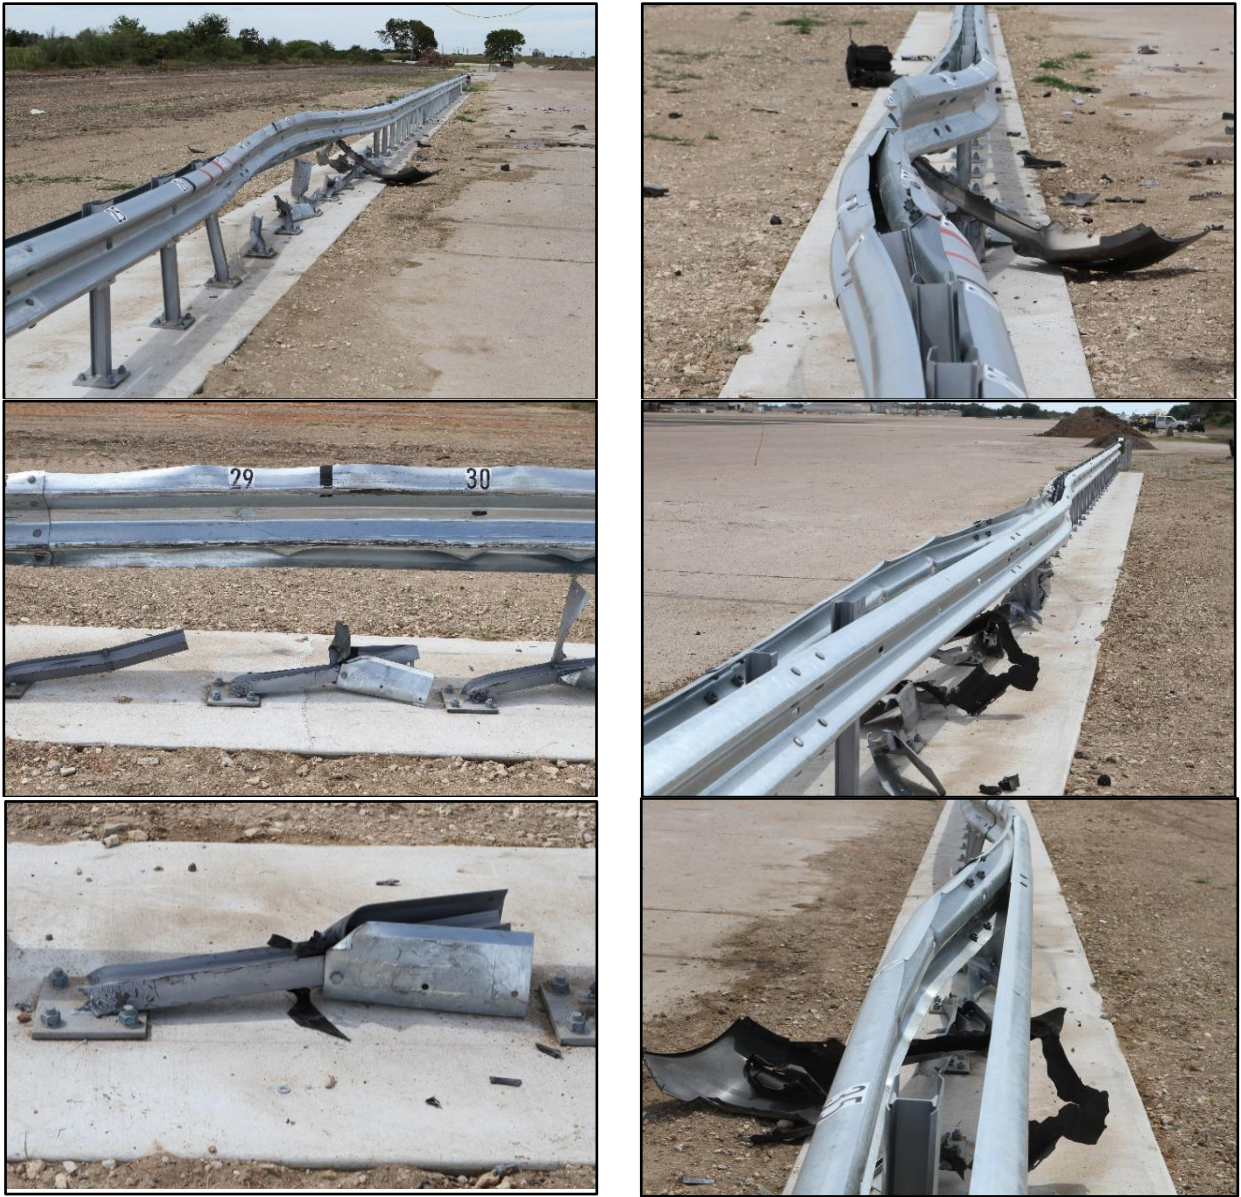
**Figure 6.3. Surface-Mounted Median Guardrail after Test 440522-01-01.**

Table 6.5 lists the post displacement details for the guardrail. Posts 28 through 34 had their upstream traffic-side flange torn at the base. The rail was scuffed and deformed at impact. No cracks or concrete damage was observed around the post baseplates. The baseplates and their epoxy anchors were also undamaged. The backer plates remained attached to the posts.

Table 6.6 describes the damage to the surface-mounted median guardrail, and Figure 6.3 illustrates that damage.

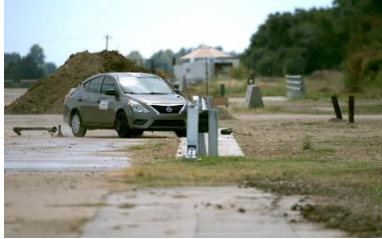
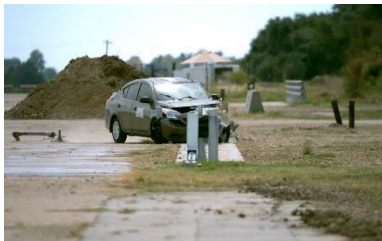
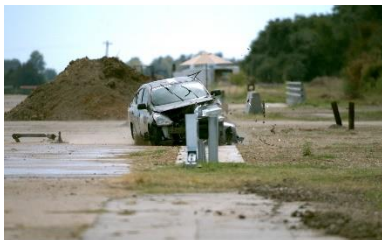
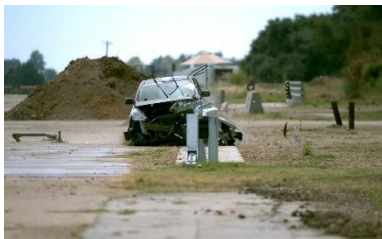
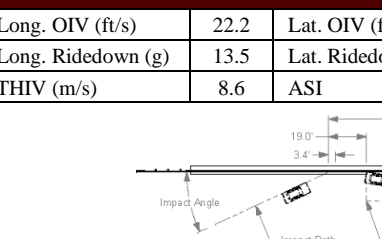
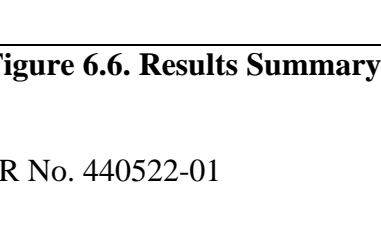
Figure 6.6. Results Summary for MASH Test 3-10 on Surface-Mounted Median Guardrail.

Test Agency		Texas A&M Transportation Institute (TTI)					
	Test Standard/Test No.		MASH 2016, 3-10 Test					
TTI Project No.		440522-01-1						
Test Date		2021-09-27						
<b>TEST ARTICLE</b>								
Type		Median Rail						
Name		Surface-Mounted Median Guardrail						
Length		239 ft 5 inches						
Key Materials		S3x5.7 weak posts, 12-gauge W-beam, concrete foundation, and SoftStop® end terminals						
Soil Type and Condition		AASHTO M147-65(2004), Type 1, Grade D Crushed Concrete

<b>TEST VEHICLE</b>							
	Type/Designation	1100C						
Year, Make and Model		2015 Nissan Versa						
Curb Weight (lb)		2,381						
Inertial Weight (lb)		2,437						
Dummy (lb)		165						
Gross Static (lb)		2,602

<b>IMPACT CONDITIONS</b>							
	Impact Speed (mi/h)	62.3						
Impact Angle (deg)		25.3						
Impact Location		3.4 feet upstream from the centerline of post 28						
Impact Severity (kip-ft)		57.7

<b>EXIT CONDITIONS</b>							
	Exit Speed (mi/h)	51.3						
Trajectory/Heading Angle (deg)		7.6/9.9						
Exit Box Criteria		Crossed						
Stopping Distance (ft)		102 downstream and 91 toward traffic side

<b>TEST ARTICLE DEFLECTIONS</b>							
	Dynamic (inches)	18.7						
Permanent (inches)		15.1						
Working Width/Height (inches)		31.6/19

<b>VEHICLE DAMAGE</b>							
	VDS	11LFQ6						
CDC		11FLEW4						
Max. Ext. Deformation (inches)		9						
Max. Occupant Compartment Deformation		2 inches in the front door panel below the seat						
<b>OCCUPANT RISK VALUES</b>								
Long. OIV (ft/s)	22.2	Lat. OIV (ft/s)	18.8	Max. 50-ms Long. (g)	-7.9	Max. Roll (deg)	11	
Long. Ridedown (g)	13.5	Lat. Ridedown (g)	9.4	Max. 50-ms Lat. (g)	6.8	Max. Pitch (deg)	5	
THIV (m/s)	8.6	ASI	1.0	Max. 50-ms Vert. (g)	-2.1	Max. Yaw (deg)	53

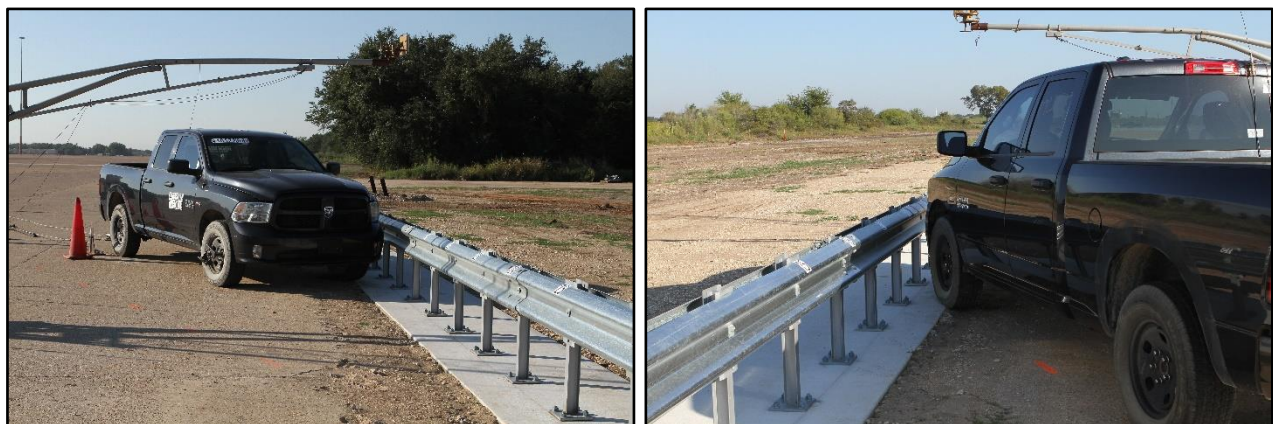
**Figure 7.1. Surface-Mounted Median Guardrail/Test Vehicle Geometrics for Test 440522-01-2.**

See Table 7.1 for details on *MASH* impact conditions for this test. The CIP for *MASH* Test 3-11 on the surface-mounted median guardrail was 4.0 ft ± 1 ft upstream of the centerline of post 20. Figure 7.1 depicts the target impact setup.

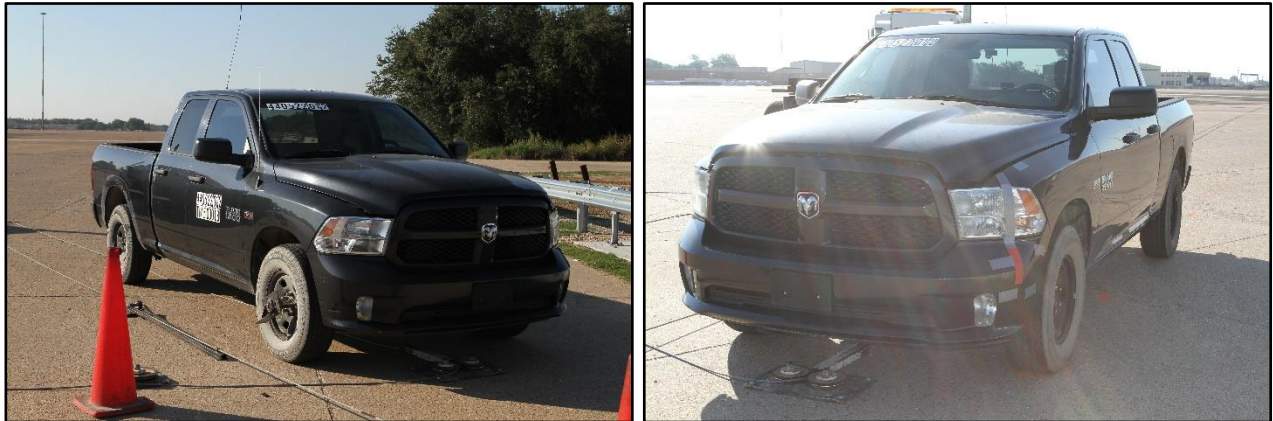
**Figure 7.2. Test Vehicle before Test 440522-01-2.**

Figure 7.2 shows the 2015 Ram used for the crash test. Table 7.3 shows the vehicle measurements. Table D.1 in Appendix D.1 gives additional dimensions and information on the vehicle.

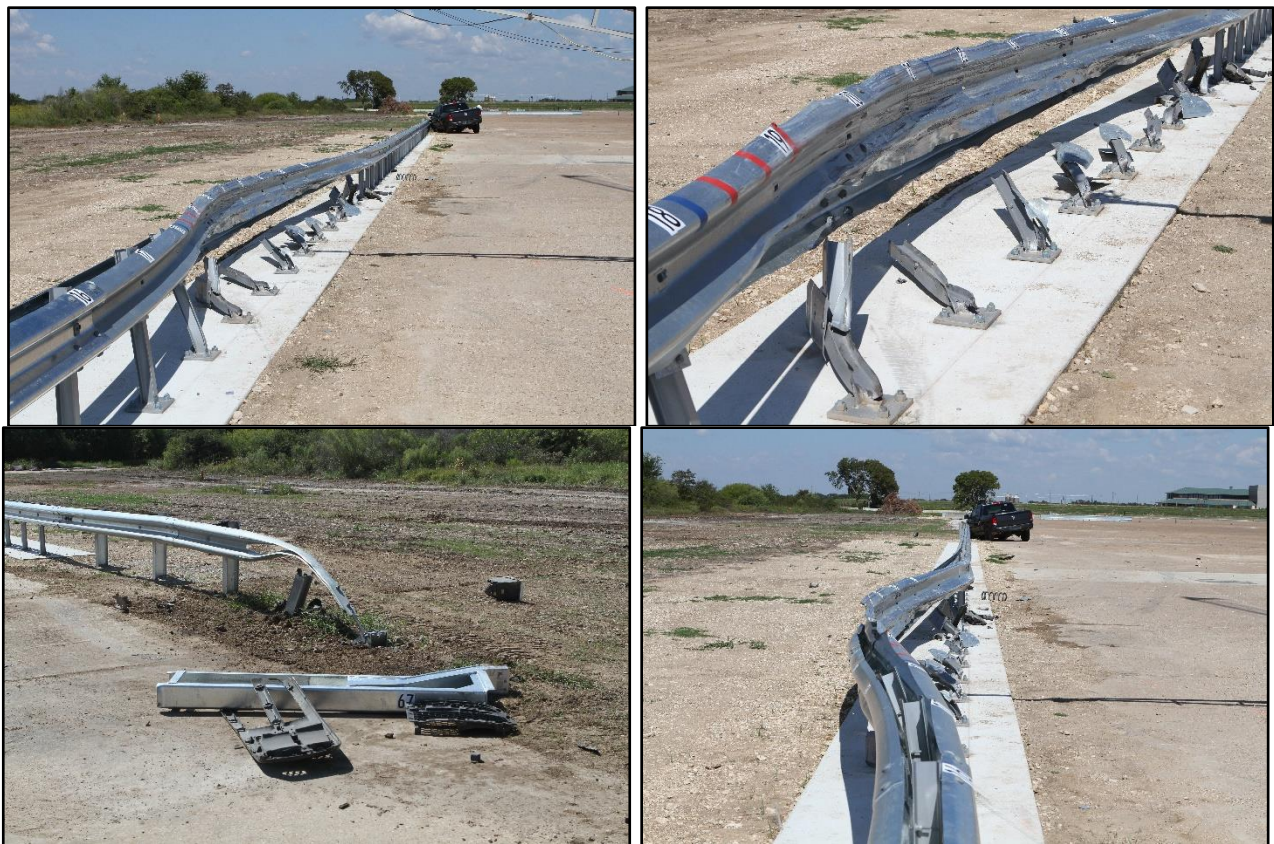
**Figure 7.3. Surface-Mounted Median Guardrail after Test 440522-01-2.**

Table 7.6 describes the damage to the surface-mounted median guardrail, and Figure 7.3 illustrates that damage.

Test Parameter	Measured
Permanent Deflection/ Location	30.3 inches toward field side at Post 22
Dynamic Deflection	37.8 inches toward field side
Working Width* and Height	45 inches at a height of 45.8 inches

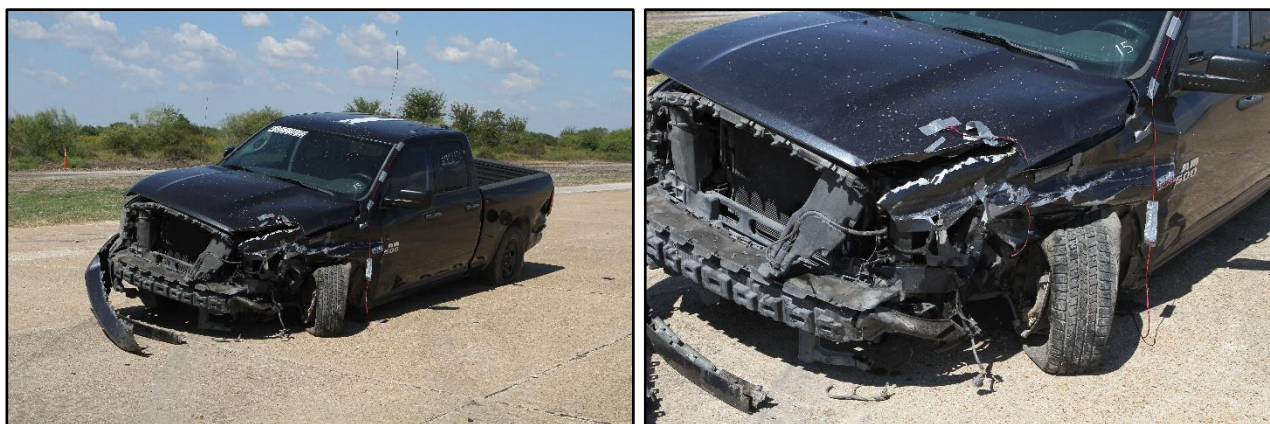
**Figure 7.4. Test Vehicle after Test 440522-01-2.**

Figure 7.4 and Figure 7.5 show the damage sustained by the vehicle. Table 7.7 provides details on the interior and exterior damage to the vehicle. Tables D.2 and D.3 in Appendix D.1 provide exterior crush and occupant compartment measurements.

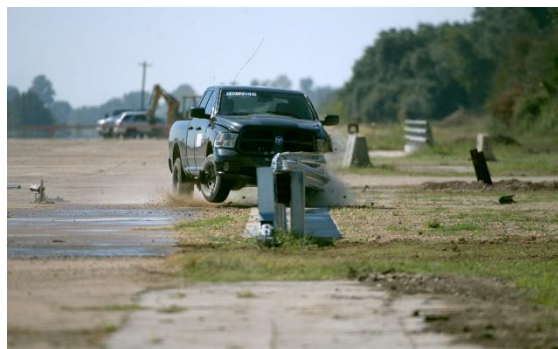
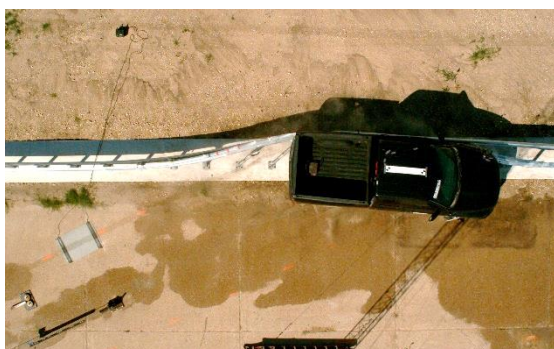
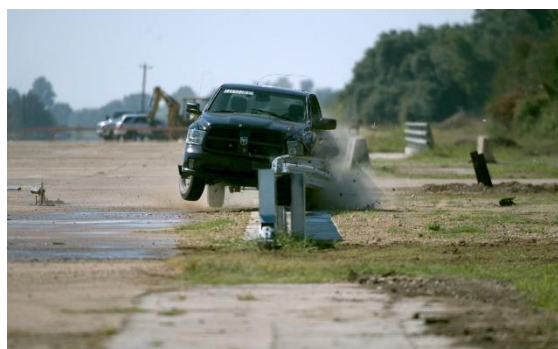
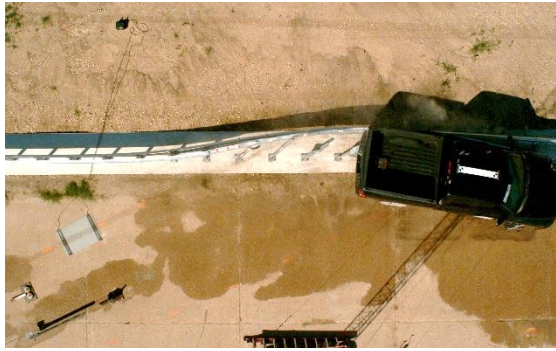
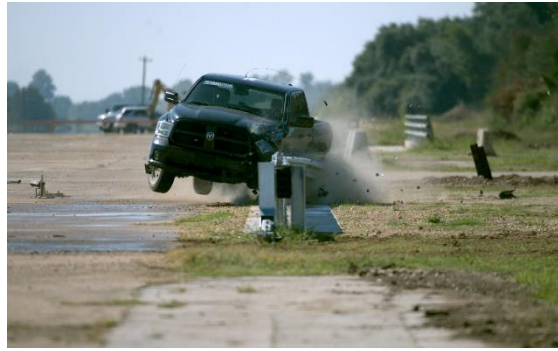
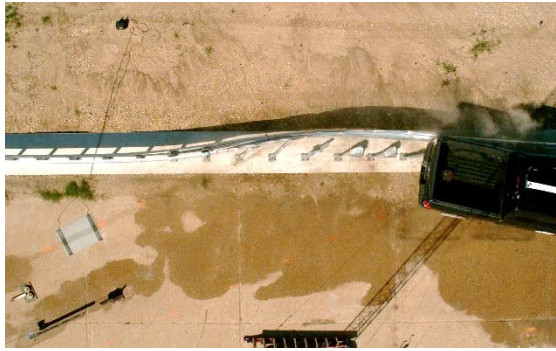
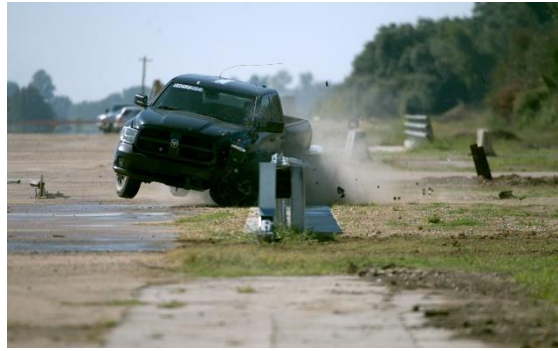
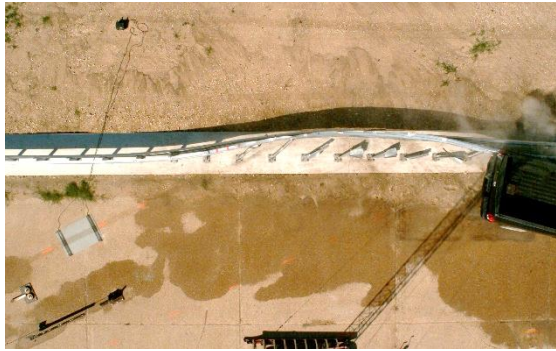
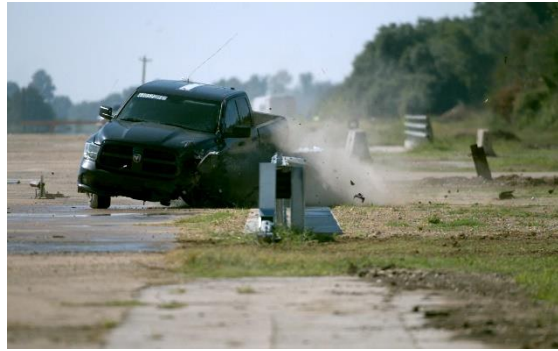
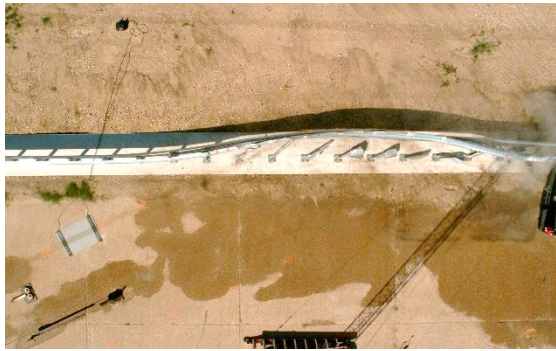
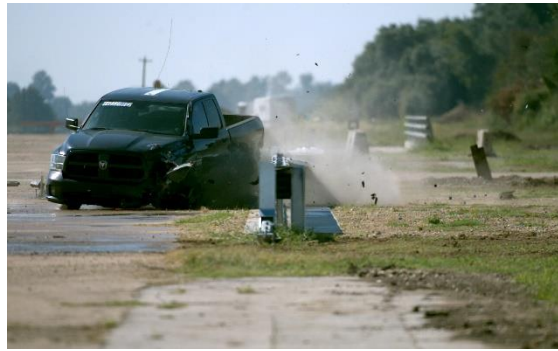
**Figure D.1. Sequential Photographs for Test No. 440522-01-2 (Overhead and Frontal Views).**

**Figure D.1. Sequential Photographs for Test No. 440522-01-2 (Overhead and Frontal Views) (Continued).**

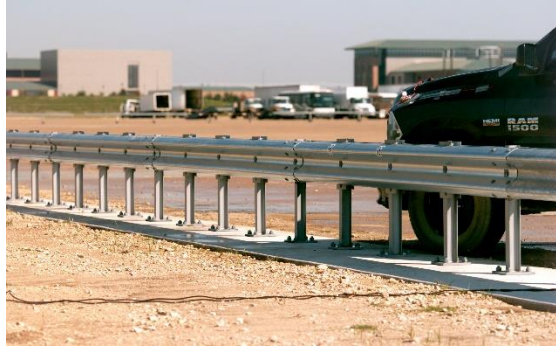
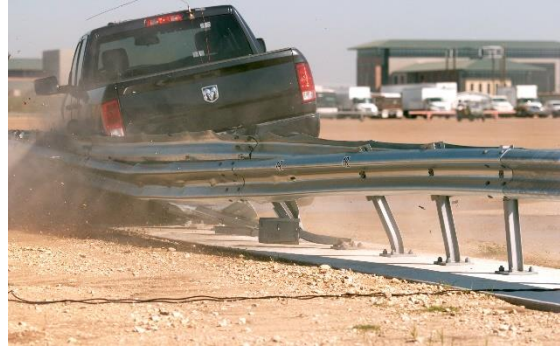
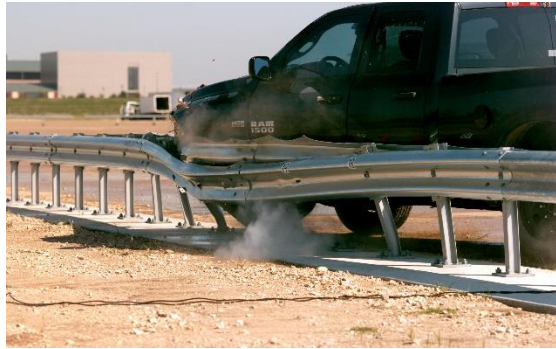
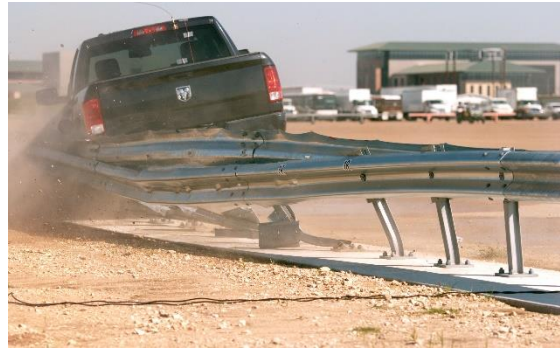
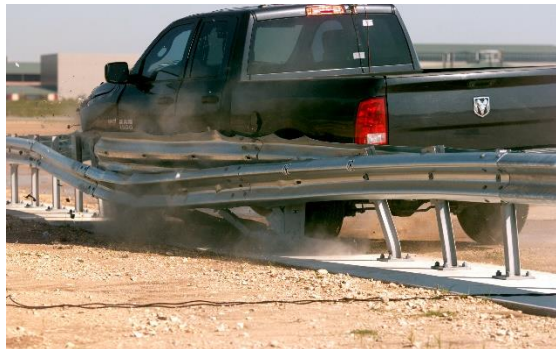
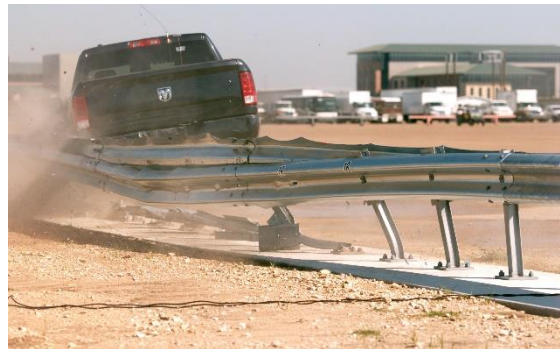
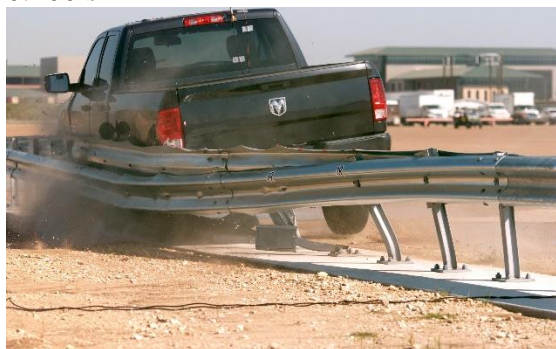
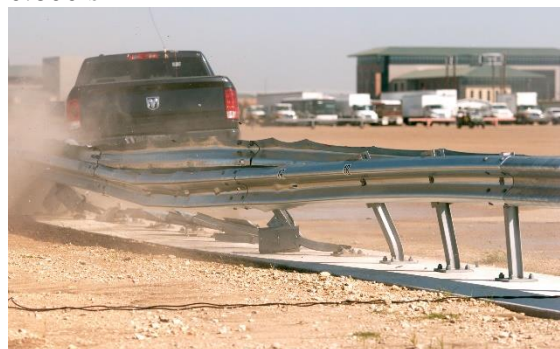
**Figure D.2. Sequential Photographs for Test No. 440522-01-2 (Rear View).**
