Test Report No. 440592

**DEVELOP GUIDELINES FOR INSPECTION, REPAIR, AND USE OF  
PORTABLE CONCRETE BARRIERS—VOLUME 2: CRASH REPORT  
COOPERATIVE RESEARCH PROGRAM**

Report 0-7059-R1-Vol2  
Project 0-7059

Project Title: Develop Guidelines for Inspection, Repair, and Use of Portable Concrete Barriers

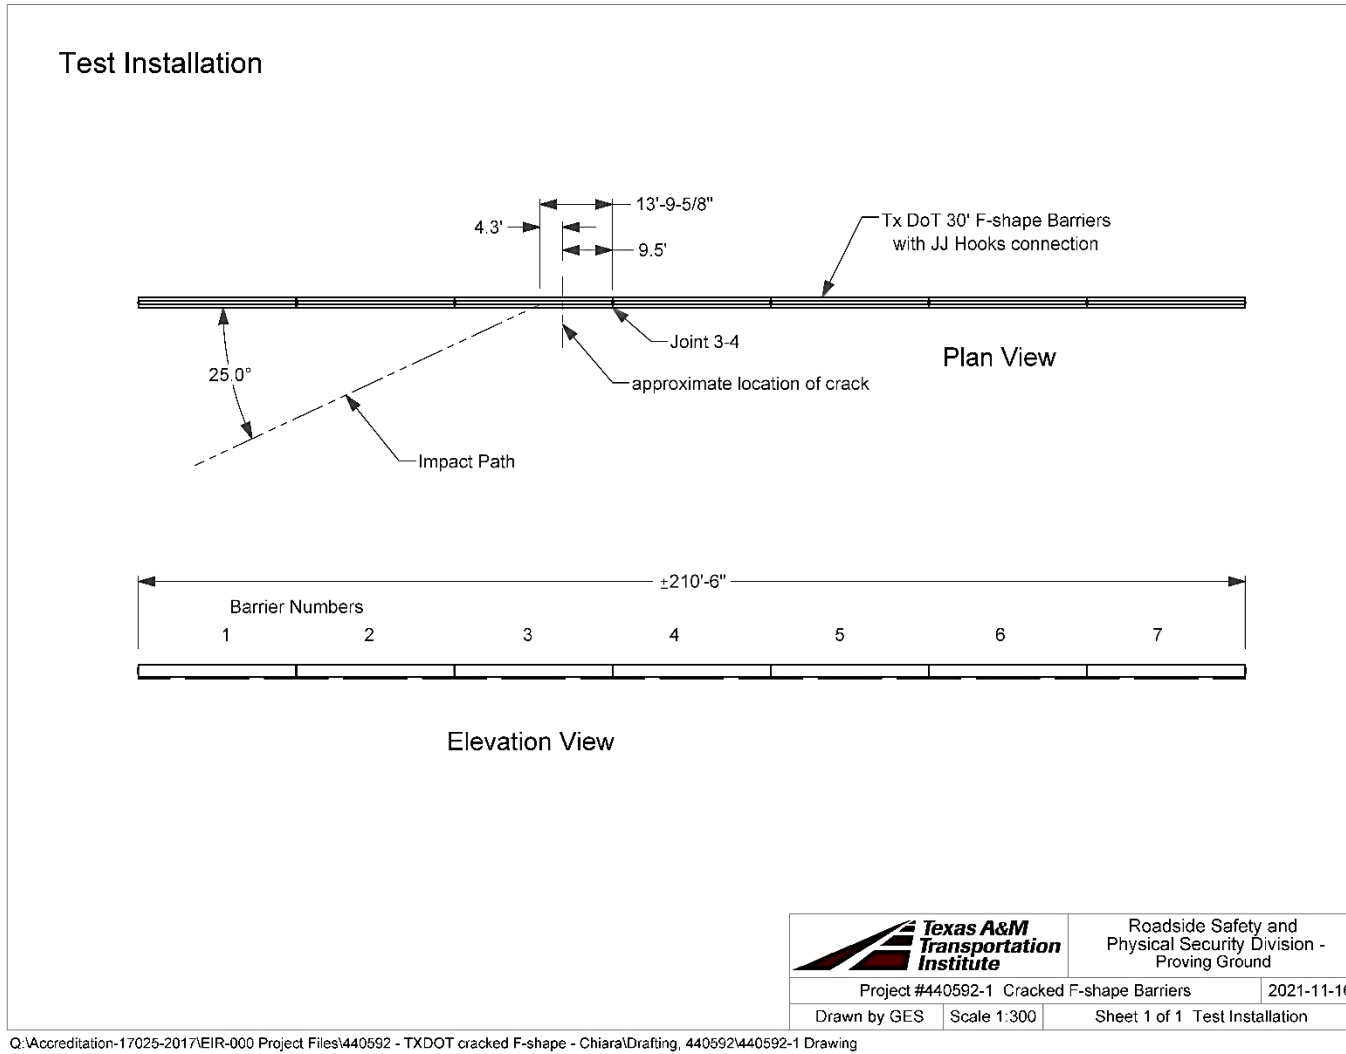
**Figure 2.3. Details on Damaged Portable Concrete Barriers.**

Each installation consisted of seven 30-ft long, 32-inch tall, F-shape barriers connected end to end with JJ hook connections, for a total length of 210 ft 6 inches. For both tests, the barrier segments were specifically selected based on their existing damage modes, which included concrete spalling, concrete cracks, and segment connection deformations.

Figure 2.1 and Figure 2.2 show pictures of the F-shape barriers before testing. Figure 2.3 shows a drawing of the test layout. Appendix A provides further details on the damaged portable concrete barriers. Drawings were provided by the TTI Proving Ground, and construction was performed by TTI Proving Ground personnel.

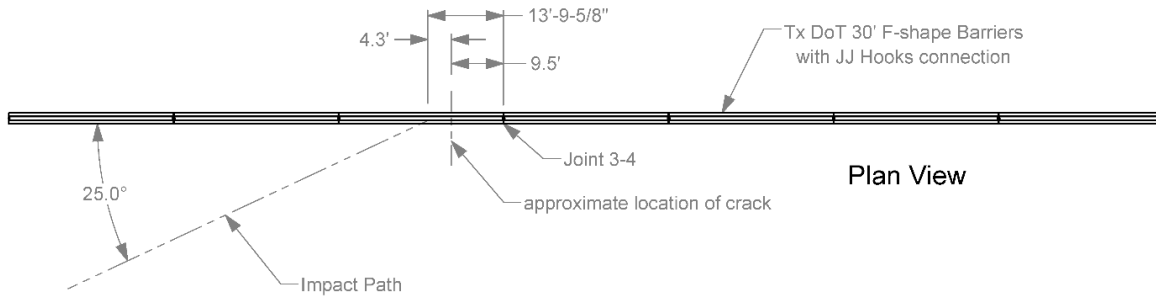
**Figure 3.1. Target CIP for *MASH* TL-3 Test No. 440592-1 on Damaged Portable Concrete Barriers.**

Table 3.1 shows the test conditions and evaluation criteria for *MASH* Test Level 3 (TL-3) for longitudinal barriers. The target critical impact points (CIPs) for each test were determined using the information provided in *MASH* Section 2.2.1 and Section 2.3.2. Figure 3.1 and Figure 3.2 show the target CIP for *MASH* Test 3-11 on the damaged portable concrete barriers.

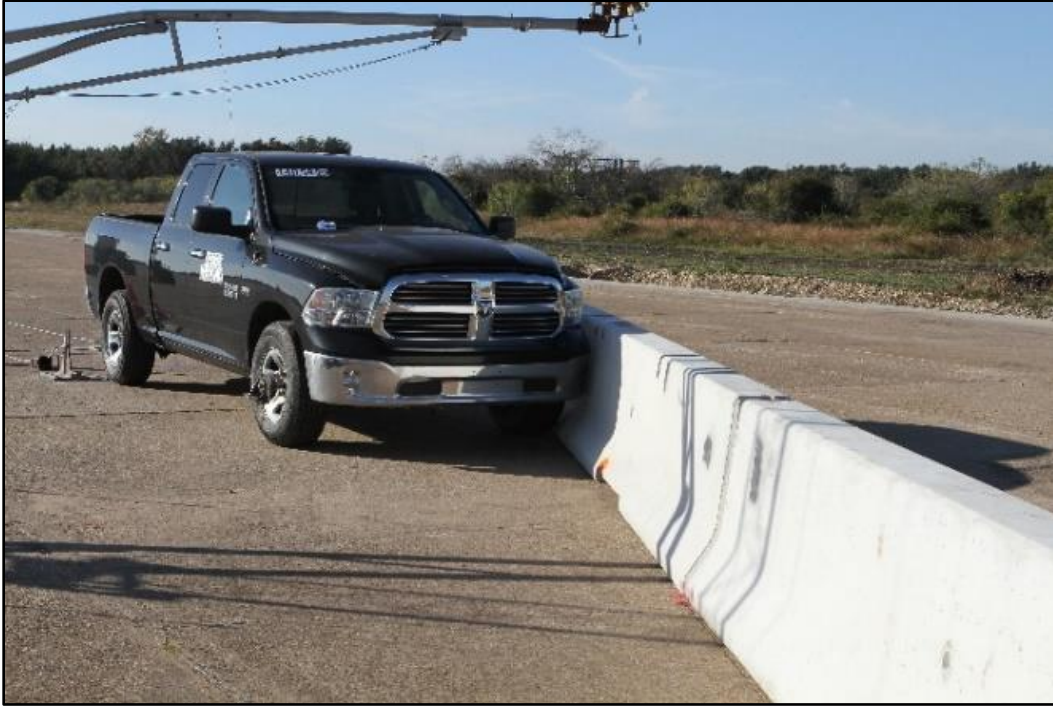
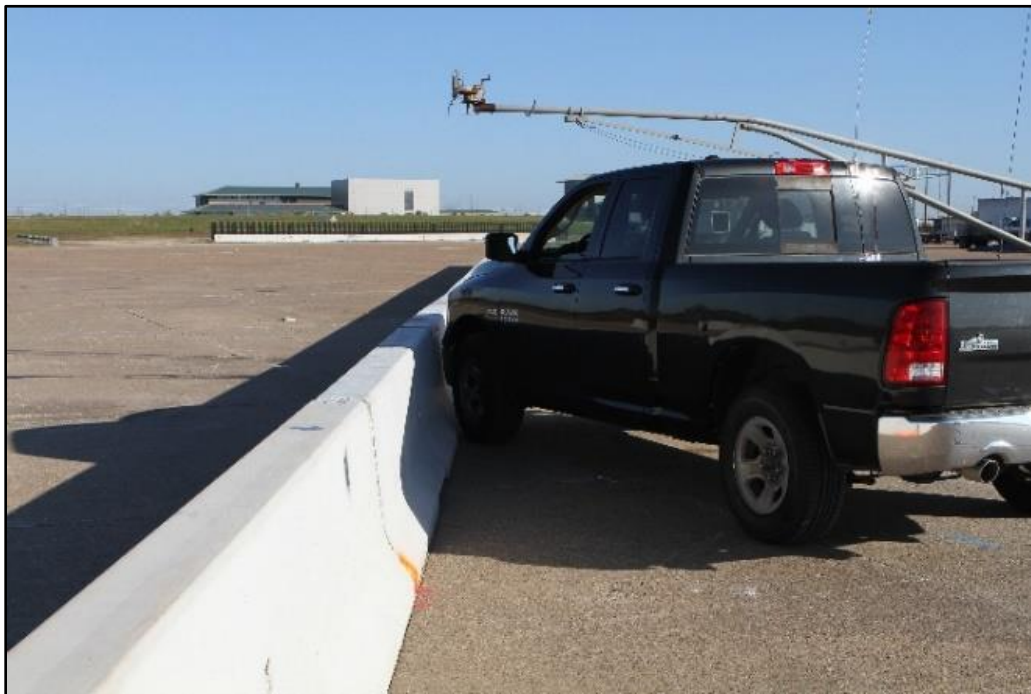
**Figure 5.1. Damaged Portable Concrete Barriers/Test Vehicle Geometrics for Test No. 440592-1, Front View.**

Table 5.1 and Table 5.2 provide details on the *MASH* impact conditions for this test, and Figure 5.1 and Figure 5.2 depict the target impact setup.

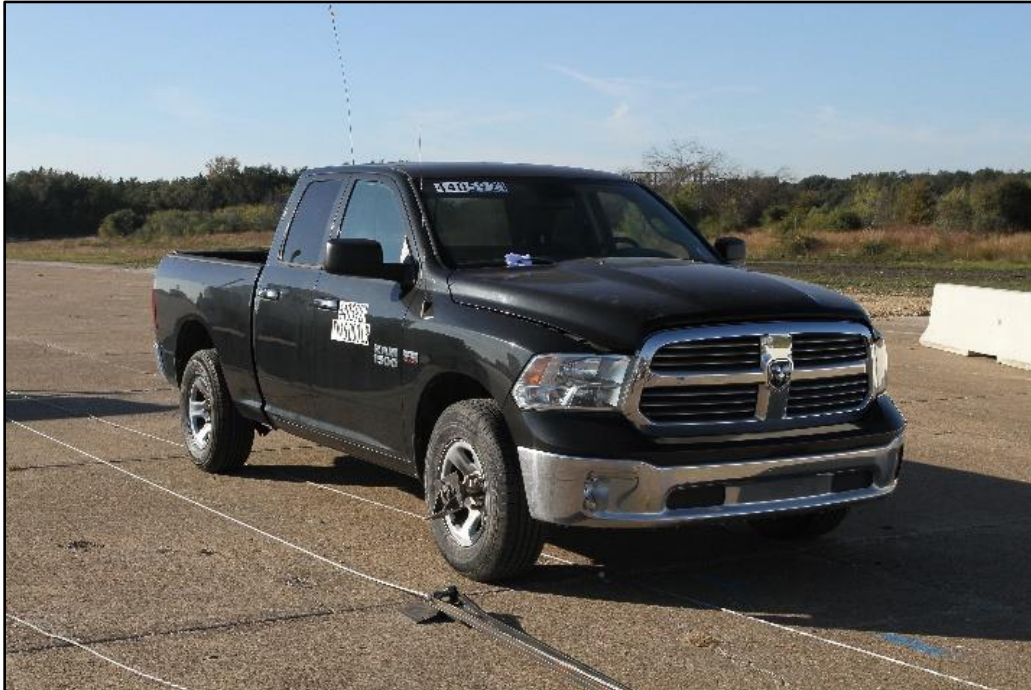
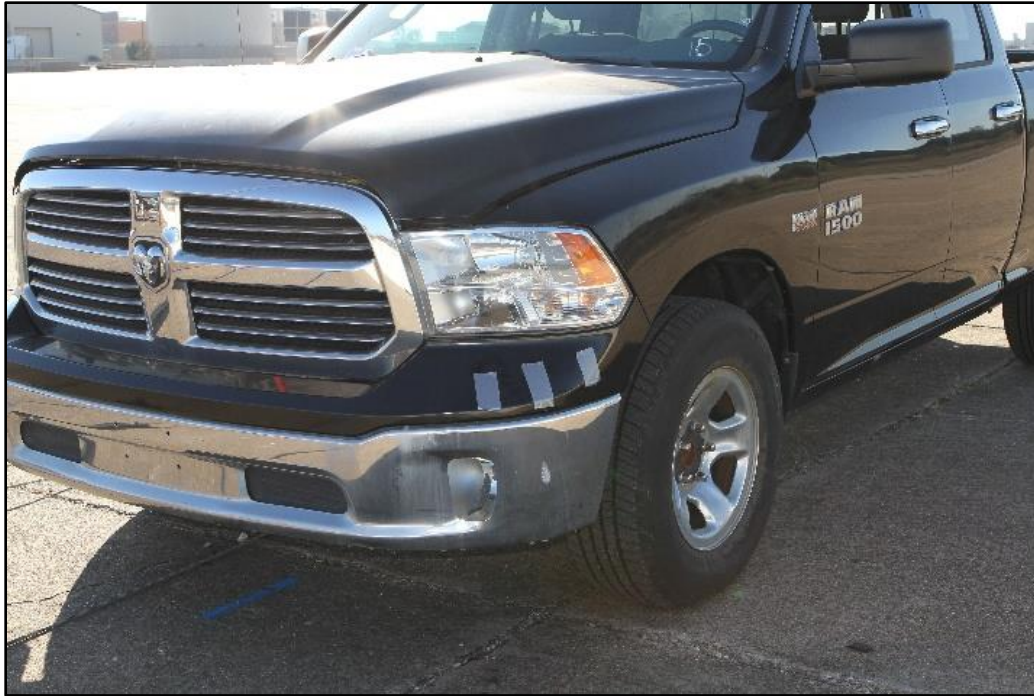
**Figure 5.3. Test Vehicle before Test No. 440592-1, Front View.**

Figure 5.3 and Figure 5.4 show the 2016 RAM 1500 used for the crash test. Table 5.4 shows the vehicle measurements. Figure C.1 in Appendix C.1 gives additional dimensions and information on the vehicle.

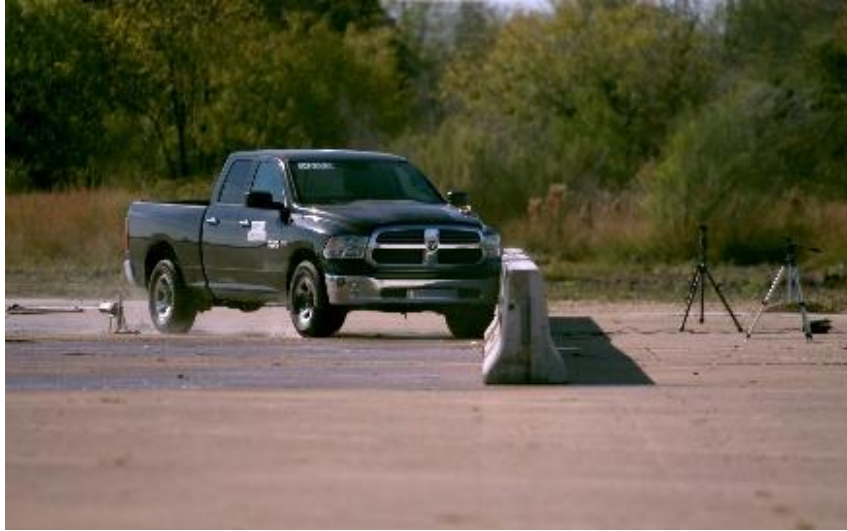
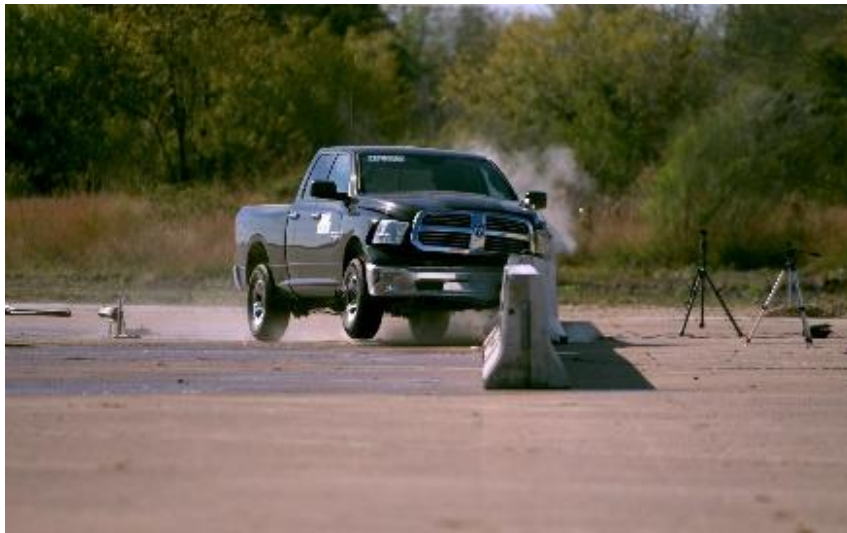
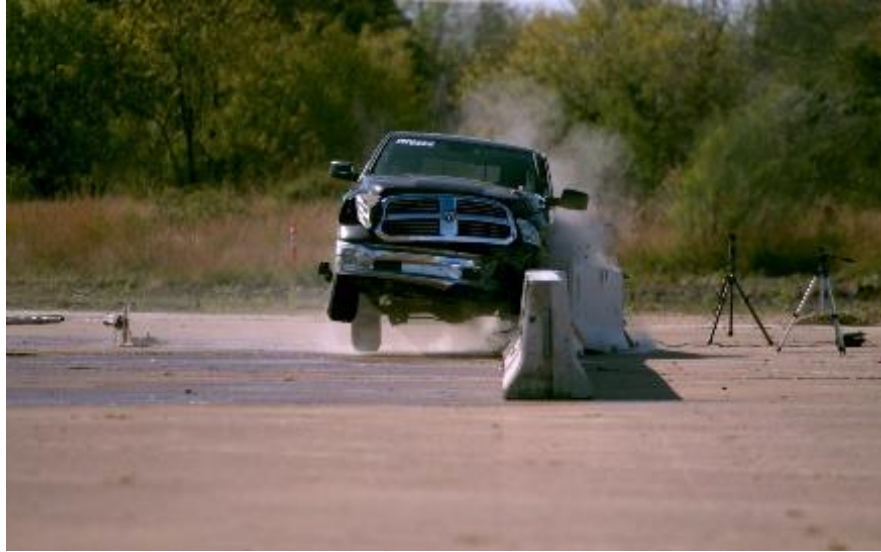
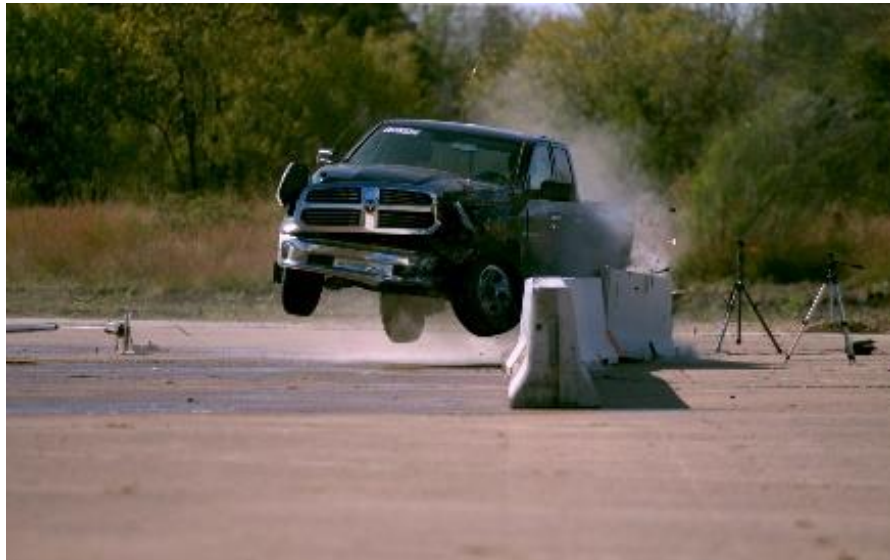
**Figure 5.8. Summary of Results for Test No. 440592-1, Sequential Test Pictures.**

Time (s)	Events
0.0000	Vehicle impacts the installation
0.0413	Upstream end of barrier 3 begins to lift
0.0430	Vehicle begins to redirect
0.0475	Large preexisting crack on backside of barrier begins to expand
0.0810	Front passenger side tire lifts off pavement
0.1090	Rear passenger side tire lifts off pavement
0.1940	Vehicle travels parallel with installation
0.4150	Vehicle loses contact with the barrier
0.5540	Front driver side tire makes contact with pavement
0.8690	Front passenger side tire makes contact with pavement

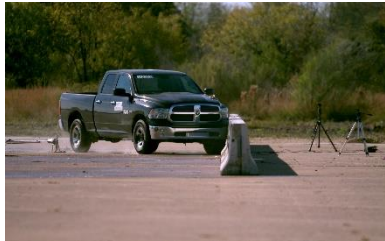
**Figure 5.9. Summary of Results for Test No. 440592-1, Summary Drawing.**

Test Agency		Texas A&M Transportation Institute (TTI)					
	Test Standard/Test No.		MASH 2016, Test 3-11					
	TTI Project No.		440592-1					
	Test Date		2021-12-01

Table 5.11, Table 5.12, Figure 5.8, Figure 5.9, and Figure 5.10 summarize the results for Test No. 440592-1.

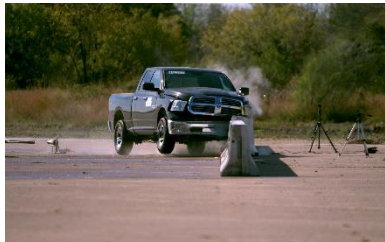
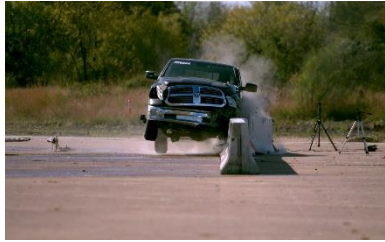
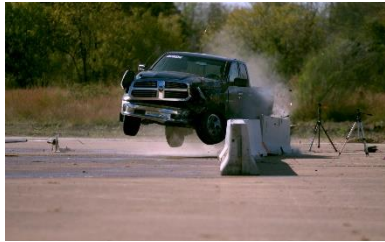
**Figure 5.10. Summary of Results for MASH Test 3-11 on Damaged Portable Concrete Barriers, Test No. 440592-1.**

<b>TEST ARTICLE</b>							
	Type		Portable Concrete Barrier					
	Name		Damaged Portable Concrete Barrier					
	Length		210 ft 6 inches

Key Materials		7 F-Shaped Concrete Barriers					
	Soil Type and Condition		Concrete Apron, Dry					
	<b>TEST VEHICLE</b>							
	Type/Designation		2270P

Year, Make and Model		2016 RAM 1500					
	Curb Weight (lb)		5083					
	Inertial Weight (lb)		5025					
	Dummy (lb)		N/A					
Gross Static (lb)		5025						
<b>IMPACT CONDITIONS</b>								
Impact Speed (mi/h)		61.8						
Impact Angle (deg)		25.2						
Impact Location		13.9 ft upstream from the centerline of the joint between barriers 3 and 4						
Impact Severity (kip-ft)		116.3						
<b>EXIT CONDITIONS</b>								
Exit Speed (mi/h)		53.3

Trajectory/Heading Angle (deg)		7/18						
Exit Box Criteria		Vehicle crossed exit box						
Stopping Distance (ft)		203 ft downstream 10 ft to the field side						
<b>TEST ARTICLE DEFLECTIONS</b>								
Dynamic (inches)		61						
Permanent (inches)		61						
Working Width / Height (inches)		85/3						
<b>VEHICLE DAMAGE</b>								
VDS		11LFQ5						
CDC		11FLEW3						
Max. Ext. Deformation (inches)		12, Left Front Bumper						
Max Occupant Compartment Deformation (inches)		1, Left Kick Panel Area; 1, Lower Left Front Door						
<b>OCCUPANT RISK VALUES</b>								
Long. OIV (ft/s)	12.3	Long. Ridedown (g)	5.0	Max 50-ms Long. (g)	-6.6	Max Roll (deg)	17	
Lat. OIV (ft/s)	21.5	Lat. Ridedown (g)	12.6	Max 50-ms Lat. (g)	11.8	Max Pitch (deg)	16	
THIV (m/s)	7.7	ASI	1.6	Max 50-ms Vert. (g)	-3.8	Max Yaw (deg)	61

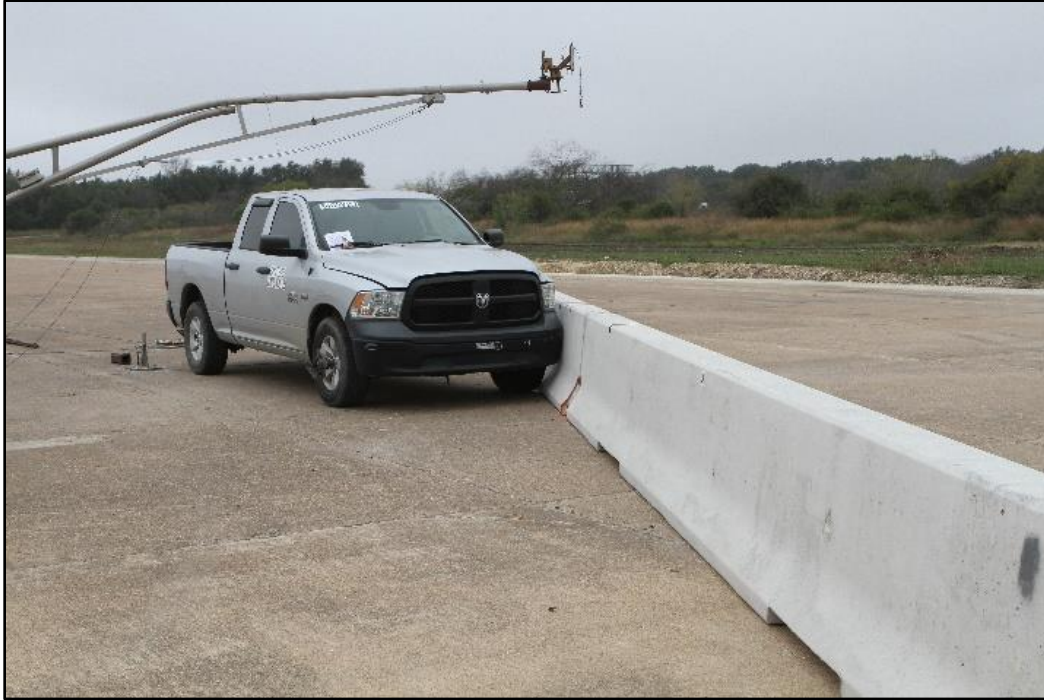
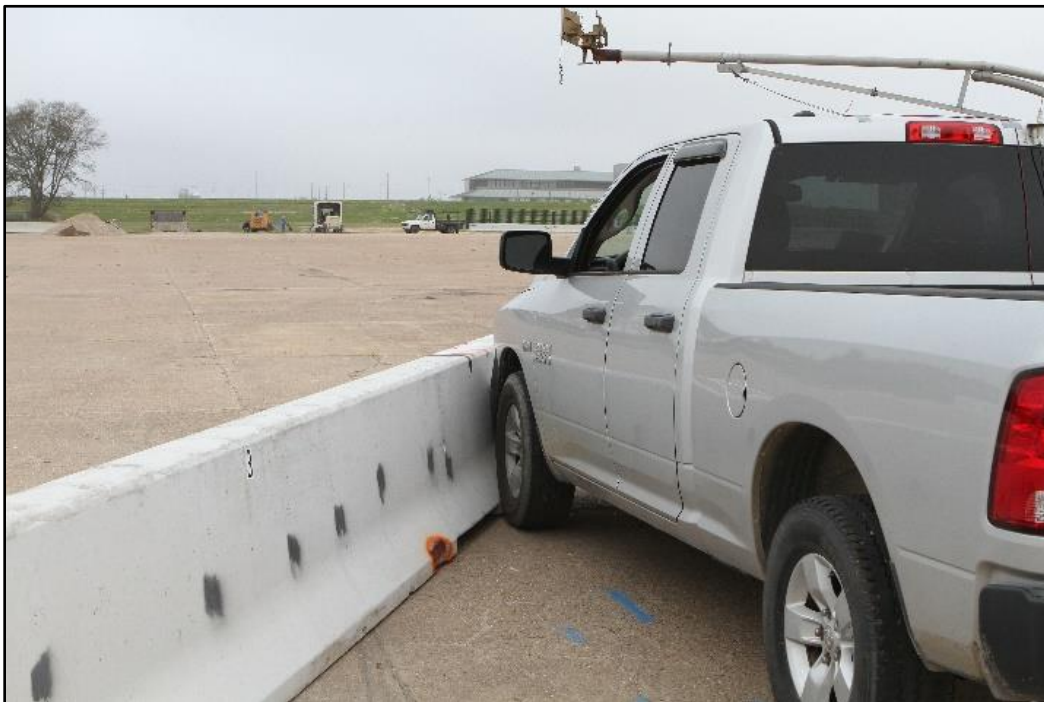
**Figure 6.1. Damaged Portable Concrete Barriers/Test Vehicle Geometrics for Test No. 440592-2, Front View.**

Table 6.1 and Table 6.2 provide details on the *MASH* impact conditions for this test, and Figure 6.1 and Figure 6.2 depict the target impact setup.

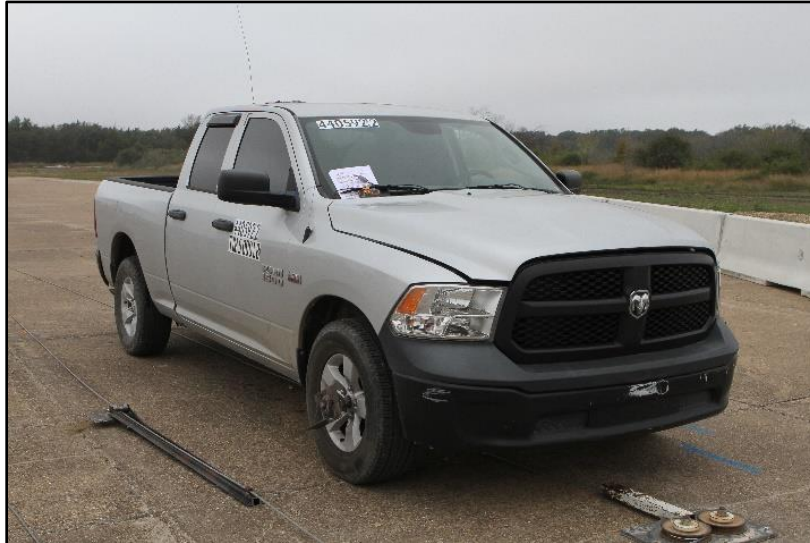
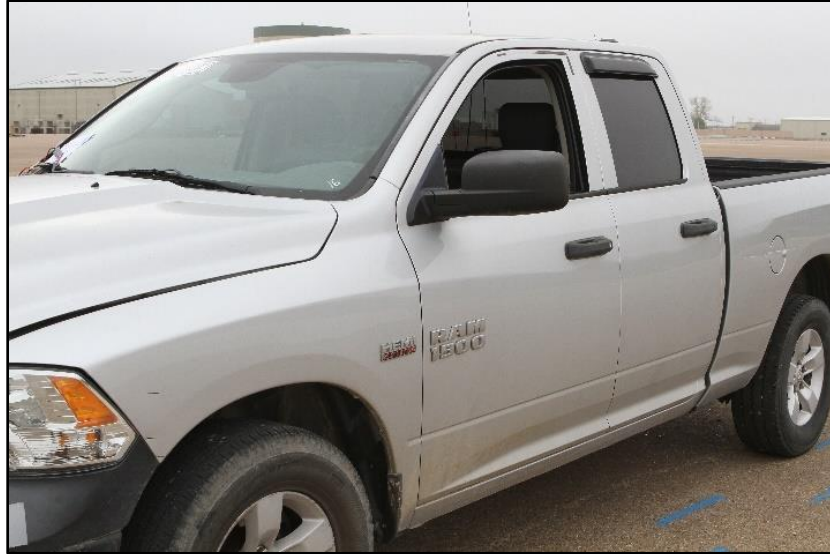
**Figure 6.3. Test Vehicle before Test No. 440592-2, Front View.**

Figure 6.3 and Figure 6.4 show the 2016 RAM 1500 used for the crash test. Table 6.4 shows the vehicle measurements. Table D.1 in Appendix D.1 gives additional dimensions and information on the vehicle.

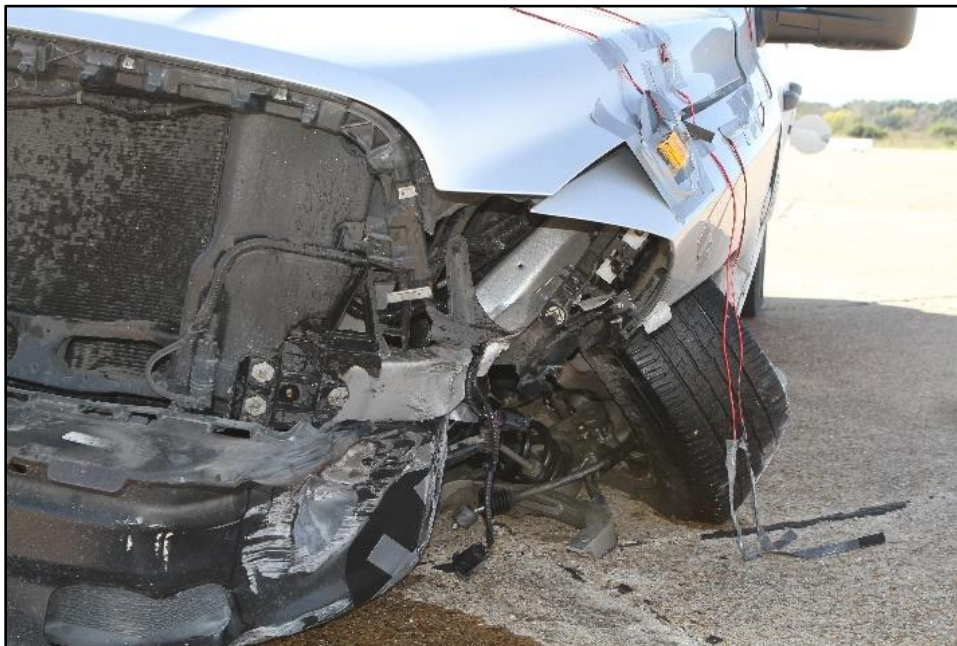
**Figure 6.6. Test Vehicle after Test No. 440592-2.**

Figures D.2 and D.3 in Appendix D.1 provide exterior crush and occupant compartment measurements. Figure 6.6 shows exterior damage to the test vehicle, and Figure 6.7 shows damage inside the test vehicle. Table 6.8 lists the occupant compartment intrusion measurements, and Table 6.9 lists damage to the vehicle.

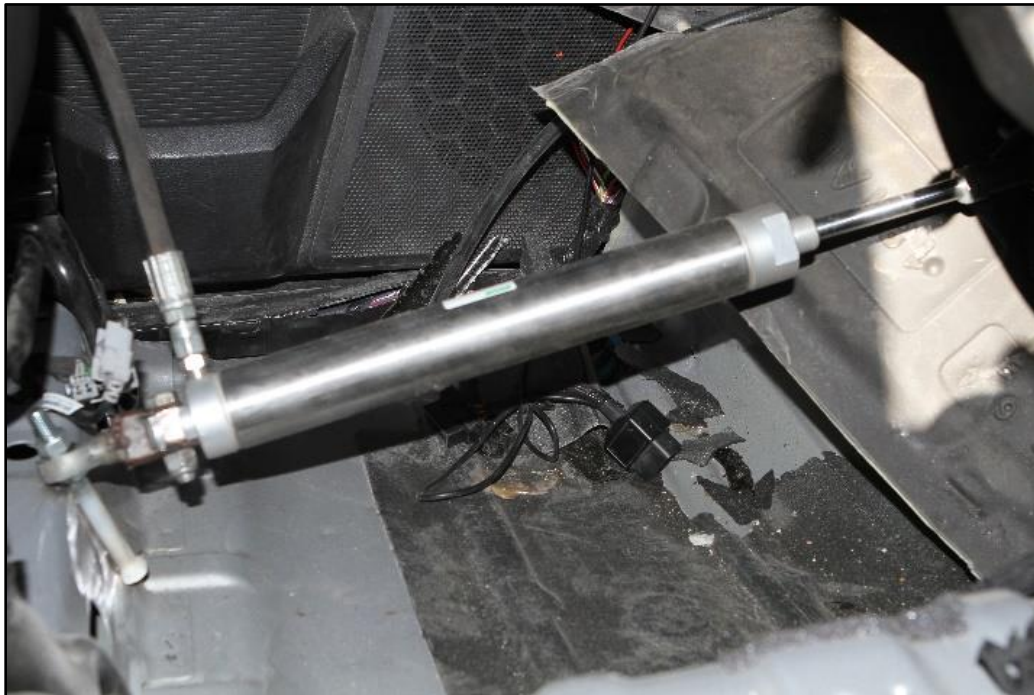
**Figure 6.7. Interior of Test Vehicle after Test No. 440592-2.**

<b>Occupant Risk Values</b>	Longitudinal OIV	19.6 ft/s
	Lateral OIV	23.1 ft/s
	Longitudinal RDA	5.1 g
	Lateral RDA	9.9 g
	THIV	9.1 m/s
	ASI	1.6
<b>Max. 0.050-s Average</b>	Longitudinal	-9.2 g
	Lateral	12.3 g
	Vertical	-3.3 g
<b>Post-Impact Trajectory</b>	Stopping Distance	440 ft downstream, 95 ft on traffic side
<b>Vehicle Stability</b>	Maximum Roll Angle	14°
	Maximum Pitch Angle	11°
	Maximum Yaw Angle	40°
	Vehicle Snagging	No indication of snagging
	Vehicle Pocketing	No indication of pocketing
<b>Test Article Deflections</b>	Dynamic	56 inches
	Permanent	56 inches
	Working Width	79.9 inches
	Height of Working Width	3 inches
<b>Vehicle Damage</b>	VDS	11LFQ5
	CDC	11FLEW3
	Max. Exterior Deformation	14 inches at left front bumper
	Max. Occupant Compartment Deformation	8½ inches, left toe pan area

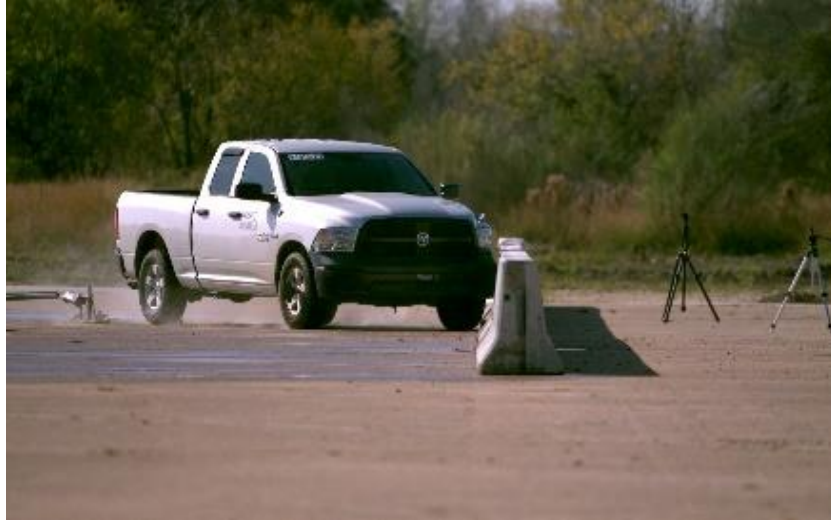
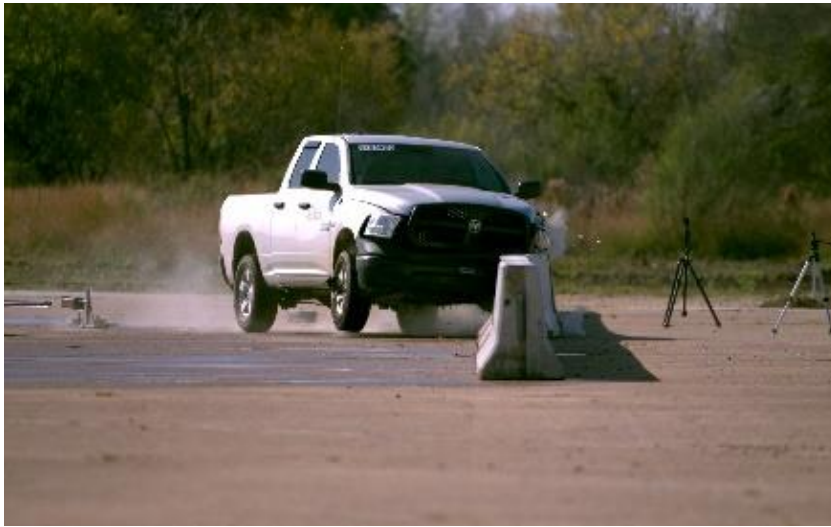
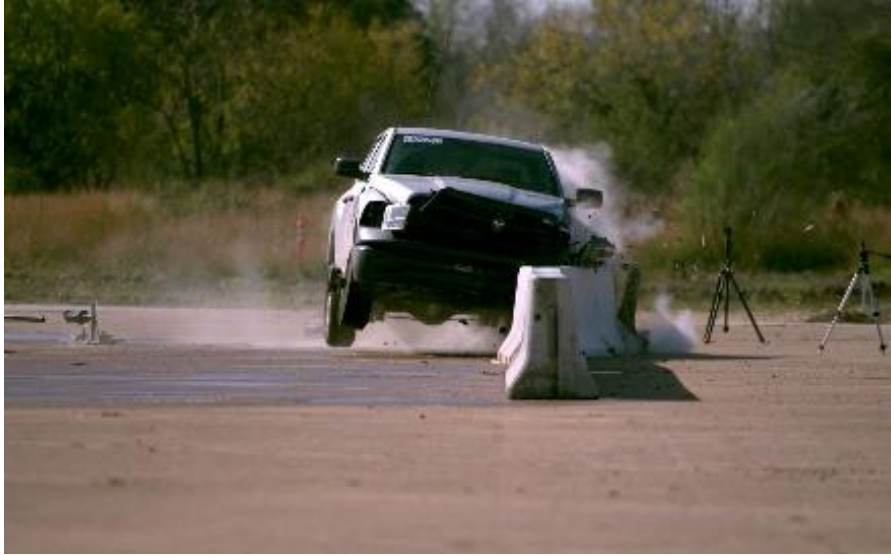
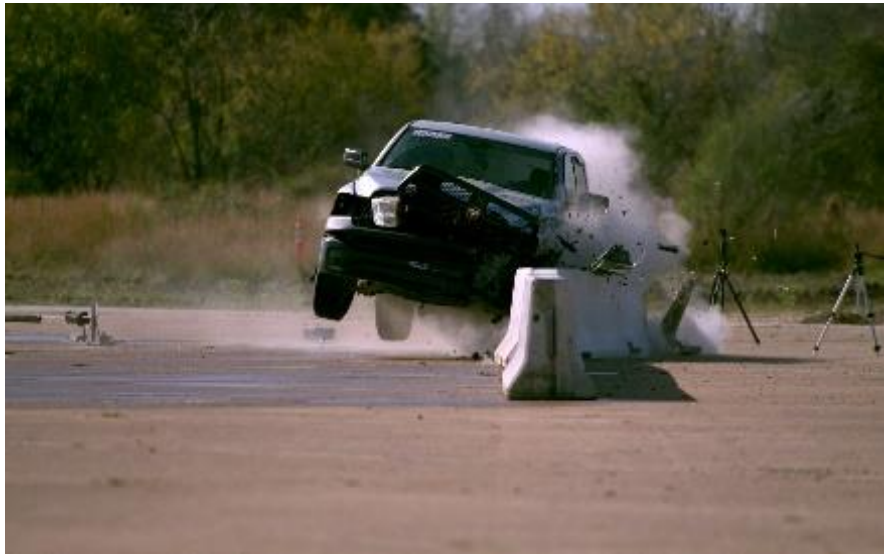
**Figure 6.8. Summary of Results for Test No. 440592-2, Sequential Test Pictures.**

Time (s)	Events
0.0000	Vehicle impacts the installation
0.0410	Vehicle begins to redirect
0.0425	Crack begins to form on field side of barrier 4 near joint 3–4
0.0790	Front passenger side tire lifts off pavement
0.1440	Rear passenger side tire lifts off pavement
0.2340	Vehicle travels parallel with installation
0.5910	Front passenger side tire makes contact with the pavement

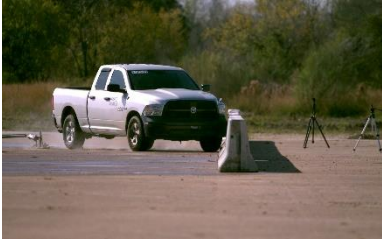
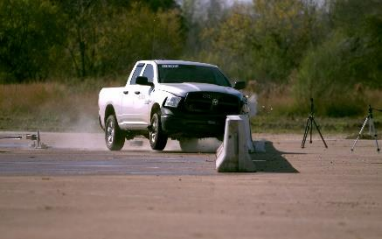
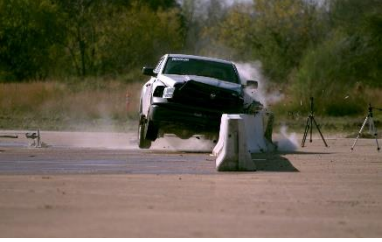
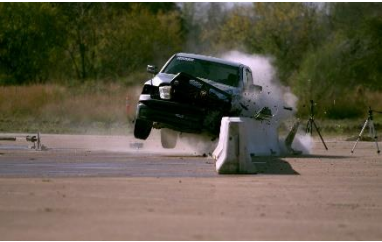
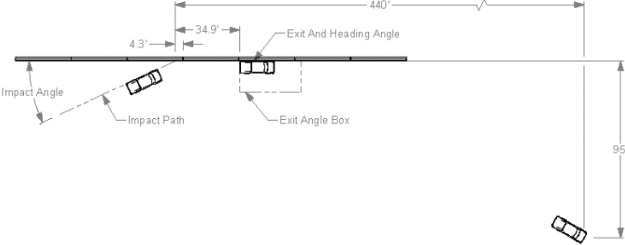
**Figure 6.10. Summary of Results for MASH Test 3-11 on Damaged Portable Concrete Barriers, Test No. 440592-2.**

0.000 s	Test Agency	Texas A&M Transportation Institute (TTI)					
	Test Standard/Test No.	MASH 2016, Test 3-11					
	TTI Project No.	440592-2					
	Test Date	2021-12-08					
<b>TEST ARTICLE</b>							
Type		Portable Concrete Barrier					
Name		Damaged Portable Concrete Barrier					
Length		210 ft 6 inches					
Key Materials		7 F-Shaped Concrete Barriers					
Soil Type and Condition		Concrete Apron, Dry

0.100 s	<b>TEST VEHICLE</b>						
	Type/Designation		2270P				
	Year, Make and Model		2016 RAM 1500				
	Curb Weight (lb)		4990				
Inertial Weight (lb)		5064					
Dummy (lb)		N/A					
Gross Static (lb)		5064

0.200 s	<b>IMPACT CONDITIONS</b>						
	Impact Speed (mi/h)		60.4				
	Impact Angle (deg)		24.9				
	Impact Location		4.3 ft upstream of the center of the joint between barriers 3 and 4				
Impact Severity (kip-ft)		109.5

0.300 s	<b>EXIT CONDITIONS</b>						
	Exit Speed (mi/h)		Out of view (not measurable)

Trajectory/Heading Angle (deg)		Out of view (not measurable)				
	Exit Box Criteria		Vehicle crossed exit angle box				
Stopping Distance		440 ft downstream of impact point 95 ft to the traffic side of the installation					
<b>TEST ARTICLE DEFLECTIONS</b>							
Dynamic (inches)		56					
Permanent (inches)		56					
Working Width/Height (inches)		79.9/3					
<b>VEHICLE DAMAGE</b>							
VDS		11LFQ5					
CDC		11FLEW3					
Max. Ext. Deformation (inches)		14, at Left Front Bumper					
Max Occupant Compartment Deformation (inches)		8½, Left Toe Pan Area					
<b>OCCUPANT RISK VALUES</b>							
Long. OIV (ft/s)	19.6	Long. Ridedown (g)	5.1	Max 50-ms Long. (g)	-9.2	Max Roll (deg)	14
Lat. OIV (ft/s)	23.1	Lat. Ridedown (g)	9.9	Max 50-ms Lat. (g)	12.3	Max Pitch (deg)	11
THIV (m/s)	9.1	ASI	1.6	Max 50-ms Vert. (g)	-3.3	Max Yaw (deg)	40

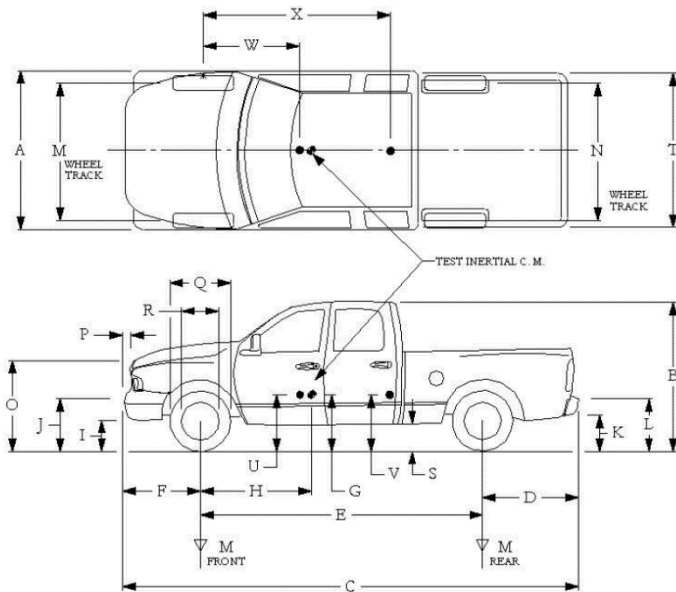
Geometry:		inches			
A	78.50	F	40.00		
B	74.00	G	28.6		
C	227.50	H	59.58		
D	44.00	I	11.75		
E	140.50	J	27.00		
	Wheel Center Height Front	14.75	Wheel Well Clearance (Front)	6.00	
	Wheel Center Height Rear	14.75	Wheel Well Clearance (Rear)	9.25	
			Bottom Frame Height - Front	12.50	
			Bottom Frame Height - Rear	22.50	
K	20.00	P	3.00	U	26.75
L	30.00	Q	30.50	V	30.25
M	68.50	R	18.00	W	59.5
N	68.00	S	13.00	X	79
O	46.00	T	77.00

RANGE LIMIT: A=78 ±2 inches; C=237 ±13 inches; E=148 ±12 inches; F=39 ±3 inches; G = > 28 inches; H = 63 ±4 inches; O=43 ±4 inches; (M+N)/2=67 ±1.5 inches

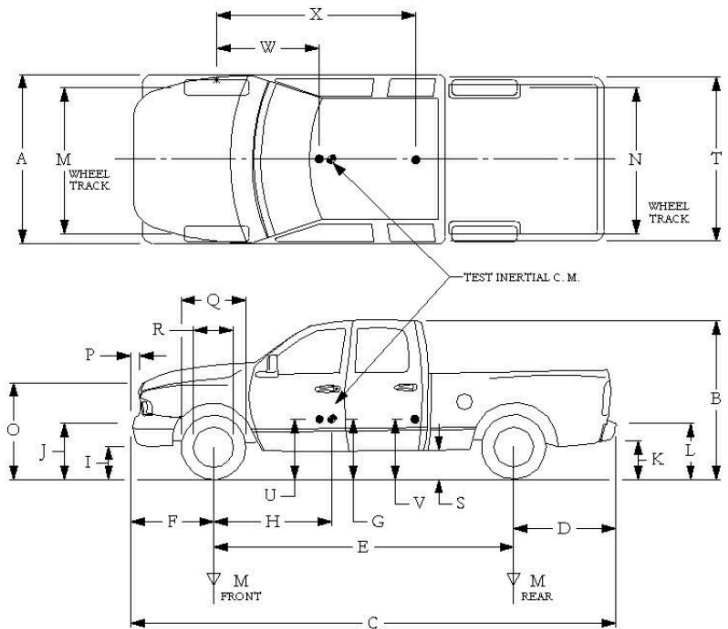
Figure D.1. Vehicle Properties for Test No. 440592-2.

lb LF: 1470 RF: 1401 LR: 1074 RR: 1119

Date: 2021-12-08 Test No.: 440592-2 VIN No.: 1C6RR6FT3GS10751  
 Year: 2016 Make: RAM Model: 1500

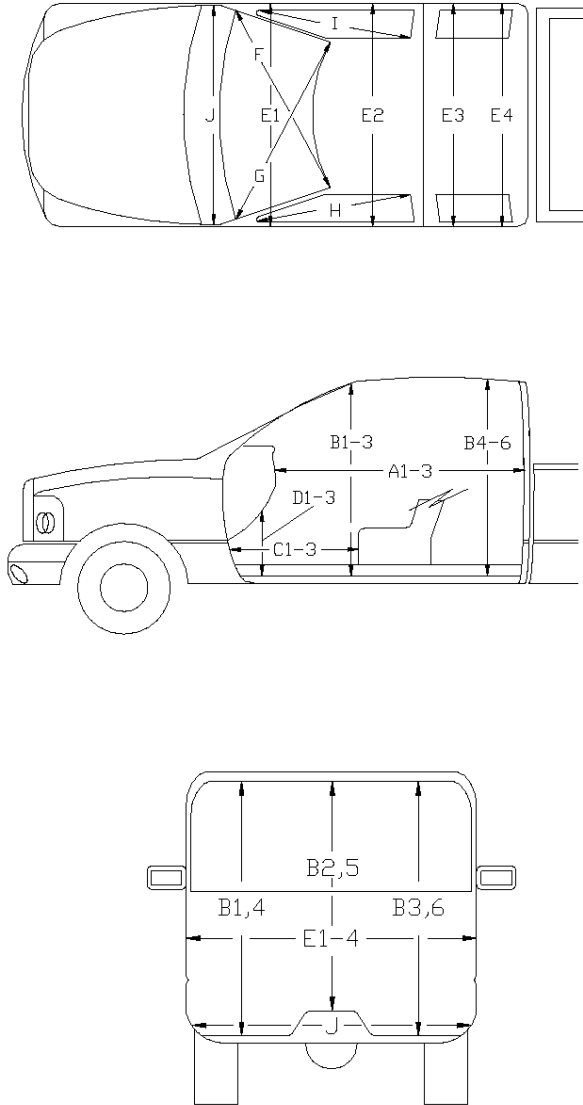
**OCCUPANT COMPARTMENT DEFORMATION MEASUREMENT**

Before	After (inches)	Differ.
A1	65.00	65.00	0.00
A2	63.00	63	0.00
A3	65.50	65.50	0.00
B1	45.00	45.00	0.00
B2	38.00	38.00	0.00
B3	45.00	45.00	0.00
B4	39.50	39.50	0.00
B5	43.00	43.00	0.00
B6	39.50	39.50	0.00
C1	26.00	17.5	8.5
C2	0.00	0.00	0.00
C3	26.00	26.00	0.00
D1	11.00	11.00	0.00
D2	0.00	0.00	0.00
D3	11.50	11.50	0.00
E1	58.50	59.5	1
E2	63.50	64.5	1
E3	63.50	63.50	0.00
E4	63.50	63.50	0.00
F	59.00	59.00	0.00
G	59.00	59.00	0.00
H	37.50	37.50	0.00
I	37.50	37.50	0.00
J*	25.00	21.5	3.5

\*Lateral area across the cab from driver's side kickpanel to passenger's side kickpanel.
