Thermal Segregation Influence on Current Asphalt Mixtures

Technical Report 0-7075-R1

TEXAS A&M TRANSPORTATION INSTITUTE
COLLEGE STATION, TEXAS

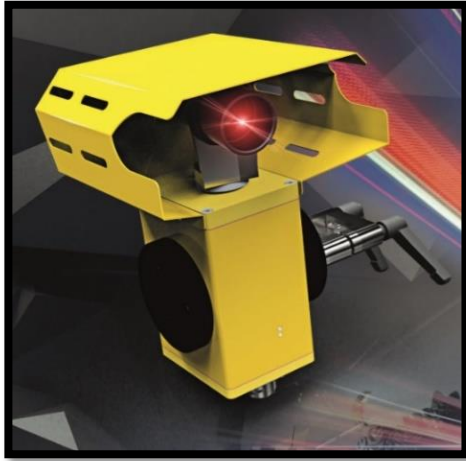
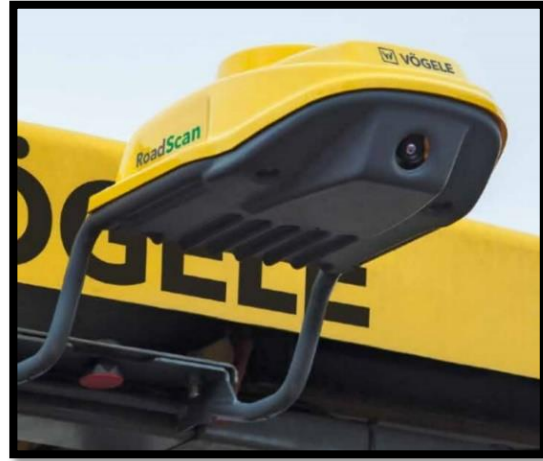
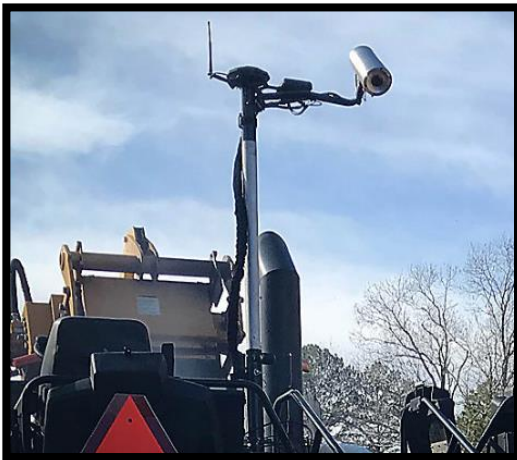
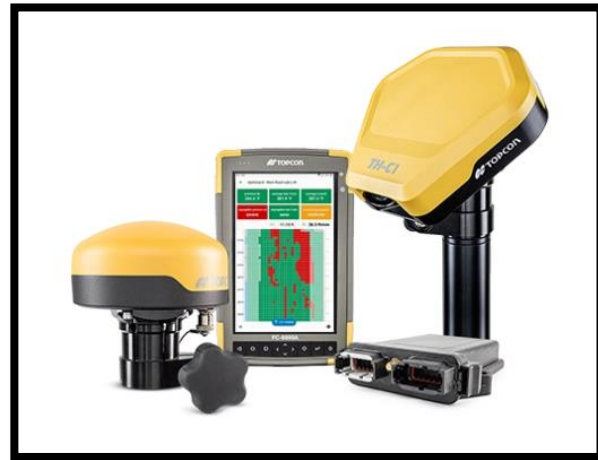
Figure 1. Representative Views of Thermal Profile Test Systems (3–6).

Figure 1 shows representative views of key hardware from these manufacturers for each system. Table 1 summarizes the key characteristics of each system.

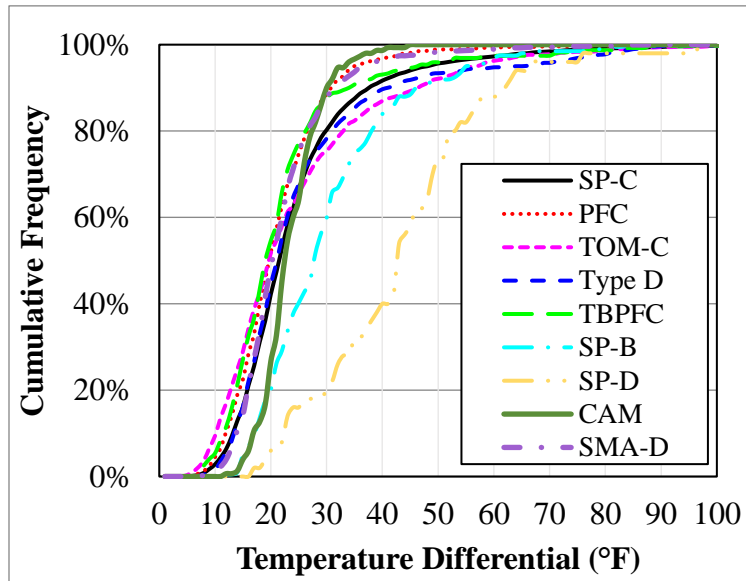
Figure 17. Temperature Differential Distributions by Mix Type.

believe results from that mix in Figure 17 may not reflect the expected outcome typically observed for that mix type if more data were available.

- The amount of moderate thermal segregation was similar, around 20 to 30 percent, for the SP-C, PFC, TOM-C, Type D, TBPFC, and SMA-D mixes. Of these mixes, the PFC and SMA-D results showed the least percentage of severe thermal segregation, and the TOM-C and Type D mixes showed the most severe thermal segregation. However, results from all these mixes showed less than 10 percent severe thermal segregation.

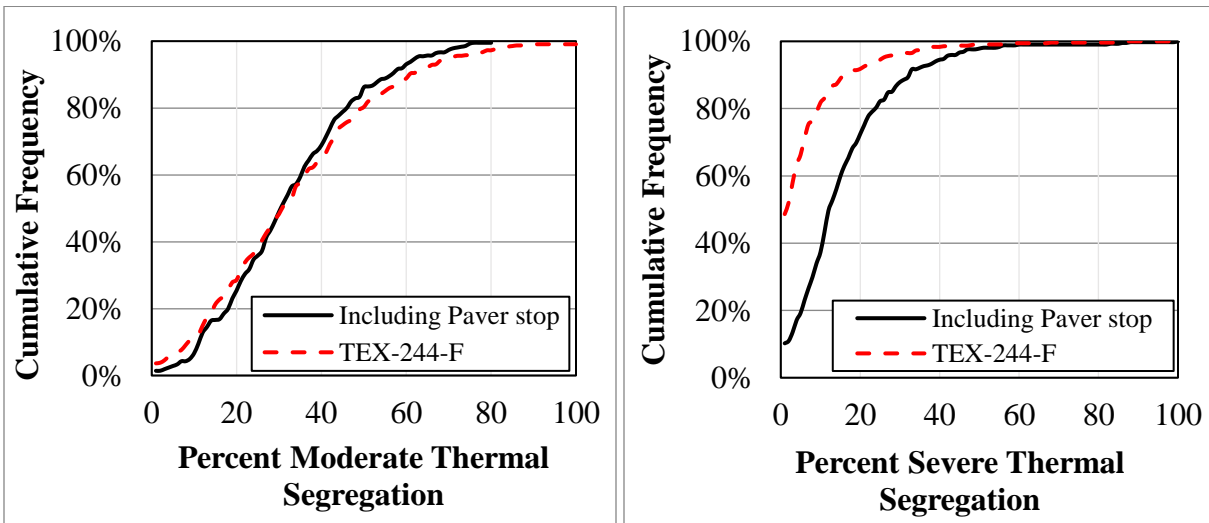
Figure 20. Distributions of Moderate (Left) and Severe (Right) Thermal Segregation with and without the Inclusion of Paver Stops.

By developing the statistical distribution of these results, depicted in Figure 20, researchers define various benchmark reference points. Using Figure 20 as a basis, Table 12 and Table 13 present recommended reference points for moderate and severe thermal segregation, respectively. These tables can be used to gauge how thermal segregation results from a particular paving pull align with typical industry operations. For example, from Table 12 and Table 13, the most uniform 10 percent of paving pulls should have no more than 8 percent moderate thermal segregation and no severe thermal segregation based on Tex-224-F.

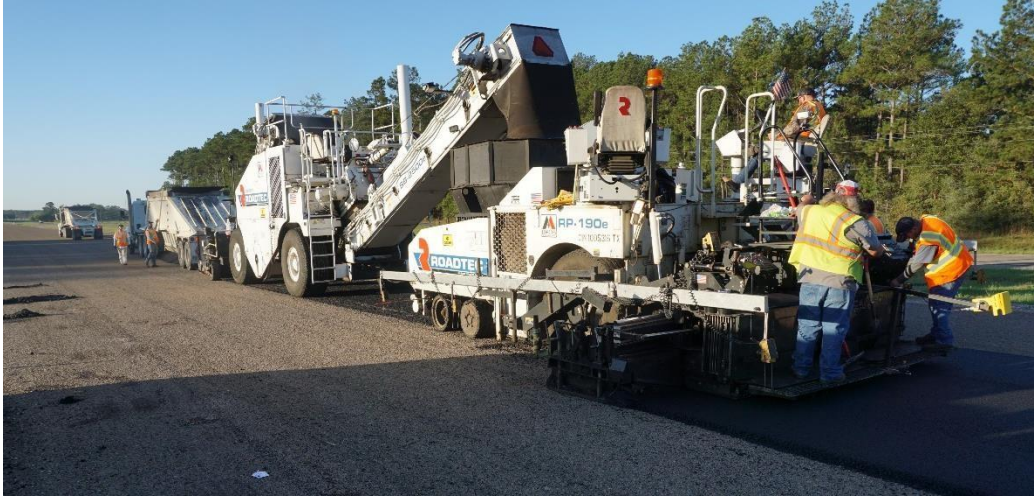
Figure 23. Paving Operation on US 69.

The mix was produced in Lufkin and hauled about 30 mi to the jobsite in tarped belly dump trucks. On site, the trucks maintained a windrow typically 50–100 ft long, from which an SB2500e transferred the mix into an RP-190E paver. The paver laid a mat 15 ft wide. Figure 23 shows the paving operation.

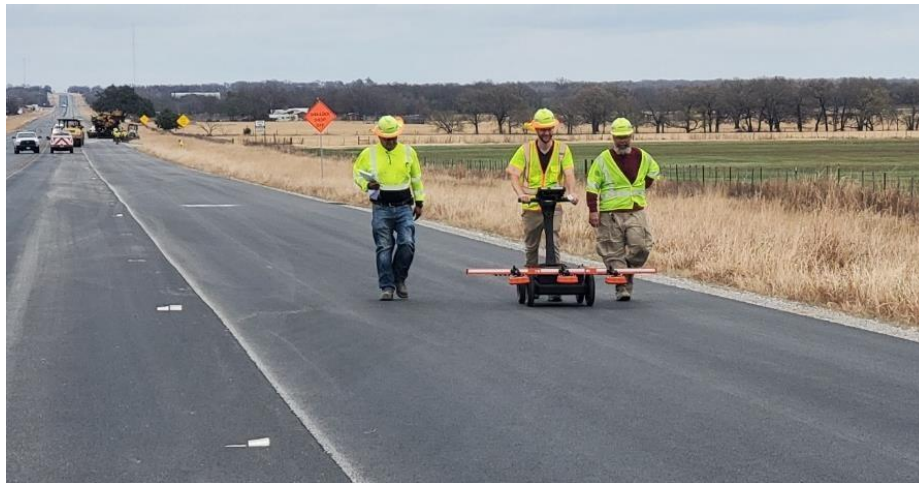
Figure 29. GPR Survey on the In-Place Mat with Multichannel GPR.

along with these selected locations. To gather additional data, researchers conducted GPR readings at each core location before extracting the cores. Figure 29 shows researchers collecting GPR data with a multichannel system.

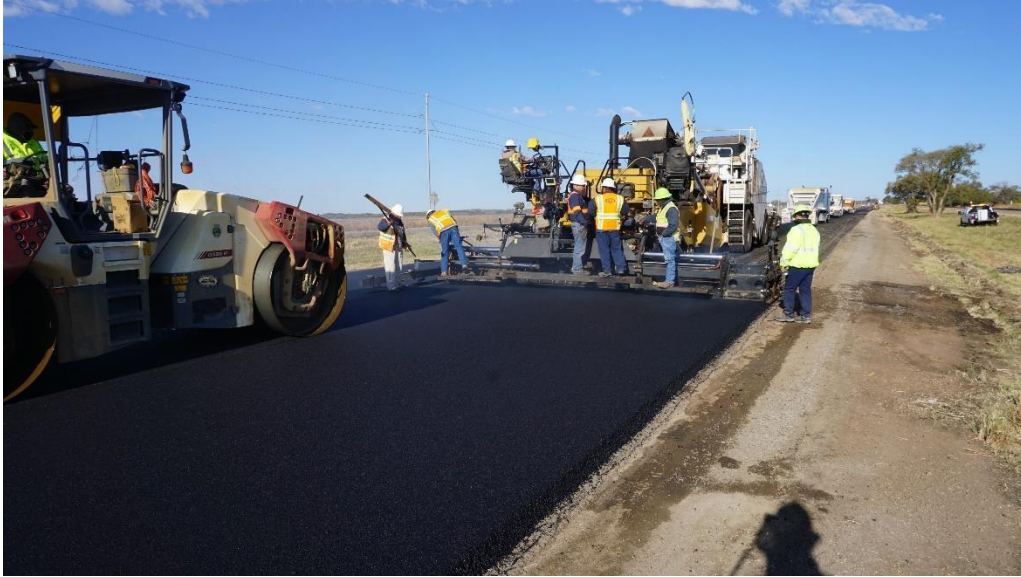
Figure 34. Paving Operation on US 287.

The mix was produced in Ashtola and hauled about 35 mi to the jobsite in tarped belly dump trucks. On site, the trucks maintained a windrow typically 50–100 ft long, from which a SB2500D transferred the mix into an AP1055E paver. The paver laid a mat 22 ft wide. Figure 34 shows the paving operation.

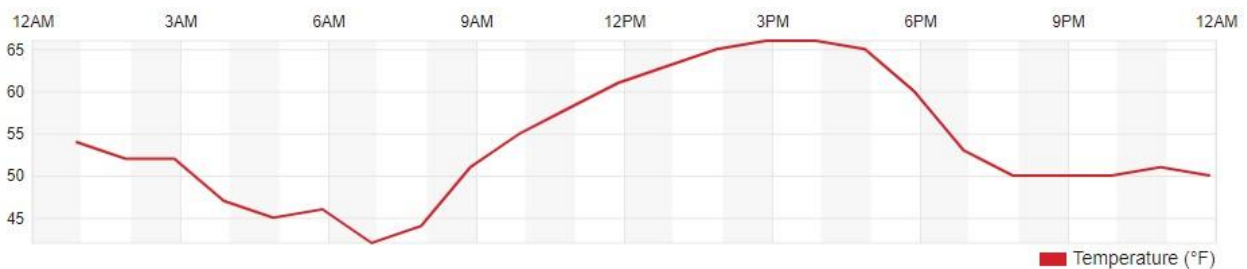
Figure 35. Air Temperature during US 287 Paving.

On the day of testing, ambient air temperatures ranged from 42 to 66°F, with light winds at approximately 5 mph from the north and then shifting from the south in the afternoon. Figure 35 and Figure 36 show the air temperature and wind speeds, respectively, as recorded at the Childress Municipal Airport throughout the day.

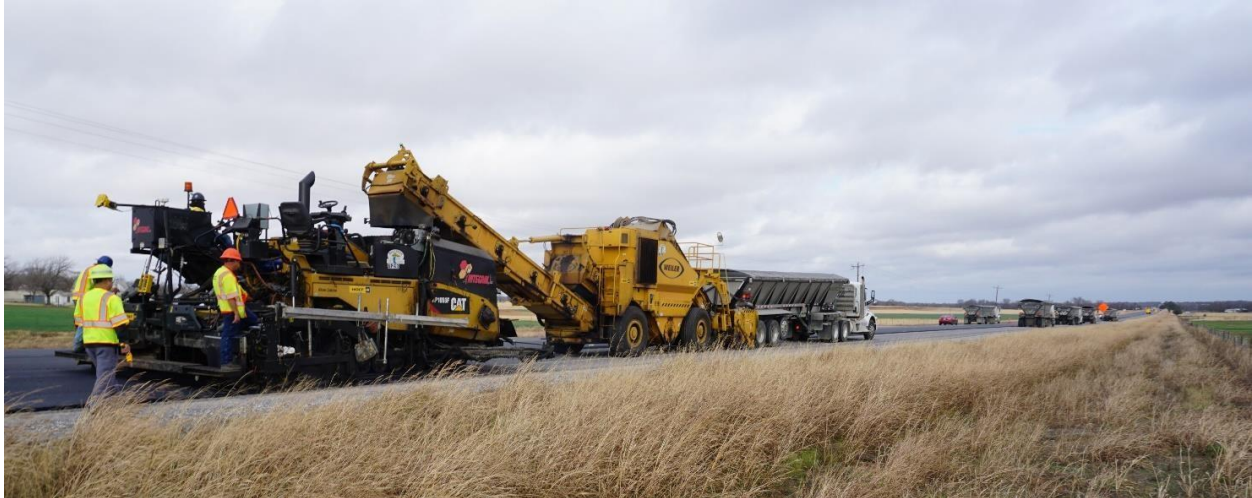
Figure 48. Paving Operation on US 183.

The mix was produced in Gorman and hauled about 22 mi to the jobsite in tarped flow-boy and end dump trucks. On site, the trucks dumped directly into an E1650 transfer device, which transferred the mix into an AP1055F paver. The paver laid a mat 16.5 ft wide. Figure 48 shows the paving operation.

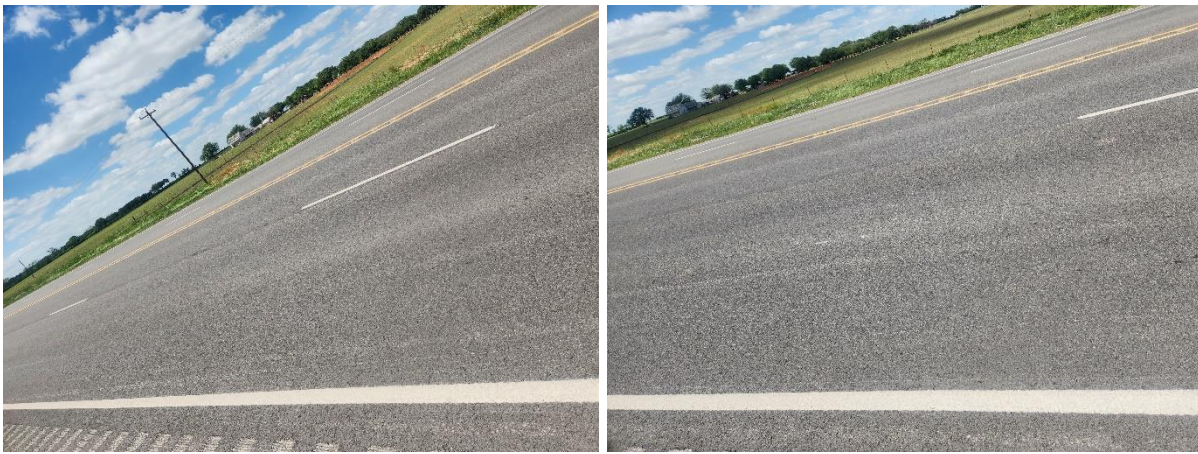
Figure 58(a) shows an excerpt from the 1-GHz air-coupled GPR survey. No significant distress was observed at the post-construction site, as shown in Figure 58(b).

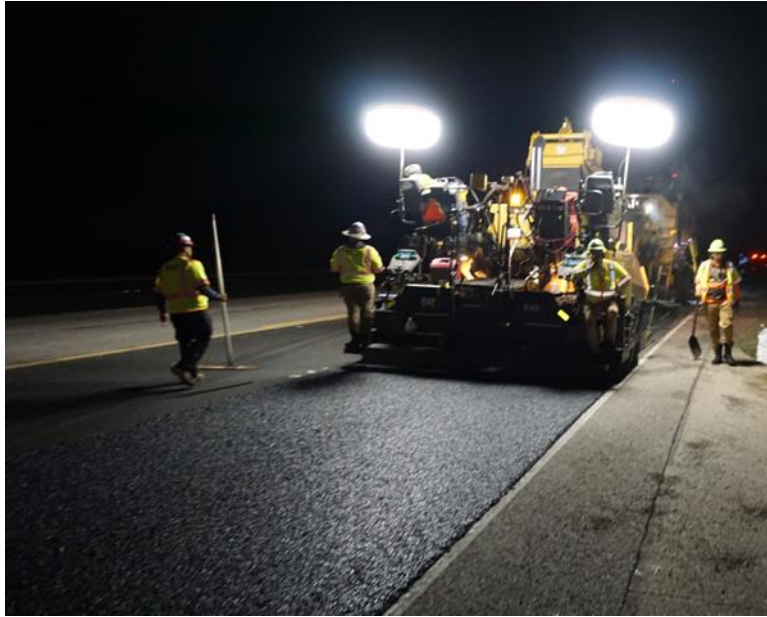
Figure 61. Paving Operation on SH 6.

The mix was produced in Lorena, Texas, and hauled about 65 mi to the jobsite in tarped belly dump and flow-boy trucks. On the jobsite, belly dump transports windrowed the entire transport, and flow-boy transports placed the entire transport into multiple small piles along the pavement surface until the transport was emptied. The mix was then picked up with an E1650 material transfer device and placed into the AP1055F paver. The paver produced a mat 13 ft wide. Figure 61 shows the paving operation.

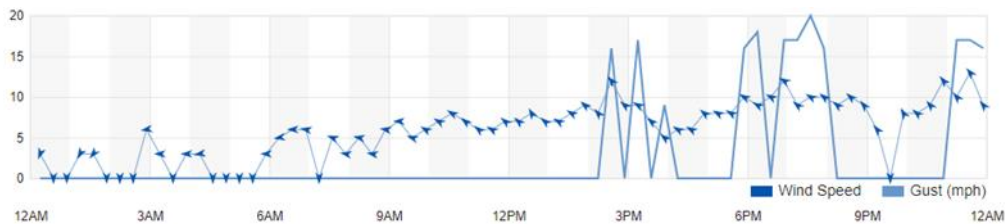
Figure 63. Wind Speeds during SH 6 Paving.

After laydown, a CB64B roller performed breakdown rolling, typically applying five passes per side plus one central pass to complete the pattern. There was no intermediate rolling, and a second CB64B roller performed finish rolling without vibration. On the testing day, paving started at about 9:00 p.m. The demonstration section ended at about 12:00 a.m. Ambient air temperatures that day ranged from 60 to 70°F, and winds were approximately 10 mph from the east/southeast. Figure 62 and Figure 63 show the air temperature and wind speeds, respectively, as recorded at the Hearne Municipal Airport throughout the day.

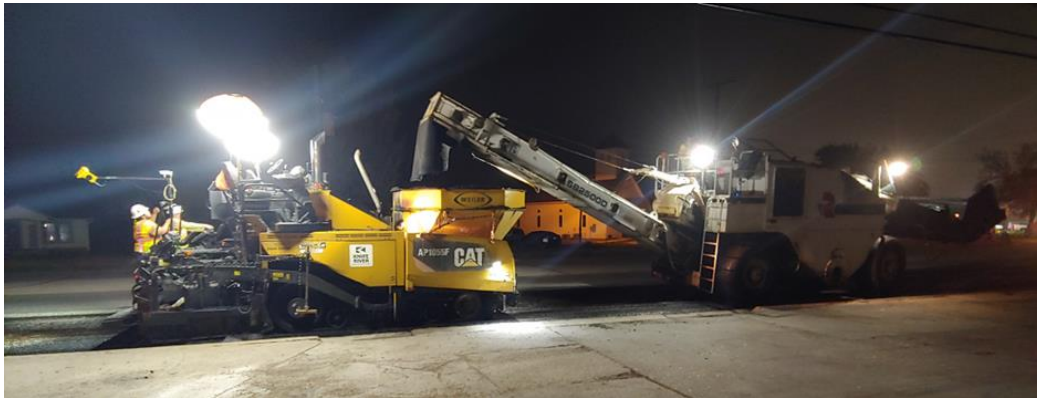
Figure 69. Paving Operation on SH 105.

The mix was produced in Bryan, Texas, and hauled about 35 mi to the jobsite in tarped belly dump trucks. On site, the trucks windrowed the entire transport, from which an SB2500D transferred the mix into an AP1055E paver. The paver laid a mat 12 ft wide. Figure 69 shows the paving operation.

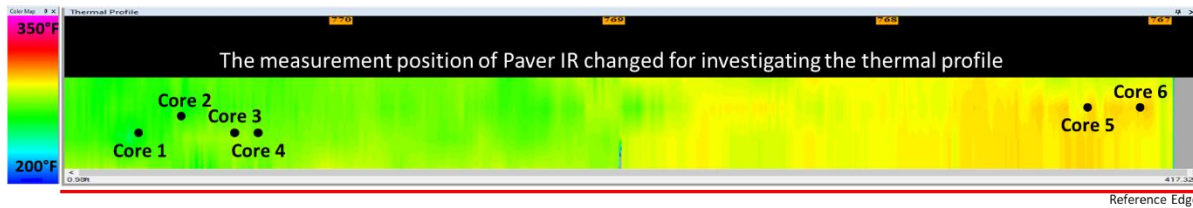
Figure 74. SH 105 Thermal Plot with Core Locations.

Based on the results shown in Table 32, researchers identified six core locations from the thermal profiles to represent the temperature differentials observed. Figure 74 shows the thermal plot along with these selected locations. Researchers collected a GPR reading at each core location before extracting the core. In this project, the thermal scanner was not properly aligned at the start of the pull, which is why the top portion of Figure 74 includes data off the mat.

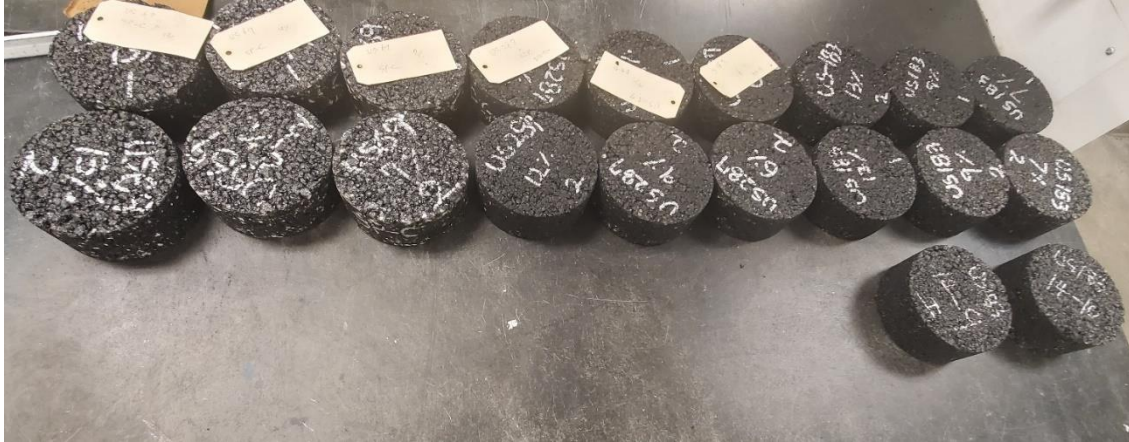
Figure 76. Example Trial Samples.

Researchers fabricated trial samples by compacting cylindrical specimens (Figure 76) using the SP gyratory compactor. The specimens for determining the mechanical and volumetric properties of HMA were prepared, and the density of test specimens during their preparation was monitored. Through several attempts, researchers developed compaction parameters for each mix to attain the target AV contents shown in Table 34.

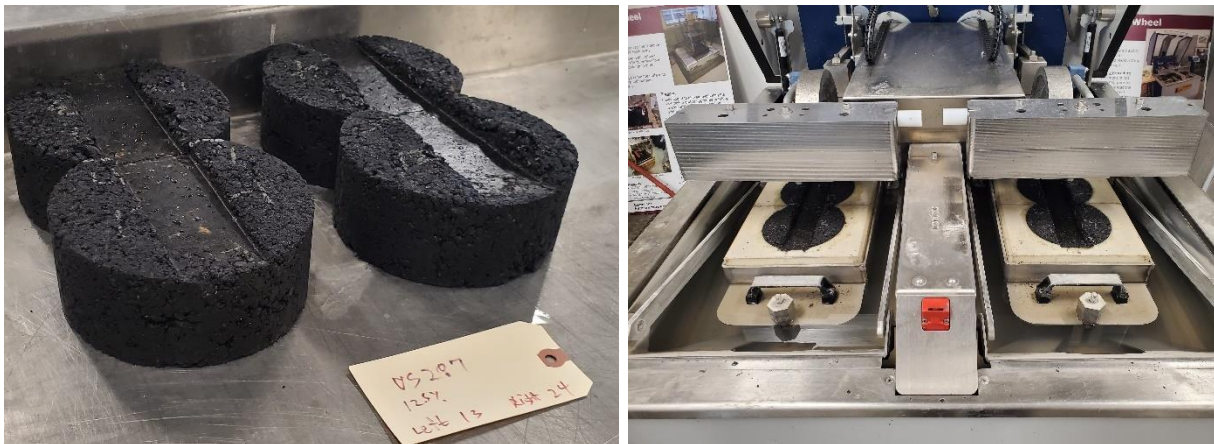
Figure 77. Example Hamburg Test (Tex-242-F).

The Hamburg wheel tracking test (Tex-242-F) determines the premature failure susceptibility of bituminous mixtures due to weakness in the aggregate structure, inadequate binder stiffness, moisture damage, and other factors, including inadequate adhesion between the asphalt binder and aggregate. Researchers followed the preparation guidelines outlined in Tex-241-F for each Hamburg test specimen. However, a modification was made on the density of the specimens. The specimens were intentionally prepared to have low, medium, and high AV contents, as specified in Table 34. Researchers performed the Hamburg test in duplicate for each mix/AV combination. Figure 77 shows example specimens after this wheel track test.

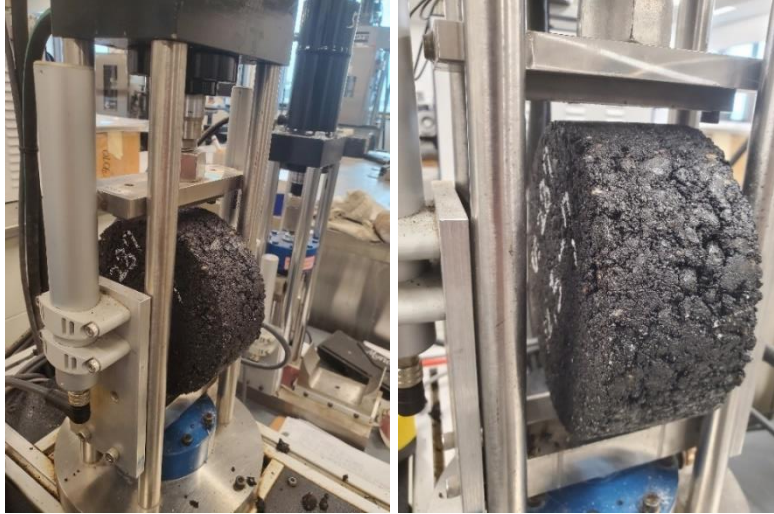
Figure 79. Example IDEAL-CT Test.

The IDEAL-CT, Tex-250-F, determines the cracking tolerance index of compacted bituminous mixtures. Researchers prepared three laboratory specimens for each target AV on the mixes from US 69, US 287, US 183, SH 6, and SH 105. For lab-molded specimens, Tex-250-F requires a specimen diameter of 5.9 in. (150 mm) and a height of 2.4 in. (62 mm) \pm 0.1 in. (2 mm), as well as an AV content of 7 ± 0.5 percent. Thus, the different AV contents used in this lab program represent a deviation from the underlying parameters in the development of the IDEAL-CT. Figure 79 shows the test in progress.

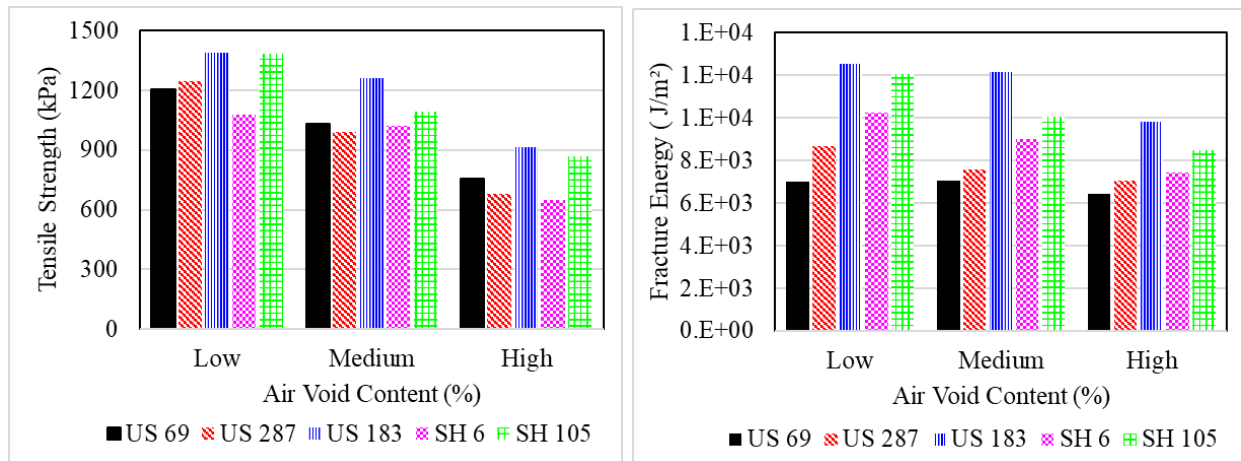
Figure 80. IDEAL-CT Test Results.

Figure 80 shows that increasing AVs decreased strength and fracture energy. The mix from US 183 and SH 105 exhibited comparably higher tensile strength and fracture energy than the other mixes.

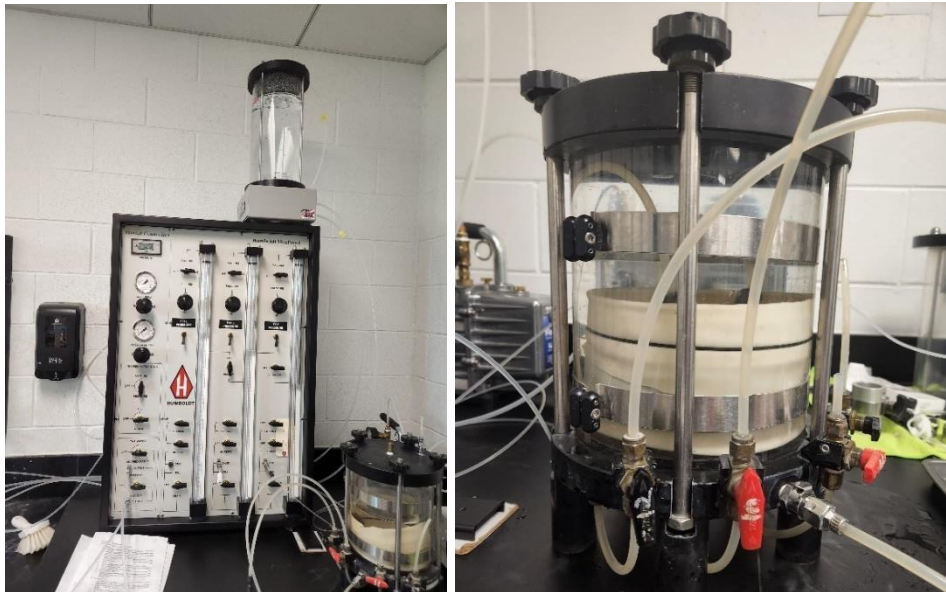
Figure 81. Permeability Test (ASTM D 5084).

Rather than fabricating specimens specifically for permeability testing, researchers conducted the permeability test using field cores from the demonstration projects. Figure 81 shows the test configuration applied to water-saturated porous materials containing virtually no air.

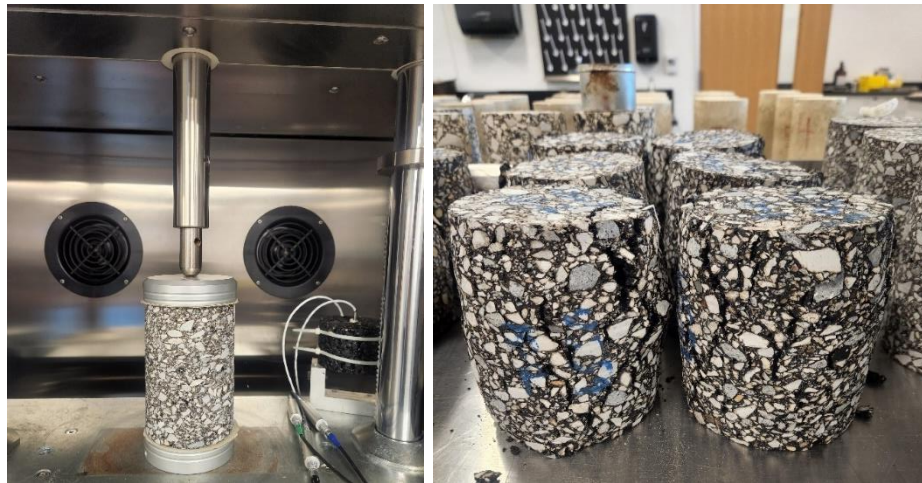
Figure 84. FN Test (Left) and Specimens after Testing (Right).

Researchers followed the guidelines specified in AASHTO T378-17 by using a deviator stress of 600 kPa and a contact stress of 30 kPa. The test was set to terminate at either 10,000 loading cycles or an accumulated 100,000 microstrains, whichever occurred first. For selecting the test temperature, researchers referred to the High Adjusted PG Temperature from LTPP Bind Version 3.1 and chose the climate data from the weather station nearest to the project location. As a result, test temperatures of 154.76, 155.84, and 154.4°F were assigned to the mixes from US 69, US 287, and US 183, respectively. Figure 84 shows the FN test in progress and examples of tested specimens after completion.

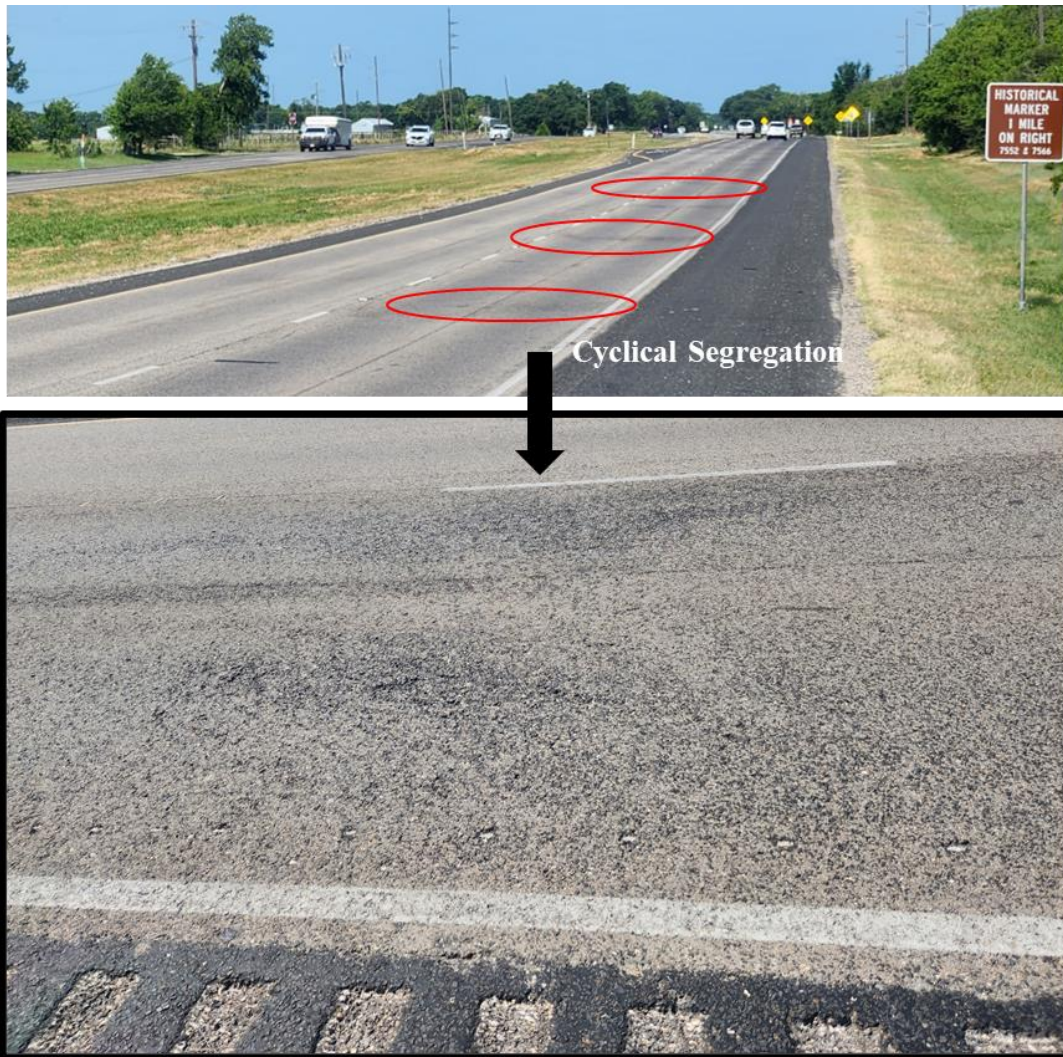
Figure 111. Cyclical Segregation on RMC Project.
