**REPORT 1163-3
EVALUATION OF LOOP DETECTOR INSTALLATION
PROCEDURES AND PREPARATION OF A TEXAS TRAFFIC SIGNAL
DETECTOR MANUAL**

FHWA/TX-90/1163-3

FINAL REPORT

Donald L. Woods

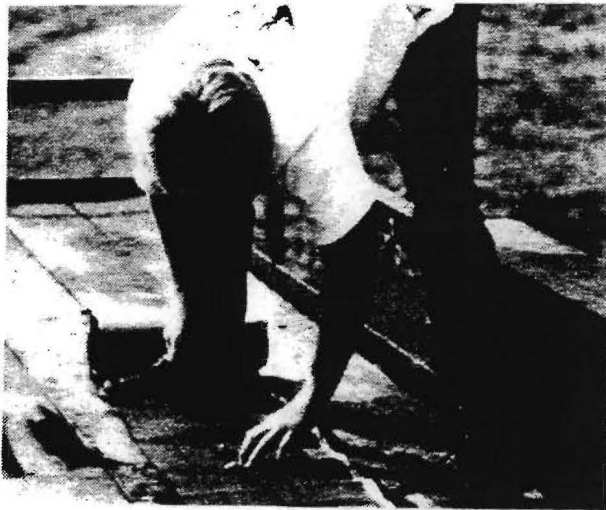
STEP 1

Pavement crack sealing comes in 12, 24, and 48 inch widths as well as 12 foot rolls. For temporary traffic loops, the material must be cut to six inch width.

A sharp pocket knife or a carpet knife work well for cutting the material to size.

Figure 9.1 illustrates the installation procedure for the temporary loop using the bituminous crack sealing material. The procedure in Figure 9.1 requires a considerable amount of time in the traffic lane. An alternative is to lay out the crack sealing material in the shop and place the wire on it. Replacing the wax paper protective sheet after the wire is in place for transport to the field. Installation in the field then requires less than 2 minutes and only one person excluding traffic control. This procedure is easy to use and was found to be very practical.

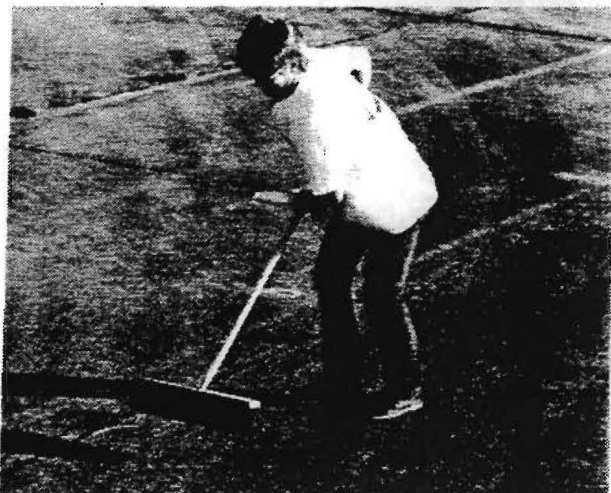
STEP 2

The pavement must be free of loose material and oil.

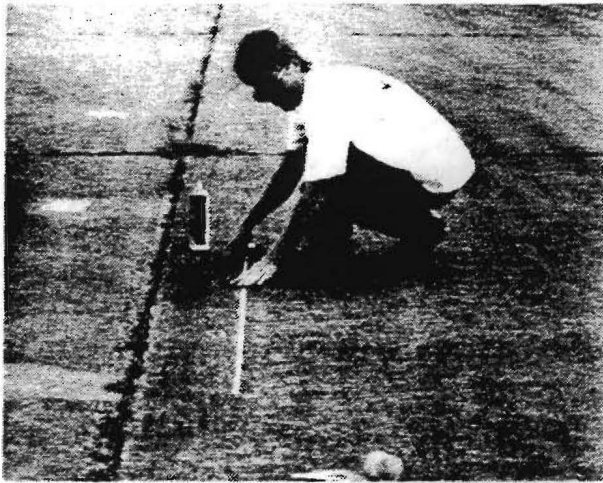
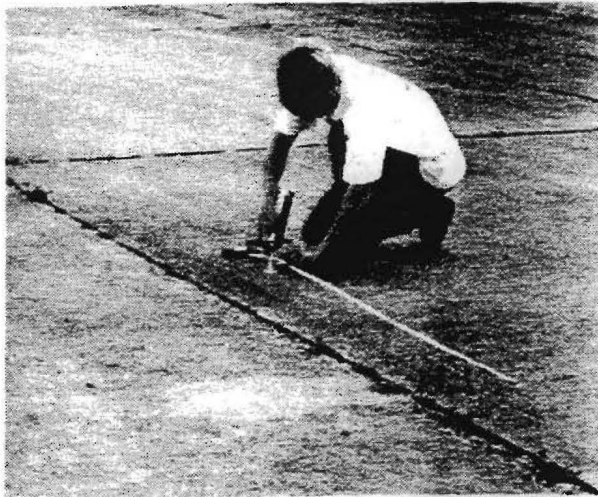
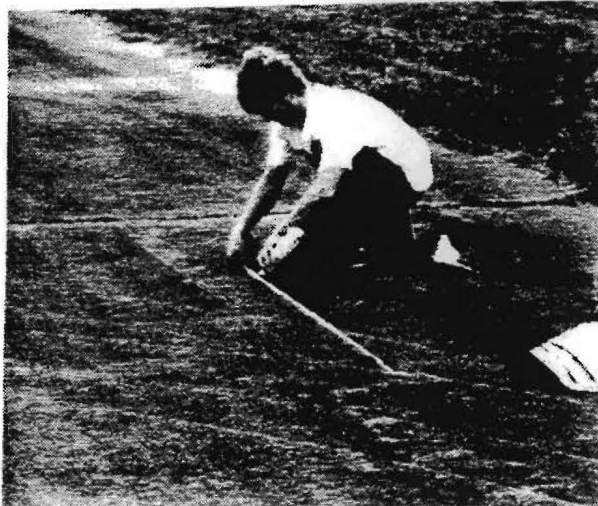
STEP 3

Locate the loop and mark the corners.

Upside down paint works well for this task.

A small dot is usually sufficient.

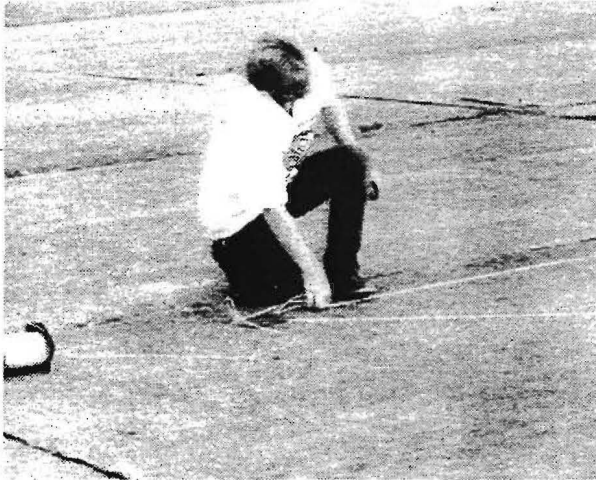
STEP 4

Place 6" x 6" tack strips at each corner and at the midpoints along long runs. Press one side down with the foot but leave the other side loose for the wire to go under.

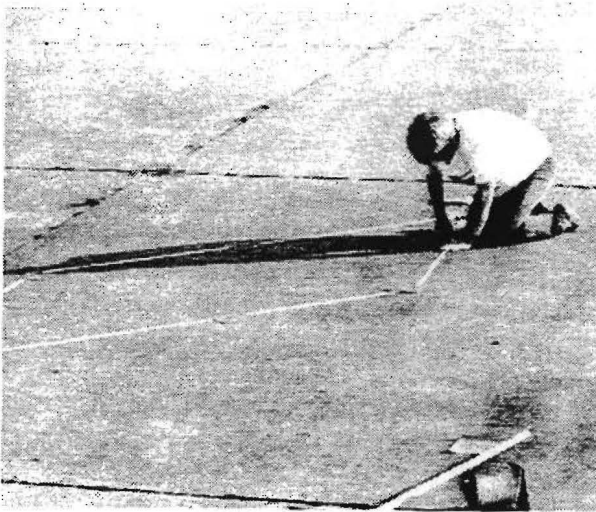
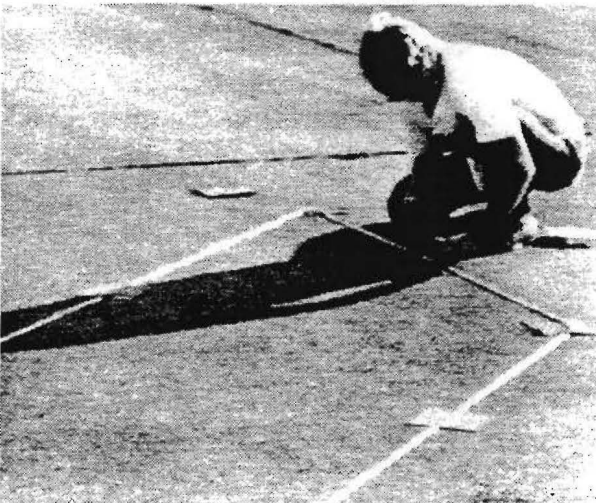
STEP 5

Note tack strips at corners and middle of each side. Place wire by lifting the corner of the tack strip.

Be certain that the wire remains tight.

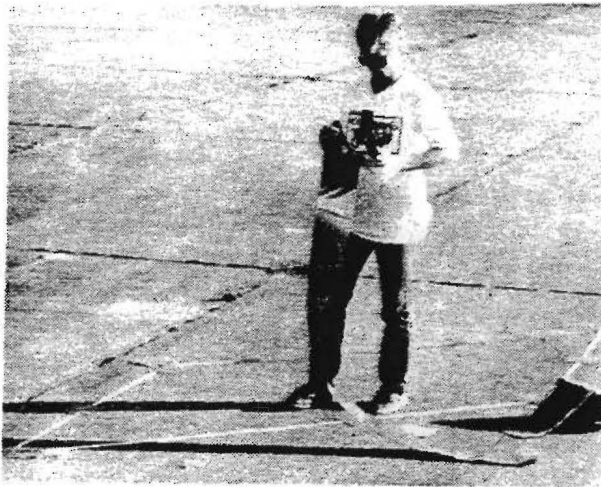
STEP 6

Place hold down fabric over wire and seal with 2" wide crack sealing material strip.

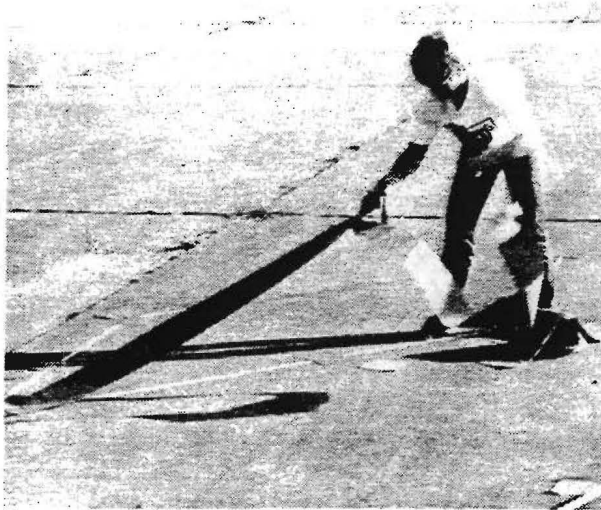
STEP 7

Place 6" wide strip of crack sealing material over the loop wire - hold down - crack sealing material combination.

Press down to adhere crack sealing material to the pavement.

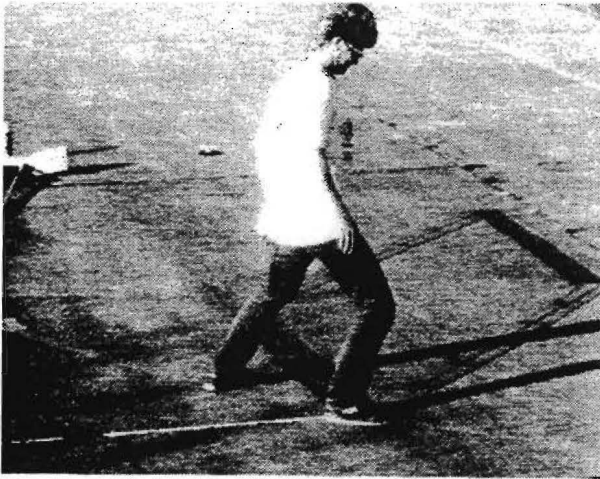
STEP 8

Seal by tamping with the foot or driving a vehicle over it.
