1. Report No. FHWA/TX-88/1179-1	2. Government Accession No.	3. Recipient's Catalog No.	
4. Title and Subtitle CRASH TEST OF MODIFIED TEXAS C202 BRIDGE RAIL		5. Report Date June 1988

CRASH TEST OF MODIFIED TEXAS C202 BRIDGE RAIL

Research Report 1179-1

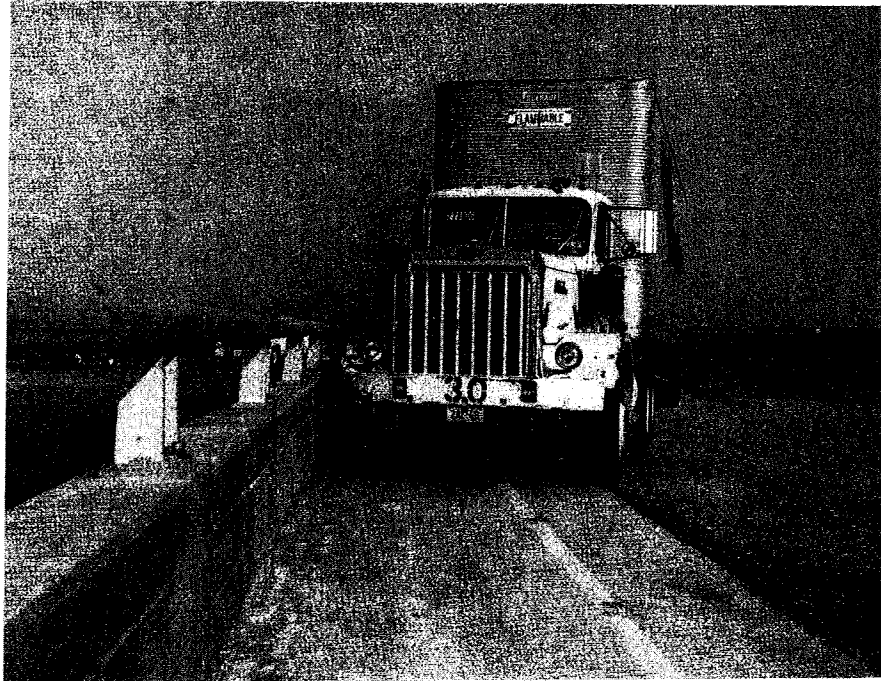
Figure 3. Comparison of the 80,000 lb Truck with Modified Combination Rail.

Drawings of this rail are shown in Figures 1 and 2. Figure 3 contains photographs comparing the size of the combination bridge rail with the van type tractor-trailer used in previous crash tests (1).

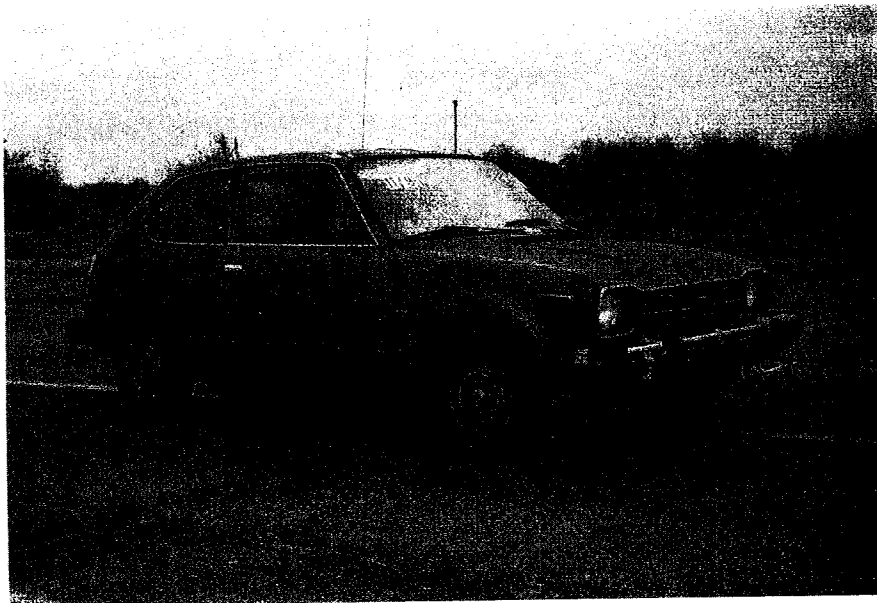
Figure 6. Vehicle before test 1179-1.

This bridge rail was crash tested with a 1979 Honda Civic weighing 1,750 lb (795 kg) but with a gross weight of 1,918 lb (871 kg) including a dummy. A drawing showing the dimensions of this vehicle along with the weights on each axle is shown in Figure 5. Before and after test photographs of the Honda are presented in Figures 6 and 7.

example of this is the 1,800 lb Honda Civic used in NCHRP 230 Test No. S13 (see Figure 6). Hood contact with posts have never been observed in tests with this vehicle.

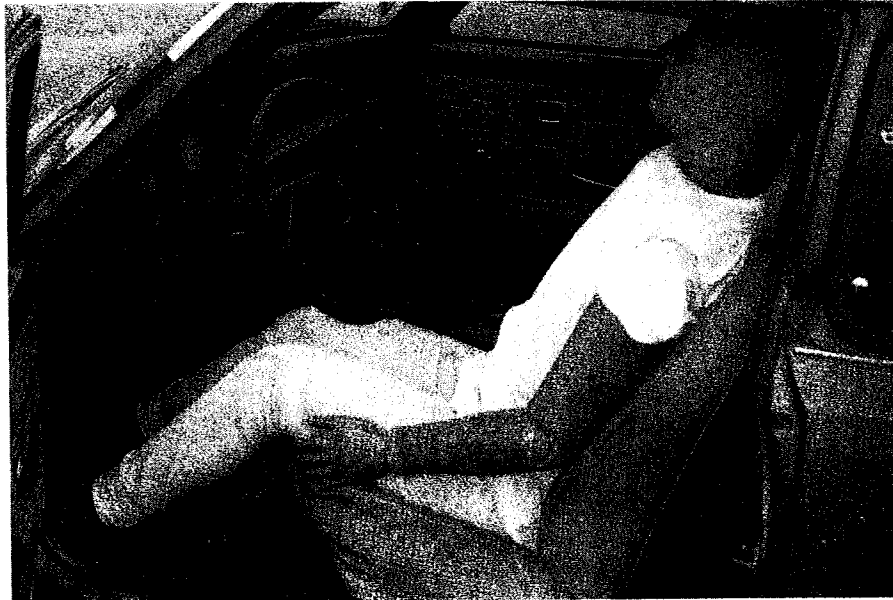
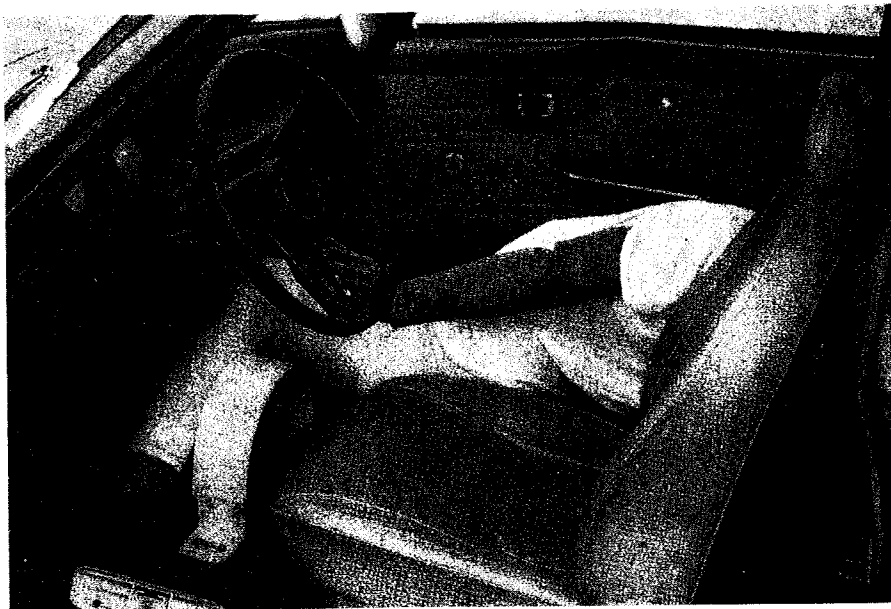
Figure 10. Anthropomorphic dummy before and after test 1179-1.

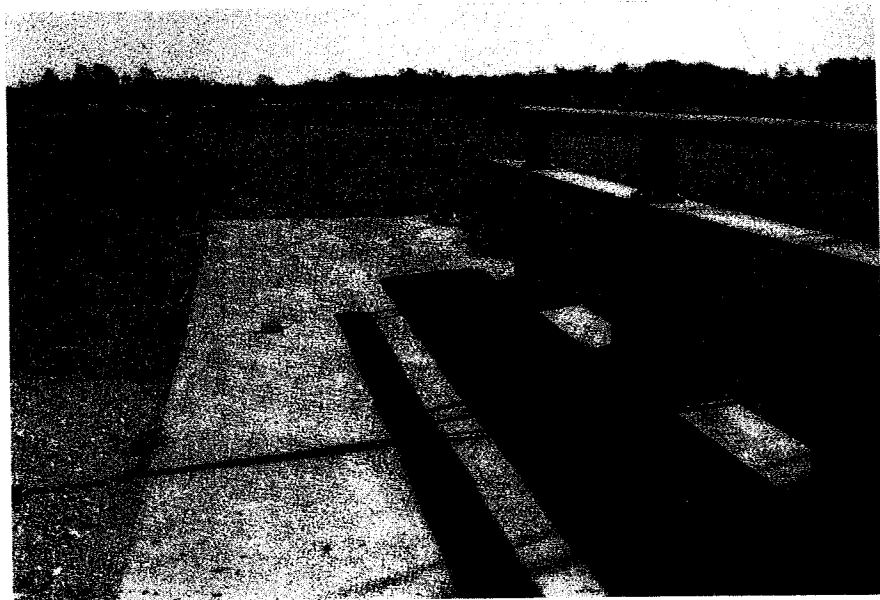
Figure 15. Bridge rail after test 1179-2.

The Cadillac impacted the rail at 59.4 mph (95.6 km/h) and 25.9° angle. Impact occurred 7.5 ft upstream of post 11 and was smoothly redirected. Figure 15 shows the bridge rail and test site immediately after test 1179-2. The Cadillac sustained damage to the right front and right side. The right front tire made light contact with concrete post 11 and the hood came in contact with the metal post directly above concrete post 11. This post contact caused slight damage to the front right tire and suspension; however, it was still rolling after contact. Severe damage to the hood resulted when it contacted the steel post and it cracked the right front windshield which is shown in Figure 14. The hood pushed the windshield inward several inches but did not penetrate the passenger compartment.

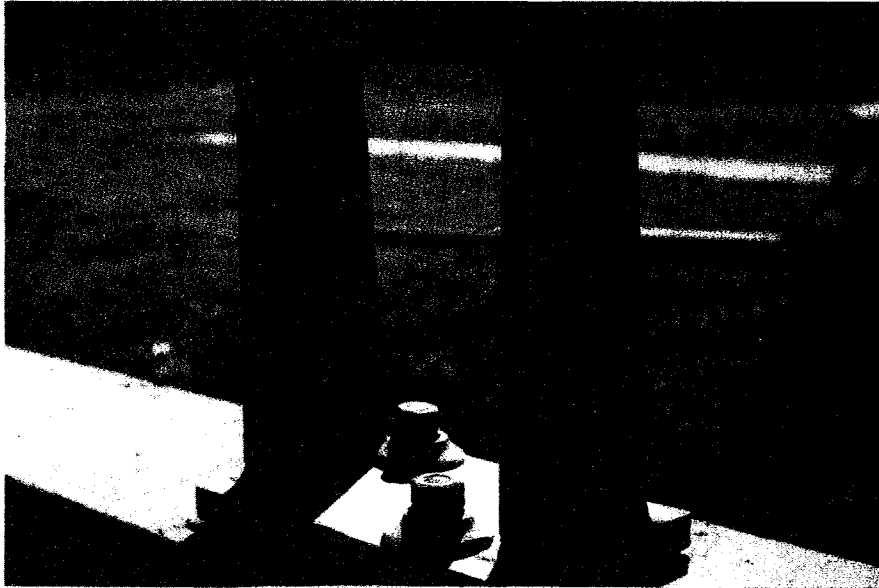
Figure 16. Damage to upper and lower posts after test 1179-2.

The Cadillac impacted 5 ft upstream of the leading edge of the concrete post and 7 ft upstream of the leading edge of the steel post. The Cadillac wheel did contact the concrete post and the damage to the wheel and suspension was moderate. The wheel was still rolling after impact, and the vehicle trajectory was good with a departure angle of only 2.0 degrees. The hood contacted the steel post and was severely damaged. The hood pushed the right front windshield inward several inches but it did not penetrate or intrude into the passenger compartment. Consequently, the Cadillac test is judged successful.
