1. Report No. FHWA/TX-89/1185-1		2. Government Accession No.		3. Recipient's Catalog No.	
4. Title and Subtitle AESTHETICALLY PLEASING CONCRETE BEAM AND POSTS BRIDGE RAIL - TEXAS TYPE T411				5. Report Date March 1989

AESTHETICALLY PLEASING CONCRETE BEAM AND POSTS
BRIDGE RAIL - TEXAS TYPE T411

Research Report 1185-1

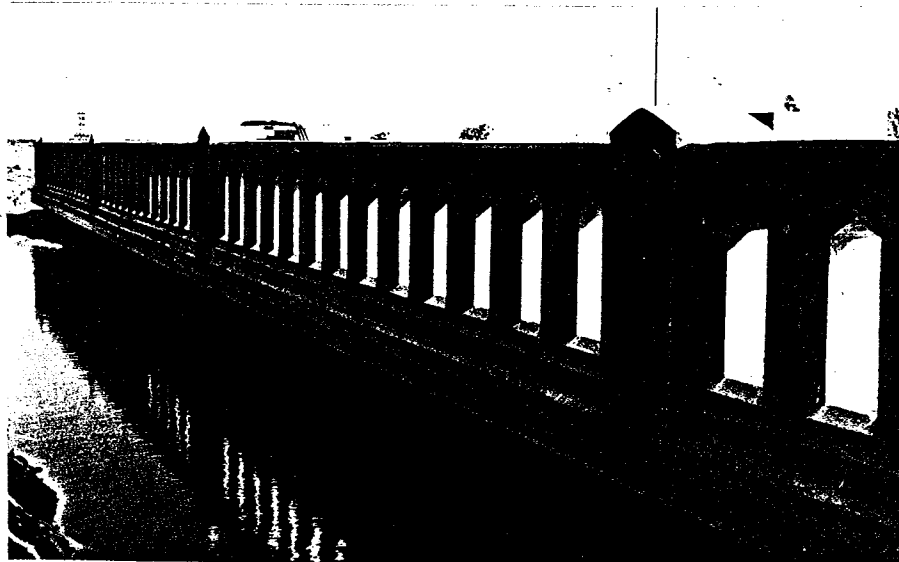
Figure 3. Installation before test 1185-1.

Figure 3 shows a photograph of the bridge rail installation prior to crash testing. The installation is 75 ft 10 in. long. The three pilasters are not super strong posts as they appear to be. They contain styrofoam blocks 10.5 in. by 13 in. by 21 in., (void) which means the pilasters are similar to the 8 in. by 18 in. openings. The use of the pilasters is thus optional since they did not contribute to the bridge rail strength as built and crash tested.

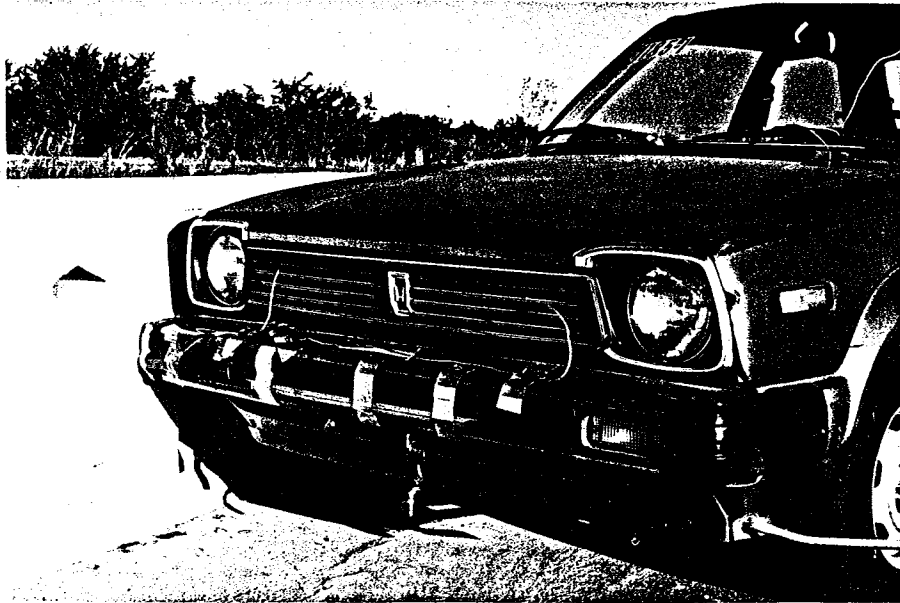
Figure 6 . Vehicle/bridge rail geometrics for test 1185-1.

The 1980 Honda Civic (figure 6) was directed into the bridge rail using a reverse tow and guidance system. Test inertia mass of the vehicle was 1,800 lb (808 kg). The height to the lower edge of the vehicle bumper was 14.25 in. (36.2 cm) and to the top of the bumper it was 19.25 in. (48.9 cm). Other dimensions and information on the test vehicle are given in Appendix C. The vehicle was free-wheeling and unrestrained just prior to impact.

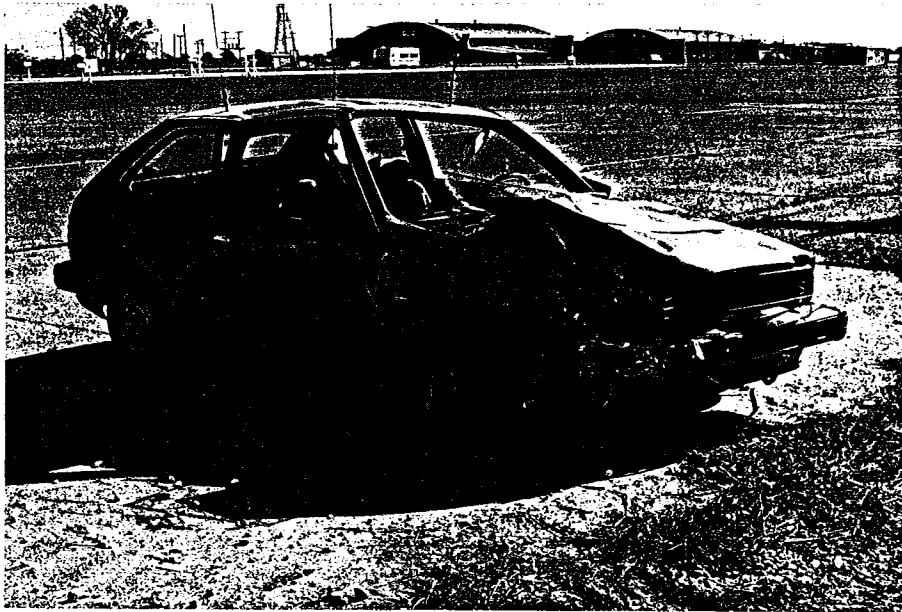
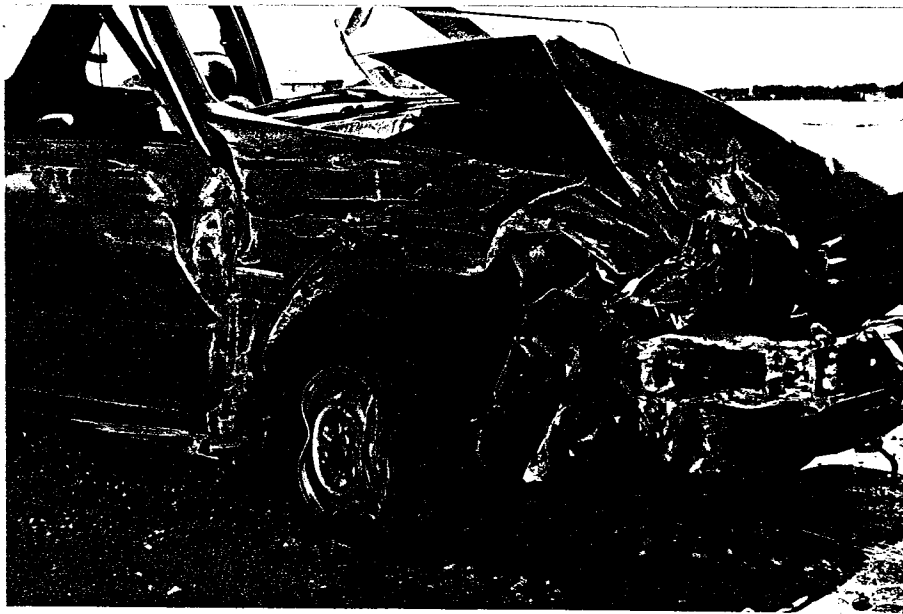
Figure 9. Vehicle after test 1185-1.

damaged. The instrument panel in the passenger compartment was bent as well as the floor pan and roof, and the windshield was broken. The right front rim was bent and the tire damaged. There was damage to the hood, grill, bumper, right front quarter panel, the right door and glass, the right rear quarter panel and the rear bumper.

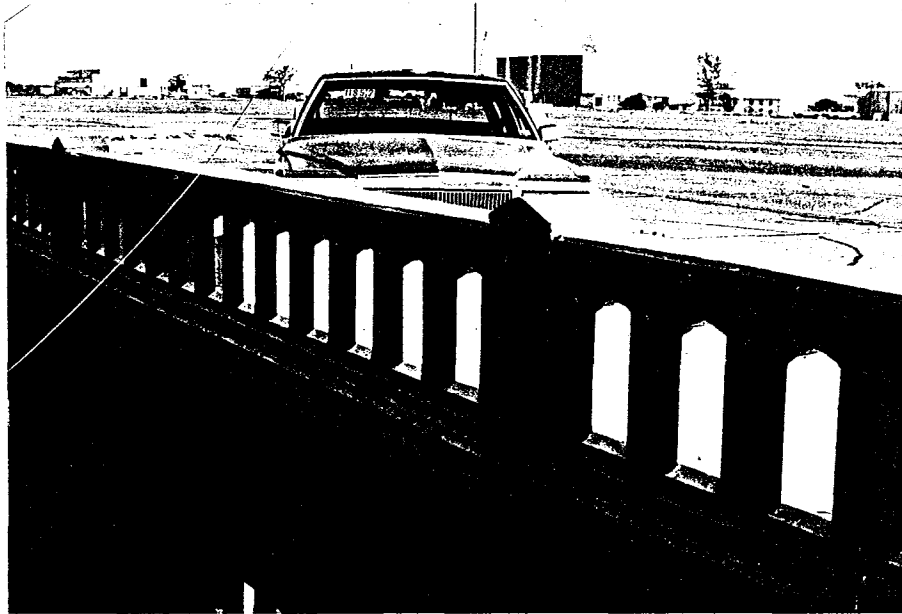
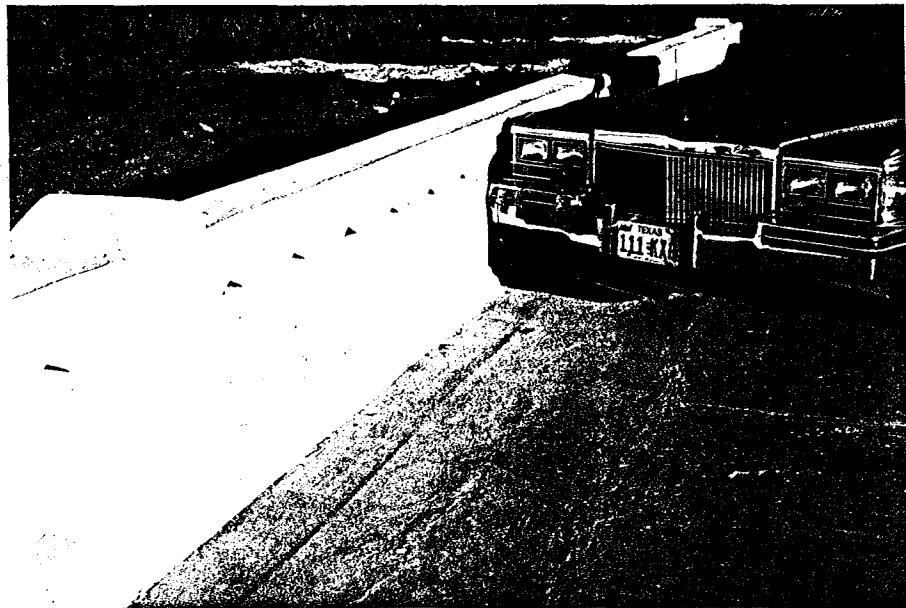
Figure 11. Vehicle/bridge rail geometrics for test 1185-2.

The 1980 Cadillac Sedan DeVille (figure 11) was directed into the bridge rail using a reverse tow and guidance system. Test inertia mass of the vehicle was 4,500 lb (2,043 kg). The height to the lower edge of the vehicle bumper was 12.5 in. (31.8 cm) and to the top of the bumper it was 21.0 in. (53.3 cm). Other dimensions and information on the test vehicle are given in Appendix E. The vehicle was free-wheeling and unrestrained just prior to impact.

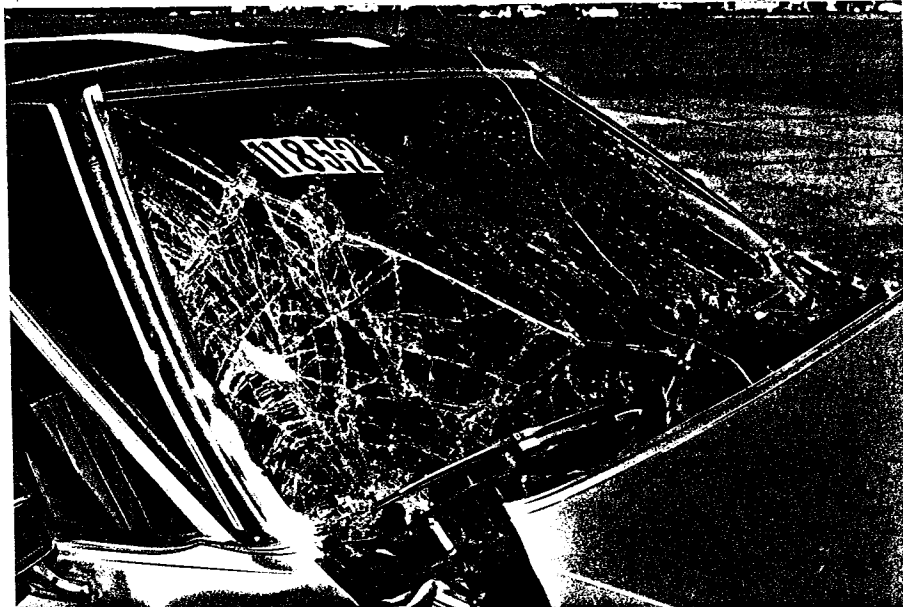
Figure 13. Vehicle after test 1185-2.

The vehicle sustained moderate damage to the right side, as shown in figure 13. Maximum crush at the right front corner at bumper height was 16.0 in. (49.6 cm). The right A-arm, the tie rod, and the upper and lower ball joints were damaged and the subframe was bent. The instrument panel in the passenger compartment was bent as well as the floor pan and roof, and the windshield was broken. The right front and rear rims were bent and the tires damaged. There was damage to the hood, grill, bumper, right front quarter panel, the right front and rear doors, the right rear quarter panel and the rear bumper.
