AESTHETICALLY PLEASING STEEL PIPE  
BRIDGE RAIL - TEXAS TYPE T421

Research Report 1185-2

Research Study No. 2-5-88/89-1185  
Aesthetically Pleasing Bridge Rails

Texas Transportation Institute  
Texas A&M University  
College Station, Texas

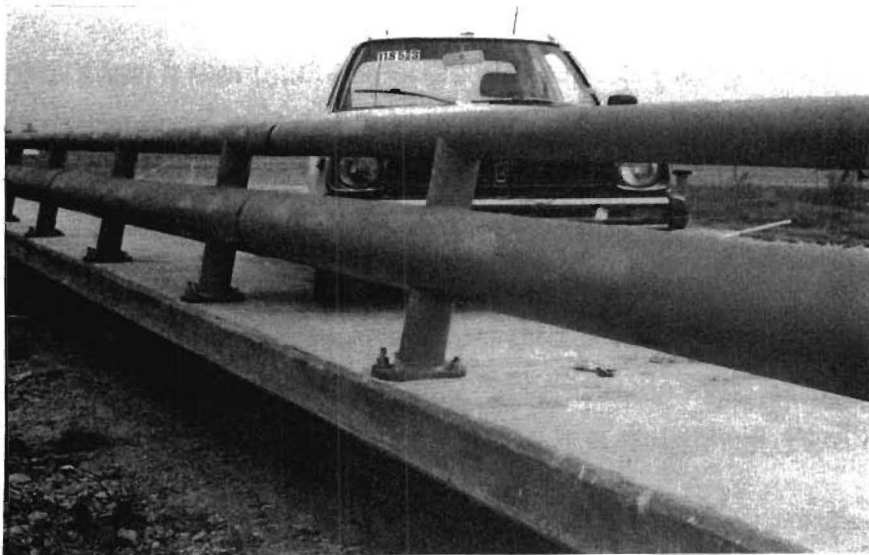
Figure 1a. T421 bridge rail installation.

Figure 1b. T421 bridge rail installation.

This bridge rail is constructed of standard steel pipe 5 in. and 10 in. in diameter. Figure 1 shows photographs of the steel pipe bridge rail installed on a typical simulated 8-in.-thick concrete bridge deck. Figures 2 and 3a show a cross section and side elevation of the T421 bridge rail. The top rail was 32 in. high and used 5-in.-diameter standard steel pipe. The lower rail uses 10-in.-diameter standard steel pipe. The 5-in.-diameter posts are sloping at a 10-degree angle so that the traffic side or face of the two rails is a vertical plane.

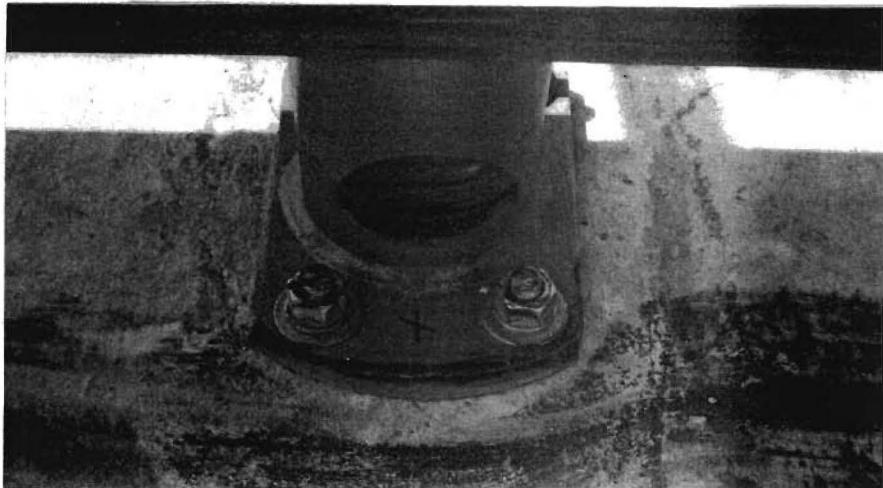
Figure 6. T421 bridge rail after Honda impact.

As can be seen in Figure 6, the rail received minimal cosmetic damage. Tire marks appeared 3 in. (7.6 cm) behind the traffic edge of the baseplate of post 7 before impacting the lower part of the post and riding over the baseplate. The vehicle was in contact with the rail for 9.25 ft (2.8 m).

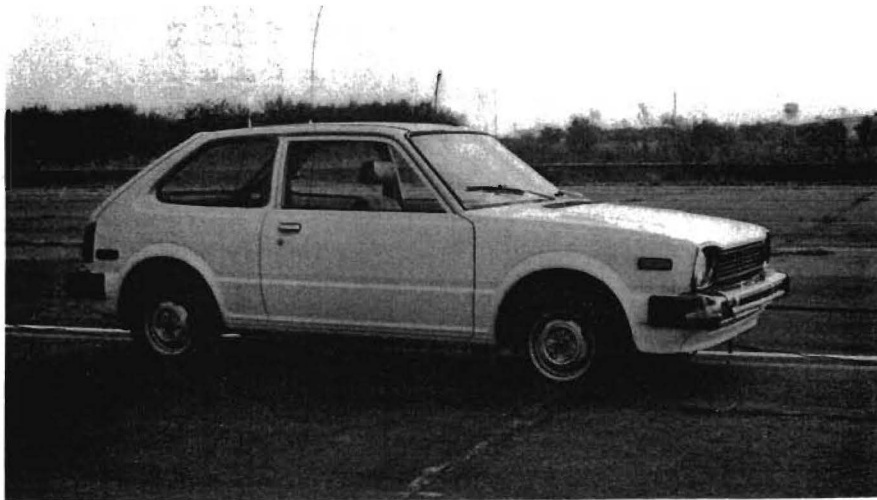
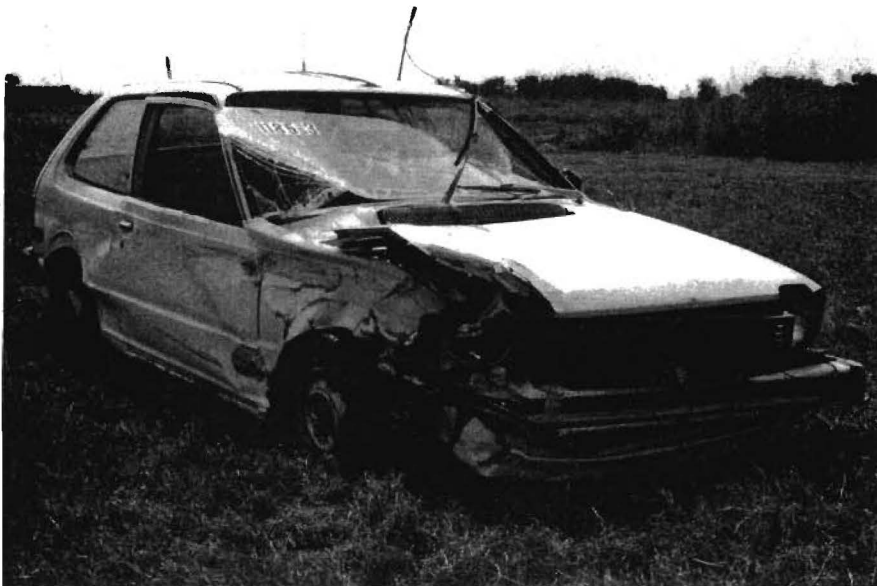
Figure 7. Honda before and after impact with T421 bridge rail.

The vehicle sustained severe damage to the right side, as shown in Figure 7. Maximum crush at the right front bumper height was 10.0 in. (25.4 cm). The c.v. joint and right strut were damaged. The right front rim was bent and the tire damaged. The roof was bent and the windshield was broken. There was damage to the hood, grill, bumper, right front quarter panel, the right door and glass, the right rear quarter panel and the rear bumper.

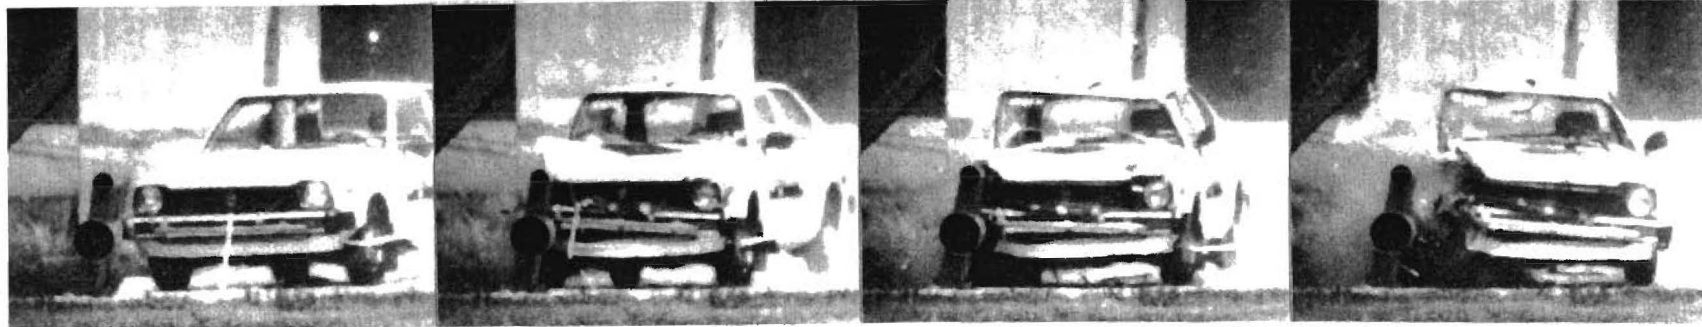
Test No. . . . . 1185-3  
 Date . . . . . 08/22/89  
 Test Installation . . . T421 Bridge Rail  
 Length of Installation . 75 ft (23 m)  
 Vehicle . . . . . 1980 Honda Civic  
 Vehicle Weight  
 Test Inertia . . . . . 1,800 lb (817 kg)  
 Vehicle Damage Classification  
 TAD . . . . . 01FR6 & 01RD6  
 CDC . . . . . 01FZEK4 & 01RDES4  
 Maximum Vehicle Crush . 10.0 in (25.4 cm)

Impact Speed . . . 59.7 mi/h (96.1 km/h)  
 Impact Angle . . . 21.4 degrees  
 Speed at Parallel . 49.7 mi/h (80.0 km/h)  
 Exit Speed . . . . 49.2 mi/h (79.2 km/h)  
 Exit Trajectory . . 5.0 degrees  
 Vehicle Accelerations  
 (Max. 0.050-sec Avg)  
 Longitudinal . . . -8.4 g  
 Lateral . . . . . 12.7 g  
 Occupant Impact Velocity  
 Longitudinal . . . 21.8 ft/s (6.6 m/s)  
 Lateral . . . . . 24.5 ft/s (7.5 m/s)  
 Occupant Ridedown Accelerations  
 Longitudinal . . . -3.9 g  
 Lateral . . . . . 6.3 g

Figure 8. Summary of results for test 1185-3.

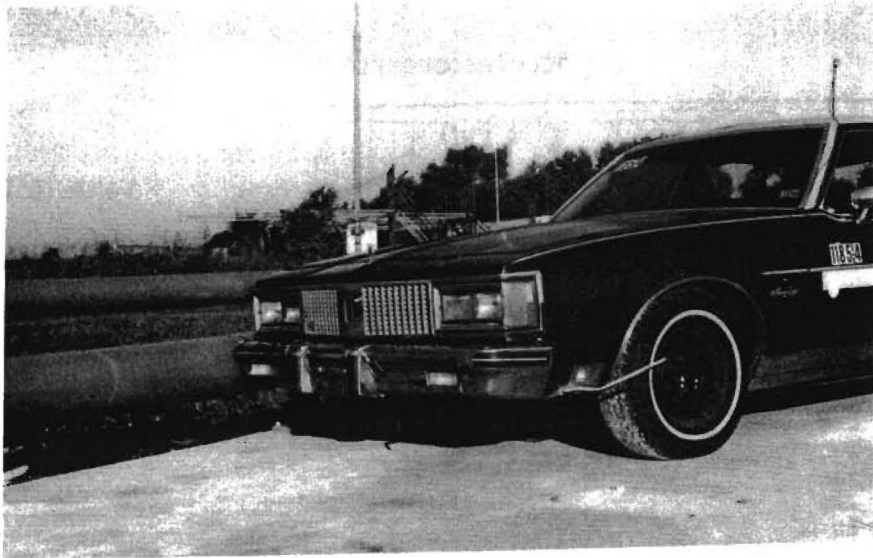
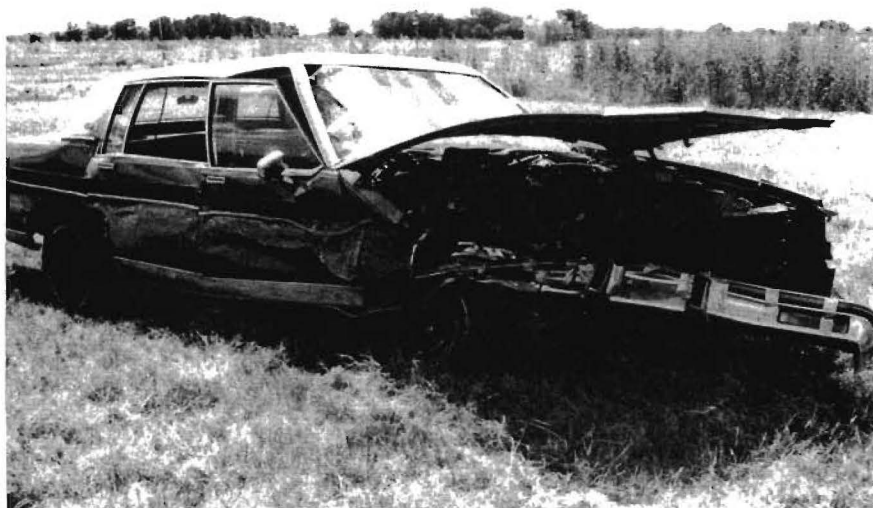
Figure 9. Oldsmobile before and after impact with T421 bridge rail.

The vehicle sustained severe damage to the right side, as shown in Figure 9. Maximum crush at the right front corner at bumper height was 18.0 in. (45.7 cm). The right front axle was pushed back 15.0 in. (38.1 cm). The right A-arm, sway bar, tie rod, and upper and lower ball joints were damaged and the subframe was bent. The instrument panel in the passenger compartment was bent as well as the floor pan and roof, and the windshield was broken. The right front and rear rims were bent and the tires damaged. There was damage to the hood, grill, front bumper, right front quarter panel, the right front and rear doors, the right rear quarter panel and the rear bumper.

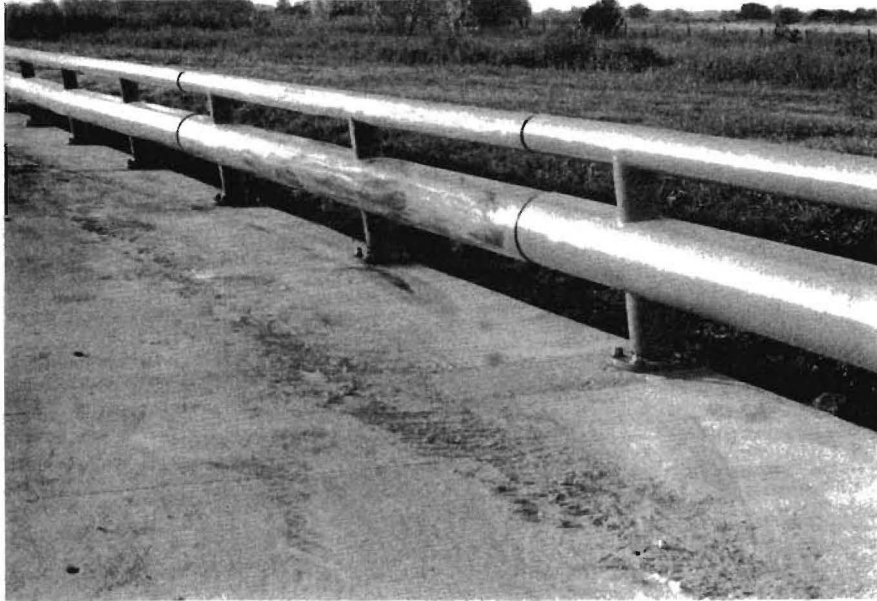
Figure 11. T421 bridge rail after Oldsmobile impact.

As can be seen in Figures 11, 12, and 13, the rail received minor damage and the slab received moderate damage. The vehicle impacted the rail between post 4 and 5. The bases on both posts 4 and 5 were pushed back approximately 0.25 in. (0.6 cm). The bridge deck behind post 4 was cracked. Tire marks appeared 5 in. (12.7 cm) behind the traffic edge of the baseplate of post 5 before the tire impacted the lower part of the post. The bridge deck around post 5 was broken, as shown in Figure 12. There were tire marks on the base of post 6 and, shortly thereafter, the vehicle left the rail. The vehicle was in contact with the bridge rail for 15.5 ft (4.7 m).

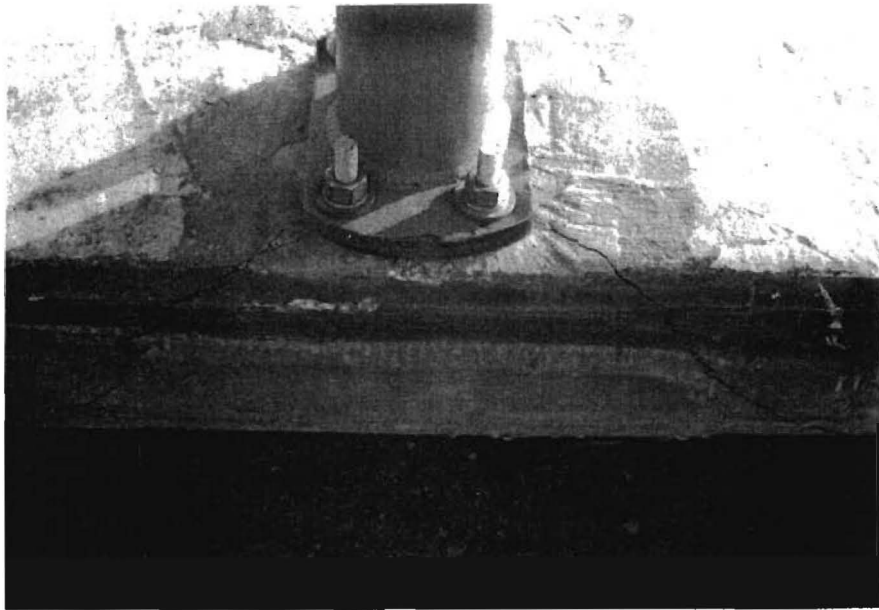
Figure 13. Post 4 and post 6 after Oldsmobile impact.

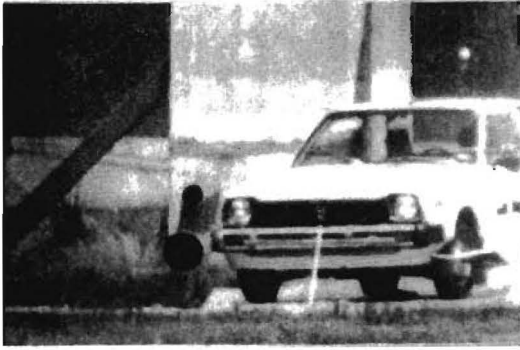
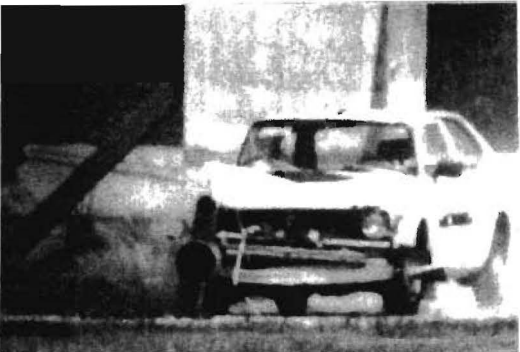
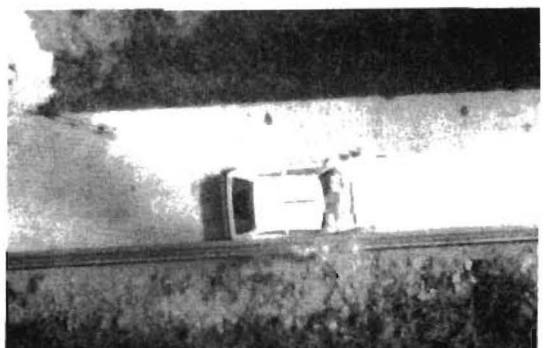
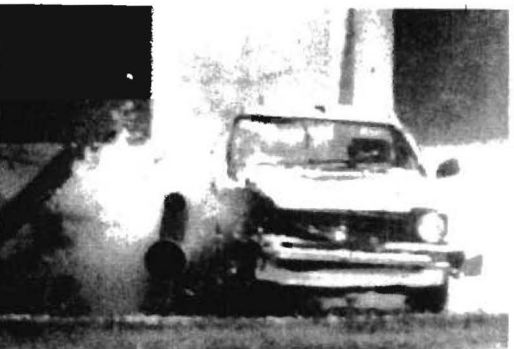
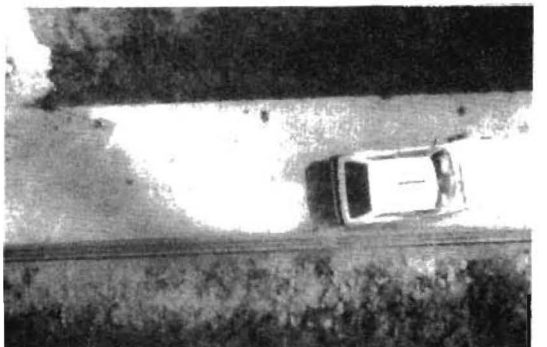
Figure B1. Sequential photographs for test 1185-3.

The speed of the vehicle at impact was 59.7 mph (96.1 km/h) and the angle of impact was 21.4 degrees. The right front bumper of the vehicle impacted the bridge rail 5 ft (1.5 m) upstream of post 7. The right front wheel made contact with the lower pipe member shortly after impact. The vehicle began to redirect at 0.042 seconds. By 0.060 seconds the vehicle had deformed to the A-pillar which caused the windshield to break. The right front wheel became wedged under the lower pipe member and impacted the lower part of post 7. At 0.162 seconds the vehicle was traveling parallel with the bridge rail at a speed of 49.7 mph (79.2 km/h). The vehicle exited the rail at 0.237 seconds traveling at 49.2 mph (79.2 km/h) and 5.0 degrees. As the vehicle left the test site, the brakes were applied. The vehicle yawed clockwise almost 180 degrees and subsequently came to rest 270 ft (82 m) from the point of impact. Sequential photographs are shown in Appendix B.

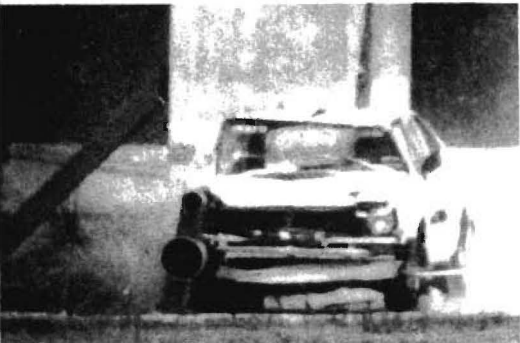
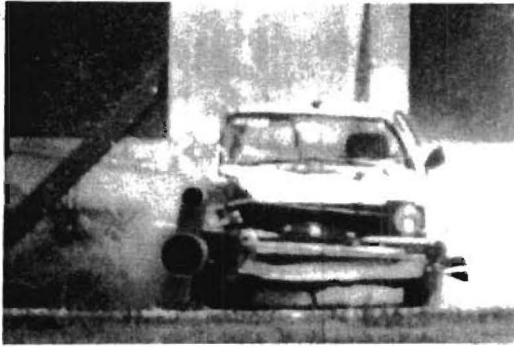
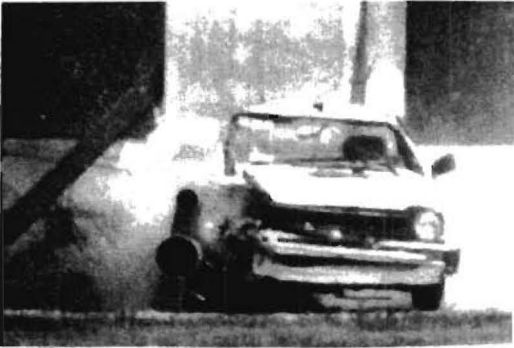
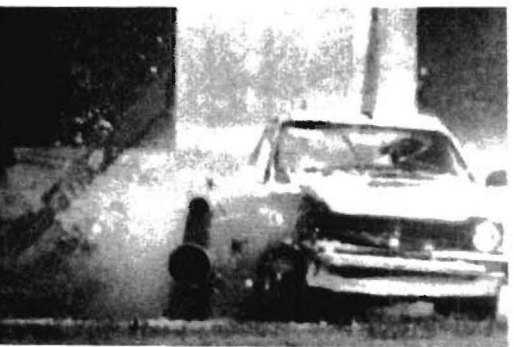
Figure B1. Sequential photographs for test 1185-3.  
(Continued)

Still photography, real-time cine, and video were used to record conditions of the test vehicle and bridge rail before and after the test. Video and real-time and high-speed cine were used to document the test. One high-speed camera was placed to have a field of view parallel to and aligned with the bridge rail at the downstream end, one was placed over the bridge rail to have a field of view perpendicular to the ground, another was placed perpendicular to the front of the bridge rail, and one was placed behind the bridge rail. The films from these cameras were used to observe phenomena occurring during collision and obtain time-event, displacement, and angular data.

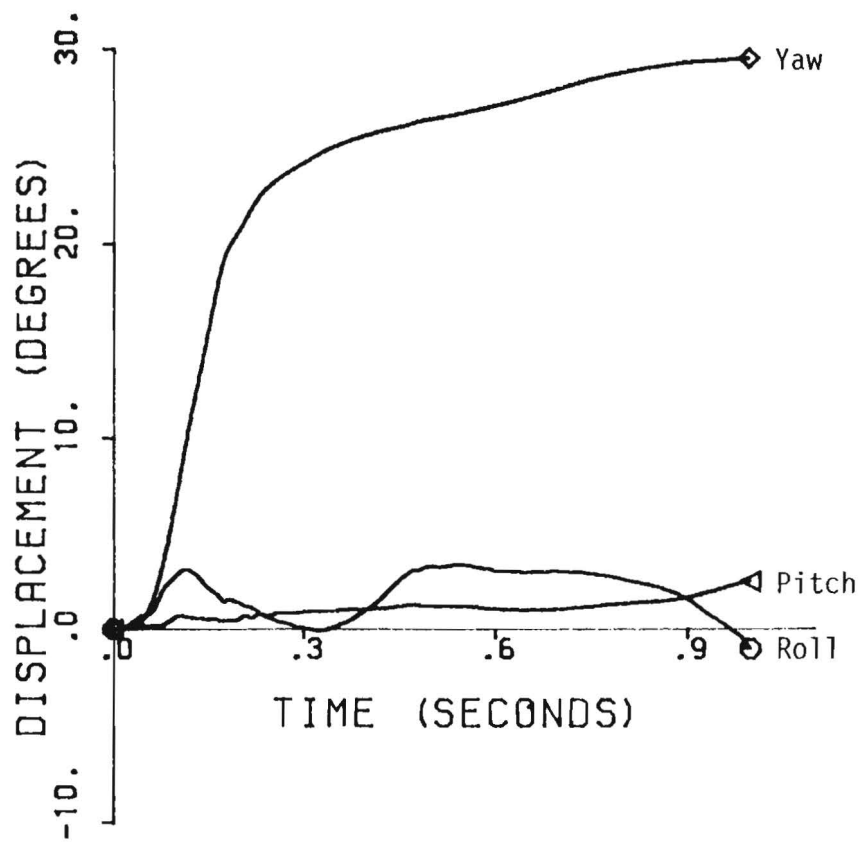
Axes are vehicle-fixed.  
Sequence for determining orientation is:

Figure C1. Vehicle angular displacements for test 1185-3.

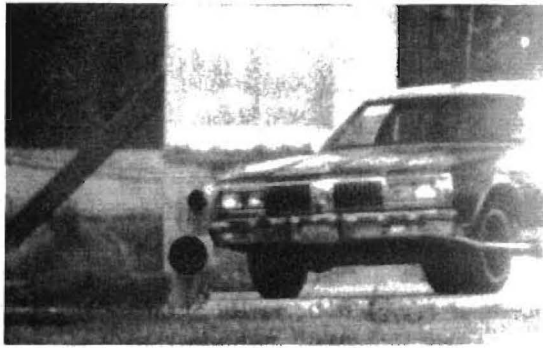
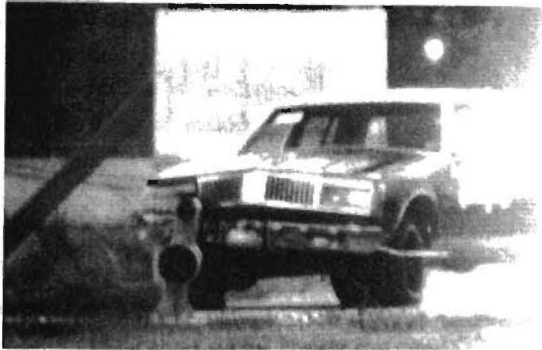
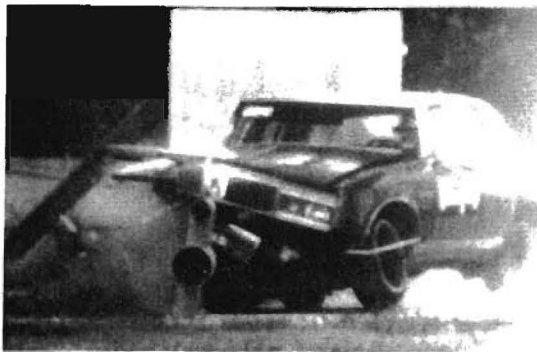
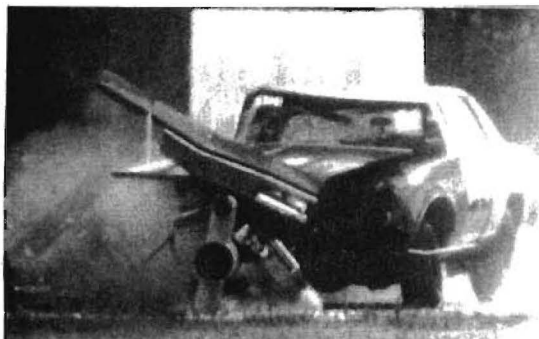
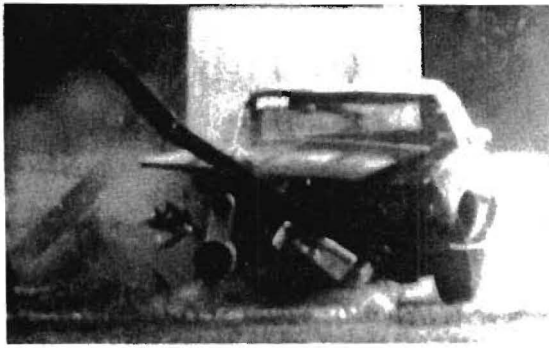
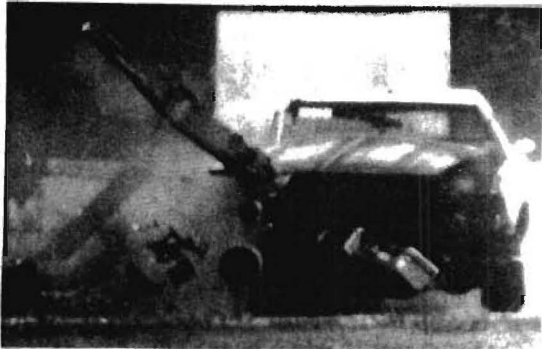
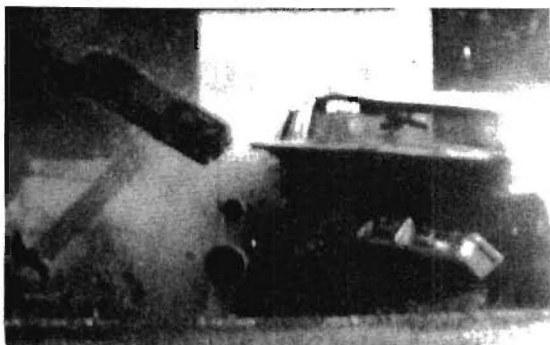
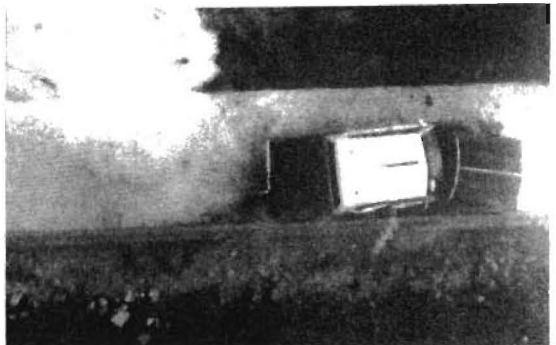
Figure D1. Sequential photographs for test 1185-4.

The speed of the vehicle at impact was 62.4 mph (100.4 km/h) and the angle of impact was 26.6 degrees. The right front bumper of the vehicle impacted the bridge rail 5 ft (1.5 m) upstream of post 5. The right front wheel made contact with the lower pipe member shortly after impact. The vehicle began to redirect at 0.067 seconds. By 0.075 seconds the vehicle had deformed to the A-pillar and the windshield broke. As the vehicle continued forward, the front bumper was forced between the upper and lower pipe member and impacted the middle portion of the post. At the same time the right front wheel became wedged under the lower pipe element and impacted the lower portion of post 5. At 0.204 seconds the vehicle began to move parallel with the bridge rail traveling at a speed of 47.6 mph (76.6 km/h). The rear of the vehicle impacted the bridge rail at 0.219 seconds and the rear bumper was forced between the upper and lower pipe elements and impacted the middle portion of the post. The vehicle lost contact with the bridge rail at 0.348 seconds traveling at 44.6 mph (71.8 km/h) and 7.6 degrees. Shortly after the vehicle left the test site, the brakes were applied and the vehicle yawed clockwise and subsequently came to rest 225 ft (69 m) from the point of impact. Sequential photographs are shown in Appendix D.
