AESTHETICALLY PLEASING CONCRETE COMBINATION PEDESTRIAN-TRAFFIC
BRIDGE RAIL - TEXAS TYPE C411

Research Report 1185-3F

Research Study No. 2-5-89/90-1185
Aesthetically Pleasing Bridge Rails

This report presents a new concrete combination pedestrian-traffic bridge rail - Texas Type C411.

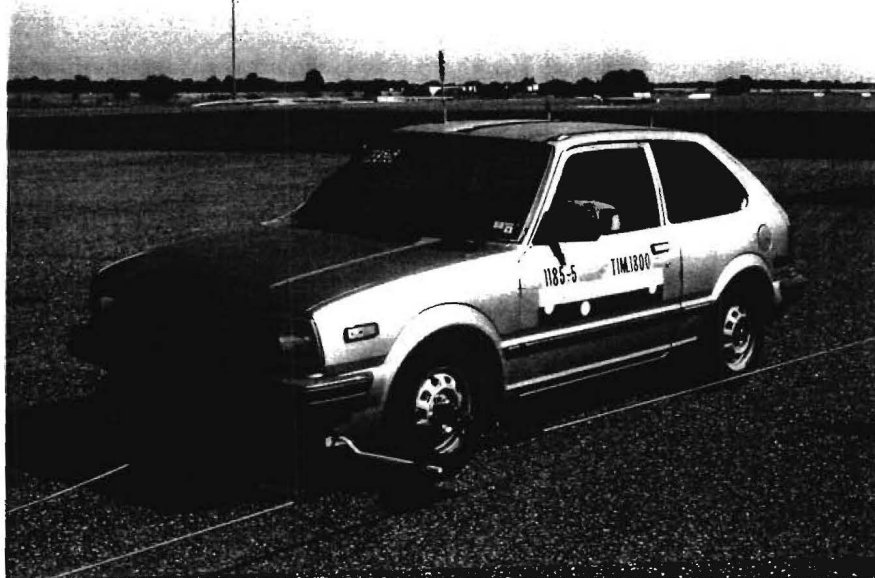
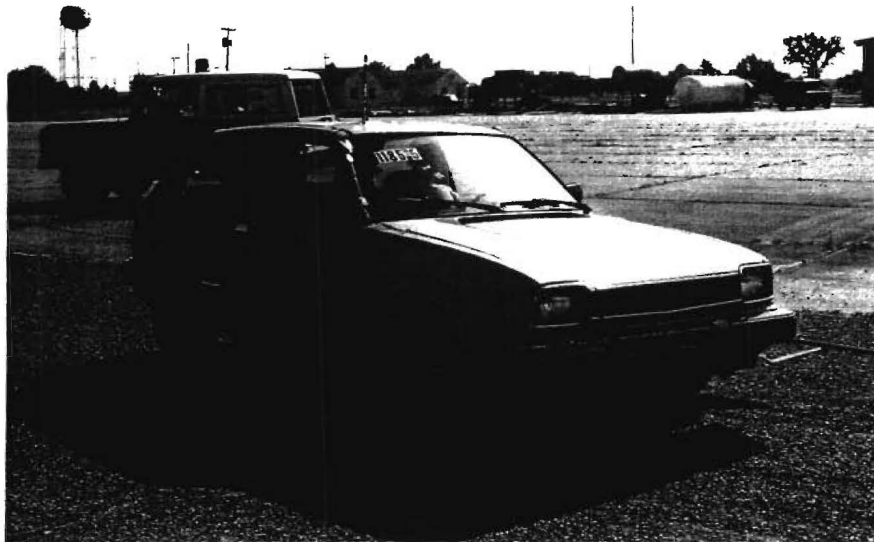
Figure 7. Vehicle before test 1185-5.

The 1982 Honda Civic (Figures 7 and 8) was directed into the bridge rail installation using a reverse tow and guidance system. Test inertia mass of the vehicle was 1,800 lb (808 kg) and its gross static mass was 1,970 lb (894 kg). The height to the lower edge of the vehicle bumper was 15.0 in. (38.1 cm) and it was 20.5 in. (52.1 cm) to the top of the bumper. Other dimensions and information on the test vehicle are given in Figure C1 of Appendix C. The vehicle was free-wheeling and unrestrained just prior to impact.

The 1982 Honda Civic (Figures 7 and 8) was directed into the bridge rail installation using a reverse tow and guidance system. Test inertia mass of the vehicle was 1,800 lb (808 kg) and its gross static mass was 1,970 lb (894 kg). The height to the lower edge of the vehicle bumper was 15.0 in. (38.1 cm) and it was 20.5 in. (52.1 cm) to the top of the bumper. Other dimensions and information on the test vehicle are given in Figure C1 of Appendix C. The vehicle was free-wheeling and unrestrained just prior to impact.

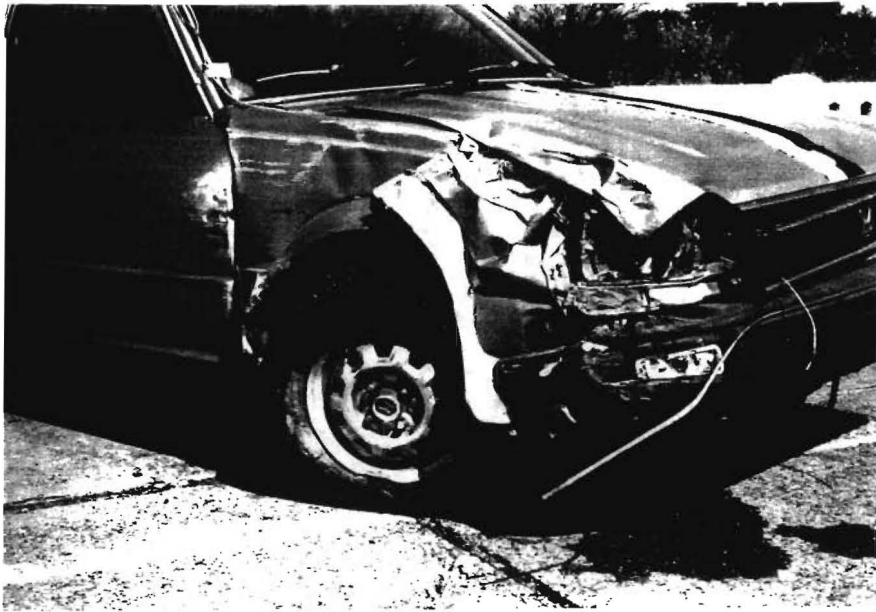
Figure 10. Damage to right side of vehicle,
test 1185-5.

The vehicle sustained moderate damage to the right side as shown in Figures 10 and 11. Maximum crush at the right front corner at bumper height was 9.0 in. (22.9 cm). The right front and rear rims were bent and the tires damaged. There was damage to the hood, grill, bumper, right front quarter panel, the right door, the right rear quarter panel and the rear bumper.

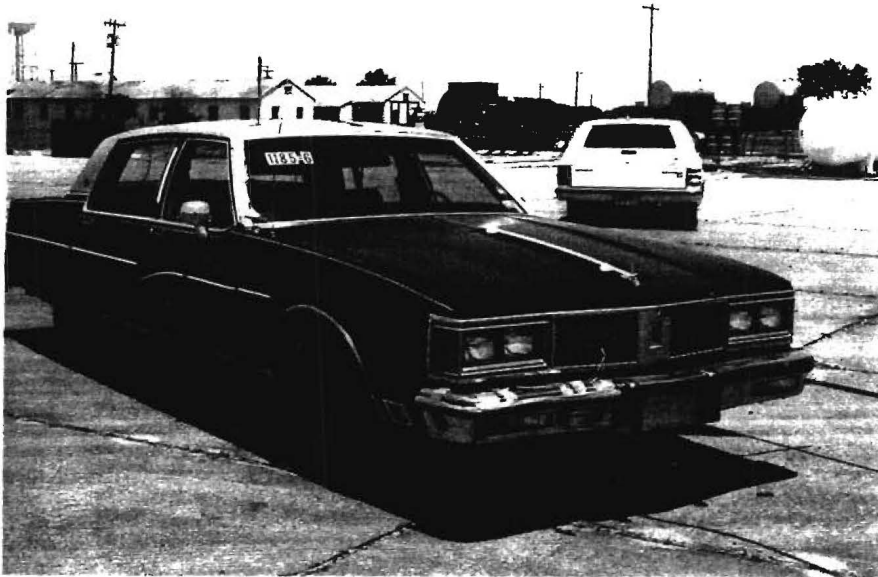
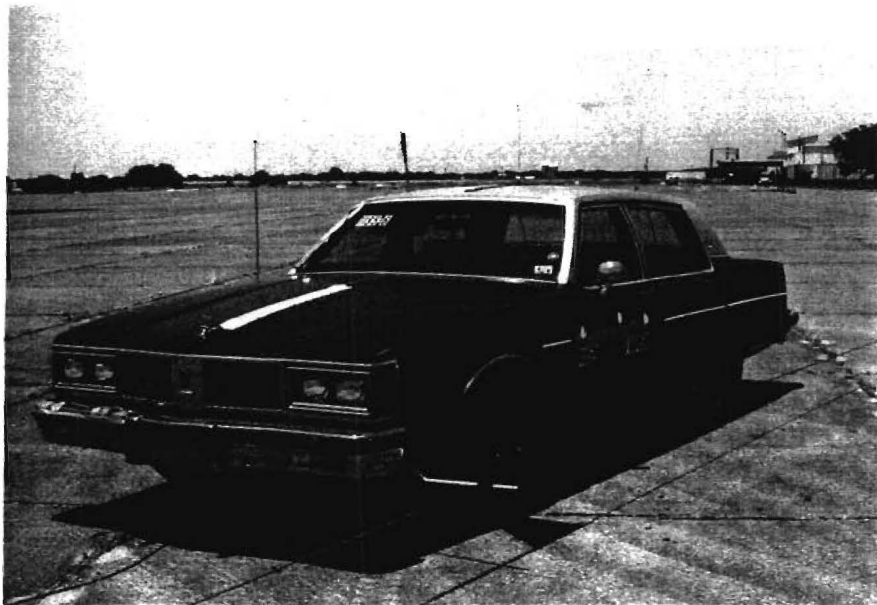
Figure 13. Vehicle before test 1185-6.

The 1982 Oldsmobile 98 (Figures 13 and 14) was directed into the bridge rail installation using a reverse tow and guidance system. Test inertia mass of the vehicle was 4,500 lb (2,043 kg). The height to the lower edge of the vehicle bumper was 12.25 in. (31.1 cm) and it was 20.75 in. (52.7 cm) to the top of the bumper. Other dimensions and information on the test vehicle are given in Figure E1 of Appendix E. The vehicle was free-wheeling and unrestrained just prior to impact.

The 1982 Oldsmobile 98 (Figures 13 and 14) was directed into the bridge rail installation using a reverse tow and guidance system. Test inertia mass of the vehicle was 4,500 lb (2,043 kg). The height to the lower edge of the vehicle bumper was 12.25 in. (31.1 cm) and it was 20.75 in. (52.7 cm) to the top of the bumper. Other dimensions and information on the test vehicle are given in Figure E1 of Appendix E. The vehicle was free-wheeling and unrestrained just prior to impact.

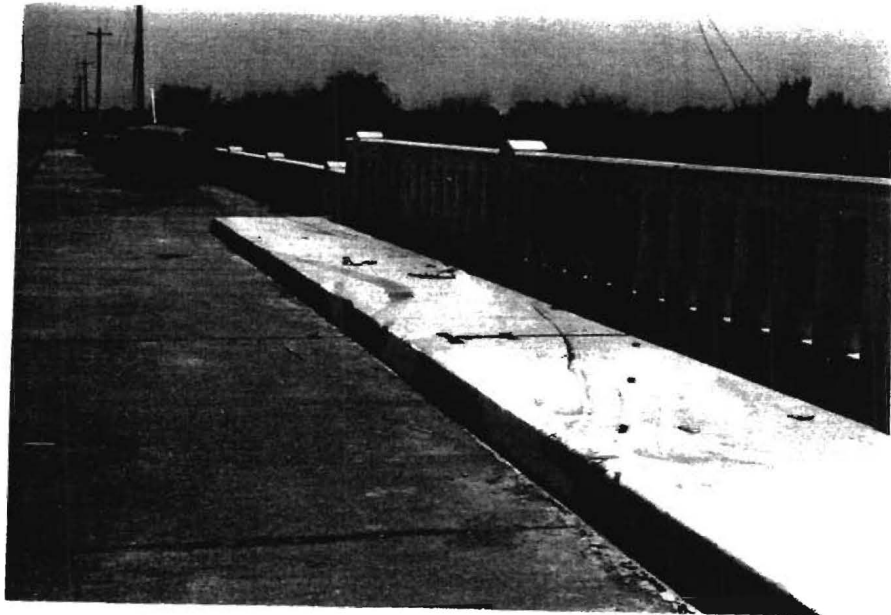
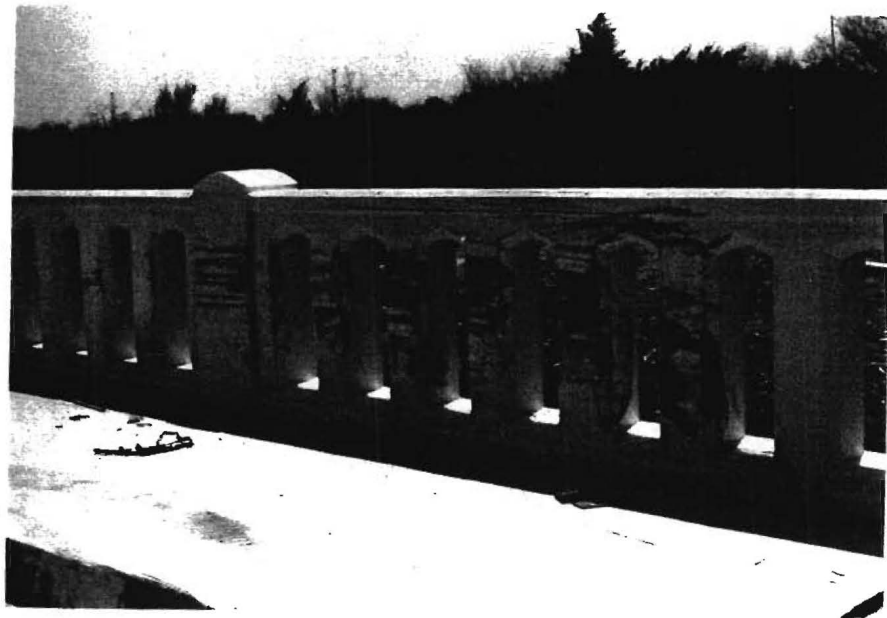
Figure 15. Bridge rail after test 1185-6.

As can be seen in Figure 15, the rail received moderate cosmetic damage. There were tire marks on the face of the bridge rail from the point of impact continuing down 15 ft (4.6 m). There was some scraping and gouging along the edges of the portholes.

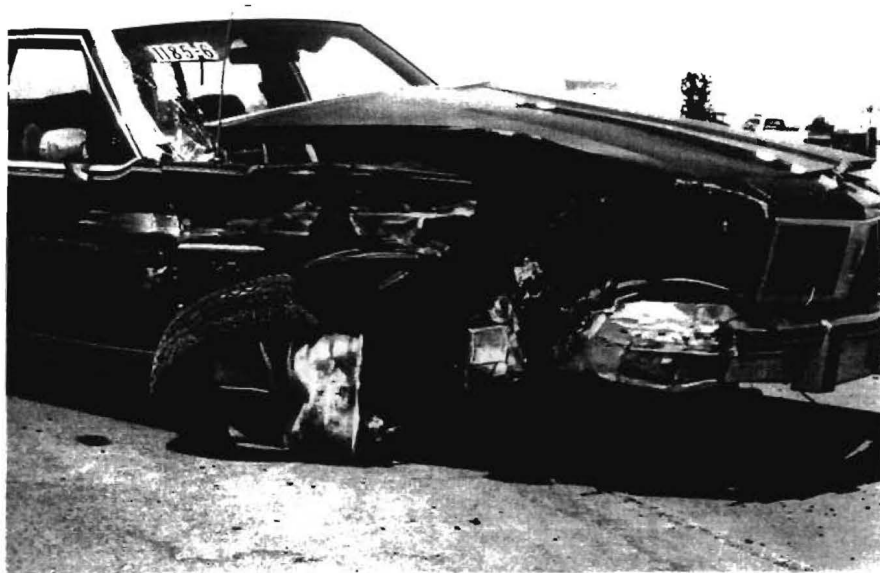
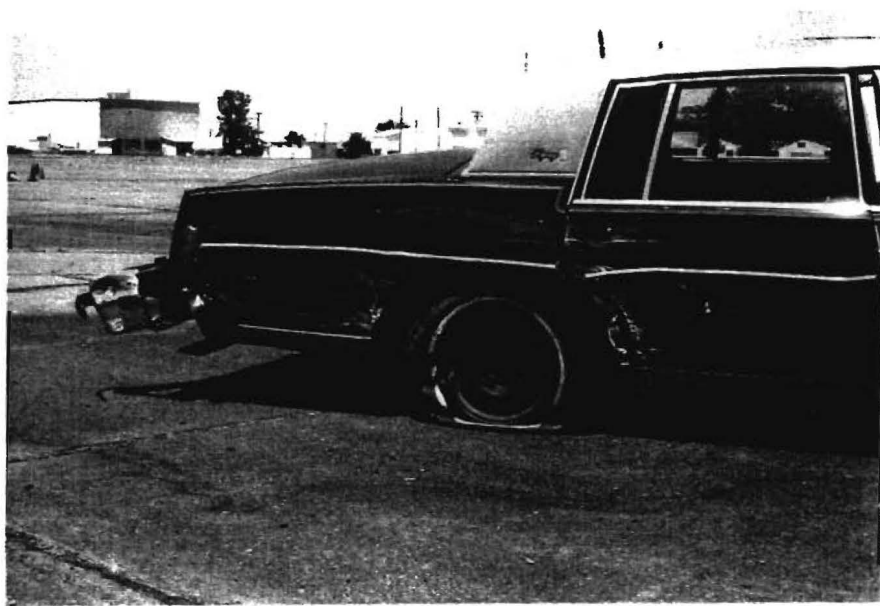
Figure 16. Damage to right side of vehicle, test 1185-6.

The vehicle sustained damage to the right side as shown in Figures 16 and 17. Maximum crush at the right front corner at bumper height was 14.0 in. (35.6 cm). The floorpan and subframe of the vehicle was bent. The right A-arm, tie rod, and sway bar were damaged. The windshield was cracked and the roof bent. The right front and rear rims were bent and the tires damaged. There was damage to the hood, grill, front bumper,

radiator and fan, right front quarter panel, the right front and rear doors, the right rear quarter panel and the rear bumper.

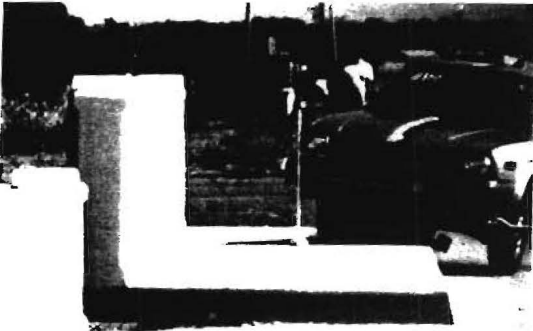
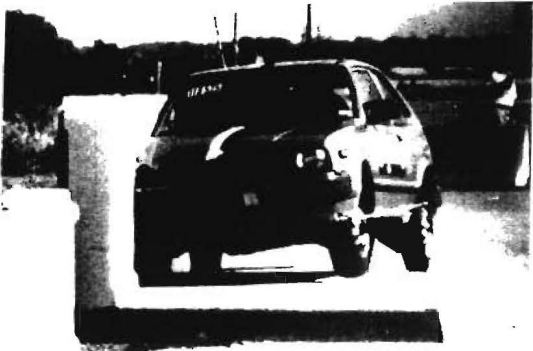
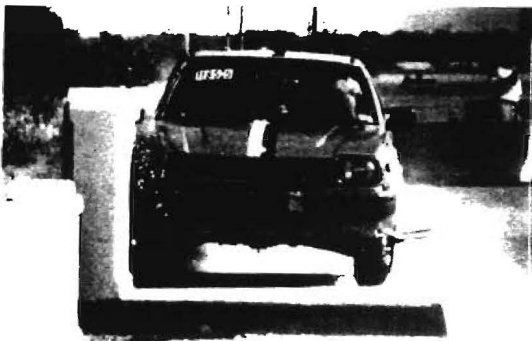
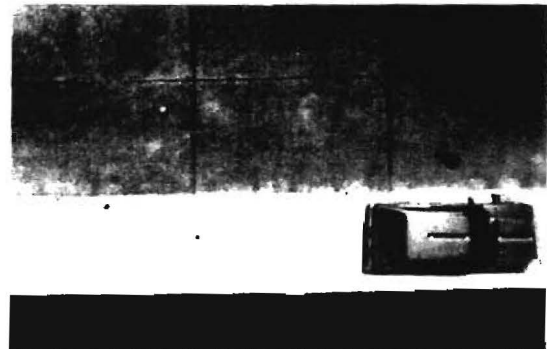
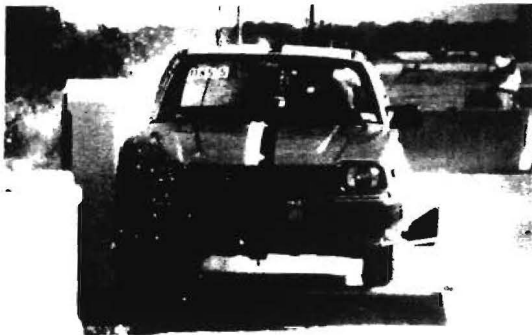
Figure B1. Sequential photographs for test 1185-5.
(Continued)

The bridge rail contained and smoothly redirected the test vehicle with no lateral movement or cracking of the bridge rail. There were no detached elements or debris to present undue hazard to other traffic. The vehicle remained upright and relatively stable during the collision. The occupant/compartment impact velocities and 10-ms occupant ridedown accelerations were within the usual recommended limits. The vehicle trajectory at loss of contact indicates no intrusion into adjacent traffic lanes.

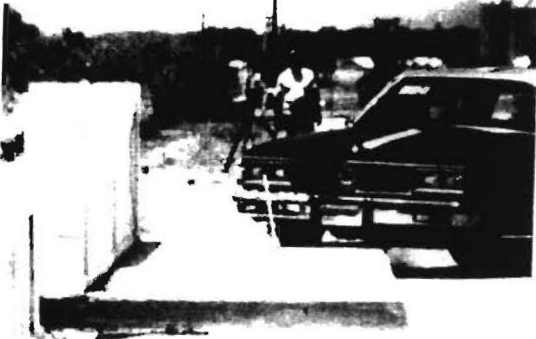
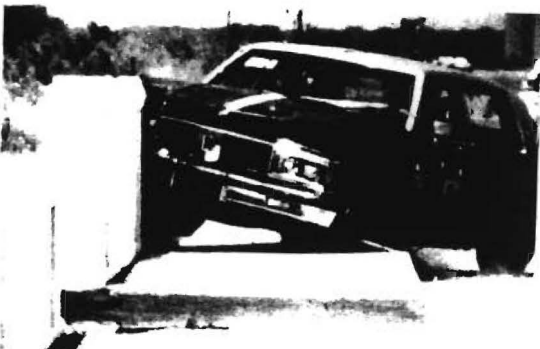
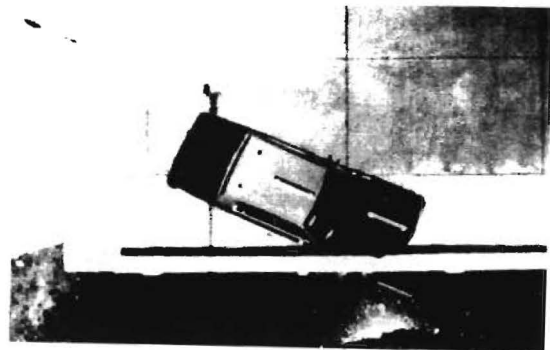
Figure D1. Sequential photographs for test 1185-6.

The bridge rail contained and smoothly redirected the test vehicle with no lateral movement or cracking of the bridge rail. There were no detached elements or debris to present undue hazard to other traffic. The vehicle remained upright and relatively stable during the collision. The occupant/compartment impact velocities and 10-ms occupant ridedown accelerations were within the usual recommended limits. The vehicle trajectory at loss of contact indicates no intrusion into adjacent traffic lanes.

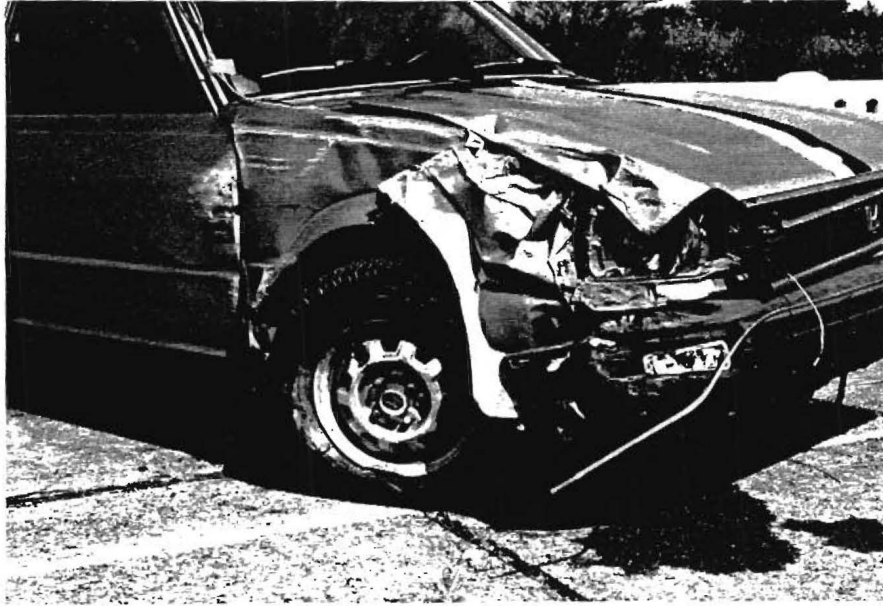
Figure 10. Damage to right side of vehicle, test 1185-5.

The vehicle sustained moderate damage to the right side as shown in Figures 10 and 11. Maximum crush at the right front corner at bumper height was 9.0 in. (22.9 cm). The right front and rear rims were bent and the tires damaged. There was damage to the hood, grill, bumper, right front quarter panel, the right door, the right rear quarter panel and the rear bumper.

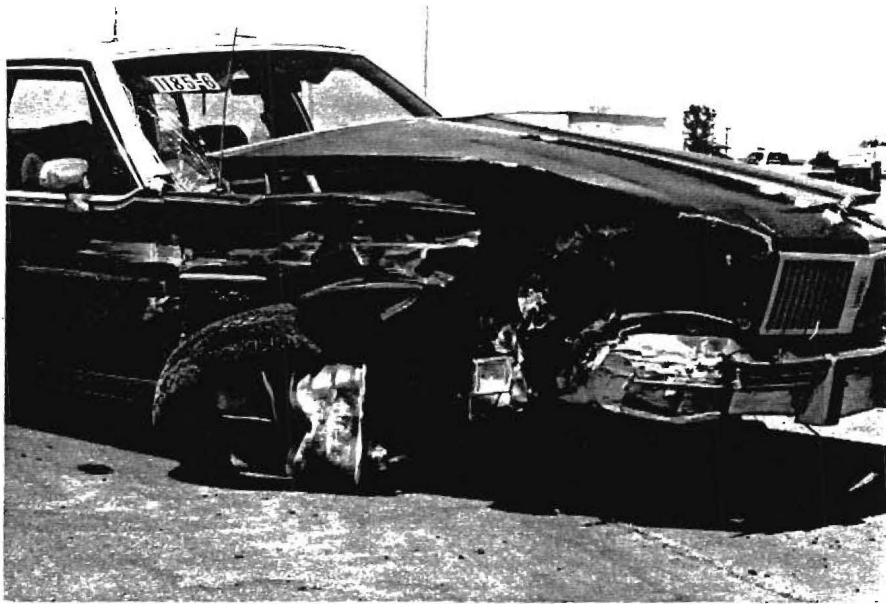
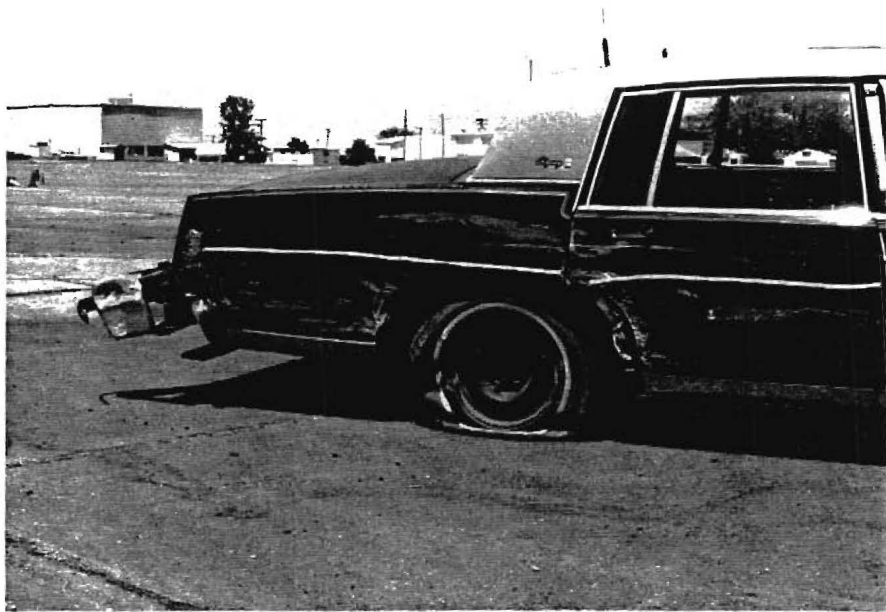
Figure 16. Damage to right side of vehicle, test 1185-6.

The vehicle sustained damage to the right side as shown in Figures 16 and 17. Maximum crush at the right front corner at bumper height was 14.0 in. (35.6 cm). The floorpan and subframe of the vehicle was bent. The right A-arm, tie rod, and sway bar were damaged. The windshield was cracked and the roof bent. The right front and rear rims were bent and the tires damaged. There was damage to the hood, grill, front bumper,

radiator and fan, right front quarter panel, the right front and rear doors, the right rear quarter panel and the rear bumper.
