**TWO POST DRIVEABLE SIGN SUPPORTS**

Study No. 2-5-91-1219

TEXAS TRANSPORTATION INSTITUTE  
TEXAS A&M UNIVERSITY SYSTEM  
COLLEGE STATION, TEXAS 77843

August 1991

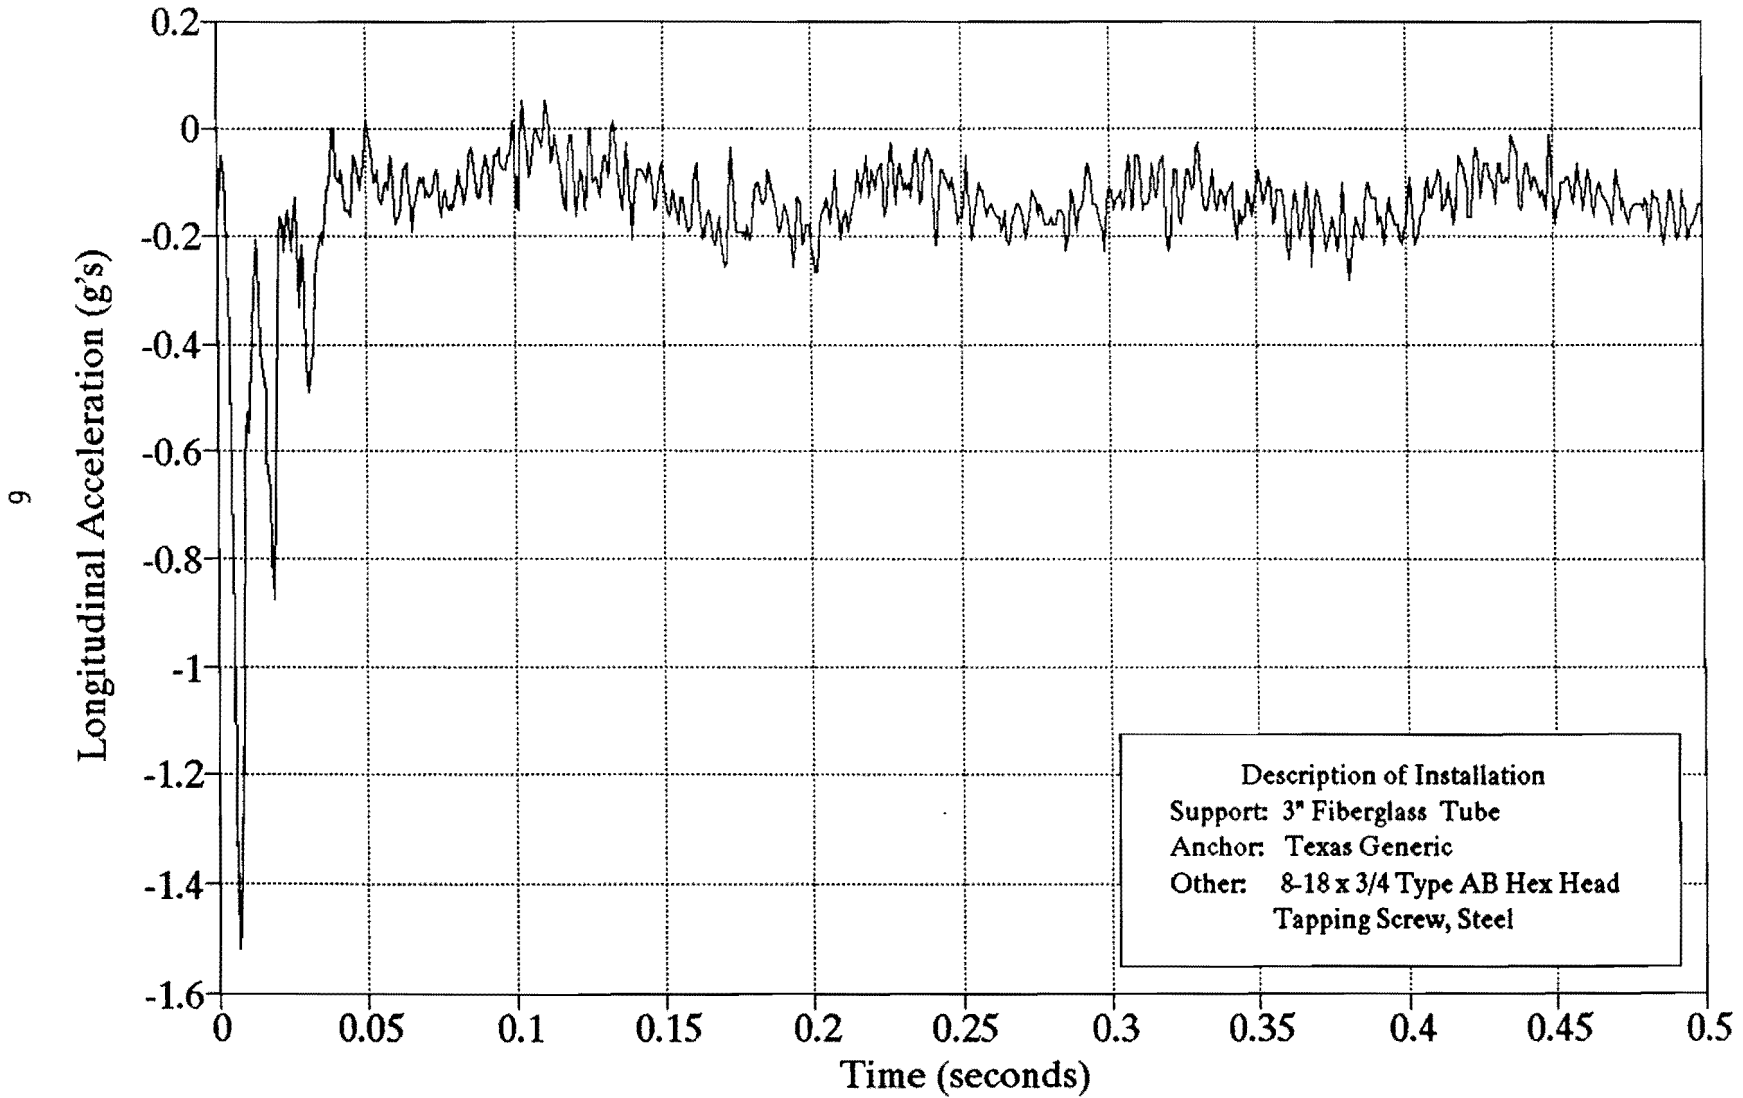
Figure 2. Pendulum longitudinal accelerometer trace (1219-P2).

A total of seven pendulum tests were conducted during the developmental effort. A performance evaluation summary of the pendulum tests is shown in Table 1. In addition, longitudinal accelerometer traces are shown in Figures 1 through 7. Tests were conducted by inserting the sign post into the modified generic anchor (with 6 inch insertion for all but test P3 which used a 12 inch insertion and a 2-1/2 in x 6 in pipe sleeve between the anchor and the post). It should be noted that in all pendulum tests, except P5 and P6, the sign post pulled out of the anchor. Comparison of the results shown clearly indicate that pullout of the sign post from the anchor is required for satisfactory impact performance.

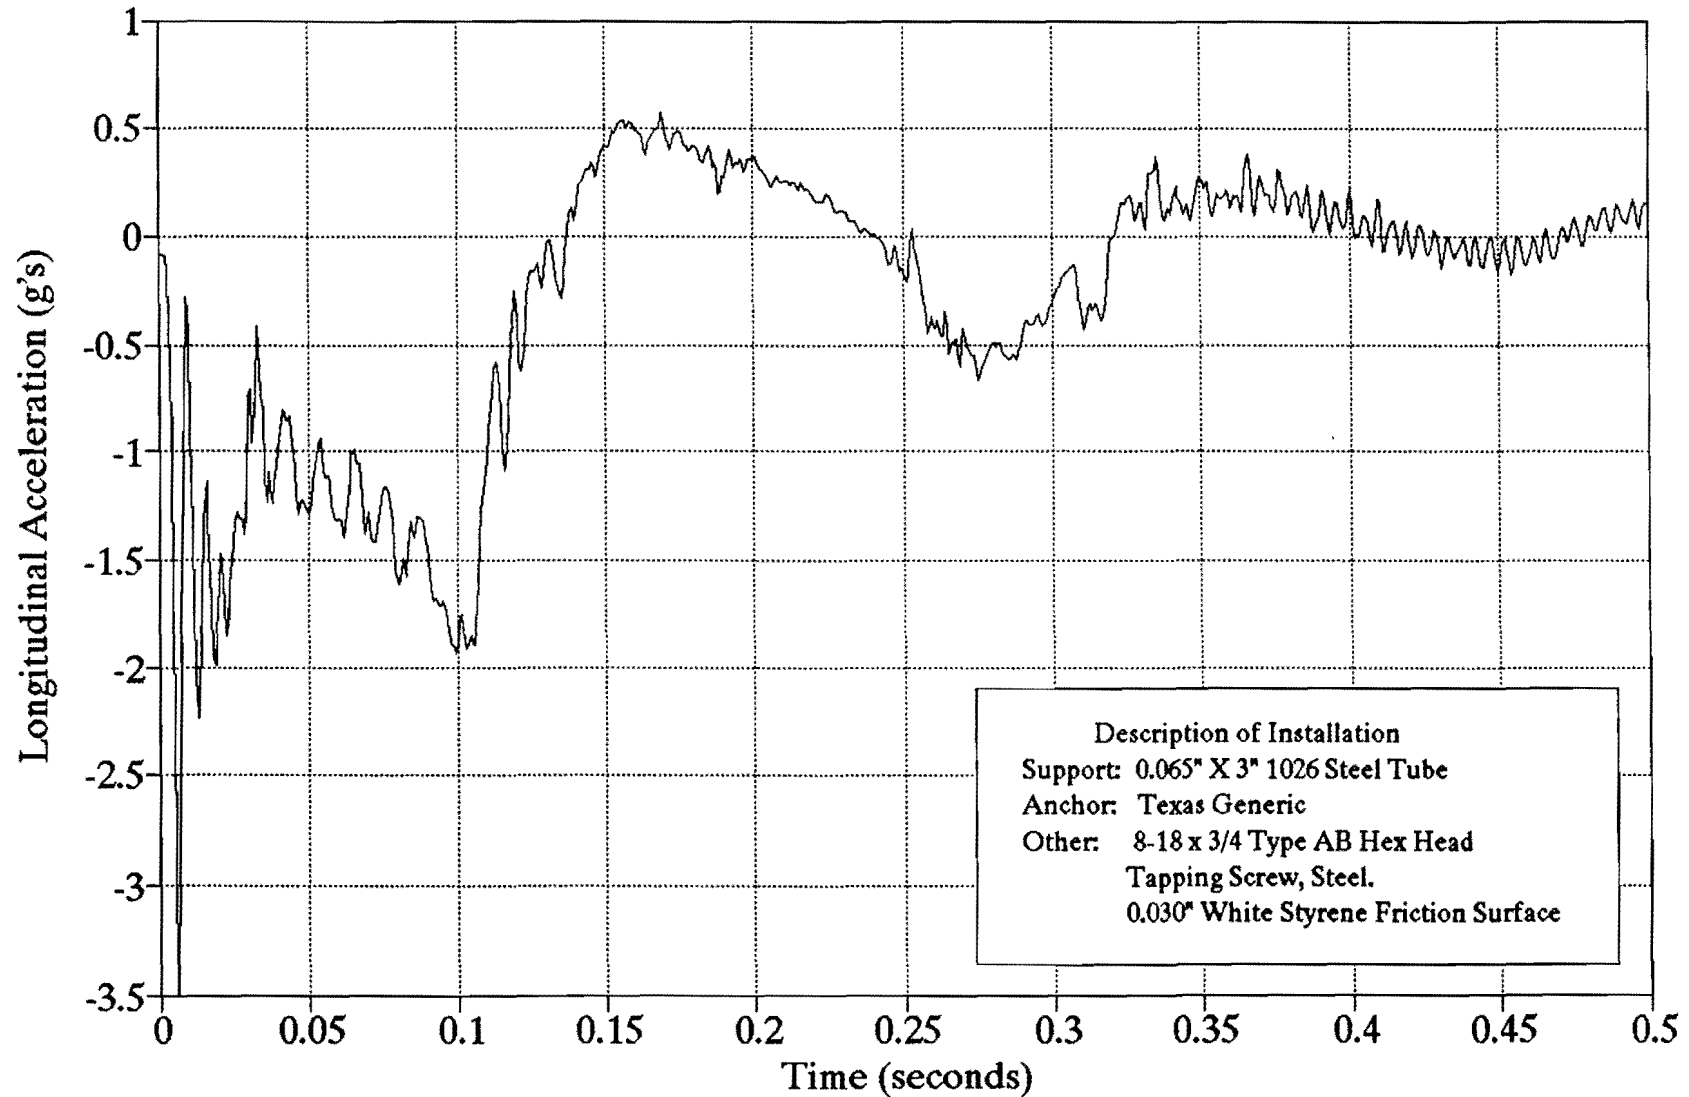
Figure 4. Pendulum longitudinal accelerometer trace (1219-P4).

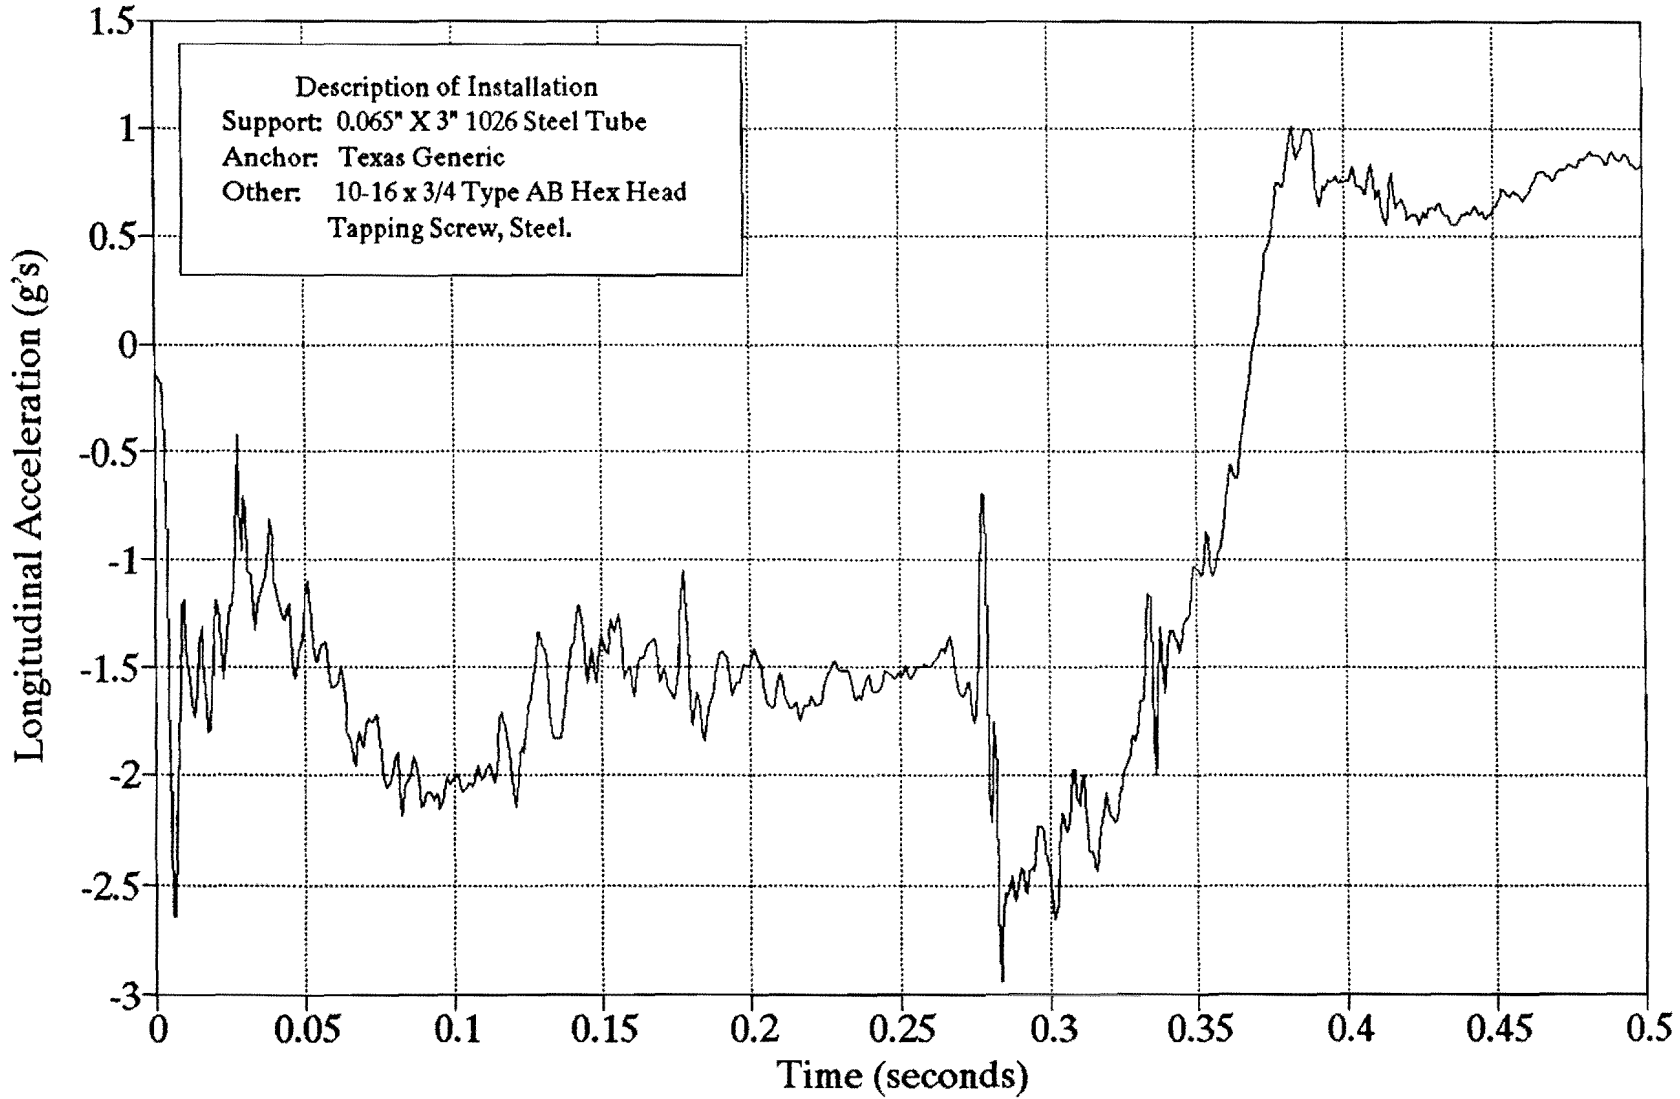
Figure 6. Pendulum longitudinal accelerometer trace (1219-P6).

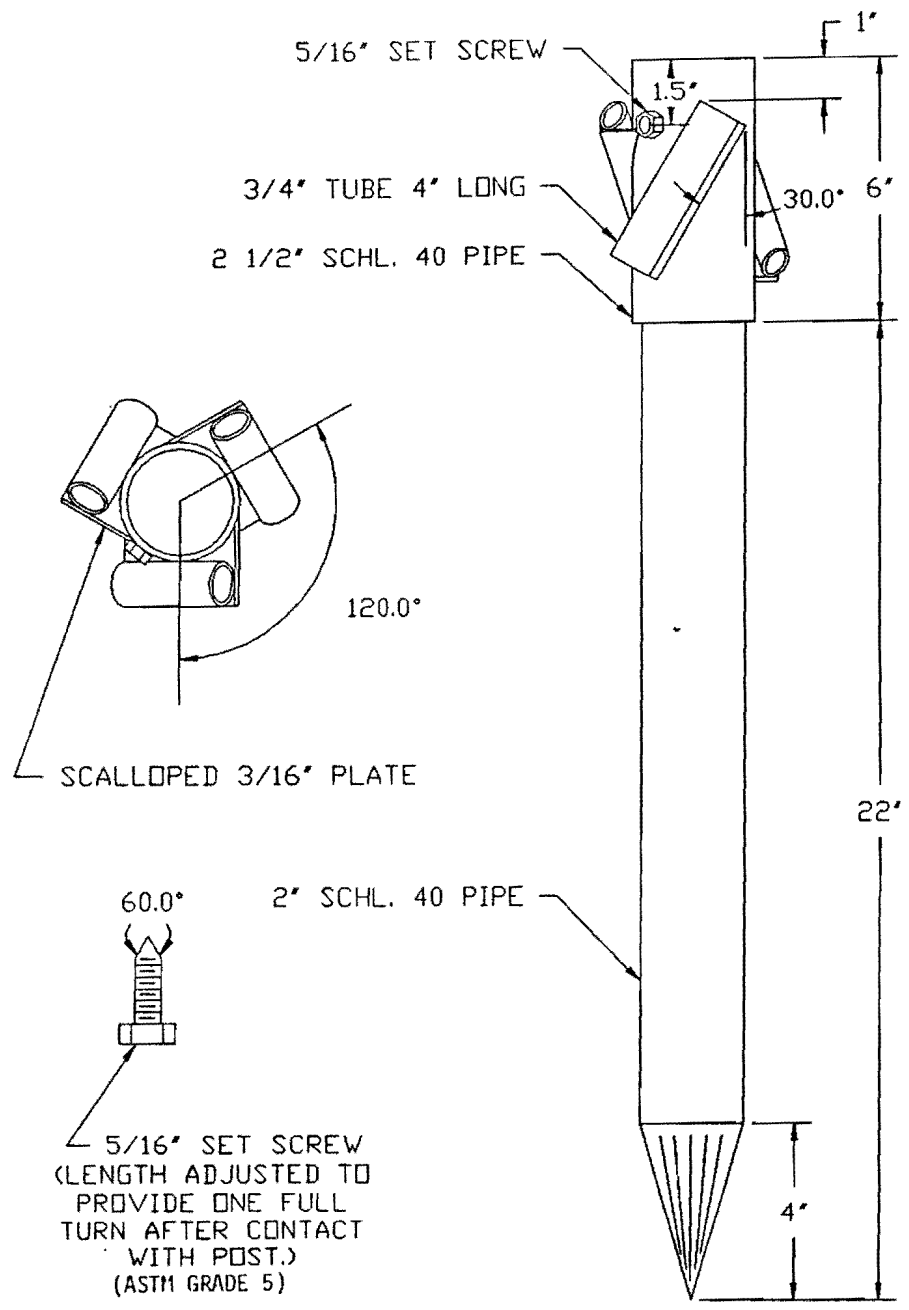
Figure 8. 1122 Generic anchor system

Figure 8. 1122 Generic anchor system (continued)

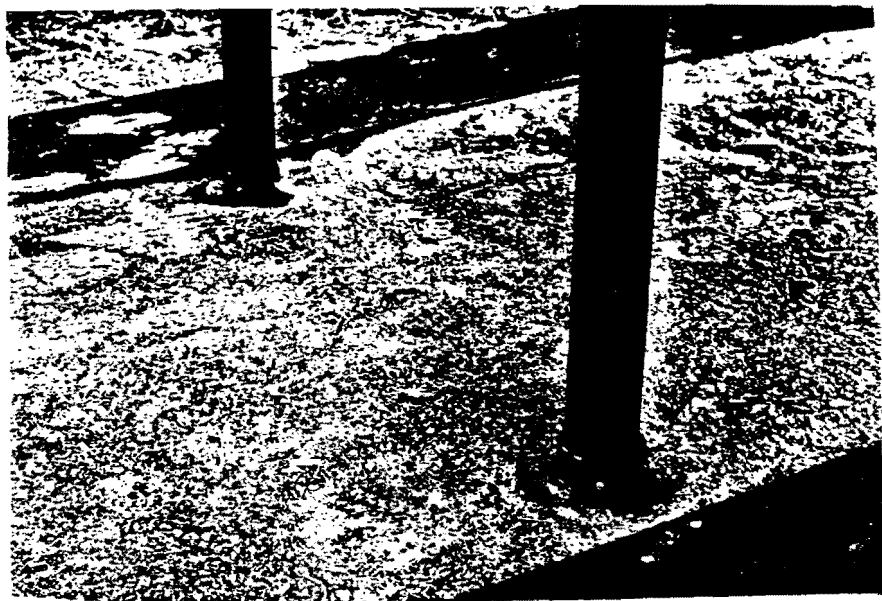
Figure 10. Sign installation before test 1219-1.

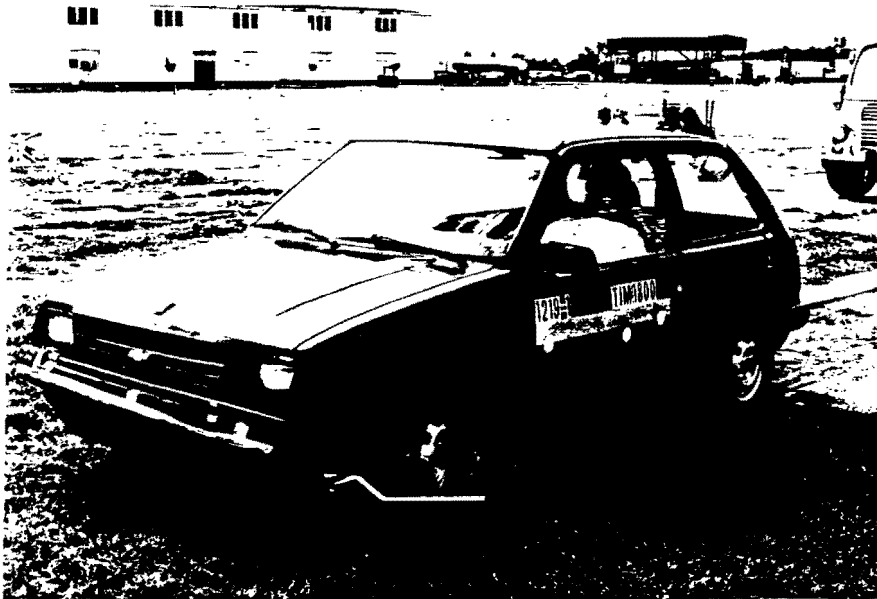
Figure 15. Vehicle after test 1219-1.

The installation yielded by pulling the left anchor from the ground and shearing the anchor/support attachment screws from the right anchor, allowing disengagement of the support from the anchor. In addition, the right anchor was pushed rearward and the sign support tubes bent (Figure 14). The vehicle sustained only minor damage to the bumper and right front fender as shown in Figure 15.

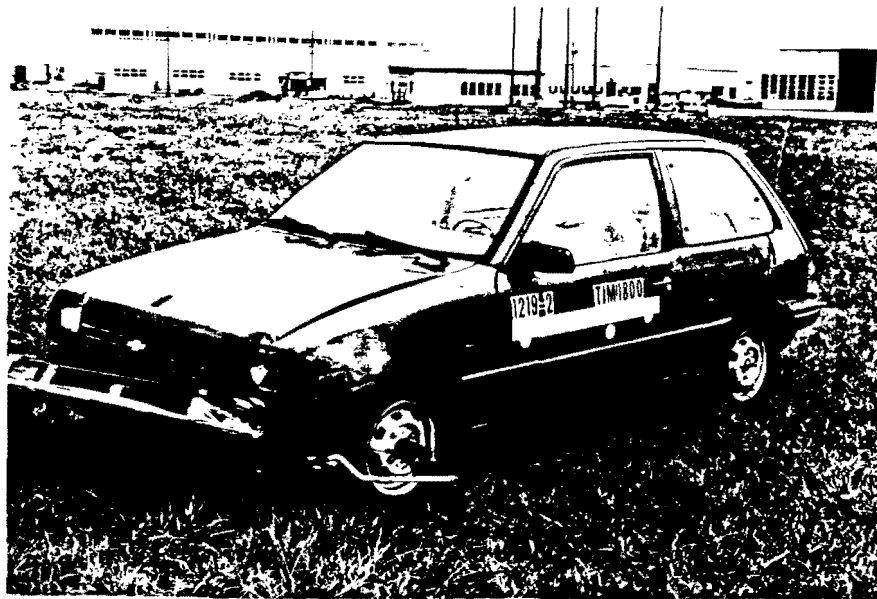
Figure 25. Vehicle after test 1219-2.

The installation yielded by shearing the anchor/support attachment screws and pulling the supports from the ground anchors. The anchors were pushed rearward and the sign support tubes bent (Figure 24). The vehicle sustained only minor damage to the bumper, hood and roof. In addition, the windshield was broken at the right-top-corner due to contact with the sign support. Post-test photographs of the vehicle are shown in Figure 25.

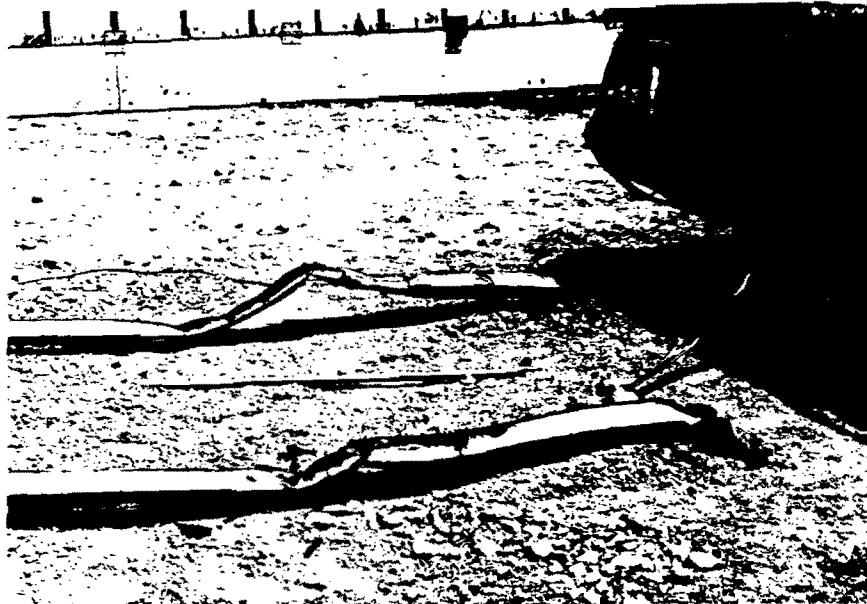
Figure 36. Sign installation after test 1219-5.

The installation did not allow the vehicle to pass safely through . The support tubes yielded, but remained attached to the ground anchors. The sign installation came to rest at the point of impact on the roadway (Figure 36). The vehicle sustained damage to the bumper, grill, hood and windshield as shown in Figure 37.

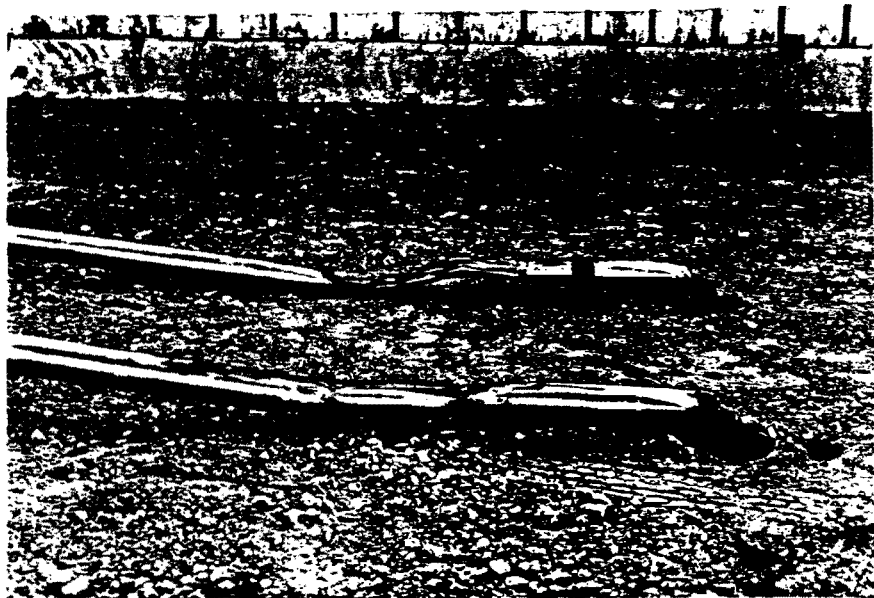
Figure 48. Sign installation after test 1219-6.

The installation did not allow the vehicle to pass safely through . The support tubes yielded, but remained attached to the ground anchors. The sign installation came to rest at the point of impact on the roadway (Figure 48). The vehicle sustained damage to the bumper, grill, hood and right front strut shown in Figure 49.

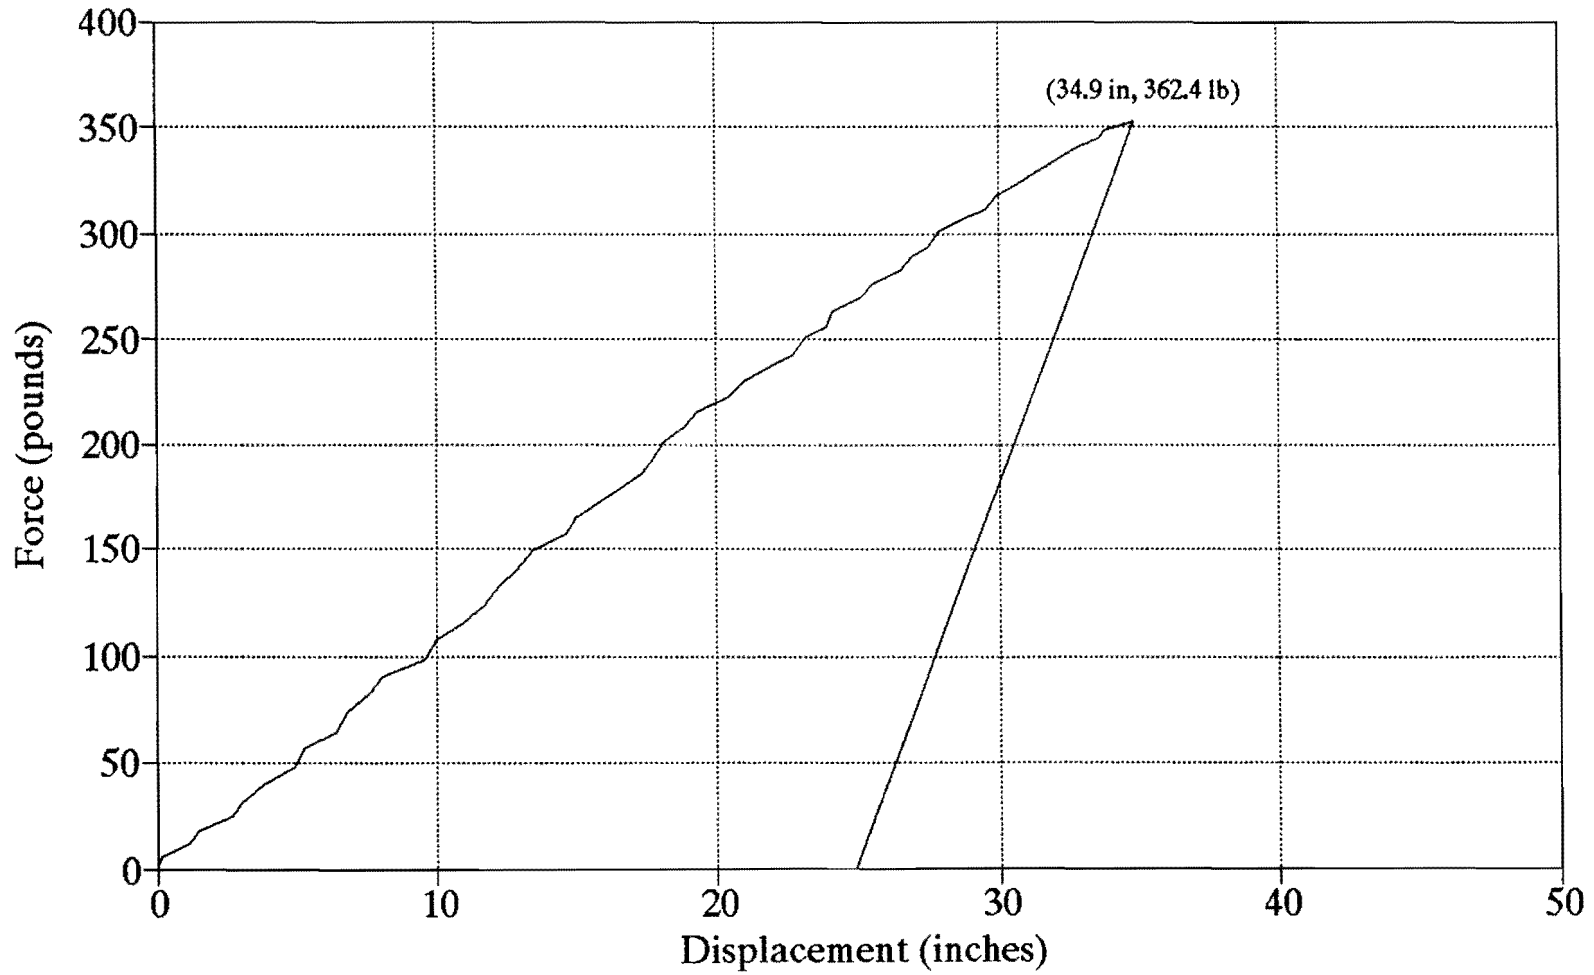
# PROJECT 1219 STATIC LOAD TEST HWYCOM SYSTEM

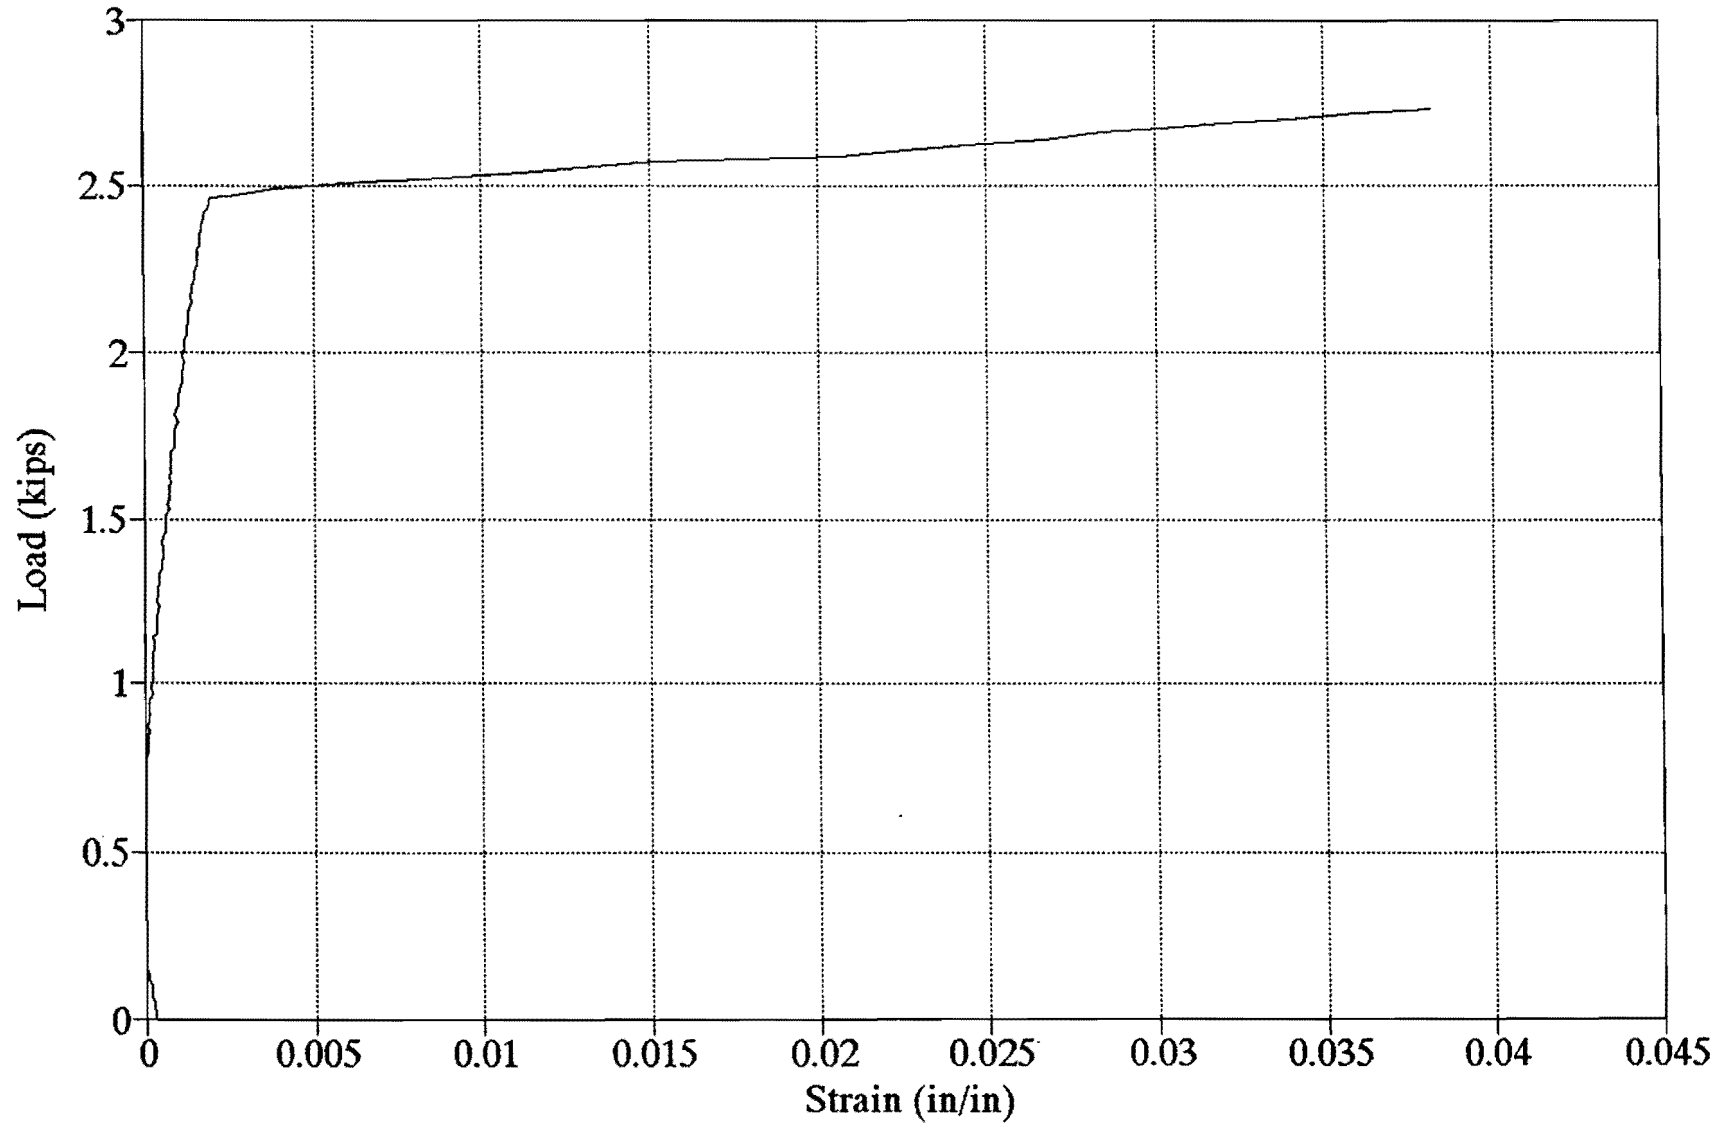
TENSILE COUPON TEST 1219-1X  
0.065" x 3.0" 1026 DOM Steel Tube
