1. Report No. FHWA/TX-93/1232-21		2. Government Accession No.		3. Recipient's Catalog No.	
4. Title and Subtitle EVALUATION OF SENSORS FOR MONITORING TRUCK SPEEDS				5. Report Date November 1993

EVALUATION OF SENSORS FOR MONITORING TRUCK SPEEDS

Research Report 1232-21
Research Study Number 0-1232
Research Study Title: Evaluation of Sensors for Monitoring Truck Speeds

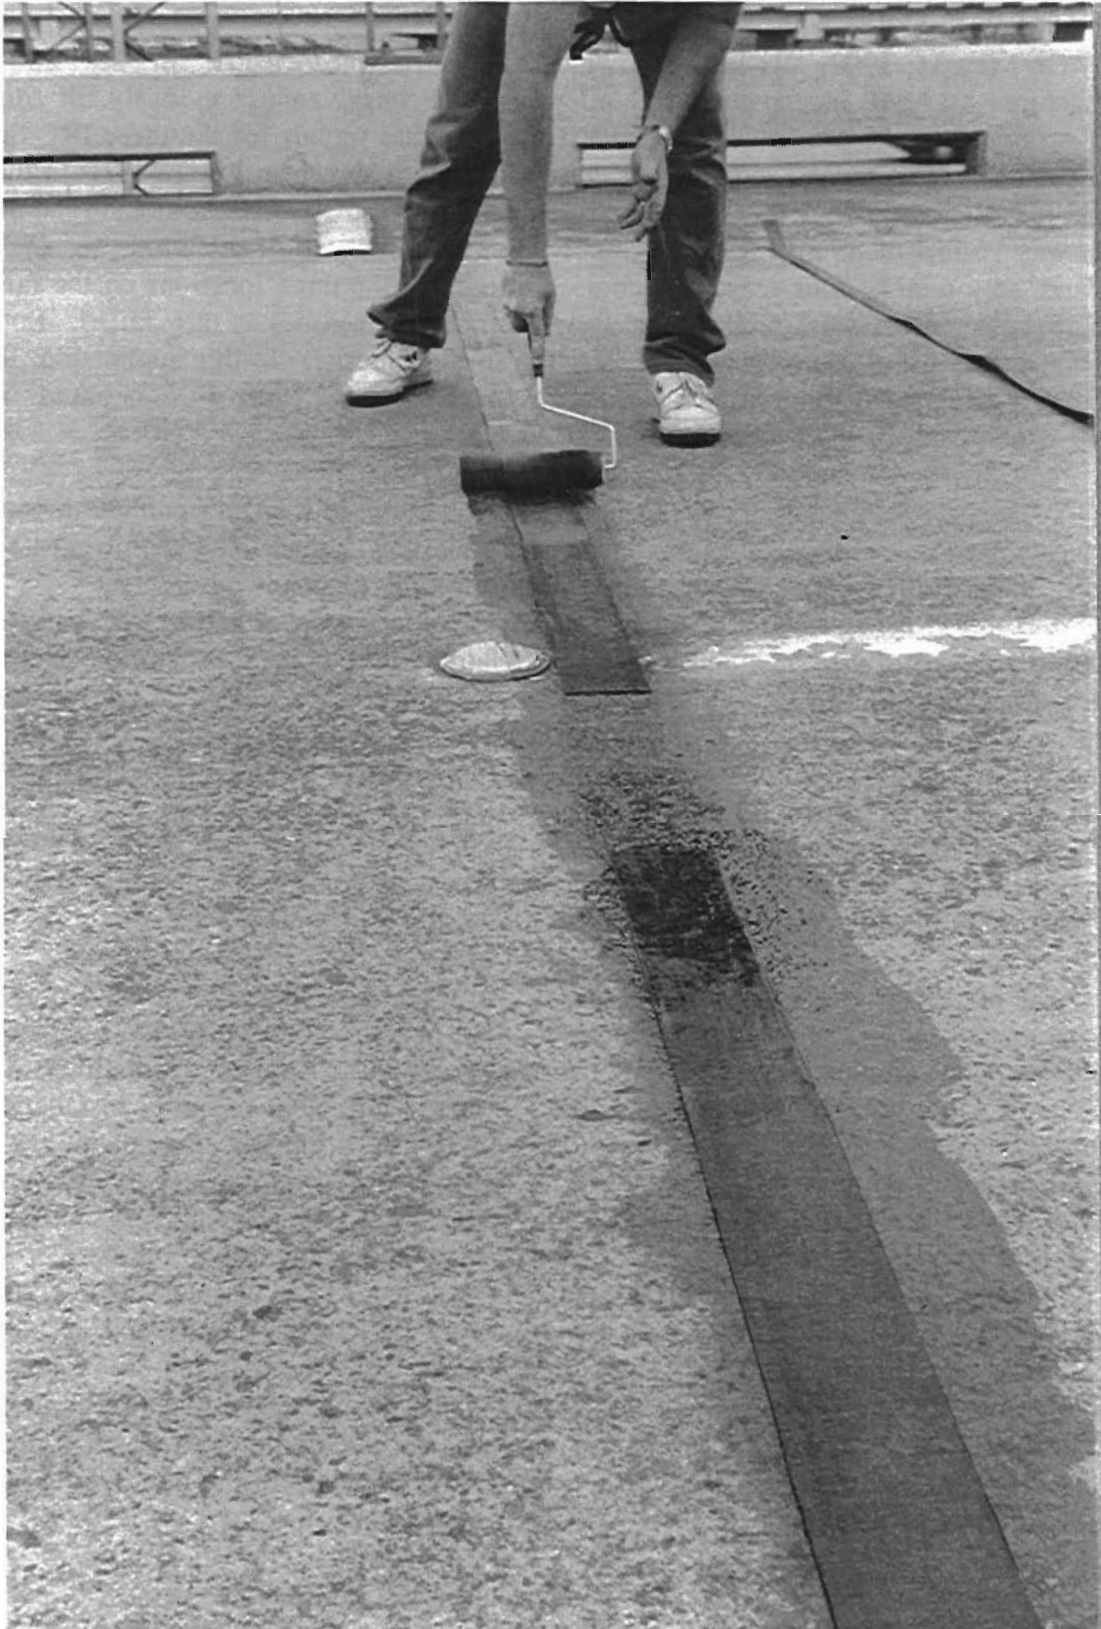
Figure 2-1. Applying Polygard and Primer for Piezo Sensors

To keep these TP sensors in position, TTI initially used a primer painted directly on the pavement surface, followed by one layer of a scale tape material called Polygard across the entire lane width. After a few minutes of curing time (depends on ambient temperature), TTI then placed a new piezo sensor directly on top of and in the center of the Polygard, being careful to maintain its position relative to the other sensor in the same lane. At least one layer (preferably two layers) of Polygard covered the sensor in an overlapping fashion to maintain its position relative to the other sensor and to protect it from traffic. Six-inch (152 mm) widths of Polygard were typically used, although 4-inch (102 mm) widths were also occasionally used. Figures 2-1 through 2-4 show the initial process of placing these sensors on the pavement. Efforts used to protect sensors and coaxial cables from damage included placement of raised pavement markers adjacent to the terminal block of each sensor and placing coaxial cables behind (downstream) shoulder tiles.

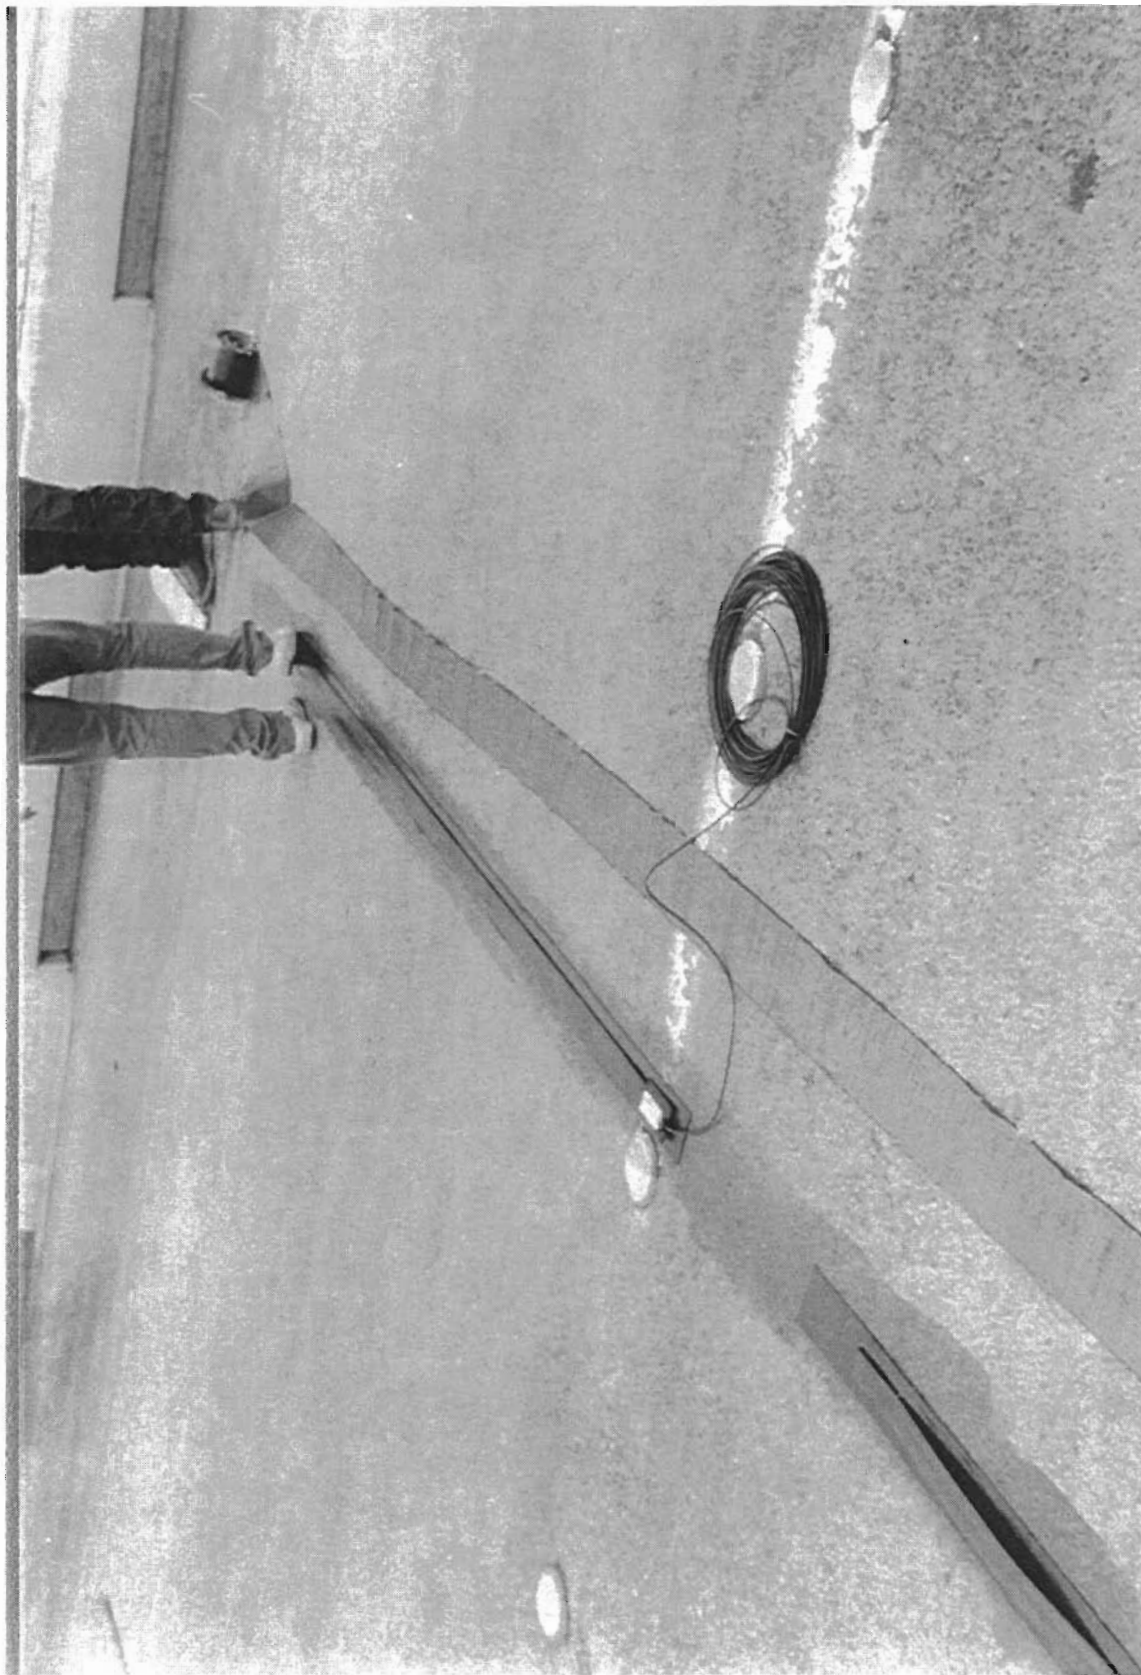
Figure 2-2. Lane 2 Piezo Sensor Prior to Covering with Polygard

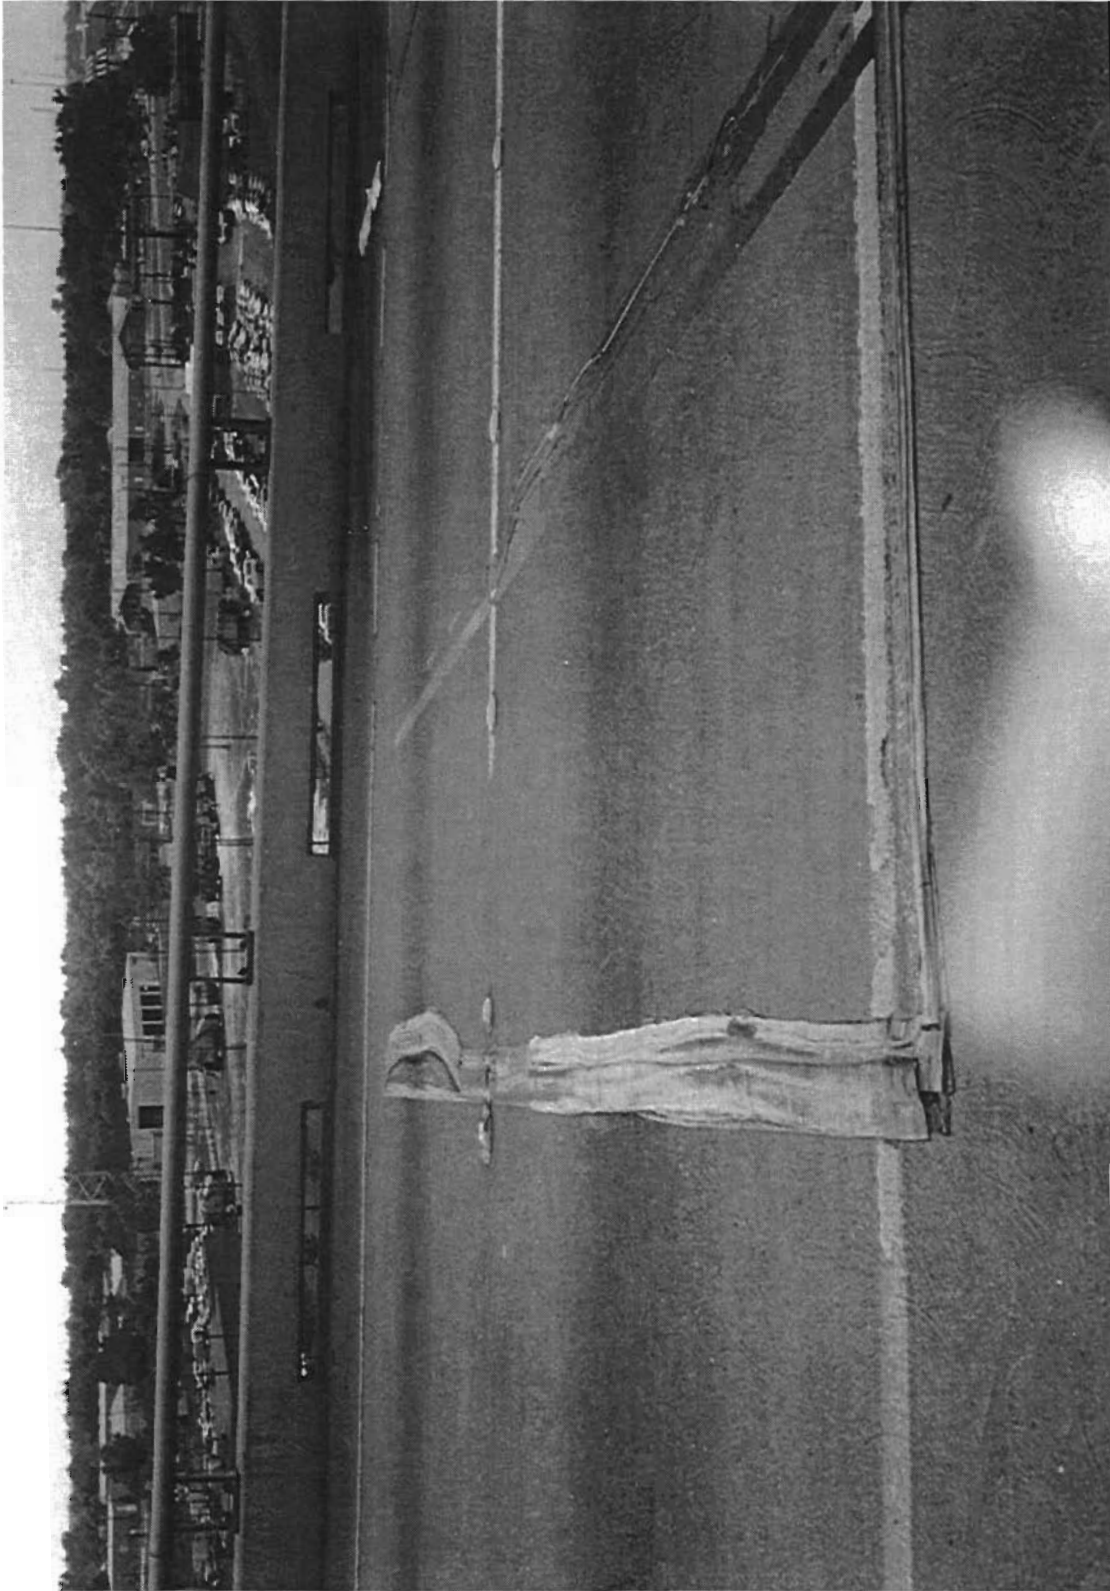
Figure 2-6. Deformed Piezo Sensors at Location C

The use of these temporary sensors produced at least two failure modes. One was simply from repeated loadings from heavy traffic volumes, particularly trucks, and the other was due to the lateral forces applied by decelerating vehicle tires to the sensors. This latter effect shoved the sensors forward in the wheel paths and caused a breakdown in the bond between the adhesive material and the pavement. After an extended period of time of this shoving action in hot weather, the adhesive bond was so weak or even nonexistent that a passing vehicle would cause visible movement in the sensor. It should be noted that the slippage of the sensors in the wheelpaths was not apparent during the cooler winter months of January, February, and part of March, as depicted by Figure 2-5. This figure is a summary of repairs and/or failures of both film and cable piezoelectric sensors.

Attempts to straighten these deformed sensors were not always successful. Stress created by the removal process sometimes caused failure, and at other times the sensor or its coaxial cable were inadvertently cut during the repair. The coaxial cable was always protected underneath one or more layers of scale tape and was difficult to locate before cutting away old material. Figure 2-6 illustrates sensor deformation in lane 2; Figure 2-7 illustrates a later view of the lane 2 replacement sensor and the lane 1 sensor beginning to shift.
