1. Report No. FHWA/TX-95/1232-28		2. Government Accession No.		3. Recipient's Catalog No.	
4. Title and Subtitle A STUDY OF SELECTED WARNING DEVICES FOR REDUCING TRUCK SPEEDS				5. Report Date November 1994

**A STUDY OF SELECTED WARNING DEVICES
FOR REDUCING TRUCK SPEEDS**

Research Report 1232-28
Research Study Number 0-1232

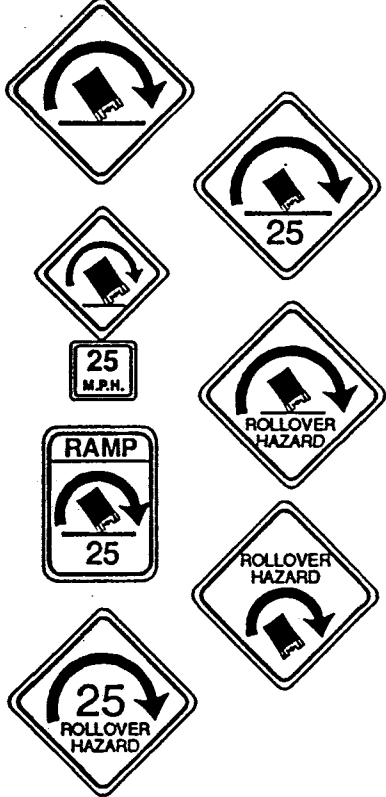
Figure 4-6. Relative Sign Detection Distances

AT RAMP TEST SIGNS	SIGN CODE	SIGN DETECTION DISTANCE (meters)	
		MEANING	READ

T-21	1.47	N/A
	T-16	1.42	0.74
	T-25	1.27	1.17
	T-24	1.14	No
	T-26	1.01	0.89
	T-7	0.81	No
	T-3	No	No
	ADVANCE TEST SIGNS		
	T-6	0.91	No
	T-9	0.71	0.36
T-10	No	No

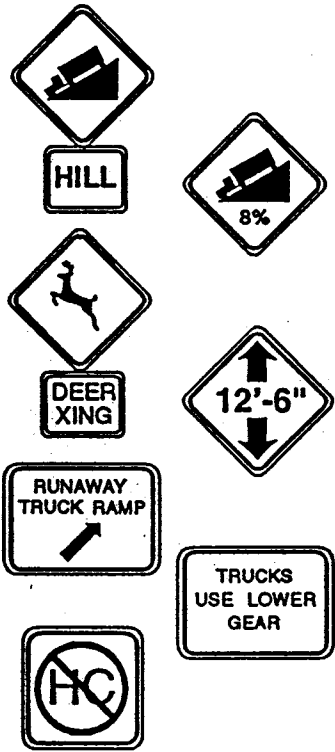
Figure 4-6. Continued

SELECTED DISTRACTORS	SIGN CODE	SIGN DETECTION DISTANCE (meters)	
		MEANING	READ

D-11	1.65	0.94
	D-2	1.35	No
	D-10	1.30	0.99
	D-3	1.27	1.17
	D-15	1.19	1.12
	D-18	0.64	0.64
	D-21	0.36	0.41

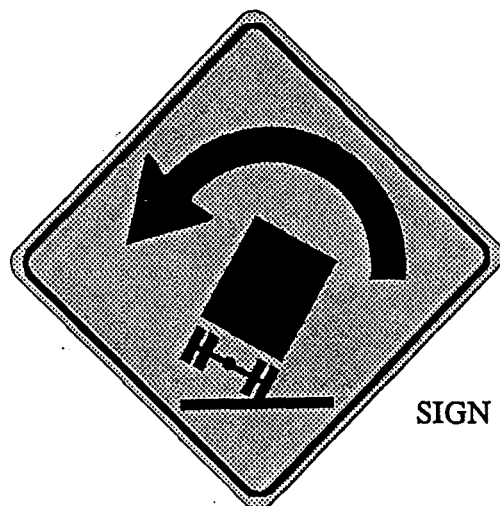
Figure 4-7. Truck Tipping Sign Used in First Interview Session

Sign Recognition Interviews. Figure 4-7 shows the "standard sign" that has been used in Pennsylvania and which was used in both of the Texas interview sessions. It will be referred to as "sign number 1" in the discussion that follows.
