1. Report No. FHWA/TX-97/1244-11		2. Government Accession No.		3. Recipient's Catalog No.	
4. Title and Subtitle INFLUENCE OF COARSE AGGREGATE IN PORTLAND CEMENT CONCRETE ON SPALLING OF CONCRETE PAVEMENTS				5. Report Date November 1995 Revised: October 1996

6. Performing Organization Code	
7. Author(s) Sanjaya P. Senadheera and Dan G. Zollinger				8. Performing Organization Report No. Research Report 1244-11

**INFLUENCE OF COARSE AGGREGATE IN PORTLAND CEMENT
CONCRETE ON SPALLING OF CONCRETE PAVEMENTS**

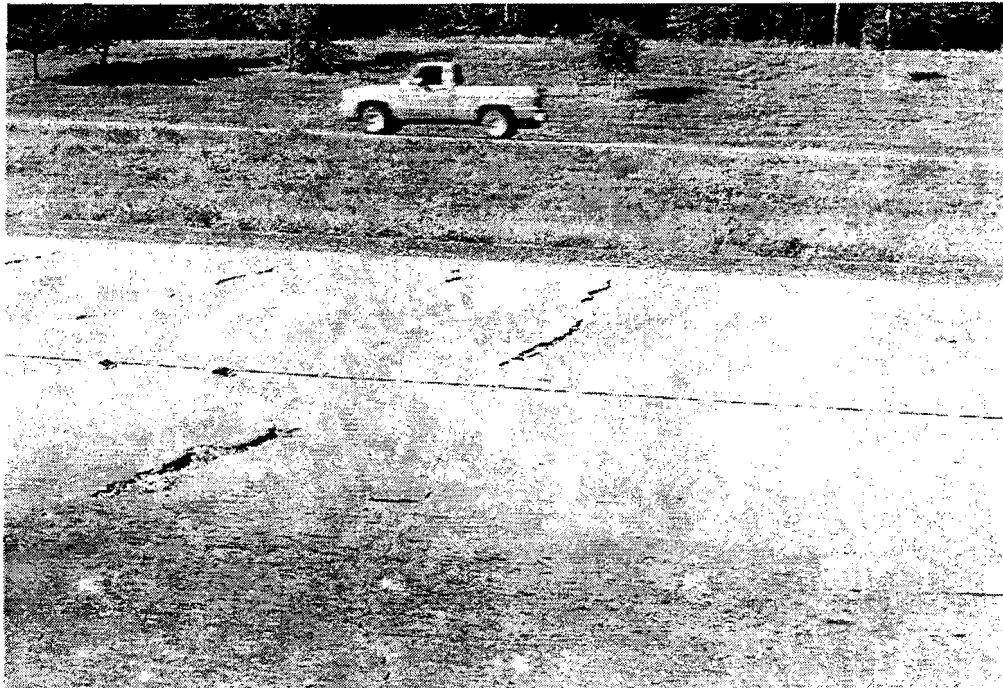
FIG. 1. Typical Spall in Concrete Pavements

Spalling is a distress in Portland cement concrete pavements where a visible surface distress is caused by pieces of concrete getting dislodged from the surface of the pavement. Fig. 1 illustrates a typical spall in a concrete pavement. Spalling primarily occurs at transverse cracks or joints in a concrete pavement. It is a form of distress which is common to both continuously reinforced concrete pavements (CRCP) and jointed concrete pavements (JCP). Spalling results in a rough ride, and it also gives the traveling public a negative perception of the integrity of the pavement. From a technical standpoint, loss of concrete due to spalling may lower the load transfer efficiency across the transverse random cracks (in CRCP) or joints (in JCP). A reduction in load transfer efficiency will increase the stress level due to traffic loading in the pavement and will

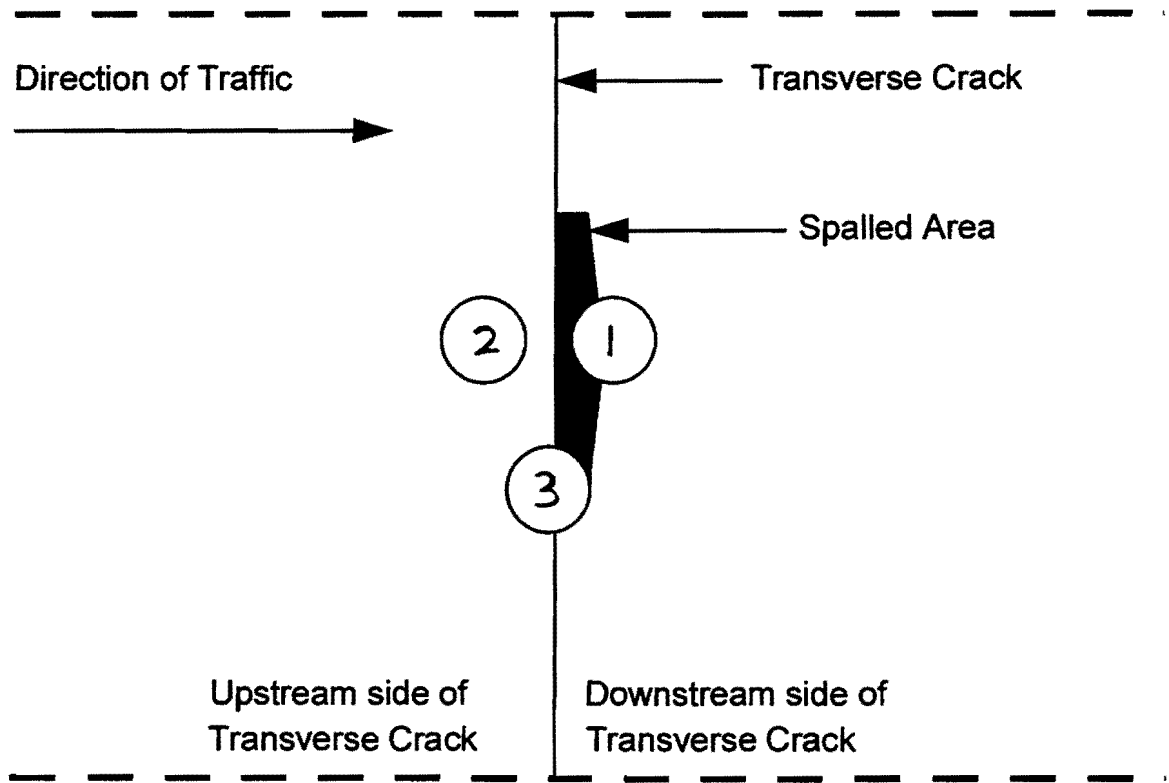
FIG. 2. Schematic Diagram for Coring, Indicating Coring Positions and Notations
Observations from Field Surveys

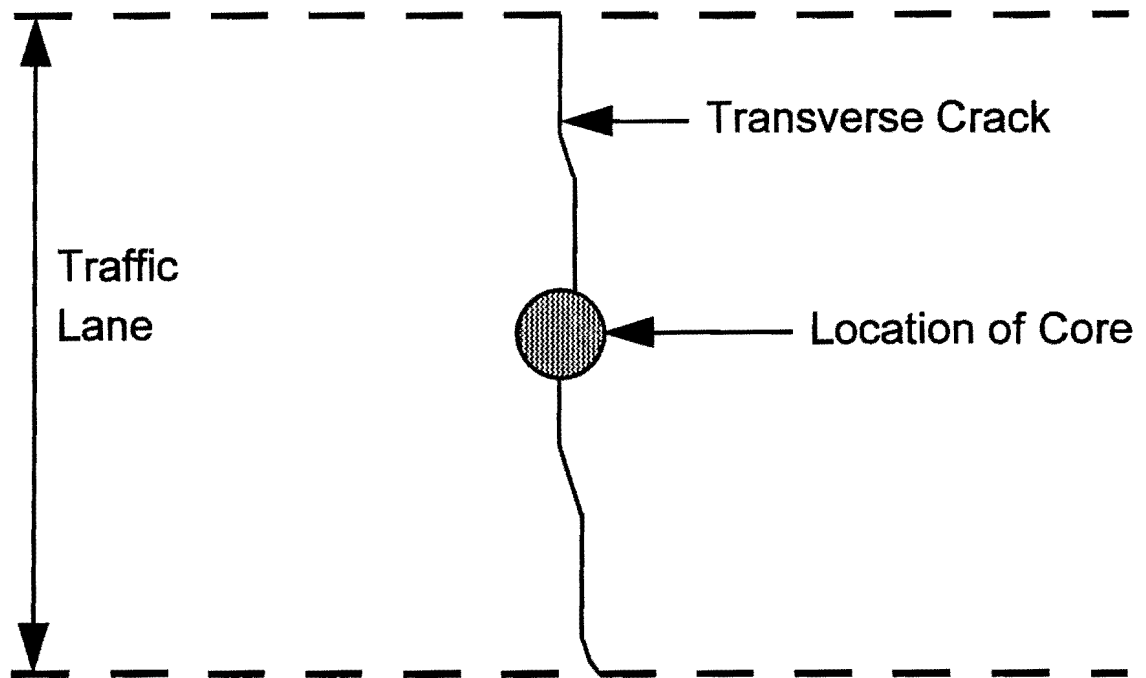
FIG. 6. Schematic Diagram Indicating the Location of the Core Shown in Fig. 5

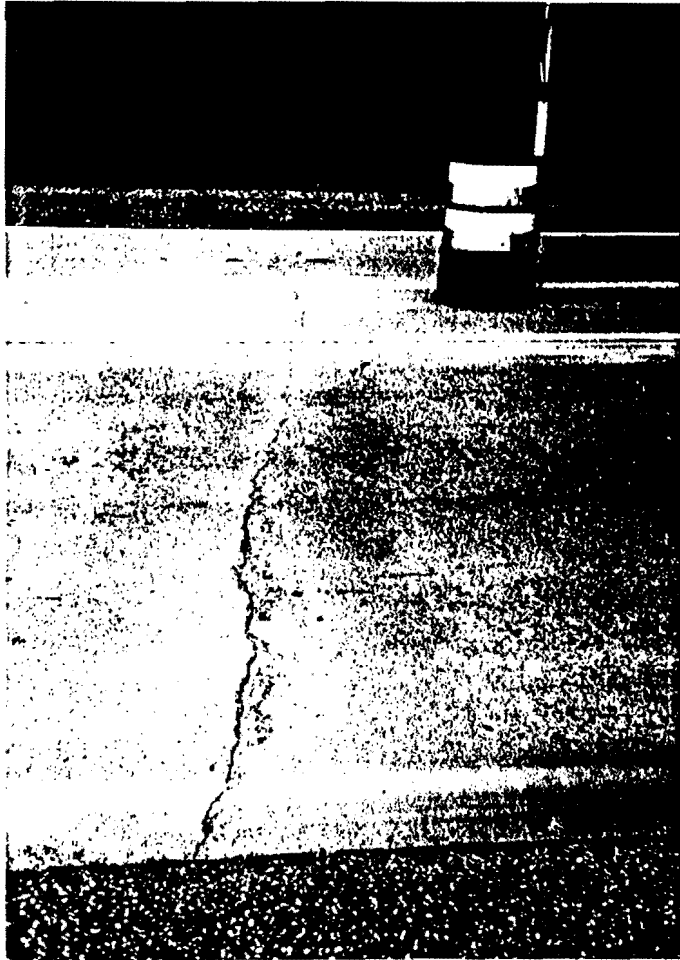
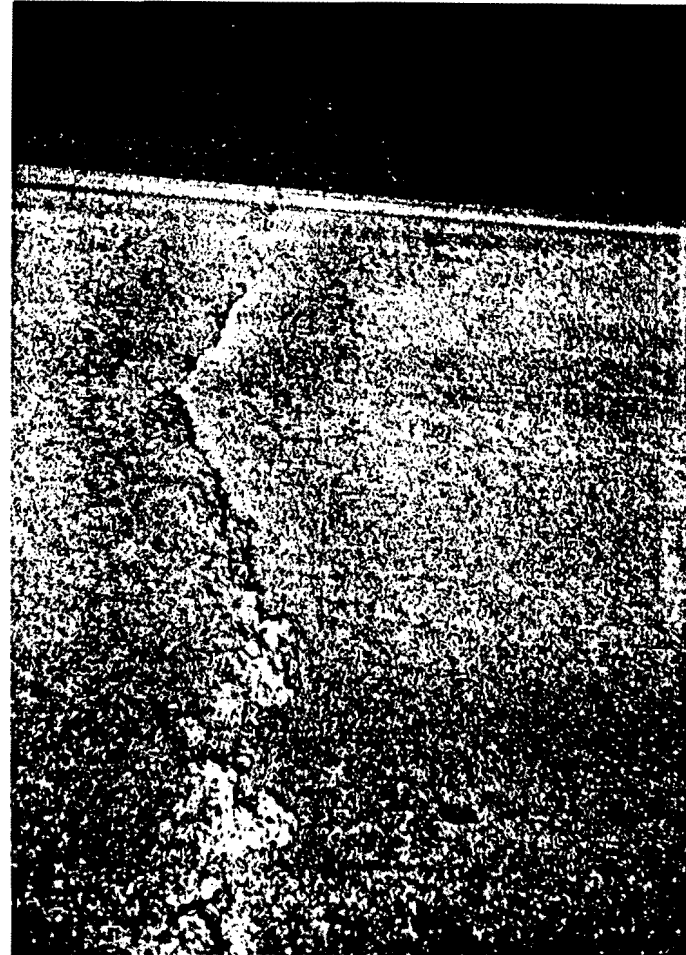
FIG. 9. Orientation of Spalling in SH-6 East Bypass in Bryan/College Station: (a) Spalling Only on Upstream Side of the Crack, and (b) Spalling on Both Sides of the Crack

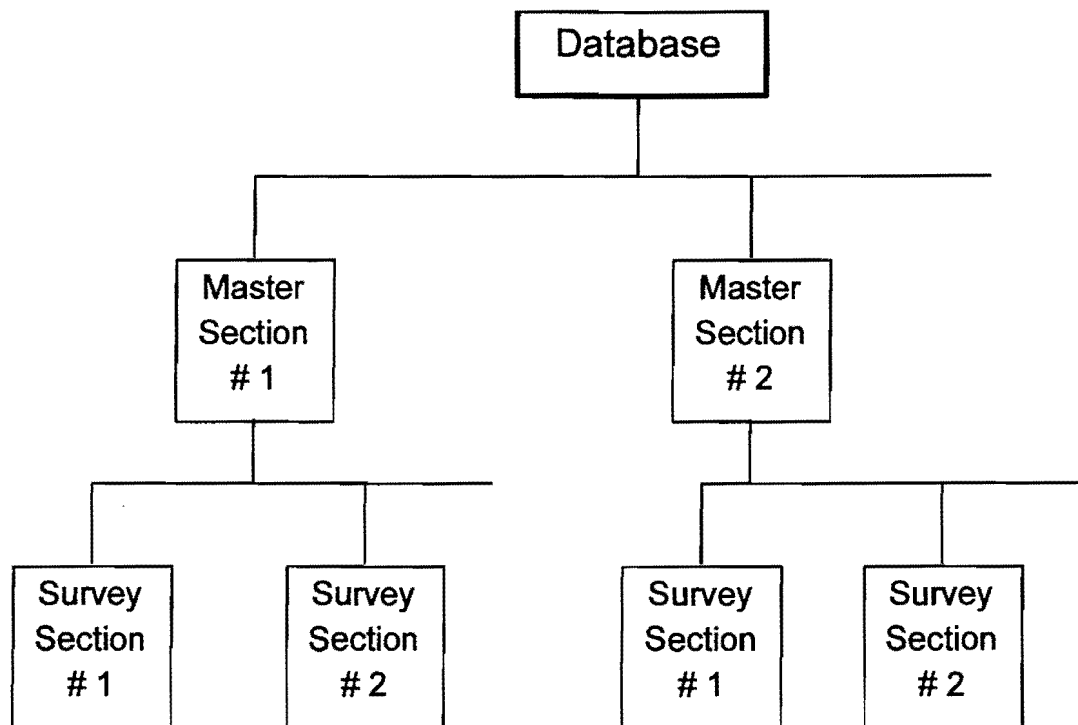
FIG. 16. Data Collection Framework for Texas Rigid Pavement Database

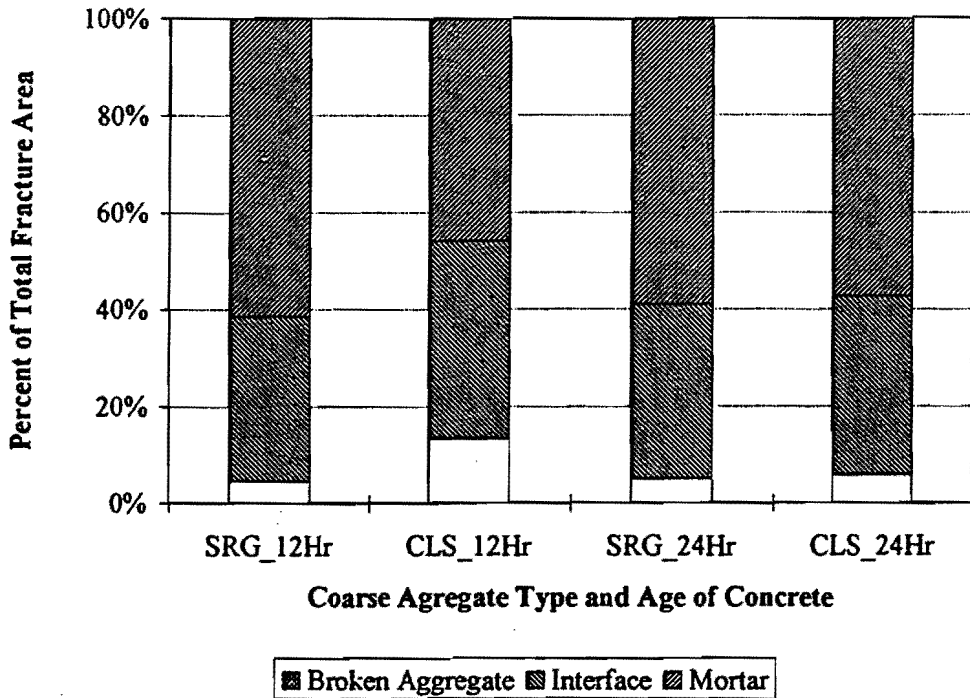
FIG. 26. Comparison of the Distribution of Fracture Surface Areas on Failure Surfaces From Indirect Tensile Fracture Tests

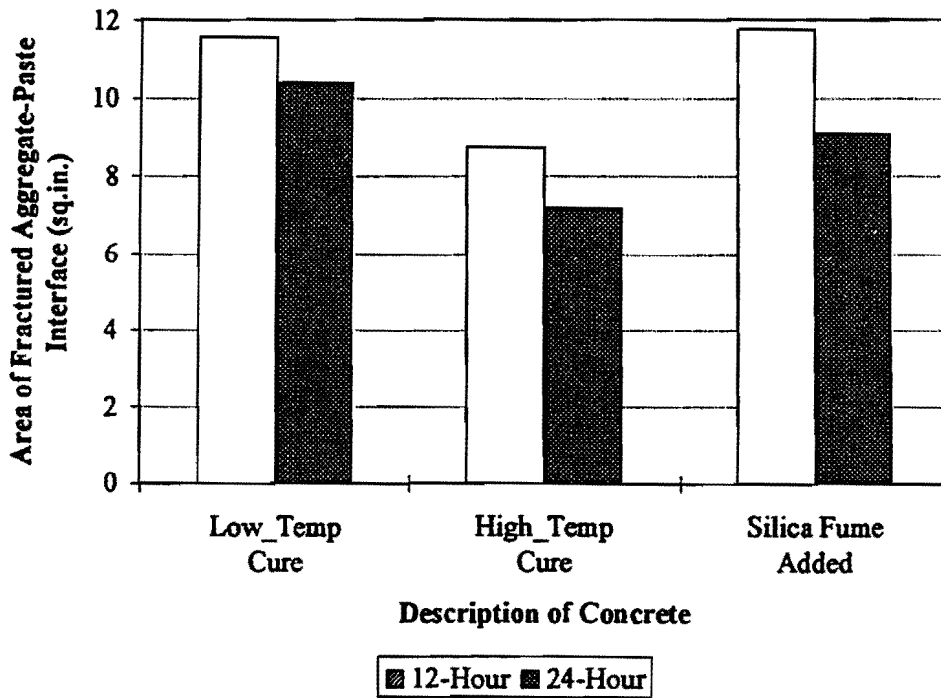
FIG. 27. Comparison of Areas of Interfacial Failure for Three Types of Crushed Limestone Concrete

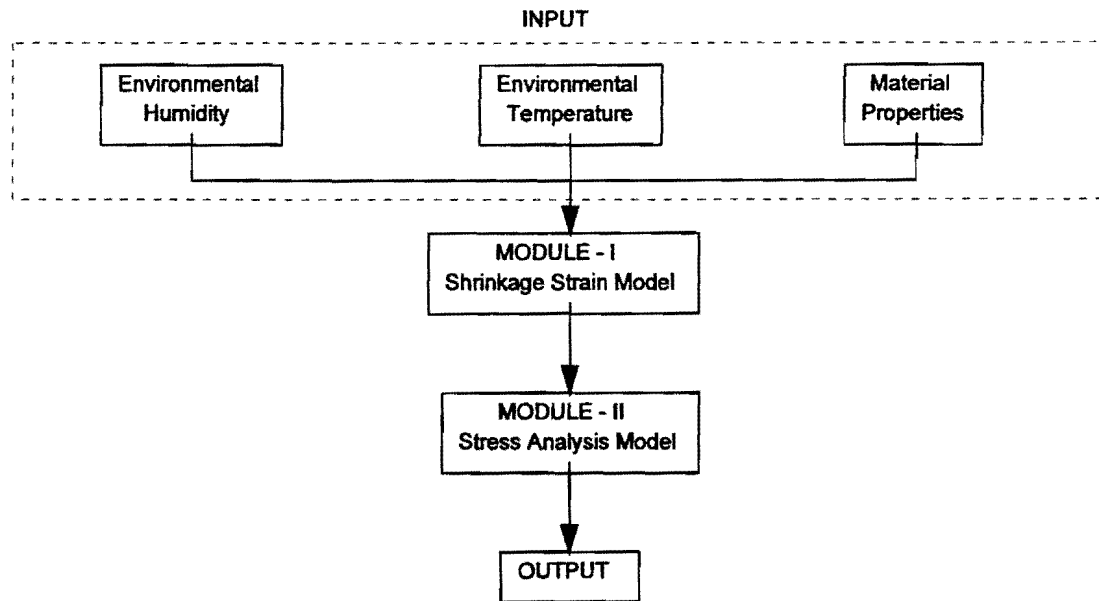
FIG. 41. Computer Program Formulation for Finite Element Analysis of Early-Age Concrete Pavements

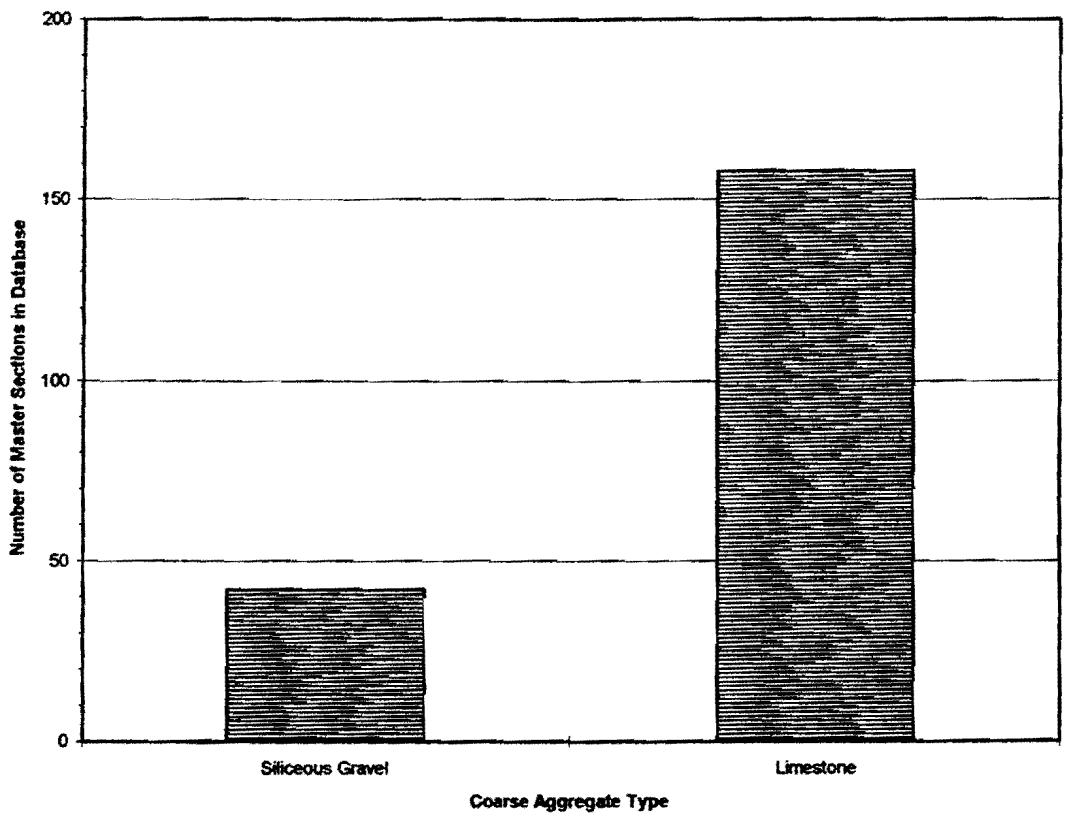
FIG. B-2. Number of Master Sections Available in TRPD, by Coarse Aggregate Type
