1. Report No. FHWA TX-91/92-1263-1F		2. Government Accession No.		3. Recipient's Catalog No.	
4. Title and Subtitle BRIDGE RAILING END TREATMENTS AT INTERSECTING STREETS AND DRIVES				5. Report Date November 1992

**BRIDGE RAILING END TREATMENTS AT
INTERSECTING STREETS AND DRIVES**

**Research Report 1263-1
Research Study No. 2-5-91-1263
Bridge Railing End Treatment at Intersecting Streets and Drives**

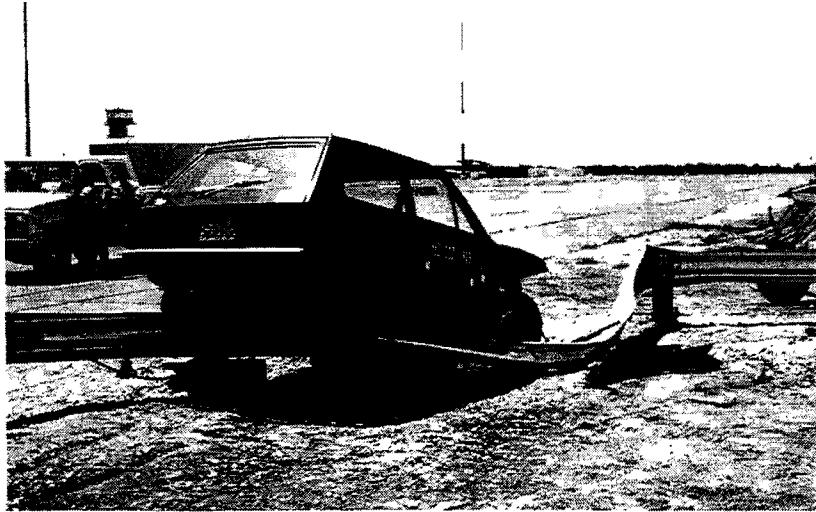
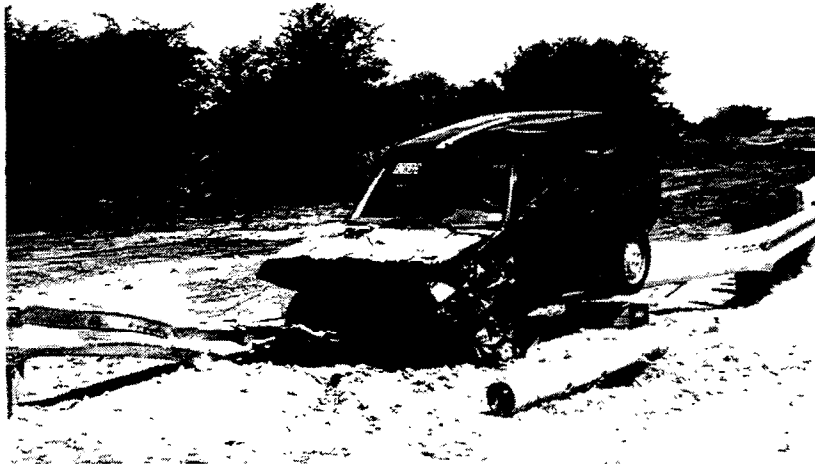
FIGURE V-3. Test Vehicle and Test Article after Test 1263-1

The system did not perform as designed for two reasons. First, upon impact, the weakened posts (referred to as CRT posts) in the curved portion began to rotate and were then pulled from the ground without fracturing as the vehicle continued to move forward. This had the effect of generating higher than expected impact forces on the vehicle. Secondly, the BCT

post downstream from the impact point did not fracture as anticipated. This caused the rail to develop higher than expected tensile forces since the anchor cable could not release from the BCT post, which also contributed to higher than expected impact forces on the vehicle.

Longitudinal occupant impact velocity was 41.8 ft/s., which exceeded the limit of 40 ft/s recommended in NCHRP Report 230 (5). This was attributed to the unexpected system behavior previously described. Modifications made to improve performance are described in the next section.

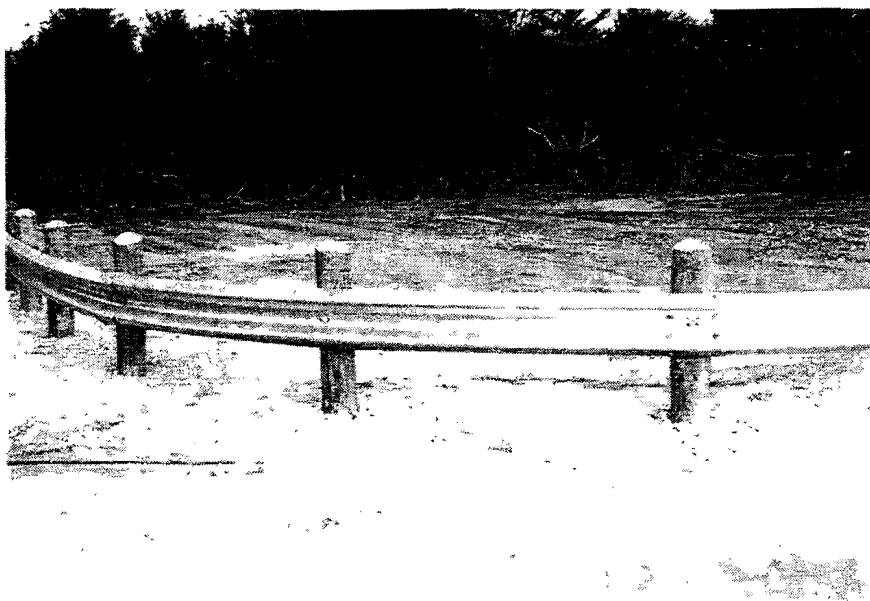
FIGURE V-5. Test Article Prior to Test 1263-2

Impact conditions for this test were the same as test 1263-1. However, two modifications were made to the installation of test 1263-1. First the most downstream BCT assembly was removed and the BCT post and sleeve was replaced by a weakened post. Secondly, the embedment depth of all weakened posts was increased from 38 in. to 44 in. to facilitate fracture of the posts during impact. The holes used to weaken the post were placed at the same location with respect to the ground line as in the previous test. These changes were used to reduce the stiffness of the system for impacts into the curved section. A plan view of the test installation is given in Figure V-4. Photos of the installation are given in Figure V-5.

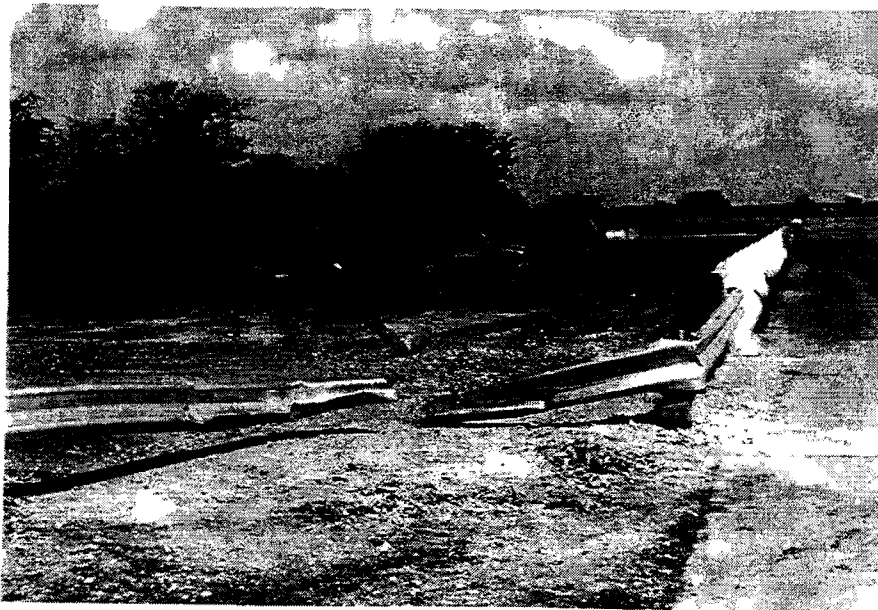
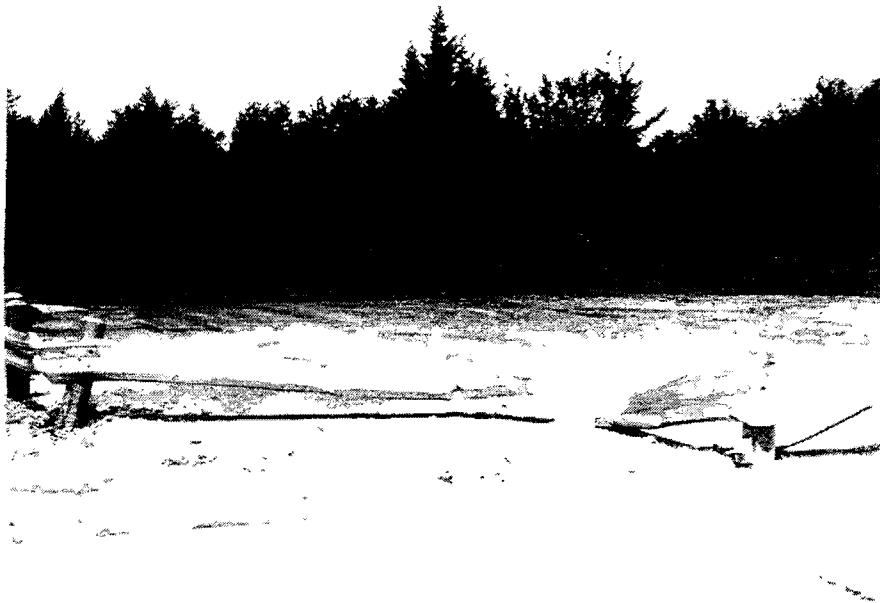
FIGURE V-6. Test Article After Test 1263-2

The vehicle impacted the test article at approximately 60 mph and 20 degrees. Upon impact, the weakened posts in the curved portion of the system fractured as designed. However, as the vehicle continued to penetrate into the system the curved W-beam fractured at a splice, allowing the vehicle to travel well beyond the intended stopping distance. This was an unexpected and unacceptable failure. Photos of the installation after the test are given in Figure V-6.

Tensile tests were performed on a specimen from the torn w-beam by an independent test lab. Results (given in Appendix F, in section describing Test 1263-2) showed the material to be within specifications with regard to yield strength, ultimate strength, and ductility. It is noted that the material in a W-beam is subjected to stresses beyond the yield strength during the normal cold-forming process. The material is further yielded during the process of bending the rail into a curved section. This is believed to alter the ductility of the material, and to make the material more susceptible to a brittle-type failure, especially if a crack were present in high

stress areas of the beam. Further study of the effect these forming processes have on the impact strength of guardrail, and curved guardrail in particular, may be warranted.

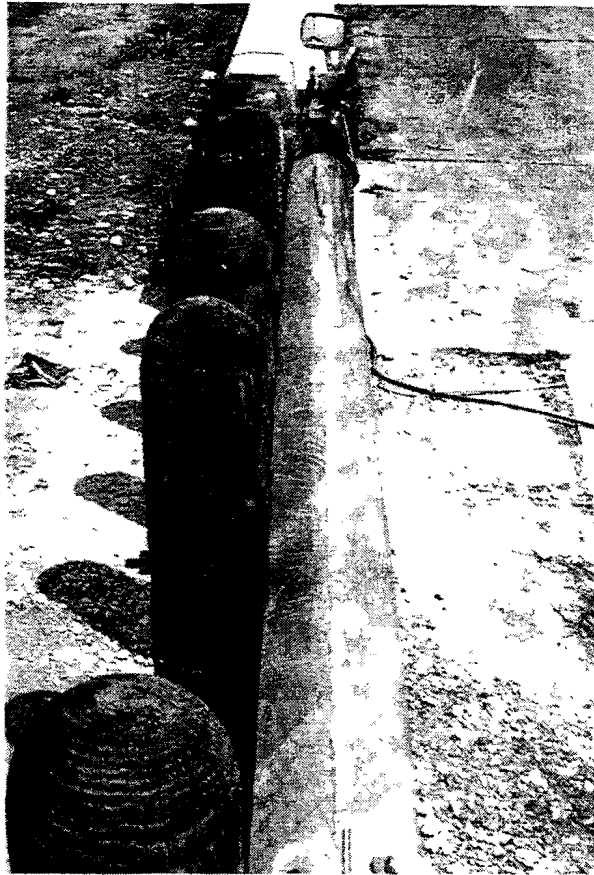
FIGURE V-12. Test Article After Test 1263-4

criteria of NCHRP Report 230. Photos of the installation and the vehicle after the test are given in Figures V-12 and V-13.

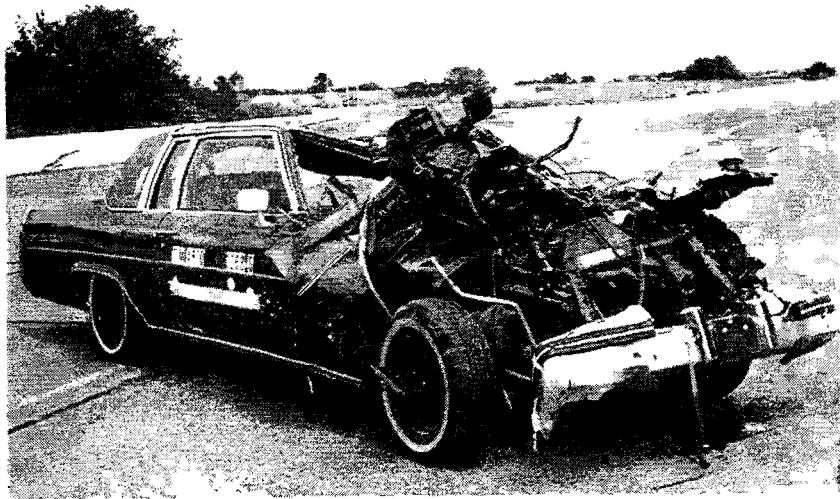
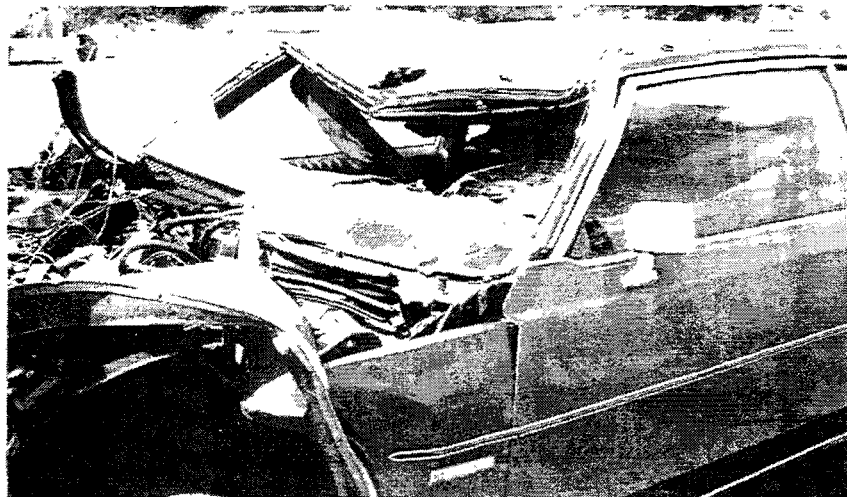
FIGURE V-15. Test Vehicle After Test 1263-5

Photos of the installation and the vehicle after the test are given in Figures V-14 and V-15. Damage to the vehicle was extensive, and the W-beam rail caused significant deformations of the occupant compartment as the vehicle went under the barrier.

The test was a failure since the vehicle penetrated beyond the barrier, and since damage to the occupant compartment was unacceptable. These results notwithstanding, there were positive aspects of the test. First, prior to the vehicle underriding the rail, the system had dissipated almost 90 percent of the vehicle's initial kinetic energy, and occupant risk parameters during this phase were well below recommended limits. It can therefore be inferred that the

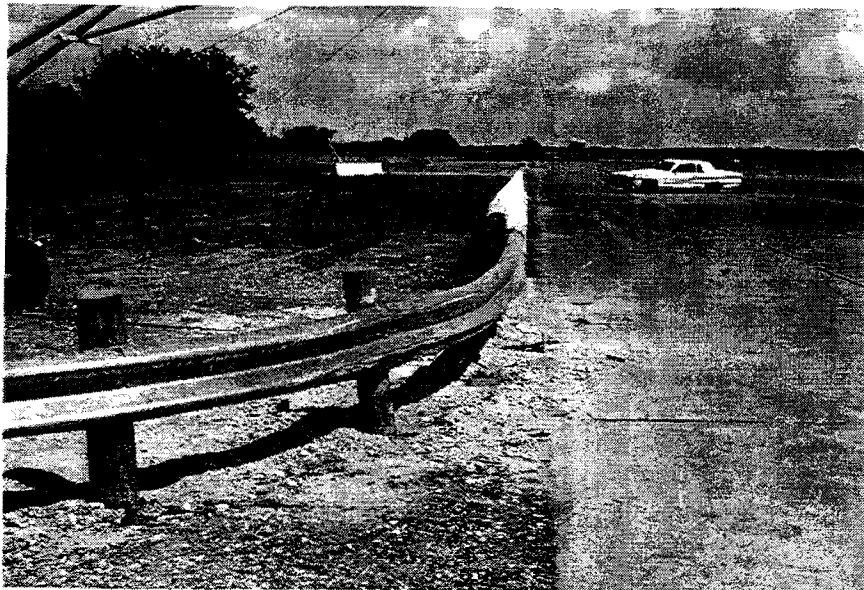
FIGURE V-17. Test Article After Test 1263-6

The vehicle impacted the curved portion of the system at 58.3 mph at an angle of 2.0 degrees. The vehicle was smoothly redirected, and the test met recommended evaluation criteria of NCHRP Report 230 (5). Damage to the barrier and to the vehicle was relatively small. Photos of the installation and the vehicle after the test are given in Figures V-17 and V-18.

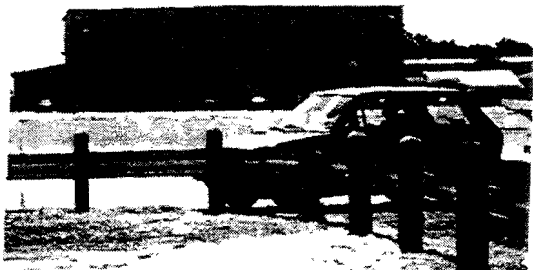
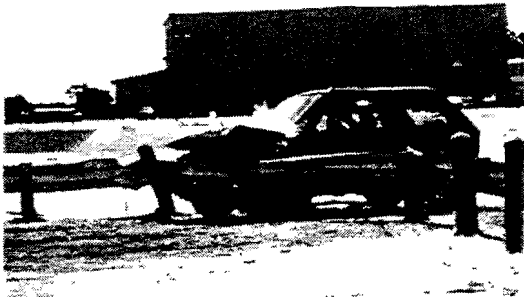
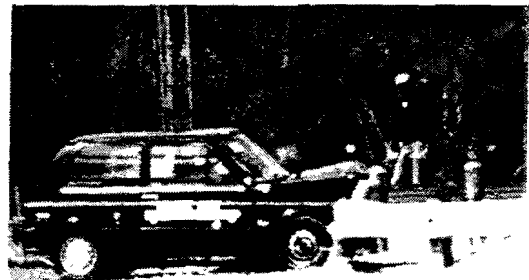
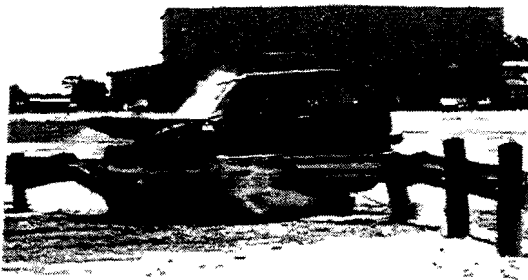
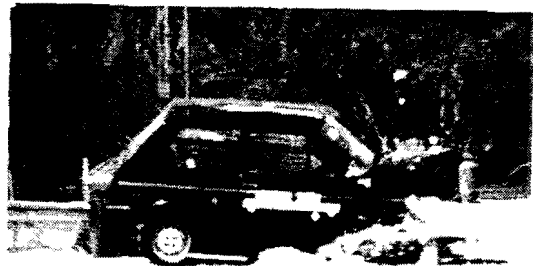
FIGURE F-9. Sequential Photographs for Test 1263-1 (Perpendicular and Side Views)

Upon impact, the posts in the curved section of rail began to deflect in the soil. Although post 7 fractured at the ground line as designed, posts 8 and 9 rotated in the soil and were subsequently pulled from the ground. As the rail continued to deflect, the cable of in-line BCT anchor tightened and prevented post 10 from failing. The tension which developed in the cable anchor prevented further deflection of the rail on the upstream end of the curve, causing the vehicle to pitch forward and yaw significantly in counter-clockwise rotation. After yawing a total of 167 degrees, the vehicle came to rest on top the guardrail near post 8. Sequential photographs of the impact are shown in Figures F-9 and F-10.

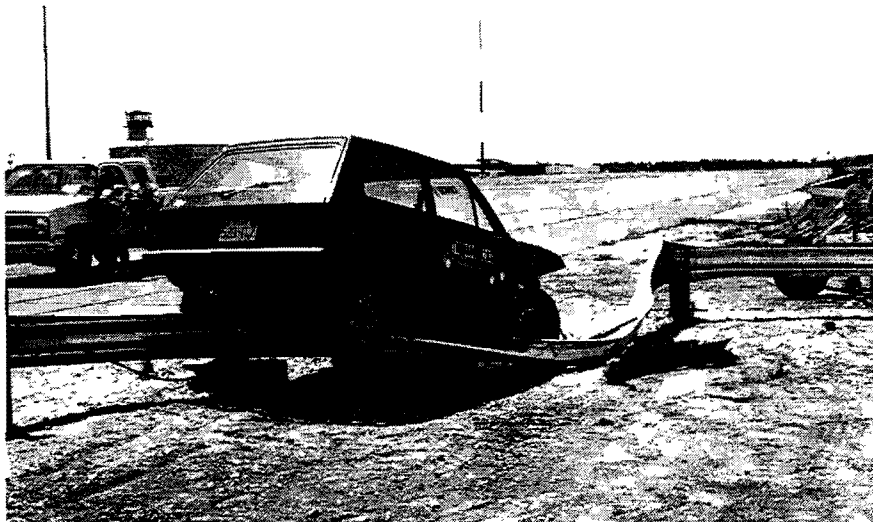
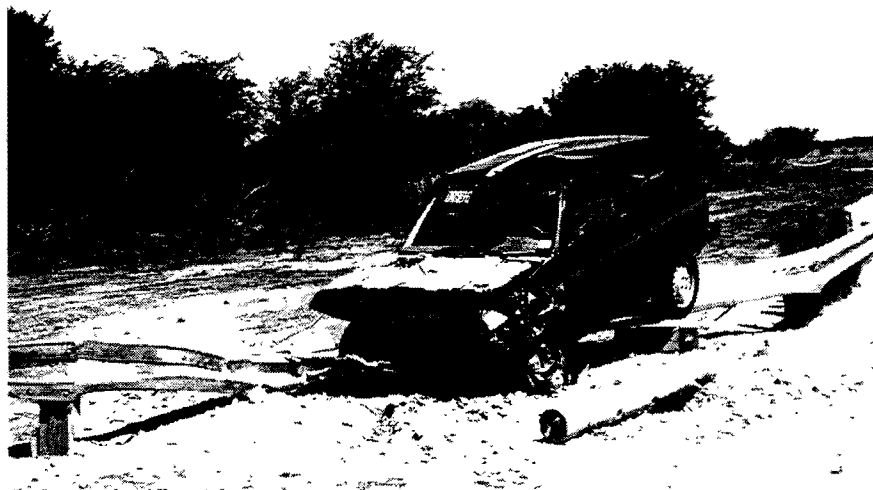
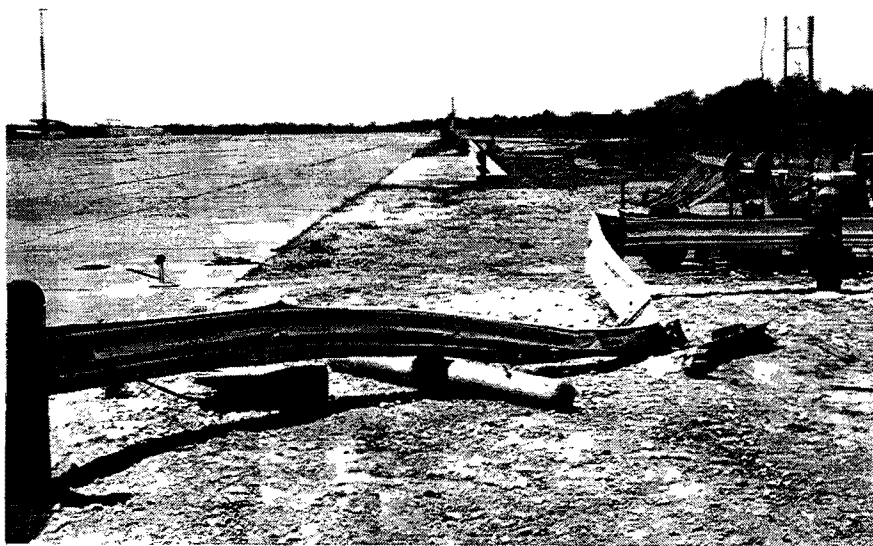
FIGURE F-11. Site after Test 1263-1

As can be seen in Figures F-11 through F-14, the short radius system experienced extensive damage. Posts 8 and 9 were pulled out of the ground and post 7 fractured at ground level. Post 10 was deflected backwards, cracked at the base, and split longitudinally. The guardrail in the curved section was bent and pulled loose from posts 8 and 9. A maximum dynamic deflection of 9.7 ft (3.0 m) occurred at post 9, and the maximum residual deformation

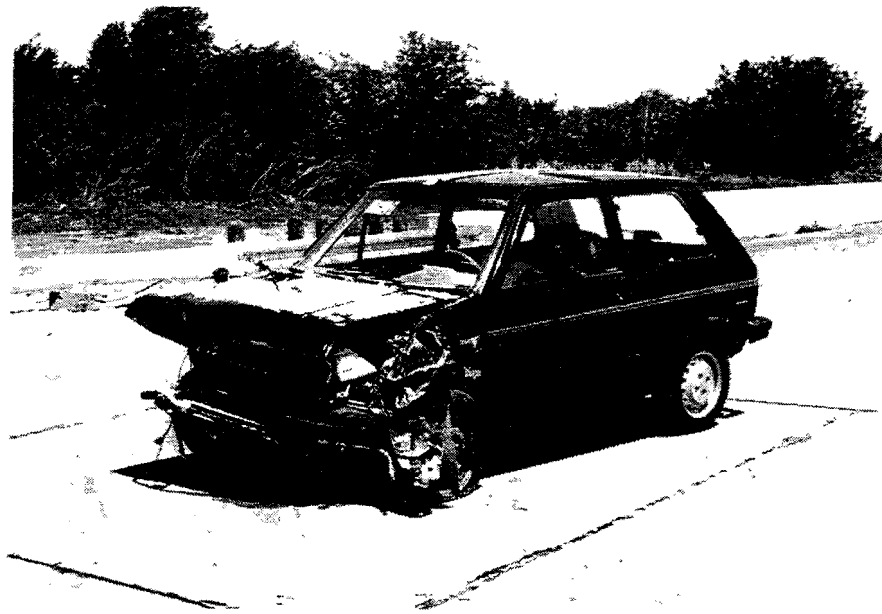
FIGURE F-15. Vehicle after Test 1263-1

The damage to the vehicle is shown in Figures F-15 and F-16. Maximum crush at bumper height was 15.5 in. (39.4 cm) and 8.5 in. (21.6 cm) at the left and right front corners of the vehicle respectively. The wheelbase on the driver's side was reduced by 9.0 in. (22.9 cm). The driver's door was deformed outward 2.0 in. (5.1 cm) and the driver's side window was broken out. There were two dents in the roof above the rear passenger compartment: 4 in x 5 in x 1/4 in deep (10.2 cm x 12.7 cm x 0.6 cm deep) on the passenger side and 7 in x 13 in x 1/2 in deep (17.8 cm x 33.0 cm x 1.3 cm deep) on the driver side. The floorpan was pushed inward toward the occupant compartment a distance of 2 in. (5.1 cm) and the steering wheel was bent. There was also damage to the front bumper, hood, grill, radiator, the left front strut, left front quarter panel, right front quarter panel, and the left front tire and rim.

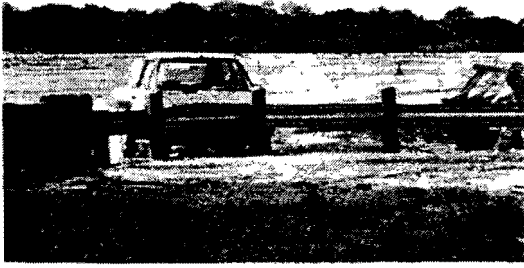
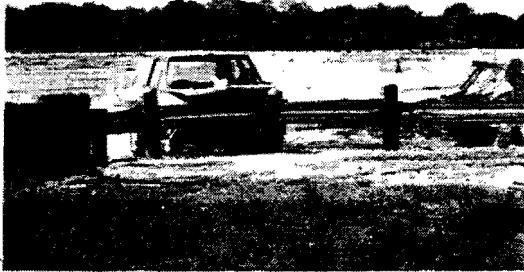
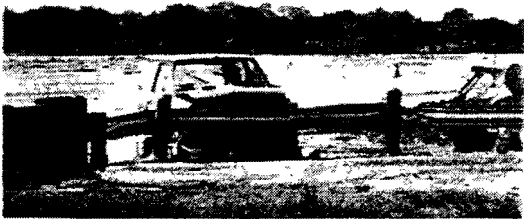
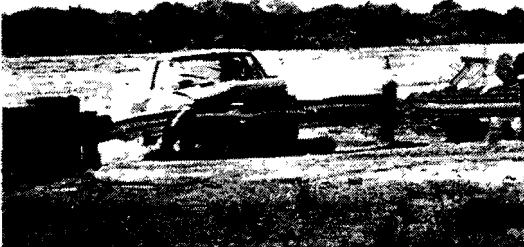
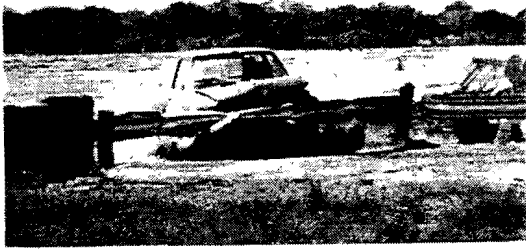
FIGURE F-27. Sequential Photographs for Test 1263-2 (Frontal and Overhead Views)

Shortly after impact, posts 8 and 9 fractured at the ground line and the system appeared to be working as designed. As the vehicle continued to deflect the rail, movement was observed at posts 7 and 10. Shortly thereafter, approximately 0.142 sec after impact, the W-beam rail element unexpectedly tore at a splice connection, permitting the test vehicle to penetrate through the rail. The brakes on the vehicle were activated at 1.2 sec after impact and the vehicle subsequently came to rest behind the guardrail installation. Sequential photographs are shown in Figures F-27 and F-28.

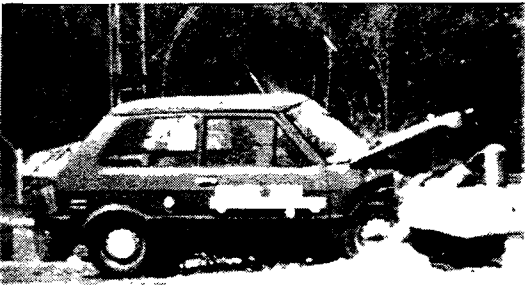
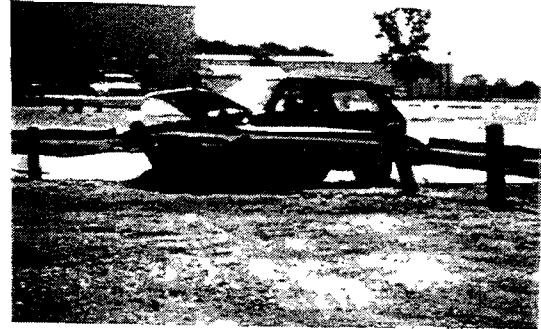
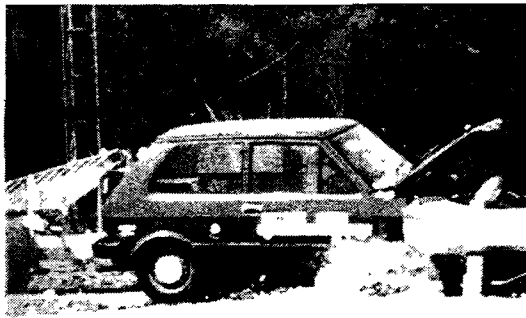
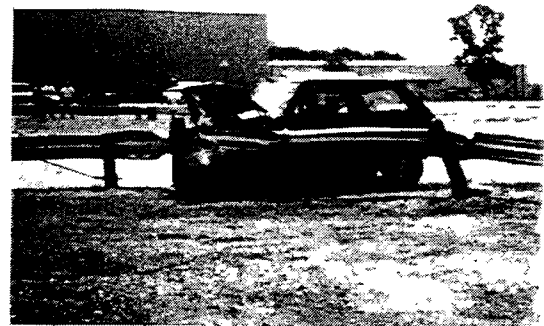
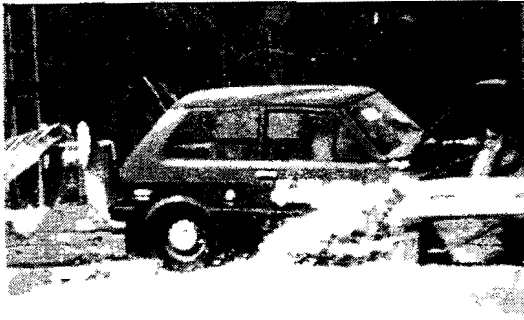
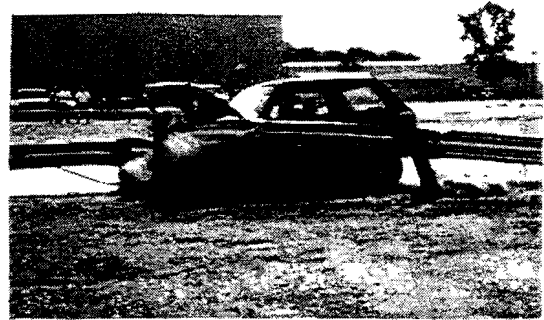
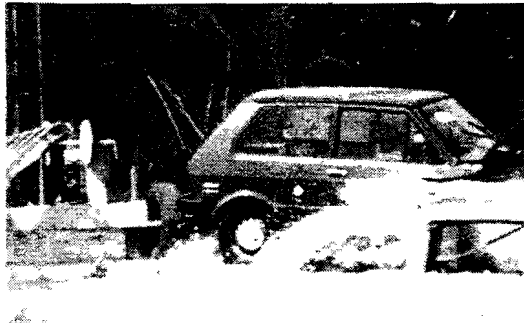
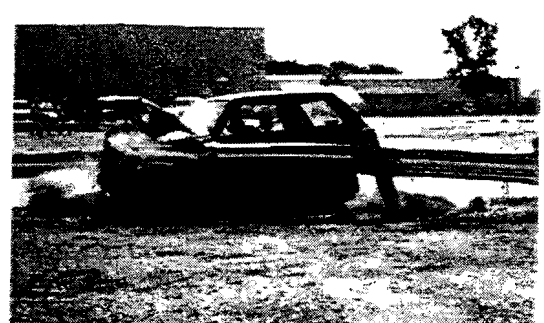
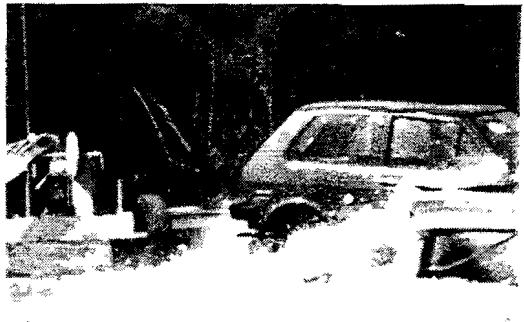
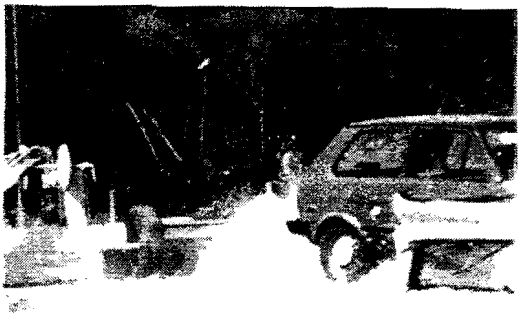
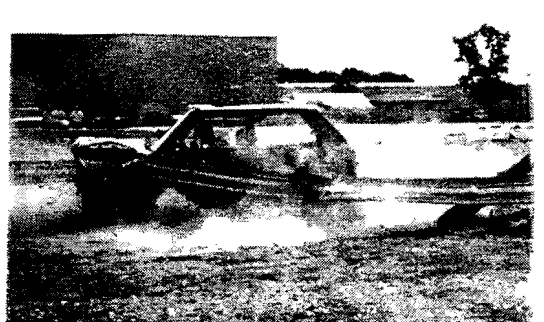
FIGURE F-47. Sequential Photographs for Test 1263-3 (Side Views)

The vehicle was directed into the guardrail as shown in Figure F-45 using the cable reverse tow and guidance system, and was released to be free-wheeling and unrestrained just prior to impact. The vehicle impacted the guardrail travelling at a speed of 60.2 mi/h (96.9 km/h) and the angle of impact was 20.7 degrees. As the vehicle deflected the rail, posts 8, 9, 10, and 11 all fractured at the ground line as designed. The vehicle was smoothly decelerated and contained. The sequential photographs of this test are shown in Figures F-46 and F-47.

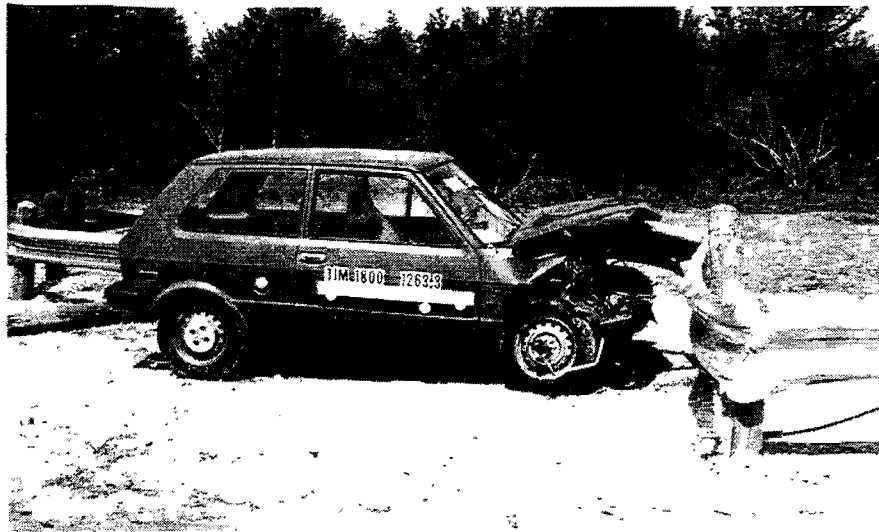
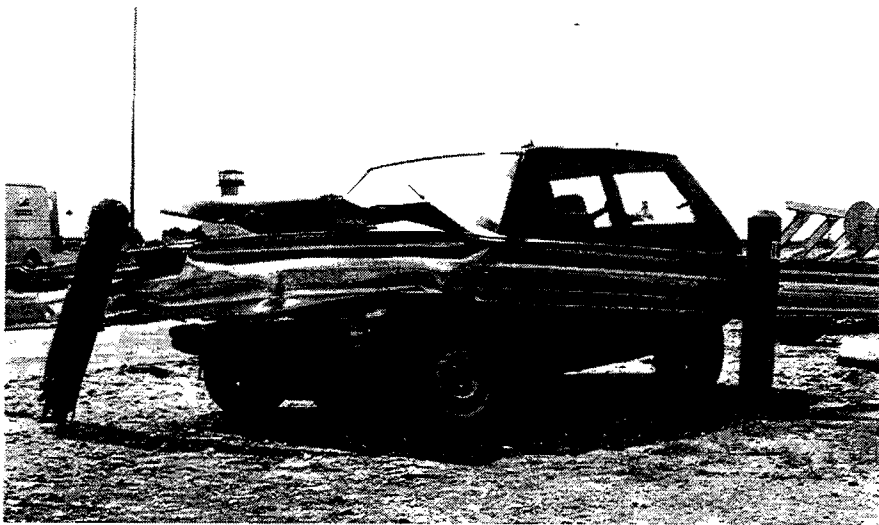
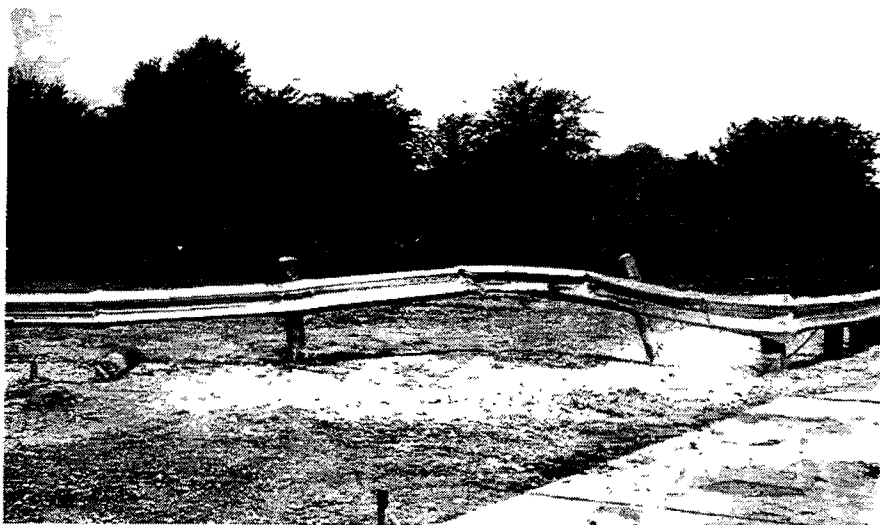
FIGURE F-48. Test Site after Test 1263-3

As can be seen in Figures F-48 through F-51, the guardrail received moderate damage. Posts 8, 9, 10, and 11 all fractured at the ground line, and post 7 was pushed over in the soil. Posts 8 and 10 remained attached to the rail, while posts 9 and 11 were detached. The top corrugation of the rail had a 2.5 in. (5.4 cm) tear approximately 2 ft (0.6 m) upstream from post 8. However, the rail did not rupture and the test vehicle was contained. Maximum dynamic rail deflection was 14.1 ft (4.3 m) at post 9 and the maximum permanent residual deformation was 12.5 ft (3.81 m) also at post 9. Measurement of the movement of the rail element at posts 7 through 11 were taken and reported for specific times as noted in Table F-4.

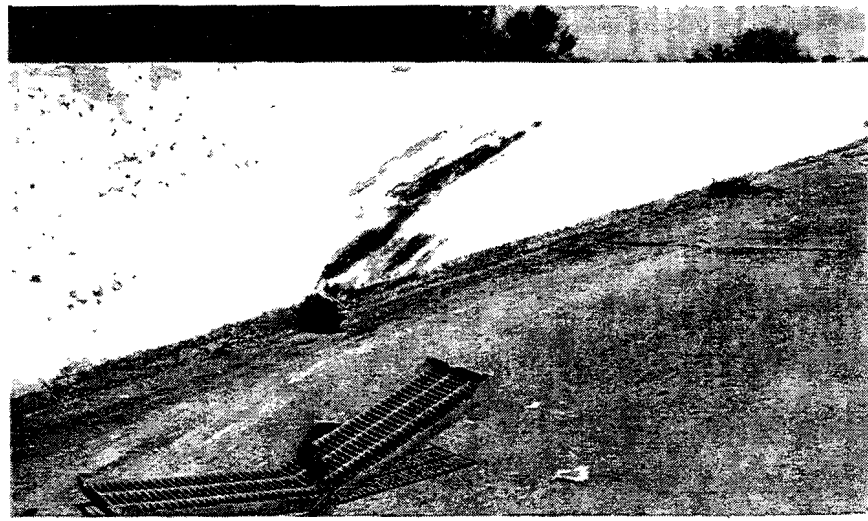
FIGURE F-65. Damage at Secondary Impact, Test 1263-4

Damage to the transition is shown in Figures F-65 through F-67. Post 2, the second post upstream from the bridge end, was gouged at the base approximately 5.5 inches above ground level. There was evidence of wheel contact at the base of the concrete bridge rail, and the tubular W-beam was deformed slightly from the point of impact to the concrete barrier. The terminal connection on the face of the concrete rail performed well and showed no signs of distress.

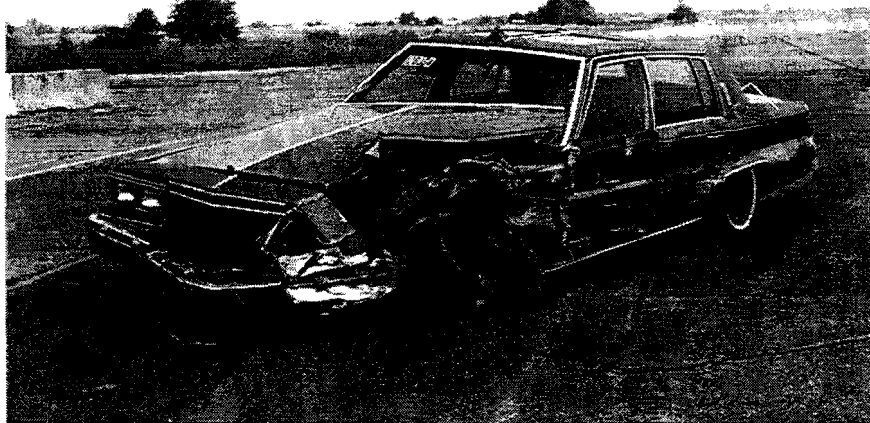
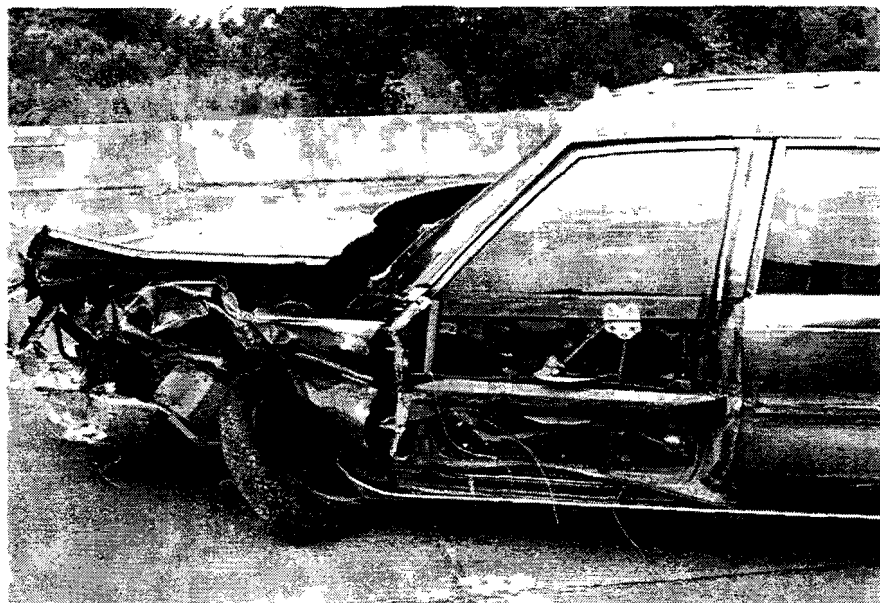
FIGURE F-68. Vehicle after Secondary Impact, Test 1263-4

As shown in Figure F-68, damage to the vehicle was minor for a test of this severity. The damage was concentrated at the left front corner and left front wheel area. Maximum crush was measured to be 13 in. (33.0 cm) at bumper height, and the wheelbase on the left side was reduced by 15 in. (38.1 cm). The floor pan on the driver's side was deformed approximately 2 in. (5.1 cm), and there was some buckling of the roof panel over the "B" pillar area. The sheet metal door skin on the driver's door snagged on the end shoe and remained attached to the guardrail. There was also damage to the left front tire and rim, left front upper and lower A-arms, left front tie rod ends, frame, hood, grill, and windshield.

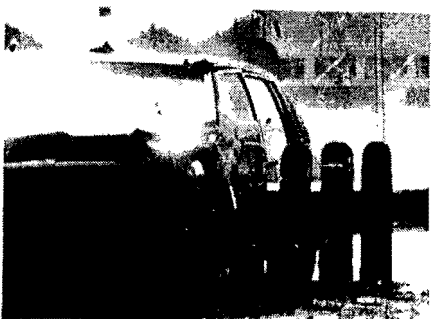
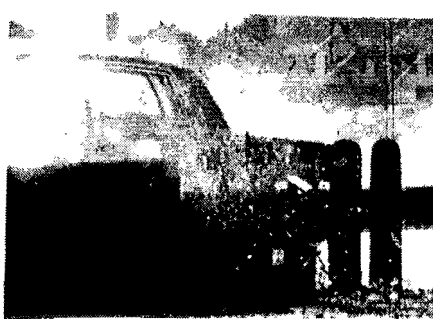
FIGURE F-69. Summary of Results for Test 1263-4

Test No. 1263-4
 Date 08/27/92
 Test Installation . . . Short-Radius
 Guardrail Treatment
 Installation Length . . 100 ft (30 m)
 Max. Dynamic Movement . Not Obtained
 Max. Perm. Movement . . 2.0 in (5.1 cm)
 Test Vehicle 1982 Cadillac Sedan
 Vehicle Weight
 Test Inertia 4,500 lb (2,041 kg)
 Gross Static 4,500 lb (2,014 kg)
 Vehicle Damage Classification
 TAD 11FL7 11LD1
 CDC 11FLEK5 11LDES1
 Maximum Vehicle Crush. . 13.0 in (33.0 cm)

Impact Speed. 57.1 mi/h (91.9 km/h)
 Impact Angle. 24.7 deg
 Speed at Parallel . . . 44.9 mi/h (72.2 km/h)
 Exit Speed 42.2 mi/h (67.9 km/h)
 Exit Trajectory 9.0 deg
 Vehicle Accelerations at center-of-gravity
 (Max. 0.050-sec Average)
 Longitudinal. -9.1 g
 Lateral 10.5 g
 Occupant Impact Velocity at true c.g.
 Longitudinal. 27.6 ft/s (8.4 m/s)
 Lateral 25.4 ft/s (7.7 m/s)
 Occupant Ridedown Accelerations
 Longitudinal -4.8 g
 Lateral -7.7 g

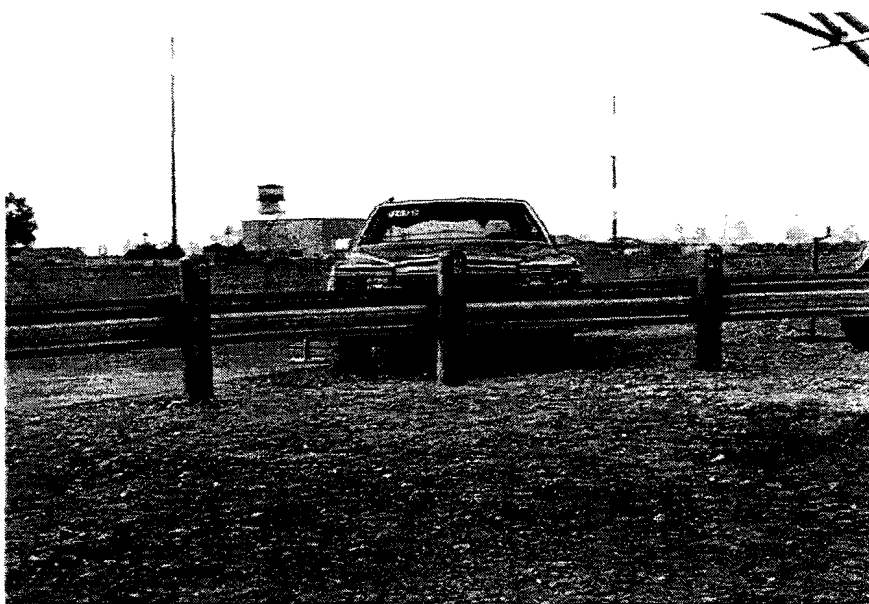
FIGURE F-79. Vehicle/Guardrail Geometrics for Test 1263-5

This test was a strength test which evaluated the structural adequacy of the short radius system for large car impacts into the curved portion of rail. In an effort to simplify fabrication and construction of the system, the radius of the curved portion of rail was increased from 14 ft-3 in. to 16 ft-0 in. for this test. With a 16 ft radius, the curved section of guardrail begins and ends at a post location and has interchangeable pieces of rail at either end of the curve. This modification decreased the stiffness of the curved region and, therefore, it was determined that the small car test did not have to be rerun since the previous configuration was more critical in terms of occupant severity. A 1982 Cadillac Coupe DeVille (Figure F-76) was used for this test. The completed test installation is shown in Figure F-77. Test inertia mass of the vehicle was 4,500 lb (2041 kg) and its gross static mass was 4,500 lb (2,041 kg). The height to the lower edge of the bumper was 12.0 in. (30.5 cm), and the height to the upper edge of the bumper was 20.25 in. (51.4 cm). Additional dimensions and other information pertaining to the test vehicle are listed in Figure F-78. The vehicle was directed into the guardrail as shown in Figure F-79 using the cable reverse tow and guidance system, and was released to be free-wheeling and unrestrained just prior to impact. The vehicle impacted the midpoint of the curved segment of guardrail travelling at a speed of 58.5 mph (94.1 km/h) and at an angle of 26.8 degrees relative to the tangent section of guardrail along the primary roadway.

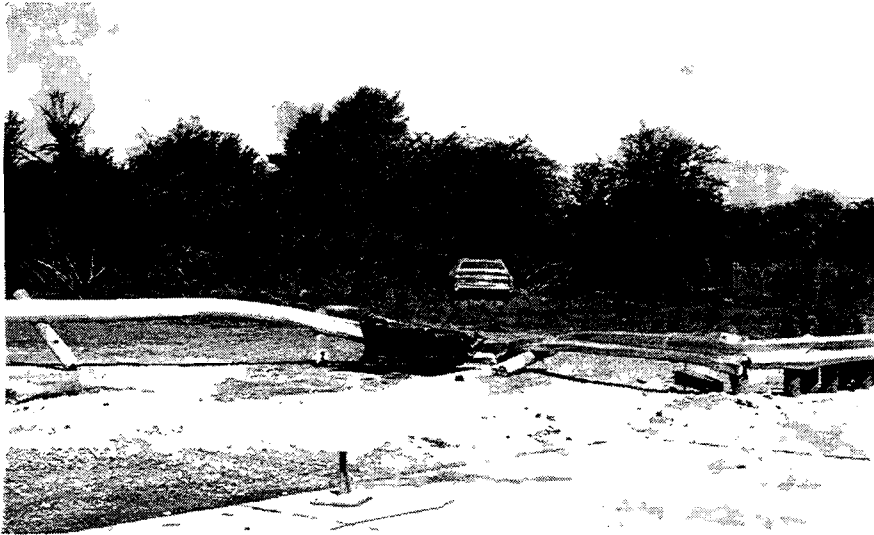
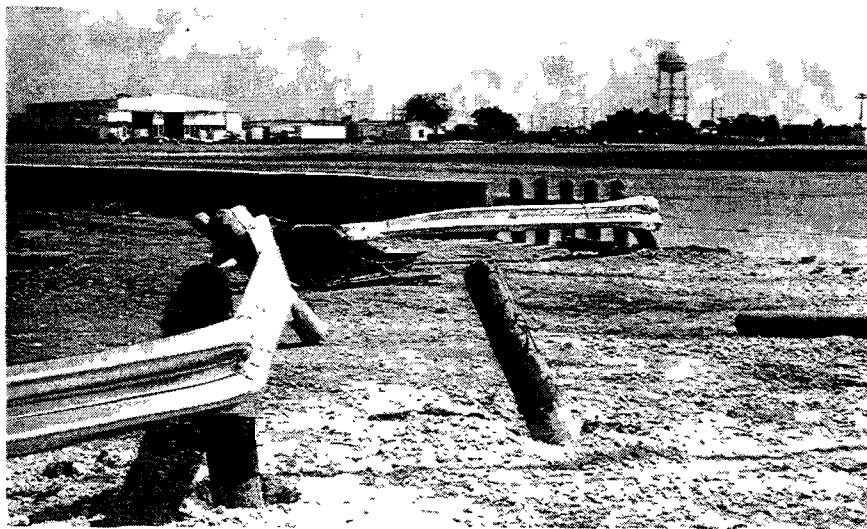
FIGURE F-80. Short Radius Guardrail after Test 1263-5

As shown in Figures F-80 and F-81, the guardrail received extensive damage. All of the weakened posts, namely posts 7 through 12, fractured at or below ground level. Standard posts 6, 13, and 14 had rotated in the soil and were leaning after the test. Posts 7, 9, 11, and 13 all separated from the guardrail. The positions of the rail at posts 6 through 11 were measured and recorded for specific times and are listed in Table F-5. The maximum dynamic deflection of 28.3 ft (8.6 m) occurred at post 9, and the maximum residual deformation was 25.4 ft (7.7 m).

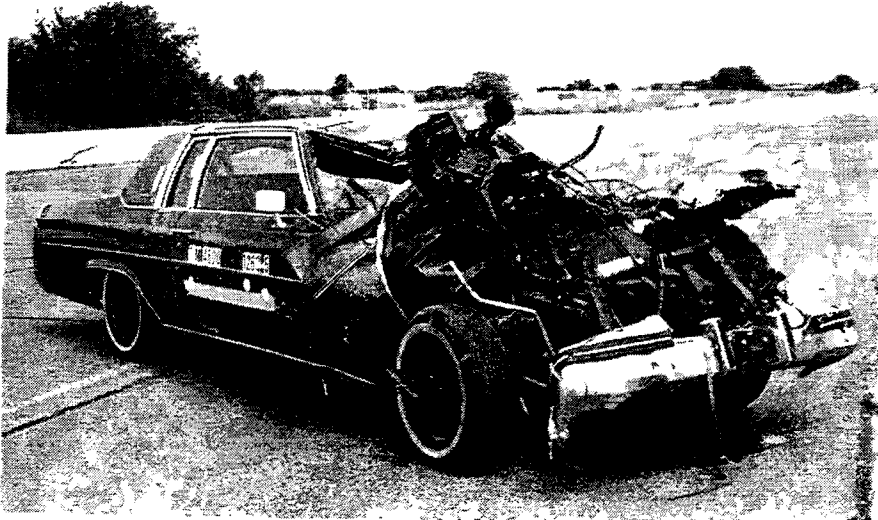
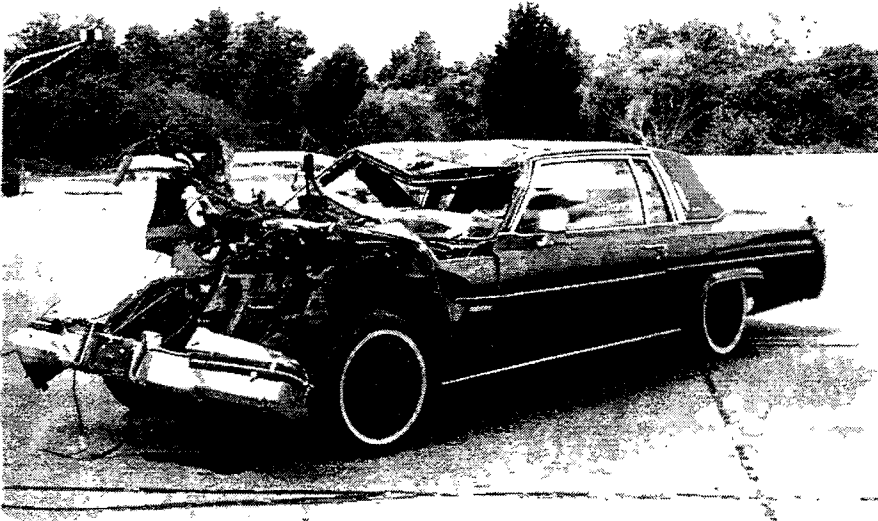
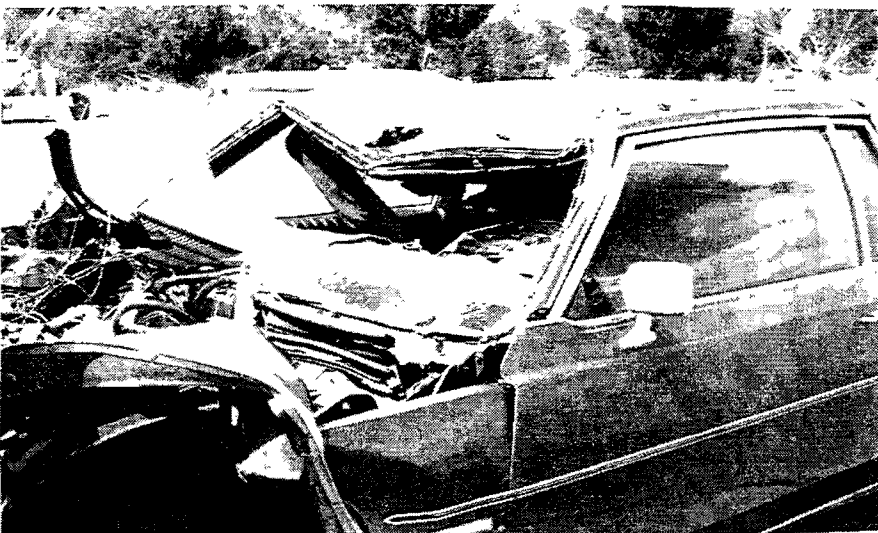
FIGURE F-82. Vehicle after Test 1263-5

As shown Figure F-82, the vehicle sustained extensive damage. Both the left and right front corners were crushed 15.0 in. (38.1 cm) at bumper height. The wheelbase on the driver's side was reduced by 1.75 in. (4.4 cm) and the doors on both sides were jammed. The hood was separated from the vehicle when the guardrail over-rode the engine compartment, and there was considerable damage to the roof. Additionally, the windshield was shattered and there was damage to the grill, radiator, fan and both front fenders.

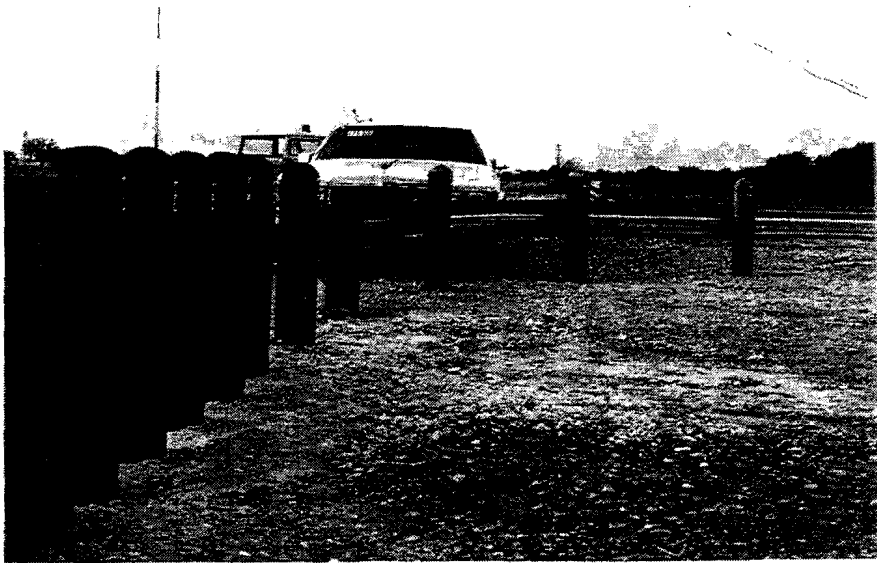
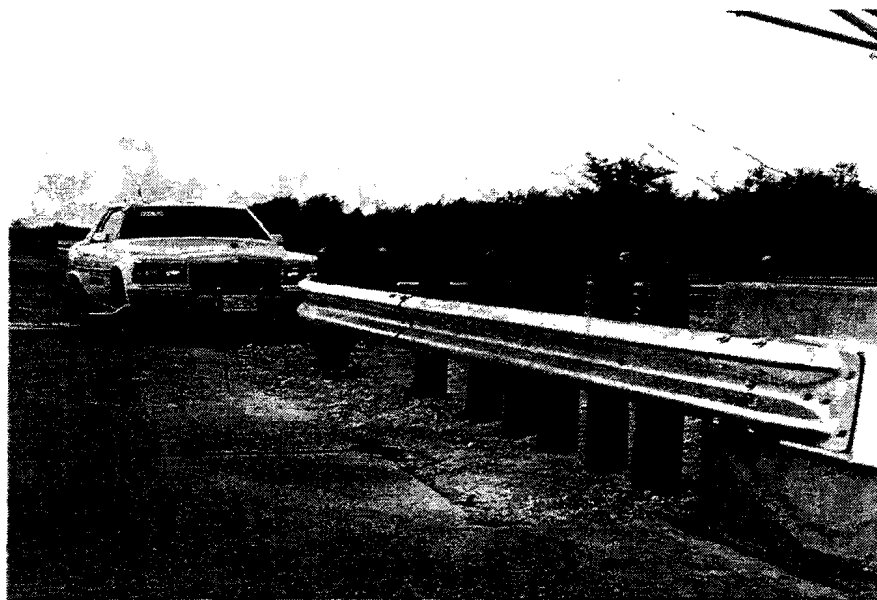
FIGURE F-93. Vehicle/Guardrail Geometrics for Test 1263-6

Due to the presence of the tubular W-beam, there was some concern about pocketing or spearing on the upstream end to the transition during shallow angle impacts into the curved section of the short radius treatment. The purpose of this test was, therefore, to evaluate the performance of the system under these conditions. A 1983 Cadillac Coupe DeVille (Figure F-90) was used for this crash test. The completed test installation is shown in Figure F-91. Test inertia mass of the vehicle was 4,500 lb (2041 kg) and its gross static mass was 4,500 lb (2,041 kg). The height of the bumper varied from 12.5 in. (31.8 cm) at its lower edge to 20.75 in. (52.7 cm) at its upper edge. Additional dimensions and other information pertaining to the test vehicle is shown in Figure F-92. The vehicle was directed into the guardrail as shown in Figure F-93 using the cable reverse tow and guidance system, and was released to be free-wheeling and unrestrained just prior to impact. At the time of contact with the guardrail, the impact speed was 58.3 mi/h (93.8 km/h) and the angle was 2.0 degrees relative to the tangent section of guardrail.

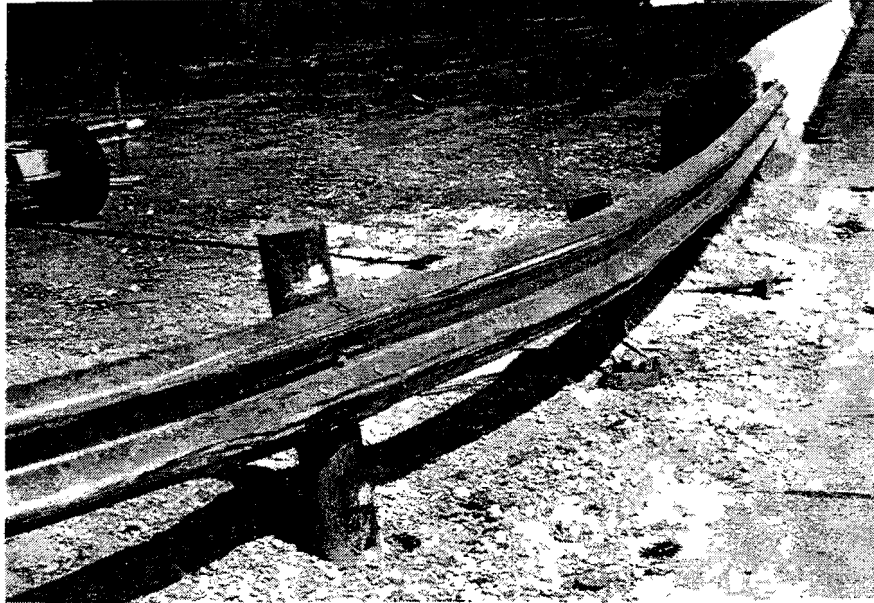
FIGURE F-94. Short Radius Guardrail after Test 1263-6

As shown in Figures F-94 through F-97, damage to the guardrail was minor in nature. There was slight displacement of the guardrail from post 6 to post 8. Post 8 was gouged approximately 5 in. (12.7 cm) to 7 in. (17.8 cm) above ground level and there was rubber transfer on both sides of the gouge. Post 7, the BCT anchor post, split longitudinally and fractured at its base.
