1. Report No. FHWA/TX-93-1268-1F		2. Government Accession No.		3. Recipient's Catalog No.	
4. Title and Subtitle NDE TECHNIQUES FOR DETECTING GROUT DEFECTS IN CABLE STAYS				5. Report Date August 1993

**NDE TECHNIQUES FOR DETECTING GROUT DEFECTS
IN CABLE STAYS**

**Research Report 1268-1F
Research Study 0-1268
NDE Techniques for Detecting Grout Defects in Cable Stays**

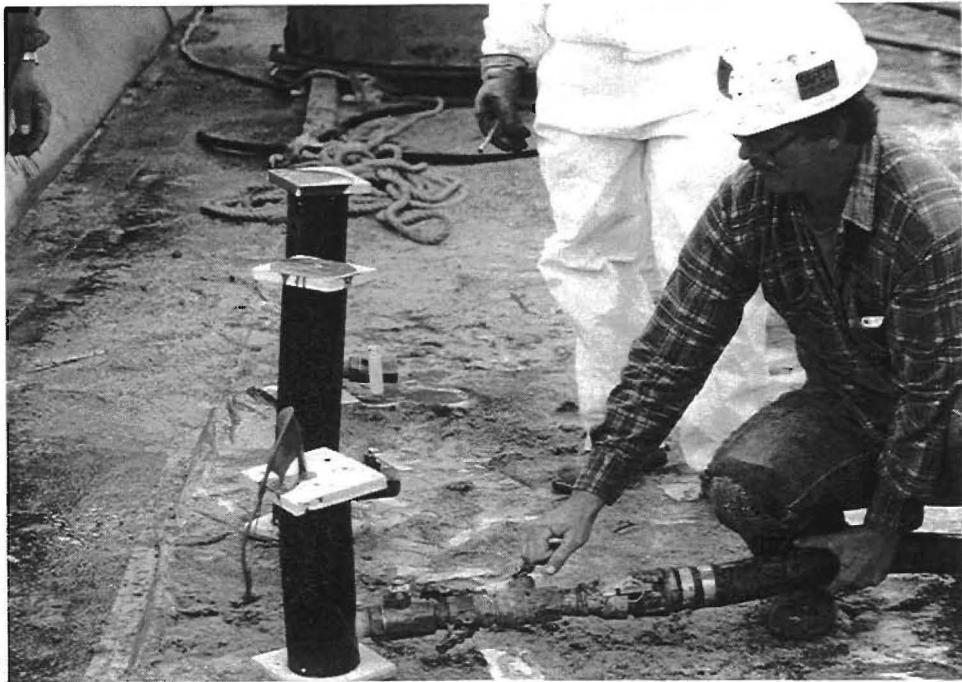
Figure 10. Field-grouted cable-stay specimens.

For the purpose of conducting laboratory investigations, several representative cable-stay samples conforming to specifications for the Neches River bridge were constructed. The first sample contained 19 steel cable strands placed in a 4.5 in. (114 mm) outer diameter (O.D.) PE pipe, 12 in. (305 mm) in length. The cables were made from standard 7-wire, 270 ksi (1,860 MPa), 0.6 in. (15 mm) diameter pre-stressing strand. The strands were centered inside the PE pipe using wooden templates. A cross section of this cable appears in Figure 9. Another sample, representing the largest cable cross section used on the Neches River bridge, contained 22 cable strands placed in a 5 in. (127 mm) O.D. pipe 18 in. (457 mm) long. A third sample was constructed without any internal strands and was simply comprised of a 4.5 in. (114 mm) outer diameter (O.D.) PE pipe, 18 in. (305 mm) in length. These samples were capped at both ends and fitted with a 1 in. (25.4 mm) diameter filling port at the lower end of the pipe. A 0.5 in. (12.7 mm) vent hole was provided through the top end cap. The samples were then grouted under field conditions at the Neches River bridge site. The grouting operation was halted after the grout began ejecting out of the vent hole as shown in Figure 10.

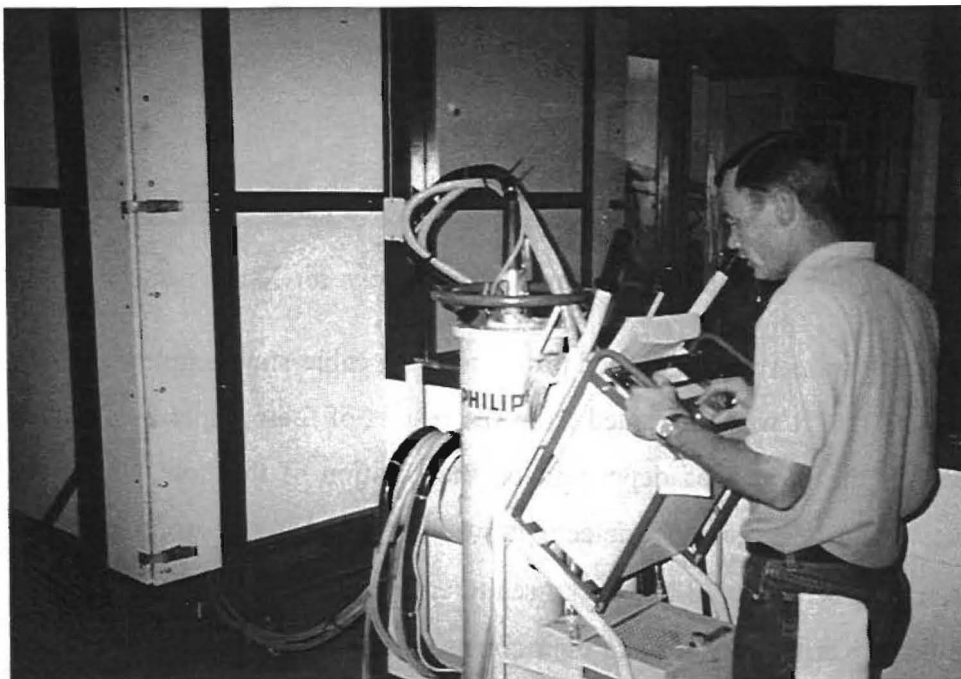
Figure 15. X-ray inspection of cable-stay specimens.

Using the parameters determined previously, the cable-stay samples were radiographed as shown in Figure 15. It was concluded from the results of these experiments that the ability to detect defects in the grout was dependent on the position of the hole within the grout layer. While defects of sufficient size are detectable when centered in the grout layer, defects adjacent to the cables could be obscured by energy scattered by the steel cables. Since flaws adjacent to the steel strands are critical in terms of their corrosion-causing potential, it was essential that such defects be detected. For this same reason, it was also desirable to be able to inspect the grout within the cable bundle for similar types of defects. Therefore, in order to more accurately detect

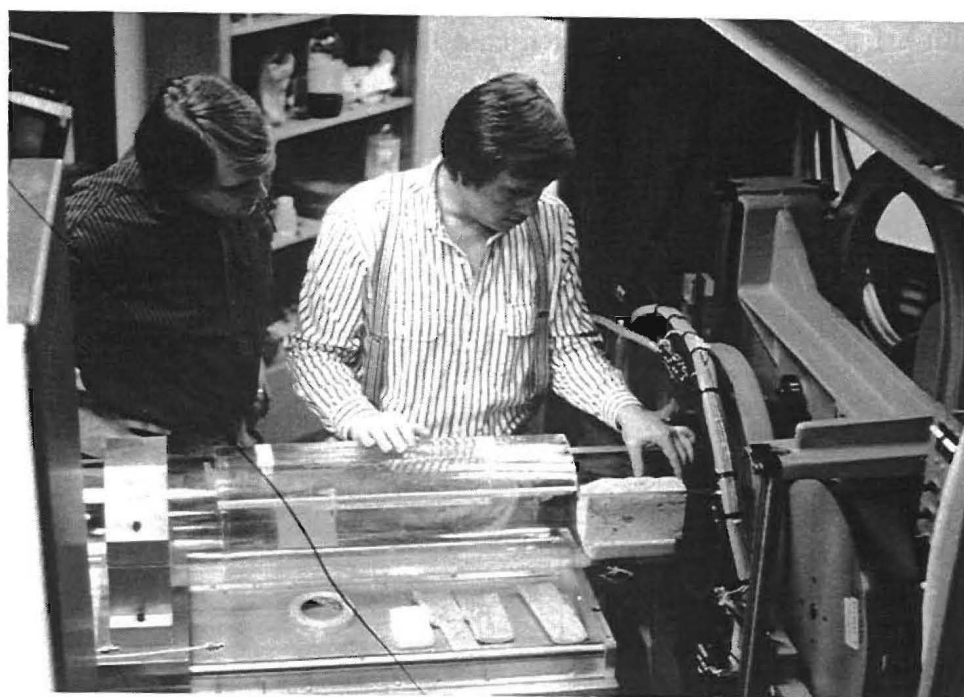
Figure 17. Initial computed tomography scanning setup.

Texas A&M University. The initial experiment, utilizing a 120 keV X-ray machine shown in Figure 17, was performed on a polyethylene-sleeved grout sample without steel strands. As shown in Figure 18 (a), this technique was very effective not only in locating all of the manufactured defects, but in characterizing their shape and size as well. In addition, an unexpected water-filled void, which is believed to have originated during the pressure grouting operation, was also discovered during the CT procedure (see Figure 18 (b)). However, subsequent inspection of an actual cable-stay sample was ineffective. This was attributed to a beam-hardening phenomenon precipitated by the polychromatic nature of the X-ray source and/or scatter from the steel strands (see Figure 19).

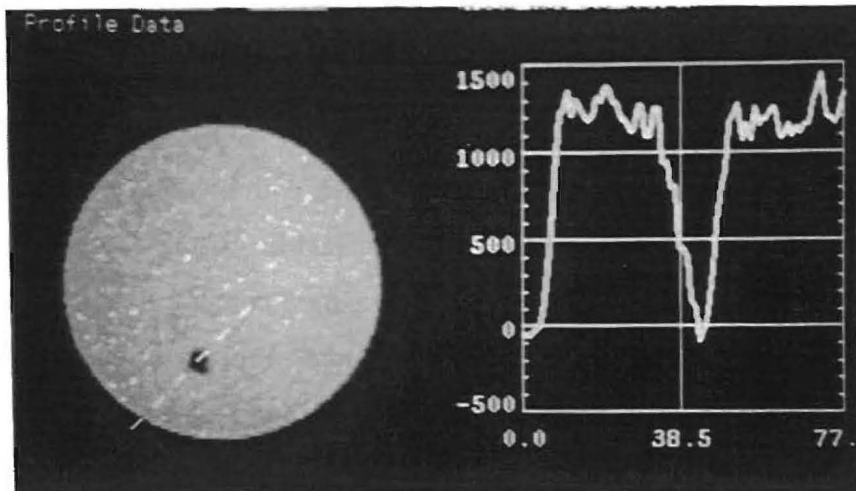
(a) manufactured defect

(b) water-filled void

Figure 18. Tomographs of grout-filled polyethylene pipe.

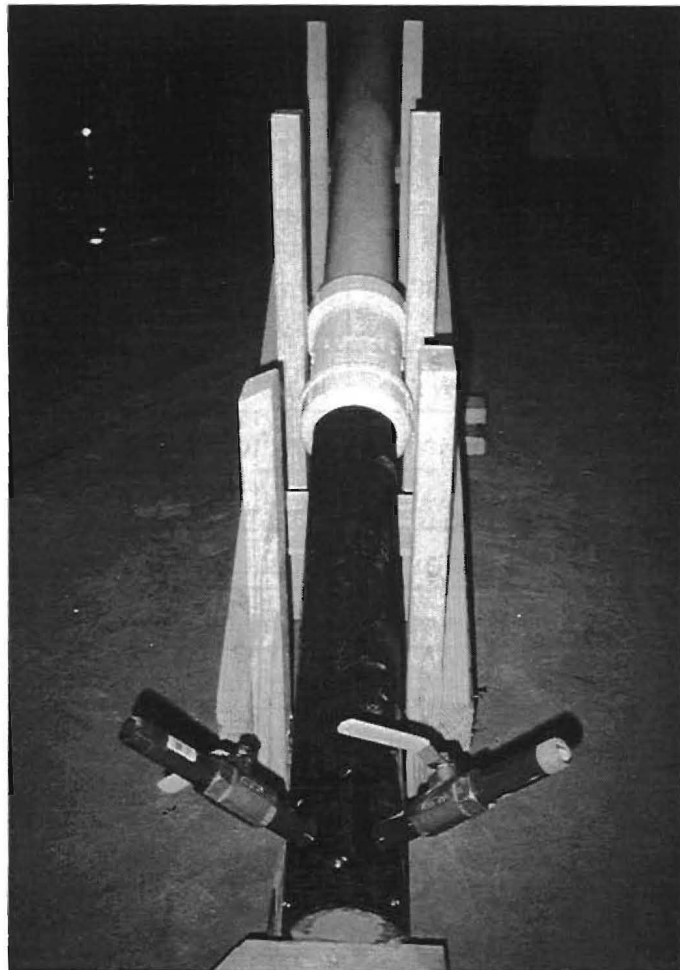
Figure 39. Inclined cable-stay sample after grouting.
