1. Report No. FHWA/TX-95/1378-1		2. Government Accession No.		3. Recipient's Catalog No.	
4. Title and Subtitle PROSCAN SYSTEM EVALUATION				5. Report Date December 1994

PROSCAN SYSTEM EVALUATION

Research Report 1378-1
Research Study Number 0-1378
Research Study Title: Development of Ride Quality Specification Criteria for ACP
Overlays

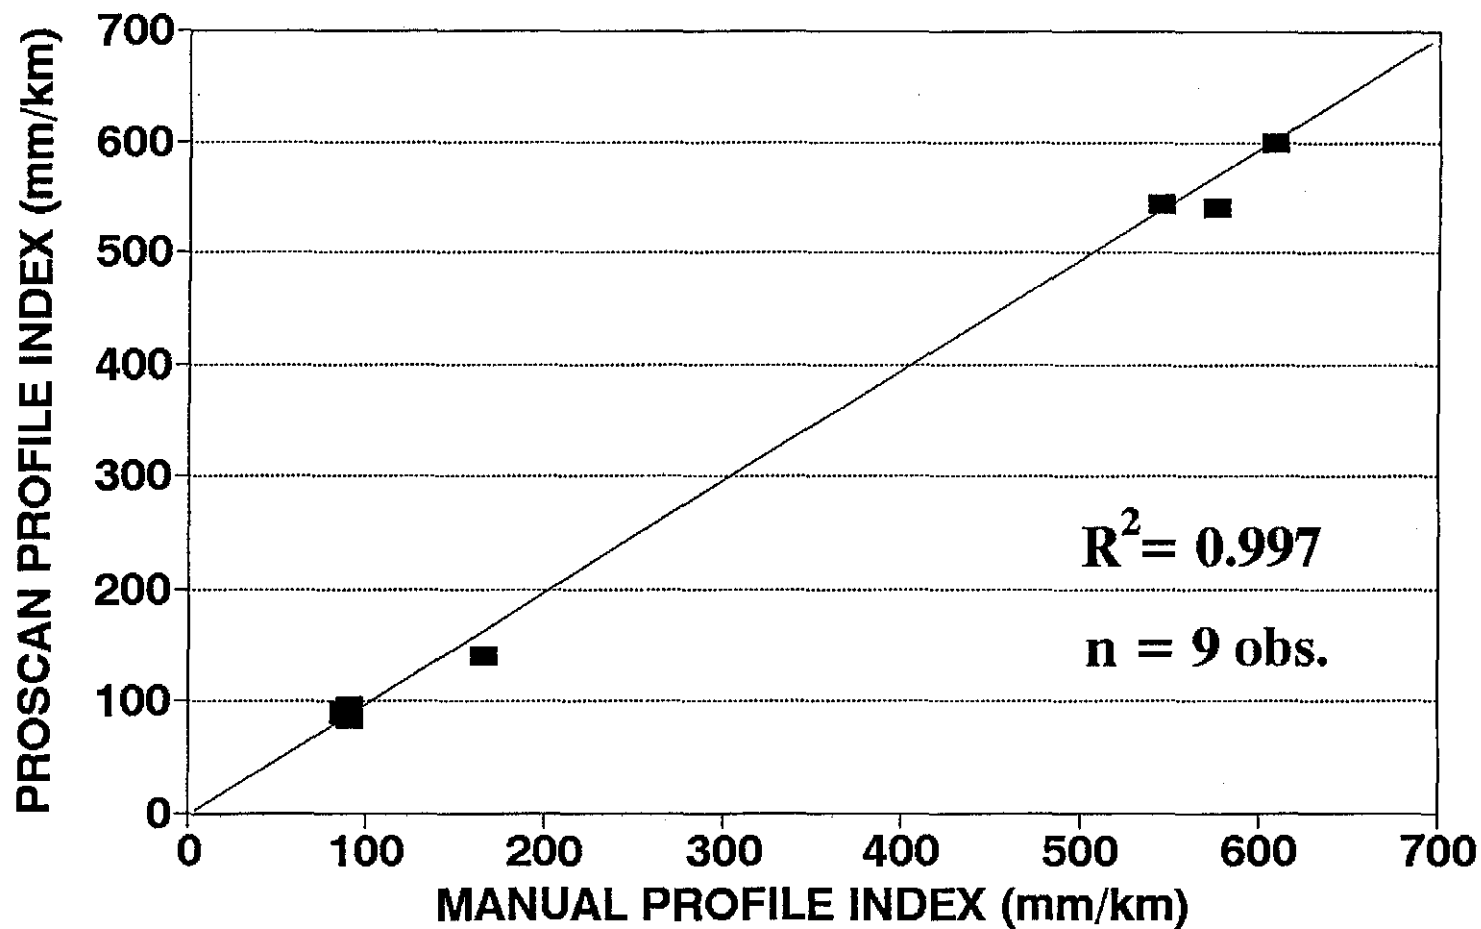
The scatter plot of the data, Figure 2, shows a strong positive linear relationship between ProScan and manual PI's as indicated by the coefficient of determination, R^2 , of 0.997. The regression equation between the ProScan and manual PI's was also determined. A slope of 1 and an intercept of 0 for the regression equation would indicate that the values obtained using both methods are equal. The actual slope calculated by regression is 0.97, and the intercept is 1.73, indicating that ProScan and manual PI's are approximately the same. Considering that the profile indices are in mm/km, the intercept value of 1.73 is negligible. Further, a statistical test of significance for the intercept coefficient showed that it is not significantly different from zero.

Figure 2. Scatter plot of ProScan and manual PI's determined for Profilogram #1.

Figure 2 revealed that the data from Profilogram #1 were limited to low and high values of roughness and that additional data were needed for the mid-range PI values. Researchers attempted to find additional test segments to survey and, based on profile data collected with TxDOT's Surface Dynamics Profilometer, identified a portion of SH 6, north of Bryan, which included segments that covered a much broader range of surface roughness. Consequently, a survey was conducted using the Bryan District's manual Profilograph. Actual testing was performed by personnel from the District office and TTI, and covered the northbound, outside lane of SH 6, from the FM 2818 overpass to the Robertson county line, a distance of 3.54 km (2.2 miles).

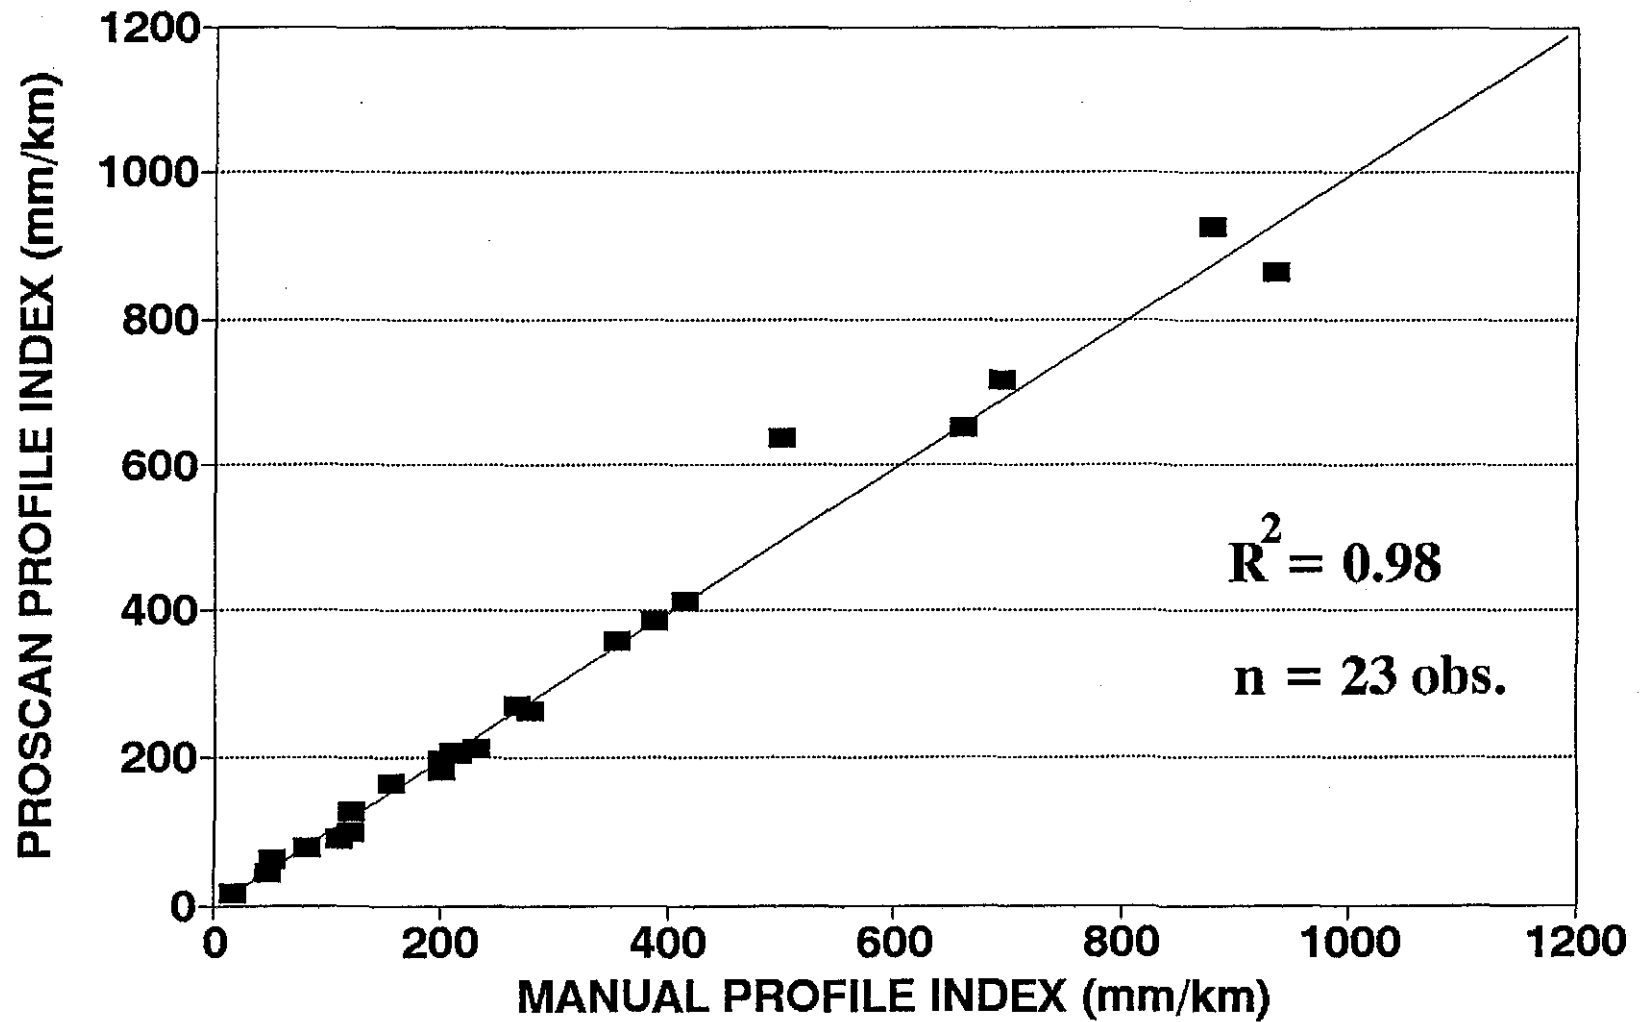
The reduced variability, notwithstanding, a comparison of the ProScan and manual PI's was conducted to verify whether ProScan is simulating acceptably the manual method of data reduction. If it is, the mean ratings from the two methods should be highly correlated, indicating that both provide similar answers. A scatter plot of the ratings for Profilogram #2 is presented in Figure 4. This plot shows a strong, positive, linear relationship between the ProScan and manual PI's as indicated by the high, R^2 , of 0.98. The intercept and slope of the regression line were determined to be -4.55 and 1.02, respectively, indicating that the ratings from both methods are approximately equal. Further, a statistical test of significance for the intercept coefficient showed that it is not significantly different from zero.

Figure 4. Scatter plot of ProScan and manual PI's determined for Profilogram #2.

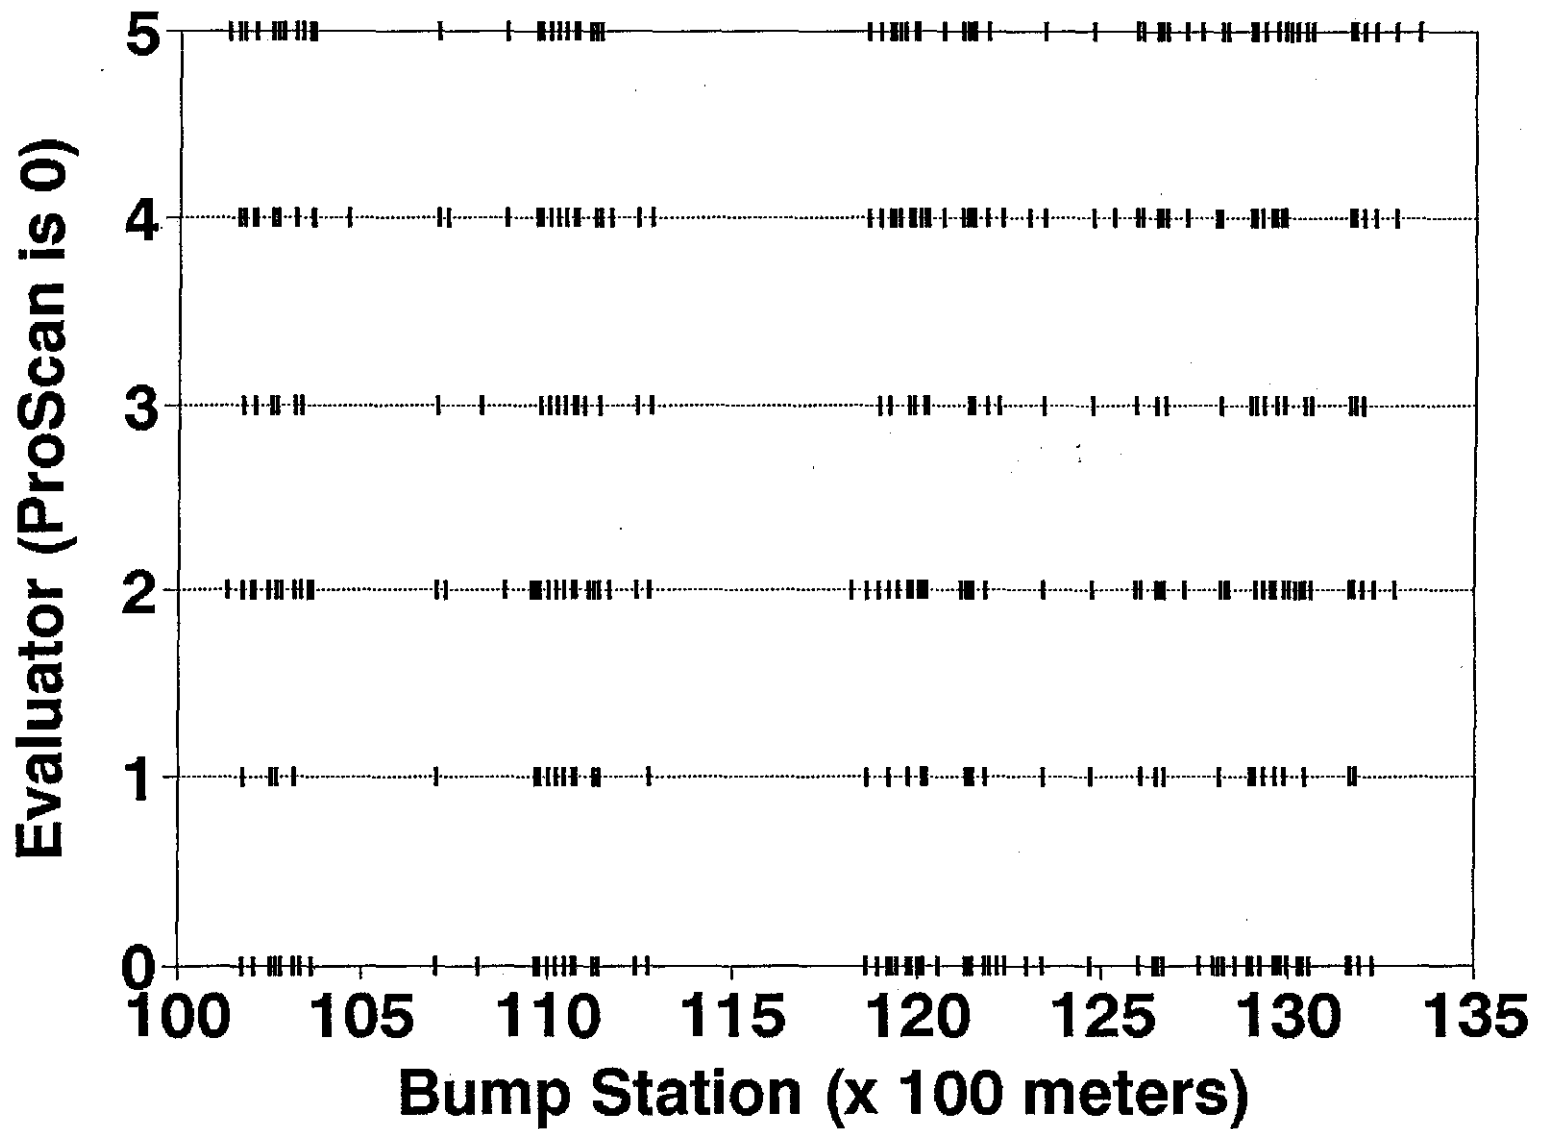
Figure 8 compares the mean bump stations from ProScan with the bump stations identified by the individual evaluators. Similarly, Figure 9 compares the dip stations. In these charts, the ProScan system is referred to as evaluator number zero. Examination of Figures 8 and 9 shows that ProScan generally detected the same defects that were found by the evaluators. As expected, there was relatively more variability in the defect stations identified by the different raters (Figures 8 and 9) than in the defects detected between repeat runs of ProScan (Figures 6 and 7). Again, this is attributed to the subjectivity inherent in the manual evaluation.

Figure 8. Comparison of bump stations from ProScan and panel of evaluators.

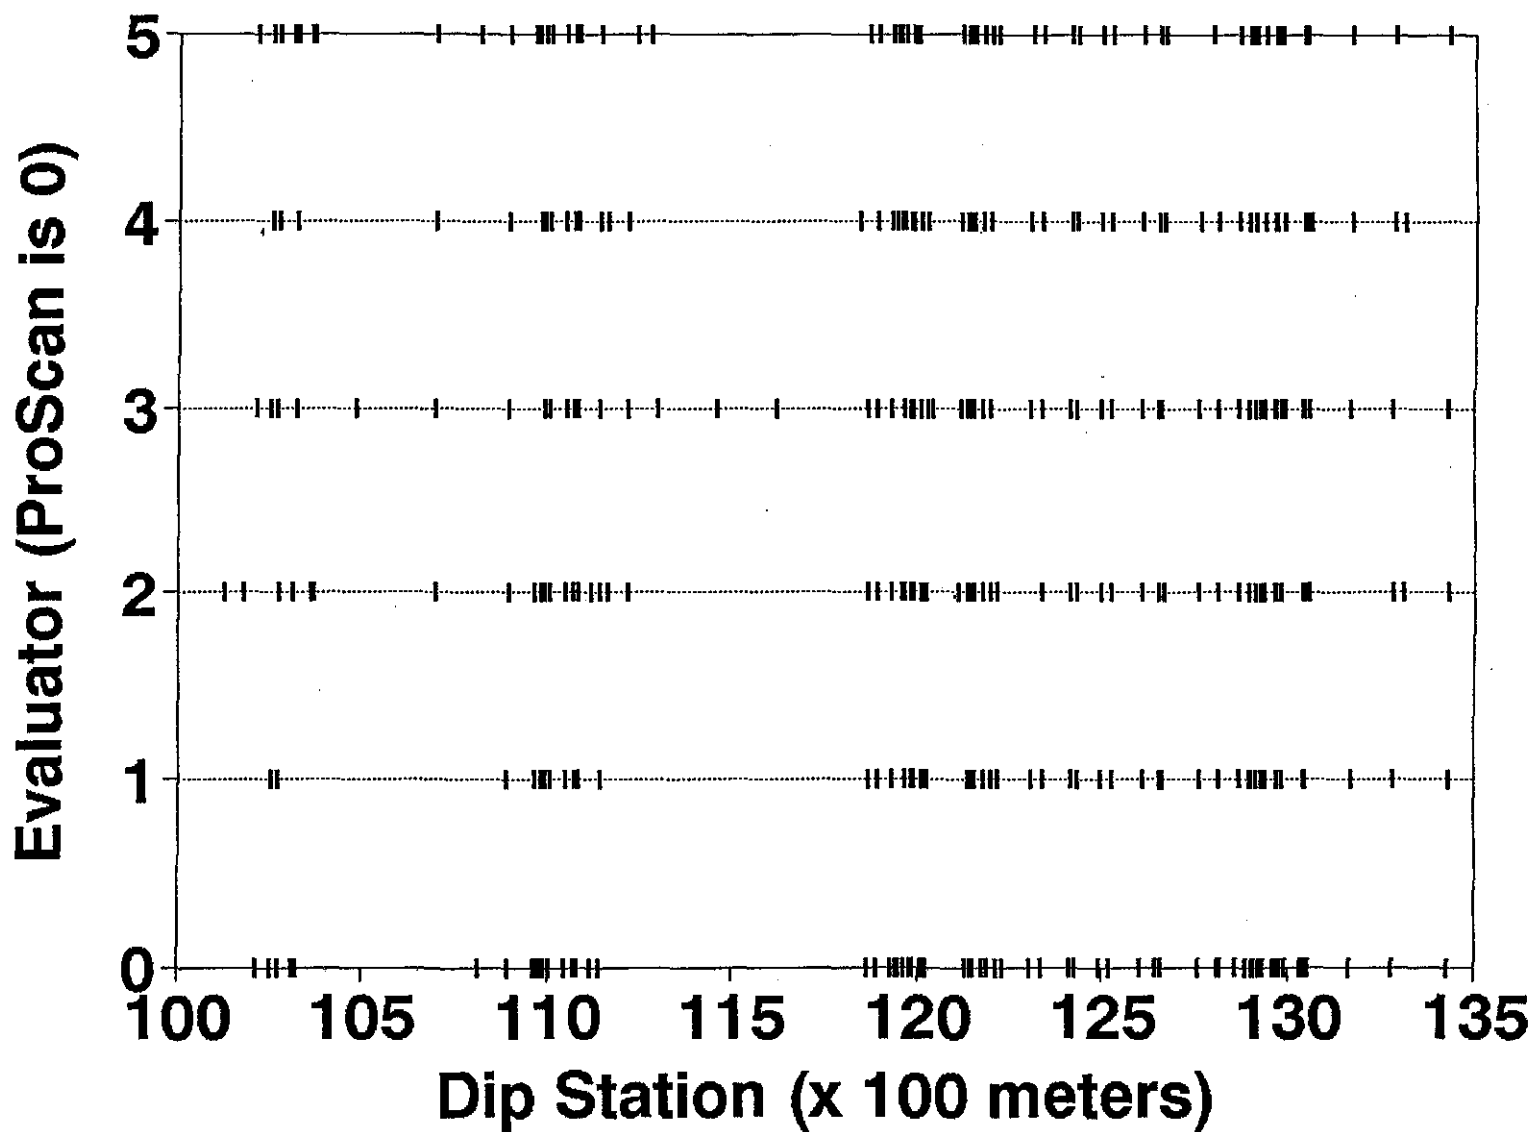
Figure 9. Comparison of dip stations from ProScan and panel of evaluators.
