FIRST PROGRESS REPORT ON CONCRETE EXPERIMENTAL
TEST SECTIONS IN BRAZOS COUNTY, TEXAS

Research Report 141-2

Quality of Portland Cement Concrete Pavement
As Related to Environmental Factors and
Handling Practices During Construction

Texas Transportation Institute
Texas A&M University
College Station, Texas

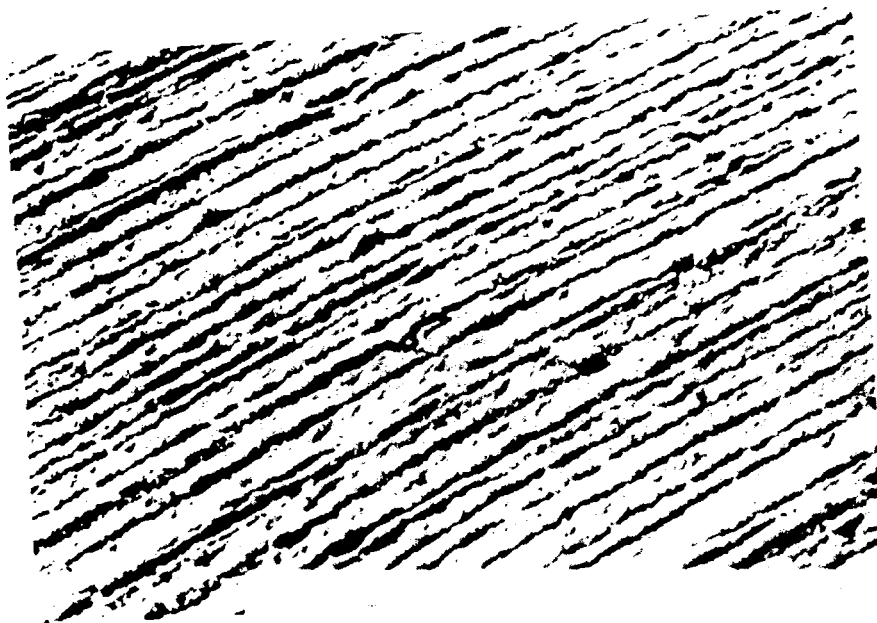
Fig. 2-9 Test Section F-2: Transverse Tine Finish
(As Constructed)

Seven surface-finish concrete test sections were constructed; a transverse brush, transverse tines, longitudinal brush, longitudinal tines, burlap drag followed by longitudinal tines, transverse natural broom, and a burlap drag as a control finish. The as-constructed finishes on the test sections are shown in Figures 2-8 through 2-14. The finishes are described in Table 2-1.

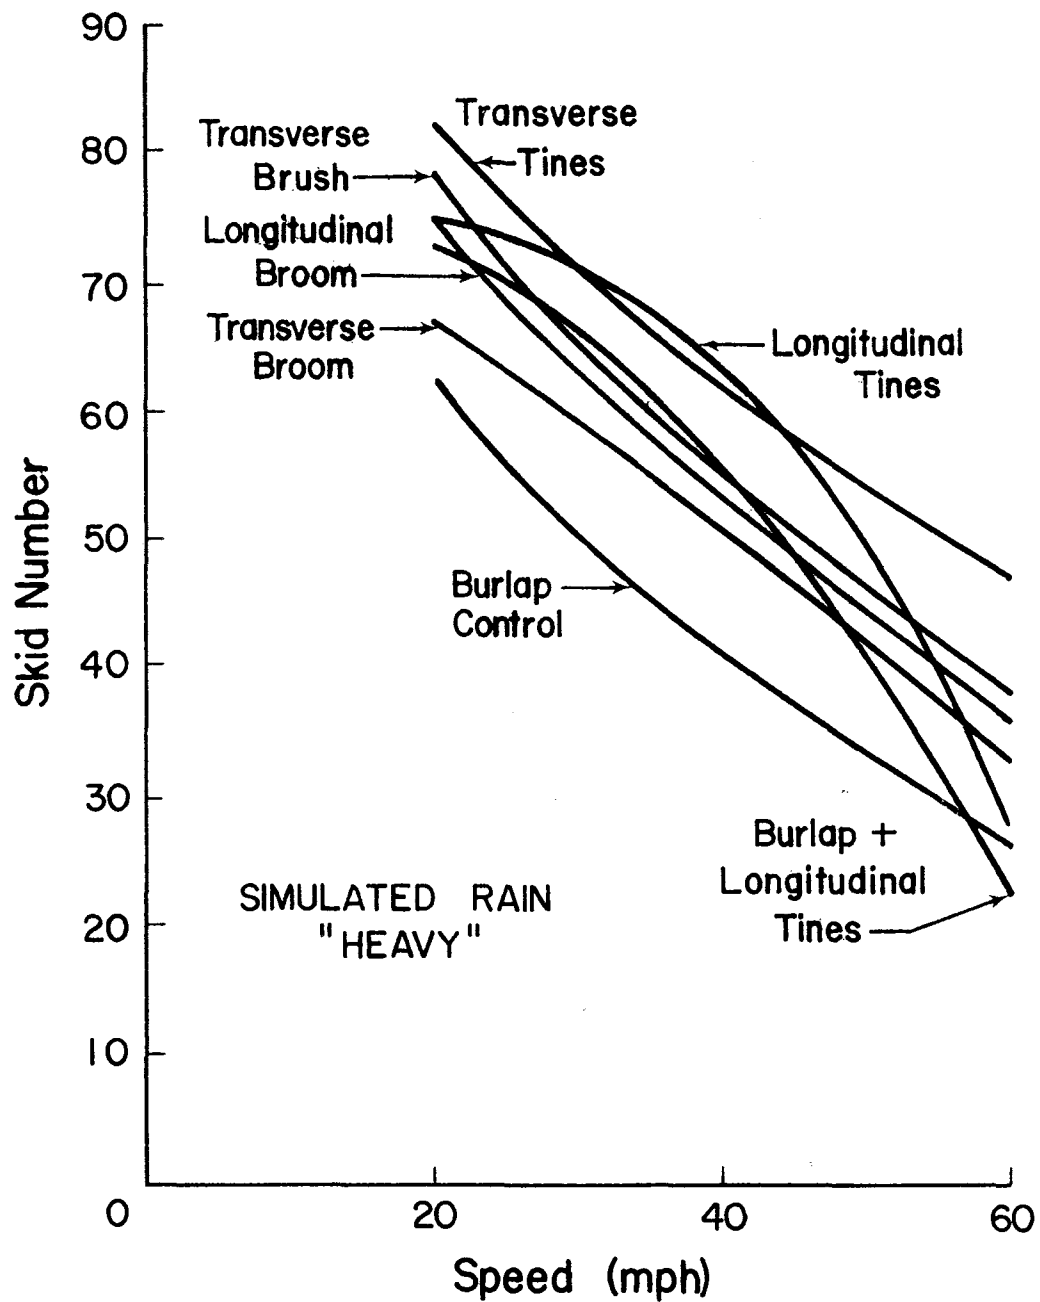
Fig. 3-11 Effect of Vehicle Speed on Skid Number of
Test Sections in Presence of Simulated Rain

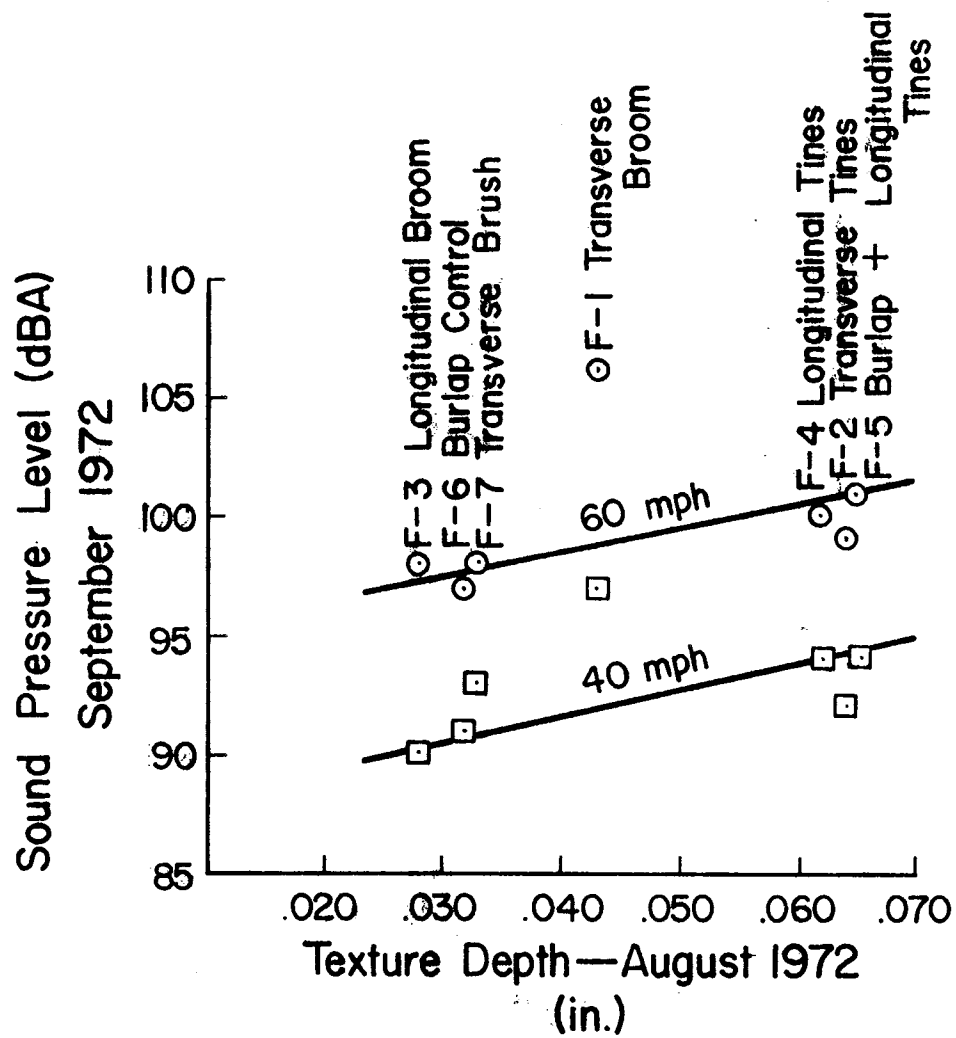
Fig. 3-16 Effect of Texture Depth on Sound Pressure Level

Sound pressure level measurements were repeated in August 1972, after the pavement had been worn somewhat and the sound level vs. texture depths are plotted on Figure 3-16. Here again a trend was established.

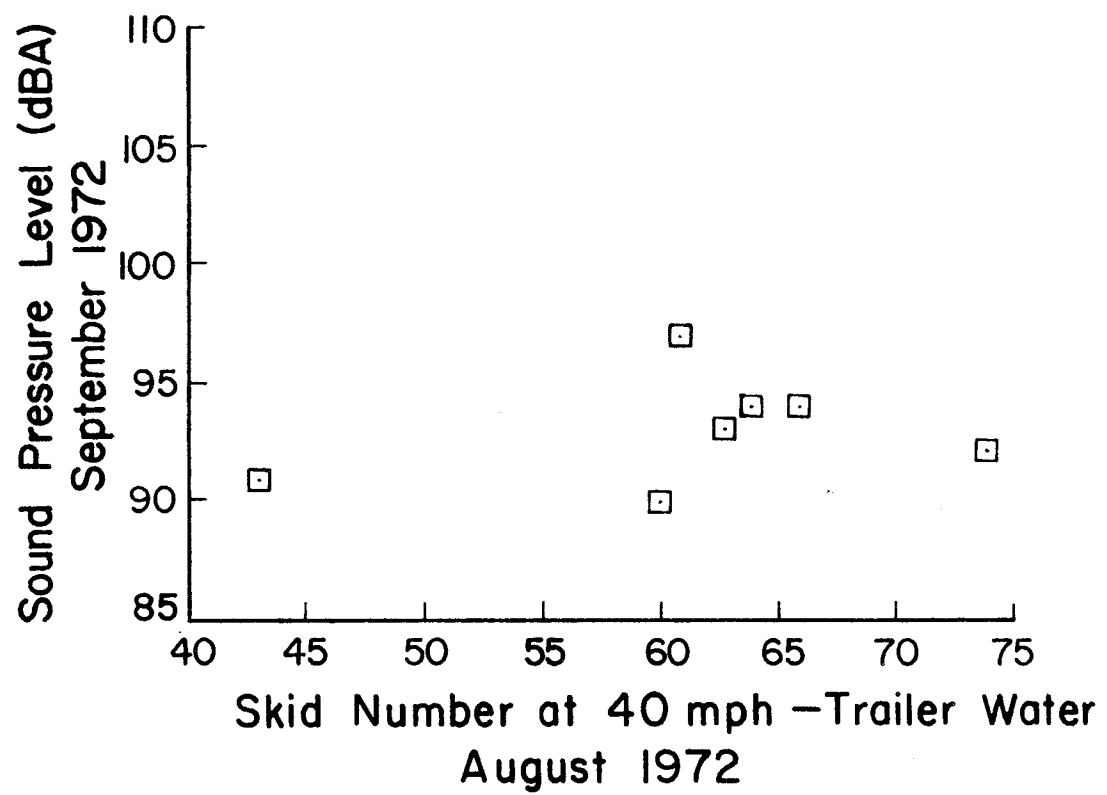
Fig. 3-17 Effect of Skid Number on Sound Pressure Level

Figure 3-17 indicates the relationship between skid number and the sound pressure level. For the particular variables under investigation in this study skid numbers correlated very poorly with the sound pressure level. This is not surprising, as texture and skid resistance are not always directly relatable. It must also be remembered that the sound pressure level information was taken on an arbitrary basis, making use of existing

equipment (see Section 4.6), and thus the data are too preliminary to draw any significant conclusions.

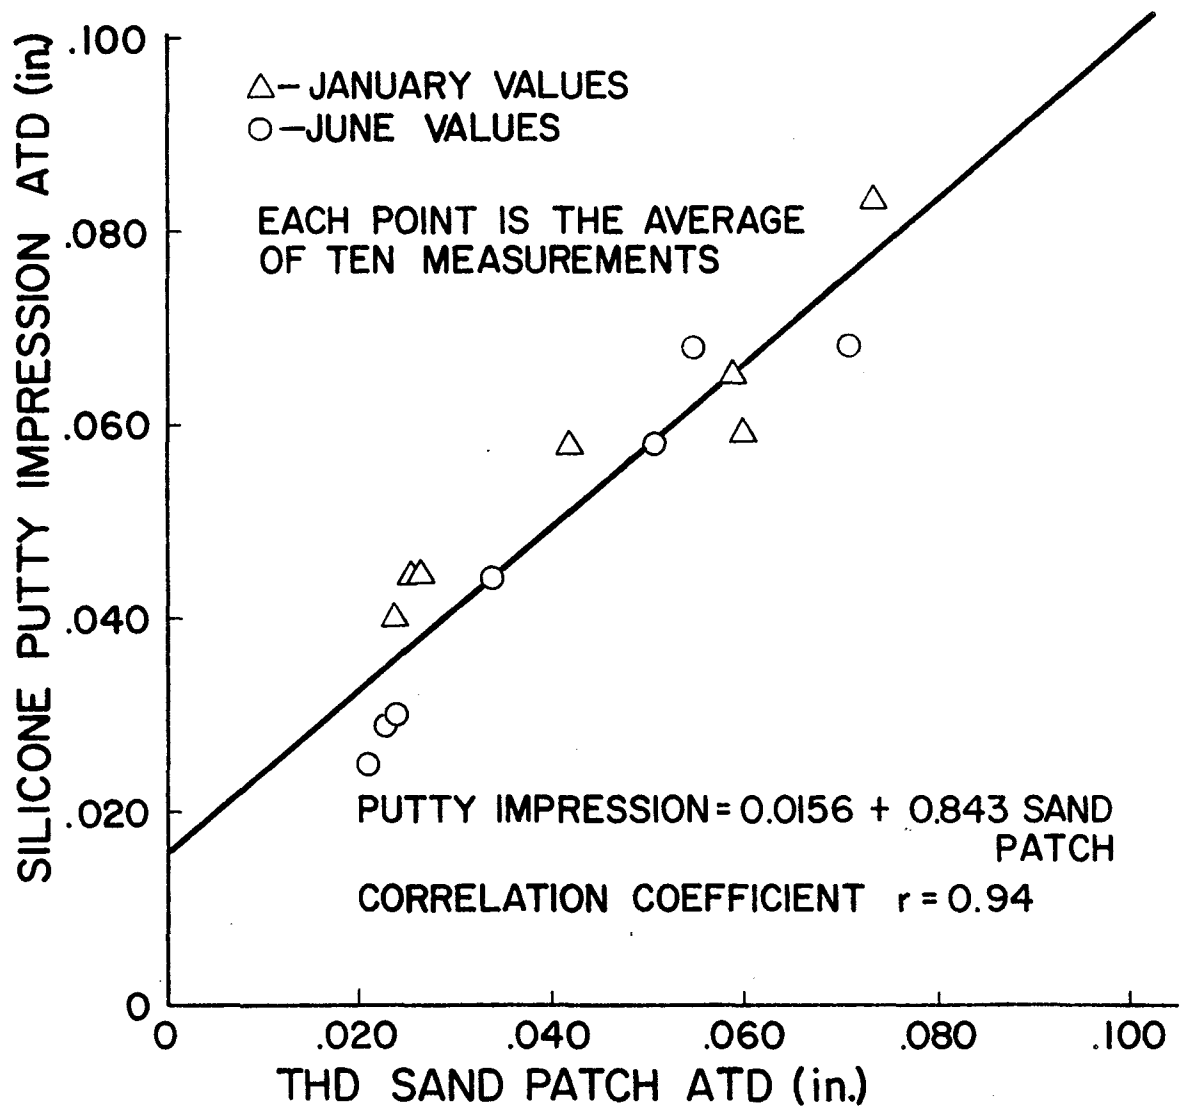
Fig. 4-3 Relationship Between Silicone Putty Impression Test
and THD Sand Patch Test
