**INITIAL EVALUATION OF SELECTED DETECTORS
TO REPLACE INDUCTIVE LOOPS ON FREEWAYS**

Report 1439-7
Project No. 0-1439
Research Project Title: Screen New Technologies
for Traffic Detection

TEXAS TRANSPORTATION INSTITUTE
The Texas A&M University System
College Station, TX 77843-3135

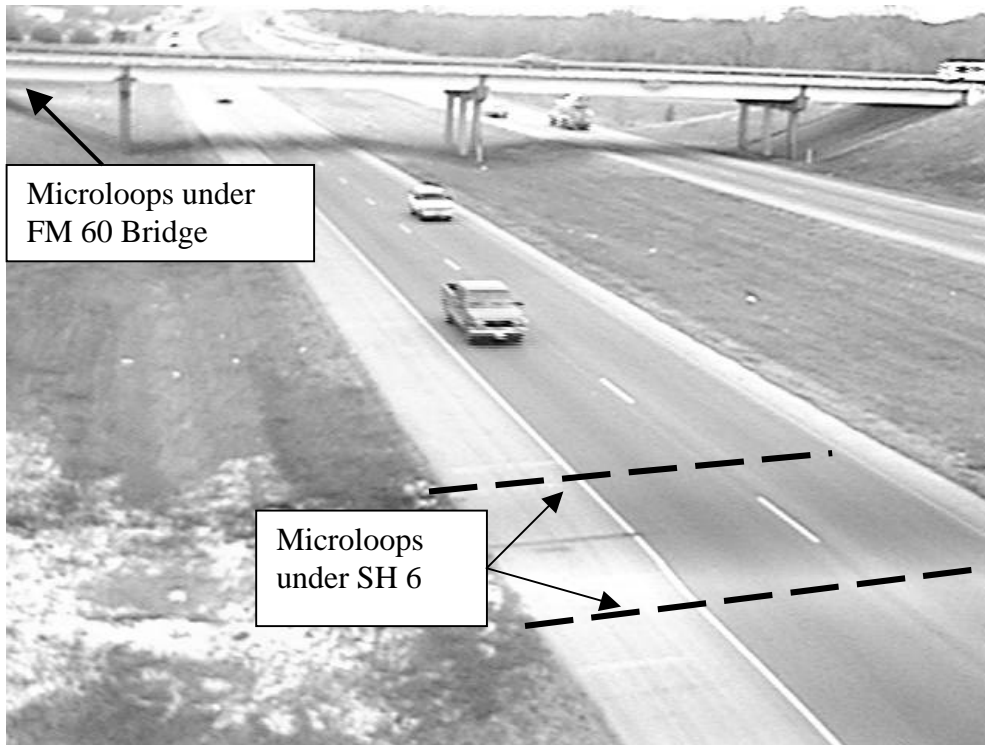
Figure 1. Surveillance Camera View of SH 6 and FM 60 Bridge.

The FM 60 bridge tests used two probes under the center lane and one probe under each of the other two lanes. Each probe set came with the designated length of lead wire to avoid splices. The manufacturer wired the probes in series where dual probes (side-by-side) were installed at a station (right lane on SH 6 and center lane on the FM 60 bridge). The bridge application required 500 ft of lead wire, but TTI requested the probes with 800 ft of leads to determine the effect the lead length might have. Wiring in series resulted in a total length of lead for the bridge center lane of 1,600 ft. The extra length did not seem to compromise performance in any way. Figure 4 shows the aluminum brace designed and built by TTI to support the probes underneath the bridge structure.

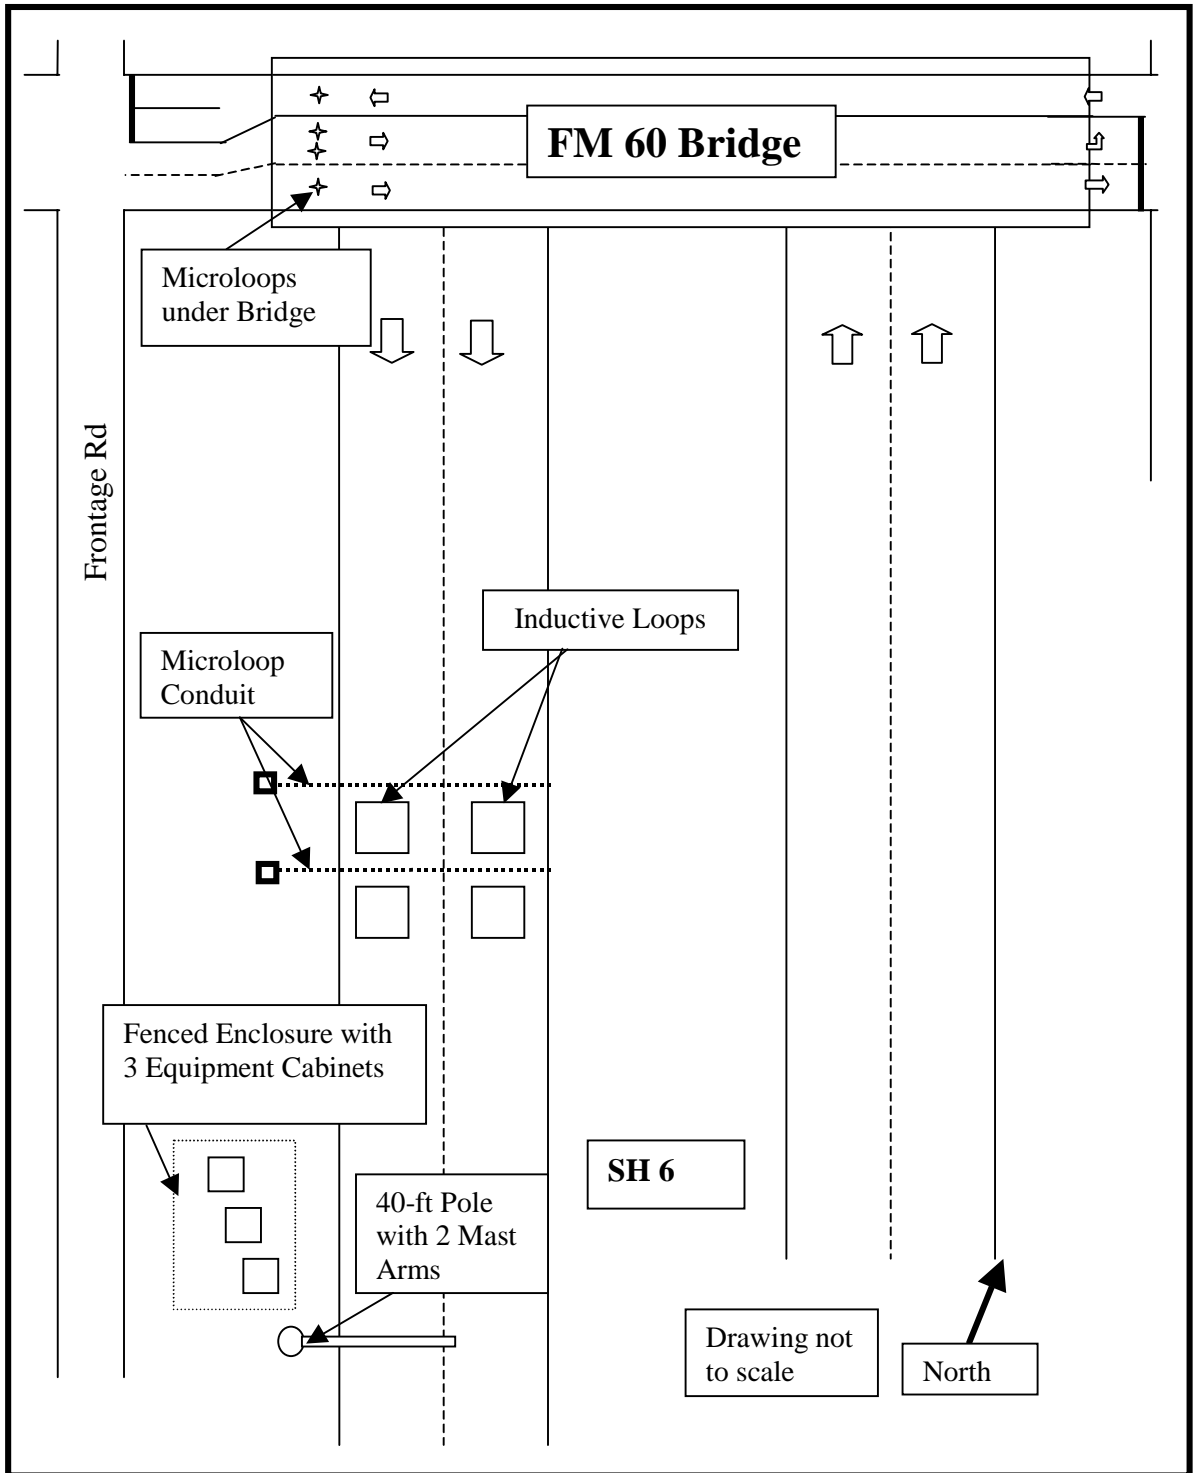
Figure 2. Schematic of Test Bed Layout.

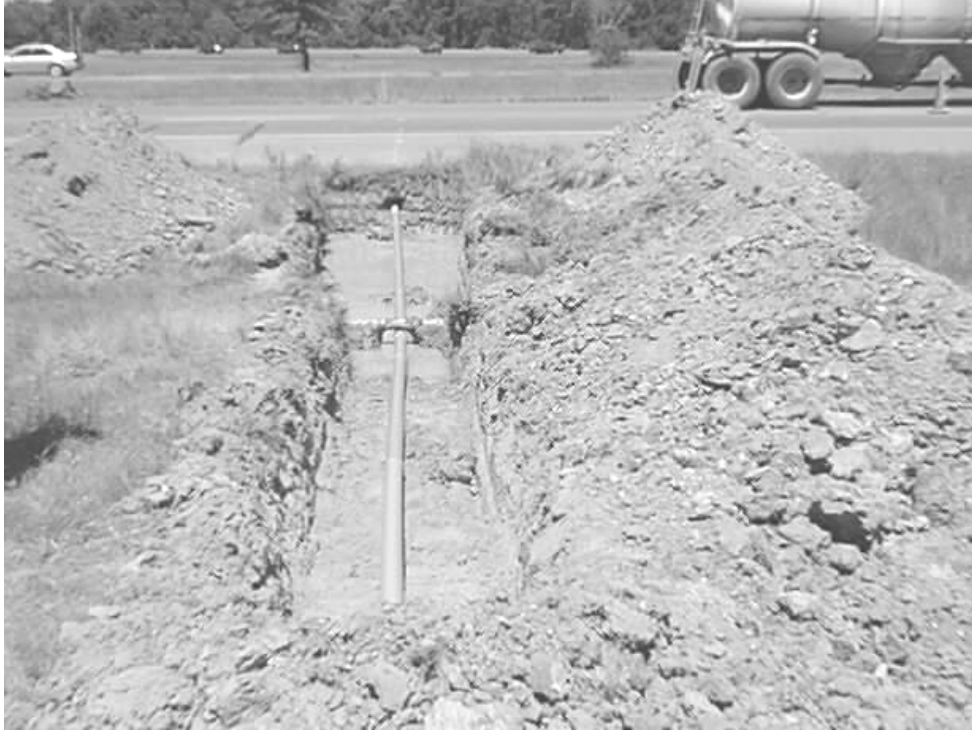
Figure 3. Installation of Microloop Conduit under SH 6.

One additional factor should be considered with the 3M microloop. It is designed to be installed at a very shallow depth below the pavement, at only 18 inches from the surface. This shallow depth caused several boring contractors concern for the College Station installation, to the point that most of them were not willing to bid on the project. There may be cases in which the microloop installation could be staged as part of the initial construction and thus overcome this problem. One TxDOT district considered installing the detectors at 36 inches below the surface to reduce the likelihood of compromising the structural integrity of the pavement. According to 3M, each probe's detection zone is shaped like a vertical cone, getting larger with height. Therefore, placement at greater depths may result in undesirable detection of tall vehicles in adjacent lanes.

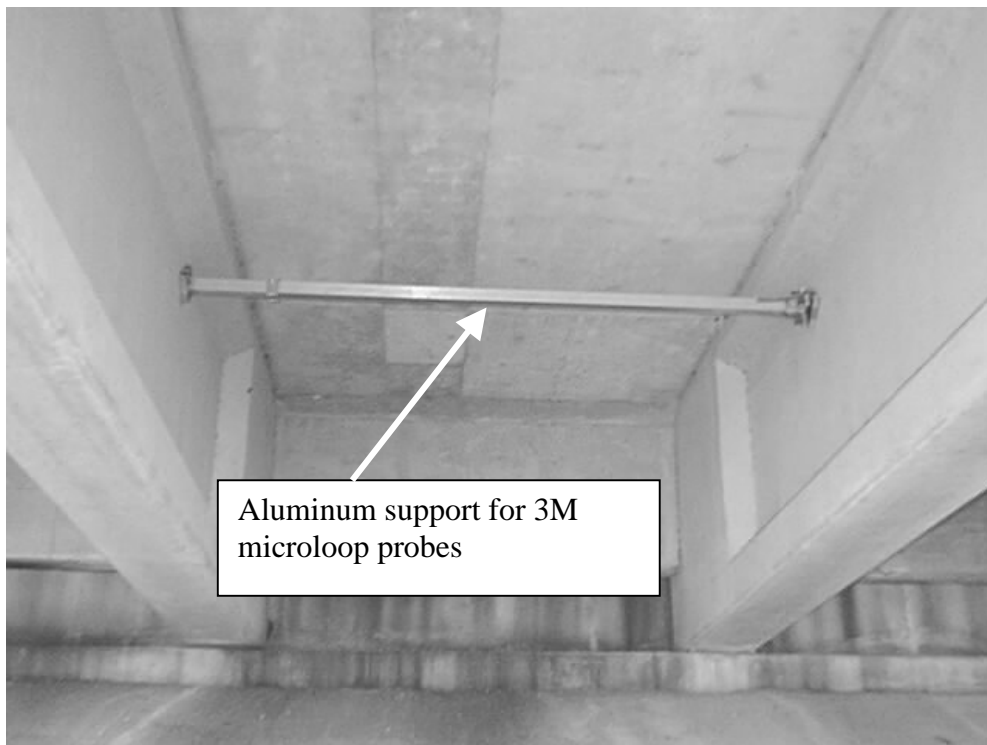
Aluminum support for 3M
microloop probes

Figure 4. View of Probe Support underneath FM 60 Bridge.

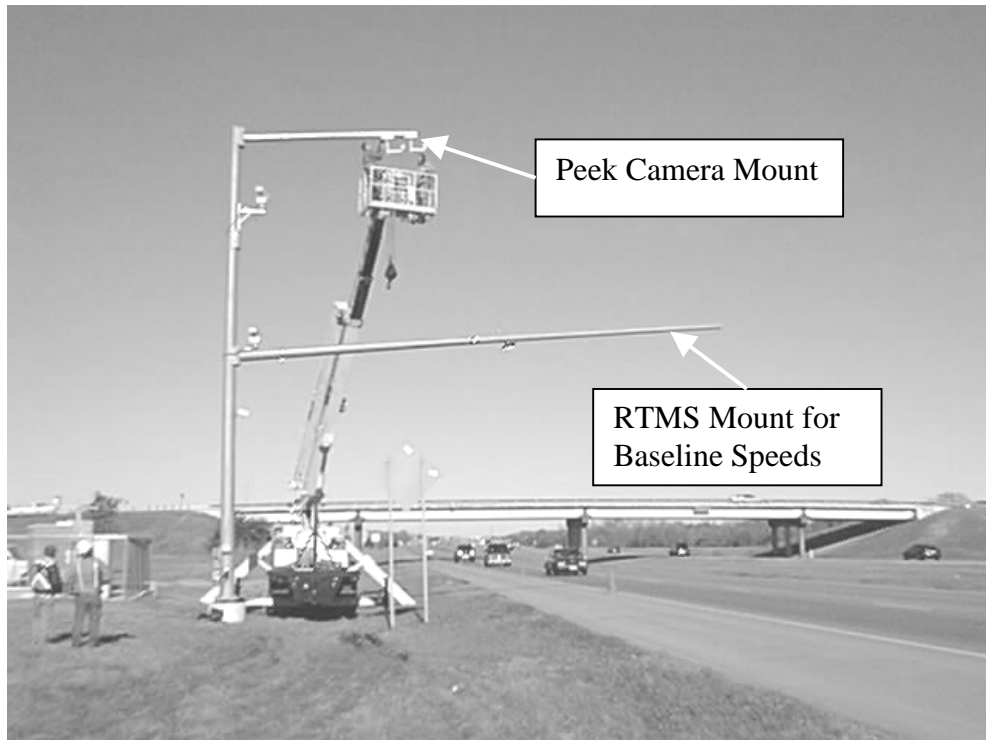
Figure 5. Installation of the Peek Camera 40 Ft above the Roadway.

Peek VPK Camera. The camera came from Peek ready to install in the field. All adjustments were already made to the camera inside its sealed enclosure. TTI aimed the camera to the position on the roadway as recommended by the vendor on-site.

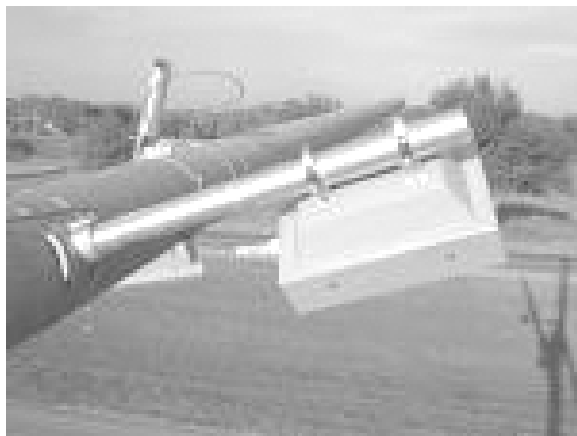
Mounting the sensor was a simple process, requiring banding the detector’s mounting bracket to the mast arm and orienting the detector generally toward the lanes to be monitored. Precise orientation is not normally required, although adjustments are sometimes necessary. An example of such an adjustment occurred when TTI mounted the detector behind the mast arm (as viewed by approaching motorists). A diamond-shaped warning sign on that same side of the mast arm initially caused the detector to double-count vehicles. TTI simply moved the detector to the “front” side of the mast arm to solve the problem. [Figure 6](#) shows the SmarTek SAS-1 mounted on the mast arm, with the view looking toward the end of the lower mast arm.

Figure 6. SmarTek SAS-1 Mounted on the Lower Mast Arm.

The SAS-1 is a passive acoustic (listen only) detector that mounts beside the roadway with the capability of monitoring up to five lanes from its sidfire orientation. The detector needs to be mounted as high as 35 ft above the roadway to accurately monitor five lanes. TTI mounted the detector 20 ft above the travel lanes because the detector was monitoring only two lanes and because of the mast arm's height. Its offset from the right lane was 25 ft (as measured at a 90-degree angle with the roadway). After test results became available, the vendor suggested that presence detection accuracy would have been better with a height of 25 ft to 30 ft and smaller offset.

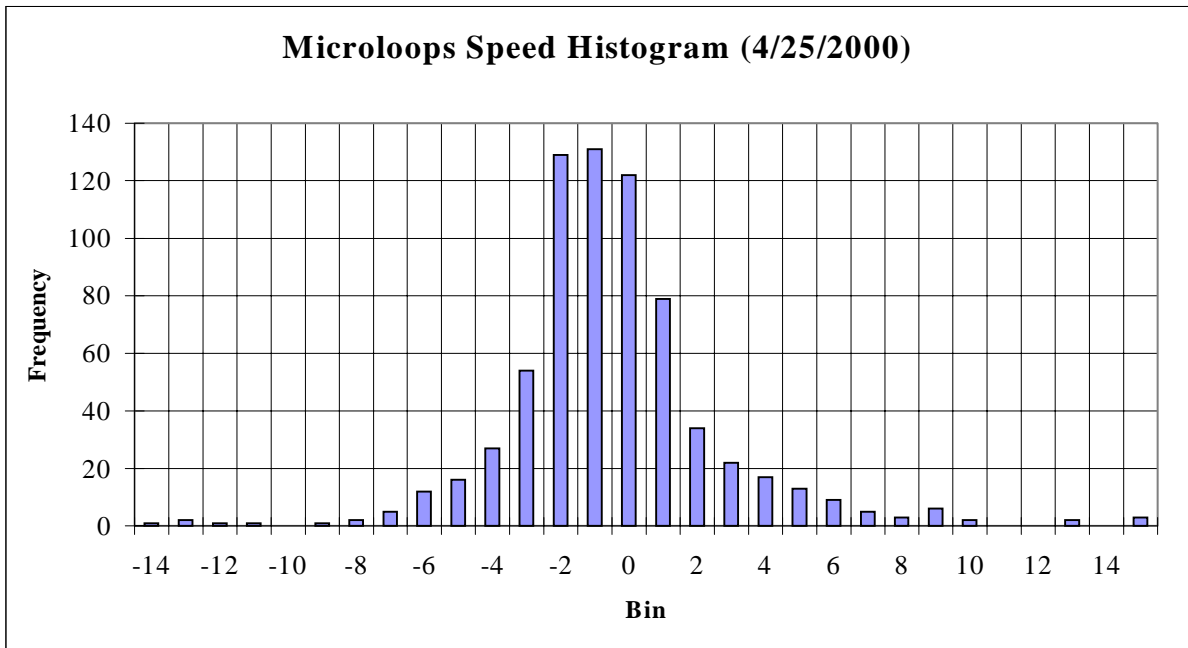
Figure 7. Example Microloop Speed Histogram.

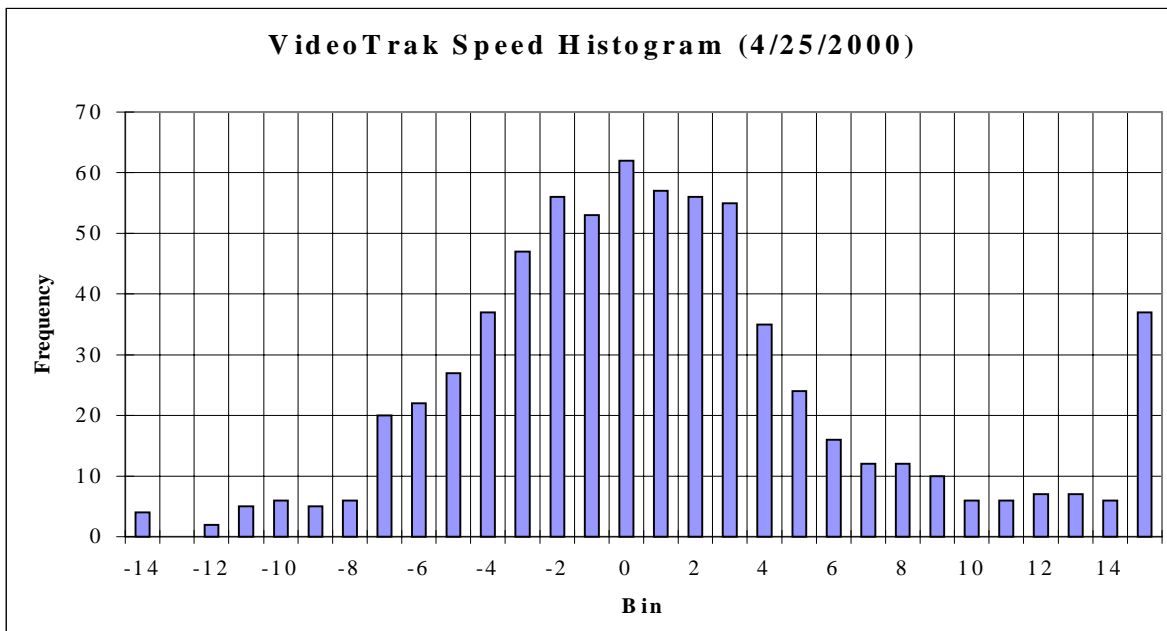
Peek VideoTrak 900. Speed results for the VideoTrak indicate a mean of +1.4 mph and a standard deviation of 6.9 mph. Because speeds, as well as counts, were significantly worse during nighttime hours (due probably to no street lighting), no data for those hours are provided. The data and results are for dry, daylight conditions except for May 1, 2000, as shown in [Appendix H](#). [Appendix H](#) shows that performance of the VideoTrak during rain was worse than depicted in [Figure 8](#). The histogram below also shows that the data are more dispersed about the sample mean than for the other two devices tested. The mean value also indicates speed bias on the high side. The tall bar at the extreme right on [Figure 8](#) shows the frequency of speeds that are over 14 mph.

Figure 8. Example VideoTrak Speed Histogram.

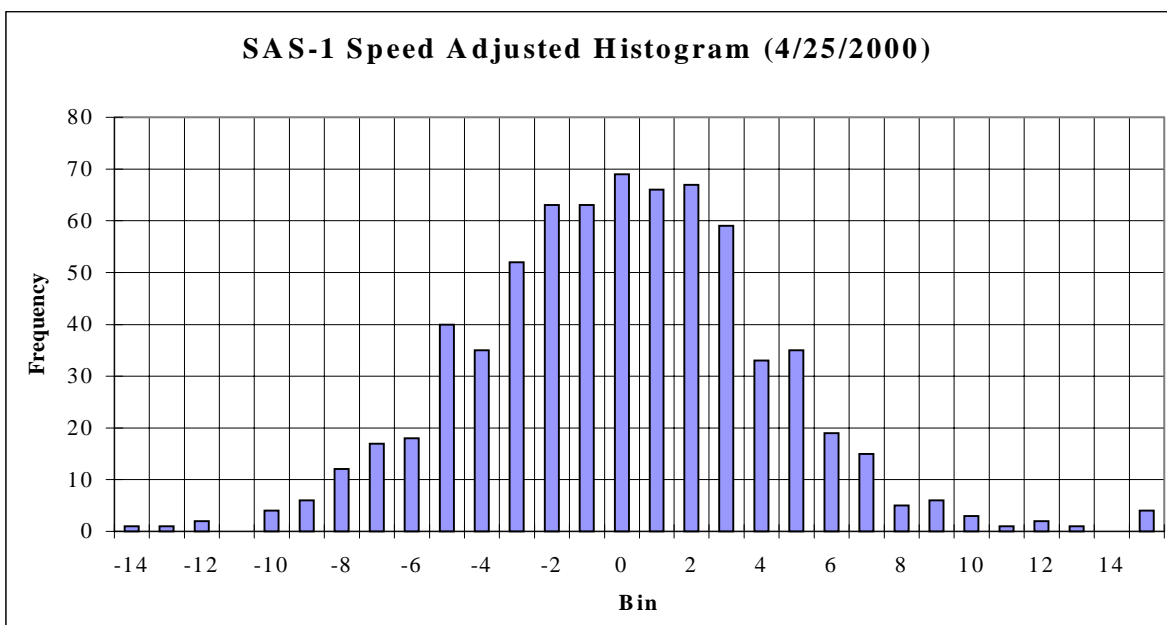
SAS-1 by SmarTek. [Figure 9](#) is an example of speed test results in dry weather. [Appendix H](#) shows results during rain, indicating that on May 1, 2000, the SAS-1 speeds increased by approximately 10 mph compared to both the RTMS and the 3M microloops. The mean value of the speed data plotted in [Figure 9](#) is -0.5 mph (based on post-calibration), and the standard deviation is 4.84 mph. This accuracy is very close to that of the 3M microloops, with slightly higher standard deviation. By view of the Normal distribution, these results suggest that the SAS-1 will predict one-minute interval average speeds within plus or minus 10 mph 95 percent of the time.

Figure 9. Example SAS-1 Speed Histogram.

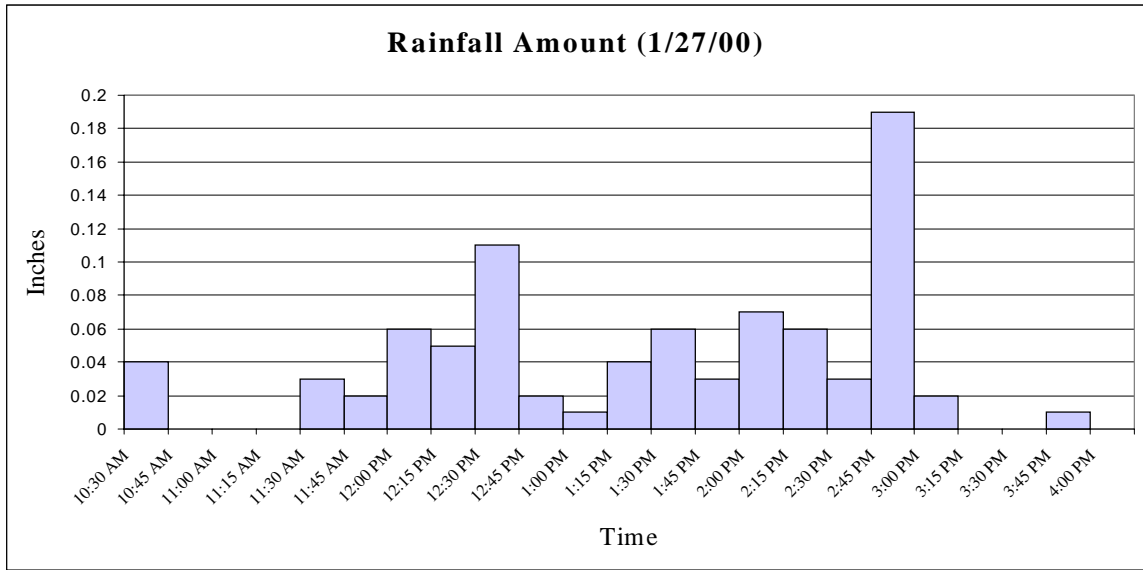
Figure D-1. Rainfall Amount (1/27/00).

Field personnel made almost all of the count accuracy tests in dry weather, with the exception occurring on January 27 when rain fell from 10:30 a.m. to 3:15 p.m. The rain was steady throughout this time interval with periods of intermittent heavier rain. Rain was a probable factor affecting performance accuracy for both the SAS-1 and the VideoTrak. Wet pavement caused the VideoTrak to overcount due to headlight reflections. Very heavy rain could also impair visibility and thus reduce performance. Lighting was a direct factor for only the VideoTrak; it demonstrated reduced accuracy at night and with long vehicular shadows during the daytime. Placement of the camera directly over the lanes might have improved both its day and its night performance, but TxDOT does not typically place cameras over lanes. Speed tests all occurred in dry weather.

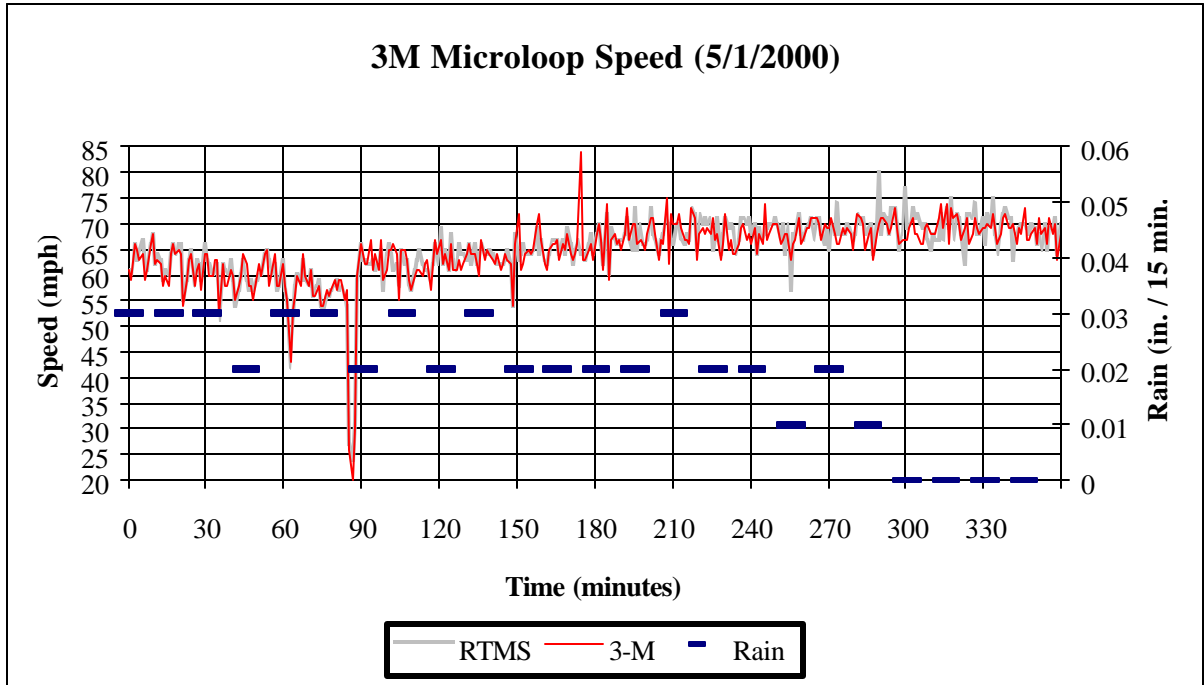
Figure H-1. 3M Microloop Time Speed Plot.

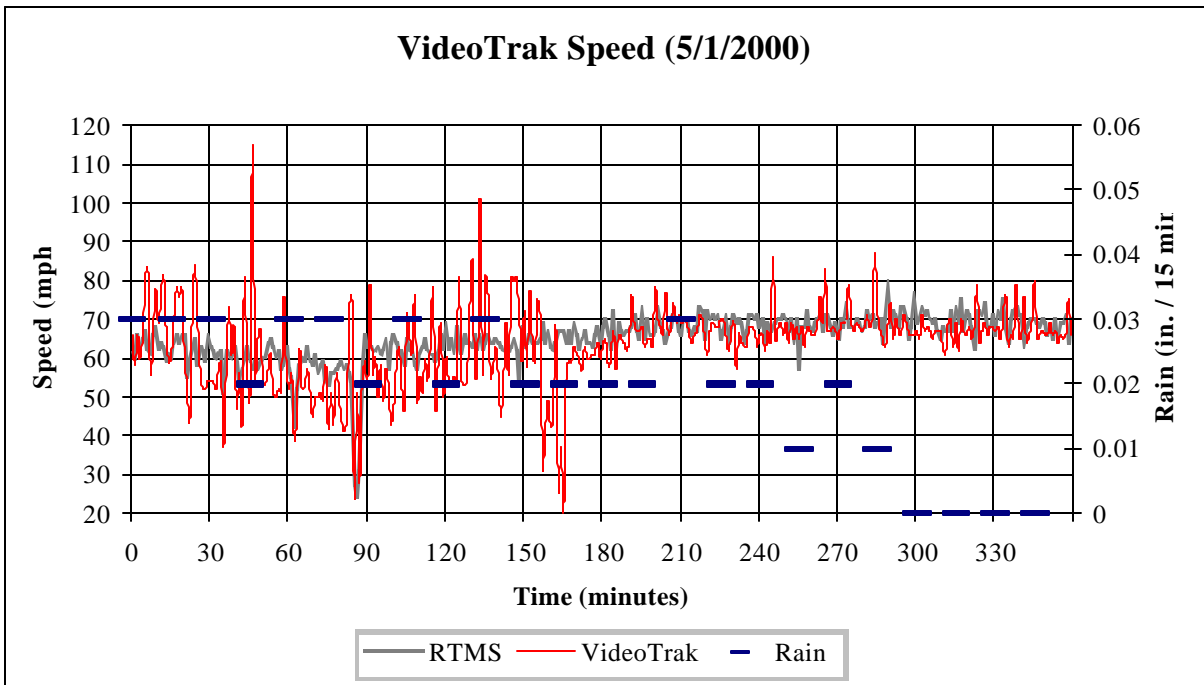
Figure H-2. VideoTrak Time Speed Plot.

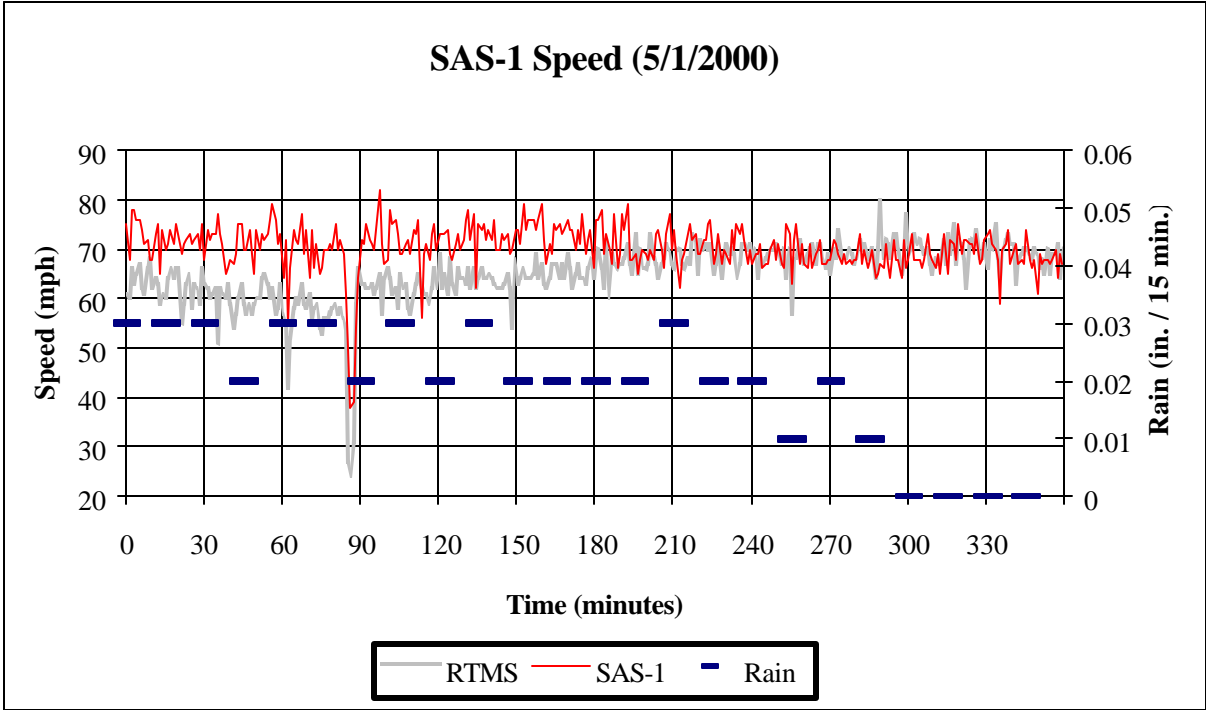
Figure H-3. SAS-1 Time Speed Plot.
