FULL SCALE CRASH TESTS  
OF A  
TIRE-SAND INERTIA BARRIER

Research Report 146-12  
Studies of Field Adaptation of Impact  
Attenuation Systems

Texas Transportation Institute  
Texas A&M University  
College Station, Texas

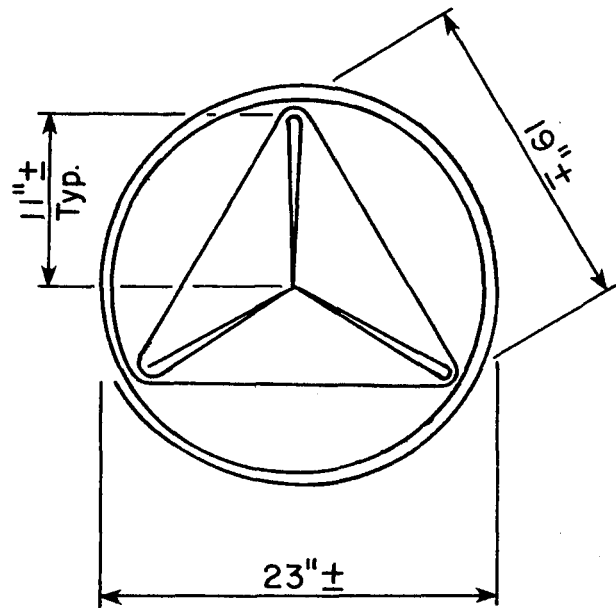
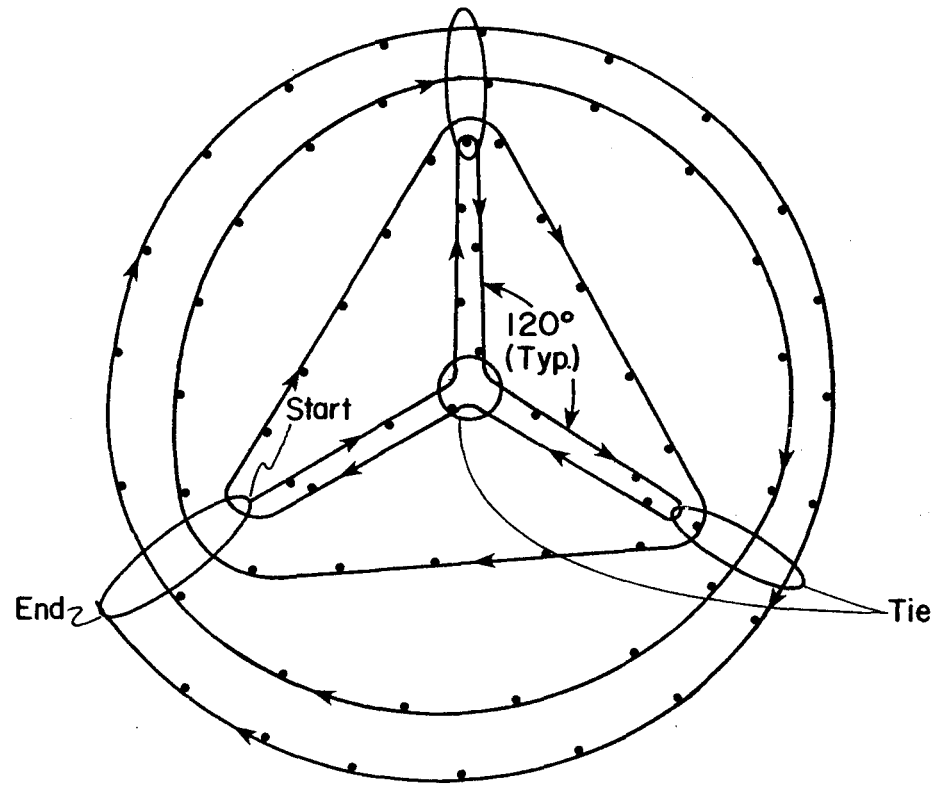
H = 18" FOR 150 LB & 230 LB MODULE  
 H = 18" FOR 460 LB & 690 LB MODULE  
 H = 12" FOR 920 LB MODULE  
 Height Varies To Suit Modules

1" X 2" X 14 GAGE X 20'-6" WIRE FENCING

FIGURE 5 WIRE CAGE SUPPORT DETAILS

Two successful supports were tested. The first was a wire cage that collapsed when impacted. The wire cage was constructed of 14 gage galvanized welded wire fabric with 1 in. by 2 in. openings. Details of construction are shown in Figure 5. The details of the second successful support is shown in Figure 6. This support is made of 55 gal steel drums with the stiffening tops and bottoms removed then cut

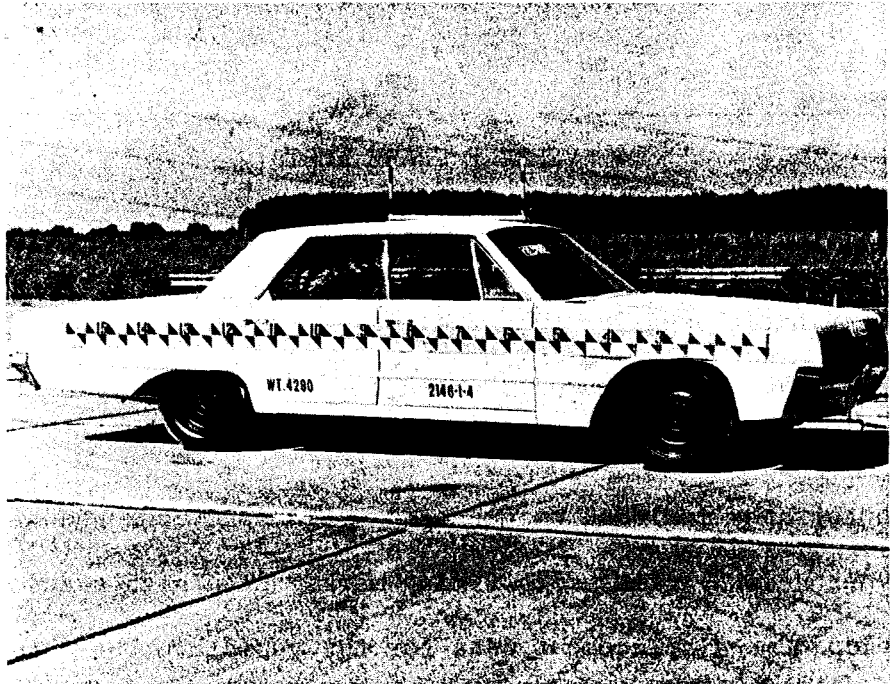
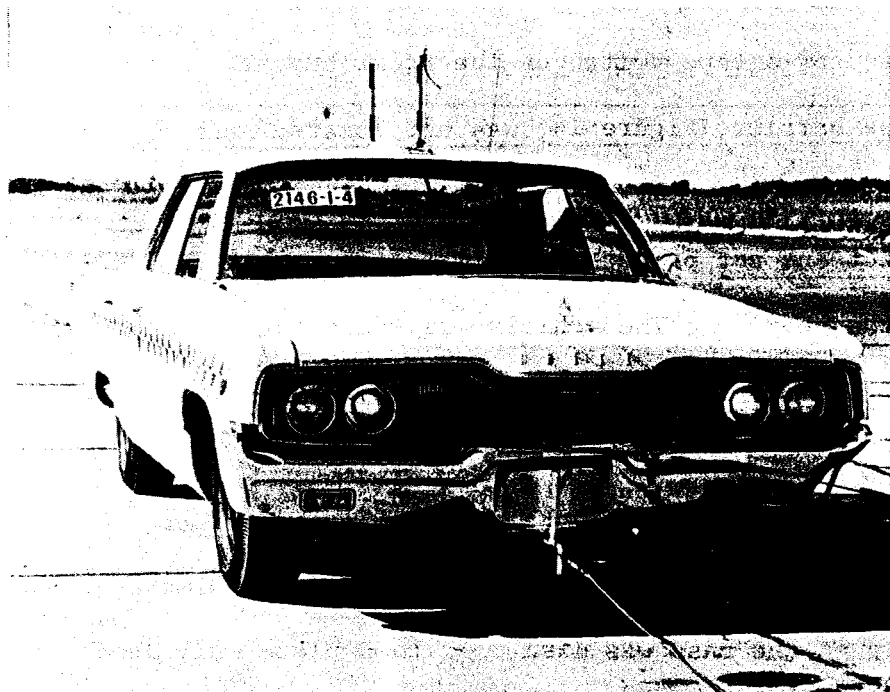
FIGURE 13 TEST 1-4 VEHICLE BEFORE IMPACT

The vehicle used for this test was a 1967 Dodge Monaco with a gross weight of 4290 lbs. Figure 13 shows the vehicle prior to the test. No accelerometers were installed.

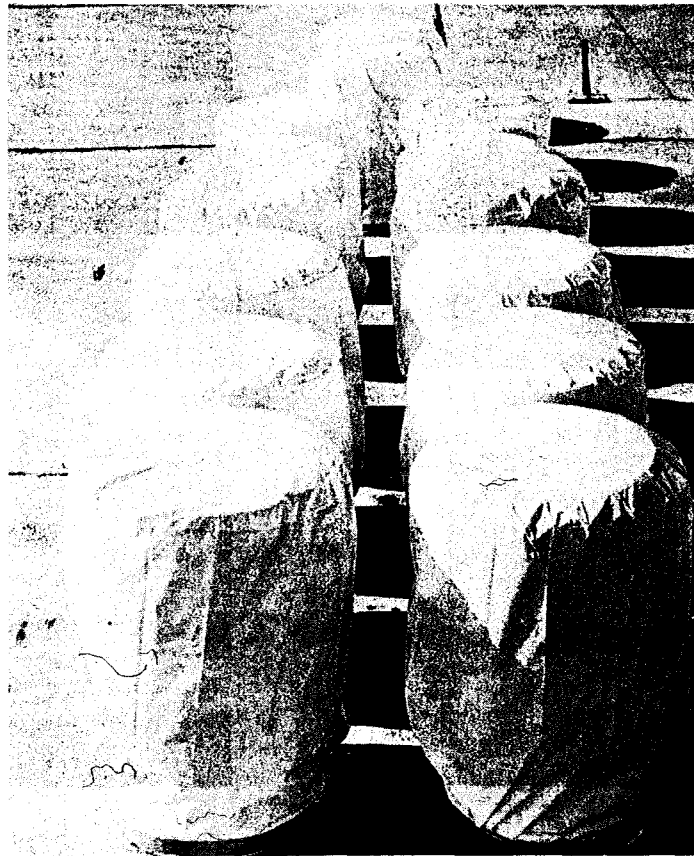
FIGURE 14 TEST 1-4 BARRIER BEFORE IMPACT

The barrier, Figure 14, was not located near any rigid backup. Also, the bases used were wire cages which were designed to collapse on impact and not produce an uplift force on the vehicle as they rolled under the vehicle. The vehicle was towed into the barrier at an impact angle of 0 degrees using the reverse tow mechanism described in Reference (6).

The hood was forced open in Test I-3. The hinges of the hood on the vehicle used in Test I-4 were broken causing the hood to fall off (Figure 14, 0.350 and 0.749 sec). Similar incidents have occurred in three previous tests on other projects.

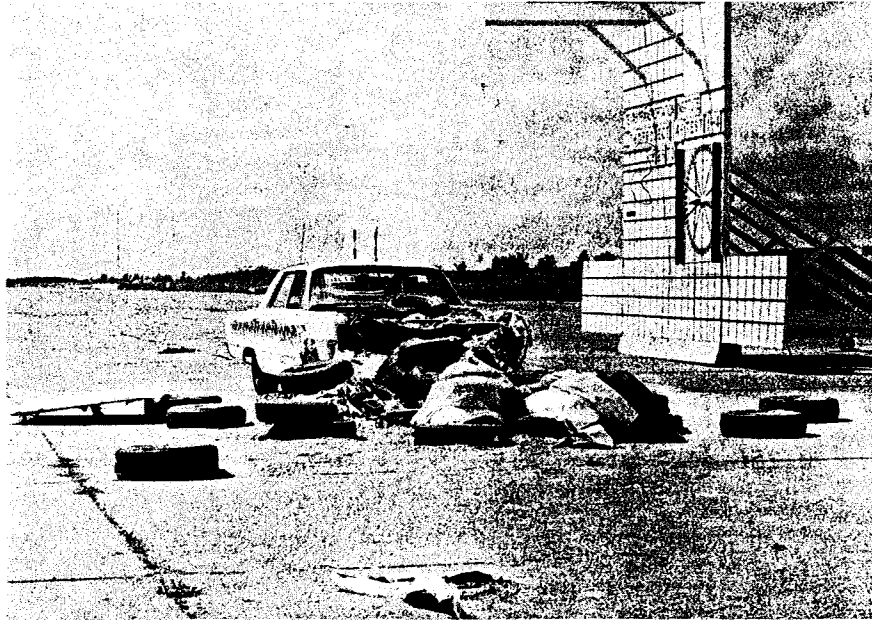
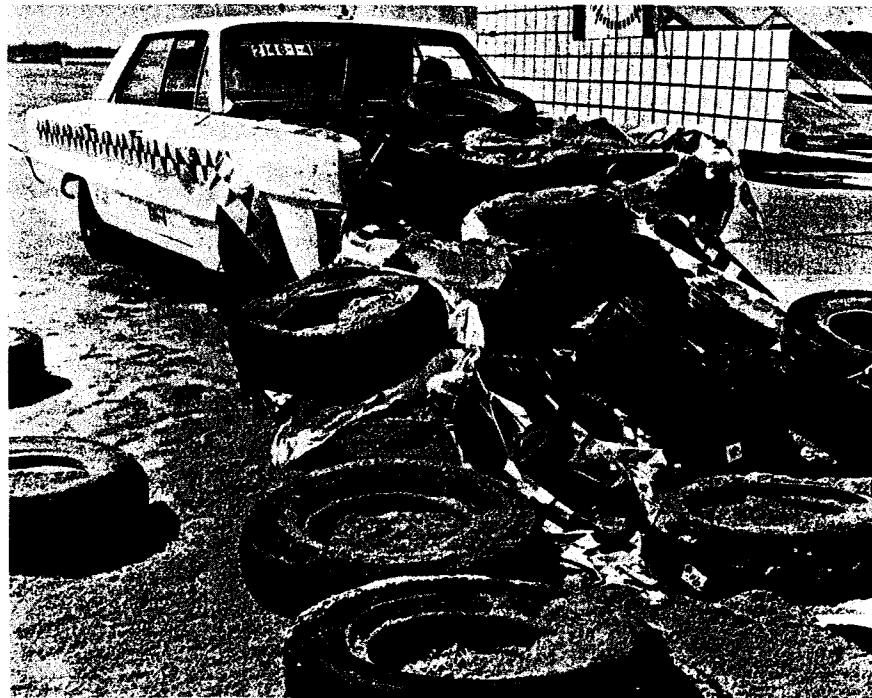
FIGURE 16 TEST 1-4 VEHICLE & BARRIER AFTER IMPACT

Two tires were hurled more than 100 feet during impact, "however 95% were within 10 feet of the rear of the attenuator." This occurred in previous tests (1, 2) with the tire-sand barrier.

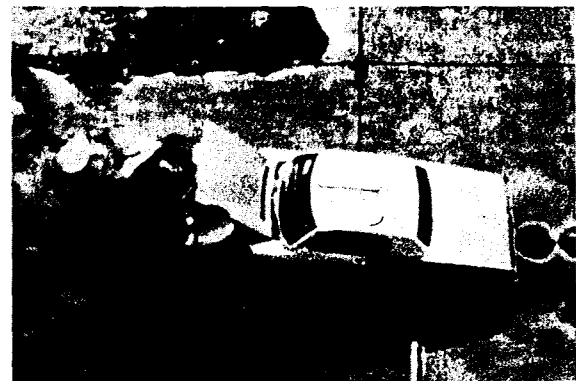
T = 0.608 sec

FIGURE 21 OVERHEAD SEQUENCE PHOTOGRAPHS OF TEST I-4

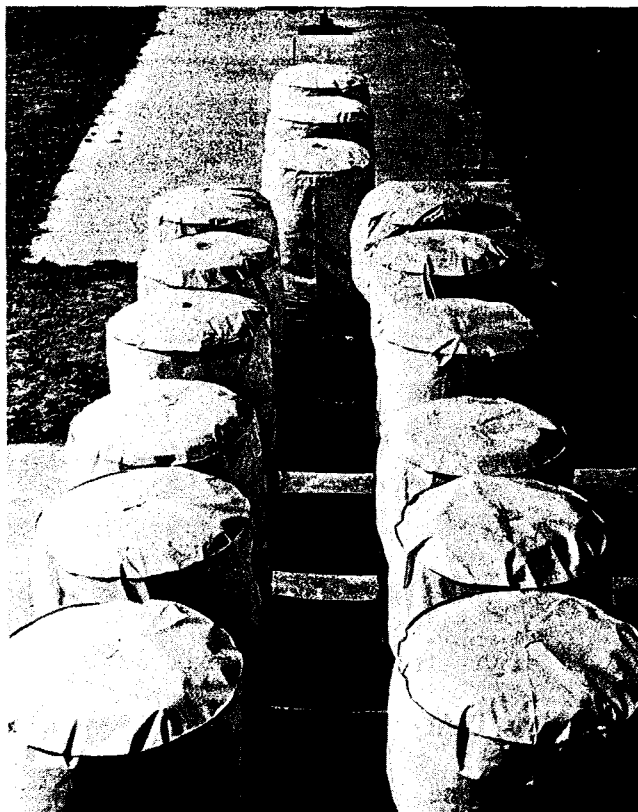
**FIGURE A-2 TEST 1-3 BARRIER BEFORE IMPACT**

The barrier, Figure A-2, was located in front of a rigid backup. The vehicle was towed into the barrier at an impact angle of 0 degrees using the reverse tow mechanism described in Reference (6).

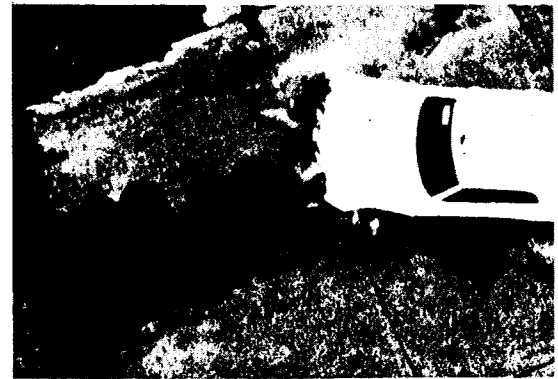
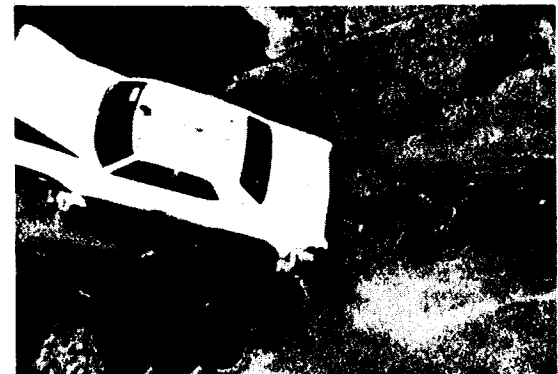
FIGURE A-8 OVERHEAD SEQUENCE OF PHOTOGRAPHS  
TEST I-5

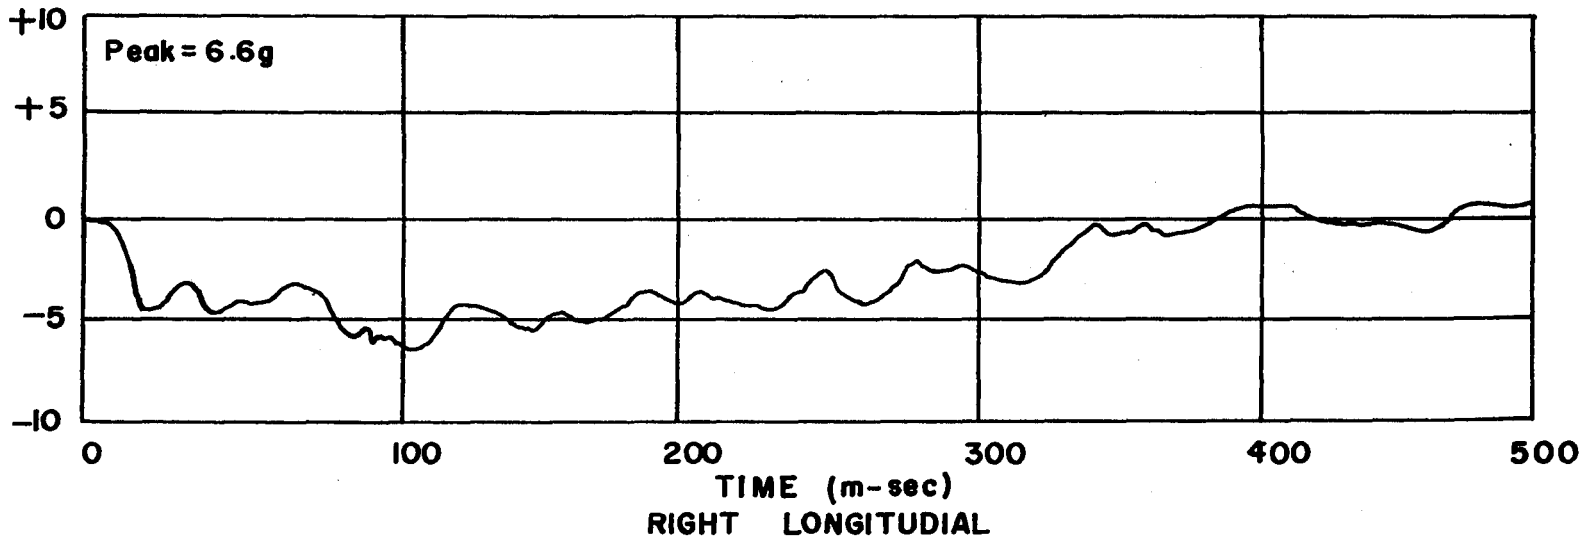
FIGURE A-13 LONGITUDINAL ACCELERATION DATA TEST 2146 I-5
