PENDULUM TESTS ON TRANSFORMER BASES
FOR LUMINAIRE SUPPORTS

Research Report Number 146-9

Studies of Field Adaptation of Impact Attenuation Systems
Research Study Number 2-8-68-146

TEXAS TRANSPORTATION INSTITUTE
Texas A&M University
College Station, Texas

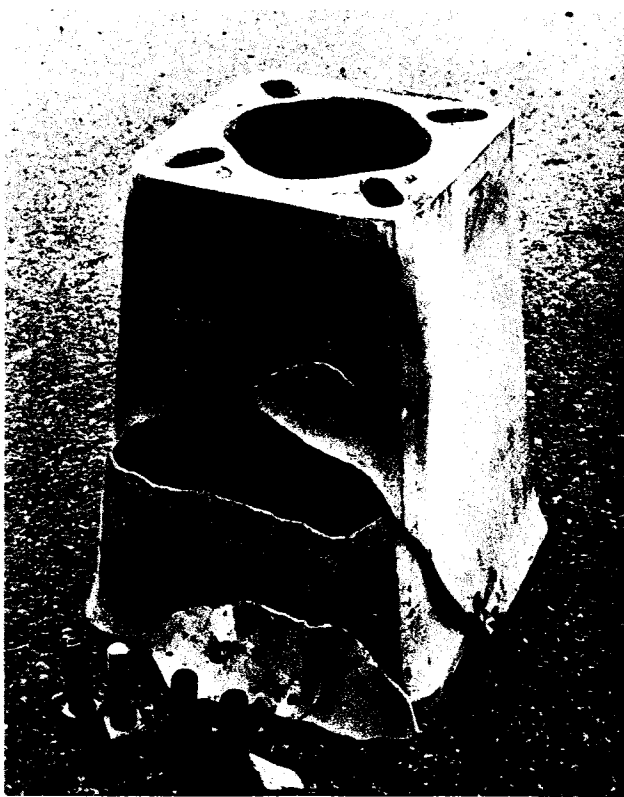
Figure 6. Transformer base before and after impact, Test I-35.

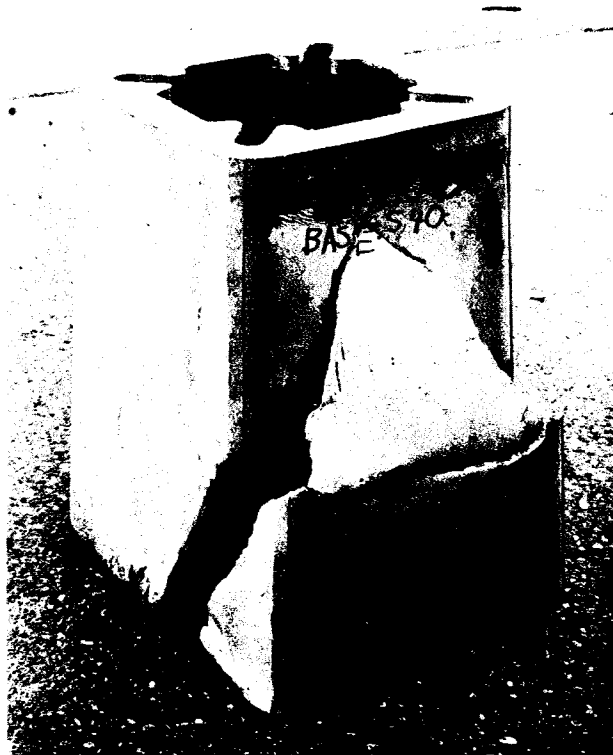
Figure 8. Transformer base before and after impact, Test S-40.
