1. Report No. FHWA/TX-98/1469-3		2. Government Accession No.		3. Recipient's Catalog No.	
4. Title and Subtitle ENHANCED TRAFFIC CONTROL DEVICES AND RAILROAD OPERATIONS FOR HIGHWAY-RAILROAD GRADE CROSSINGS: THIRD-YEAR ACTIVITIES				5. Report Date July 1997

**ENHANCED TRAFFIC CONTROL DEVICES AND RAILROAD  
OPERATIONS FOR HIGHWAY-RAILROAD GRADE CROSSINGS:  
THIRD-YEAR ACTIVITIES**

Research Report 1469-3  
Research Study Number 0-1469  
Research Study Title: Enhanced Traffic Control Devices and  
Railroad Operations for Highway-Railroad Grade Crossings

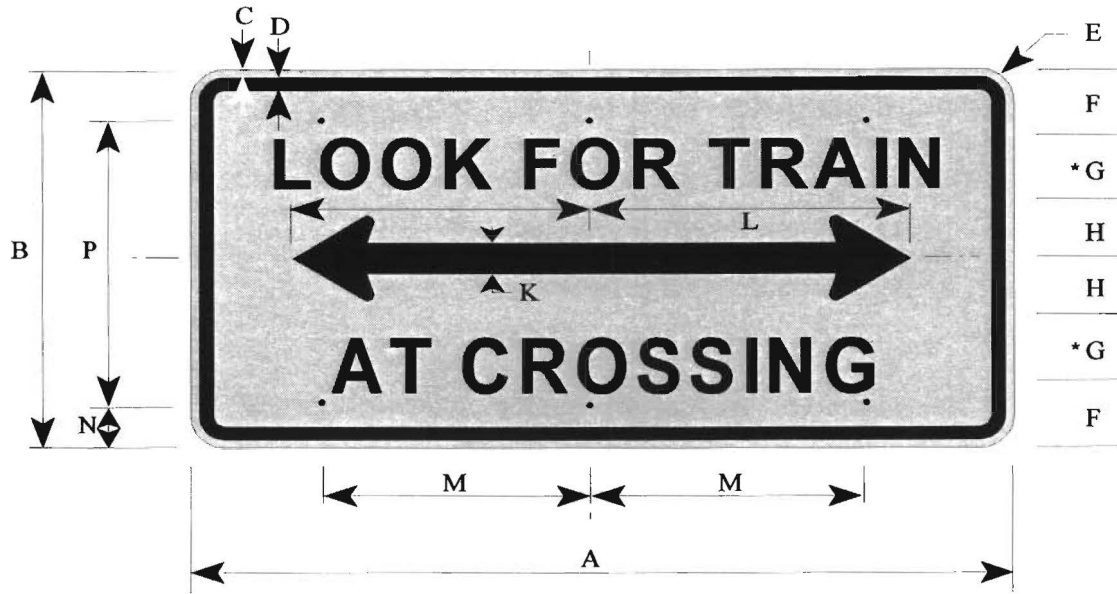
\* CONDENSE SPACING 15%

**COLORS - Border, Legend & Symbol - BLACK; Background - YELLOW (Refl)**

To address this problem, the research team and the Texas Department of Transportation (TxDOT) developed a "LOOK FOR TRAIN AT CROSSING" supplemental sign to be installed directly below the W10-1 sign. This supplemental sign provided the driver with a written message consistent with the desired action at the crossing and minimized the potential of a driver misunderstanding the meaning of the flashing strobe light. The sign contained 10-centimeter letters, using a 122-centimeter (48-inch) sign width. This letter height was based on a ratio of legibility distance to letter height of 7:1 assuming 20/20 Snellen vision. The final design and sizing requirements for the supplemental sign are presented in Figure 2.1. In July 1996, after thoroughly evaluating the proposed vehicle-activated strobe and supplemental sign design, TxDOT granted permission to undertake a field implementation and evaluation of these enhancements at a passive highway-railroad grade crossing.

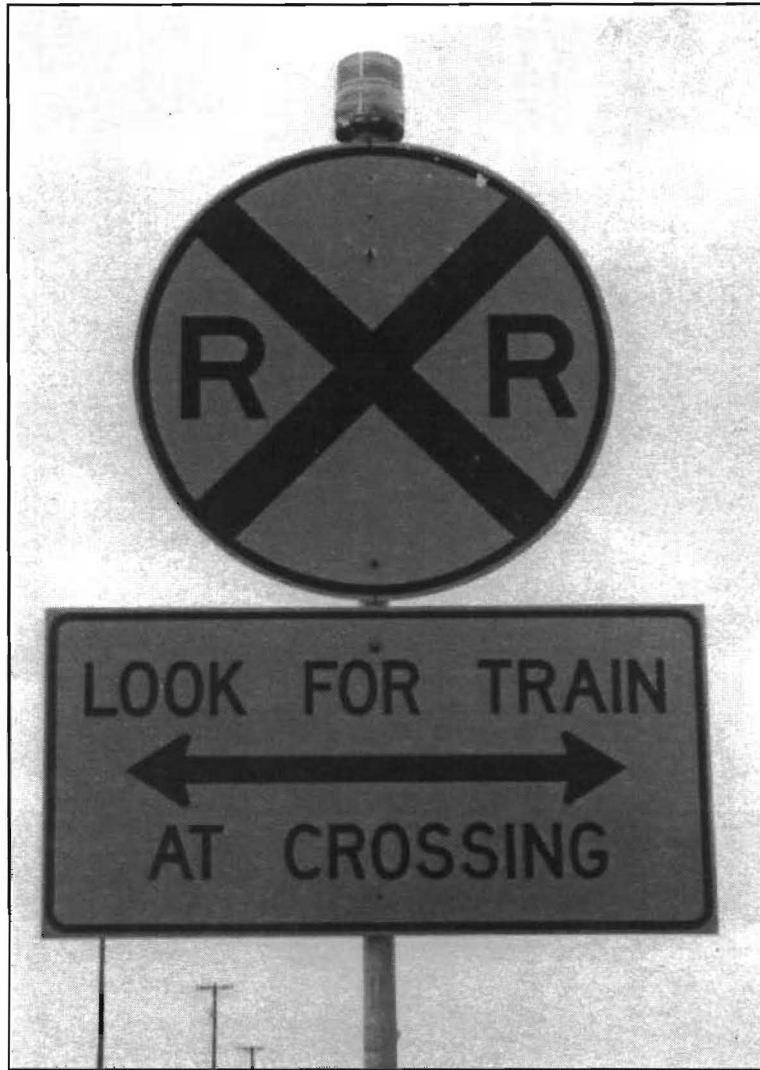
**Figure 2.4. Strobe Light and Supplemental Sign Enhancement**

After the data collection for the *before* speed study was complete, the enhanced sign system was installed. The "LOOK FOR TRAIN AT CROSSING" supplemental sign was installed by TxDOT personnel and placed under the W10-1 sign on both approaches to the grade crossing. This supplemental sign was manufactured specifically for this study by the sign shop at TxDOT's Waco District Office since it was a unique design not previously used on Texas roadways. The research team then installed the vehicle-activated strobe light and associated loop detector equipment on the east approach. The strobe light was operated for a two-week period prior to the commencement of the *after* speed data collection. Allowing the strobe light to operate for a short period of time prior to data collection provided an opportunity for the research team to observe and confirm the operation of the strobe light. This two-week period of time also provided an opportunity for drivers to become familiar with the strobe light, reducing its *novelty* effect. The dynamic nature of the strobe, as compared to static devices, was also believed to reduce the novelty effect. Figure 2.4 illustrates the enhanced sign system.

The strobe light used in this study was a Tri-Light Mars model ST-2 full size strobe measuring 16.5 cm in height by 13.7 cm in diameter. The strobe light flashed at one million candle power and 90 flashes-per-minute. A magnetic mount held the strobe light to the top of the warning sign post. A shield was placed in back of the strobe light limiting the visibility of the flash to 180 degrees in the direction of the approaching traffic. The flashing strobe light was not visible to drivers traveling in the opposing direction.

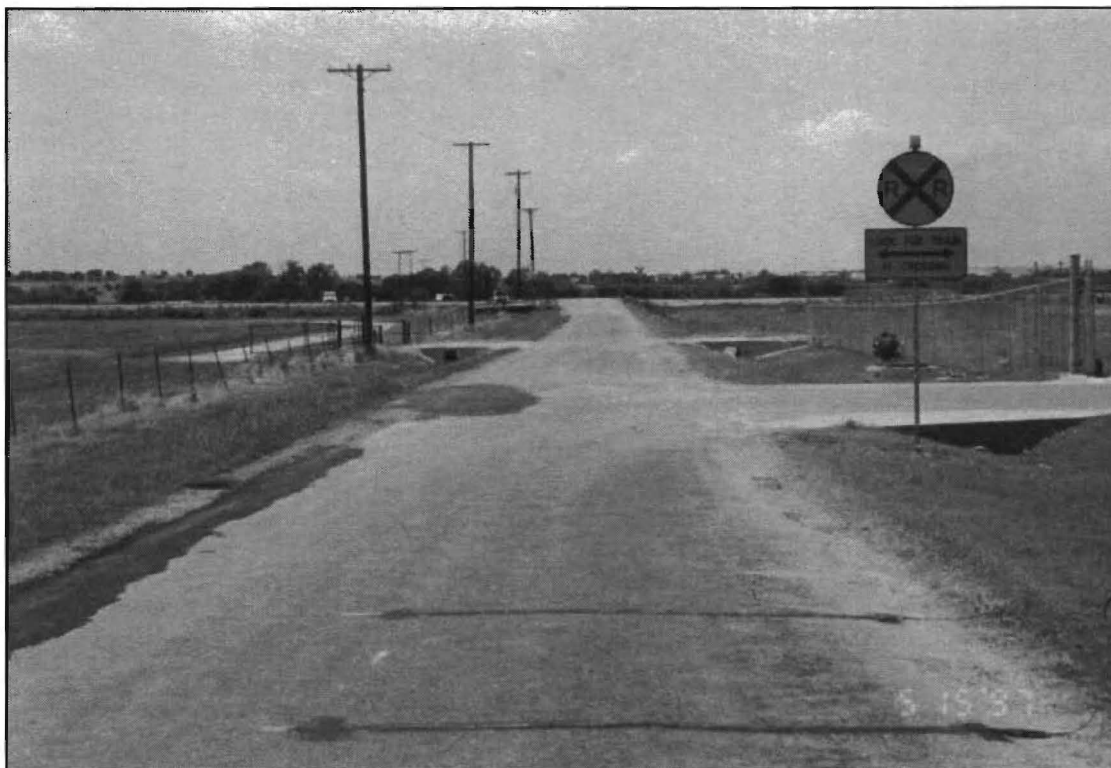
**Figure 2.7. Completed Experimental Set-Up on East Approach**

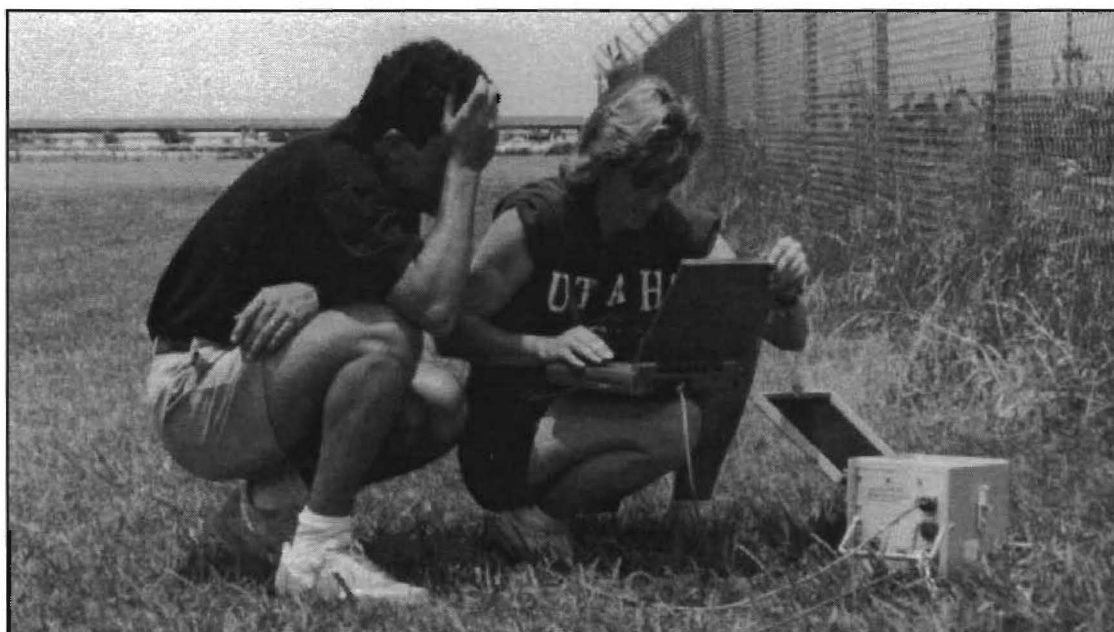
**Figure 2.8. Field Data Collection**

Two weeks passed between the installation of the enhanced sign system and the commencement of the *after* speed study. As mentioned, this time allowed the research team to evaluate the operation of the system as well as provided time for drivers to become familiar with the vehicle-activated strobe light and supplemental sign. The *after* speed study was conducted using the same study methodology as the *before* speed study, including the same data collection equipment placed at the 400-, 200-, 150-, 100-, 50-, and 10-m locations. As with the *before* speed study, data collection was completed first on the east approach and then on the west approach. Every effort was made to assure consistency between data collection periods and procedures. At the conclusion of the *after* speed study, speed data obtained by the traffic classifiers was downloaded to a computer software package for computation and analysis. Figure 2.8 depicts the field component of the data download process.

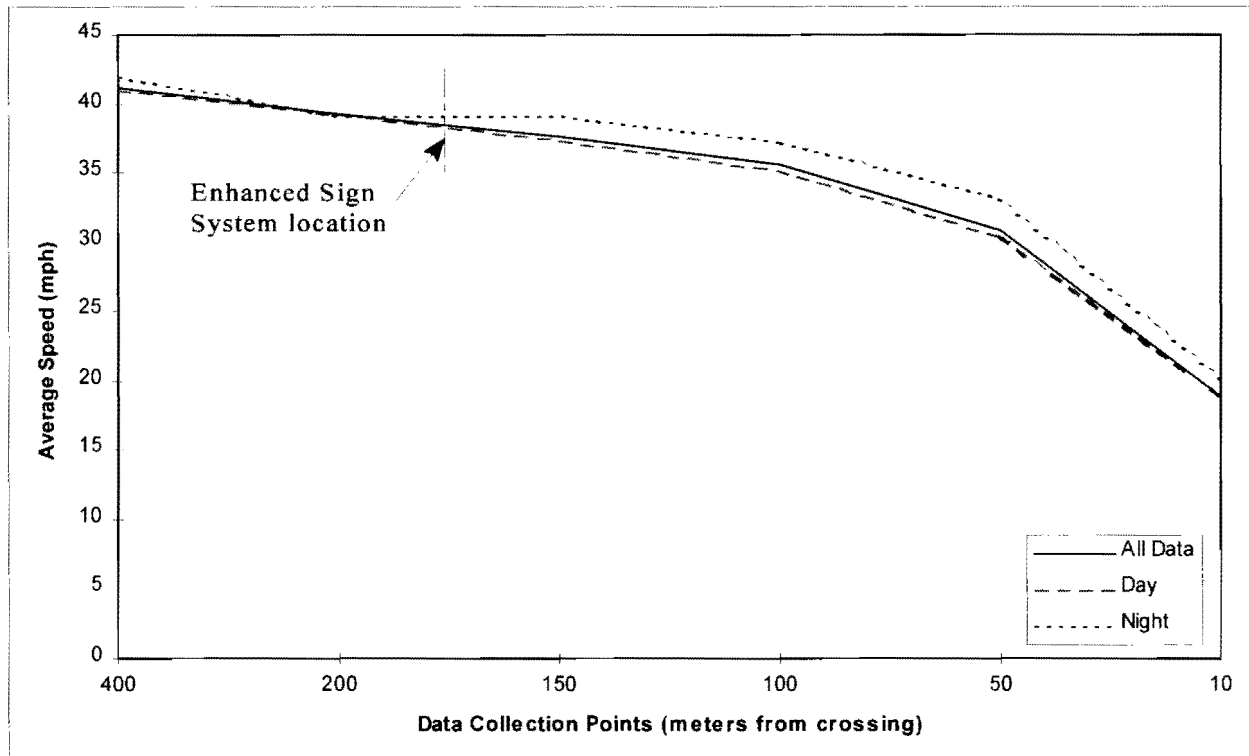
Figure 3.1. Speed Profile for East Approach

Table 3.1 presents a summary of the speed data during all time periods on both the east and west approaches to the highway-railroad grade crossing. Data obtained during night driving conditions, assumed to be 7:00 p.m. to 7:00 a.m., is presented in Table 3.2. Speed profiles for the east and west approach to the grade crossing are shown in Figures 3.1 and 3.2, respectively.

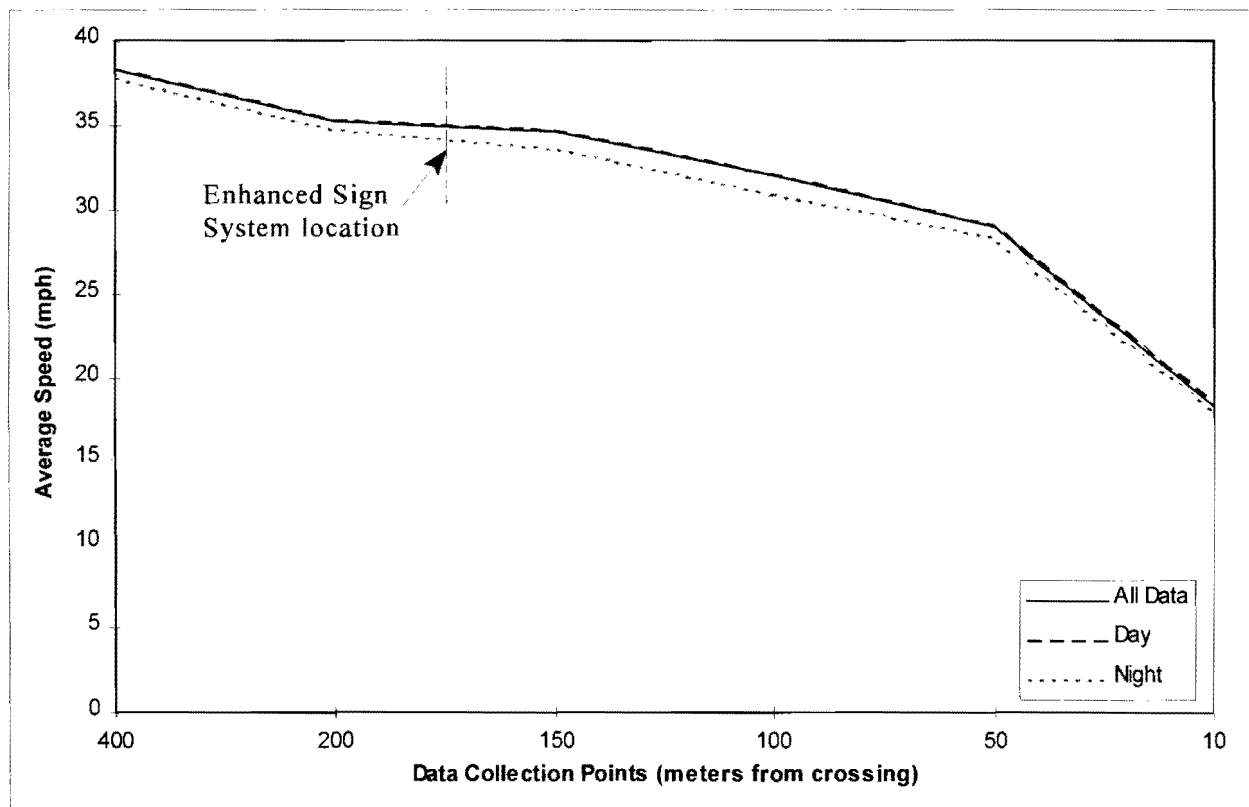
Figure 3.2. Speed Profile for West Approach

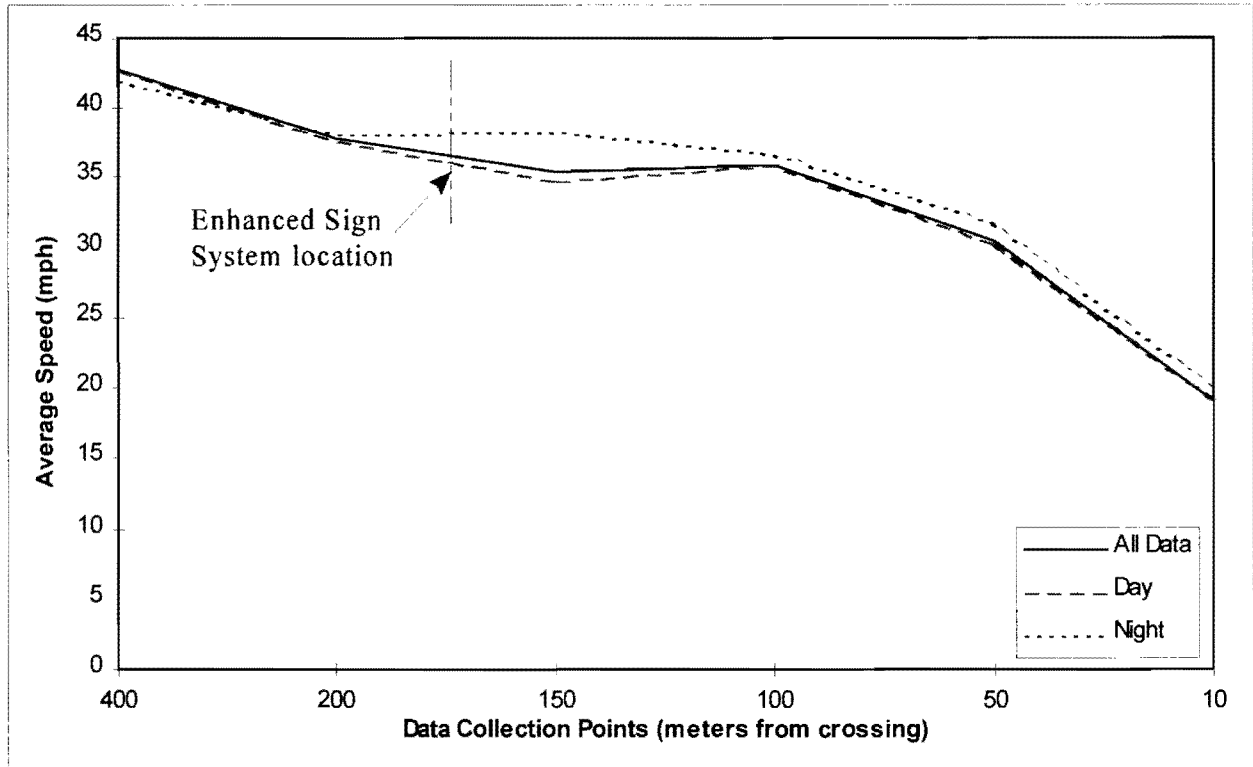
Figure 3.3. Speed Profile for East Approach

The *after* speed study was conducted over a four-week period in April and May of 1997 using the same study methodology as the *before* speed study, including the same data collection equipment and locations. Speed data was transferred from the classifiers to a laptop computer for computation and analysis. Speed data was carefully reviewed to assure no erroneous speeds were included in the database. Table 3.3 presents the speed data obtained during all time periods, and Table 3.4 presents the speed data obtained during night driving conditions, assumed to be 8:00 p.m. to 7:00 a.m. Note that the beginning of night driving conditions was changed from 7:00 p.m. in the *before* study to 8:00 p.m. in the *after* study to account for the change in sunset times over the duration of this study. Speed profiles for the east and west approaches are shown in Figures 3.3 and 3.4.

As in the *before* speed study, night speeds on the east approach were found to be slightly higher than day speeds. Again, this anomaly is attributed to the effects of slow vehicles at the driveway entrances to the USDA facility. Except within 50 m of the crossing, night speeds on the west approach were found to be less than day speeds. The traffic classifiers placed at 10 m and 50 m on the west approach were disturbed by Union Pacific construction activities at the grade crossing and by heavy rains during data collection. The classifier at 10 m was found to *miss* speeds less than 12 mph, and as a result, the average speed recorded by the classifier was higher than the actual average speed at this location. One of the two piezo sensors necessary for speed determination at the 50-m location was shifted slightly during a heavy rain storm. The spacing of the classifier's piezo sensors narrowed resulting in recorded speeds that were higher than actual vehicle speeds.

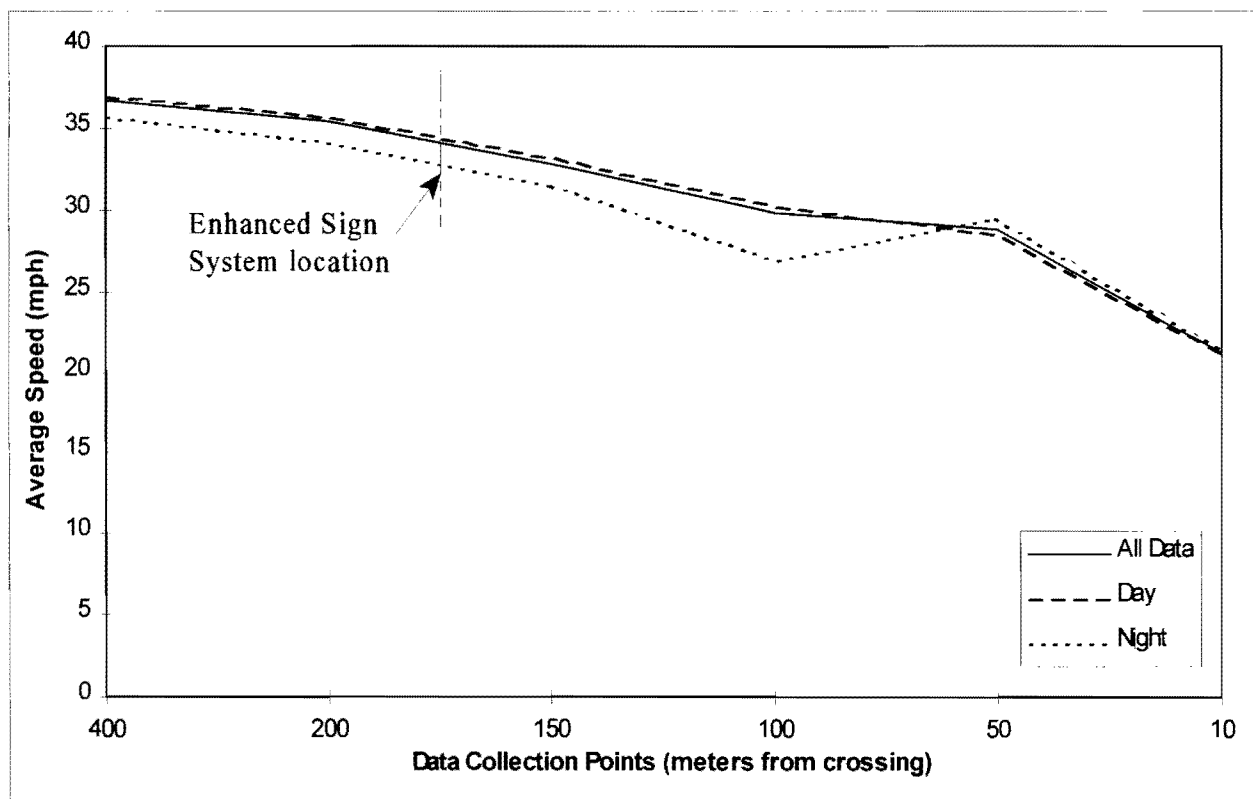
Figure 3.4. Speed Profile for West Approach

through vehicles. These results can be observed in Table 3.2 and Figure 3.4. On the west approach, night speeds were consistently less than day speeds.

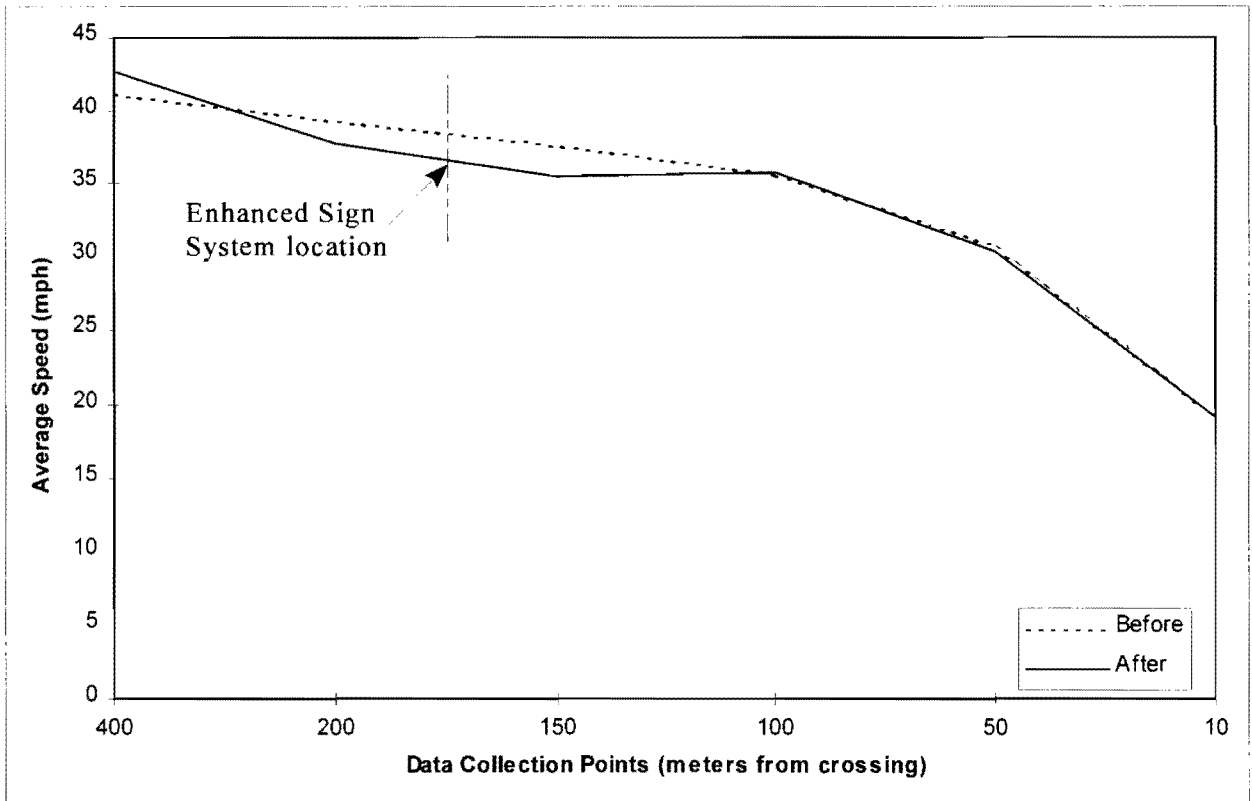
Figure 3.5. Average Speed on East Approach (Day and Night Conditions)

Figures 3.5 and 3.6 present a speed profile comparison of the *before* and *after* average speed results on the east approach to the highway-railroad grade crossing. Figure 3.5 shows the average speeds for all data (day and night), and Figure 3.6 shows the average speeds obtained during night driving conditions. The vertical line at 175 m on both Figures 3.5 and 3.6 represents the location of the enhanced sign system. As shown in Figure 3.5, average speeds after the enhanced sign system was placed in the field were slightly higher at the 400-m control location. Speeds were lower at the 200- and 150-m locations and approximately the same at the 100-, 50- and 10-m locations. Average night speeds were nearly identical at the 400-m control location and slightly lower at all of the other data collection locations.

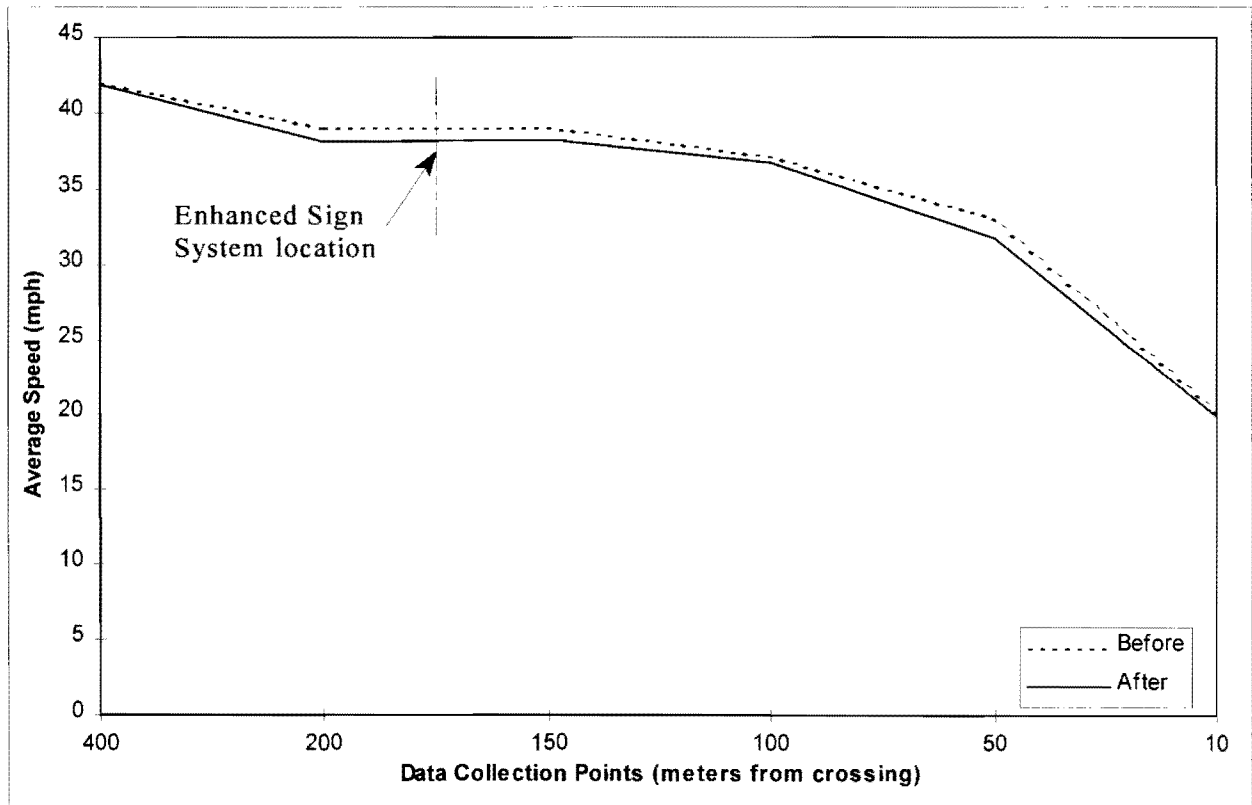
Figure 3.6. Average Speed on East Approach (Night Conditions)

Only the 50-m location on the east approach showed a significant decrease in average night speed. All other locations on the east approach showed decreases in average night speed but not at a statistically significant level. Average night speeds on the west approach showed significant speed decreases at the 400-, 150- and 100-m locations. A decrease in average night speed was also observed at the 200-m location but not at a significant level. The significant increase in night speed at the 10-m location was attributed to the questionable accuracy of the speed data as noted in Section 3.3.

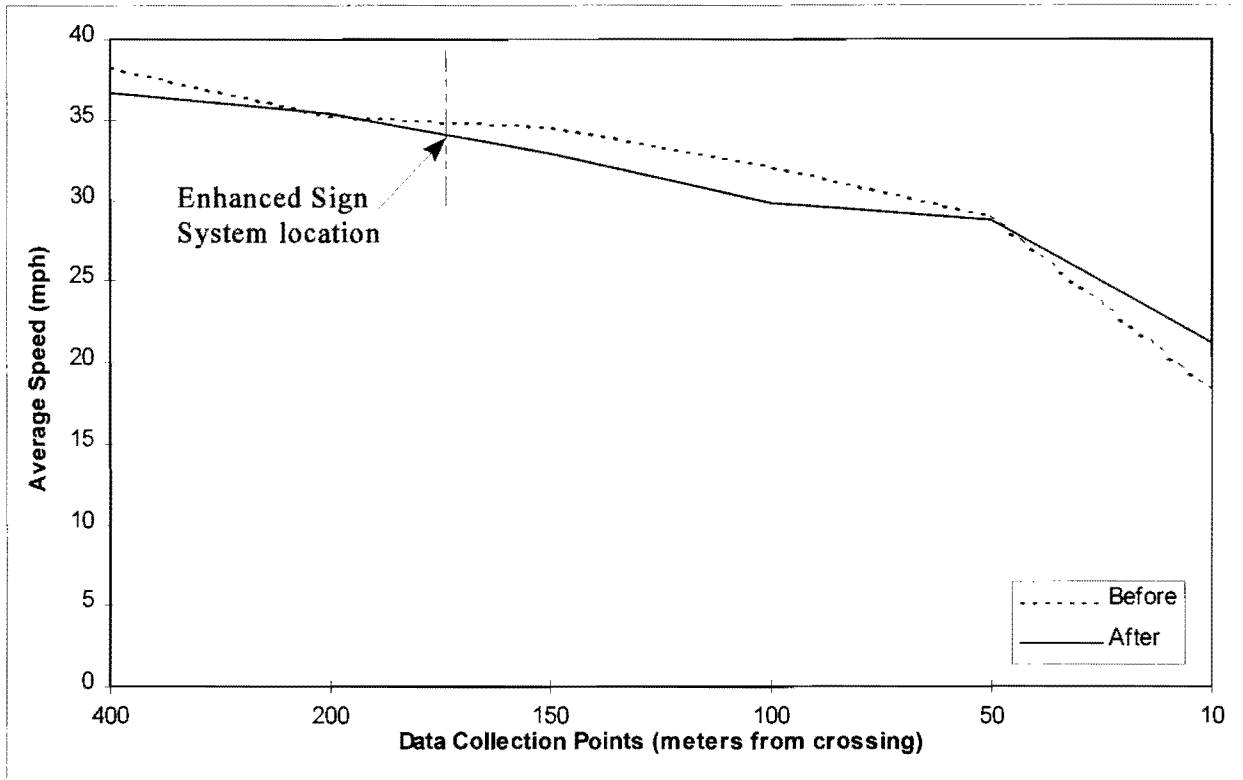
Figure 3.7. Average Speed on West Approach (Day and Night Conditions)

Similar reductions in average speeds were observed on the west approach. Significant reductions in average speed were found at the 400-, 150- and 100-m locations in both day and night driving conditions. These findings include a four mile-per-hour reduction at the 100-m location during night conditions. Although the accuracy of the 10- and 50-m locations are of question, the results obtained at the other data collection locations suggest that speed reductions would have been observed throughout the west approach if the classifiers had operated properly.

Average speeds on the west approach at the 100-m location decreased approximately 7 percent from 32.0 mph in the *before* study to 29.8 mph in the *after* study. Average night speeds decreased approximately 13 percent from 31.0 mph in the *before* study to 27.0 mph in the *after* study. The average speeds on the east approach remained consistent in both the *before* and *after* conditions. The findings on the west approach were consistent with the research hypothesis and suggest that the enhanced sign system was effective in reducing vehicle speeds as drivers entered the nonrecovery zone. This reduction in average speeds also reduces stopping sight distance requirements which may have a positive effect on safety at the grade crossing.

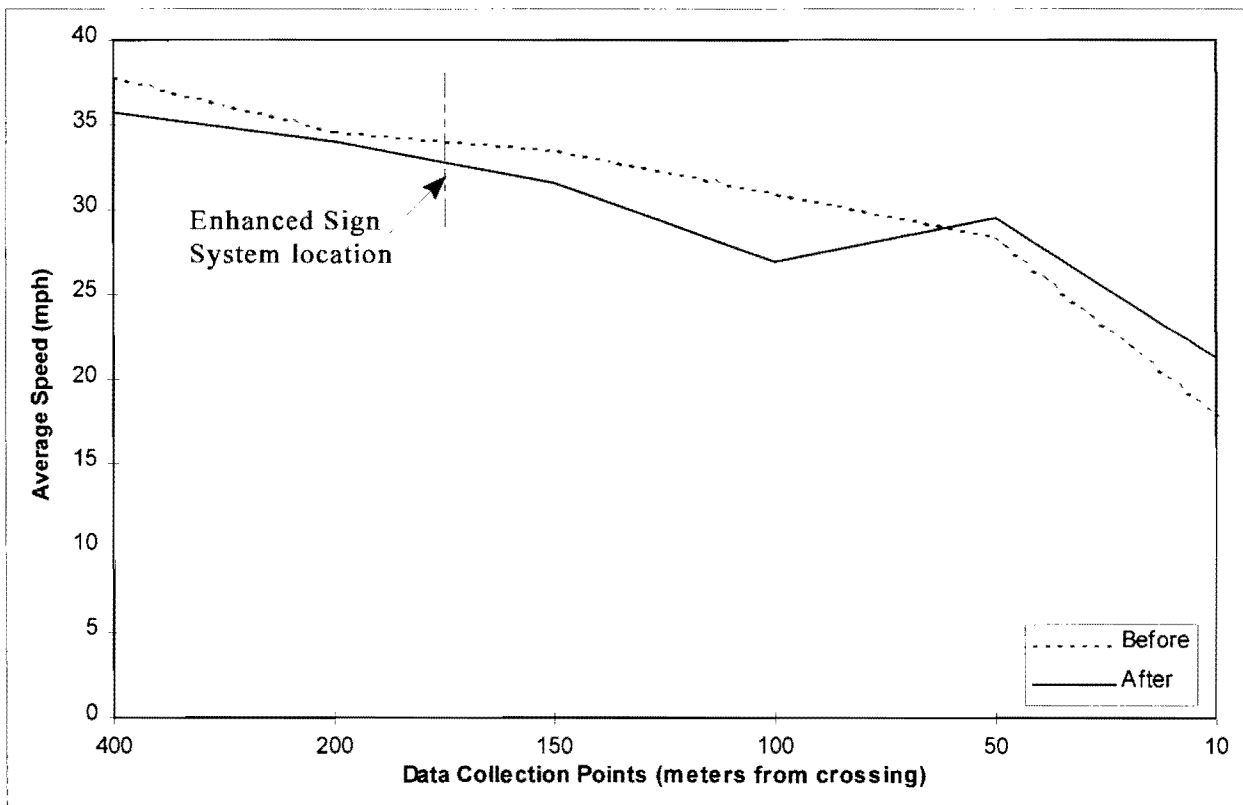
Figure 3.8. Average Speed on West Approach (Night Conditions)

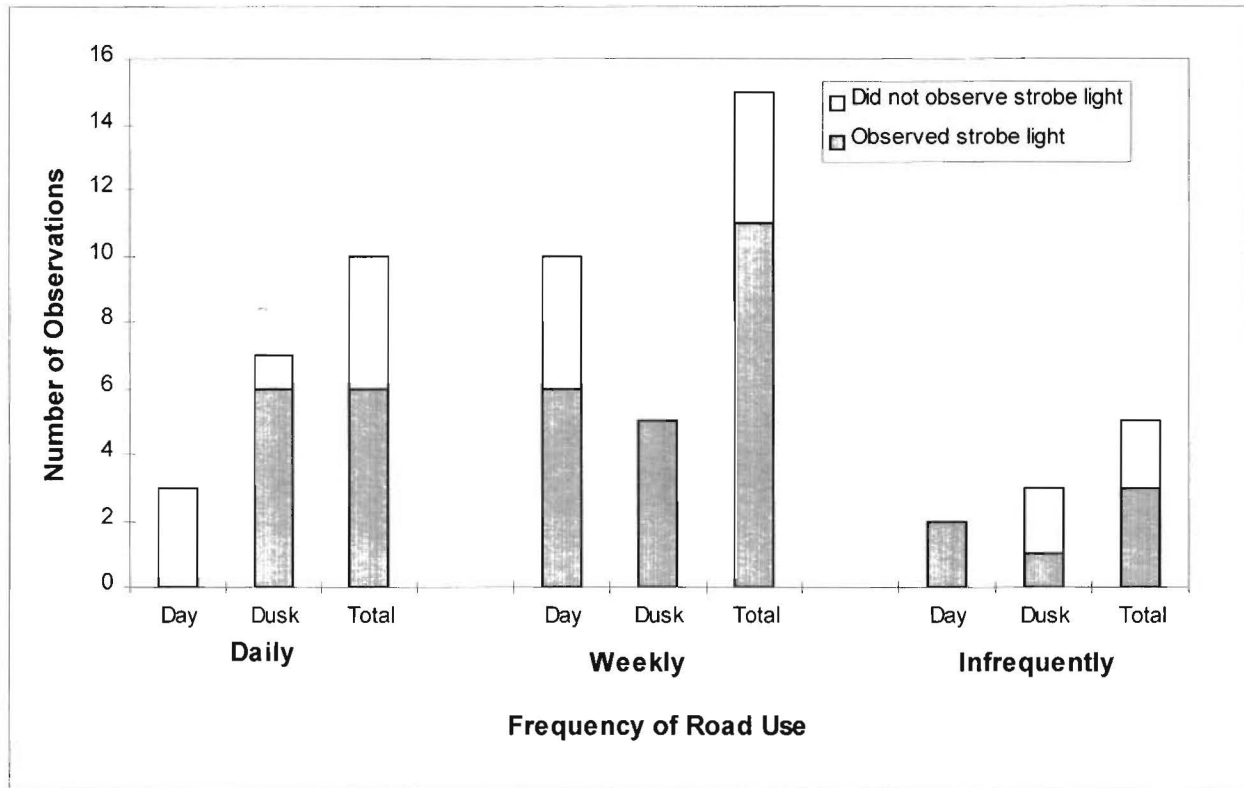
Figure 4.1. Driver Observance of Strobe Light by Frequency of Road Use

Figure 4.1 shows the distribution of those drivers who saw the flashing strobe light before and after 7:45 p.m. with respect to the frequency that they traveled Blackland Road. Before 7:45 p.m., none of the drivers who used Blackland Road on a daily basis recalled seeing the flashing strobe light, although 86 percent (6 of 7) of the daily drivers recalled seeing the strobe after 7:45 p.m. A similar pattern was observed in the drivers who reported using Blackland Road approximately once per week as 60 percent (6 of 10) of the drivers recalled seeing the strobe light before 7:45 p.m., and 100 percent (5 of 5) observed the strobe light after 7:45 p.m. Both of the unfamiliar drivers that traveled Blackland Road prior to 7:45 p.m. recalled seeing the strobe light while only one of the three unfamiliar drivers after 7:45 p.m. recalled seeing the strobe light.

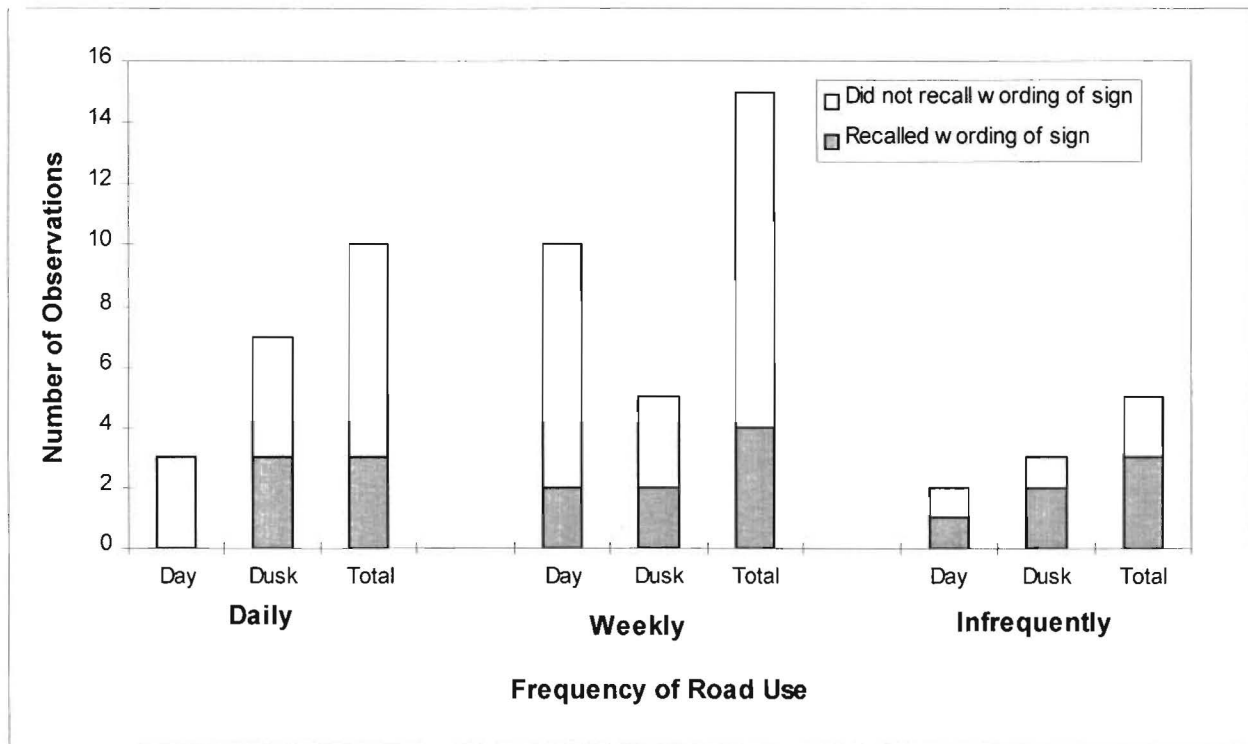
Figure 4.2. Driver Observance of Supplementary Sign by Frequency of Road Use

Figure 4.2 shows the distribution of those drivers who recalled the exact or similar wording of the supplemental sign before and after 7:45 p.m. with respect to the frequency that they used the grade crossing. Before 7:45 p.m., none of the daily drivers recalled the wording of the sign. After 7:45 p.m., 43 percent (3 of 7) of the daily drivers recalled the exact or similar wording of the sign. Of the weekly drivers, 20 percent (2 of 10) recalled the wording of the sign before 7:45 p.m. and 40 percent (2 of 5) recalled the wording of the sign after 7:45 p.m. Only one of the two infrequent or unfamiliar drivers that passed the crossing before 7:45 p.m. recalled the wording of the sign, and two of the three drivers after 7:45 p.m. recalled the wording.

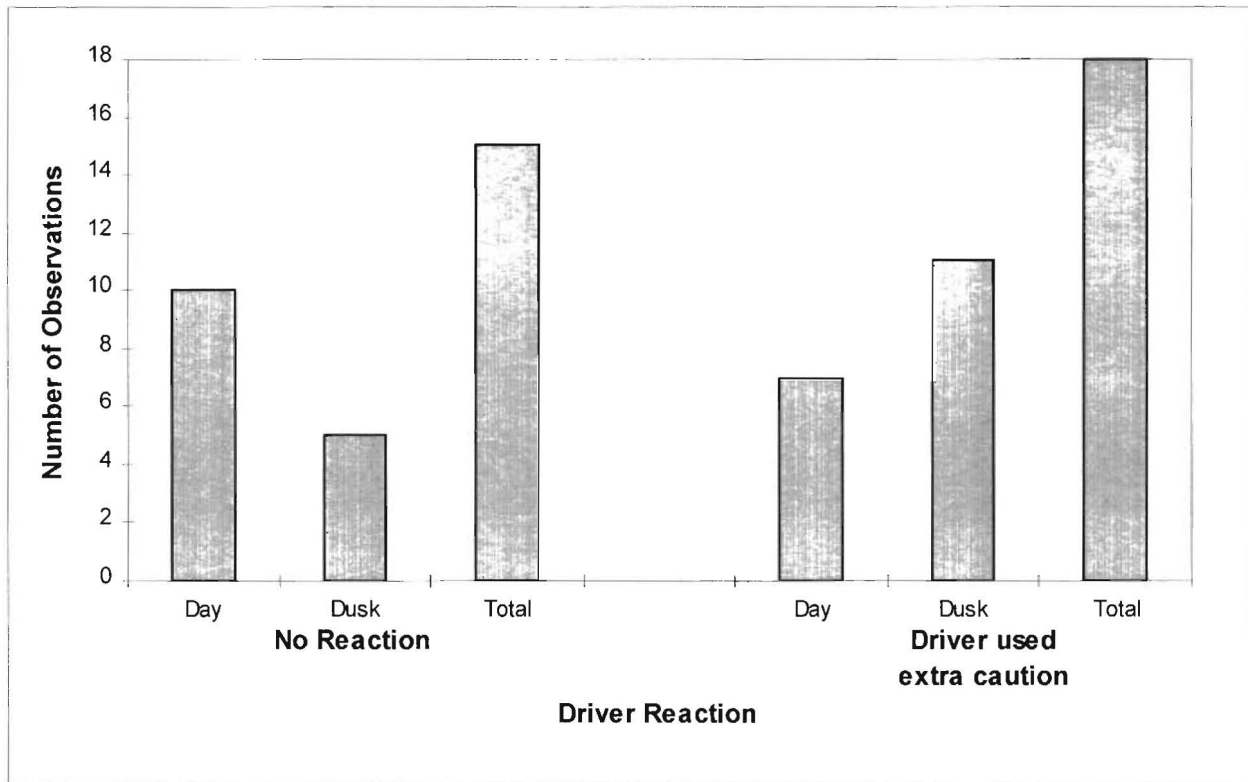
Figure 4.3. Driver Reaction to Strobe Light by Time Period

Figure 4.3 shows driver reactions to the flashing strobe light with respect to the time of survey (i.e., light conditions). Nearly 59 percent (10 of 17) of the drivers showed no reaction in the first half of the study. In the second half, 69 percent (11 of 16) of the drivers indicated that they used additional caution at the crossing. Figure 4.4 summarizes overall response to the enhanced sign system. All combinations of the following are shown, including observed strobe light, did not observe strobe light, recalled the wording of sign, and/or did not recall the wording of sign. Prior

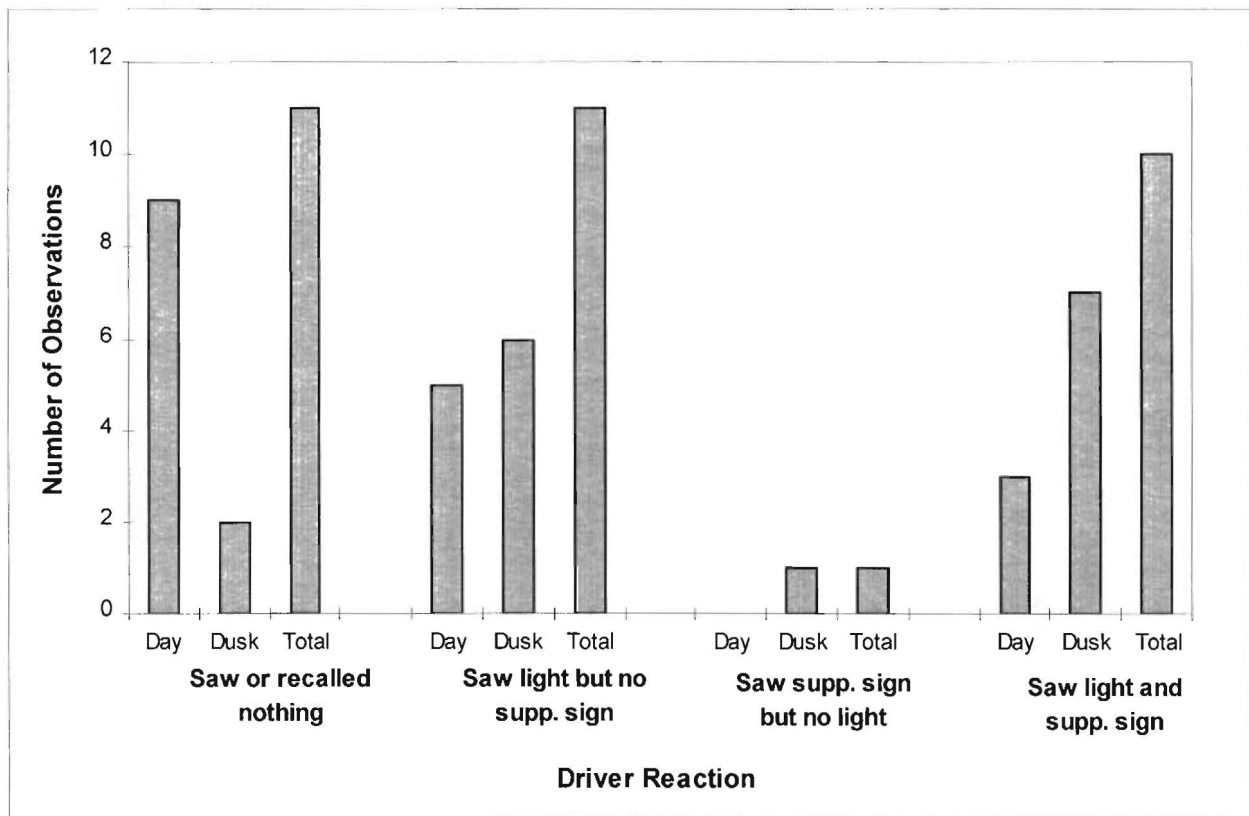
Figure 4.4. Driver Reaction to Strobe and Supplemental Sign

to 7:45 p.m., 82 percent (9 of 11) of the drivers reported seeing neither the flashing strobe light nor the supplemental sign. After 7:45 p.m., 70 percent (7 of 10) of the drivers recalled seeing the flashing strobe light and could recall the wording of the supplemental sign.
