1. Report No. FHWA/TX-98/1472-1F		2. Government Accession No.		3. Recipient's Catalog No.	
4. Title and Subtitle TIGHTENING PROCEDURES FOR LARGE-DIAMETER ANCHOR BOLTS				5. Report Date December 1996 Resubmitted: June 1997

6. Performing Organization Code	
7. Author(s) R. W. James, P. B. Keating, R. W. Bolton, F. C. Benson, D. E. Bray, R. C. Abraham, and J. B. Hodge				8. Performing Organization Report No. Research Report 1472-1F

TIGHTENING PROCEDURES FOR LARGE-DIAMETER ANCHOR BOLTS

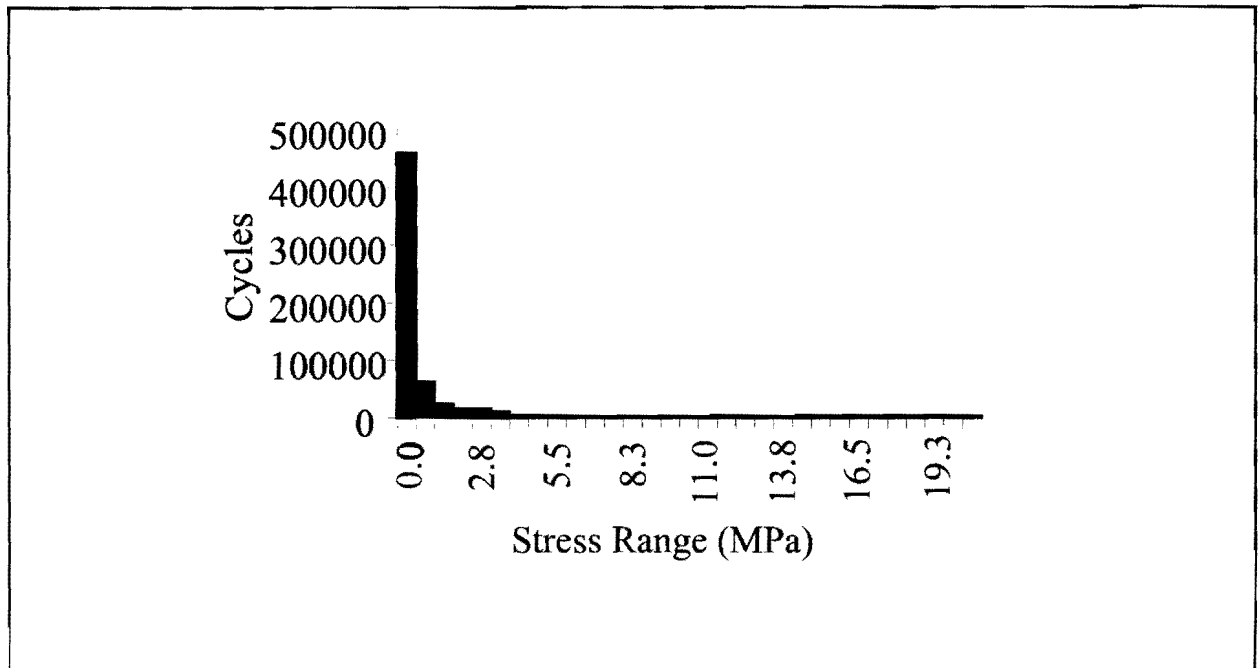
FIGURE 4 Stress range histogram for north bolt.

seen in Figure 4 through Figure 6.

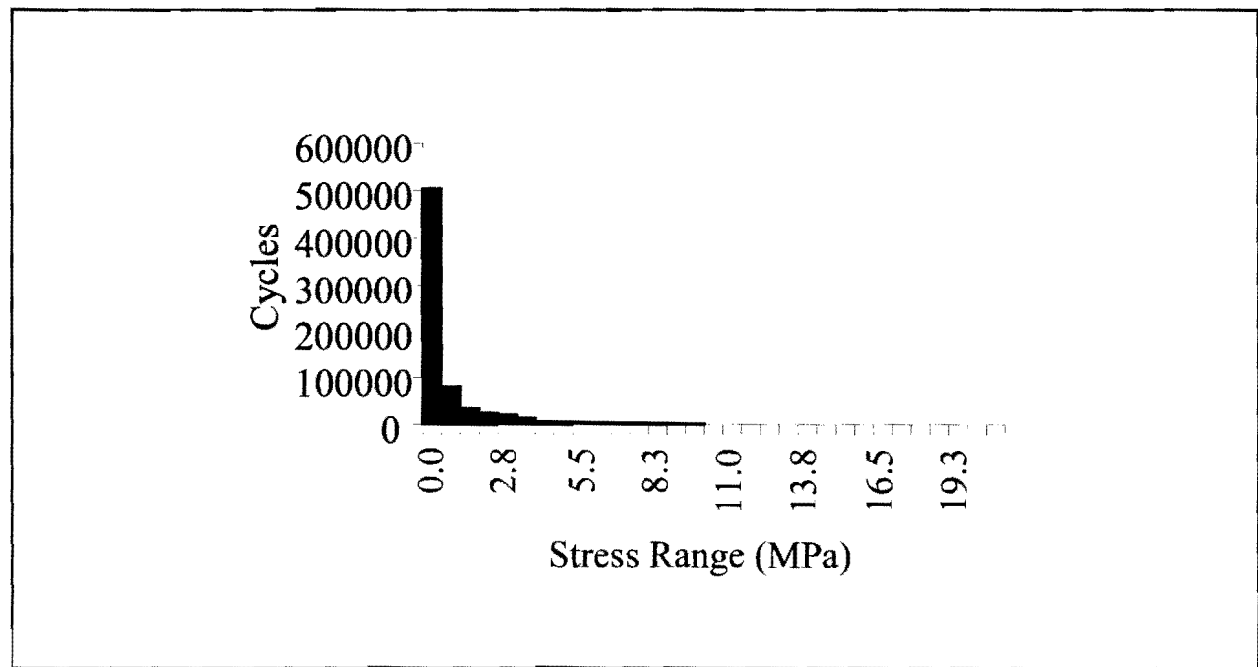
FIGURE 5 Stress range histogram for south bolt.

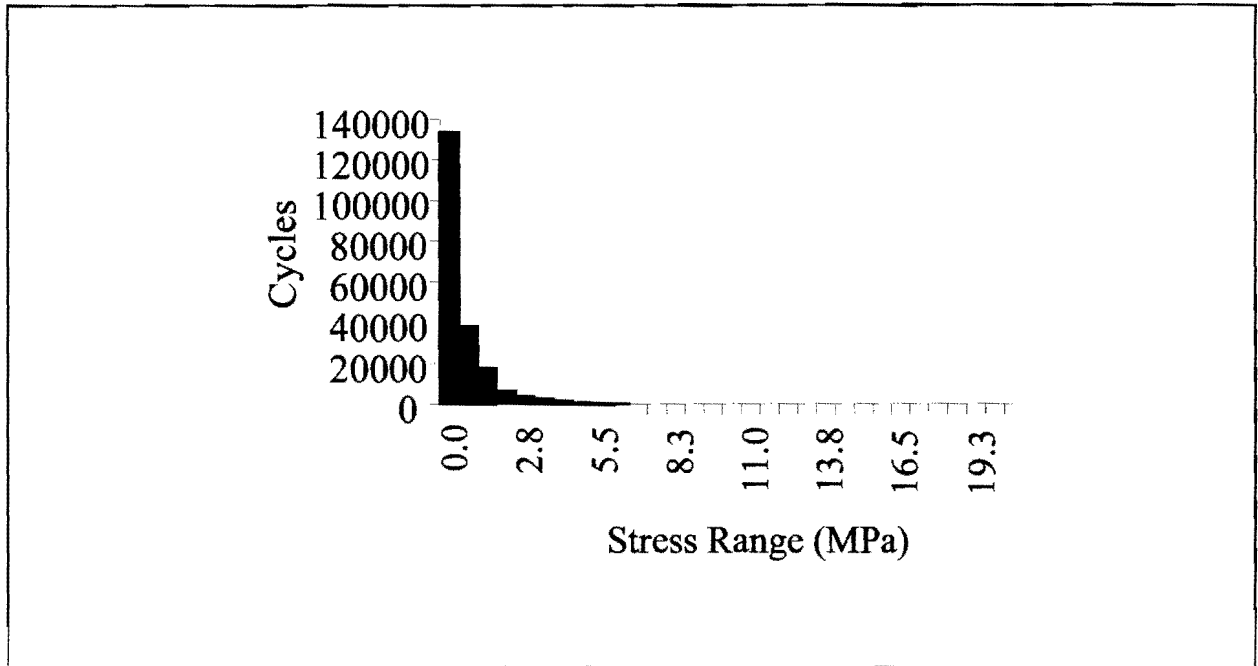
FIGURE 6 Stress range histogram for west bolt.

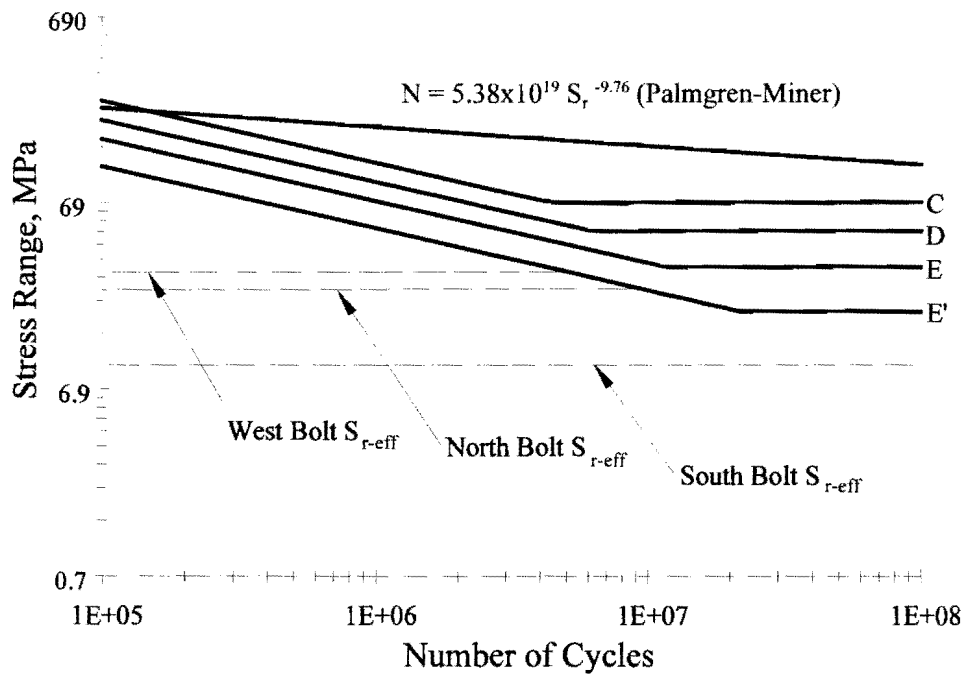
The horizontal straight line portion of the AASHTO detail category S-N curves represents the endurance limit, defined as the stress at which failure will not occur even for an infinite number of cycles. Essentially, the anchor bolts show infinite life. Theoretically, however, the bolts do not have infinite life, even though the effective stress ranges fall below the endurance limit of detail Category E'. For a detail to have infinite life, the maximum stress seen in a variable amplitude loading history must also fall below the endurance limit. The stress range histograms of HMIP anchor bolts studied indicates maximum stresses greater than the 31 MPa (4.5 ksi) endurance limit of the Category E detail. An estimate of the fatigue life can be determined based on Category E', because the critical effective stress range of 29 MPa (4.2 ksi) seen in the west bolt is greater than the endurance limit of 18 MPa (2.6 ksi) from the Category E' curve. Using this critical effective stress range, an expected fatigue life of 5.1 million cycles is obtained for the Category E' detail.

FIGURE 7 Effective stress ranges on AASHTO Categories.

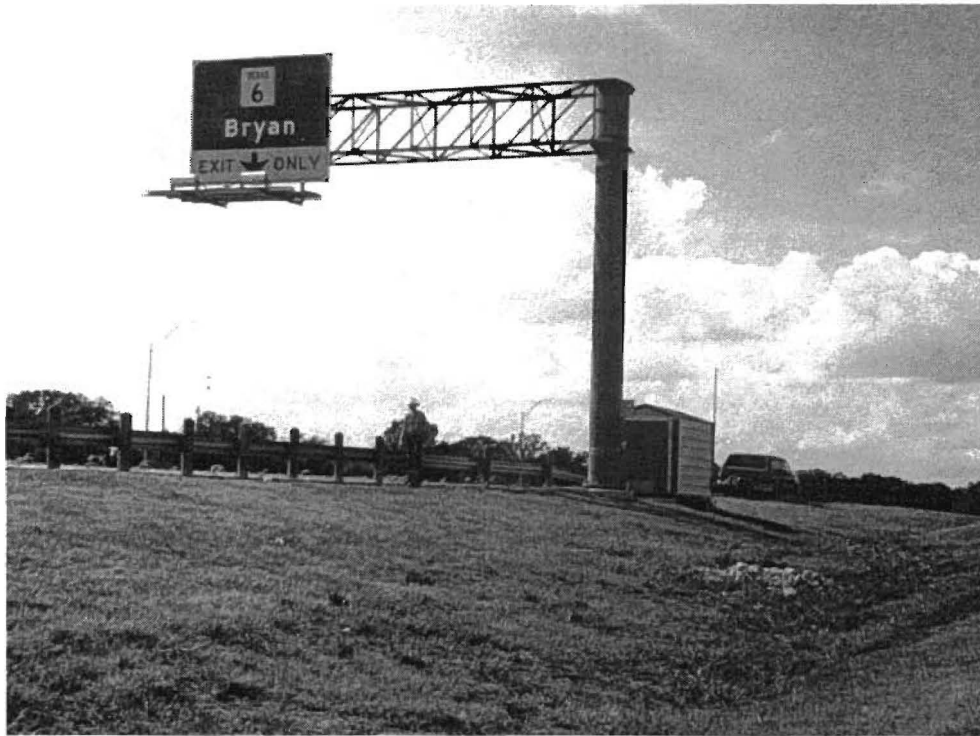
FIGURE 8 Photograph of COSS field study structure near Hempstead, Texas.

The COSS tower is nominally 8.2 m (27 ft) tall with a 10.7 m (35 ft) cantilevered span supporting a single 3.8 m (12.5 ft) wide by 3 m (10 ft) tall highway sign at the end of the span. The cantilevered span is a standard TxDOT 1.4 m (4.5 ft) by 1.4 m (4.5 ft) truss structure. The structure tower is a single 762 mm (30 in.) OD circular pole with a wall thickness of 10.3 mm (0.406 in.). A 1040 mm (41 in.) by 51 mm (2.00 in.) thick circular baseplate supports the tower (see Appendix A). The tower is attached to the foundation by eight symmetrically spaced 57 mm (2.25 in.) double-nutted anchor bolts as seen in Figure 9. The anchor bolt threads are 8 UN, and the anchor bolt nuts and washers were not tack welded in place.

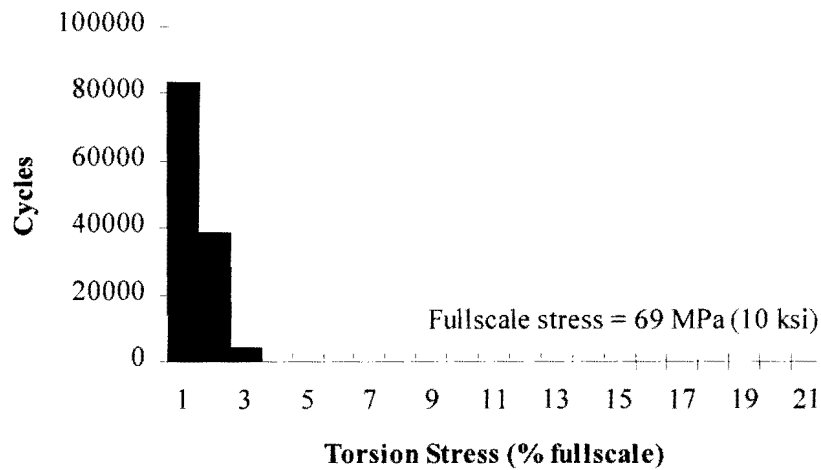
FIGURE 18 Stress histogram of axial stress in COSS field specimen near Hempstead, Texas.

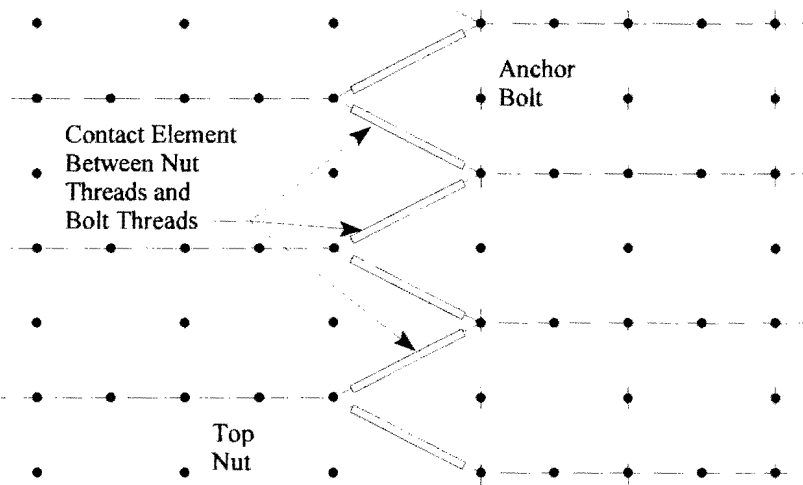
The model boundary conditions have vertical element distributed loads imposed upward on the centerline of the plate, as shown in Figure 27. Boundary conditions of this model also include the contact surfaces shown in Figure 26. The elements in the plate are not connected directly to the elements in the bottom nut because the nuts are snug tight and the plate and nuts do not act as a continuous unit; therefore, contact elements are used here. Contact elements are not used at the bottom of the bottom nut because loading is always in the vertical direction. Contact elements also exist in between the bolt and nut threads. The base of the model is fixed in the horizontal and vertical directions. The edges of the nuts are fixed against lateral translation. These boundary conditions are used in conjunction with the truss elements attached to the nuts to prevent rigid body motion of the four nut sections. The contact element modeling between the threads can be seen in Figure 27.

FIGURE 27 Nodal connectivity at the threads.

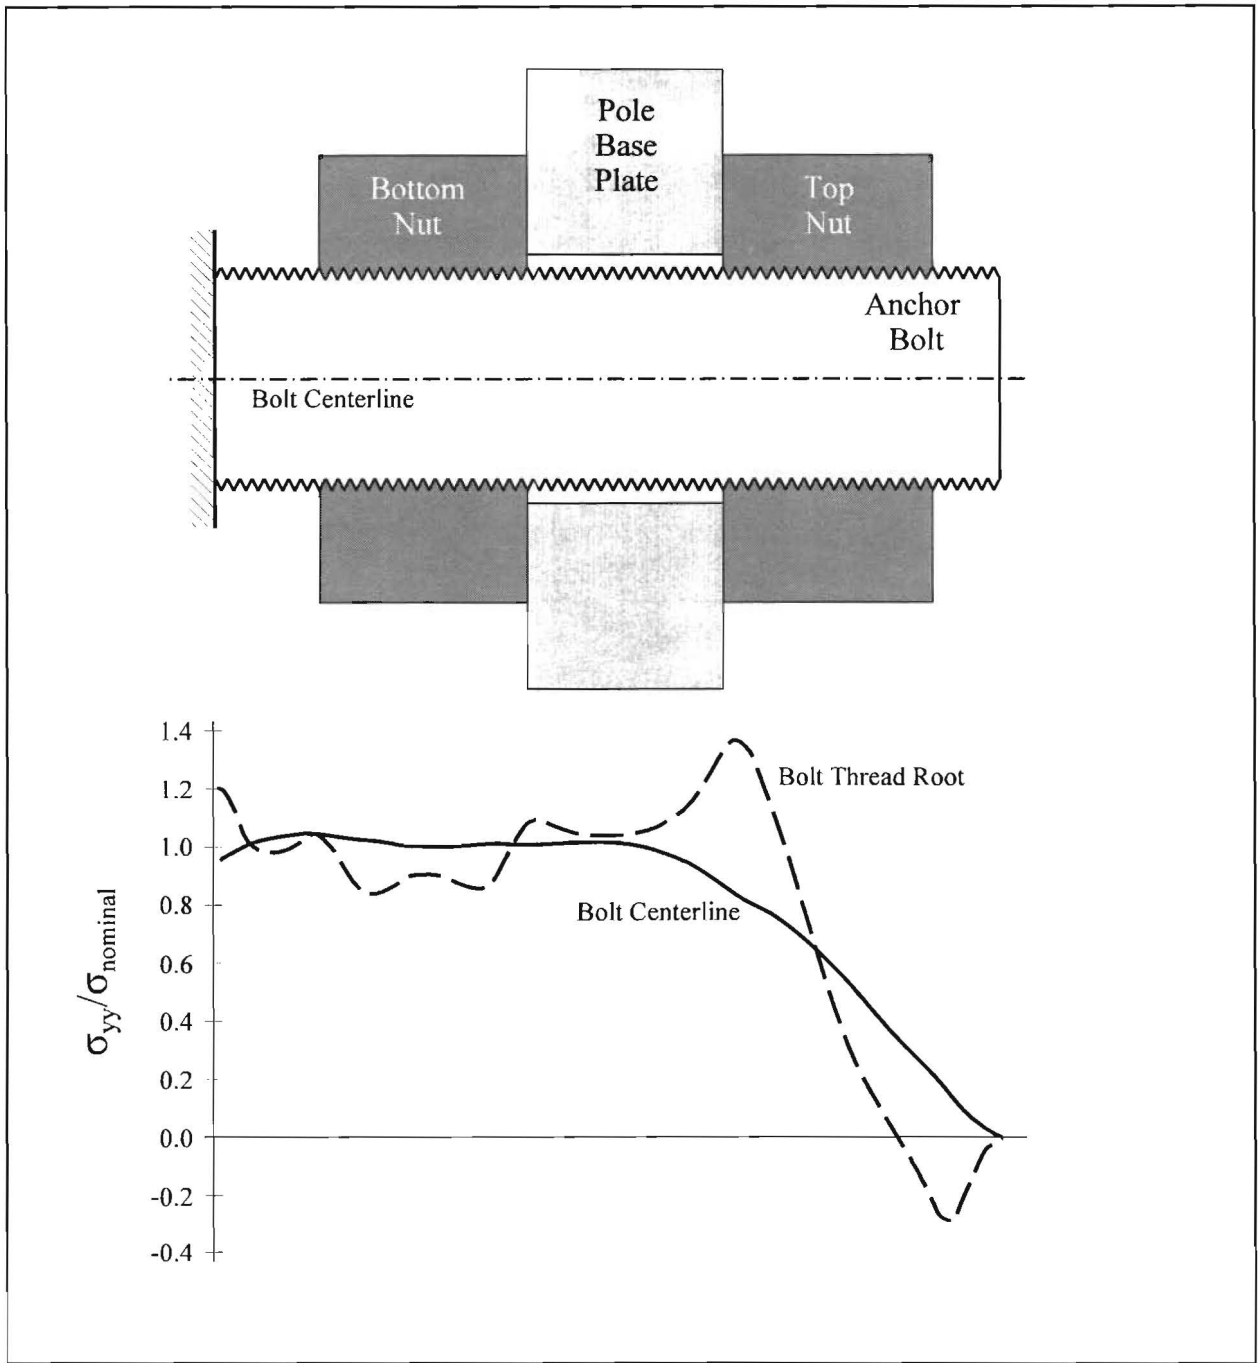
FIGURE 30 Variation of normalized axial stress with position in snug tight bolt.

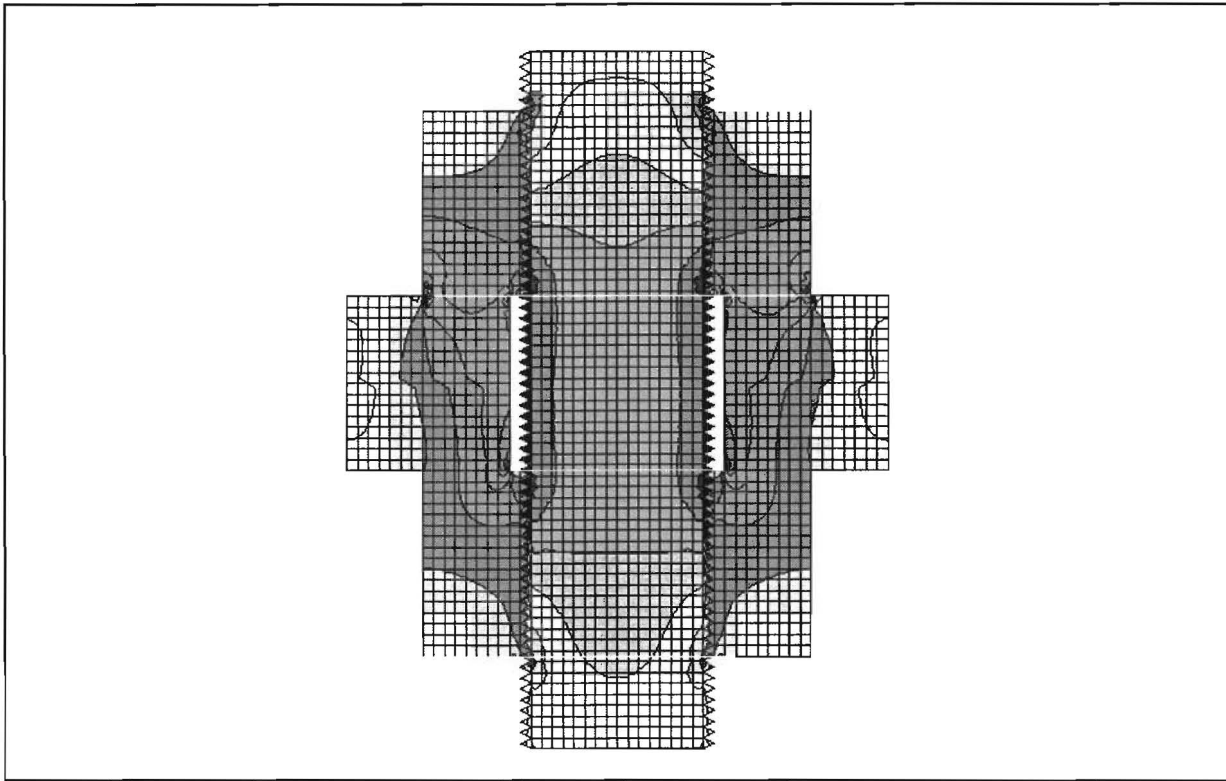
FIGURE 33 σ_{yy} stresses in preloaded bolt with externally applied load.

A stress concentration can now be seen in Location 2. The variation of axial stress, σ_{yy} , normalized with respect to the average or nominal axial stress, $\sigma_{nominal}$, with position along the length of the bolt can be seen in Figure 34 for the anchor bolt connection with a 480 MPa (70 ksi) preload. Again, the solid line represents the axial stress at the centerline of the bolt, and the dashed line represents the axial stress at the bolt thread root.

The finite element mesh of a preloaded double nut anchor bolt is also represented in Figure 26. The preloaded finite element model assumes a preload level equal to 70% of the maximum yield stress of the material. Again, the contact elements in between the threads are used, as seen in Figure 27. These contact elements allow the preload to draw the nuts together and relieve the stresses in the threads in the presence of a vertical load applied to the plate. The preload is imposed by subjecting the elements making up the bolt to an initial state of stress. This is accomplished by giving the specified elements initial stress boundary conditions. This preload stress in the bolt varies from a maximum of 480 MPa (70 ksi) in the middle of plate to zero at the top of the top nut and the bottom of the bottom nut. Figure 32 shows the axial stresses induced by the preload. Using these new boundary conditions, a vertical load is applied to the plate. Figure 33 shows the axial stresses due to this loading.

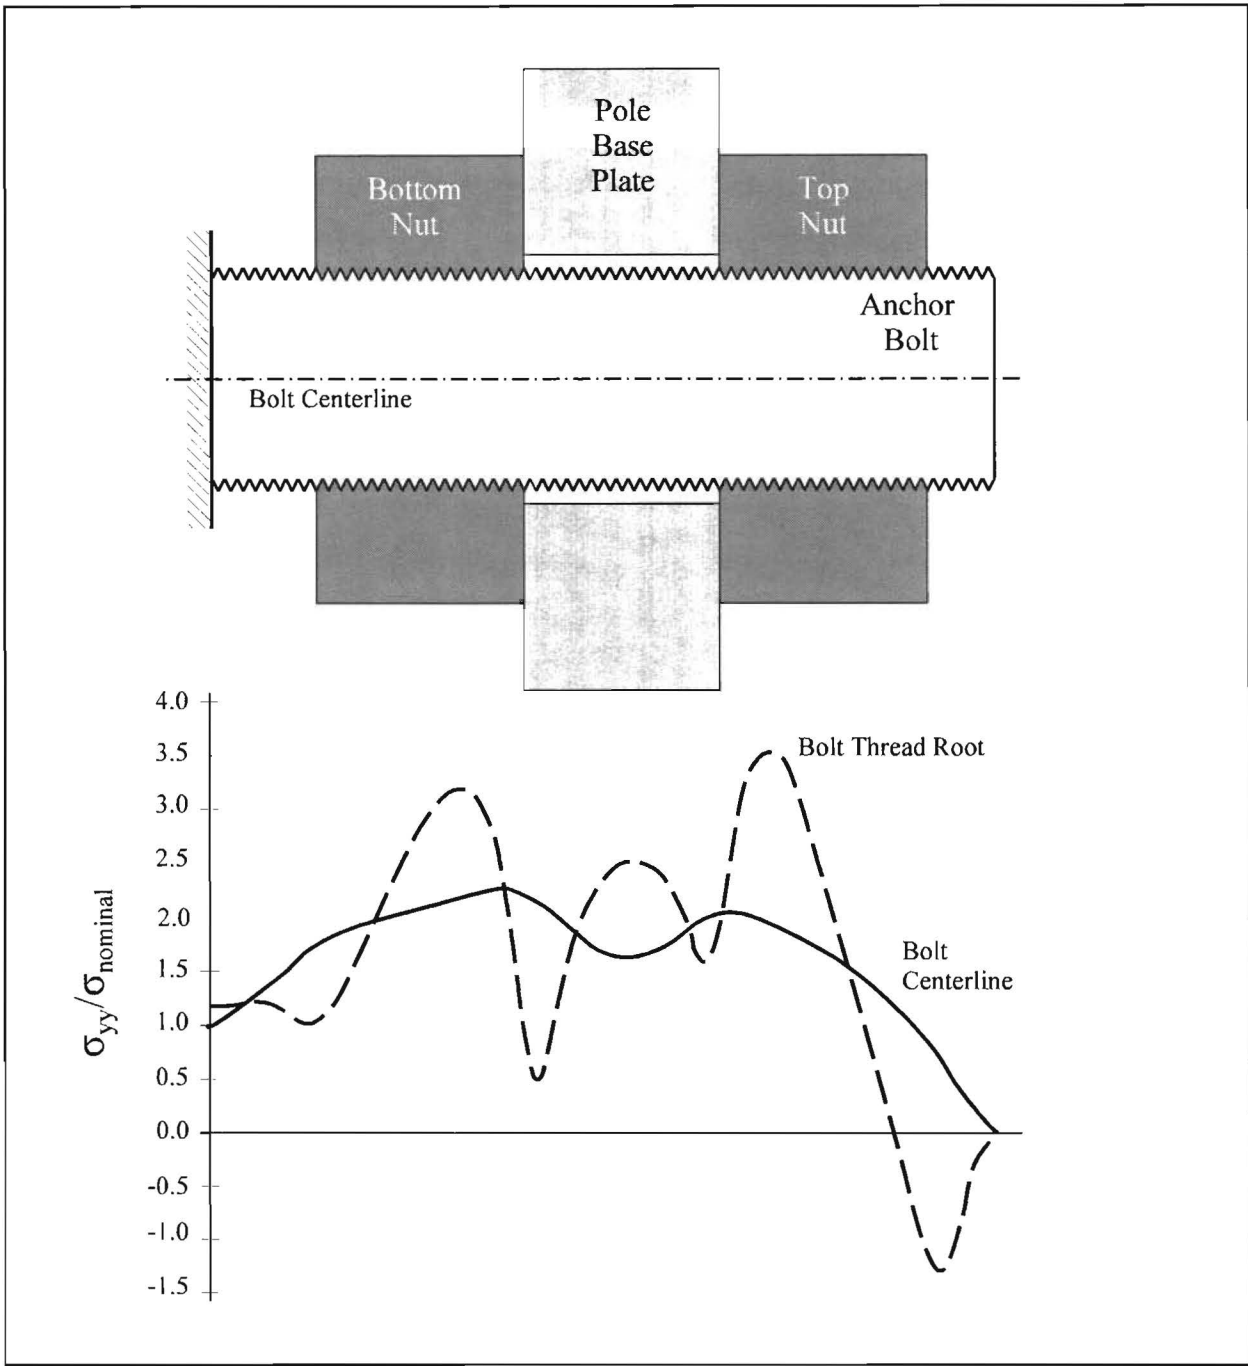
Figure 41 shows the variation of axial stress, σ_{yy} , normalized with respect to the average or nominal axial stress, $\sigma_{nominal}$, with position along the length of the bolt for a 480 MPa (70 ksi) preload. Figure 42 shows the stress range, S_r , at the bolt thread root normalized with respect to the nominal stress, $\sigma_{nominal}$, for the same 480 MPa (70 ksi) preload.

FIGURE 41 Variation of axial stress with position for misaligned preloaded bolt.

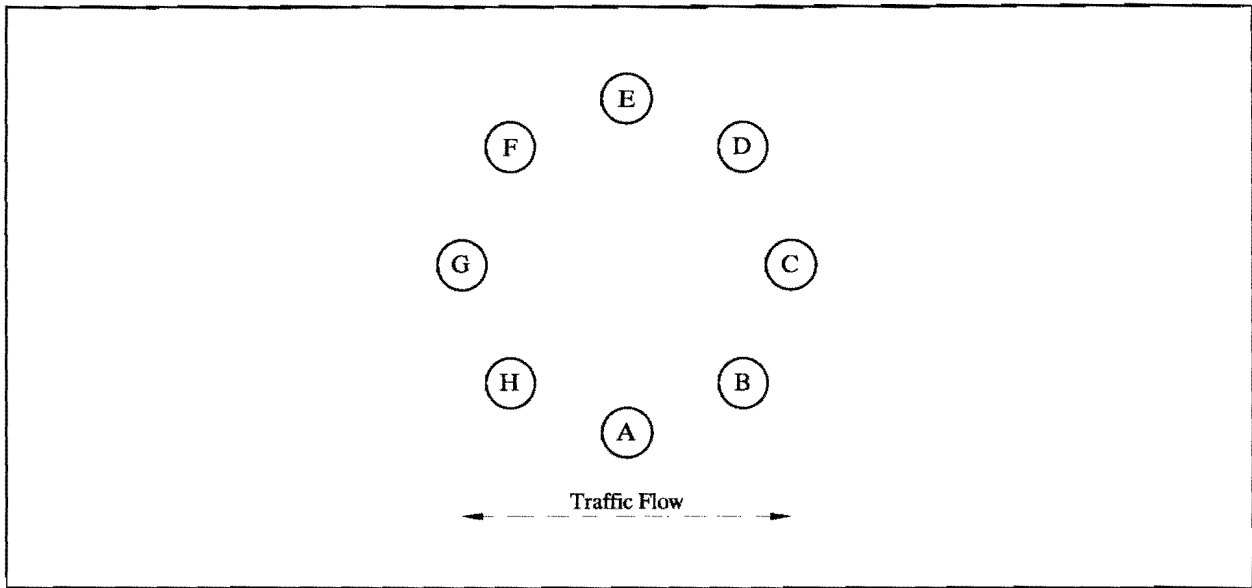
For each specimen, selected anchor bolts were instrumented with strain gages in different sections of the bolt. For the first test of the first specimen, the bolts were arranged and labeled as shown in Figure 46. Longitudinal keyways were milled on opposite sides of the bolt for the placement of strain gages, allowing the leads to pass beneath the nuts. Figure 47 shows the location, size, and orientation of the keyways on the bolts.

FIGURE 46 Anchor bolt pattern and nomenclature (8-bolt pattern).

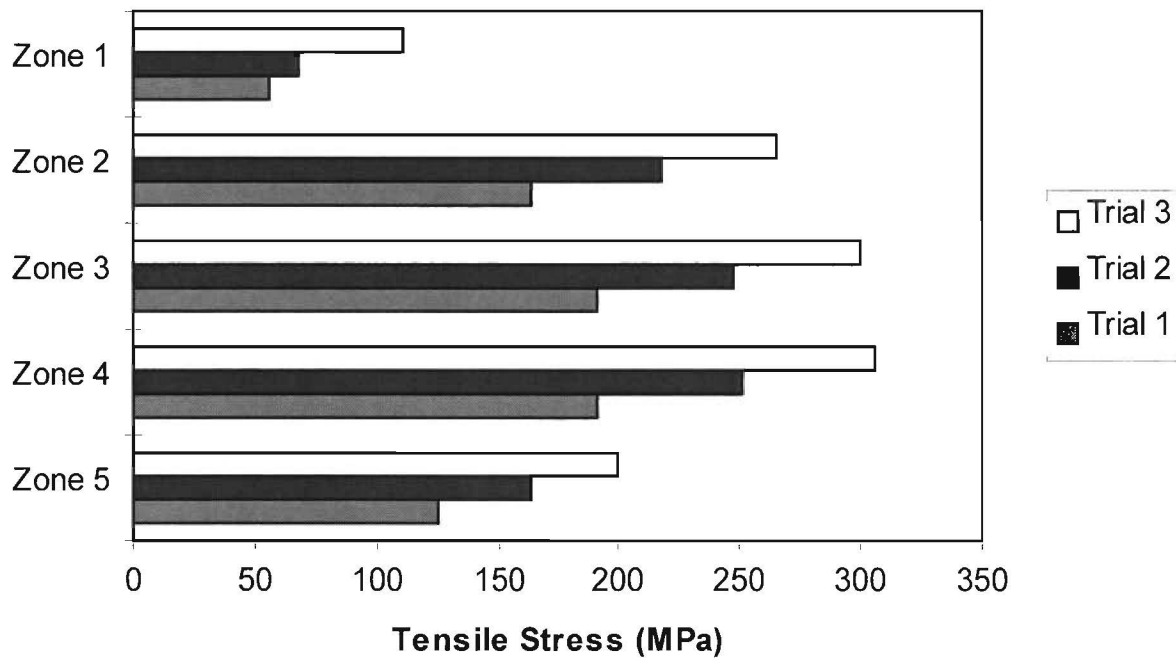
Figure 61 Measured preload stress in consecutive trials to 60 degrees past snug tight, 8 UN bolts.

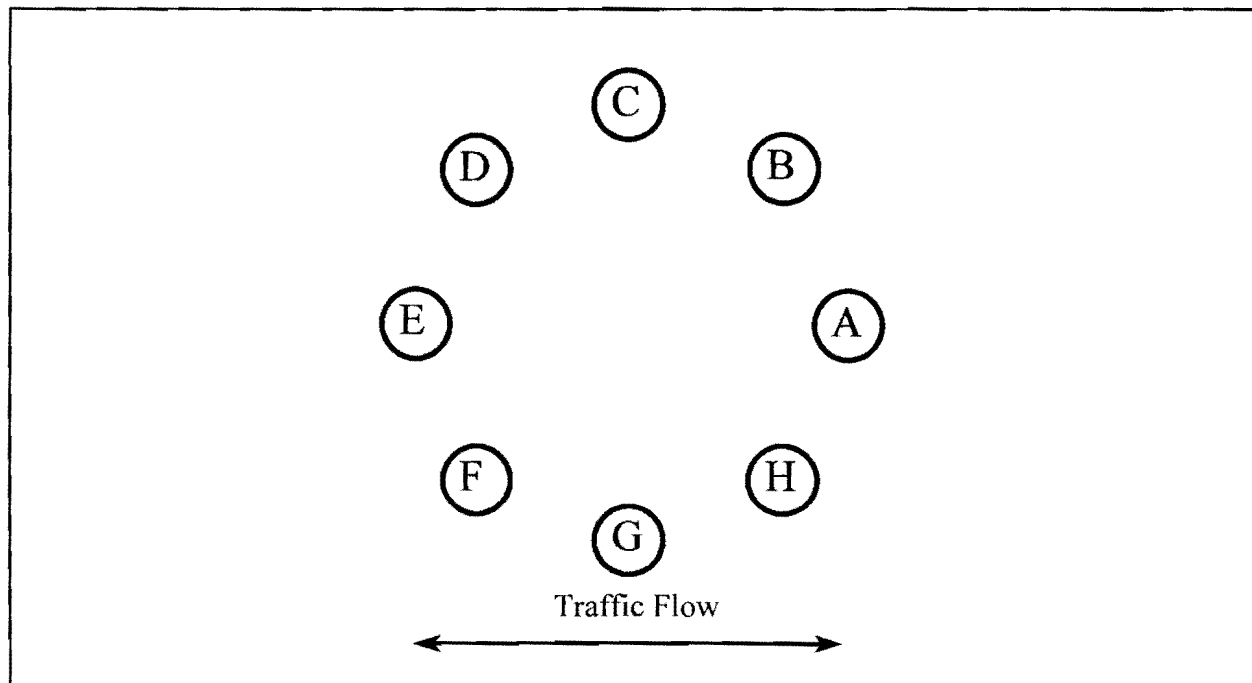
Figure 72 Orientation of 8 UN anchor bolts in first fatigue test.

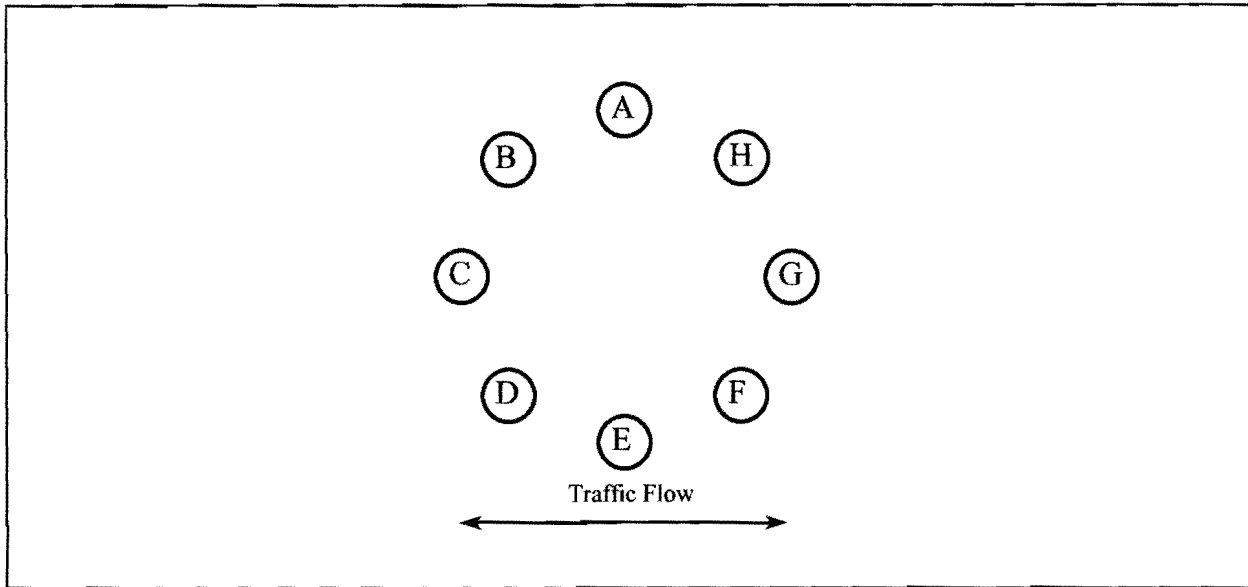
Figure 73 Orientation of specimen in second fatigue test of 8 UN threaded bolts.

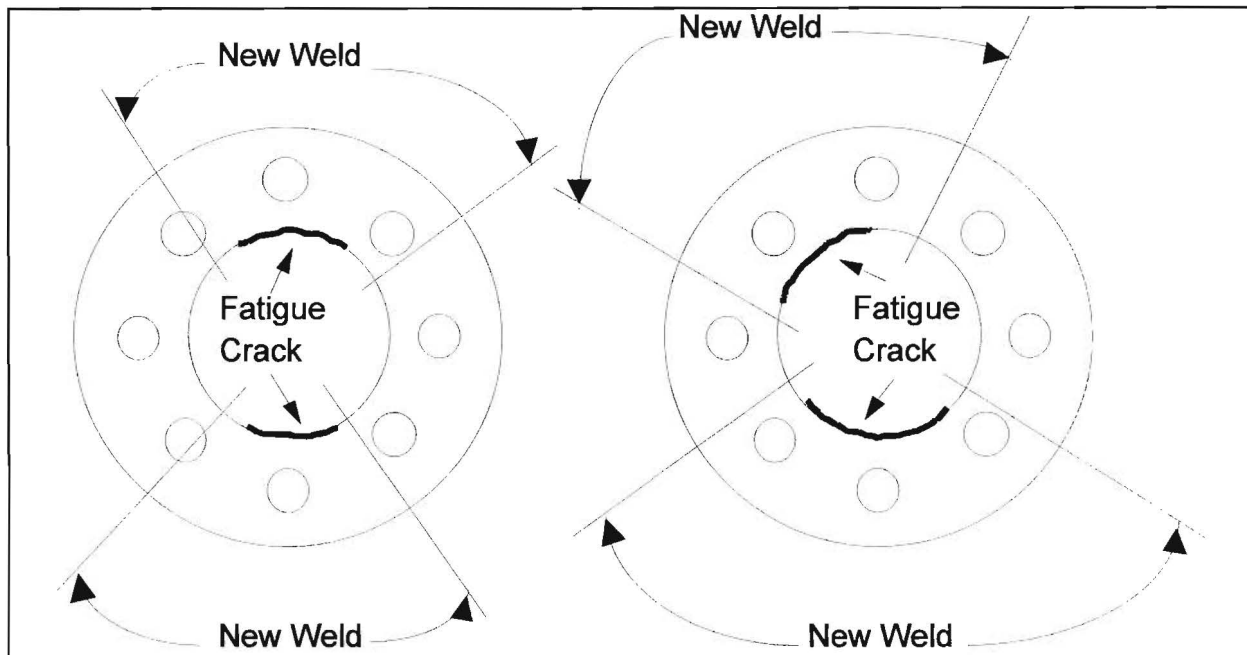
Figure 76 Crack and repair locations on pole-baseplate weld.

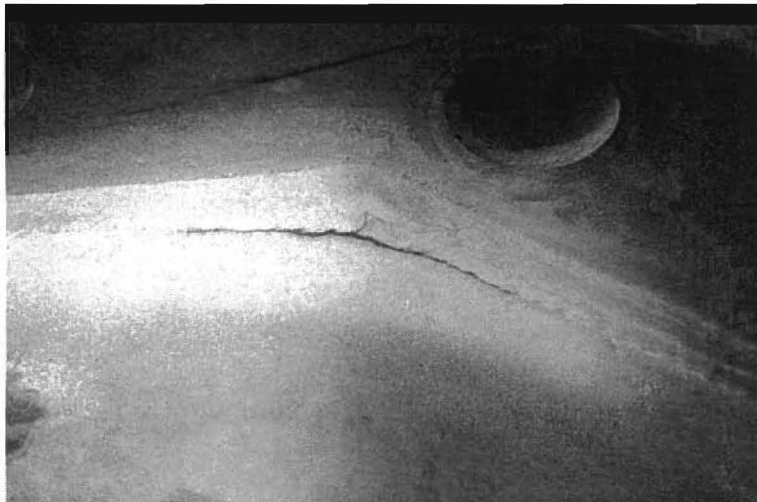
FIGURE 85 Photograph of fatigue crack adjacent to bolt L in HMIP 4 1/2 UNC laboratory specimen.

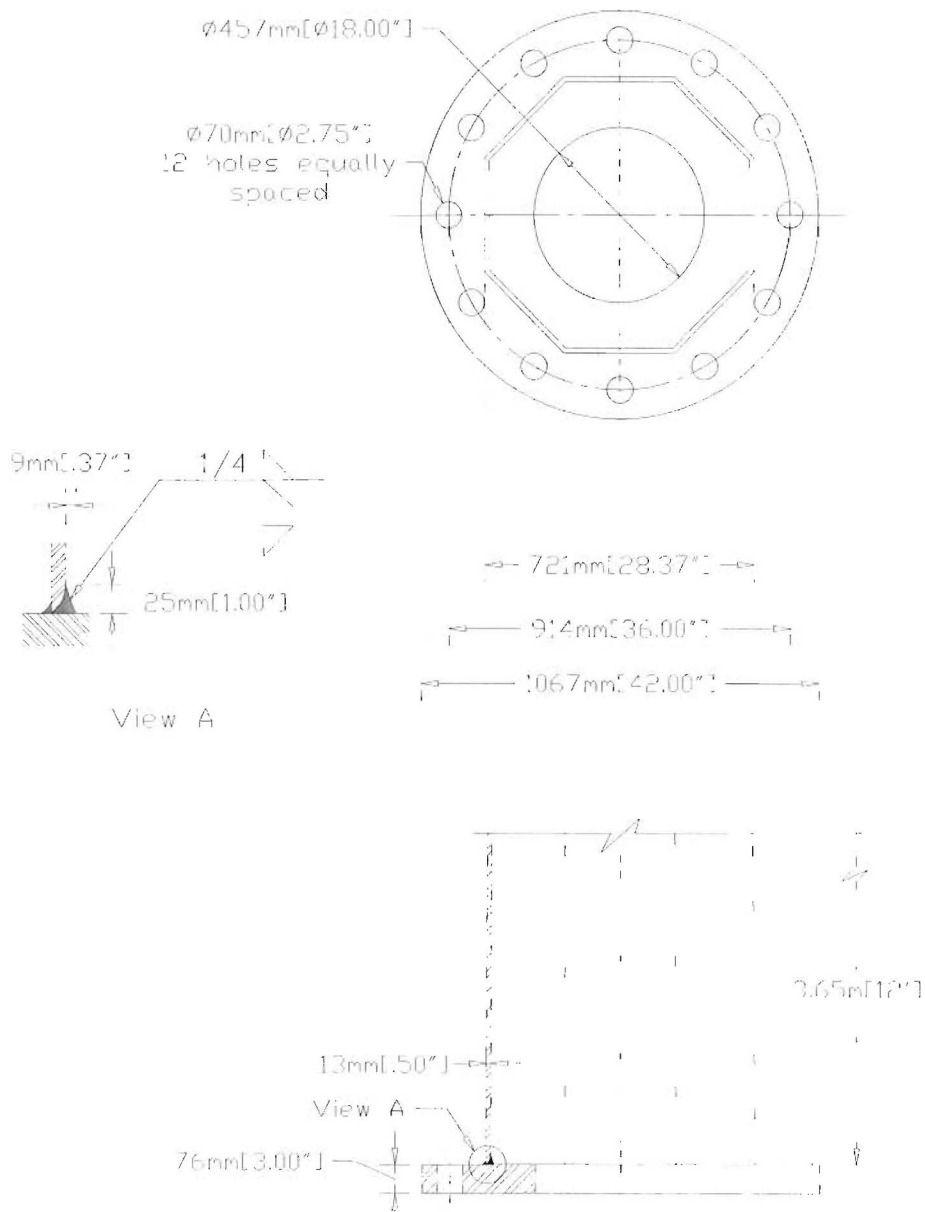
Figure A-4 Schematic drawing of HMIP specimen used in laboratory study.
