**SELECTING REHABILITATION OPTIONS FOR FLEXIBLE
PAVEMENTS: GUIDELINES FOR FIELD INVESTIGATIONS**

Tom Scullion
Research Engineer
Texas Transportation Institute

Report 1712-4
Project Number 0-1712
Research Project Title: Development of Strategy Selection Procedure
for Rehabilitation of Flexible Pavements

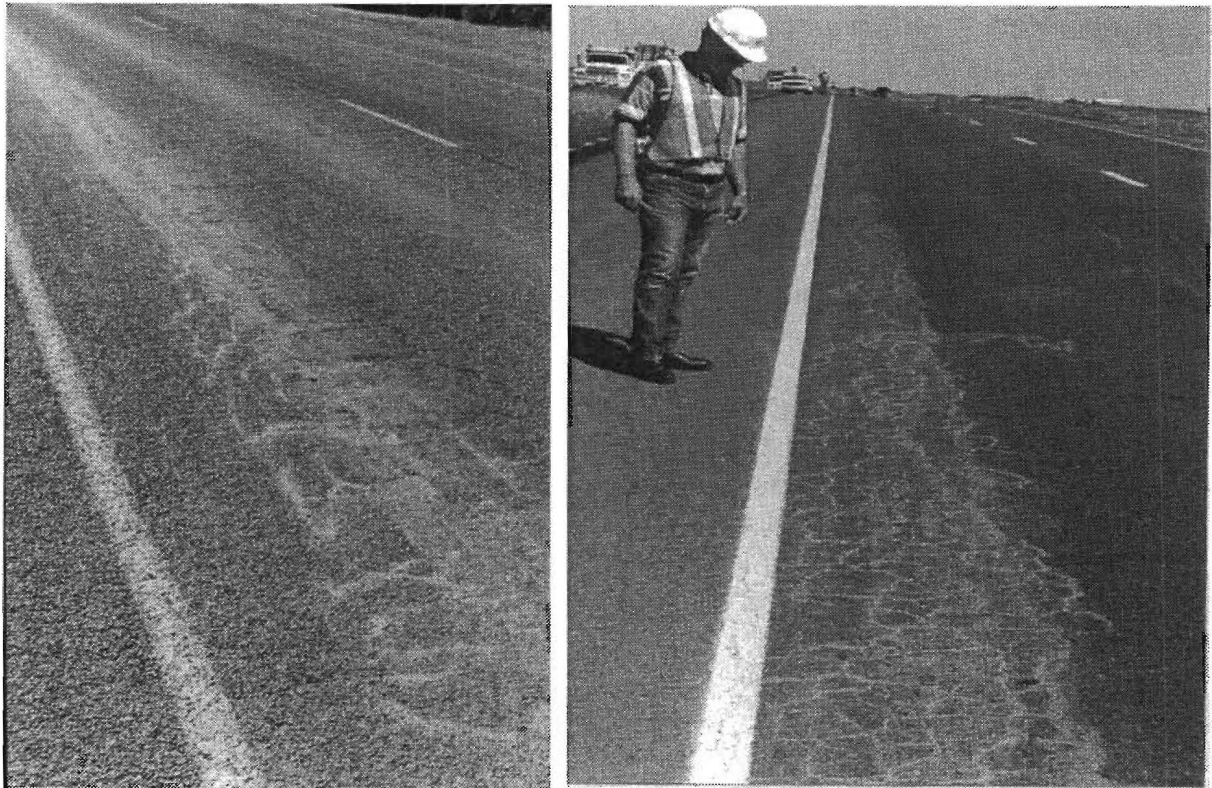
ALLIGATOR CRACKING

Alligator cracks are a network of multi-sided blocks (polygons) resembling the skin of an alligator. This type of cracking is frequently referred to as fatigue cracking. It is associated with traffic and initially appears in the wheel path area. The blocks formed are less than 1 foot by 1 foot.

Structural deficiency	(Weak or wet base or subgrade, thin layers)
Excessive air voids in HMA	
Asphalt cement properties	(Burnt binder)
Stripping of asphalt from aggregate	(Problems in an old buried HMA layer)
Layer debonding	(Poor construction practices)
Construction deficiencies	(Poor joints, segregation)

The occurrence of alligator cracking is also accelerated by a host of materials and design issues, such as the state of bonding between layers, the presence of stripping in lower HMA layers, and moisture trapped within lower layers. Research has shown that trapping moisture can be caused by a range of design decisions such as placing stabilized shoulders on flexible base pavements, using different stabilized layers within the same stabilized base (for example a lower layer of stabilized recycled materials with an upper layer of stabilized new materials) and the use of impermeable fabrics with HMA layers. The presence of excessive moisture in lower layers can readily be detected by a GPR survey. Neither of the cases shown at the top of this section are classical fatigue cracking. The cracking in the photo on the left was caused by stripping of a lower HMA layer, and in the right photo by layer debonding.

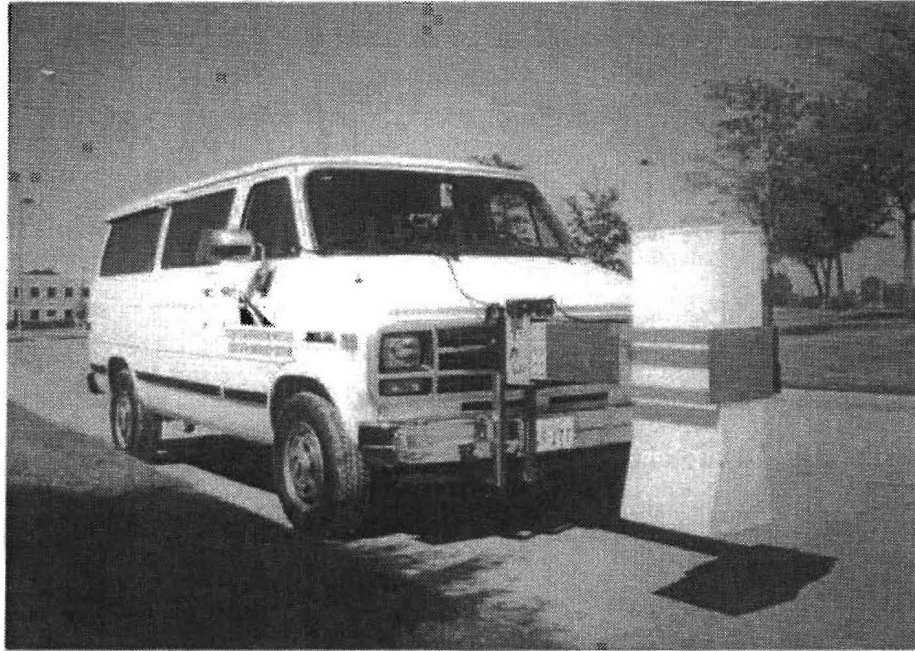
Figure 1. GPR equipment and principles of operation.

Figure 1 shows the TTI Ground Penetrating Radar vehicle with the Pulse Radar antenna. The antenna transmits pulses of radar energy, with a central frequency of 1 GHz, into the pavement. These waves are reflected at significant layer interfaces in the pavement. The data acquisition system captures and displays these reflected waves as a plot of return voltage versus arrival time. As shown in Figure 1, the largest peak A_1 is the reflection from the pavement surface; the amplitudes before the surface reflection are internally generated noises known as the “end reflection”. Although not related to the pavement structure, the time between the end reflection and the surface reflection is related to the height of the antenna above the ground; this measurement provides a means of accounting for antenna bounce as the system drives over rough highways. The reflections of major significance to pavement engineers are those that occur after

(a) TTI GPR Equipment

(b) Principles of GPR. The incident wave is reflected at each layer interface and plotted as return voltage against time of arrival in nanoseconds.

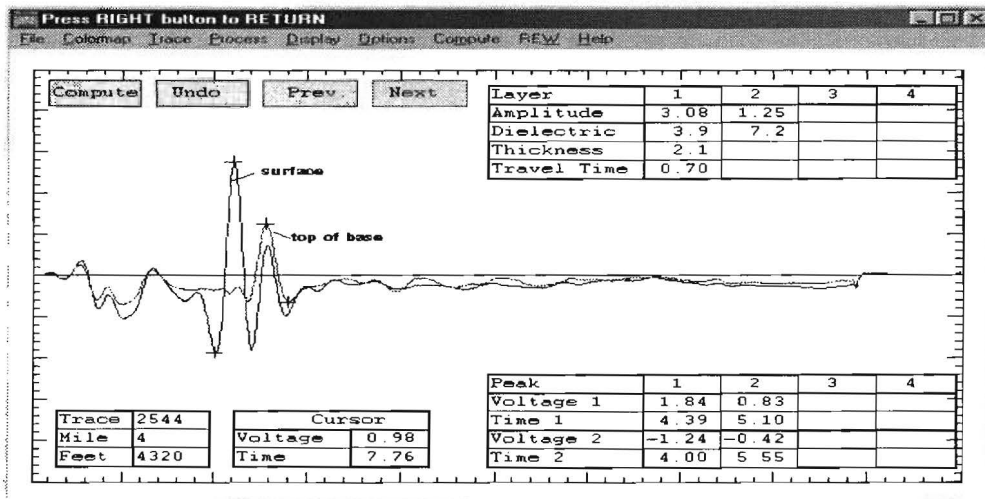
Figure 5. Moisture Trapped beneath a Surface Seal (Highly Variable Surface Reflection).

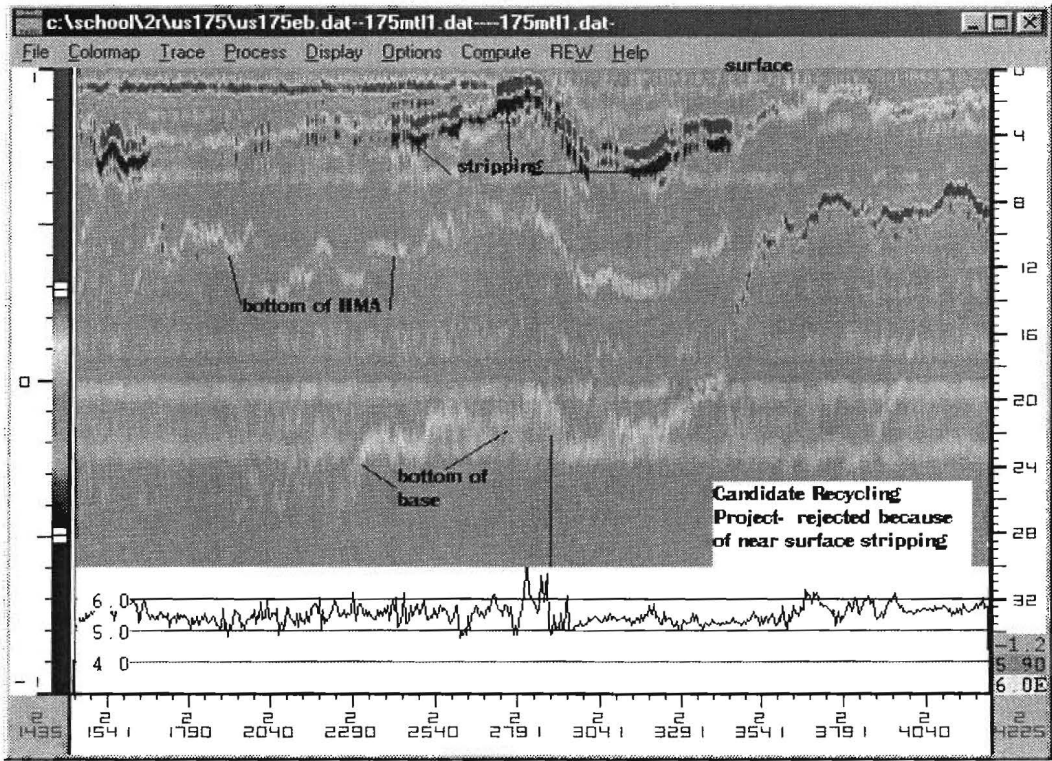
Figure 6. GPR Reflection Patterns from a Pavement with Near Surface Stripping.

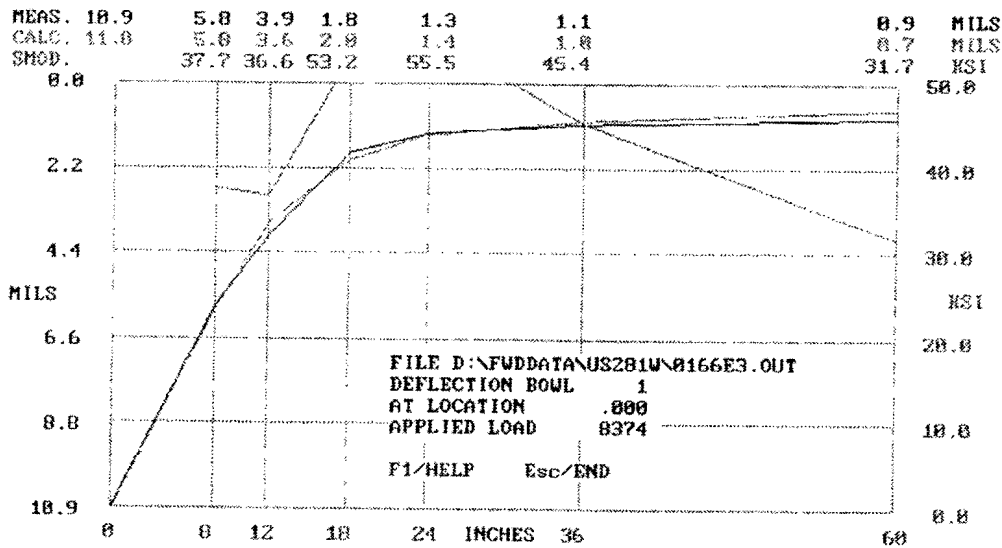
Figure 13. Evaluating the Need for a Four-Layer Analysis. The Composite Single-Layer Modulus Solution Shows a Definite Peak at the Sensor 24 inches from the Load.

Four-layer analysis should only be performed if the three-layer results are unsatisfactory. Often in Texas, four layers are required primarily to handle stabilized subbases and subgrades. To check if a stabilized lower layer is present within MODULUS 5.1, review the plot of “Measured versus Computed” solutions. If a stabilized layer is present, a plot such as shown in Figure 13 is expected. This figure shows a pavement with a 5-inch asphalt surface, a 14-inch

flexible base, and a stiff 20-inch stabilized subbase. In this instance, field testing with DCP found that the penetration rates were higher in the base than in the stabilized subbase. This result is also observed in the single-layer solution (SMOD), where the highest moduli are computed with the sensor readings 18 and 24 inches from the load. In this instance a four-layer backcalculation analysis should be performed. If a stabilized subgrade layer is to be included as Layer 3, assign it a modular range from 25 to 250 ksi. If the MODULUS results are still unsatisfactory, then either coring or Dynamic Cone Penetrometer testing should be performed.

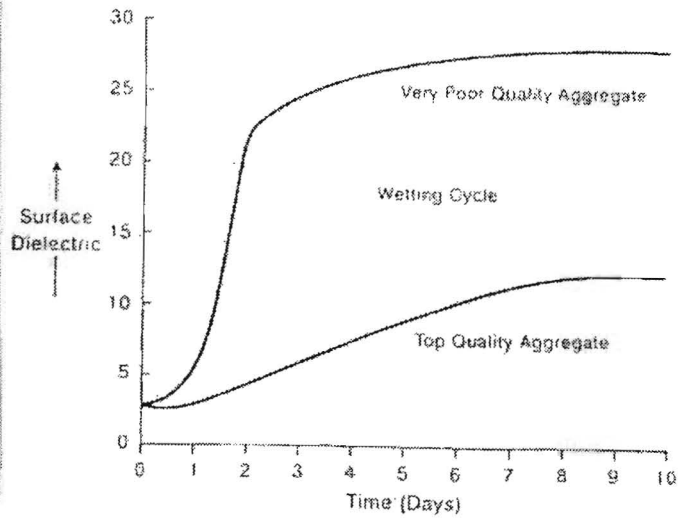
Figure 15. Tube Suction Test (5).

a. Dielectric Measuring Equipment

b. Test Set-up

c. Surface Measurement

d. Typical Results.

In the past five years, the Texas Transportation Institute has been evaluating a new test procedure, the tube suction test, to identify poorly performing unstabilized base materials (5, 14, 15). In the TST the moisture susceptibility of any material is evaluated in terms of its capillary rise characteristics and the resulting surface dielectric values. The test set up for the TST is shown in Figure 15. It involves compacting a 6 by 8-inch sample at optimum moisture content in a concrete cylinder mold with a series of small diameter holes drilled in its base. The sample is dried in a 40 °C room for several days, and then the capillary rise of moisture is monitored with a dielectric probe, which measures the dielectric properties of the surface of the sample. High surface dielectric measurements indicate suction of water by capillary forces. The mineralogy of the fines contributes to the affinity for water. The dielectric itself is the measure of the unbound moisture within the base. It is this “free” moisture rather than the bound moisture which is thought to be responsible for poor performance under applied vehicle loads and poor resistance to freeze-thaw cycling. Studies have been underway in both Texas and Finland to relate the laboratory and field performance of materials classified by the TST (6, 15). These laboratory studies found that materials ranked poorly by the TST also had poorer load bearing capability as measured by their resilient modulus and permanent deformation properties. They also reported that poorly ranked materials were also highly susceptible to frost damage. Based on Texas and Finnish studies, tentative criteria have been established for unstabilized base material. If the surface dielectric exceeds a value of 10, then that material may not perform well under heavy traffic loads in areas which are subject to freeze-thaw cycling. A failure level of 16 has been proposed. Materials exceeding this value should be considered for chemical stabilization.
