| 4. Title and Subtitle<br>RECOMMENDATIONS ON BUILDING A PAVEMENT LAYER<br>DATABASE FOR TxDOT | | | | 5. Report Date<br>November 1998<br>Revised: June 1999 | |

**RECOMMENDATIONS ON BUILDING A PAVEMENT LAYER  
DATABASE FOR TxDOT**

Tom Scullion  
Associate Research Engineer  
Texas Transportation Institute

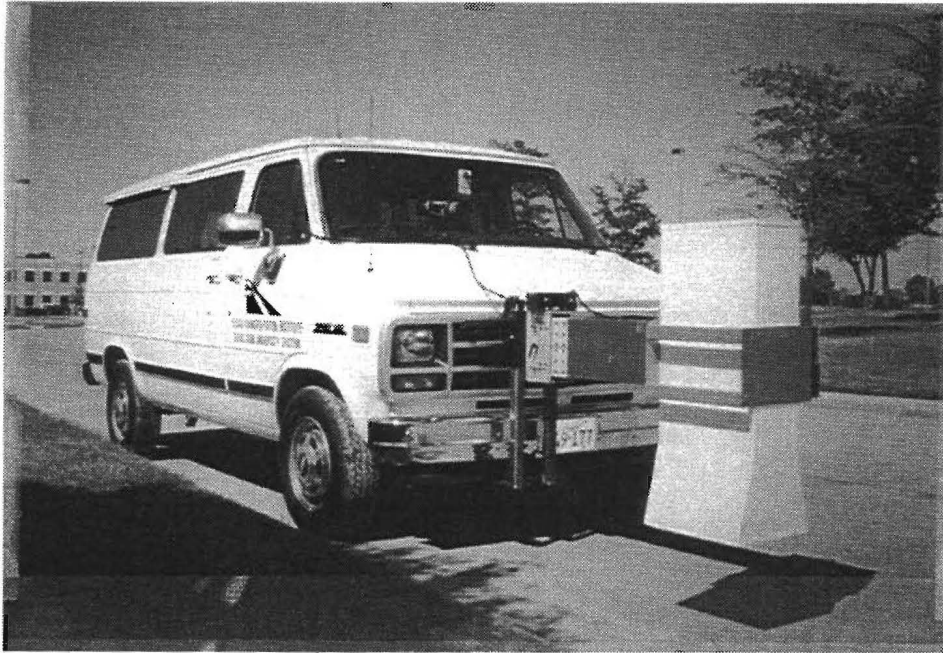
**Figure 7. GPR Equipment and Principles of Operations.**

The TTI's GPR unit is shown in Figure 7. This system sends discrete pulses of radar energy into the pavement system and captures the reflections from each layer interface within the structure. This particular GPR unit transmits and receives 50 pulses per second and can effectively penetrate to a depth of 0.6 m (2 ft). A typical plot of captured reflected energy versus arrival time for one pulse is shown at the bottom of Figure 7, as a graph of volts versus time in nanoseconds. The automated COLORMAP software (3), developed by TTI to process this data, measures the amplitudes of reflection and time delays between peaks to compute both layer dielectrics and thicknesses.

a. TTI GPR Equipment.

b. Principles of Ground Penetrating Radar. The Incident Wave is Reflected at Each Layer Interface and Plotted as Return Voltage Against Time of Arrival in Nanoseconds.

With reference to Figure 7 the reflection  $A_1$  is the energy reflected from the surface of the pavement,  $A_2$  and  $A_3$  are from the top of the base and subgrade, respectively. These amplitudes of reflection are used to calculate individual layer dielectrics. These are electrical properties of the pavement materials. The engineering properties which most influence these dielectrics are the moisture content and density of the individual layers. If the moisture content for a layer increases, then the amount of energy reflected from the top of the layer would increase resulting in an increase in calculated layer dielectrics. An increase in air voids would have the opposite effect. If the amount of air in a layer increases, the energy reflected and resulting dielectric would decrease. TTI has established a range of typical dielectrics for most paving materials. For example HMA layers normally have a dielectric value between 4.5 and 6.5, depending on the coarse aggregate type. Computed values significantly higher than this would indicate the presence of excessive moisture, lower values could indicate a density problem or indicate that an unusual aggregate, such as lightweight, has been used in the Hot Mix Asphalt (HMA).

The examples below illustrate how changes in materials properties and structure would influence GPR return signals shown in the lower part of Figure 7.

- 1) If the thickness of the surface layer increases, then the time interval between  $A_1$  and  $A_2$  would increase.
- 2) If the base layer becomes wetter, then the amplitude of reflection from the top of the base  $A_2$  would increase.
- 3) If there is a significant defect within the surface layer then a reflection will be observed between  $A_1$  and  $A_2$ . This could be either a positive reflection for trapped moisture or a negative reflection for stripping.
- 4) As the unit travels along the highway it collects traces at regular intervals; therefore, GPR has the potential to monitor the uniformity of the surfacing layer. Large changes in the surface reflection  $A_1$  would indicate changes in either the density (decrease in amplitude) or moisture content (increase in amplitude) along the section.

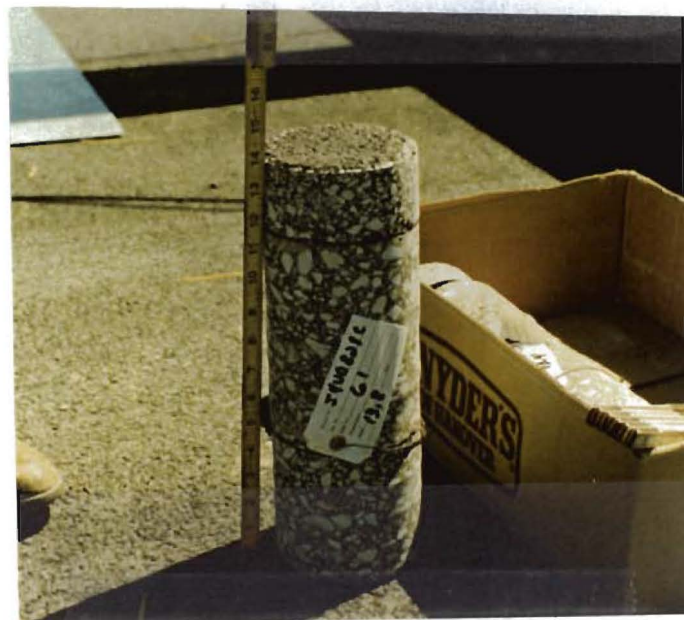
Figure 8. GPR Trace a Field Validation Core from a Thick Homogeneous HMA Pavement.

An example of an actual GPR reflection from a flexible pavement with thick HMA layers is shown in Figure 8. This is judged to be an “ideal” reflection, with a clear reflection from the surface  $A_1$ , the top of base ( $A_2$ ), and top of subgrade ( $A_3$ ). These types of GPR reflections are found with newly constructed homogeneous flexible pavements. As the core shows, well-compacted defect-free cores can be taken when GPR traces such as this are obtained. The COLORMAP software automatically measures the amplitudes and time delays between peaks and computes layer thicknesses and dielectrics. For this trace the calculated values are shown in the box in the upper right-hand corner of the figure.

With older pavements the GPR traces are often more complex than that shown in Figure 8. The fact that there are no significant reflections within the HMA layer indicates that it is homogeneous; however, with older pavements, strong reflections are often found within the HMA. Large positive reflections indicate the presence of trapped moisture, and large negative reflections indicate either the presence of a low-density layer, which could be lightweight aggregates, or a buried defect such as stripping.

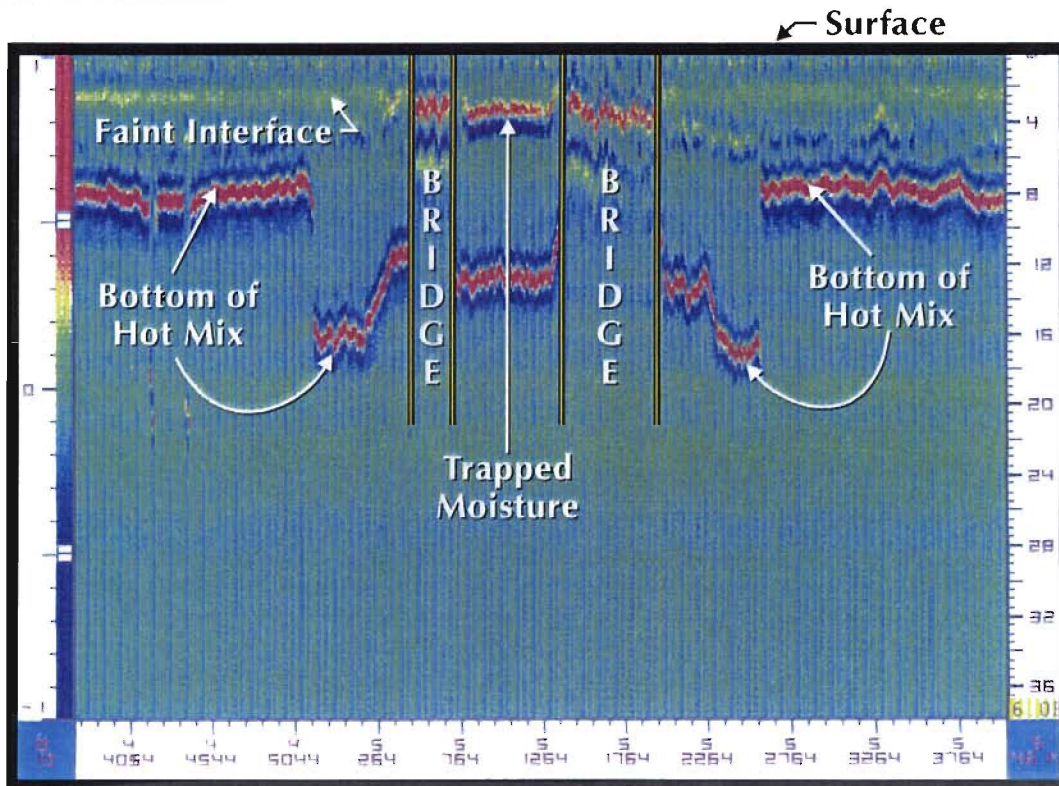
Figure 10. Annotated GPR Results from a Section of US 59 in the Atlanta District. The Scale at the Left is Depth in Inches. The Scale at the Bottom is Distance in Miles and Feet.

a thin overlay. Significant features of this figure are a) the large change in HMA thickness on the approach to the bridge, b) away from the bridges there is no significant reflection from the bottom of the last overlay which indicates similar materials bonded together, and c) a clear old/new HMA interface between the bridges, this as will be described later, indicates moisture trapped at a depth of 3 to 4 in below the surface.

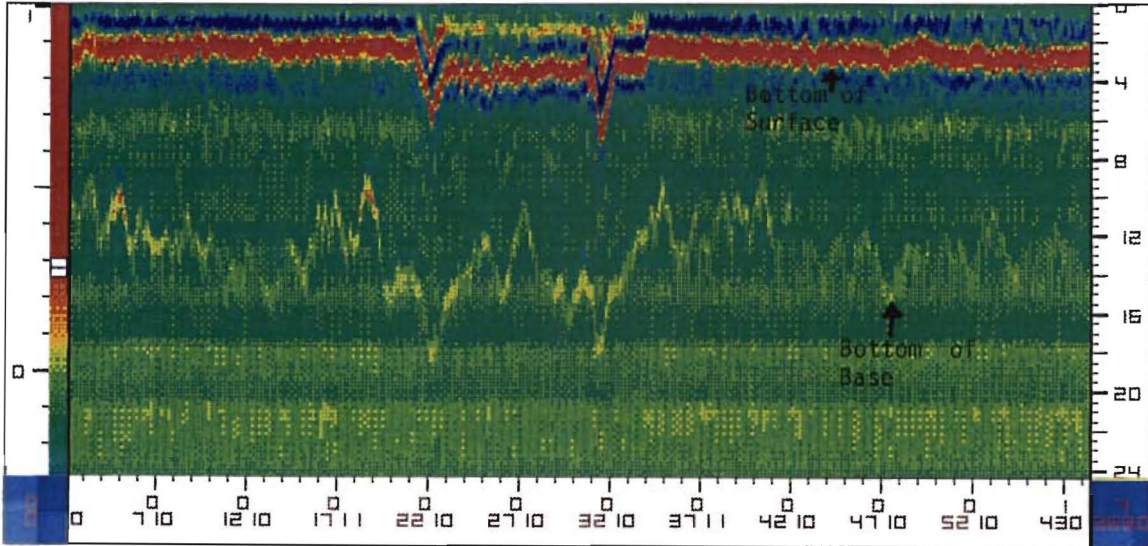
Figure 11. GPR Data from FM 2979.

The GPR data collected on this section is shown in Figure 11, and the processed thickness data and validation core are shown in Figure 12. The top figure in Figure 11 is the standard COLORMAP color-coded printout for this section. The bright red line at a depth of 65 to 100 mm (2.5 to 4 in) is the reflection from the top of the base layer. In one location a localized thickening of the surface layer was found with thicknesses up to 6 in. A validation core (Figure 12) was taken in the thickened section, and a total of 100 mm (4 in) of surfacing including two thin HMA layers was found. It was concluded that the entire section had received at least one HMA resurfacing which was not reported in the plans. The lower part of Figure 11 shows a single GPR trace from the section,

a. COLORMAP Display with Annotation.

b. Individual GPR Trace.

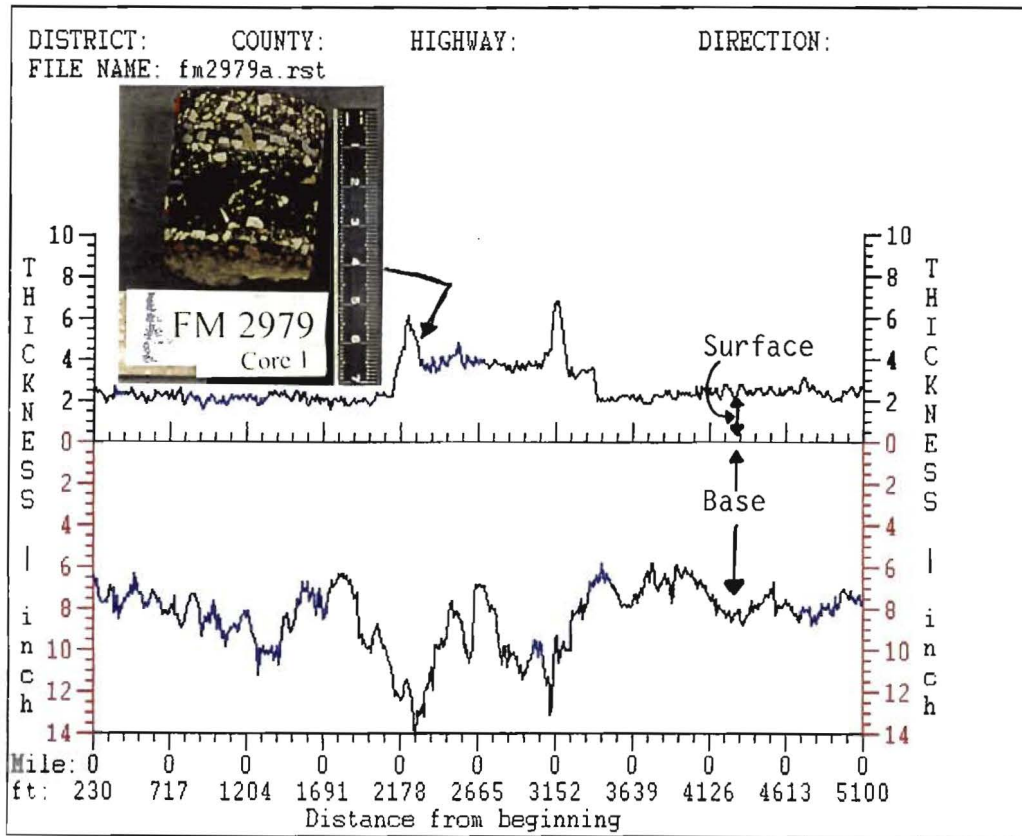
a. Layer Thickness Computed from GPR.

the reflections from the surface, top of base, and top of subgrade are noted as  $A_1$ ,  $A_2$ , and  $A_3$ , respectively. Figure 12a shows the computed surface and base thicknesses for the section together with a validation core. The lower part of Figure 12 shows the computed GPR surface and base thicknesses summarized in 150 m (500 ft) sections. If GPR is to be used to update the PLDB it would be the average layer thickness values from Figure 12b which would be used. For newer pavements with few overlays and no defects, GPR has been found to compute layer thicknesses to within 5% of actual core thickness without taking a calibration core.

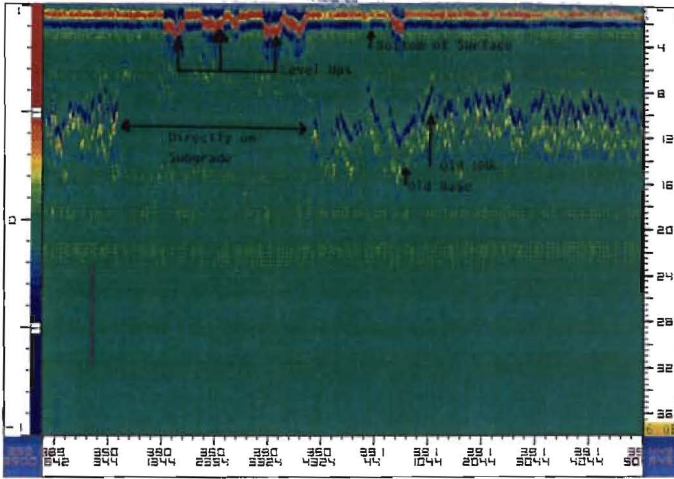
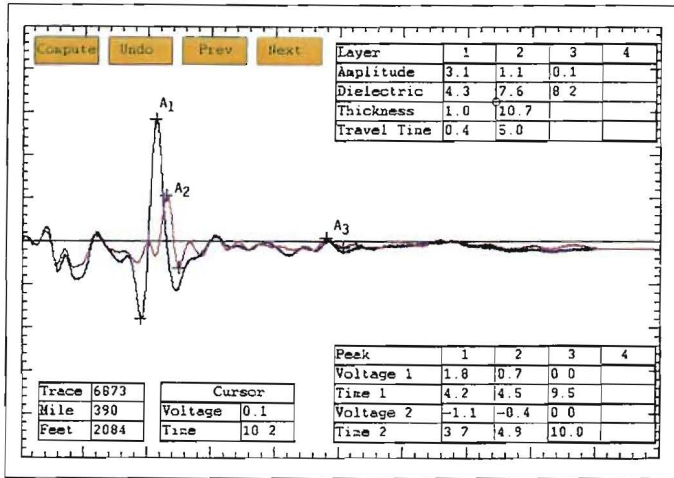
The section of US 283 between TRM 386 and 396 was rehabilitated in 1985. In most of the section, 150 mm (6 in) of new flexible base was laid directly on top of the old pavement. In a few places the old pavement was removed and a new thicker base was placed directly on top of the subgrade. The GPR/PLDB comparison for a short section of US 283 including both cross-sections is shown in Figures 13 and 14 . Figure 13a shows the COLORMAP display of the GPR data for a 2 mi section. The surface is the horizontal line at the top of the figure, the surface is very thin (less than 50 mm (2 in)) and is seen as the thin red line near the surface, and the bottom of the base is marked by the blue reflections approximately 250 to 300 mm (10 to 12 in) below the surface. The change in pavement structure is shown as a clear break in reflection from the bottom of the base. The blue reflector from the bottom of the base is a transition from a high dielectric to a lower dielectric which is an unusual case. Normally the transition is marked by a positive reflection indicating an increase in moisture content from base to subbase layer. In this case the new base was placed directly on top of an existing HMA surfacing, and the negative (blue) reflection is from the top of the old HMA layer. The section where this blue reflector disappears is where the base was placed directly on top of the subgrade. Figure 13b shows an individual GPR trace from the area where the new base was placed on the subgrade. In this trace the reflection from the top of the base  $A_2$  can only be clearly identified after surface removal, small positive reflector  $A_3$  is from the top of the subgrade. As the amplitude of  $A_3$  is small, the contrast in dielectrics (moisture content) between the base and subgrade is also small. Figure 13c is from an area where the new base was placed on top of the old HMA layer. The difference between 13b and 13c is the negative reflection ( $B_1$ ) in 13c, this is the reflection from the top of the old HMA layer.

a. COLORMAP Display.

b. GPR Trace in New Section on Subgrade A<sub>1</sub>, A<sub>2</sub>, A<sub>3</sub> Reflection from Top of Surface, Base Subgrade, Respectively.

c. GPR Trace with New Base Directly on Top of Old HMA Layer. Reflection B<sub>1</sub> from Top of Old HMA Layer.

**Figure 13. Case 1 Good Tie in between Plans and GPR US 283 SB (Brownwood).**

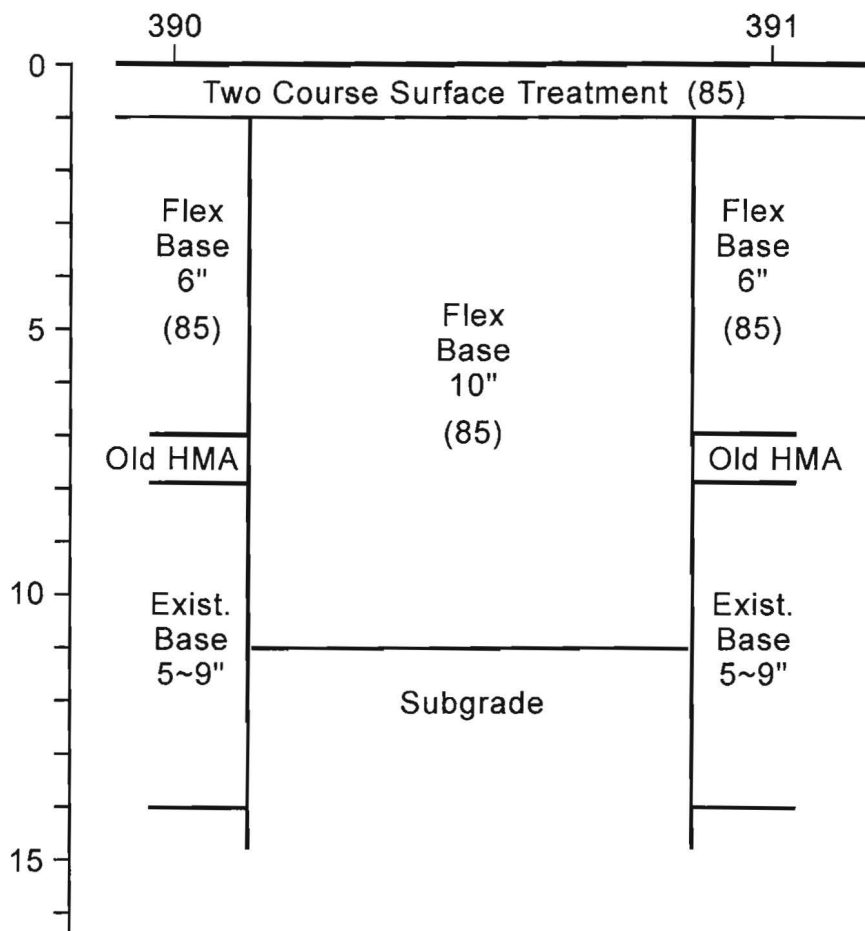
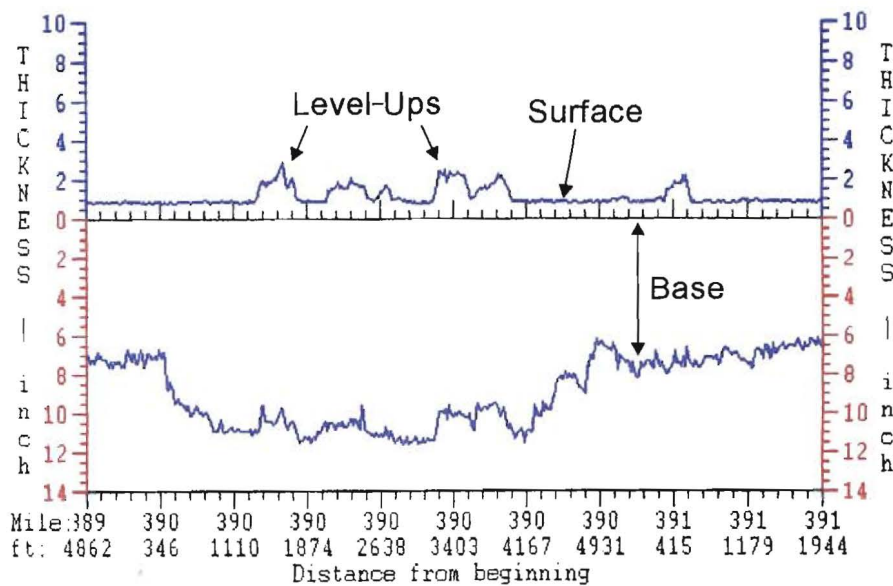
**Figure 14. Summary Results from US 283 (Case 1).**

The plan versus GPR layer thickness profiles are shown in Figure 14. The top figure was sketched directly from the PLDB built by Mr. Godfrey. The lower figure was automatically generated from COLORMAP. In general, the correspondence is very good. The only difference between the plans and the GPR is the apparent localized level-ups placed on the surfacing layer primarily in the section built directly on the subgrade. These are maintenance treatments which can be clearly seen in the video.

a. Pavement Structure from Brownwood PLDB.

b. Layer Thickness from GPR.

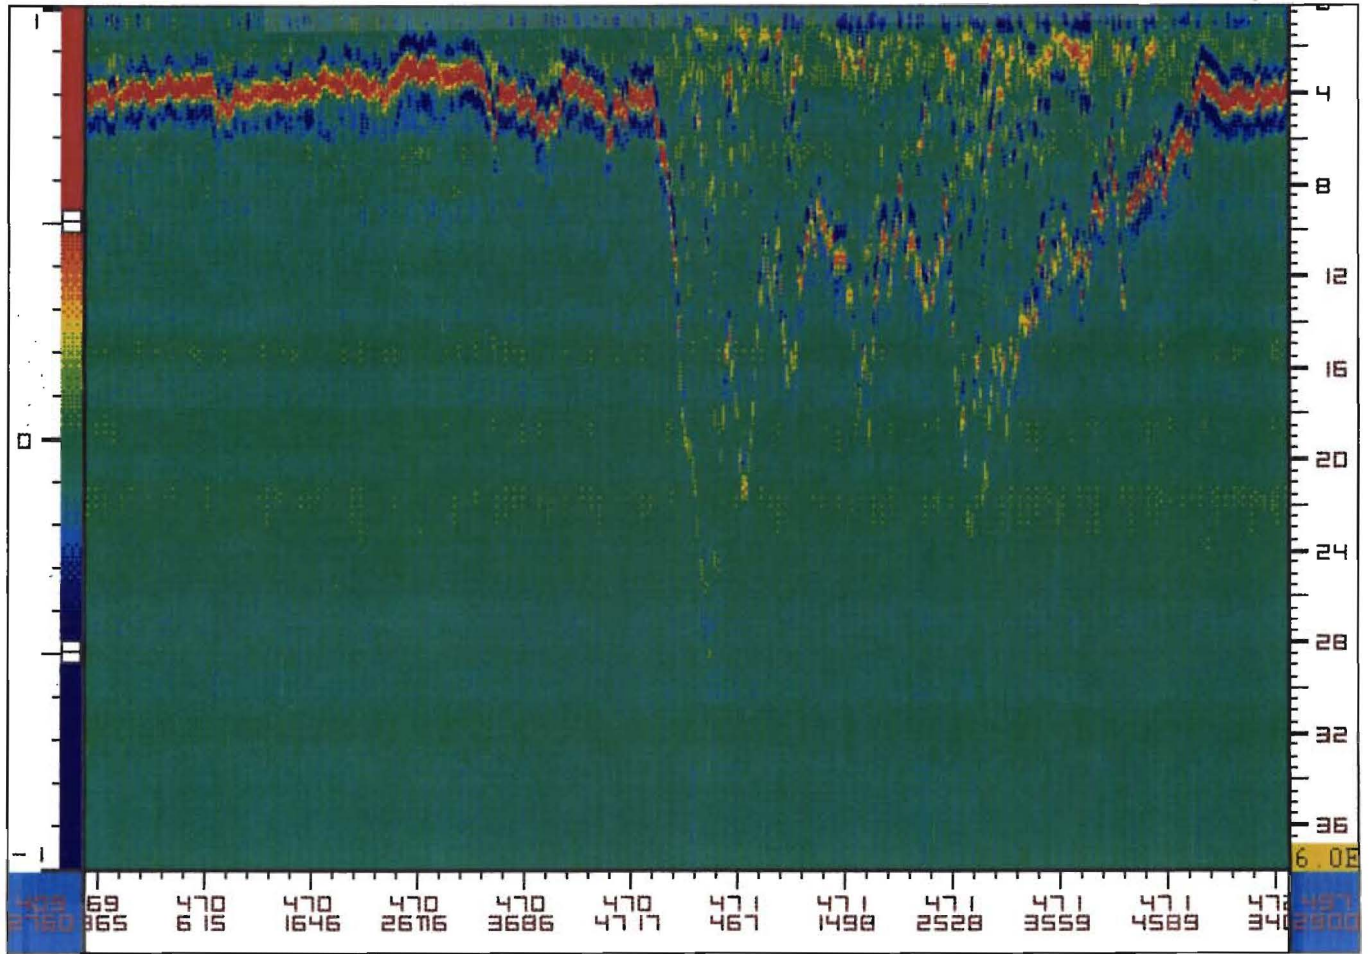
The plan thickness from US 190 west of Brady indicated a uniform 100 mm (4 in) of HMA over a thick granular base. However, close to the San Saba county line the section goes through an expansive clay area which has received substantial maintenance. The COLORMAP display for a 2.2 mi section is shown in Figure 15. Again the surface is at the top of the figure, and the solid red line at a depth of 100 mm (4 in) below the surface is from the top of the base layer. The scale at the bottom of the figure is distance converted into the TRM referencing scheme (Miles + Feet). As can be seen in Figure 15 around TRM 470 +5000 ft, a sudden major thickening of the HMA layer occurs. This overlaid section is approximately 1 mi in length.

Figure 15. COLORMAP Display from an Expensive Clay Section on US 190 (Brownwood District).

Using the COLORMAP layer thickness calculation procedures, the data in Figure 15 was converted into an HMA thickness profile as shown in Figure 16a. Within COLORMAP the thickness data is further summarized into 0.1 mi sections in the table at the bottom of Figure 16. For each 10th mile section a minimum, maximum, and average HMA thickness is calculated. From experience with similar pavements these estimates are typically within 5% of the actual core thickness. As will be recommended later in this report, it is proposed that the initial PLDB be built with plan thicknesses which will then be validated with a GPR survey. In this case the plan thicknesses will be updated with the thickness from the average HMA thickness column of Figure 16b.

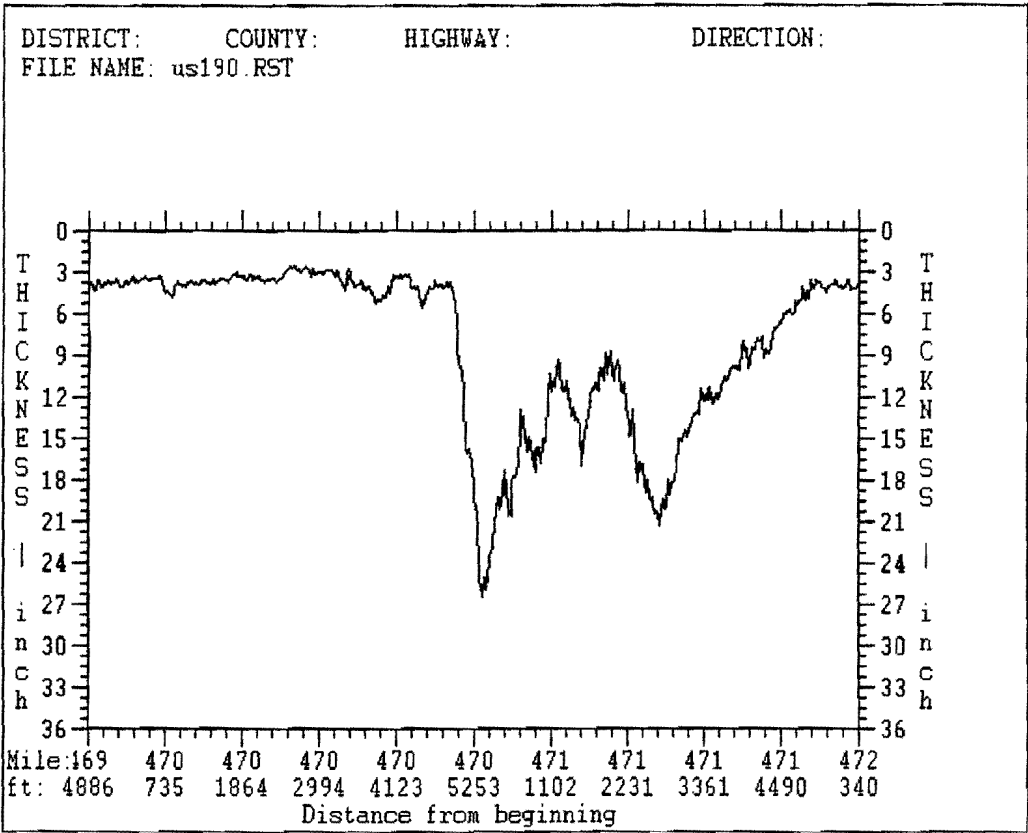
a. Thickness of HMA as Computed by COLORMAP.

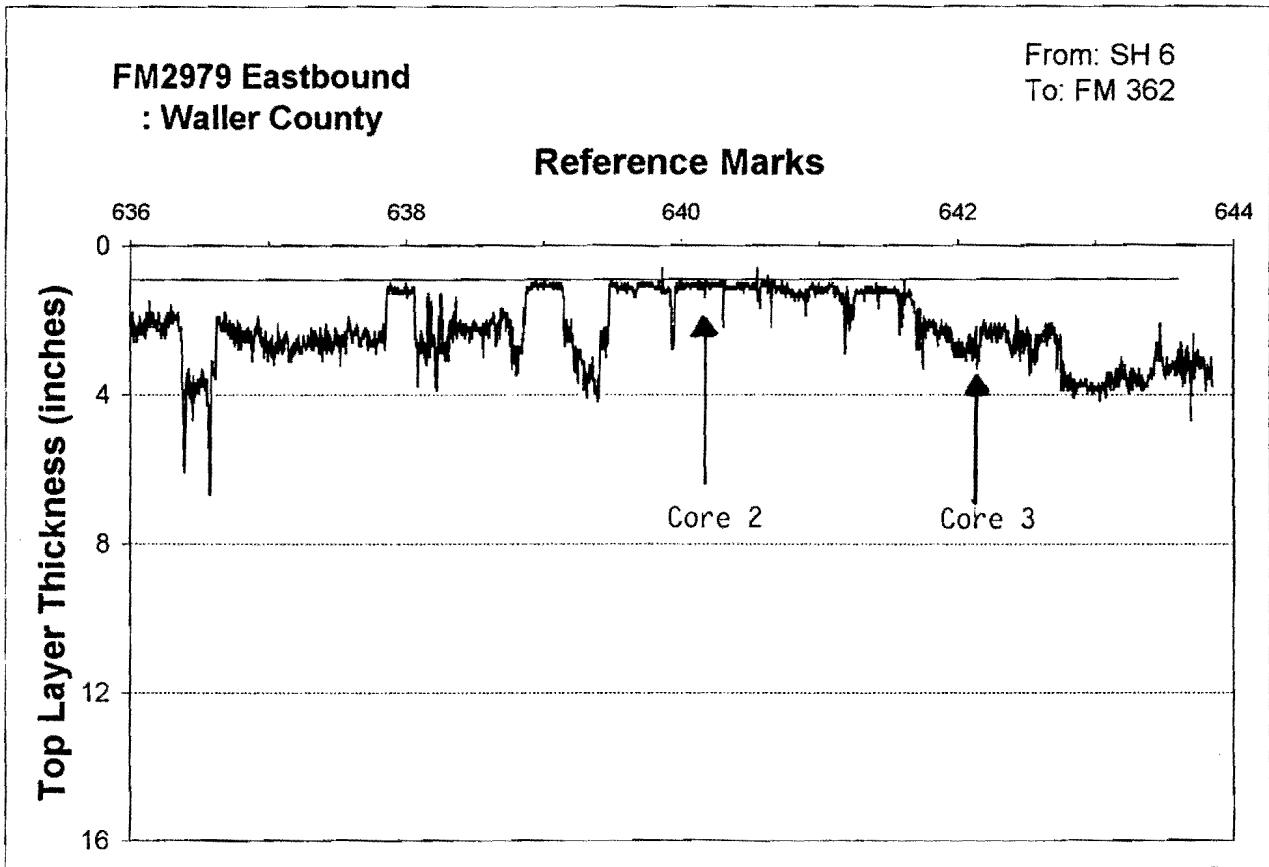
Figure 17 shows the complete GPR thickness profile for all of FM 2979 in Waller County. This is an 8 mi section from SH 6 to FM 362. Figures 11 and 12, presented earlier, gave the surface and base thickness profiles from a short section at the start of this highway. The plans stated that the entire 8 mi section had multiple seal coats but no HMA with an estimated total thickness of approximately 25 mm (1 in). As can be seen from Figure 17, a short section in the middle of the highway does have close to the plan thickness. However the majority of the project has a total surface thickness of between 65 and 100 mm (2.5 and 4 in). Validation cores were taken from this project, and their locations are noted on Figure 17. Photographs of the actual cores are shown in Figure 18. The actual core thickness correlates well with the GPR thickness estimates. No defects were obvious in either core.

Figure 17. Case 3 Using GPR to Correct Surface Thickness (Plan Thickness = 1 in) FM 2979 (Waller County, Houston).

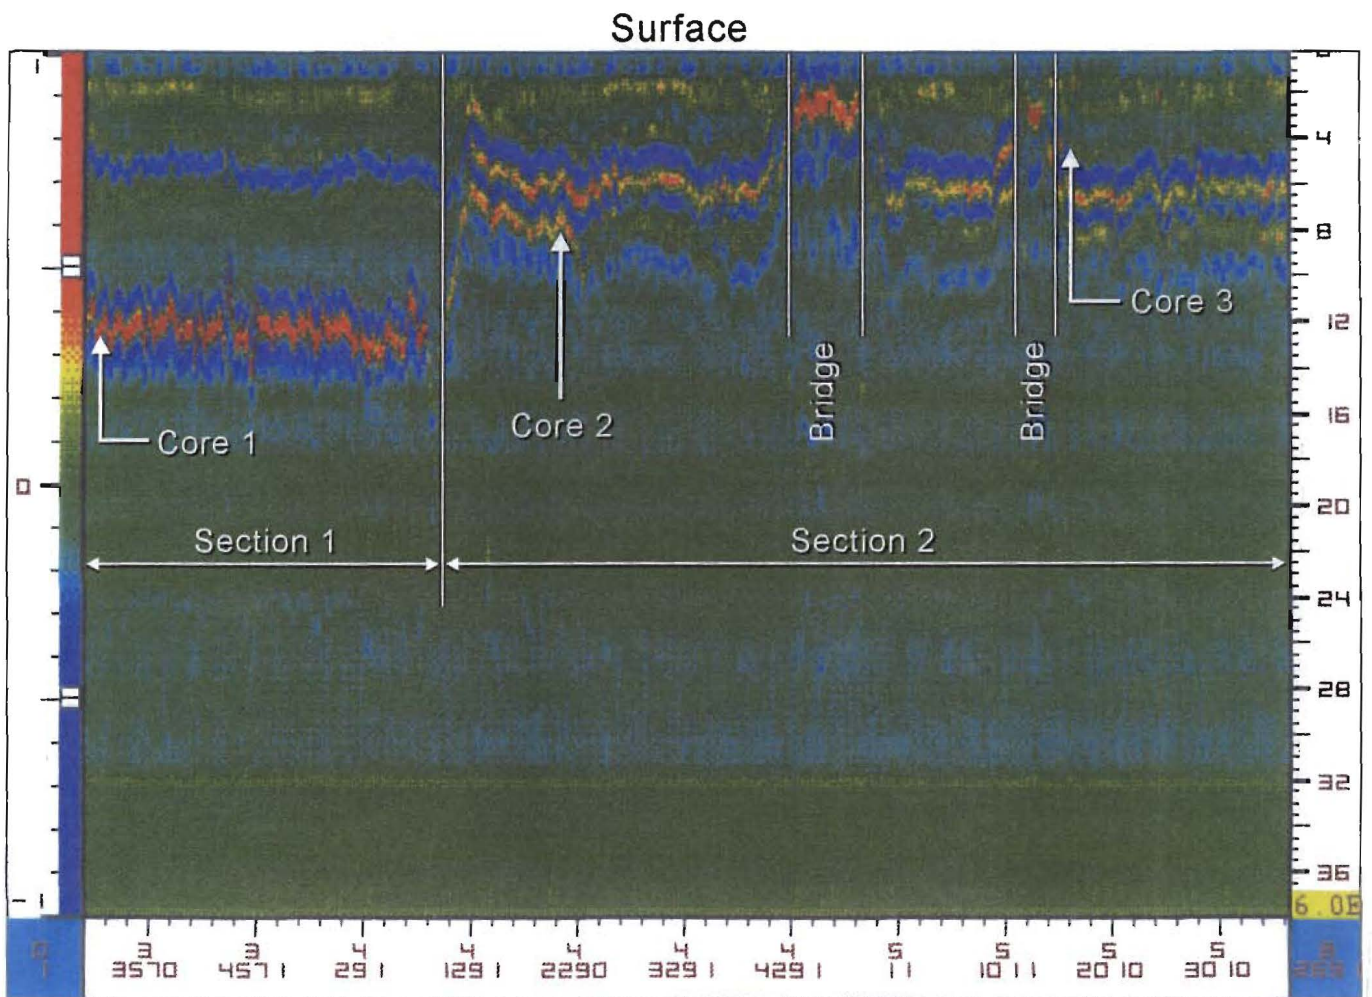
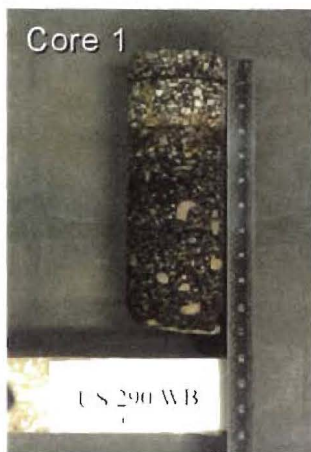
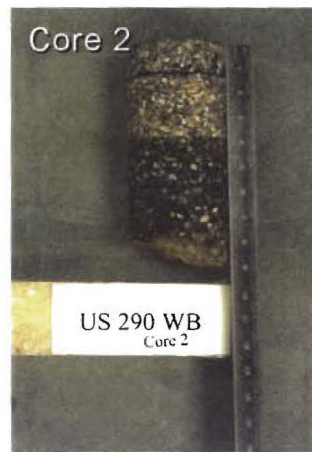
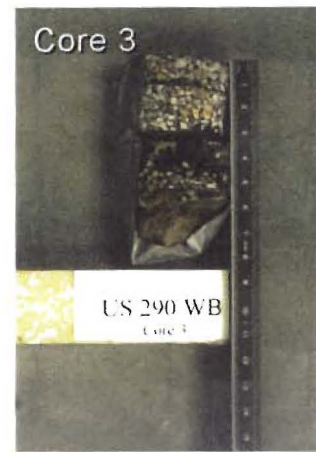
In developing its pavement layer database, the Houston District went back to its most recent set of plans and extracted the base and surface type information. However, on this section of US 290 the plans stated that the base was either Asphalt Stabilized Base (ASB) or Flexible Base (Iron Ore Gravel). Because of the confusion, no entries were made to the database for this section. To identify the location of the change in base types, it was necessary to dig back through the historical plan sheets for this section. It was found that as more and more projects are performed on the same section less and less accurate information gets passed from plan sheet to plan sheet. In this case the old plan sheets identified a change in base at the location that was identified in Figure 19. However, in Case Study 5, no change in base type was identified in the plans for this highway, whereas a clear break was indicated in the GPR data.

From Figure 19 section 1 was found to contain three HMA layers (25 mm, 50 mm, 25 mm) over an asphalt stabilized gravel base. Section 2 was found to contain between 125 and 200 mm (5 to 8 in) over an Iron Ore Base. The cores taken from this pavement are shown at the bottom of the figure. One word of caution here, the GPR data was collected while traveling at 60 mph over the pavement collecting one trace for every 3 m (10 ft) of pavement. Core locations were identified from the video images so they may not be a perfect match between the GPR trace and the resulting core. The individual GPR traces from the location of cores 1 and 3 are shown in Figure 20. Cores 1 and 2 were solid with only minor defects. Core 3 disintegrated on coring and appears to have substantial moisture damage (stripping) 75 to 100 mm below the surface. This GPR data is complex and warrants further discussion.

In section 1 a continuous blue line is observed at a depth of 100 to 125 mm below the surface. This is also apparent in Figure 20a as the negative reflection is calculated to be approximately 100 mm below the surface. The negative reflection indicates a transition from a higher dielectric to a lower dielectric. This is the reflection from the top of the asphalt-stabilized gravel layer indicating that the limestone surfacing layers have a higher dielectric than the river gravel mix. This was confirmed in the laboratory where surface dielectric measurements were made with the Adek Dielectric Probe (4). The lower HMA layer was found on average to have a 30% lower dielectric value than the upper limestone layer.

**Figure 19. Identifying Section Breaks on US 290.**

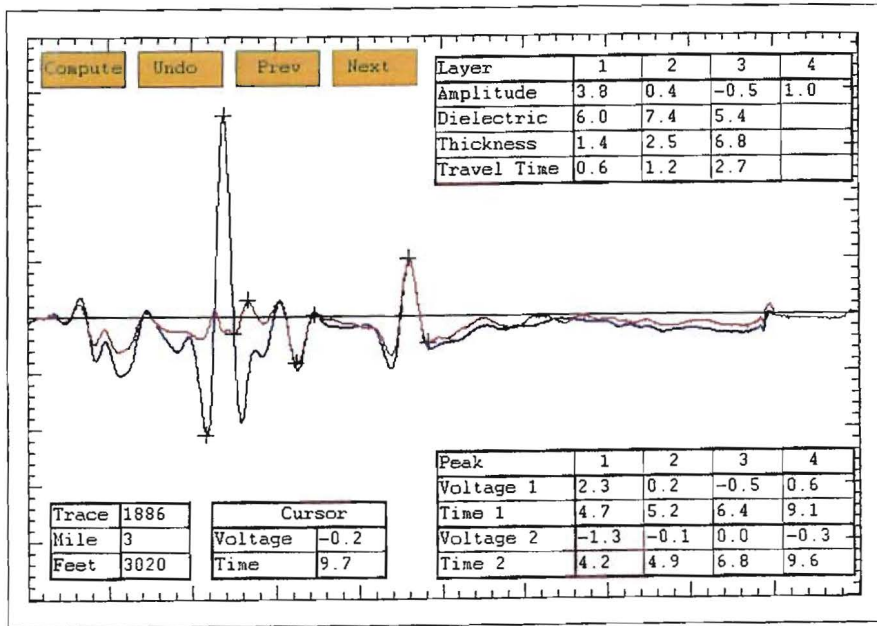
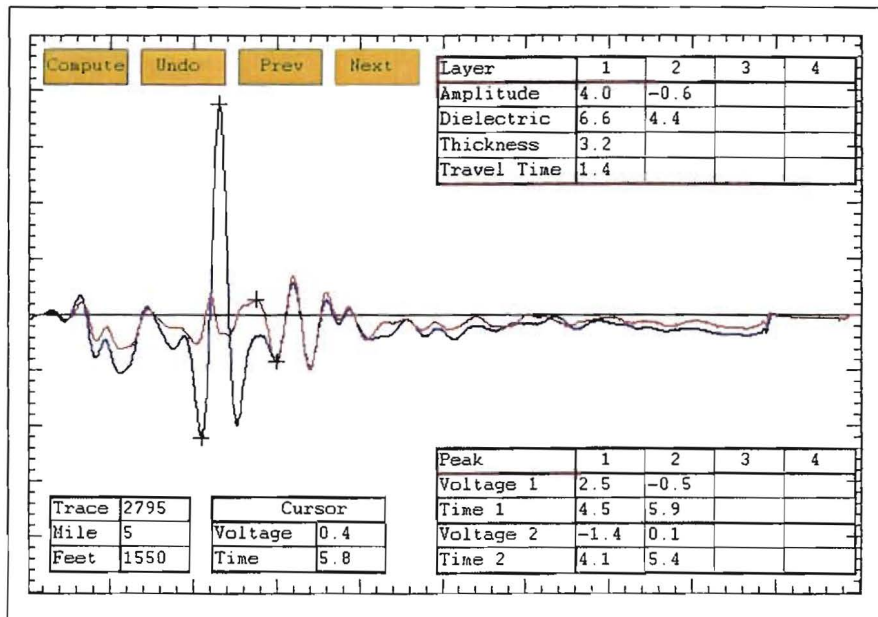
Figure 20. Individual GPR Traces from US 290.

a. GPR Reflection for Core 1 Location.  
 (No Defect, Change in HMA Layer Materials)

b. GPR Reflection for Core 3 Location.  
 (Complex, Change in Materials and Defect)

The problem becomes more complex when reviewing the core and GPR trace for core location 3. This core has about 75 mm of limestone HMA over 50 mm of deteriorated gravel HMA over an iron ore gravel base. Past work at TTI (5) has indicated that when stripping is found in HMA layers, it usually appears as a low-density layer in the GPR reflection. Low dielectric generates negative reflections. With Figure 20b the GPR trace after the surface reflection is complex as both the natural materials and deteriorations are both generating negative reflections which are superimposed upon one another. In these cases it is impossible to identify whether the negative reflections are naturally occurring or the result of subsurface deterioration. All that can be defined from the GPR interpretation is that at a certain depth below the surface a lower dielectric layer will be encountered. The only guidelines that can help interpret whether the reflection is natural or if it is the result of deterioration is if the reflection is consistent or intermittent along the section. From section 1 in Figure 19 the negative (blue) reflection is constant along the section which indicates a uniform nondeteriorated low dielectric layer.

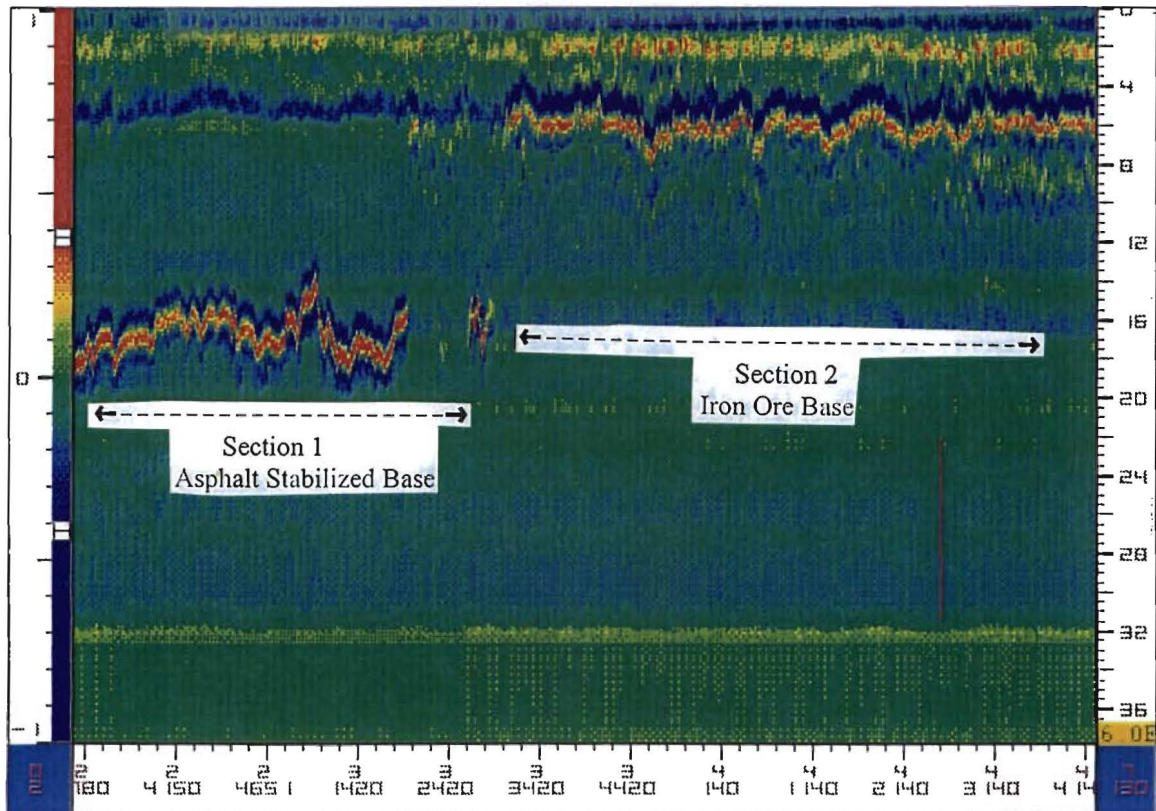
Figure 21 shows the COLORMAP display from another section of US 290. For this section, the plans indicated that there was a change in construction in the middle of this section. However, it was reported that the base in both sections was Iron Ore Gravel. Cores were taken in both sections, and section 1 was found to have an asphalt-stabilized gravel base, whereas section 2 had an iron ore gravel base. On reviewing the complete set of plans, it was discovered that the error was caused by wrongly transferring the base type information from an earlier set of plans.

**Figure 21. Case 5 Wrong Base Type. Plans Wrongly State Both Sections Have Same Base Type (ASB).**

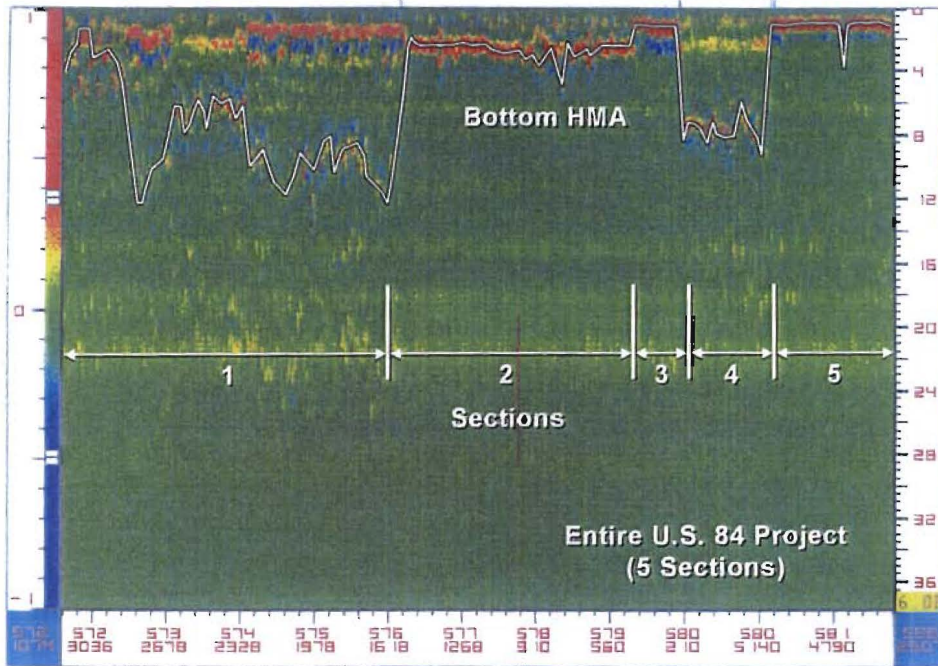
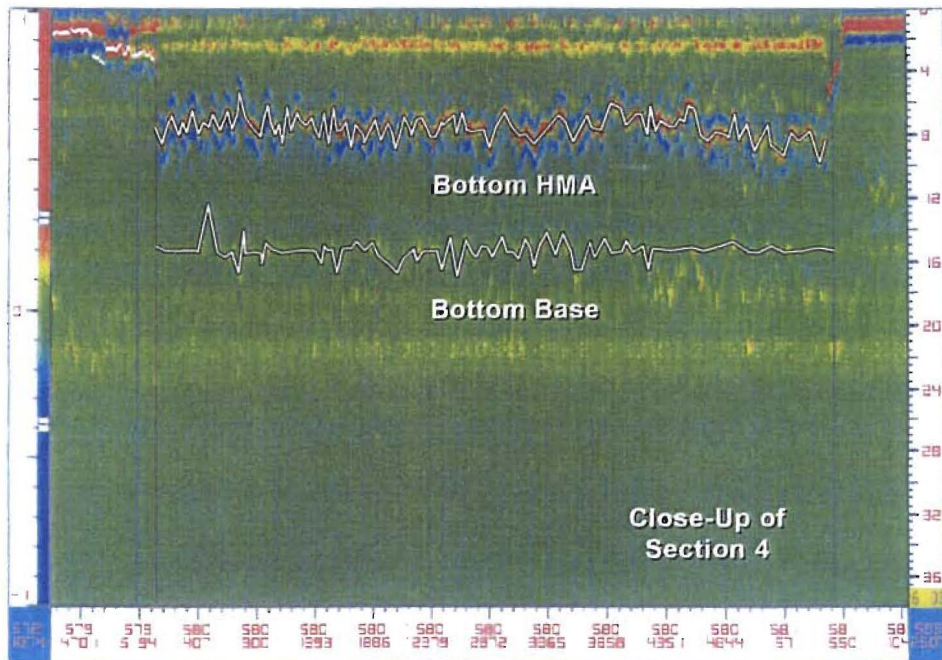
**Figure 22. US Section Breaks on US 84.**

This case study illustrates the value of using GPR for checking the pavement layer database developed from plan sheets. The section is a 10 mi stretch of US 84 from Brownwood to the Coleman county line. The COLORMAP display for the entire section is shown in Figure 22a. A blowup of section 4 is shown in Figure 22b, this being for a short section of thick HMA pavement through the city of Bangs. The data available within the RL file built by Mr. Godfrey of the Brownwood District is shown in Figure 23a. From the GPR data the highway was broken up into five sections. The GPR is most useful for checking the thickness of the upper pavement layers. For sections 2 through 5 the comparison between plan and GPR thickness is fairly good. The only minor discrepancy appears to be in section 4 where the most recent overlay was not included in the plan sheets. In this section the plans showed 110 mm (4.5 in) of ASB with several chip seals. The GPR total HMA thickness was computed to be between 160 and 200 mm (6.5 to 8 in) and the current surface is HMA.

a. Entire 10 Mile Section.

b. Close-up of Section 4.

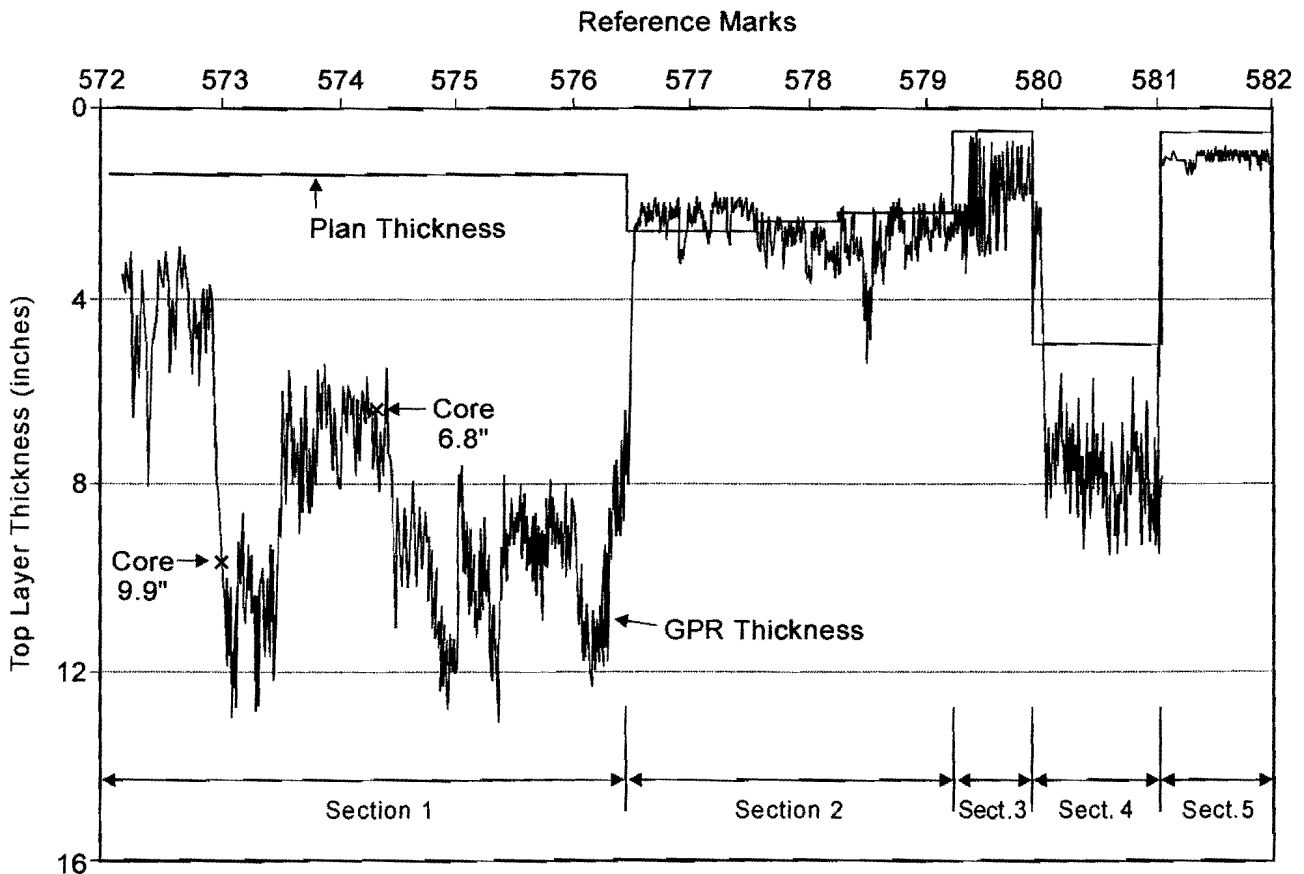
Figure 23. Plan vs. GPR Thickness for US 84.

The major discrepancy between the plan thicknesses and GPR results was on section 1. In this section the plans were confusing. This was a two-lane section that was eventually widened to be four lane divided. There was confusion in the district about the thicknesses in this section. The database included 30 mm (1.2 in) of HMA with a thick granular base. The GPR thickness estimates ranged from 100 mm at the start of the section to almost 300 mm in some locations. The GPR estimates compared reasonably with the core thickness in section 1 as shown in Figure 23b.

a. Plot of Road Life Thickness.

b. Comparison of Plan Thickness and GPR Thickness for the HMA Layer.

If GPR is to be used to update the existing RL data file, it is proposed that the surfacing layer thicknesses shown in Figure 23b would be used.

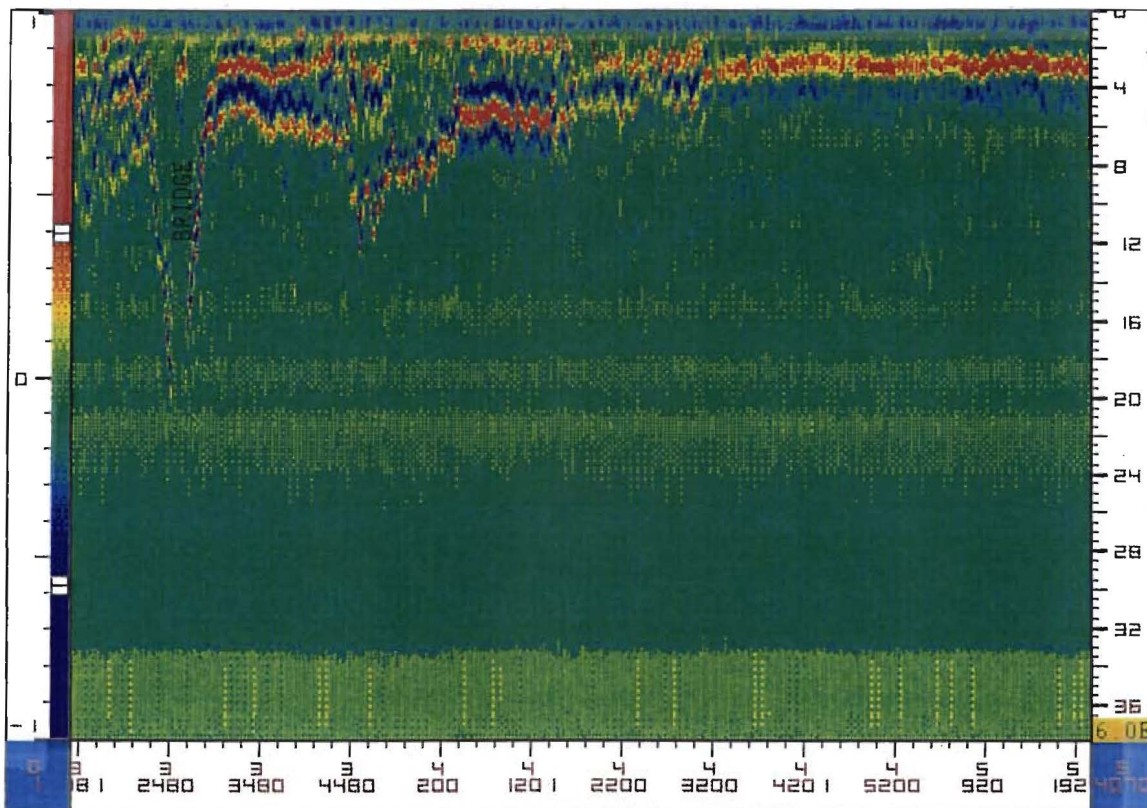
The problem of identifying defects in HMA was discussed earlier in Case 4. In that case the identification of the defect was complicated by the variety of the materials used, some of which produced similar GPR reflections to a low-density type defect such as stripping. On FM 362 the situation is a little easier to detect. Figure 24 shows the COLORMAP display from a section of FM 362. The plans sheets show around 75 mm of HMA with localized thickening close to bridges. The bridge is observed in the data around 3 mi + 2,500 ft from the start of testing. The 75 mm (3 in) thick section begins around 4 mi and 3,200 ft. Between these two locations the HMA thickness is variable.

Figure 24. Case 7 Defects in HMA (FM 362, Houston).

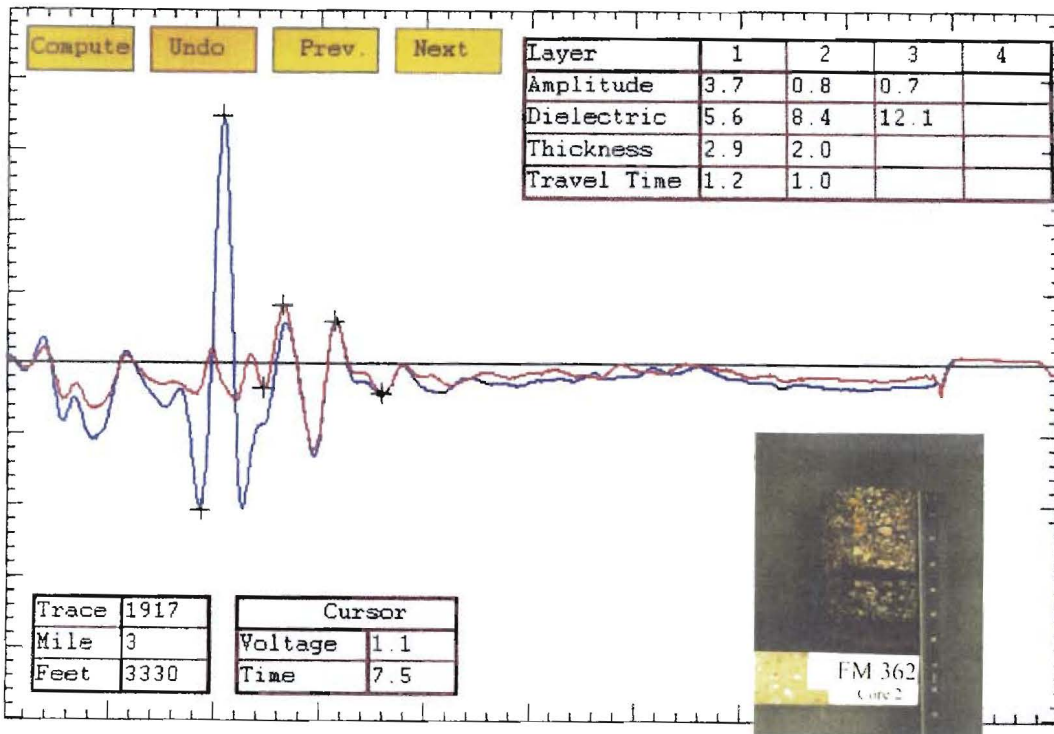
Figure 25. GPR Traces from Core Locations.

The GPR trace from the 75 mm section (Figure 25b) is viewed as an ideal GPR reflection from a thin HMA on top of a dry (good) flexible base. The trace consists of two positive reflections, one from the surface the other from the top of the flexible base. The computed thickness and dielectric values shown in Figure 25b are reasonable and the core was homogeneous defect free.

The trace from the thicker section nearer the bridge was somewhat more complex as shown in Figure 25a. The trace has three positive peaks and an overlapping negative peak between positive peaks 2 and 3. All that can be inferred from this trace is that approximately 3 in below the surface a layer with a lower dielectric will be found. In this instance it turned out to be a thin stripped layer as shown on the photograph. When complex overlapping reflections are found in GPR signals, it becomes difficult to make an accurate estimate of total GPR thickness. In these cases the best estimate is probably to assume a constant dielectric for the entire layer such as is done in the COLORMAP display shown in Figure 24 where an asphalt dielectric of 6 is assumed. For complex traces such as Figure 25a with this simplifying assumption the computed thickness is typically within 10% of the actual.

a. Defect in HMA.

b. No Defect Trace.

With traces such as those shown in Figure 25b, a dielectric value is computed for each reflection received from the amplitude of surface reflection from each layer. Experience has shown that with traces similar to this thickness, estimates from GPR will be within 5% of the actual core thickness.
