1. Report No. FHWA/TX-98/1804-4	2. Government Accession No.	3. Recipient's Catalog No.	
4. Title and Subtitle NCHRP REPORT 350 TEST 3-11 OF THE TEXAS TYPE T6 BRIDGE RAIL		5. Report Date July 1998

**NCHRP REPORT 350 TEST 3-11 OF
THE TEXAS TYPE T6 BRIDGE RAIL**

Letter Report 1804-4
Research Project Number 0-1804
Research Project Title: Evaluation and Testing of Bridge Rails
and Transitions to NCHRP Report 350 Criteria

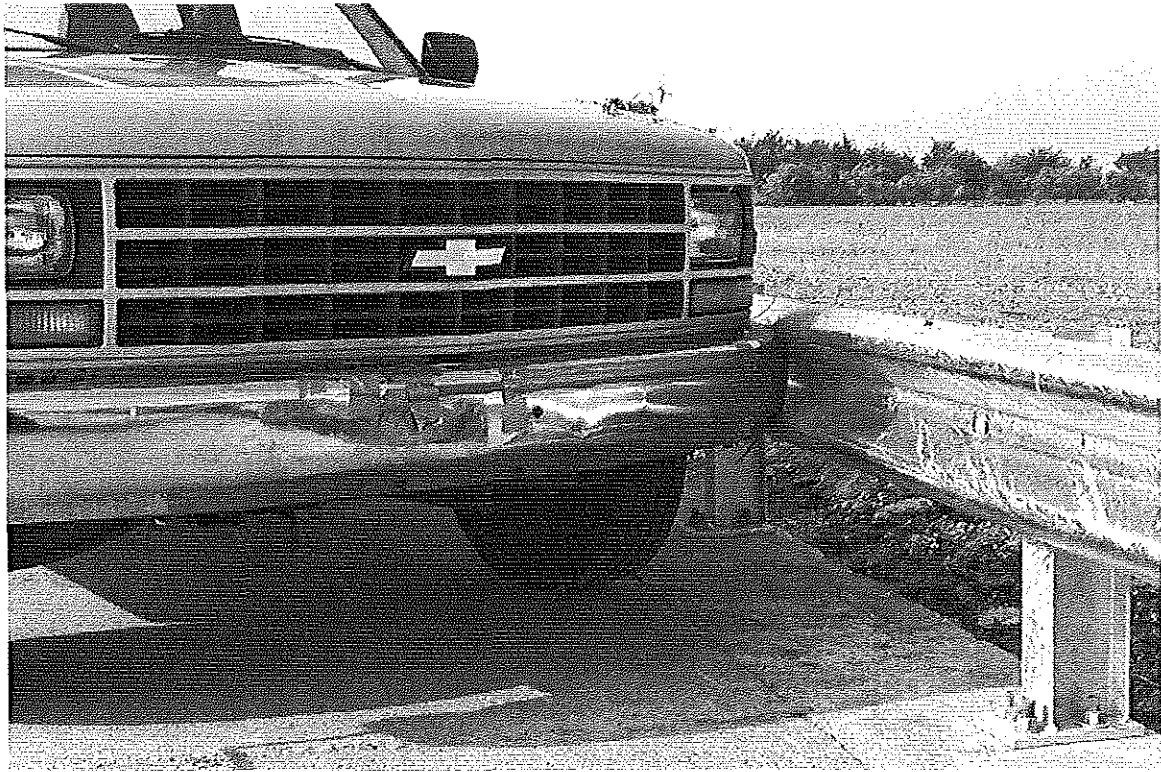
Figure 3. Vehicle/Installation Geometrics for Test 418048-2

A 1993 Chevrolet 2500 pickup, shown in figures 3 and 4, was used for the crash test. Test inertia weight of the vehicle was 2000 kg and its gross static weight was 2000 kg. The height to the lower edge of the vehicle bumper was 400 mm and it was 620 mm to the upper edge of the bumper. Additional dimensions and information on the vehicle are given in figure 5. The vehicle was directed into the installation using the cable reverse tow and guidance system, and was released to be free-wheeling and unrestrained just prior to impact.

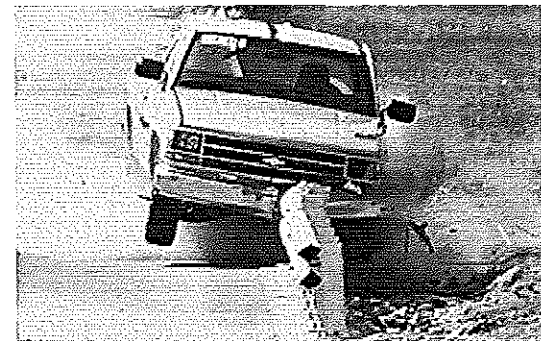
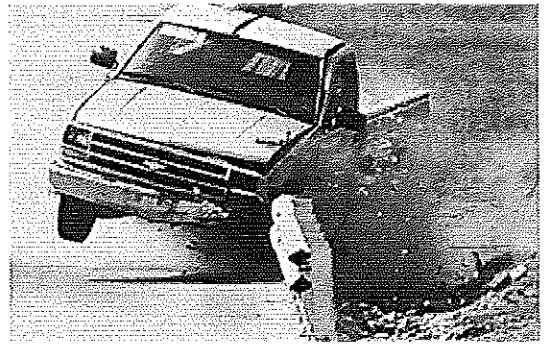
**Figure 6. Sequential Photographs for Test 418048-2
(Overhead and Frontal Views)**

The vehicle, traveling at 99.9 km/h, impacted the Texas Type T6 bridge rail 1170 mm downstream from post 6 at a 26.6 degree angle. At 0.030 s, the left front bumper deformed as it contacted the rail, and post 7 moved. The vehicle redirected at 0.039 s as it was traveling 73.5 km/h. At 0.043 s, the left front tire contacted post 7 as the post was deforming toward the field. The tire snagged on post 7 and deflated as it was under the rail at 0.078 s. At 0.088 s, post 8 separated from the bridge deck, was thrown to the field side of the rail at 0.125 s, and then bounced back under the rail element. Post 9 separated from the bridge deck at 0.145 s. The vehicle's right front tire lost contact with the ground at 0.170 s. Post 9 was thrown to the field side of the rail at 0.200 s and then bounced back into the traffic lanes. Shortly afterward, the left rear tire contacted the rail near post 9. At 0.256 s the vehicle was parallel with the rail and was traveling at 73.5 km/h. The right rear tire left the ground at 0.263 s, vehicle's nose pitched down and the vehicle rolled counterclockwise. The right front of the vehicle became airborne at 0.375 s. At 0.559 s the vehicle was traveling 61.6 km/h and lost contact with the rail at a 27.8 degree exit angle. Brakes on the vehicle were not applied. The vehicle subsequently came to rest on its left side at 0.725 s and slid to a stop, resting 41.2 m down from impact and 11.4 m in front of the installation. Sequential photographs of the test period are shown in figures 6 and 7.

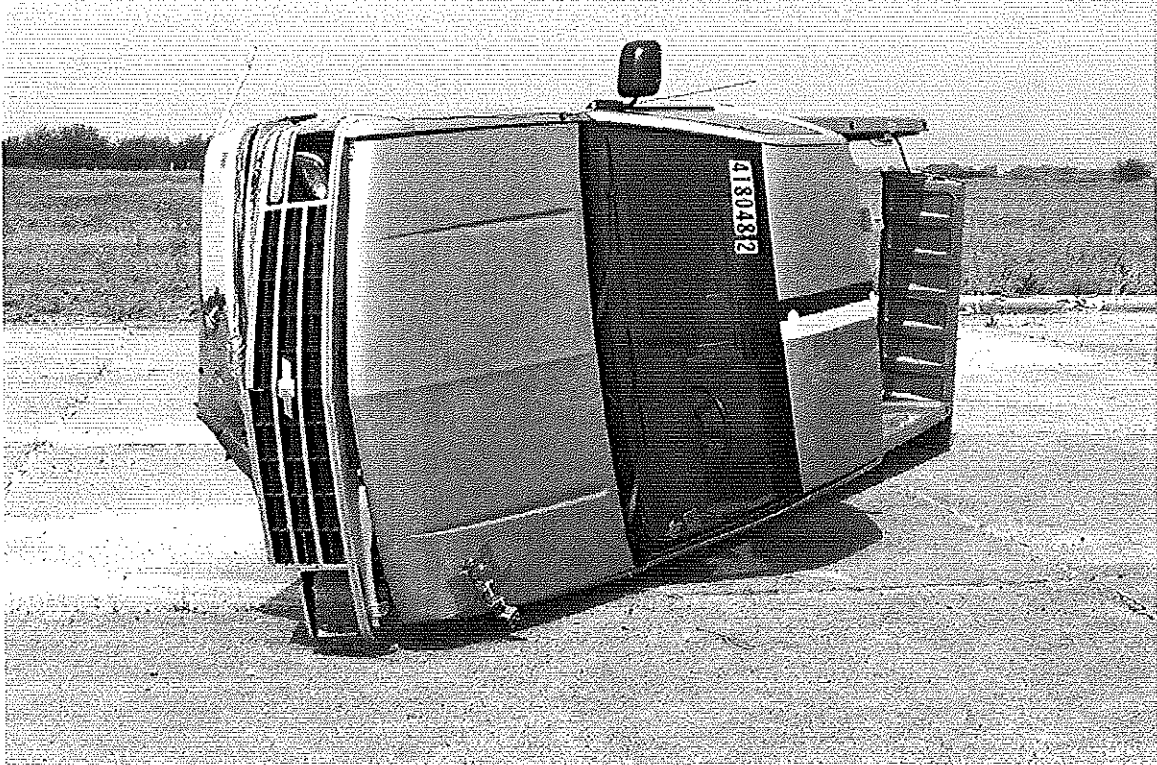
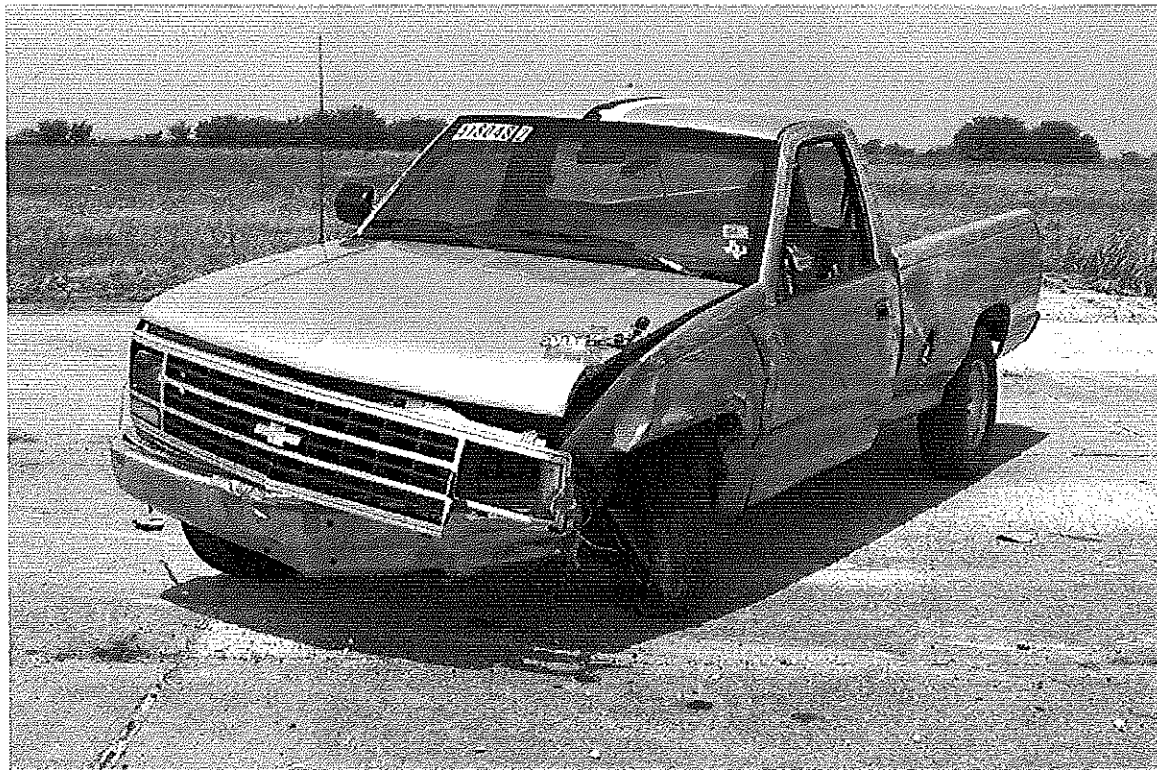
After being uprighted
Figure 11. Vehicle after Test 418048-2

The vehicle after impact with the bridge rail is shown in figures 11 and 12. Structural damage to the vehicle included deformation of the left front of the frame, stabilizer bar, upper and lower left arms, rods, and Pittman arm. The bumper, hood, grill, radiator, left front and rear quarter panels, left door and window, and the left front tire and wheel also received damage. Maximum crush to the vehicle was 570 mm at the top of the front bumper on the left side. Maximum occupant compartment deformation was 20 mm (6.5 percent reduction in space) in the floor pan area. These measurements were taken at points of reference taken prior to the test. The interior of the vehicle is shown in figure 13. Exterior crush and occupant compartment measurements are shown in tables 1 and 2.

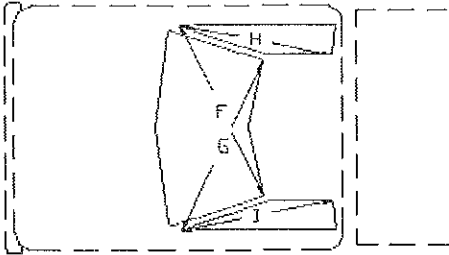
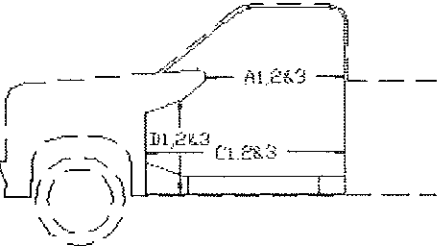
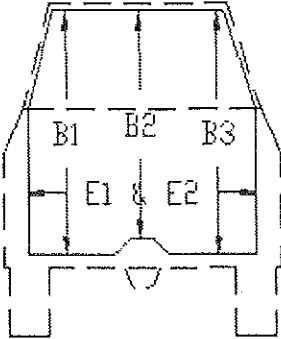
Table 2. Occupant Compartment Measurements for Test 418048-2

A1 <u>1037</u>	<u>1037</u>
	A2 <u>1084</u>	<u>1084</u>
	A3 <u>1041</u>	<u>1041</u>
	B1 <u>1078</u>	<u>1060</u>
	B2 <u>1041</u>	<u>1030</u>
	B3 <u>1080</u>	<u>1080</u>

C1 <u>1373</u>	<u>1355</u>
	C2 <u>1233</u>	<u>1233</u>
	C3 <u>1375</u>	<u>1375</u>
	D1 <u>310</u>	<u>290</u>
	D2 <u>97</u>	<u>90</u>
	D3 <u>312</u>	<u>312</u>

E1 <u>1592</u>	<u>1582</u>
	E2 <u>1595</u>	<u>1580</u>
	F <u>1475</u>	<u>1475</u>
	G <u>1475</u>	<u>1475</u>
	H <u>900</u>	<u>900</u>
	I <u>900</u>	<u>900</u>
