EVALUATION OF ASPHALT-RUBBER INTERLAYERS

Research Report 187-20F
Research Study Number 1-10-77-187.4
Study Title: Monitoring Asphalt-Rubber Test Pavements

May 1993
Revised February 1994

TEXAS TRANSPORTATION INSTITUTE
Texas A&M University System
College Station, Texas 77843-3135

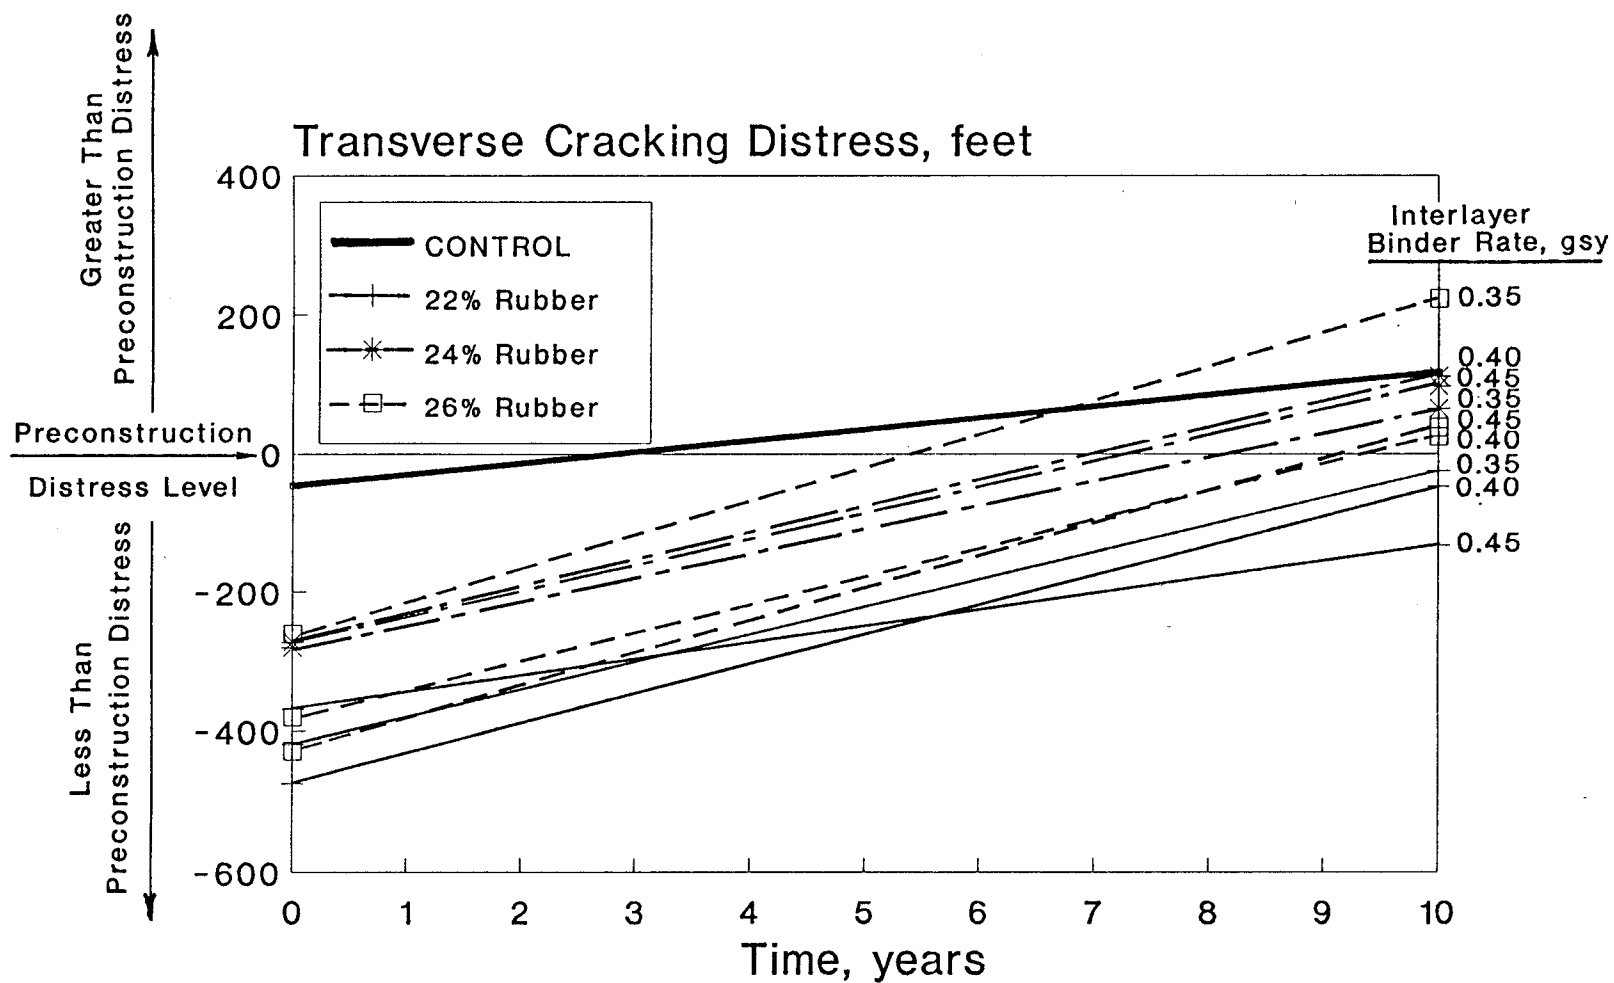
combination with respect to reducing transverse cracking. The next best combination is concentration 26 for binder rates 0.40 (1.8 l/m²) or 0.45 (2.0 l/m²). Figure 5 depicts these models. The point at which these lines cross the zero axis is the time at which these sections reached their preconstruction distress levels. Table 4 lists these times in years. Thus we see that the control section is actually the worst in that these sections reach their preconstruction distress levels in 2.8 years. Of course, this is also due to the fact that these sections did not have much preconstruction distress, as noted earlier. Concentrations of 22 took the longest to reach preconstruction distress levels, regardless of the binder rate. However, keep in mind that only for binder rate 0.40 (1.8 l/m²) can this be stated with any degree of reliability. In general, examining these lines it would appear that concentration is a more significant factor in transverse cracking performance than binder rate, and the middle concentration rate appeared to be the least effective.

Figure 5. Time to Reach Preconstruction Transverse Cracking Level for El Paso Test Sections.

It appeared that the fairest measure of how well a treatment performed was the length of time required for the pavement to reach its preconstruction distress level. Using this measure, the control section which had no interlayer performed worse than all of the interlayer sections. However, the control section was not a good control for the treated sections in that it had very little distress to start with and then changed very little over the entire study period (low cracking rate). The asphalt-rubber interlayer sections were more distressed to begin with, and so even though the cracking rates were higher, they performed better, relative to their preconstruction status.

Rubber concentrations of 22, 24, and 26 percent by total weight of binder were evaluated. Concentrations of 22 percent all had the longest time periods to reach the preconstruction distress level, regardless of the binder application rate. However, only for one of the test sections can this be stated with any degree of reliability. In general, it appears that rubber concentration is a more significant factor than binder application rate in reducing reflection cracking.
