1. Report No. FHWA/TX-94/187-23	2. Government Accession No.	3. Recipient's Catalog No.	
4. Title and Subtitle MONITORING OF CEMENT STABILIZED SOIL RETAINING WALLS		5. Report Date November 1993

**MONITORING OF CEMENT STABILIZED  
SOIL RETAINING WALLS**

**Research Report 187-23  
Research Study Number 0-187, Task 8  
Research Study Title: Monitoring of Cement  
Stabilized Retaining Walls**

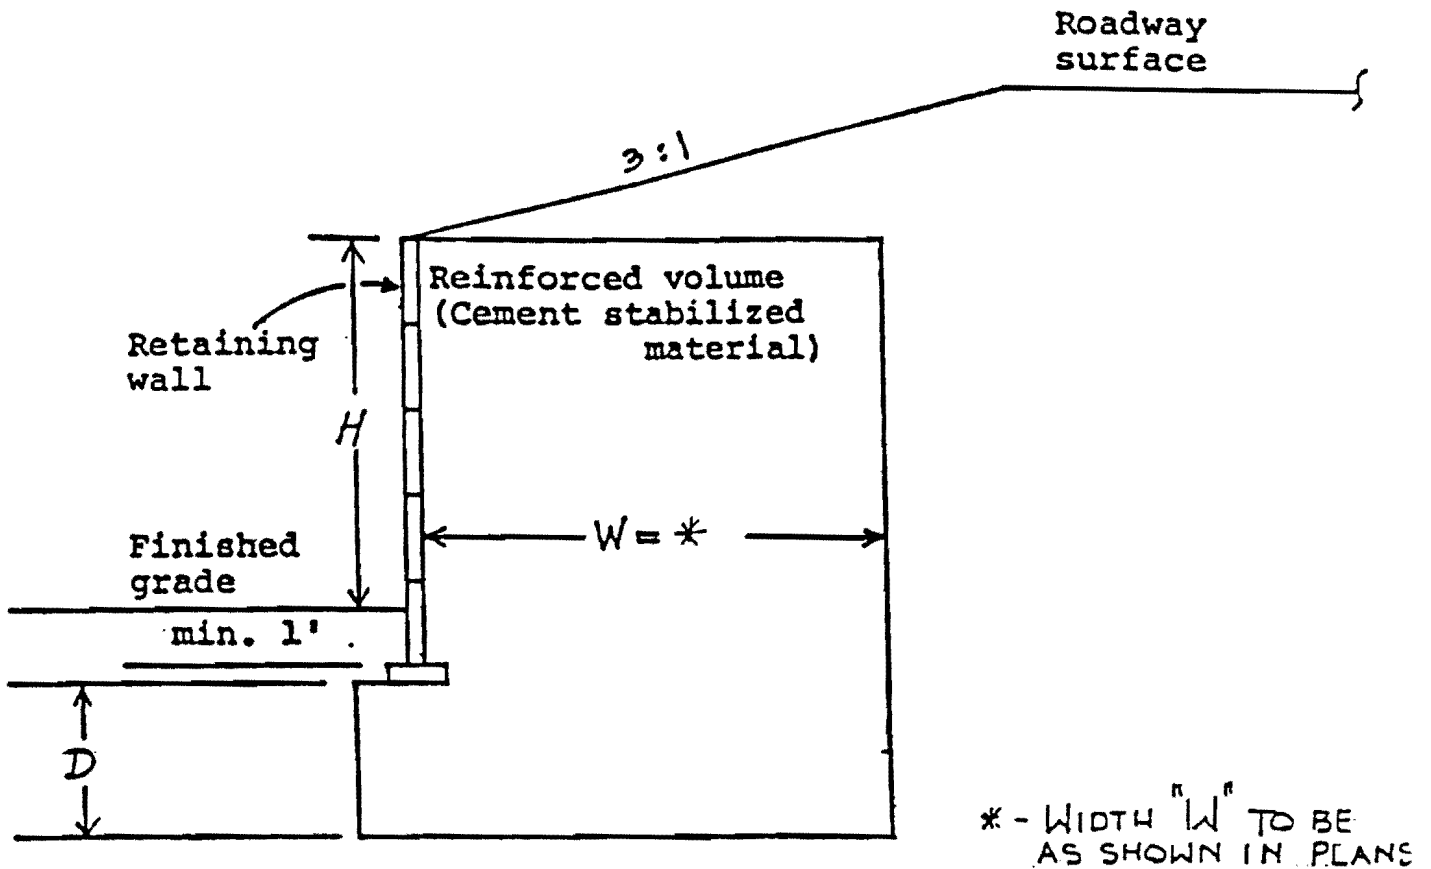
Figure 3.1 Cross-section of wall 9

Section view

At wall 9 two vertical inclinometers were initially installed, one in the stabilized fill

and the other in the soil (Figure 3.1), although the vertical inclinometer in the soil was later damaged and useful readings were never obtained from this unit. The capped end of the inclinometer casings were installed to a depth equivalent to the existing ground surface. The grooves of the casings were aligned parallel (i.e., N-S) and perpendicular (i.e., E-W) to the wall. Stabilized fill and soil were placed in lifts around the inclinometer casings, depending upon their location, to provide support. Figure 3.6 shows a photograph of the installation of the vertical inclinometers.
