APPROACH-END TREATMENT OF CHANNELIZATION--
SIGNING AND DELINEATION

An Interim Report on
Project HPS-1-(27)-J

TEXAS TRANSPORTATION INSTITUTE

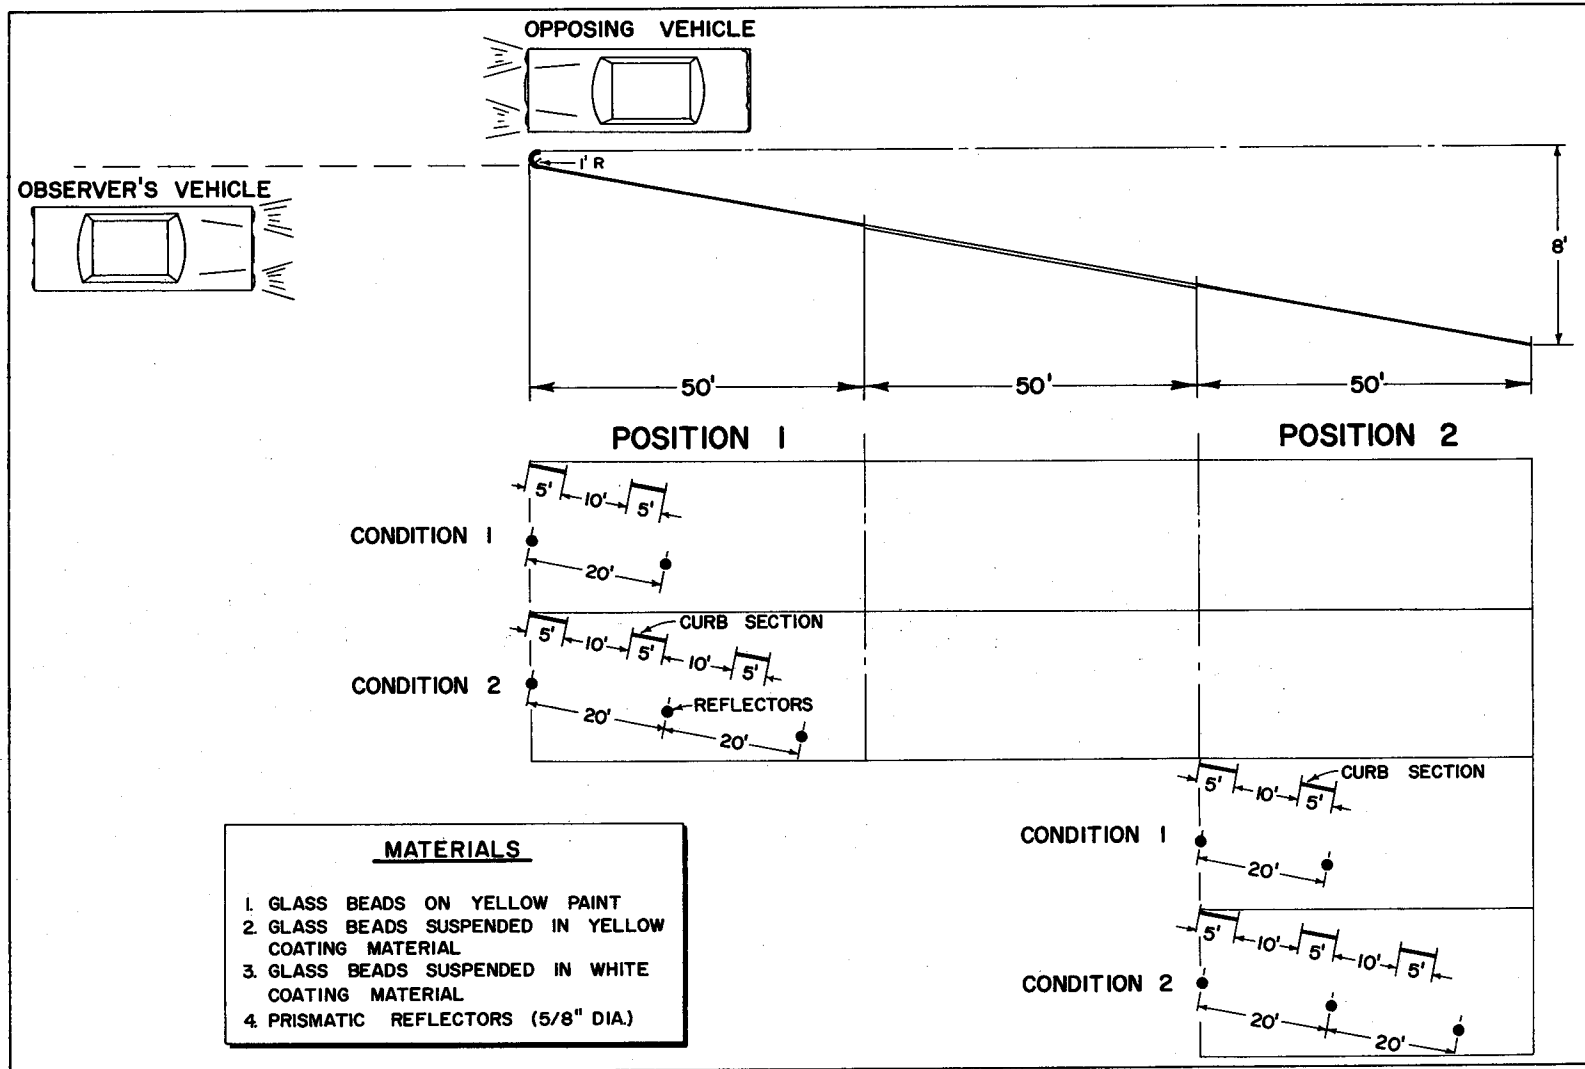
FIGURE 1

To simulate a channelizing island, curb sections, 5 feet in length, were constructed of wood and shaped to resemble a barrier-type island curb. The curb sections were coated with the various materials to be tested. The prismatic reflectors were mounted in wooden blocks that could easily be aligned with the path of the test vehicle. To form the approach-end of the island, an island nose was shaped from sheet metal and reflectorized, and either the curb sections or the reflectors were placed along a line from the island nose tapered for a lateral transition of 8 feet in 150 feet of length. The details of the island layout and the test conditions are shown in Figure 1.

PLAN OF DELINEATION TEST SITE

The materials were tested at two positions along the taper to determine any effects of the relative position of the materials with respect to a vehicle with opposing headlights at the island nose. As indicated in Figure 1, Position 1 consisted of placing the curb sections and the reflectors in the 50-foot section of the taper immediately following the island nose. For Position 2, the curb sections and reflectors were placed in the third 50-foot section of the taper as shown.

To test the effect of length or continuity of the delineation provided by the materials, two test conditions were established. Condition 1 consisted of two curb sections placed ten feet apart, or two reflectors placed 20 feet apart. For the Condition 2, three curb sections or three reflectors were used at the same spacing. These conditions are illustrated in Figure 1.

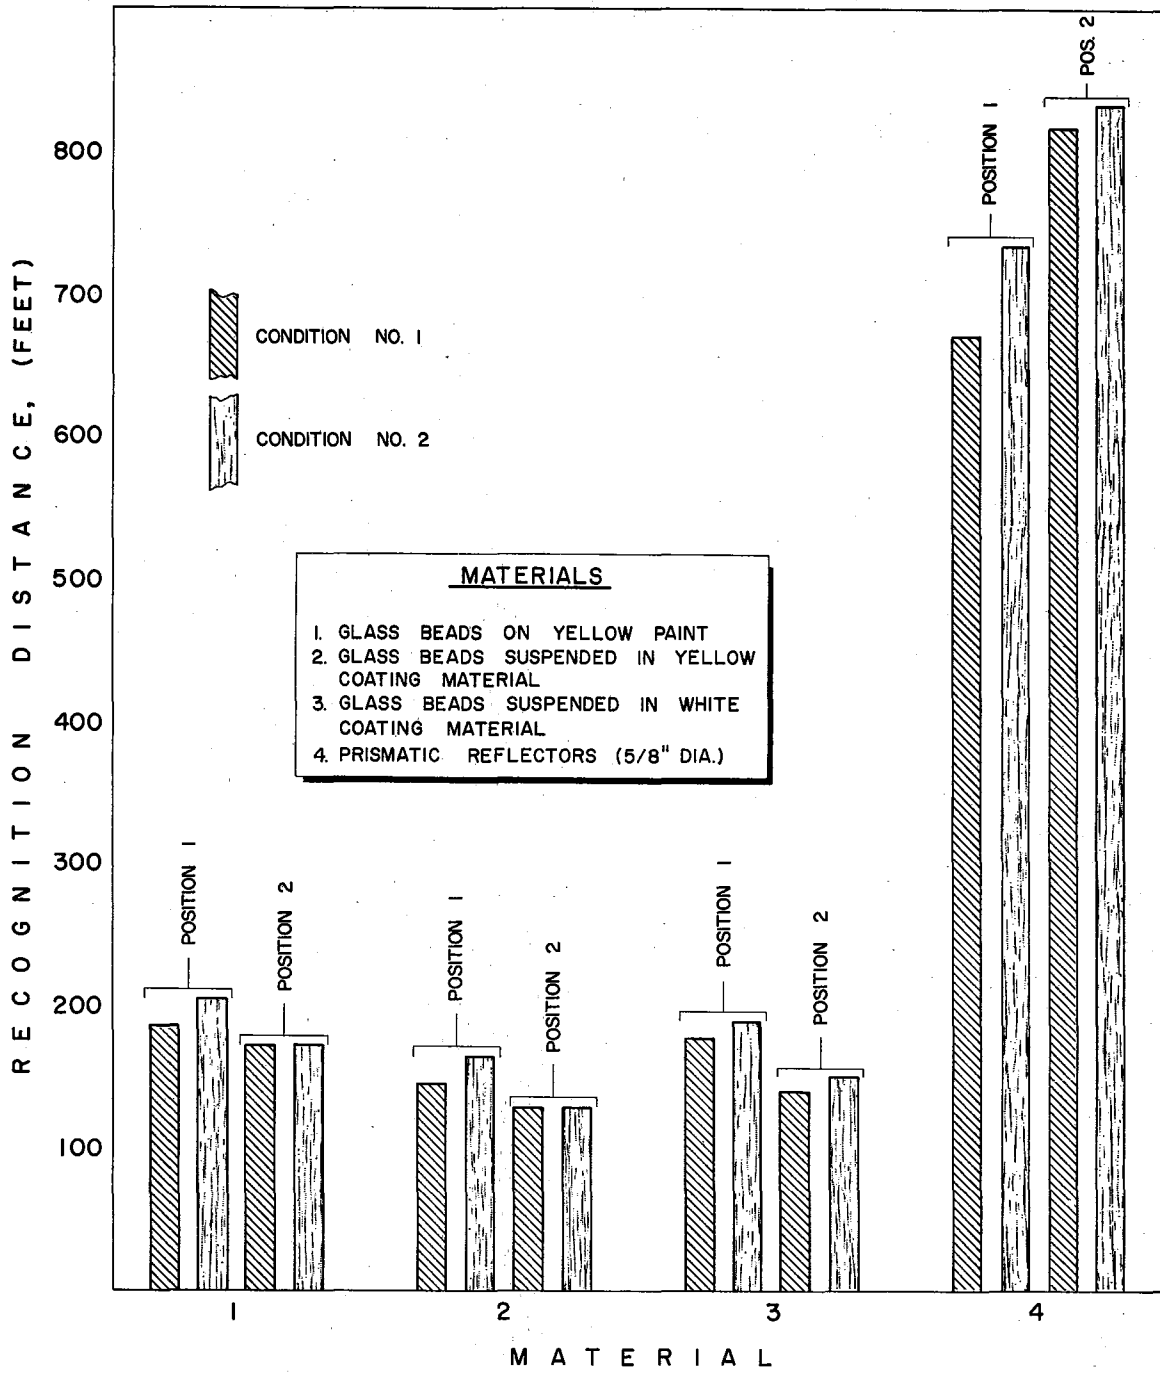
FIGURE 2

The results of the study shown graphically in Figure 2 indicate that the prismatic reflectors were visible at distances three to four times those of the other materials. These results show further that there was no appreciable difference in the visibility distances of any

**VISIBILITY DISTANCE OF CURB
DELINEATION MATERIAL**

of the coating-type materials. Actually, Material 1, beads-on-paint, was visible at a greater distance than the other two coating materials. However, the visibility distances of all three materials were below what could be considered acceptable for good delineation. Table A of the Appendix lists the results in detail to provide a more exacting comparison.

A comparison of the visibility distances of the materials according to their position relative to the island nose and hence relative to the opposing vehicle (Positions 1 and 2, Figure 1) showed that the coating-type materials were less effective in Position 2 than in Position 1 (See Figure 2). On the other hand, the visibility distance of the reflectors was increased approximately 100 feet by moving them to Position 2, 100 feet behind the island nose. This increase in performance was attributed to the fact that moving the reflectors 100 feet along the taper also moved them 5 feet laterally and reduced the effect of the "halations" of the lights of the opposing vehicle. The other three materials showed a slight decrease because their reflective power was not great enough to compensate for the increased distance from the light source. The visibility distances were measured from the island nose, rather than from the actual position of the material.

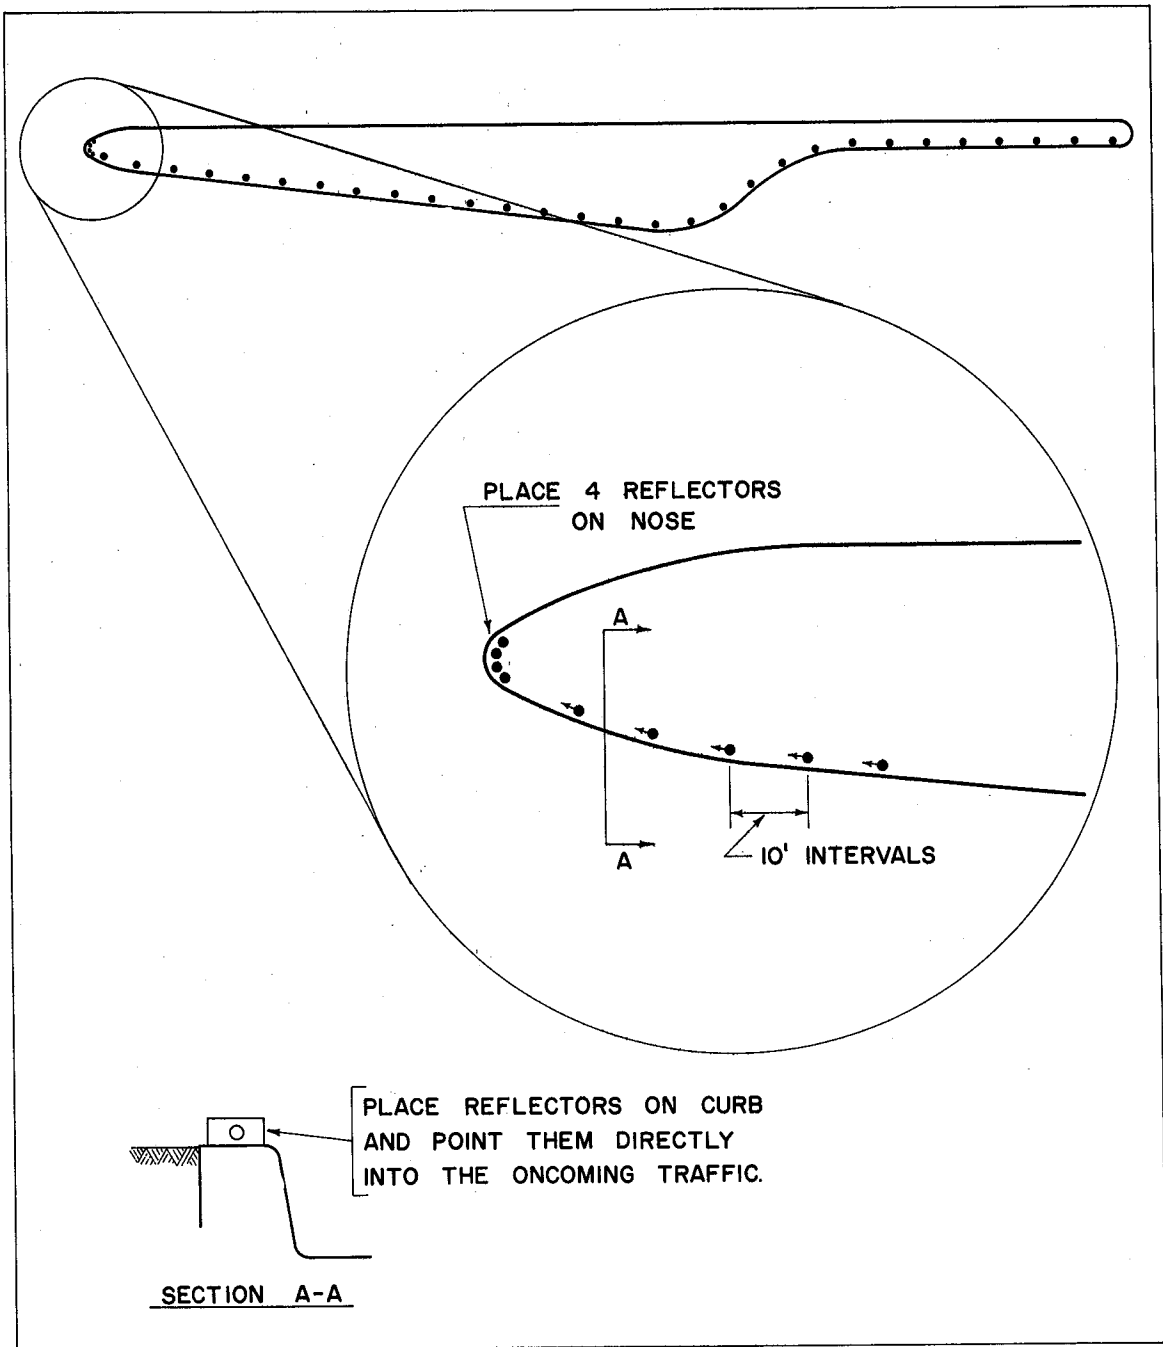
FIGURE 3

INSTALLATION LAYOUT FOR PERFORMANCE STUDIES

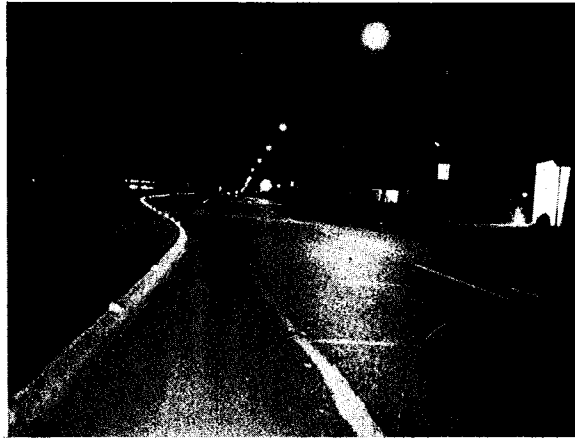
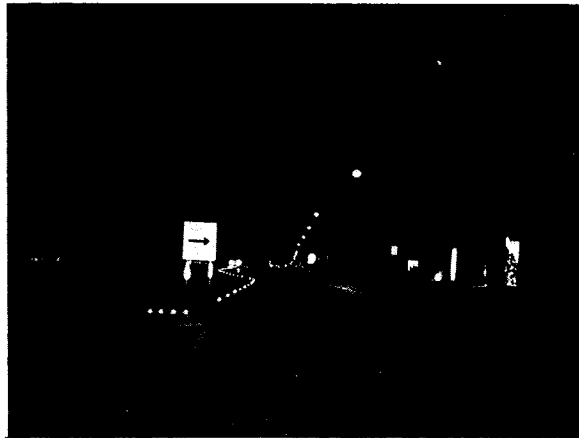
FIGURE 4

The Bryan urban installation is shown in Figure 4. These pictures illustrate the real advantage of the prismatic reflectors. Due to their great range of visibility, the entire divisional island, including the added left-turn lane, is clearly outlined before the driver. As an indication of the range of visibility, the island was approximately 500 feet in length with an opening at 310 feet which can be detected in the photograph. This view is comparable to the driver's view of the island when approaching with high-beam headlights. For low-beam conditions, approximately the same view is seen with slightly less intensity.

NIGHT VIEW OF DELINEATORS AT THE
BRYAN URBAN INSTALLATION

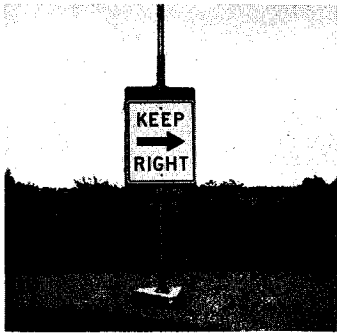
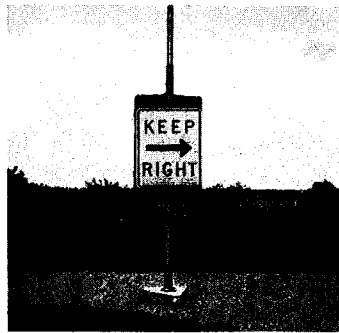
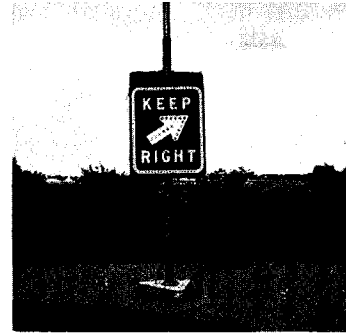
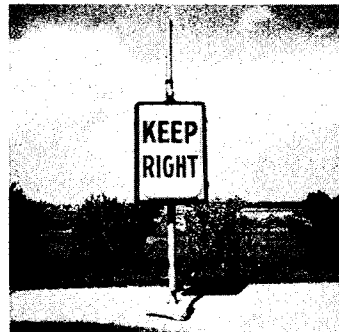
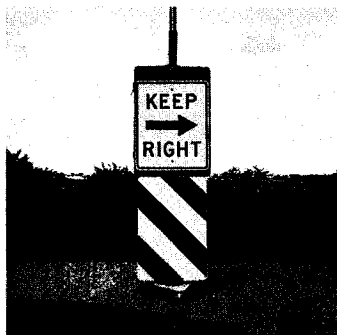
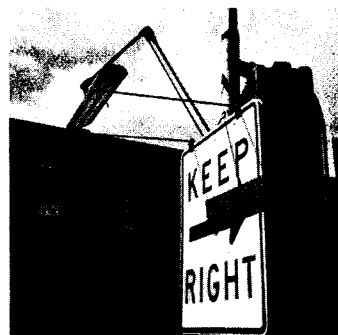
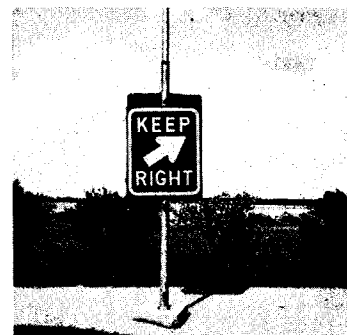
FIGURE 5

The reflective sheeting type of sign construction is represented by sign Number 2 of the selection. Sign Number 7 is of the same type but was tested with external illumination.

TEST SIGNS

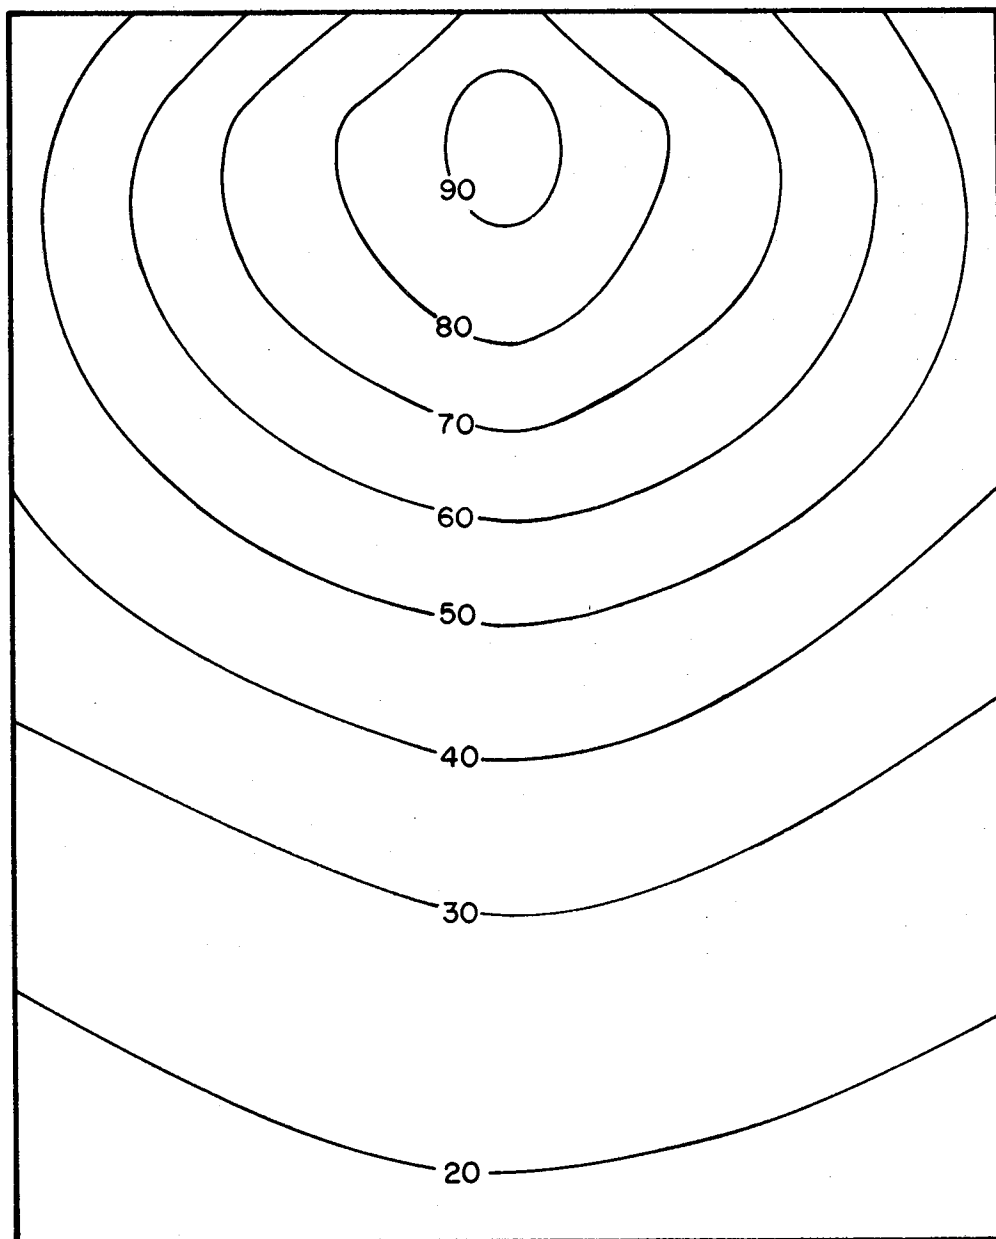
FIGURE 6

LIGHT INTENSITY PATTERN FOR EXTERNALLY
ILLUMINATED SIGN
(SIGN NO. 6, FIGURE 5)
(MEASUREMENTS IN FOOT CANDLES)

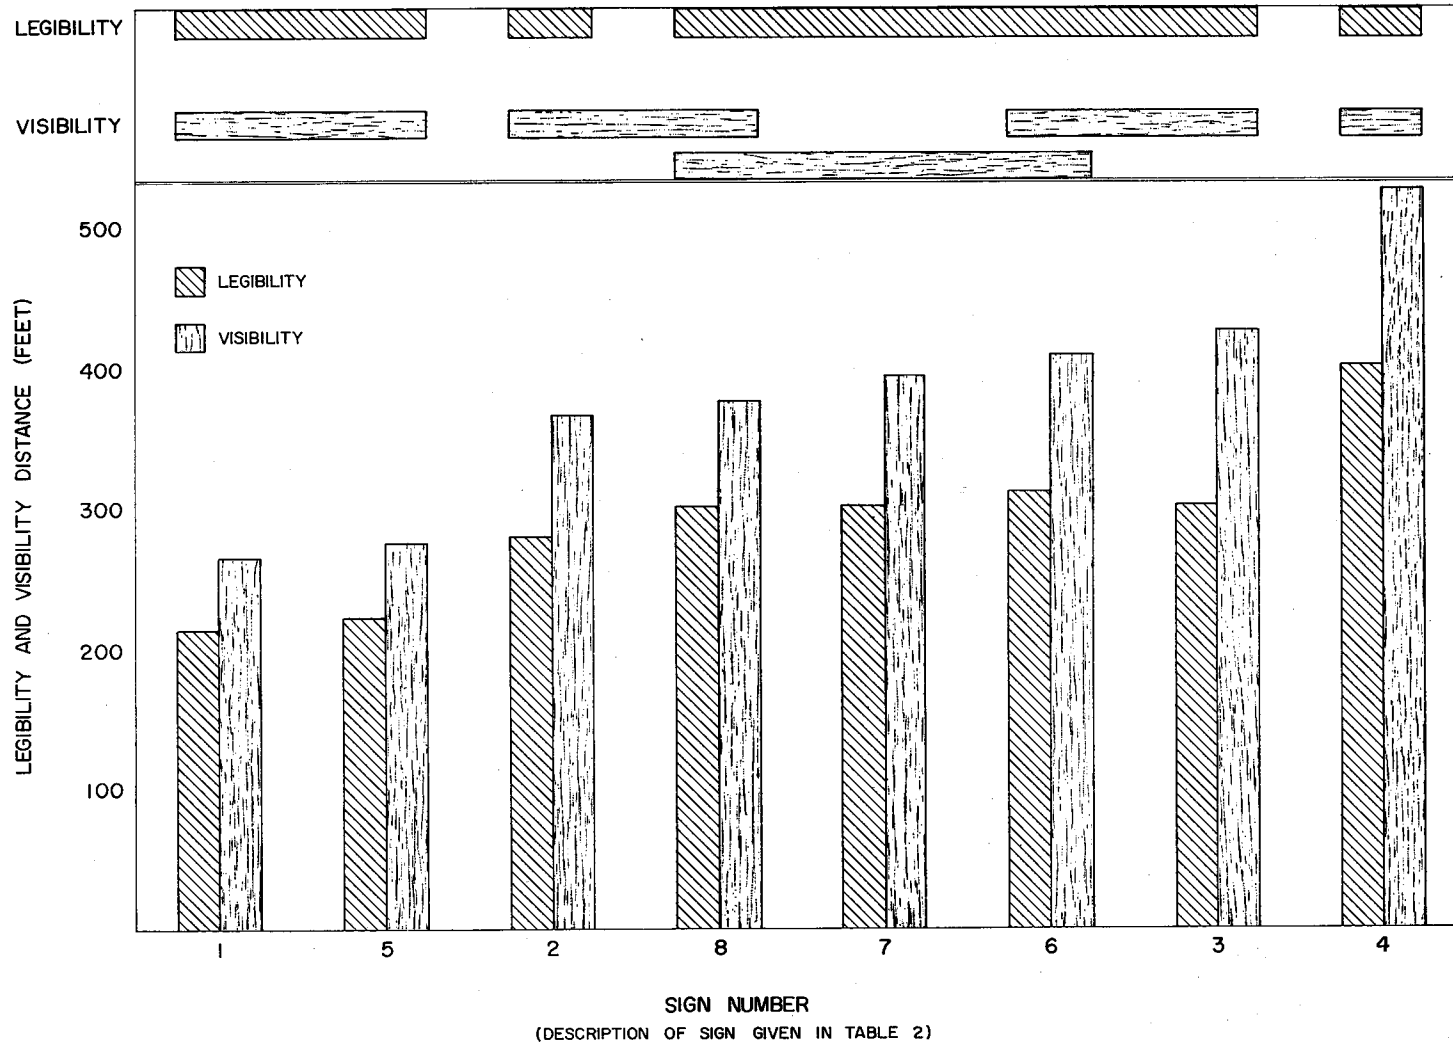
FIGURE 7

The results of the visibility tests on the signs are shown in Figure 7.

LEGIBILITY AND VISIBILITY DISTANCE OF SIGNS TESTED

The results of this test are not completely clear cut, because, as noted, there were overlaps in the ranges at sign Numbers 6 and 8. Actually, these signs can be considered in both of the groups but the groups cannot be combined.

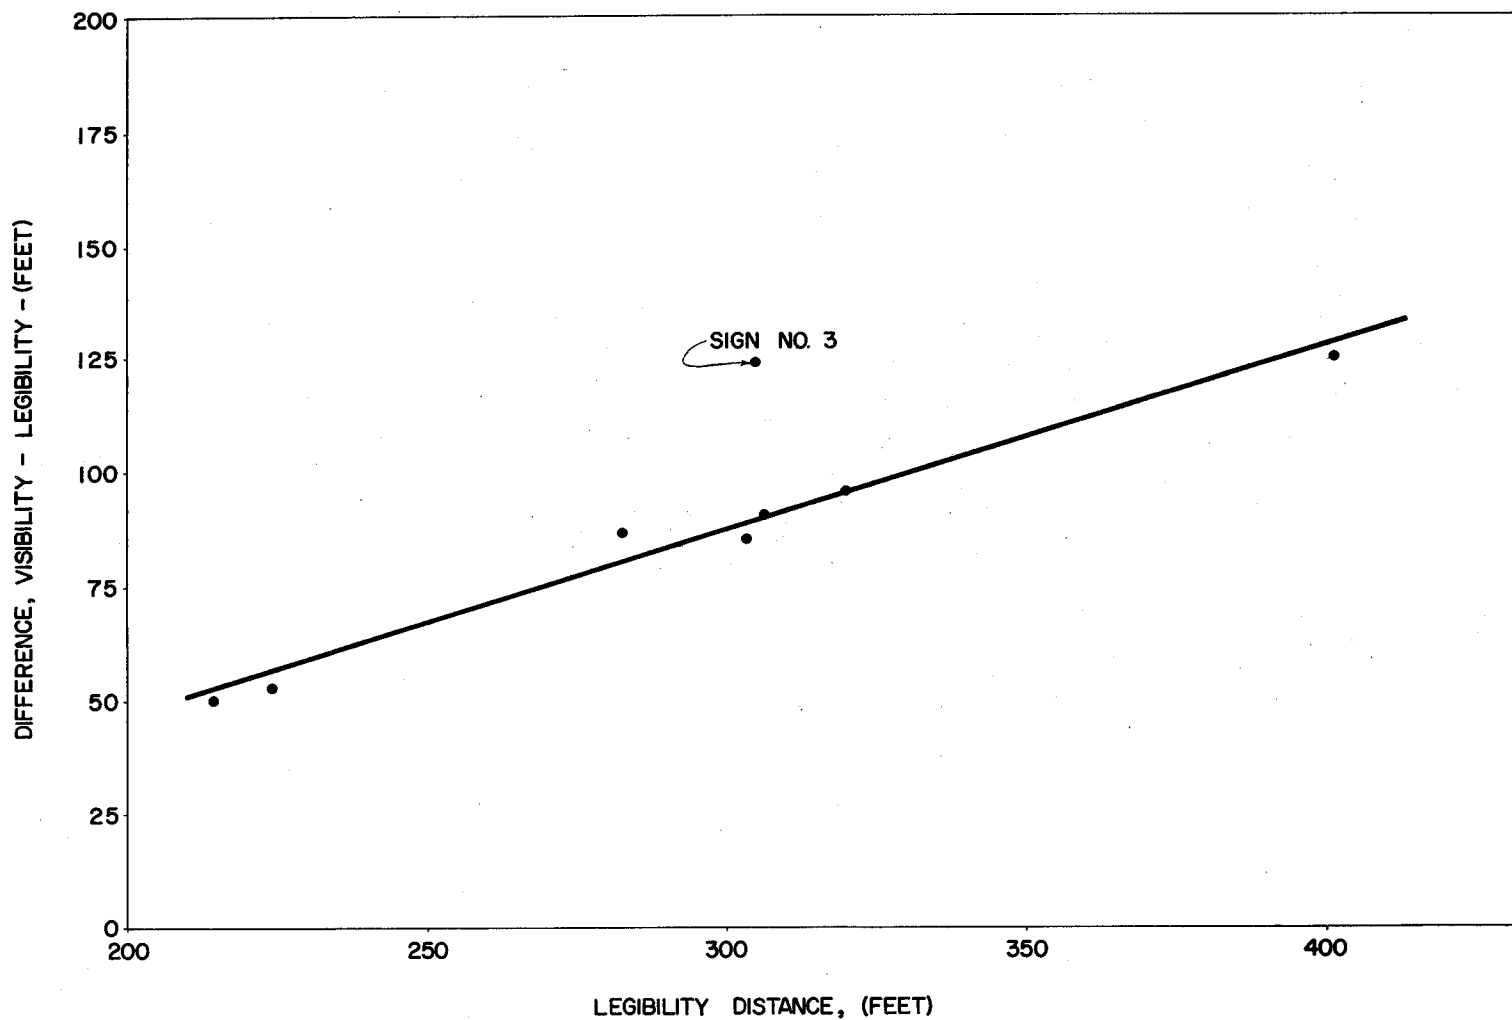
FIGURE 9

RELATIONSHIP BETWEEN VISIBILITY AND LEGIBILITY
DISTANCES OF THE SIGNS

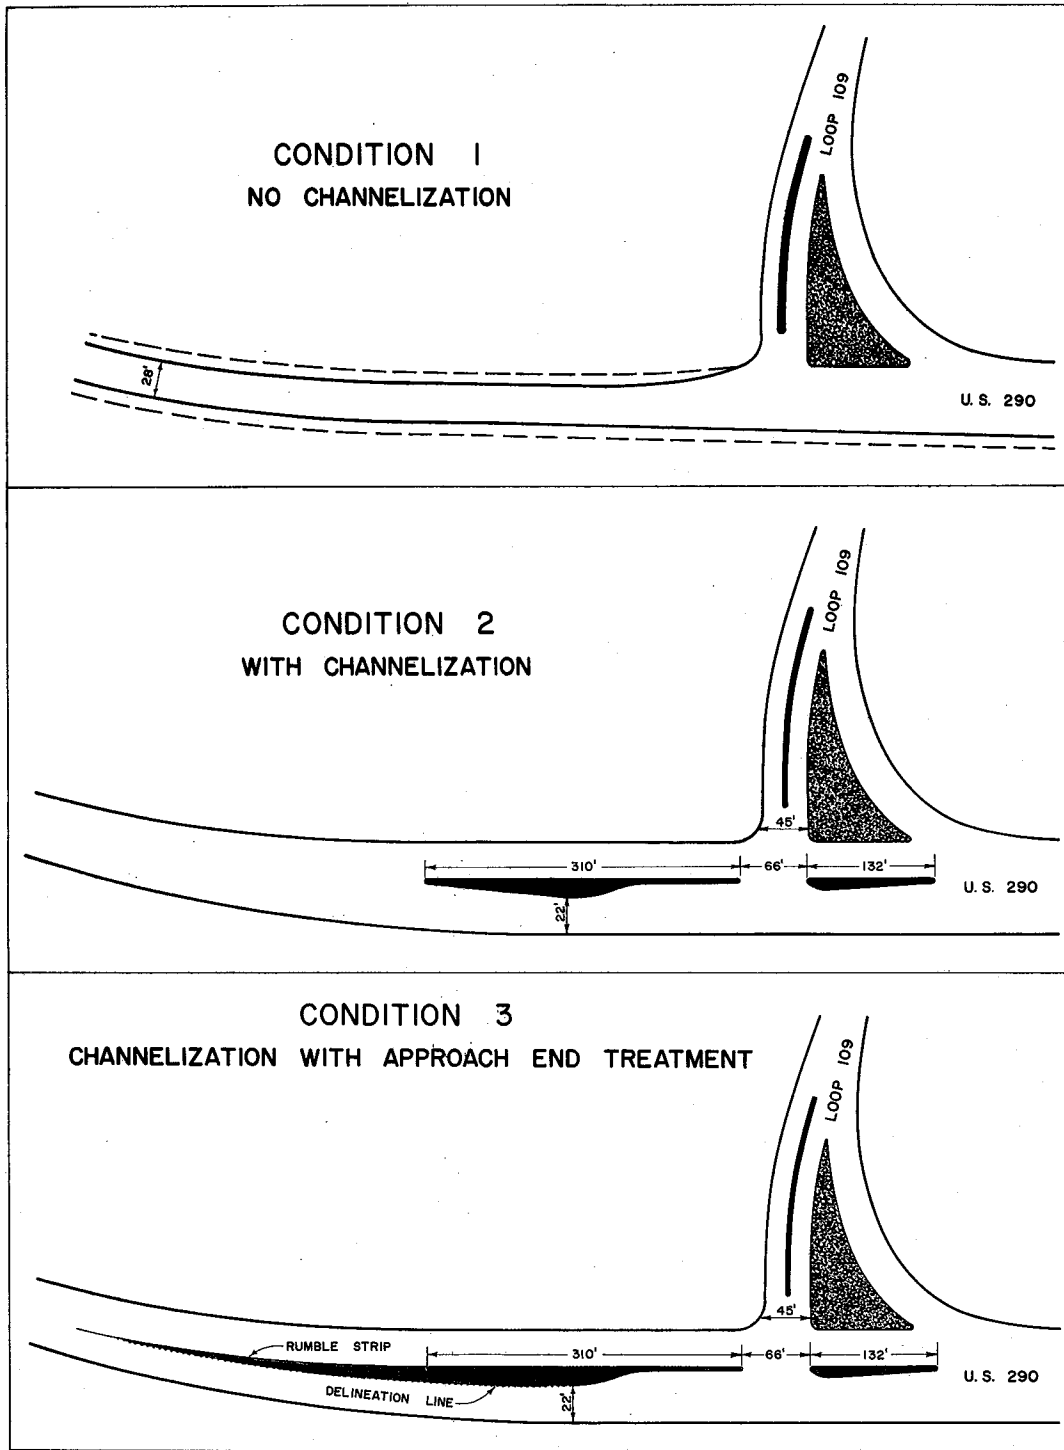
FIGURE 10

PLAN VIEW OF STUDY SITE SHOWING THREE STAGES OF CHANNELIZATION

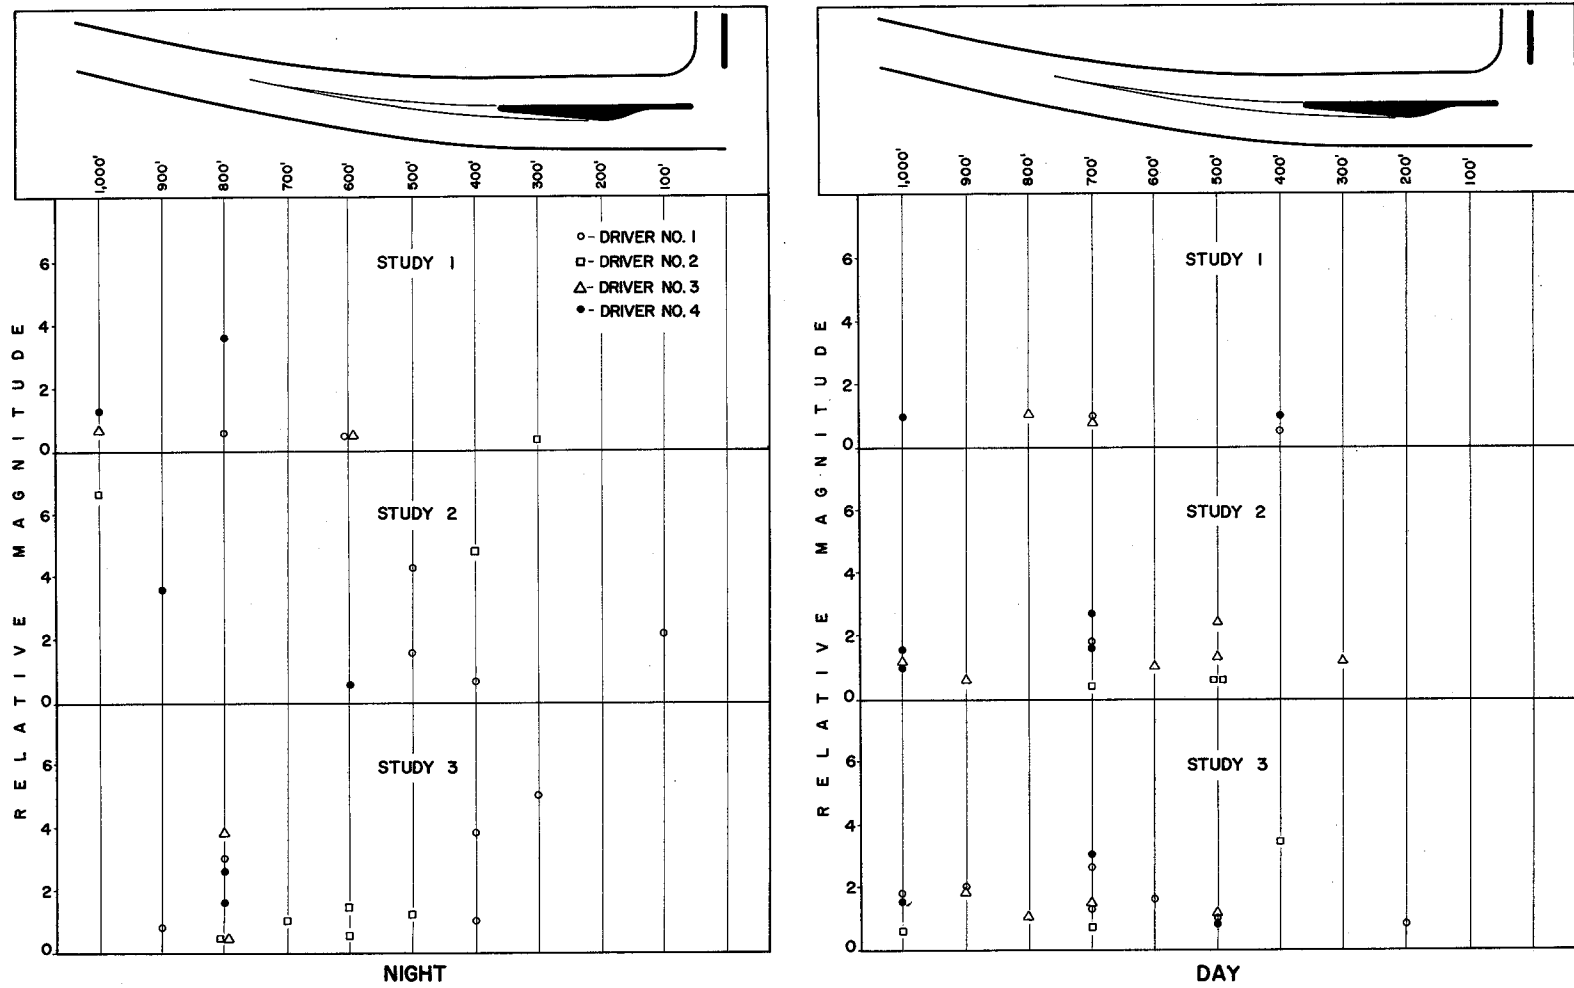
The results of the GSR studies shown in Figure 11 indicate a relatively small number of tension responses in all of the studies for both day and night. It was noted that the number of responses per study ranged from 6 for Study 1 (no channelization-day) up to 17 for Study 3 (channelization with special approach-end treatment). These responses were observed during four runs made by each of four drivers, or a total of 16 runs for each study. Also, two drivers were more responsive than the other two, contributing approximately 65 per cent of the responses. In view

GSR TENSION RESPONSES-THROUGH VEHICLE RUNS

Referring to the results in Figure 11, it can be observed that a greater number of responses were recorded in Study 3 for both day and night runs. These responses were distributed along the general area of the delineation line but showed a greater concentration at a point 800 feet from the intersection. This point corresponded to the beginning of the delineation line. These patterns and the increased number of responses indicate that the special approach-end treatment did serve to forewarn the driver of the introduced channelization and the intersection ahead.

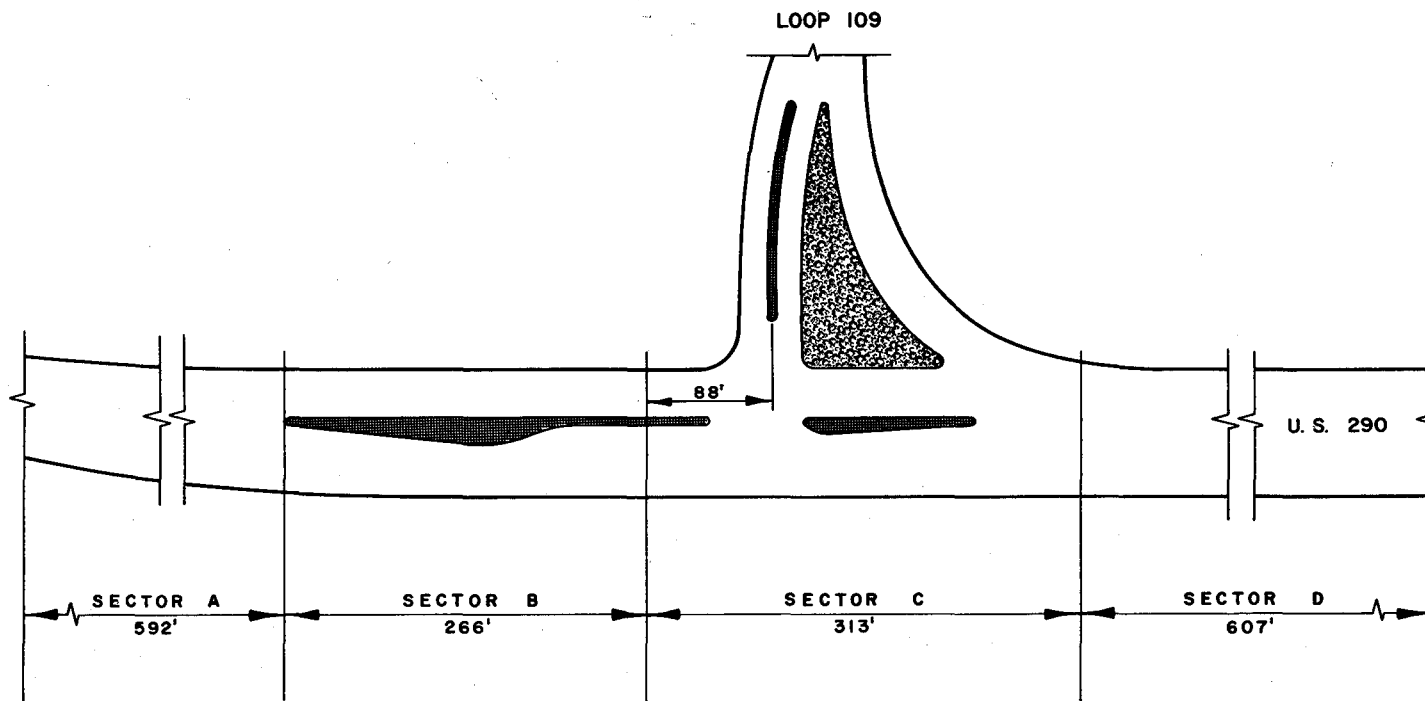
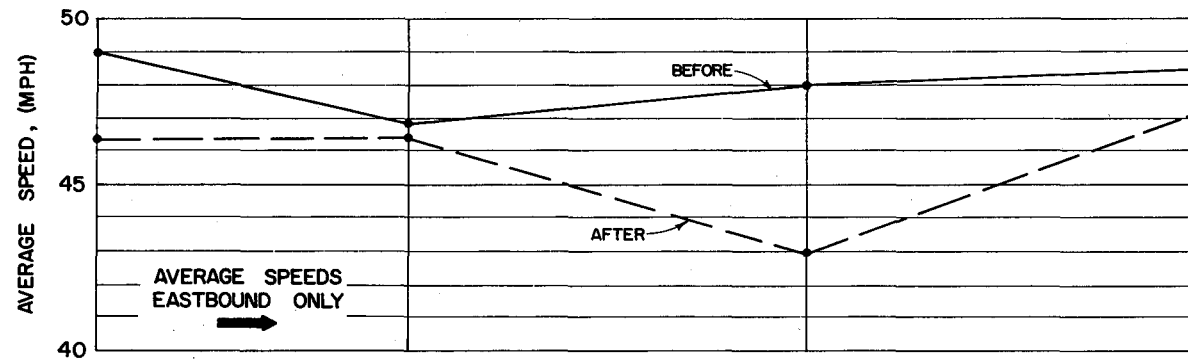
FIGURE 12

INDIVIDUAL VEHICLE SPEED STUDY

As described earlier, the Individual Vehicle Speed Study method was used to measure traffic speeds through four sectors of the study section, as shown in Figure 12. The speeds observed for the "before" and "after" conditions of channelization are shown comparatively in Figure 13. It should be pointed out that this comparison was limited to speeds in the Eastbound direction only.

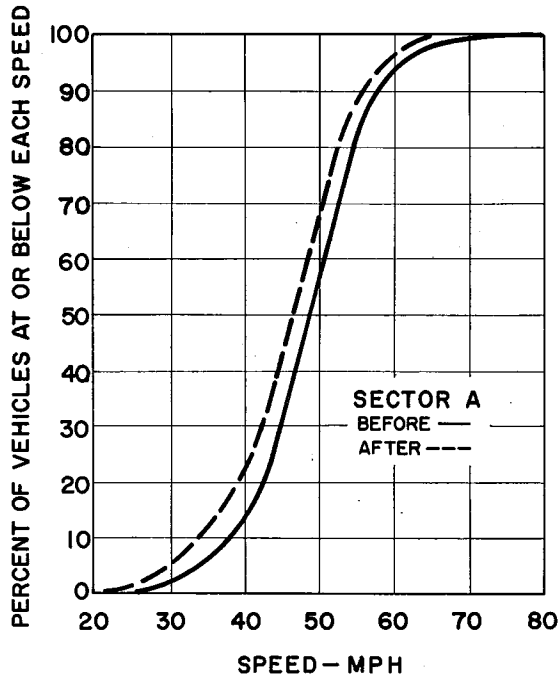
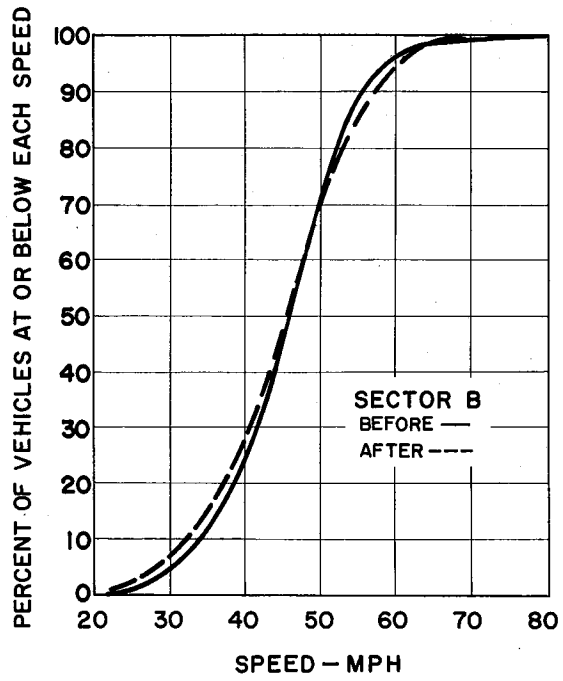
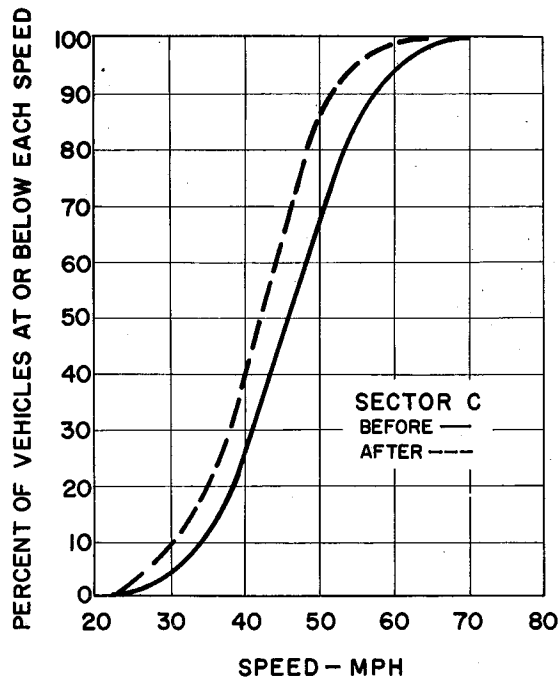
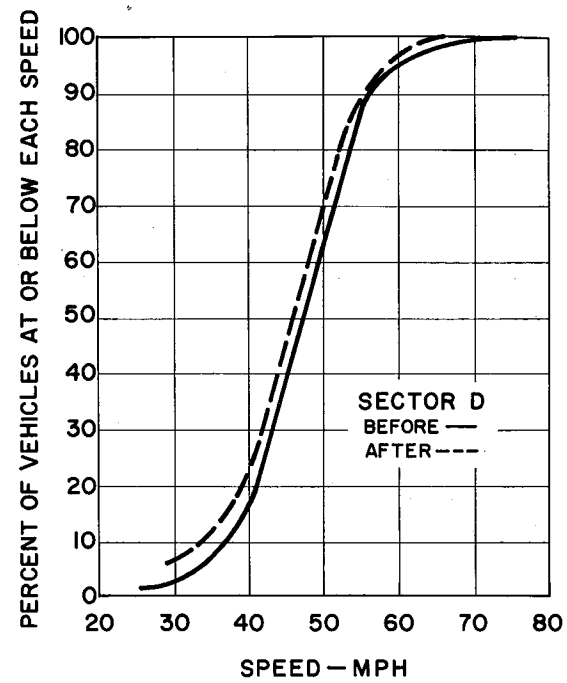
FIGURE 13

Statistical tests utilized in comparing the speed samples for the "before" and "after" conditions showed significant differences in the mean or average speeds in Sectors A and C but not in Sectors B and D. These differences are shown graphically in Figure 12. The difference observed in Sector A indicated that channelization and the special approach-end treatment caused traffic to reduce speed at a greater distance from the intersection. The reduction in speed in Sector C indicated that drivers were made more aware of the potential hazard at the intersection, and did not return to normal speed until they were clear of the channelized section. Before channelization was installed, the drivers returned to normal speed immediately after clearing the intersection. According to these results, channelization has, in effect, extended the "intersection area" to the limits of channelization, and

SPEED DISTRIBUTION CURVES FOR "BEFORE" AND
"AFTER" CONDITIONS OF CHANNELIZATION

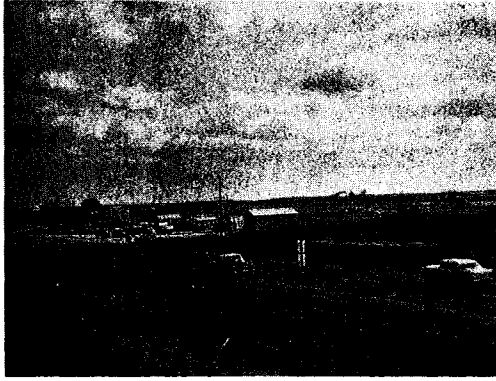
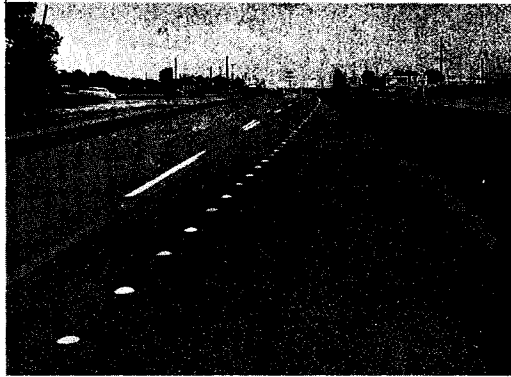
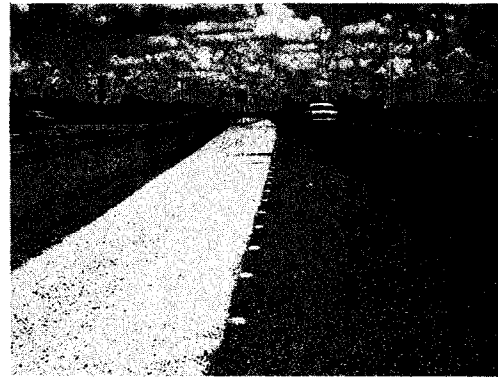
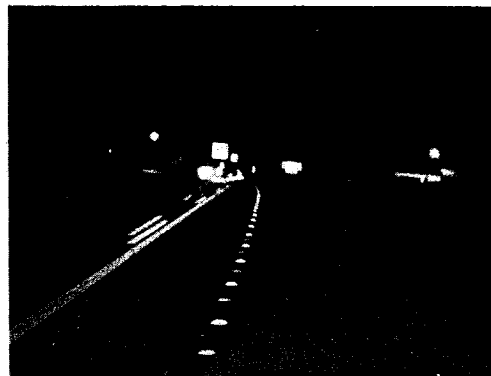
VIEWS OF ELGIN STUDY
FIGURE 14

CONDITION 1 - NO CHANNELIZATION

CONDITION 2 - CHANNELIZATION

CONDITION 3 - DELINEATION LINE

CONDITION 3 - RUMBLE STRIP

CONDITION 3
NIGHT VIEW OF
DELINEATION LINE

was considered to be very effective. Figure 14 shows the relative brightness produced by the delineators.
