**RETROREFLECTIVE RAISED PAVEMENT MARKER FIELD TESTING:
INITIAL INTERIM REPORT**

Research Report 1946-1
Research Study 2-18-92-1946

Division of Maintenance and Operations,
Texas Department of Transportation

TEXAS TRANSPORTATION INSTITUTE
Texas A&M University System
College Station, TX 77843

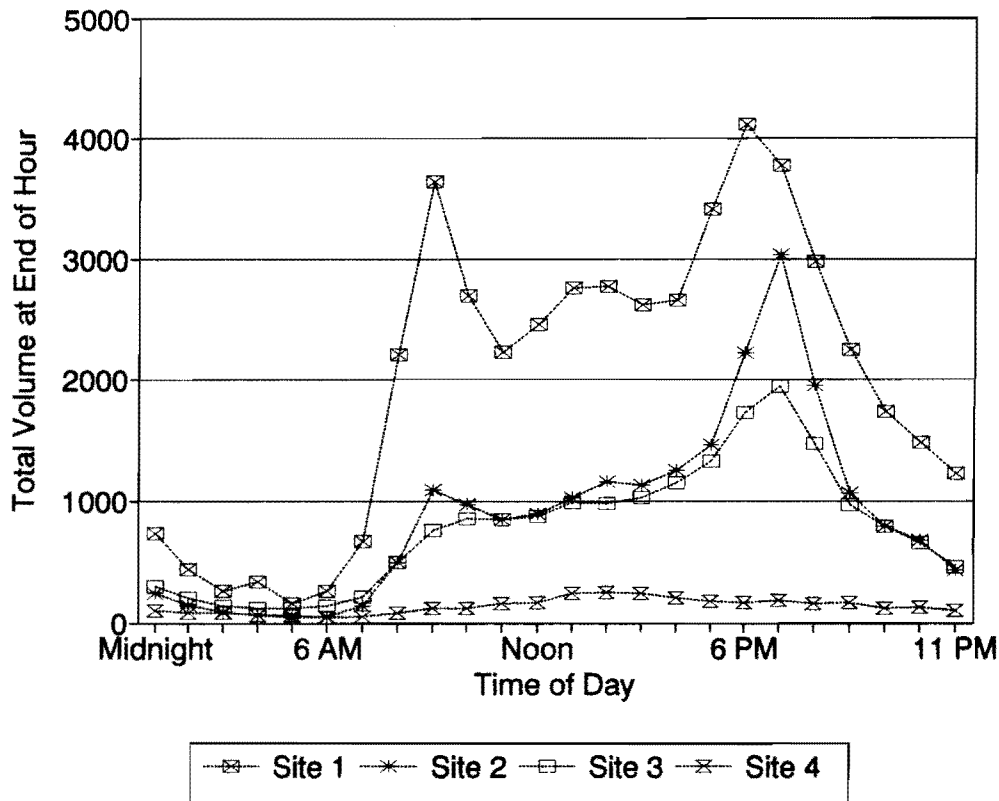
Figure 2. Hourly Traffic Volumes by Site.

Site 2, in comparison, is a radial freeway facility serving outbound commuters, and traffic volumes display a single peak during the afternoon period (see Figure 2). Peak-hour volumes recorded at this site were slightly higher than 3,000 vph. Meanwhile, the total daily volume northbound at site 2 is much less than that of site 1, ranging between 21,200 vpd and 21,400 vpd on the southern and northern ends of the study section, respectively.

Even though it is located several miles outside of San Antonio, volumes at site 3 are also quite high, averaging 18,600 vpd in the westbound direction. Based on these counts, it appears that the ADT at site 3 may be slightly greater than the 10,000 to 30,000 vpd range for which this site was selected originally. This section of interstate apparently serves a sizeable driving population commuting to and from San Antonio. As Figure 2 illustrates, a distinctive peak hour (approaching 2,000 vph) is evident in the afternoon.

Finally, site 4 is characterized by very low volumes, near 3,300 vpd in the westbound direction. In addition, there is essentially no peaking during morning or evening rush hours (see Figure 2). The maximum hourly volume at this site is only 250 vph.

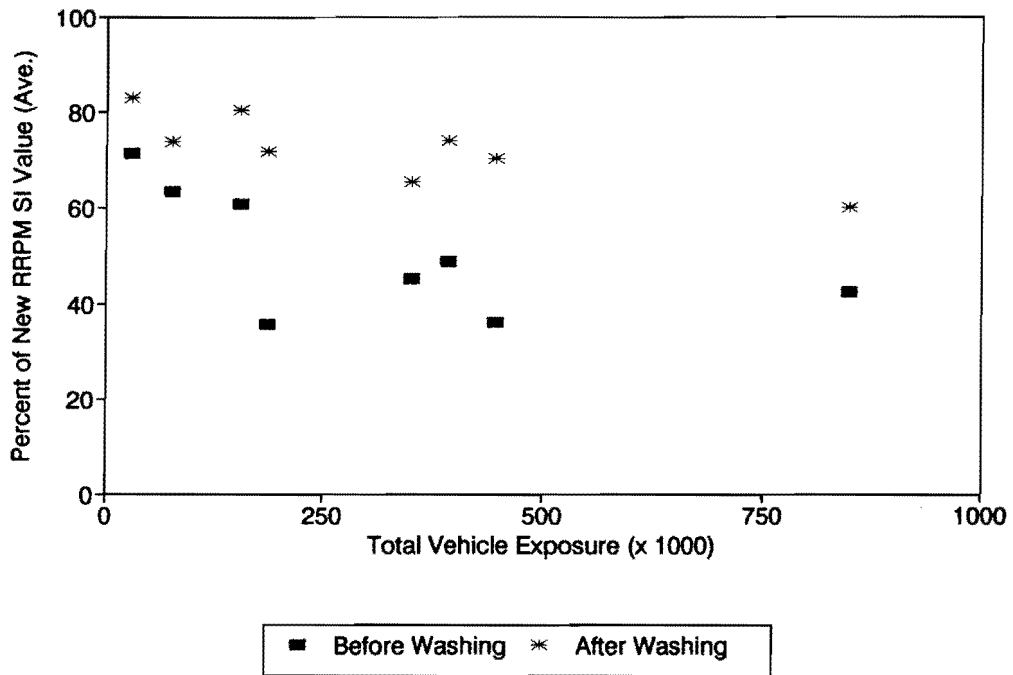
Figure 3. Average Percent of New RRPM Reflectivity versus Amount of Traffic Exposure.

To more directly assess the effects of the traffic conditions at each site upon the average reflectivity retention at each site, the values in Table 10 were plotted against estimates of three different measures of traffic exposure. Again referring back to Chapter 2, traffic studies performed at each site yielded daily rates of the total traffic volumes, truck volumes, and lane-changing frequencies to which the RRPMS were being exposed. These were presented in Table 3. By multiplying that data by the number of exposure days RRPMS at each site (see Table 5), an estimate of the total exposure to date for each traffic measure was computed for each site. These estimates were then plotted together against the average remaining reflectivity percentages, as shown in Figures 3 through 5.

Comparing the graphs of Figures 3 through 5, it appears that reflectivity degradation is related to all three traffic exposure measures (total traffic, truck traffic, and lane-changing rates). That is as exposure to all three traffic measures increases the average percent of remaining reflectivity decreases. This is expected, since those sites with high total traffic volumes also have high total truck volumes and lane-changing activity. However, it seems that reflectivity degradation of both unwashed and washed RRPMs is most strongly related to total truck exposure (a steeper slope of the data with less scatter). Once additional reflectivity data is collected, the relationship between reflectivity and traffic conditions will be examined more rigorously using statistical methods.

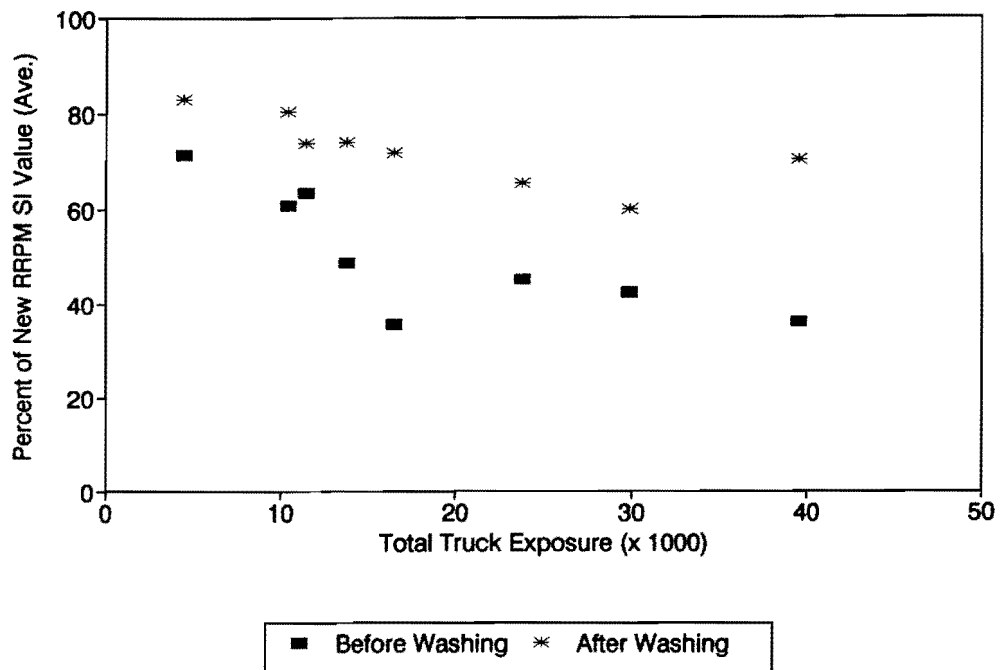
Figure 4. Average Percent of New RRPM Reflectivity versus Amount of Truck Traffic Exposure.

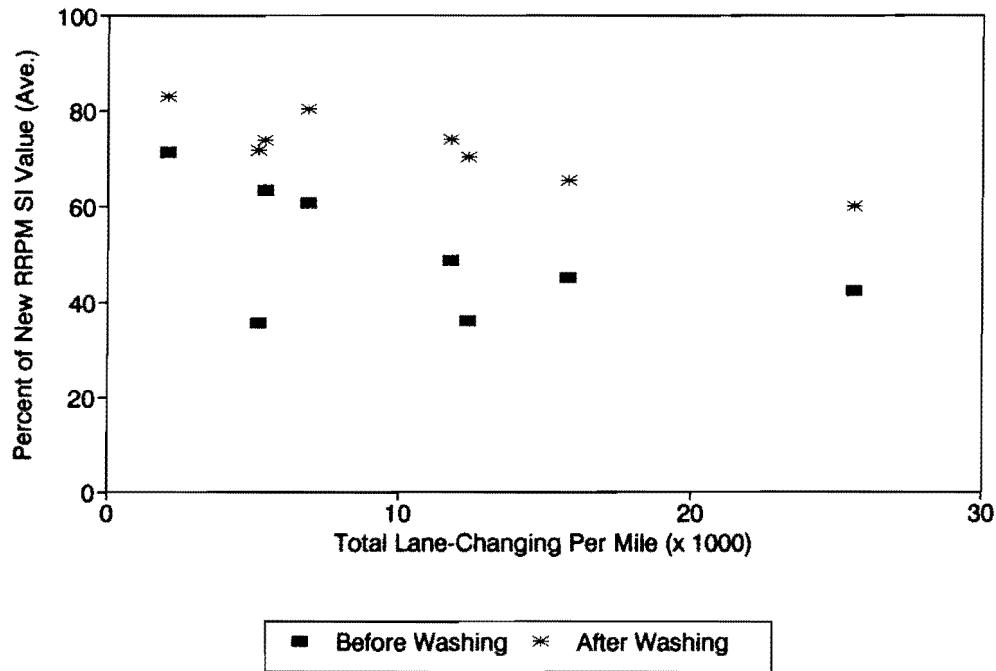
Figure 5. Average Percent of New RRPM Reflectivity versus Amount of Lane-Changing Per Mile.

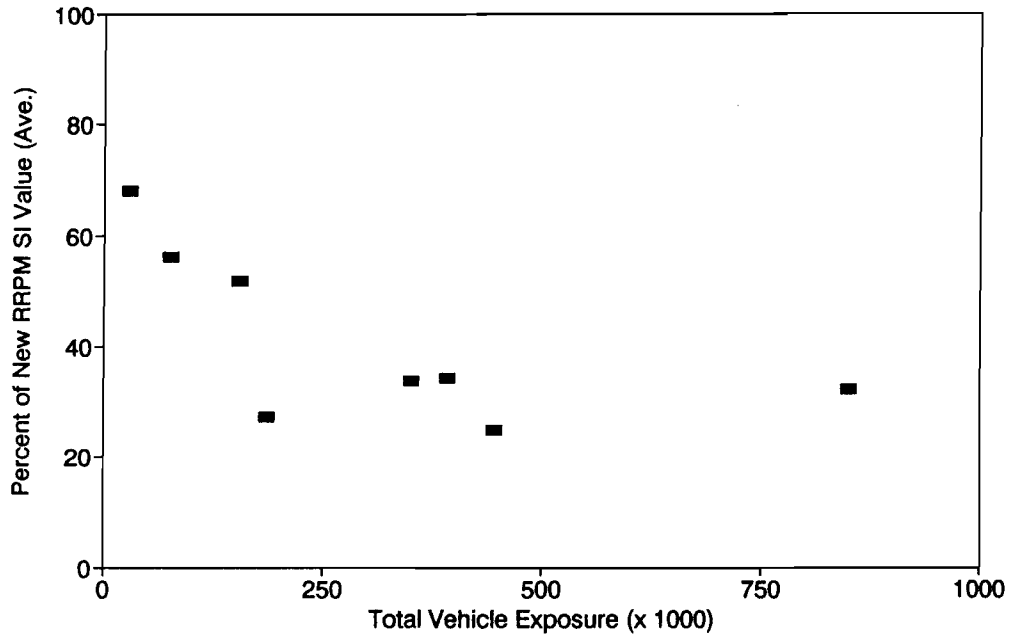
Figure 6. Average Percent of Field-Measured New RRPM Reflectivity Retention versus Amount of Traffic Exposure.

Figures 6 through 8 illustrate the relationship that exists between the average percent of remaining reflectivity and the traffic exposure measures calculated in the previous section. As before, the most consistent relationship appears to be between reflectivity degradation and total truck exposure at each site. The relationship appears to be less significant between retention and total traffic exposure, and least dependent upon lane-changing exposure rates.

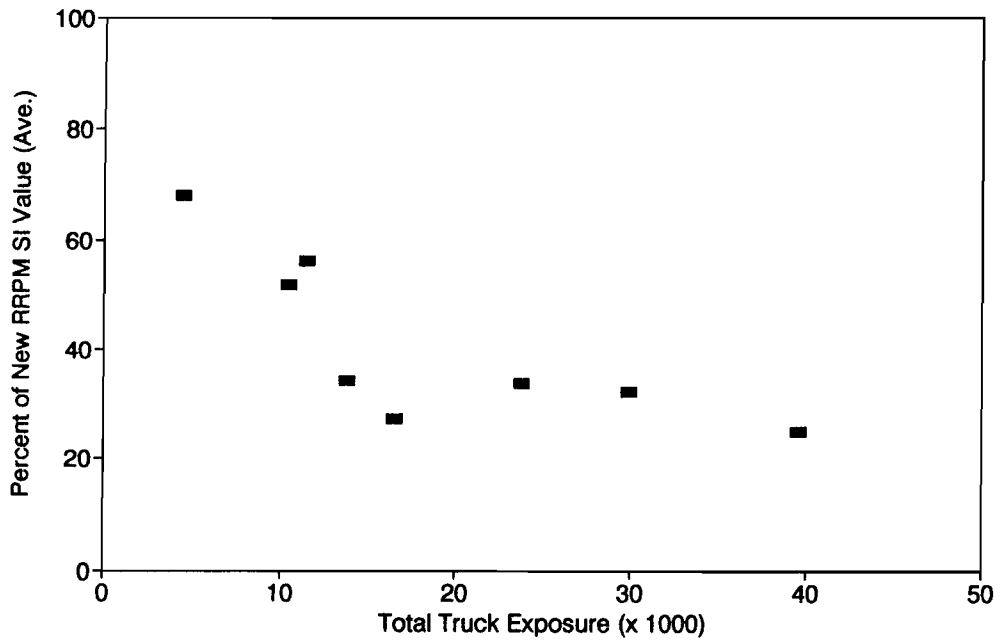
Figure 7. Average Percent of Field-Measured New RRPM Reflectivity Retention versus Amount of Truck Traffic Exposure.

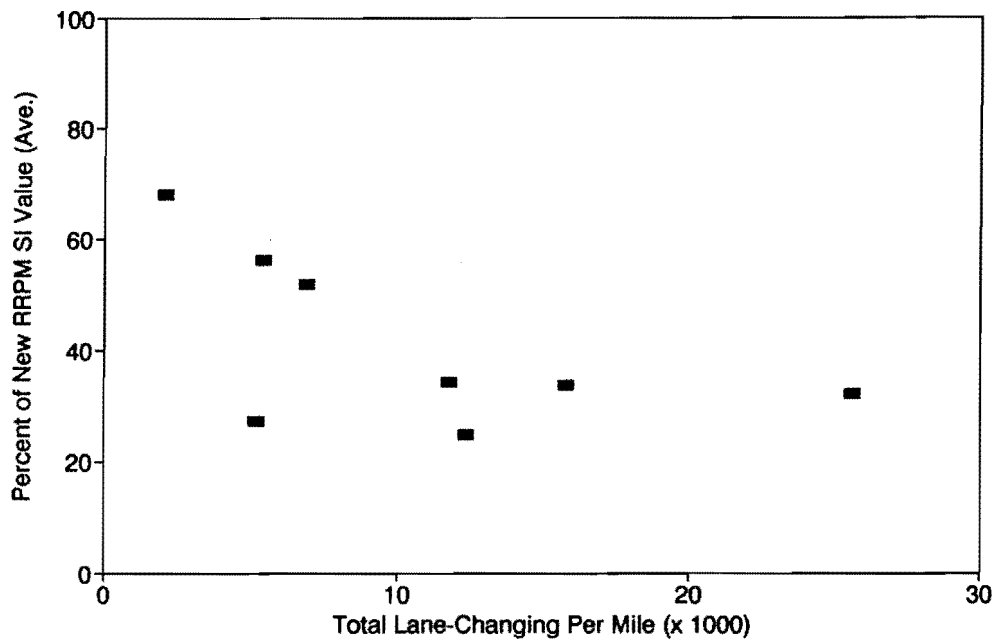
Figure 8. Average Percent of Field-Measured New RRPM Reflectivity Retention versus Amount of Lane-Changing Per Mile.
