1. Report No. TX-92/1949-2		2. Government Accession No.		3. Recipient's Catalog No.	
4. Title and Subtitle DEVELOPMENT OF AN END TREATMENT FOR A LOW-PROFILE CONCRETE BARRIER				5. Report Date November 1992

**DEVELOPMENT OF AN END TREATMENT FOR  
A LOW-PROFILE CONCRETE BARRIER**

Research Report No.

2-8-92-1949

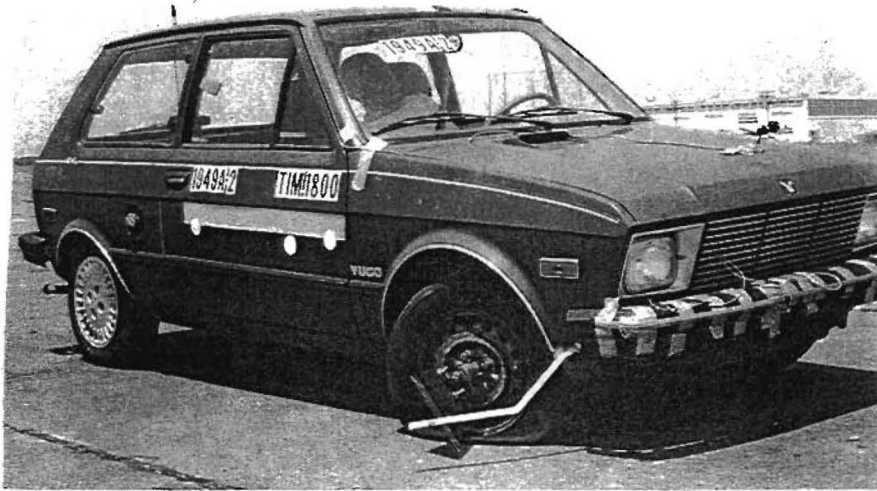
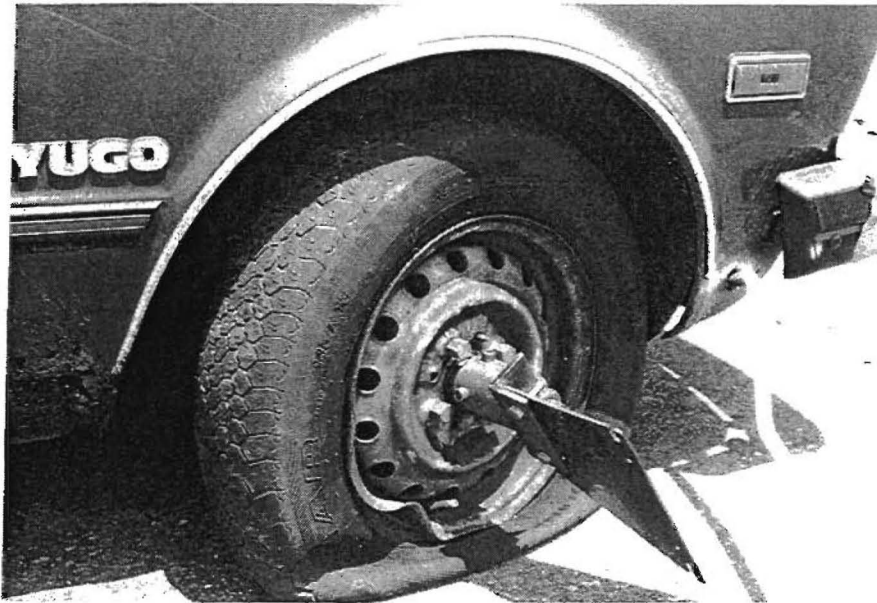
Figure 16. Vehicle after Test 1949A-2.

The vehicle sustained damage to the right front wheel as shown in Figure 16. There was no direct crush to the vehicle. The only other damage was a small dent in the roof on the rear passenger side. The dent measured 6 in. x 4 in. x 1/4 in. deep (15 cm x 10 cm x 0.6 cm) and was considered to be due to the twisting motion induced in the vehicle body as the right side of the vehicle traversed the end treatment.
