1. Report No. TX-01/2105-2		2. Government Accession No.		3. Recipient's Catalog No.	
4. Title and Subtitle GUIDELINES FOR BRIDGES OVER DEGRADING AND MIGRATING STREAMS. PART 1: SYNTHESIS OF EXISTING KNOWLEDGE				5. Report Date January 2001

GUIDELINES FOR BRIDGES OVER DEGRADING AND MIGRATING STREAMS. PART 1: SYNTHESIS OF EXISTING KNOWLEDGE

Research Project Title: Develop Guidance for Design of New Bridges and Mitigation of Existing
Sites in Severely Degrading and Migrating Streams

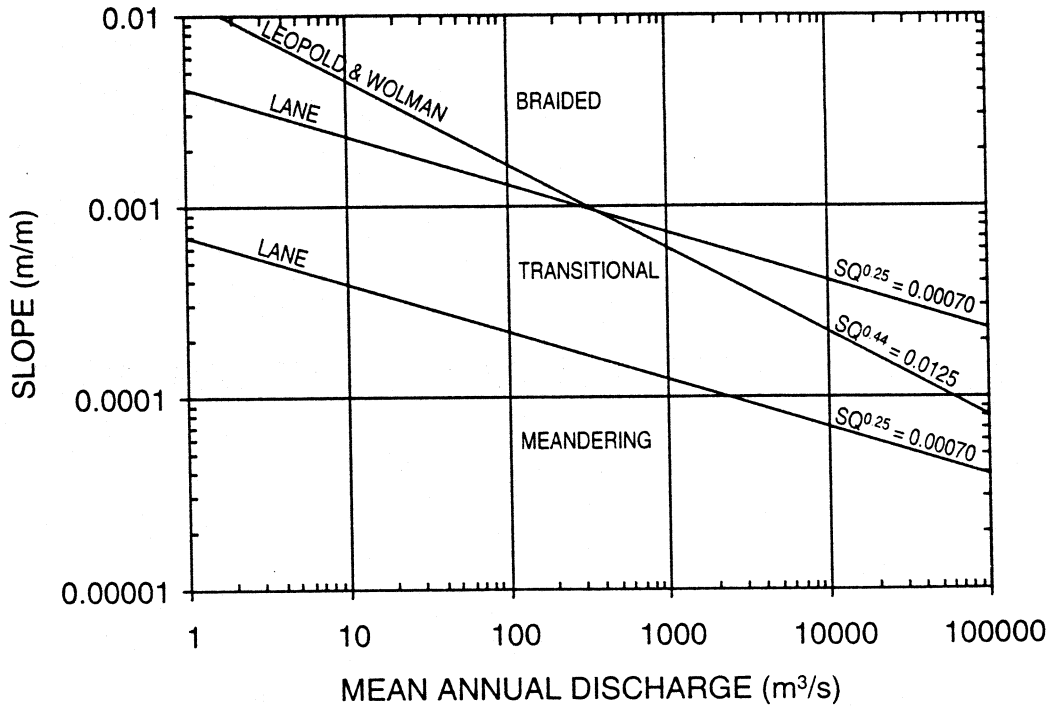
Figure 2.5. Interrelation between Stream Form, Channel Bed Slope, and Mean Discharge (after Lane 1957).

A sandbed is predicted to meander for $S_0 Q^{0.25} \leq 0.00070$ and a sandbed is further predicted to be braided for $S_0 Q^{0.25} \geq 0.0041$. A transition zone is indicated to occur between these two relations. In this zone, a stream is indicated to be able to change rapidly from one stream form to the other depending on changing conditions. Based on data for a variety of natural streams, Leopold and Wolman (1960) determined that for meandering streams $S_0 Q^{0.44} \leq 0.0125$ and for braided streams $S_0 Q^{0.44} \geq 0.0125$

The relations of Figure 2.5 provide an assessment of stream nature that can be used in conjunction with earlier indicators of stability in an essentially qualitative assessment of potential stream stability.

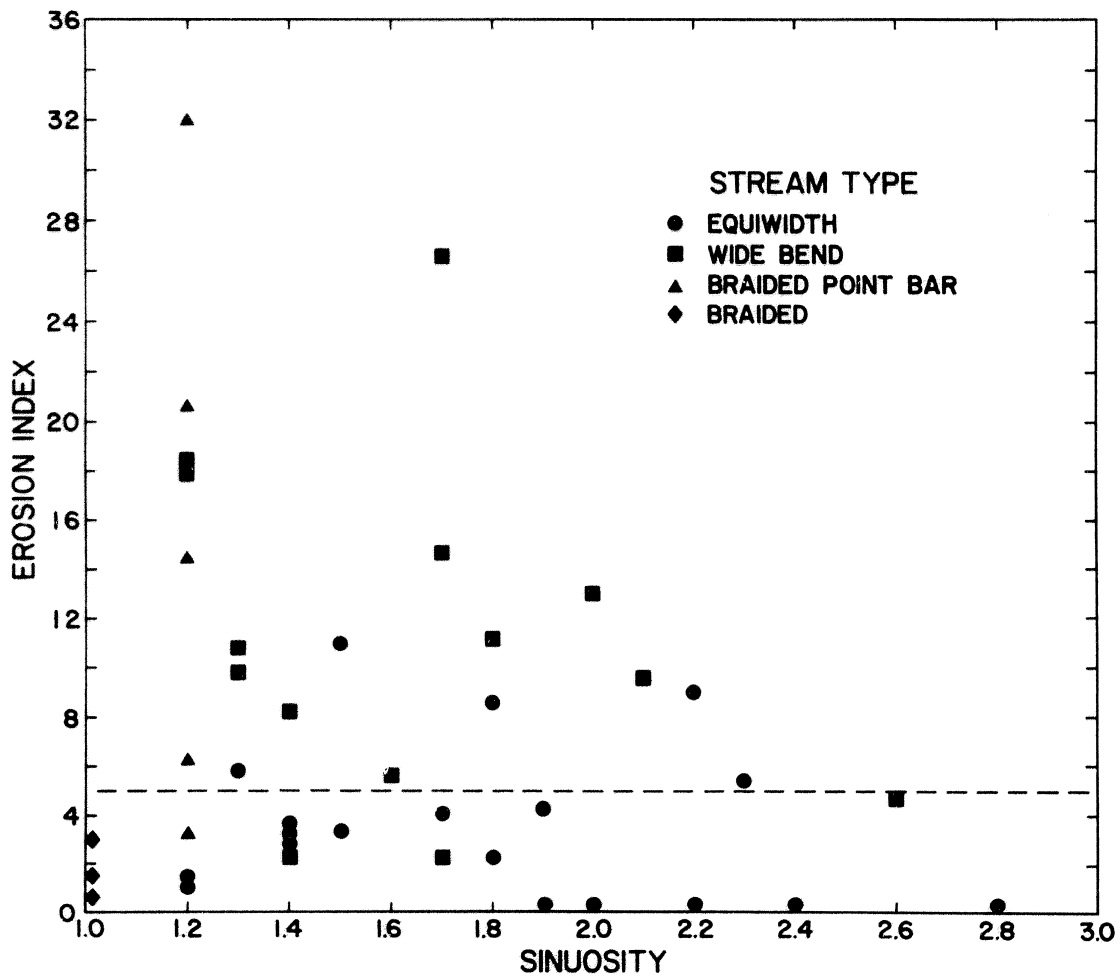
Figure 6.4. Erosion Index in Relation to Sinuosity for Different Types of Streams (Brice 1982).

- Meandering does not necessarily indicate instability. In Figure 6.4, equi-width streams having sinuosity in the range of 2-2.8 are among the most stable streams. An unstable stream will not remain highly sinuous for very long, because the sinuosity will be reduced by frequent meander cutoffs.
- Where instability is present along a reach, it occurs mainly at bends. Straight segments may remain stable for decades.
- The highest erosion index values are for reaches whose sinuosity is in the range of 1.2 to 2 and whose type is either wide bend or braided point bar. An erosion index value of 5 separates these types from most equi-width streams, and it also approximates the rate of erosion at which loss of agricultural land becomes obvious. It is an unstable boundary between stable and unstable reaches.

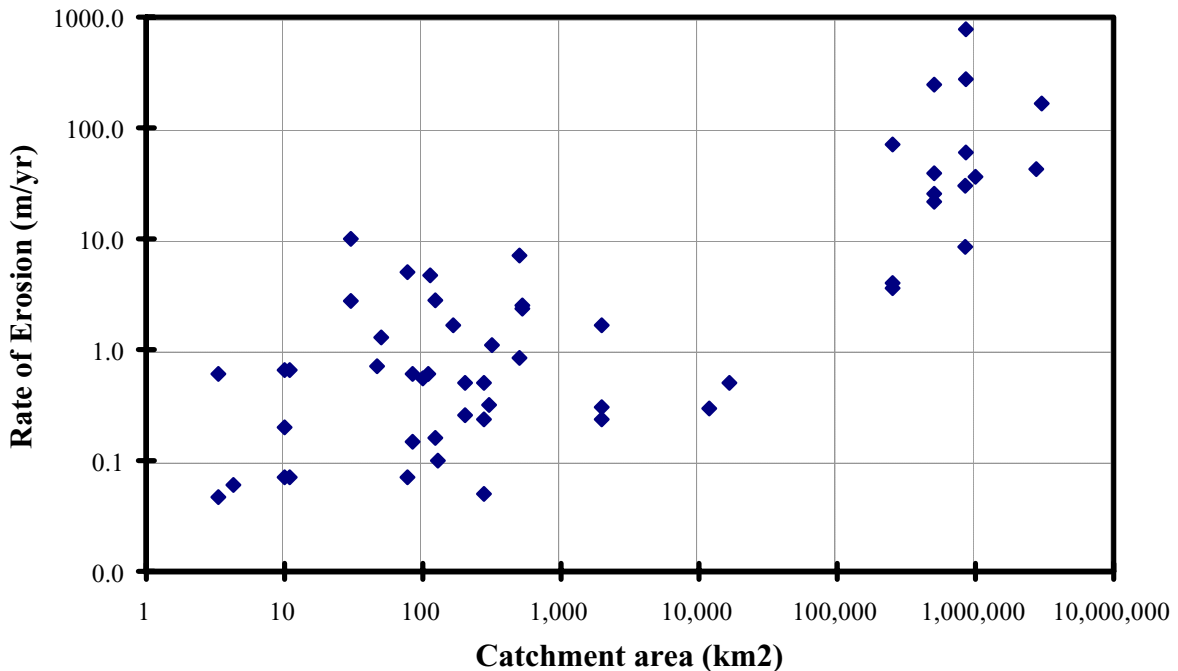
Figure 6.6 Relationship between Erosion Rates and Catchment Area (Hooke 1980).

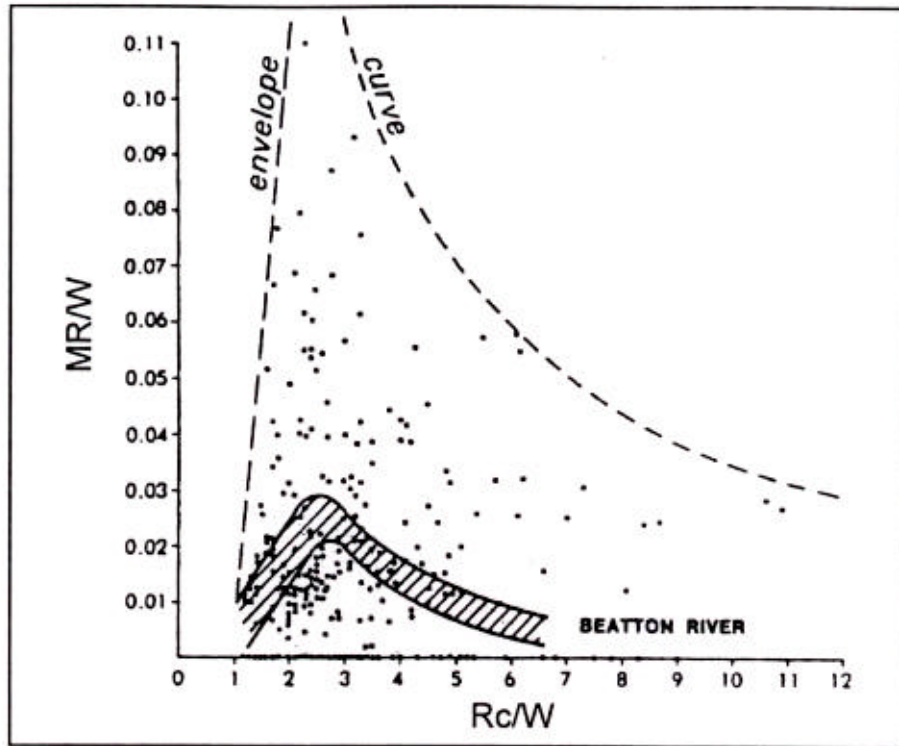
Figure 6.14. The Relation between Relative Migration Rates (after Nanson and Hickin 1983, 1986).

The radius of curvature of bends influences lateral migration rates of meandering rivers. This migration rate is normalized with respect to the channel width W (Figure 6.14). Normalized migration rates (MR/W) are highest when the radius of curvature-channel width ratio (R_c/W) is about 2.5, and they are lower when R_c/W is both higher and lower because of the lack of flow convergence and energy loss, respectively.

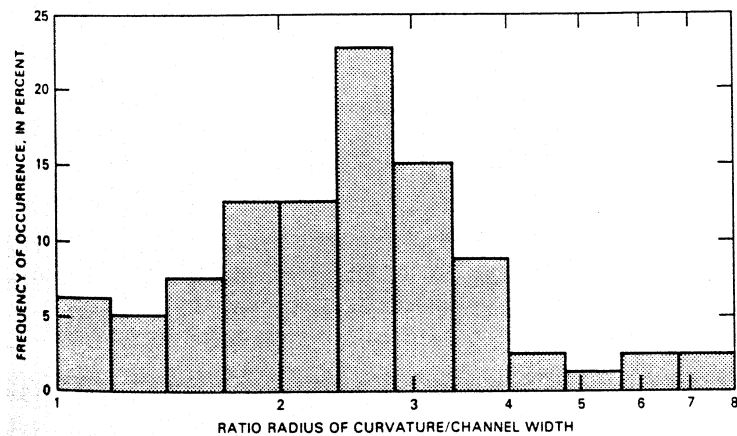
Figure 6.17. Frequency Distribution of R_c/W Values for 79 Streams (Williams 1986).

The frequency of distribution of the 79 available R_c/W values (Figure 6.17) is asymmetric. The computed geometric mean value of R_c/W is 2.43. The central two-thirds of the distribution lies between values of 1.6 and 4.4, and about one-third of the values are less than 2.0.

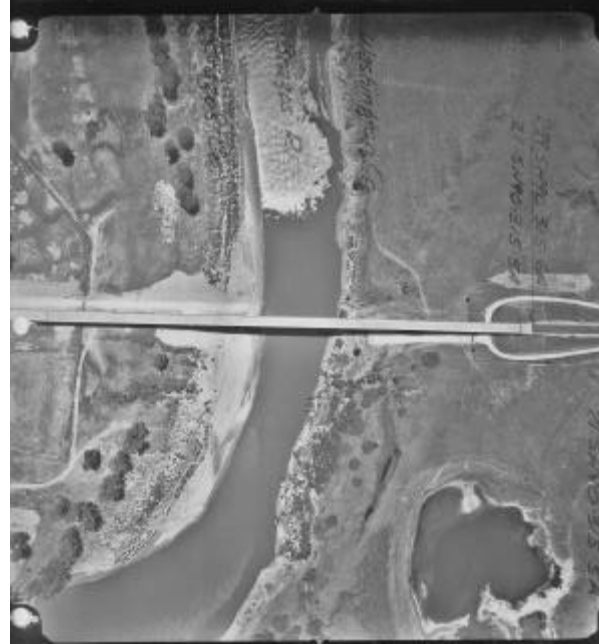
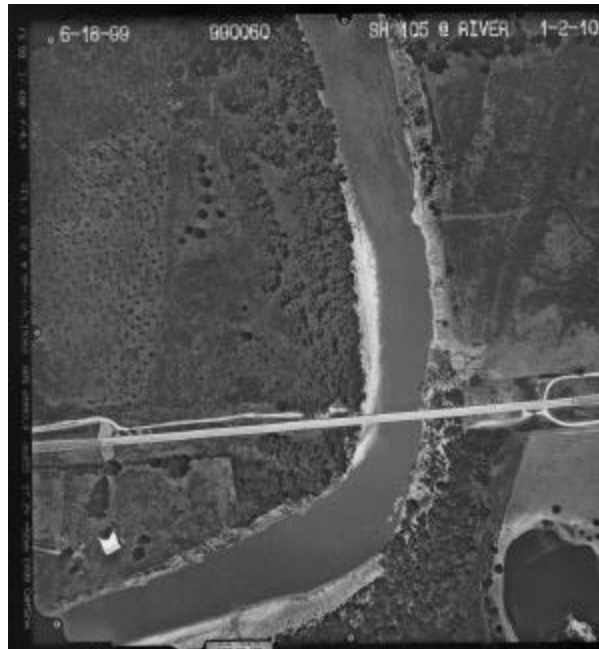
Figure 11.2. Channel Migration between 1969 and 1999.

Over the past 30 years, the channel upstream of the bridge has migrated about 400 feet towards the SH 105. The channel appears to be fairly stable between 1969 and 1988 with only about 100 feet of lateral migration over this period. Over the past eleven years (1988-1999), however, the channel migrated at a much faster rate towards the SH 105 bridge crossing. The movement is occurring upstream of the crossing at the first bend of the main channel. There is also an associated slide on the west bank which was believed to be aggravated by a large stock pond. In addition, there is a large meander to the north of the bridge. The meander is moving south and east, and a considerable amount of the overbank has been lost upstream of the bridge. The lateral channel migration can be clearly seen from the 1969 and 1999 aerial photographs shown in [Figure 11.2](#). [Figure 11.3](#) shows a detailed sketch by George Odom of TxDOT drawn from aerial photographs taken in 1969, 1978, 1988, and 1999.

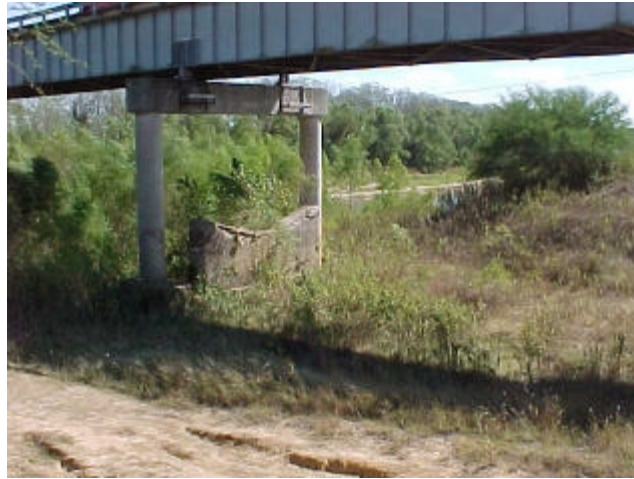
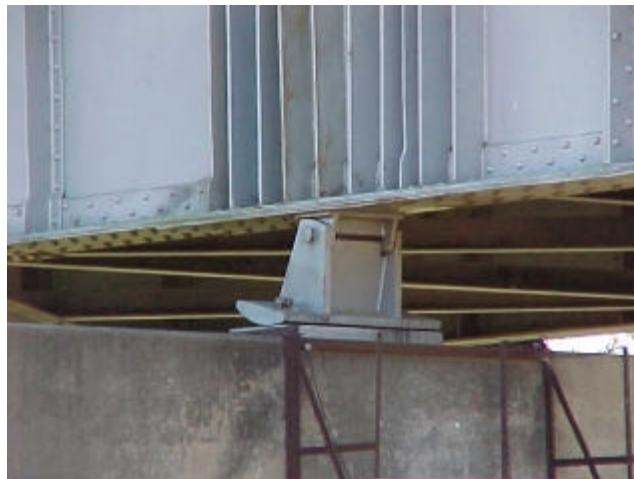
Figure 11.4. Pier No. 50 on the West Bank of the Brazos River.

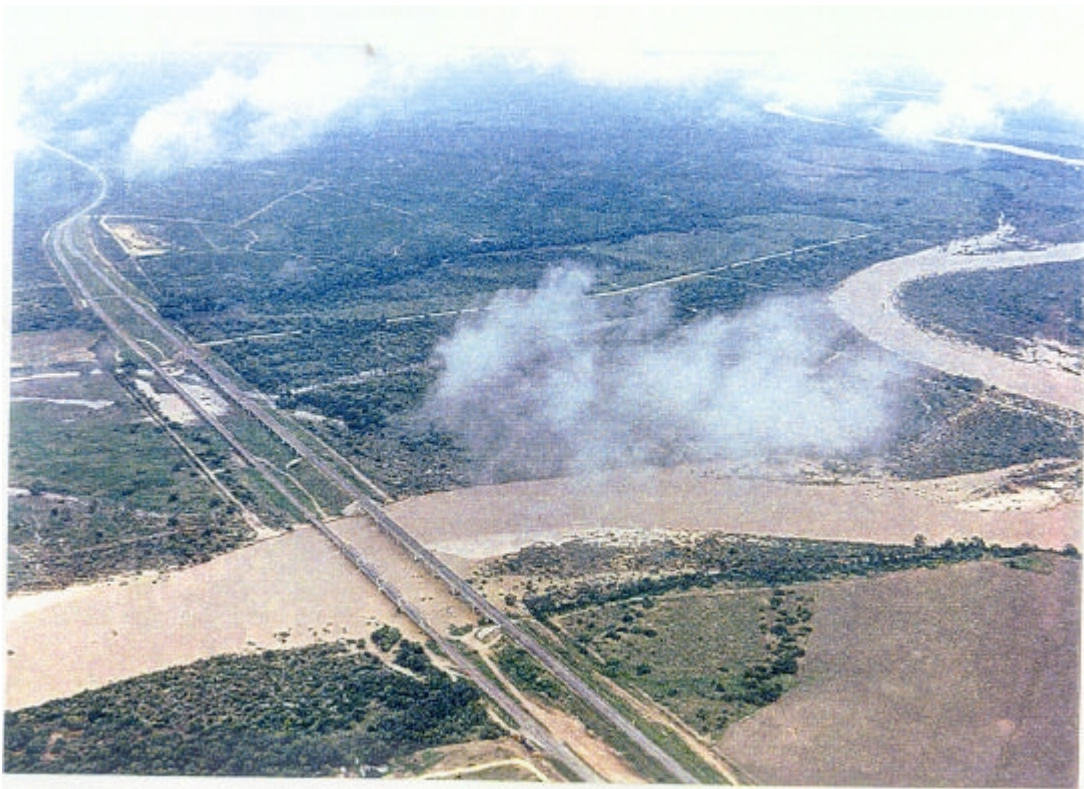
Figure 11.6. U.S. 90 Bridge and Relief Structure at the Nueces River.

The U.S. 90 crossing of the Nueces is located about six miles west of Uvalde, Texas, and about 88 miles west of San Antonio (Figure 11.6). It consists of a west bound bridge and a relief structure which were constructed about 1967, and an older east bound bridge and relief structure.

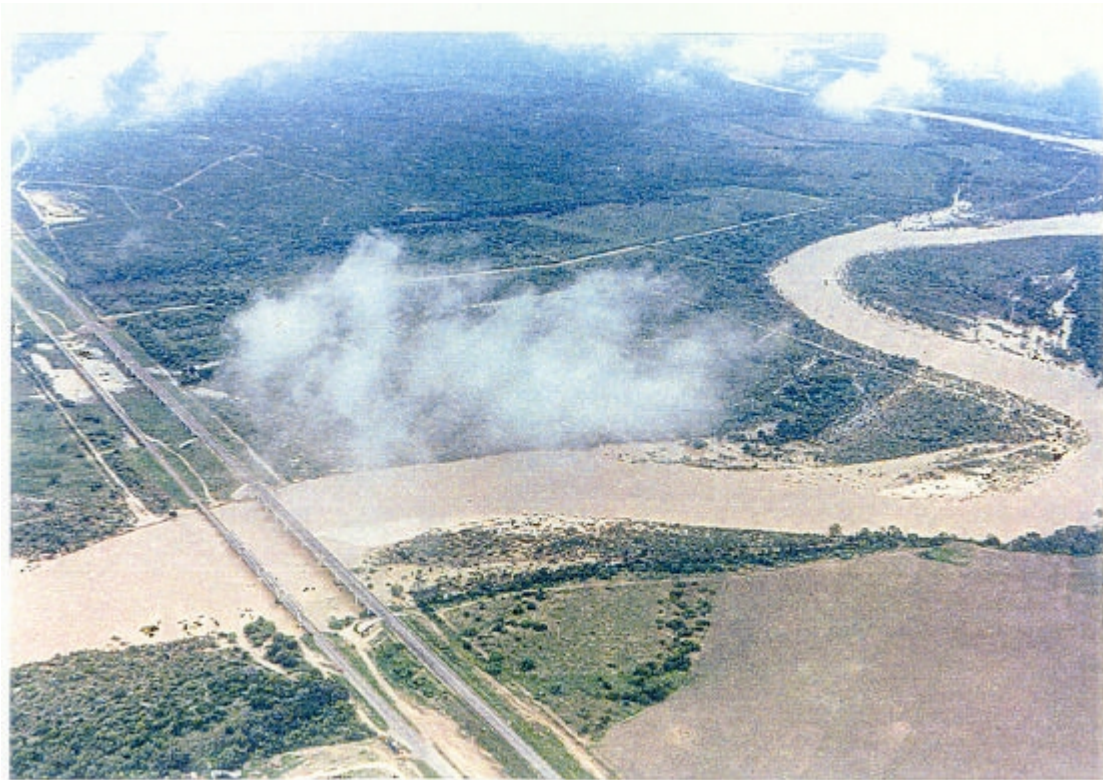
Figure 11.8. U.S. 90 Bridge at the Nueces River –Looking Northwest.

Inspection of the U.S. 90 EBML Bridge over the Nueces River by Michael B. Raspbury on September 2, 1998, found significant problems with the substructure foundation due to stream instability and channel degradation. The western bank of the river had shifted to the west approximately four span lengths (about 180 ft) since the previous inspection in April 1996. Also the channel had degraded approximately 4 ft to 5 ft at its deepest point based on a comparison to the 1996 channel profile measurements. The combination of channel shifting and degradation reduced the depth of the original foundation up to 15-ft at the west approach bents (Bent Nos. 8-12 from the east). The bridge inspection records classify the bridge as having high susceptibility to scour and show that a scour evaluation had not yet been done at the time of the 1998 inspection. After the inspection, it was recommended to take the following actions:

3. Consider installing countermeasures such as rubble riprap at the west approach bents to protect against further scour or degradation.
4. Consider countermeasures for stabilizing the west bank in coordination with remedial measures to be undertaken for the west bank of the U.S. 90 WB structure. The west bank has shifted approximately 180 ft to the west from April 1996 to September 1998, which suggests that further movement should be expected.

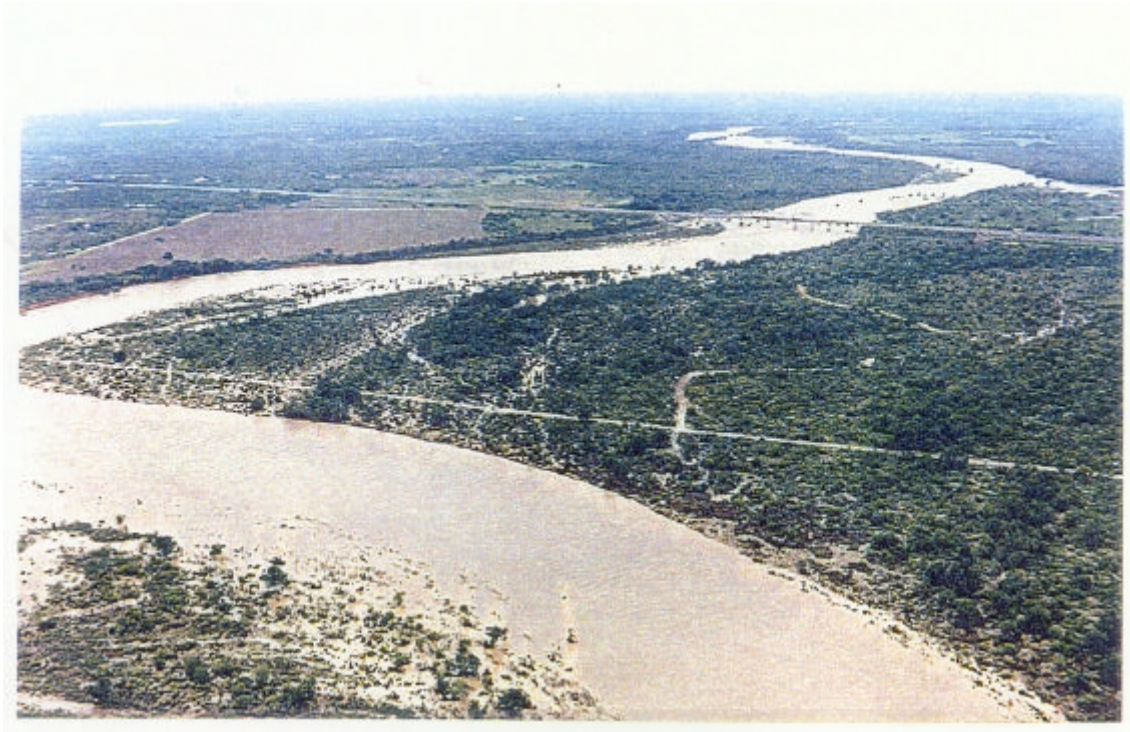
Figure 11.9. Nueces River North of U.S. 90 Bridge (Relief on Right Side)–Looking South.

According to the memorandum prepared by David Stolpa on April 29, 1999, there was an apparent development of a meander in the river towards the west abutment. The photographs show that the abutment and about 500 feet of embankment separating the main channel bridges from the relief structures were under attack. As seen in [Figure 11.11](#), the river actually seems to be heading in a direction towards recapturing the old channel that is now crossed by the relief bridges. The photos also clearly show the subsequent development of what was once a lateral bar, at the east bank, into a point bar along the inside of the meander. This new bar development, along with the horizontal resistance of the west abutment, appears to be forcing a situation for which the river can currently compensate only by attacking the streambed at the west abutment. Thus, a scour/degradation threat also appears to continue for the drilled shafts of the Bents 7 through 10.

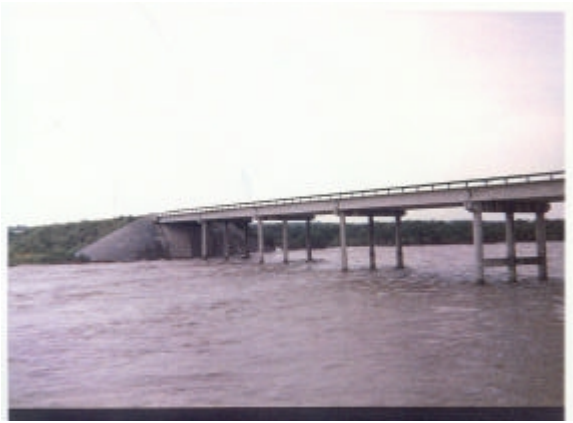
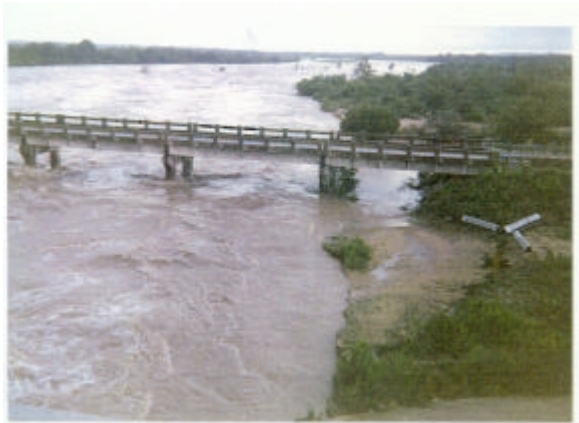
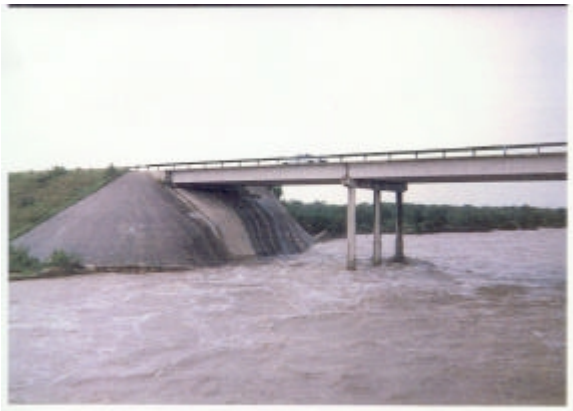
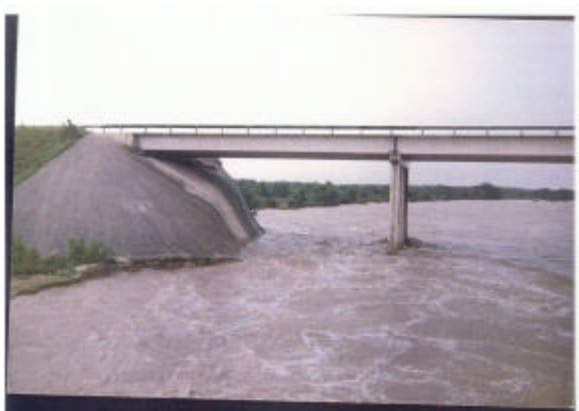
Figure 11.10. 1998 Flood.

Bridge performance at the site appears to have been satisfactory until recent years when an apparent shift in the river and degradation of the streambed became noticeable about 1996. Recent flooding apparently has resulted in severe lateral migration as well as vertical degradation of the main channel. The extent of channel migration can be seen from the aerial photographs shown in Figures 11.8 and 11.9. The most recent extreme event shown in Figure 11.10 occurred during the period of August 24-26, 1998, when the river experienced a sharply defined flood peak of about 82,000 cfs followed about 30 hours later by a second peak of roughly 68,000 cfs. Subsequent flooding also resulted in the failure of the concrete riprap of the west abutment of the West Bound Main Lane (WBML) Bridge and threatened the west abutment of the East Bound Main Lane (EBML) Bridge. This damage was contained and repaired by placement of a rock berm along the damaged reach.

The district constructed a rock riprap protection to prevent additional exposure of the drilled shafts. The new rock berm has stabilized the situation for the time being. Several countermeasures were discussed concerning the long-term response to the problem. Basically, the options were: 1) to try to contain and manage the river, 2) harden the west abutments of the two parallel main bridges and monitor them, and 3) span the intervening embankment between the main and relief bridges, and let the river determine its course. David Stolpa recommended in his memorandum dated April 29, 1999, that the Hydraulic Section support Option 3 as the long-term solution to the problem at the site. Bridging the intervening embankment was judged to be the most cost-effective approach that could provide safe operation of the road even if this section of the U.S. 90 WBML structure comes under renewed attack.

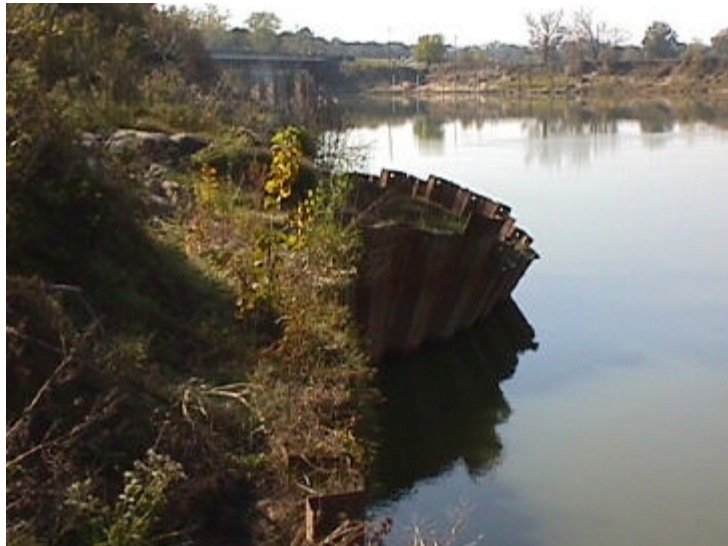
Figure 11.13. Failure of the Sheet Pole Wall as a Countermeasure.

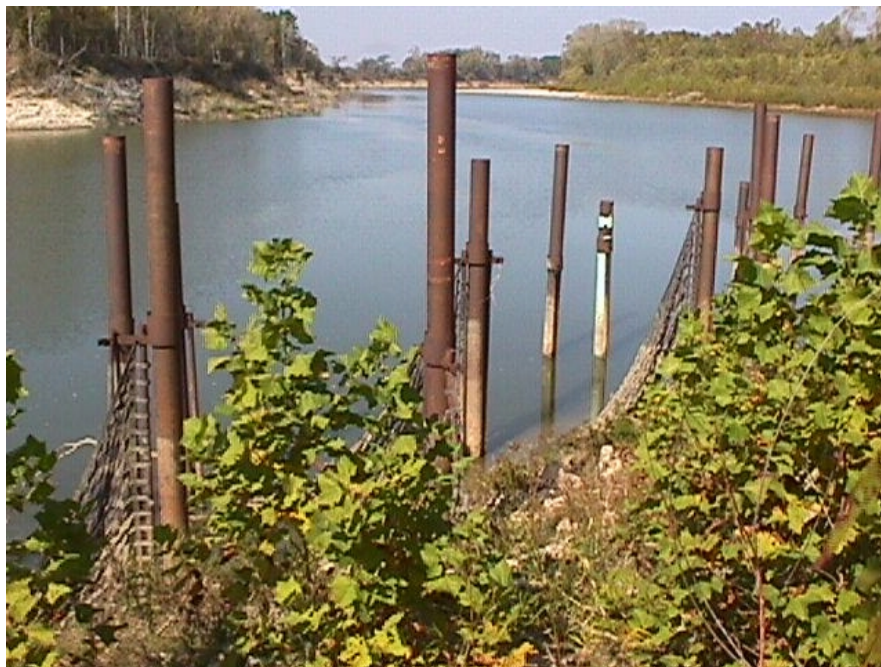
Figure 11.14. Erconet Palisades as Countermeasures.

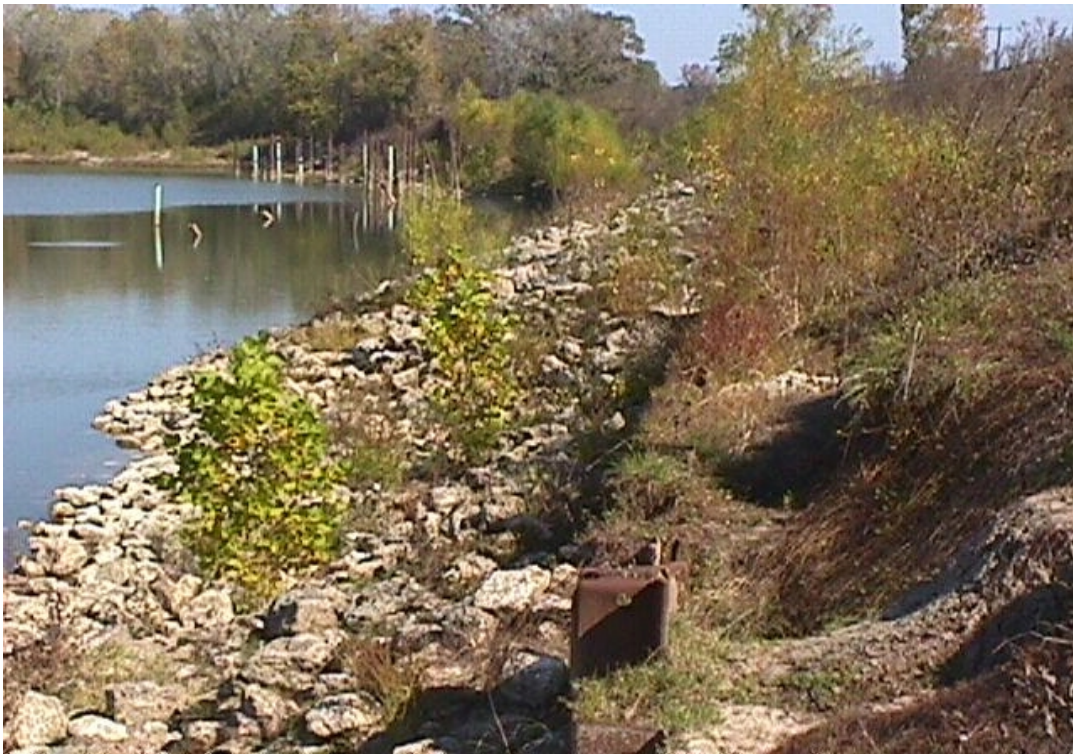
Figure 11.15. Riprap as a Countermeasure.

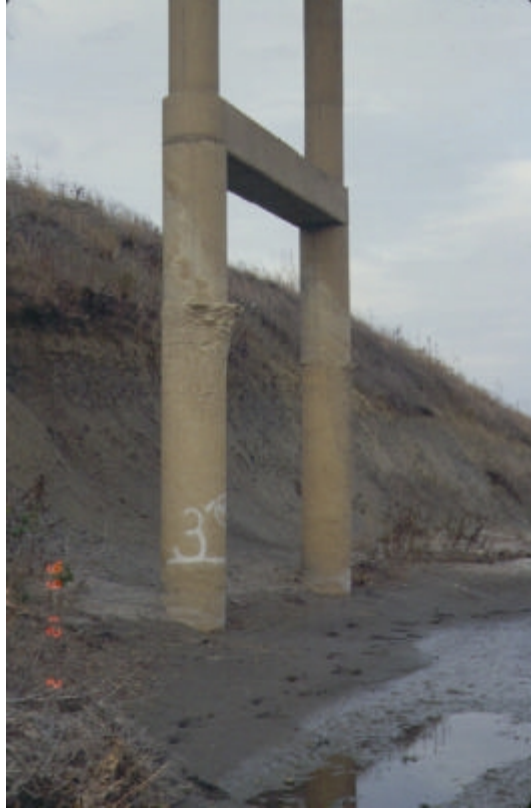
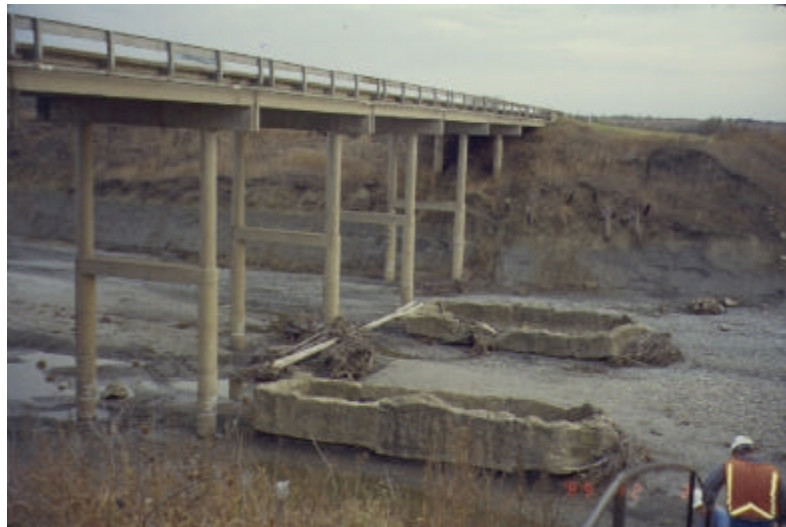
Figure 11.16. Exposed Piers on the North Sulfur River.

This structure is an 8-40 ft span (concrete slab and girder) bridge on 24 in diameter 23 ft long drilled shafts (Figure 11.18) (Kathy, unknown on 1997 profile but shown on 1963 profile?). It was built in 1963, and at that time the bottom of the river was 90 ft wide. In 1985, the bottom of the river had become 150 ft wide with most of the widening taking place on the south side. On the south side (at pier 2), the ground level had been eroded vertically 27 ft from 1963 to 1985. During the same period, the center of the bottom of the river had been lowered by 7 ft. The soil at the south abutment is clay. The erosion seems to have slowed down when it reached the clay shale which underlies the clay layer. A river bottom profile is available in 1963 and in 1985. (Kathy, the profile in 1997/1999 does not seem to correspond to the other profiles).

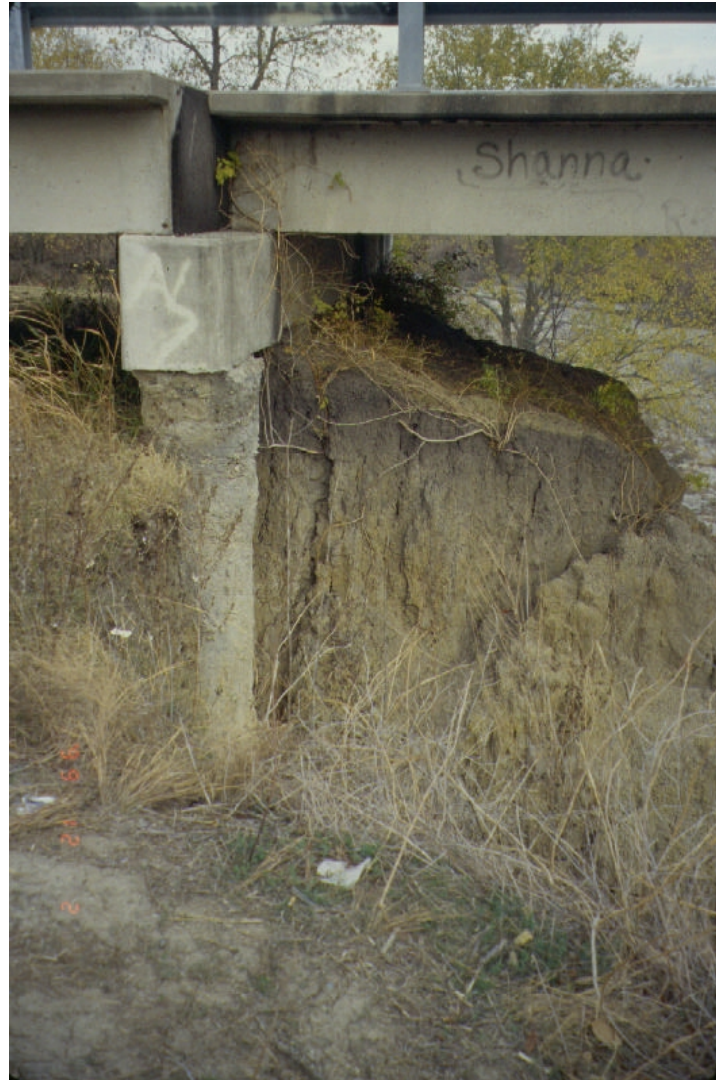
Figure 11.17. Erosion of Abutment on the North Sulfur River.

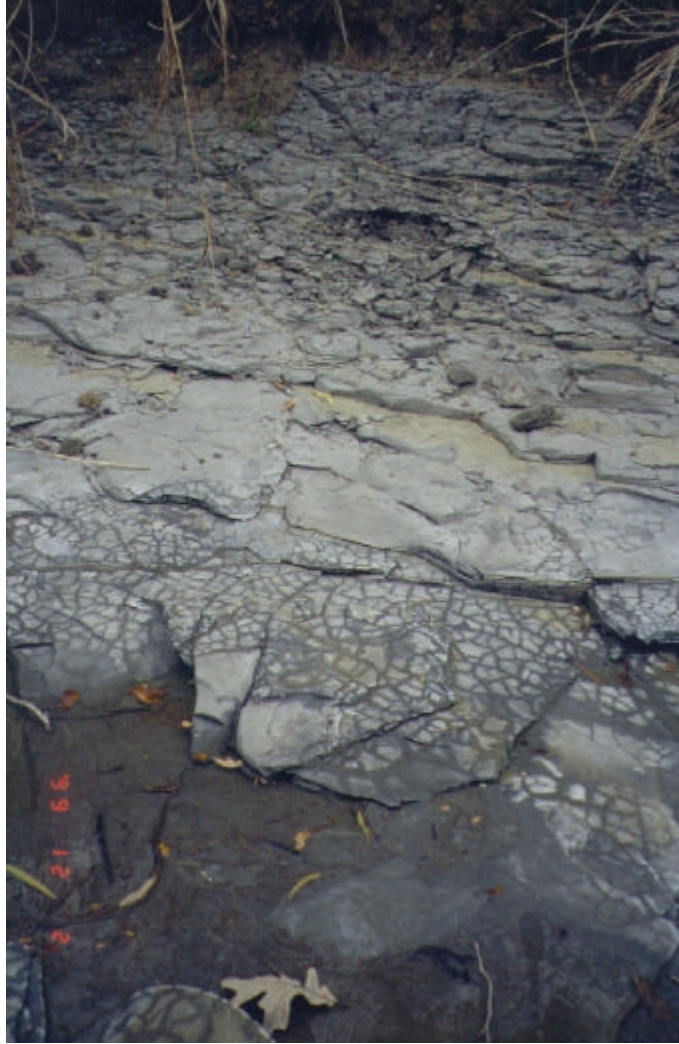
Figure 11.21. Erosion of Clay Shale.

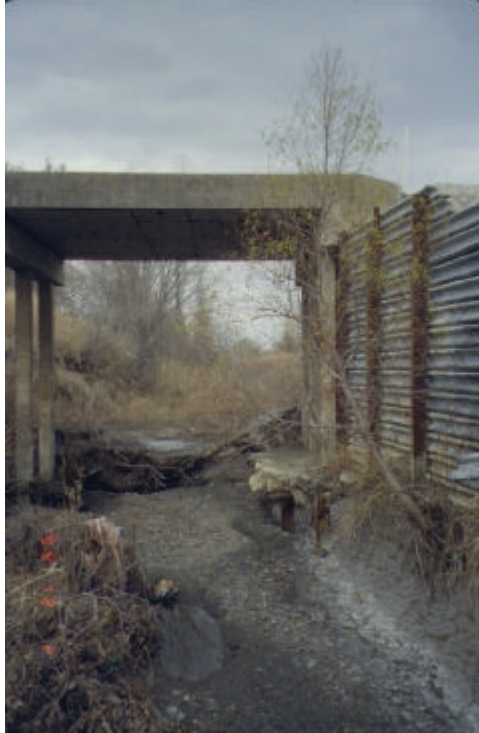
Figure 11.22. Guardrail Wall for Abutment Protection.

abutment and reach its equilibrium. In some cases one more span is not sufficient for the river to reach its equilibrium. **Buttressing the abutments** is done by stacking guard rails one on top of the other as a vertical barrier and holding the guard rail wall with short sections of driven H piles (Figure 11.22). **Grouting the embankment** is used in combination with the guard rail wall to form a single hardened unit (Figure 11.23). The grouting is done by pouring cement paste over the existing slopes of the embankment and letting the cement penetrate under its own weight into the fill. **Gabions** are used to line channels in places where the erosion rate is severe. They are man-power intensive but seem to fulfill their purpose. One of the observations with gabions is that undermining and scour occur at the transitions between the gabions and the river channel (Figure 11.24). One should ensure that this transition is not abrupt but rather a smooth and flexible one. **Concrete surfacing** of the riverbed up-stream and down-stream of bridges or culverts was used in some instances. This countermeasure seemed to work at the bridges but suffered from the same problem as the gabions: edge scour and undermining. Interestingly no riprap was encountered as a countermeasure.

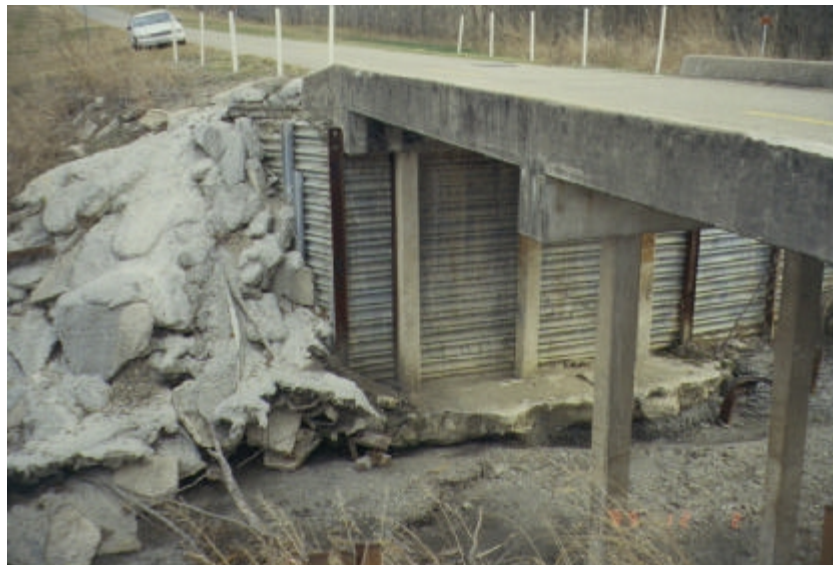
Figure 11.23. Guardrail Wall and Grouted Embankment.

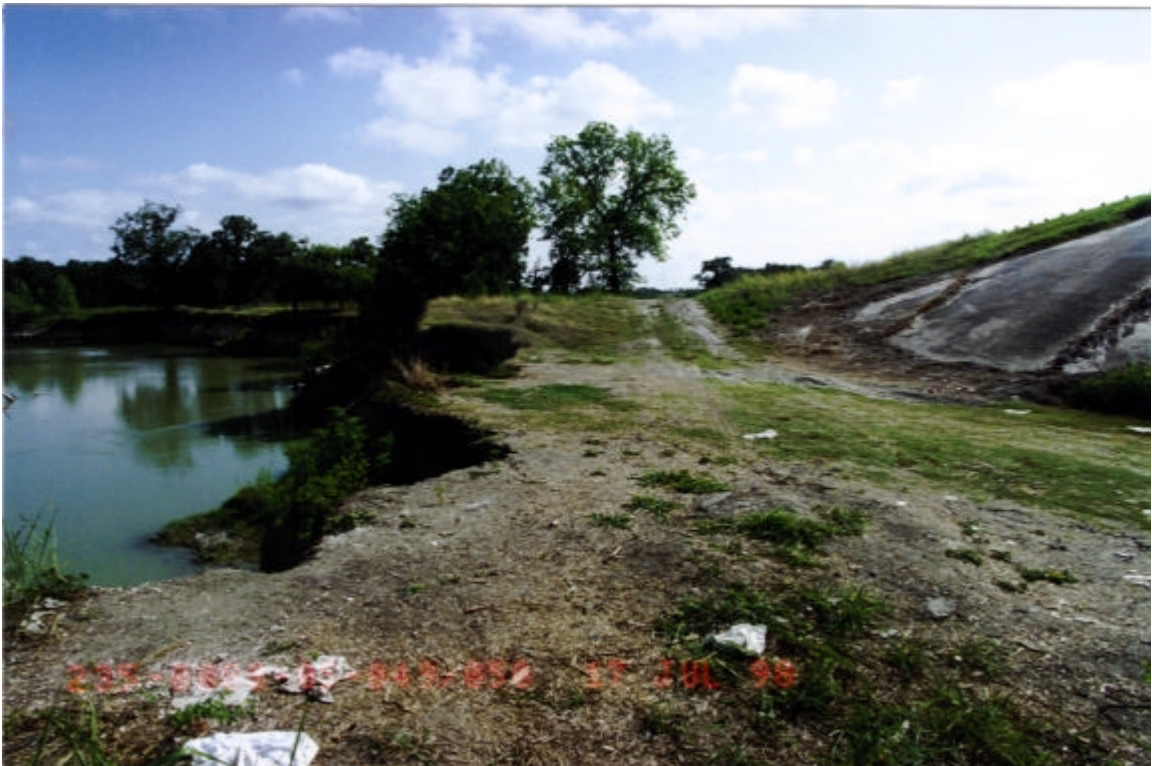
Figure 11.26. Bank Erosion near U.S. 59 at Guadalupe River Bridge.

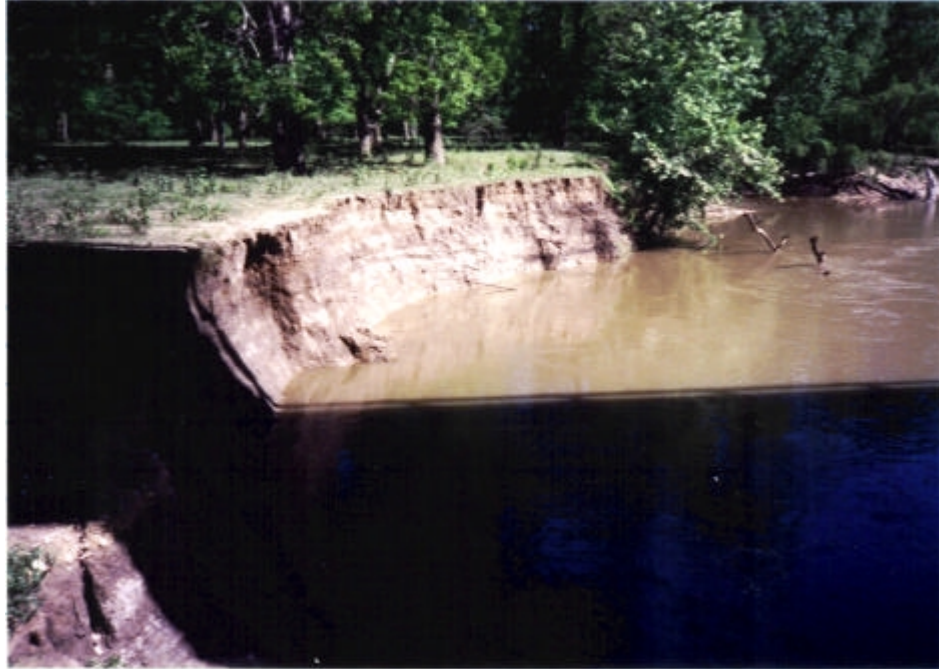
Figure 11.28. Channel Migration at SH 80 at Guadalupe River Bridge.

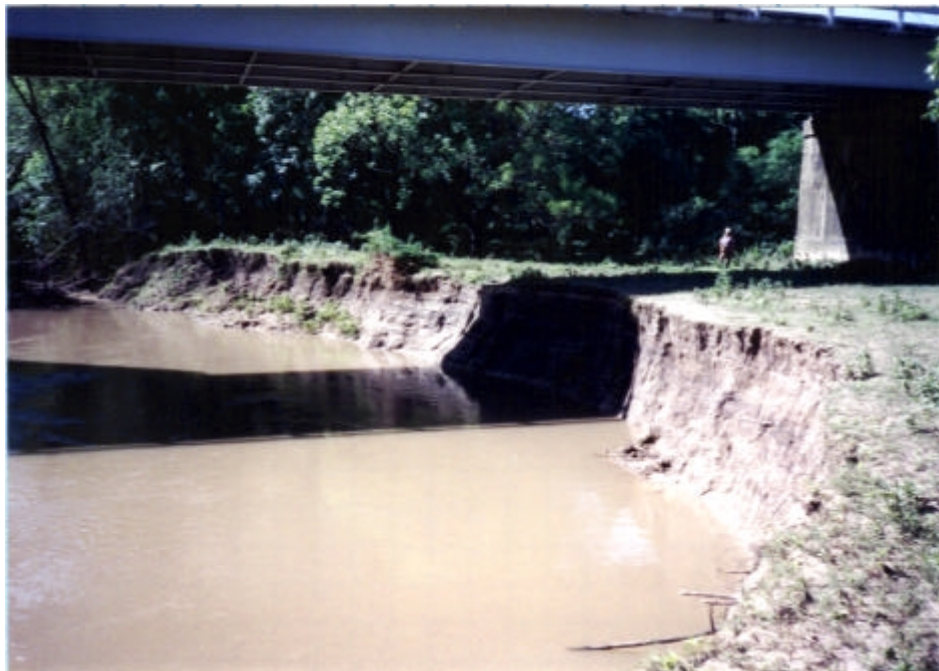
Figure 11.29. Bank of Meander before Installation of Ercon Nets.

This meander migration problem was not considered to be an emergency. Therefore a solution less expensive than adding a span could be used. The solution which was retained was to use Ercon nets (Figure 11.29 and 11.30) (Similar to Erconet Palisades 11.3.4 Countermeasures). The first step in the construction of the nets is to drive 10 in diameter pipe piles in a series of lines protruding into the river flow. These lines of piles are oriented in a downstream direction and protrude about 50 ft into main channel which is about 100 ft wide. The top of the piles is about 20 ft above the river bed. A cable is strung across the tops of the piles in one line. Hanging from the cable are meshes made of the same material used for seat belts in cars. Six lines of these meshes were placed upstream of the pier over 200 ft of river length and one downstream. The meshes were installed in 1995 and in 1999 the situation seemed to have reversed itself slightly. The cost of the nets was 122,000 dollars. One observation was that it is important for the pile closest to the bank to be actually driven into the flood plain material so that no gap exists between the finished mesh and the bank.

At the time of construction (1953) the main channel was bridged by the main span and was in a slight curvature meander. In 1993 the main channel had migrated 75 ft to the west/south-west towards the west abutment (Figure 11.28). The channel had also deepened by 10 ft. The combination of the two movements exposed 16 ft of one of the center piers which is now in the middle of the new channel.

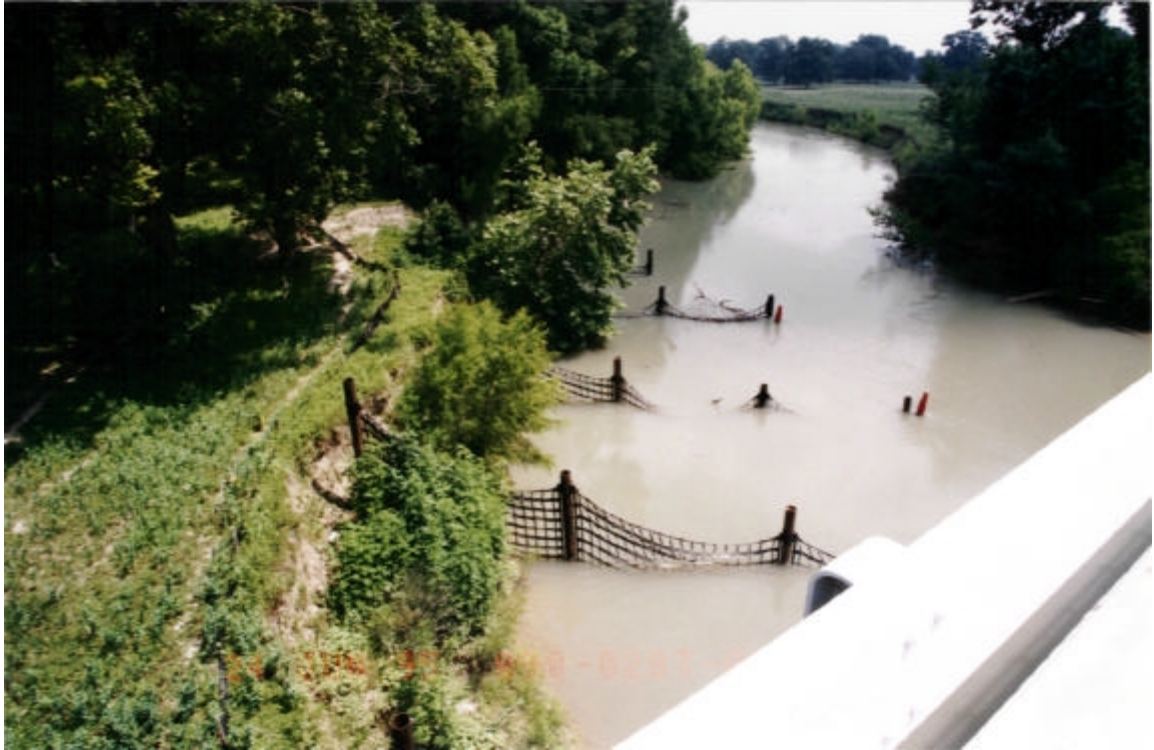
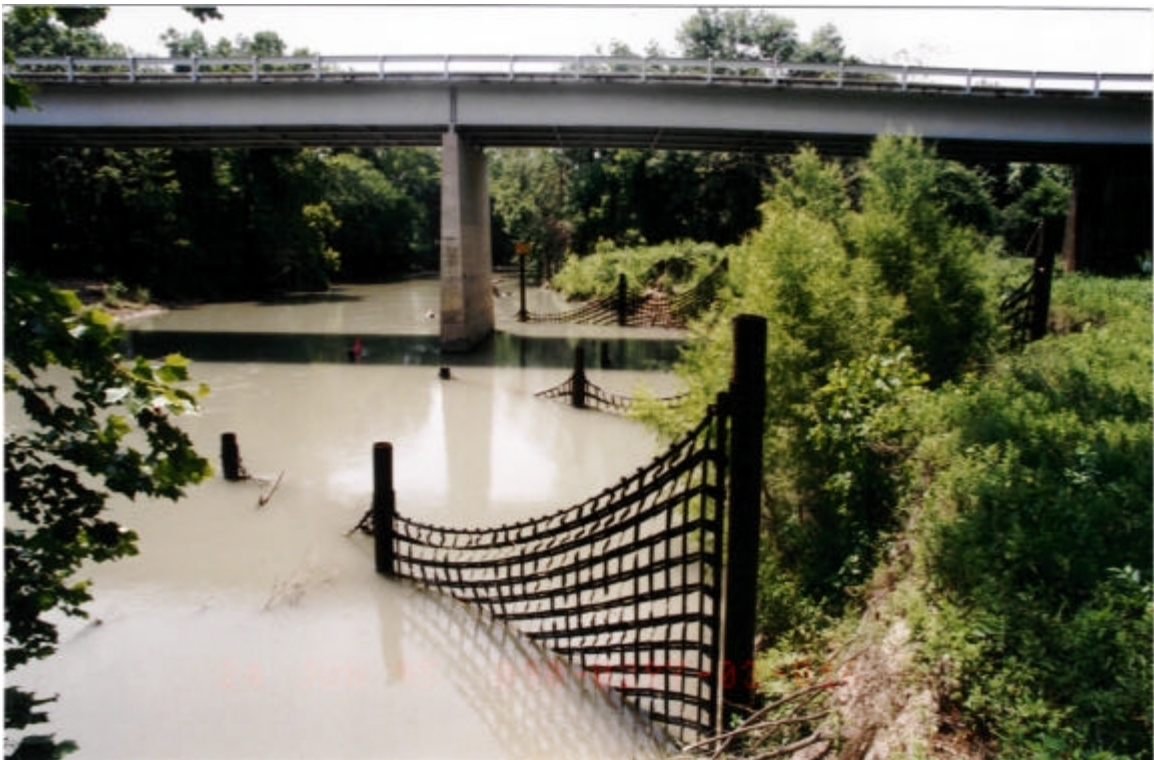
Figure 11.30. Bank of Meander after Installation of Ercon Nets.
