VEHICLE DETECTOR EVALUATION

Report 2119-1
Project Number 0-2119
Research Project Title: Evaluation of Vehicle Detection Systems

Sponsored by
Texas Department of Transportation
In Cooperation with the
U.S. Department of Transportation
Federal Highway Administration

October 2002

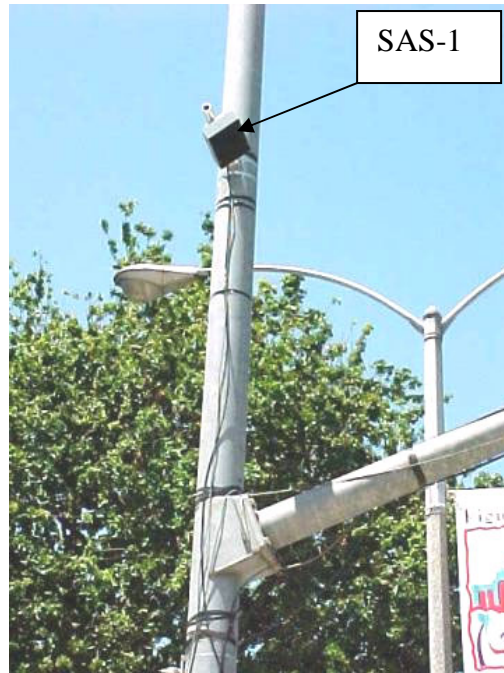
Figure 3. SAS-1 Mounting Location for Tests by City of LA.

City of LA representatives stated that they evaluated the SAS-1 as a count and system detector alternative. In that context, city staff recommended that the SAS-1 detector should be a candidate for locations where they cannot install loops. Personnel who evaluated the SAS-1 found that its detection accuracy equals that of inductive loop detectors for a two- to three-lane roadway. The unit is also able to detect traffic flow across a painted median when mounted at sufficient height. This ability can allow a single unit to provide advance detection between two closely spaced intersections (e.g., a diamond interchange). City of LA staff concluded that the SAS-1 can achieve a peak daily accuracy relative to loop detectors as high as 99.99 percent, and peak daily accuracy relative to adjusted true traffic volume¹ was 99.8 percent. [Table 3](#) summarizes these findings.

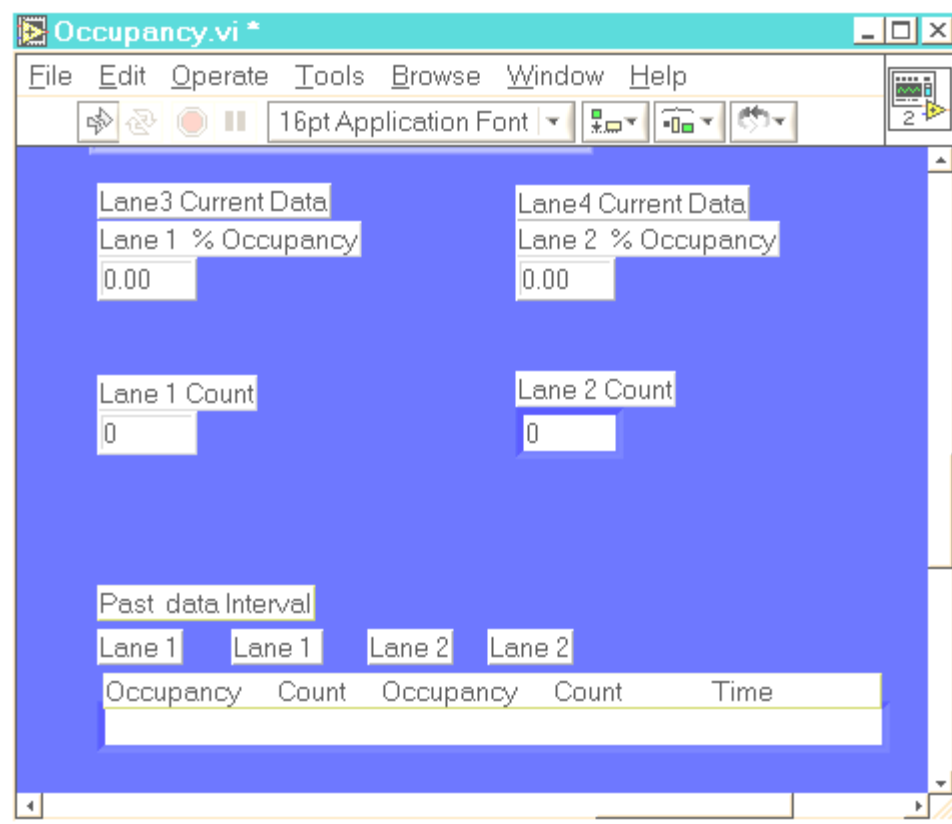
Figure 5. TTI Occupancy Program User Interface.

The TTI occupancy calculation system consisted of a National Instruments high-speed counter/timer PCI card installed in a computer located in the Austin ATMS TxDOT cabinet. Installers piggybacked onto two TxDOT inductive loop amplifier outputs from two single loops first in lanes 3 and 4, then later to lanes 1 and 2. The loop amplifiers provided the input needed by the occupancy system. The system checked loop presence status 100,000 times per second and measured a precise time the loop was occupied, summed these times, and divided by a period of 1, 5, or 15 minutes to calculate occupancy. It then time-stamped the data and wrote the data to a text file. TTI developed the system software using National Instruments LabView. [Figure 5](#), shown on the next page, is the occupancy software program user interface.

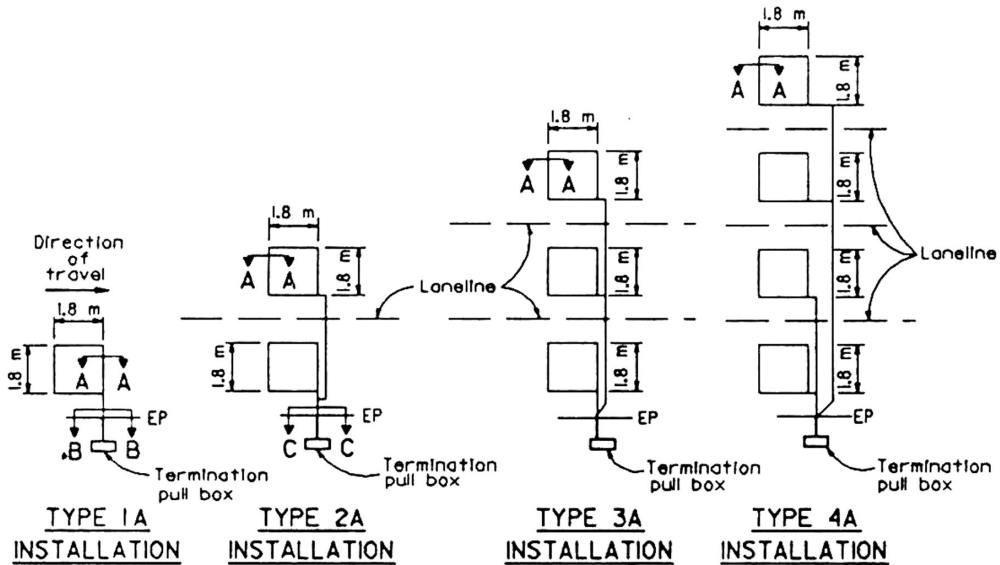
Type A loop detector configurations illustrated

1. 1A thru 4A = 1 Type A loop configuration in each lane.
 2. 1B thru 4B = 1 Type B loop configuration in each lane.
 3. 1C = 1 Type C loop configuration entering lanes as required.
 4. 1D thru 4D = 1 Type D loop configuration in each lane.
 5. 1E thru 4E = 1 Type E loop configuration in each lane.
 6. 1O thru 4O = 1 Type O loop configuration in each lane.
- (Use Type A, B, C, D, E or O loop detector configurations only when specified or shown on plans)
