1. Report No. DHT 1-5-75-219-1F		2. Government Accession No.		3. Recipient's Catalog No.	
4. Title and Subtitle EVALUATION OF BRIDGE SLAB STRENGTHENING SYSTEM				5. Report Date August 1976

Evaluation of Bridge Slab Strengthening System

Research Report Number 219-1F

Research Study 1-5-75-219

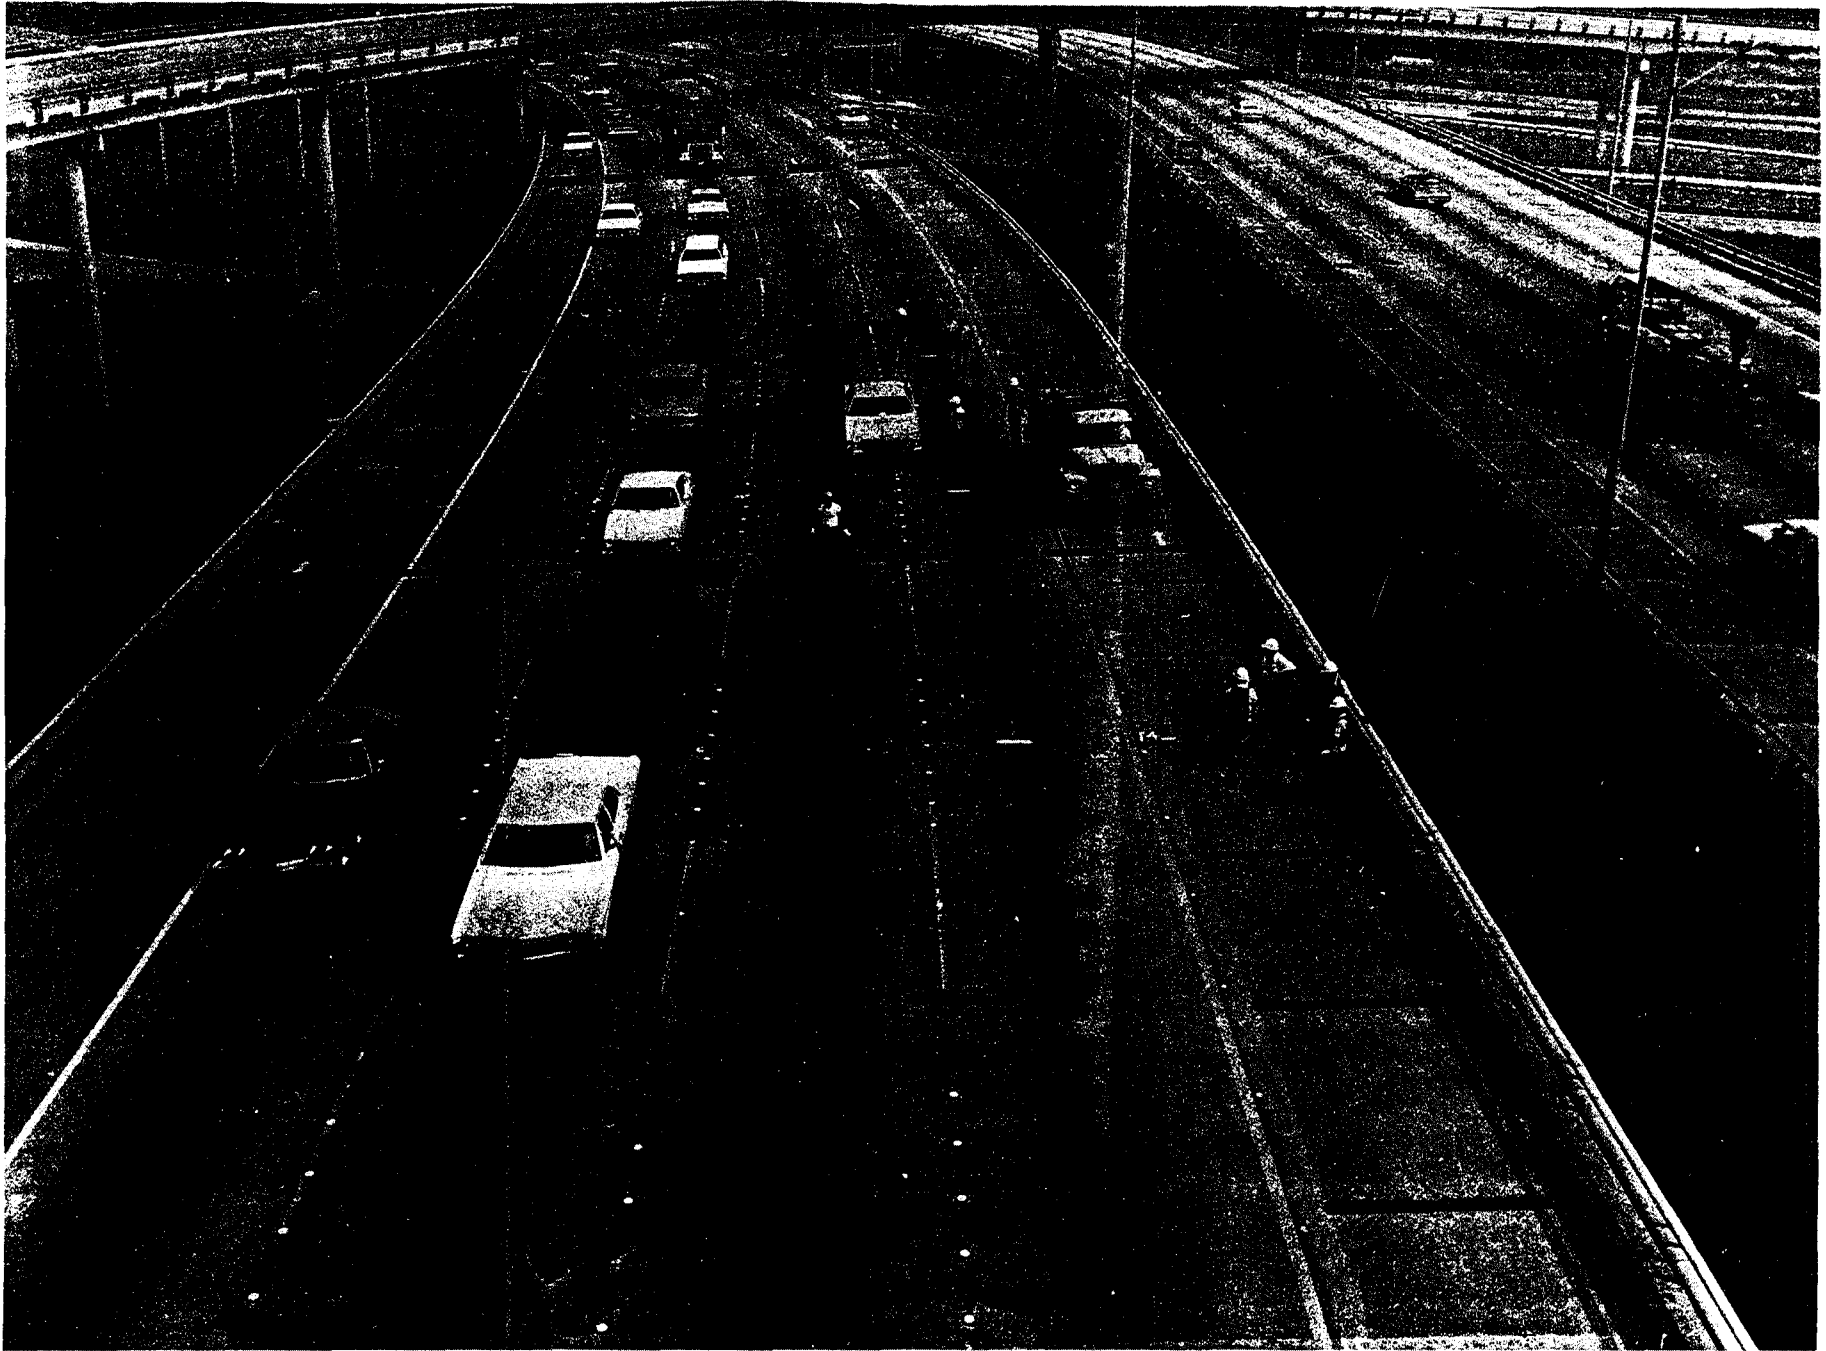
Figure 2.1. Structure 97 at Time of Strengthening  
(Strengthened Area is Between Dashed Lines)

Figures 2.1 through 2.6 are photographs showing the condition of slabs on structures 97 and 98.

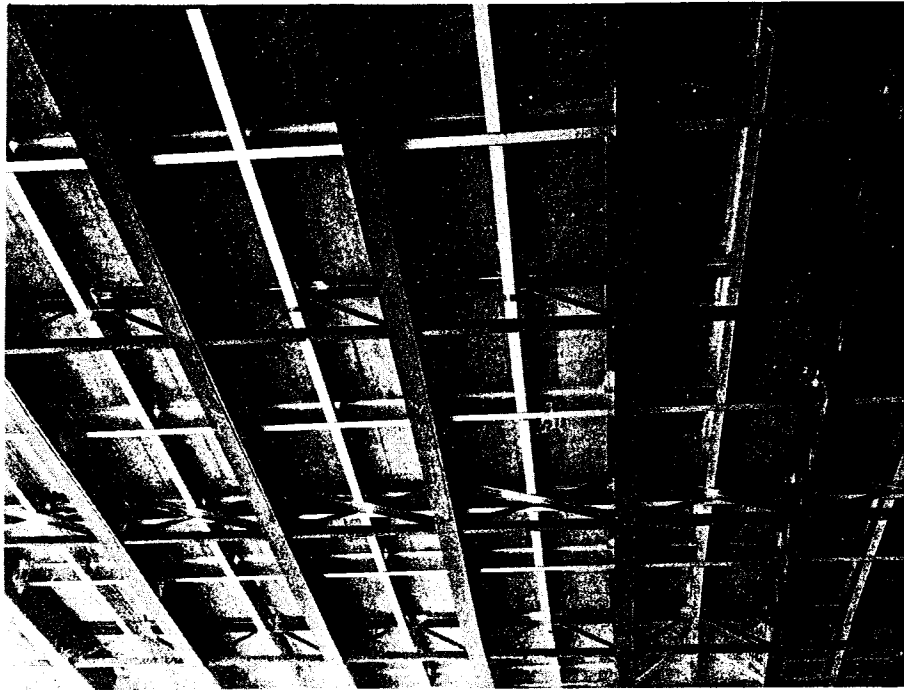
Figure 4.4. Strengthening System in Place

(453 kg). The stringers were then jacked into place using approximately one-half the load used for the floorbeams. This method produced a very tight fit between the slab and shim plates. Figures 4.4 through 4.8 show the grid system in place.

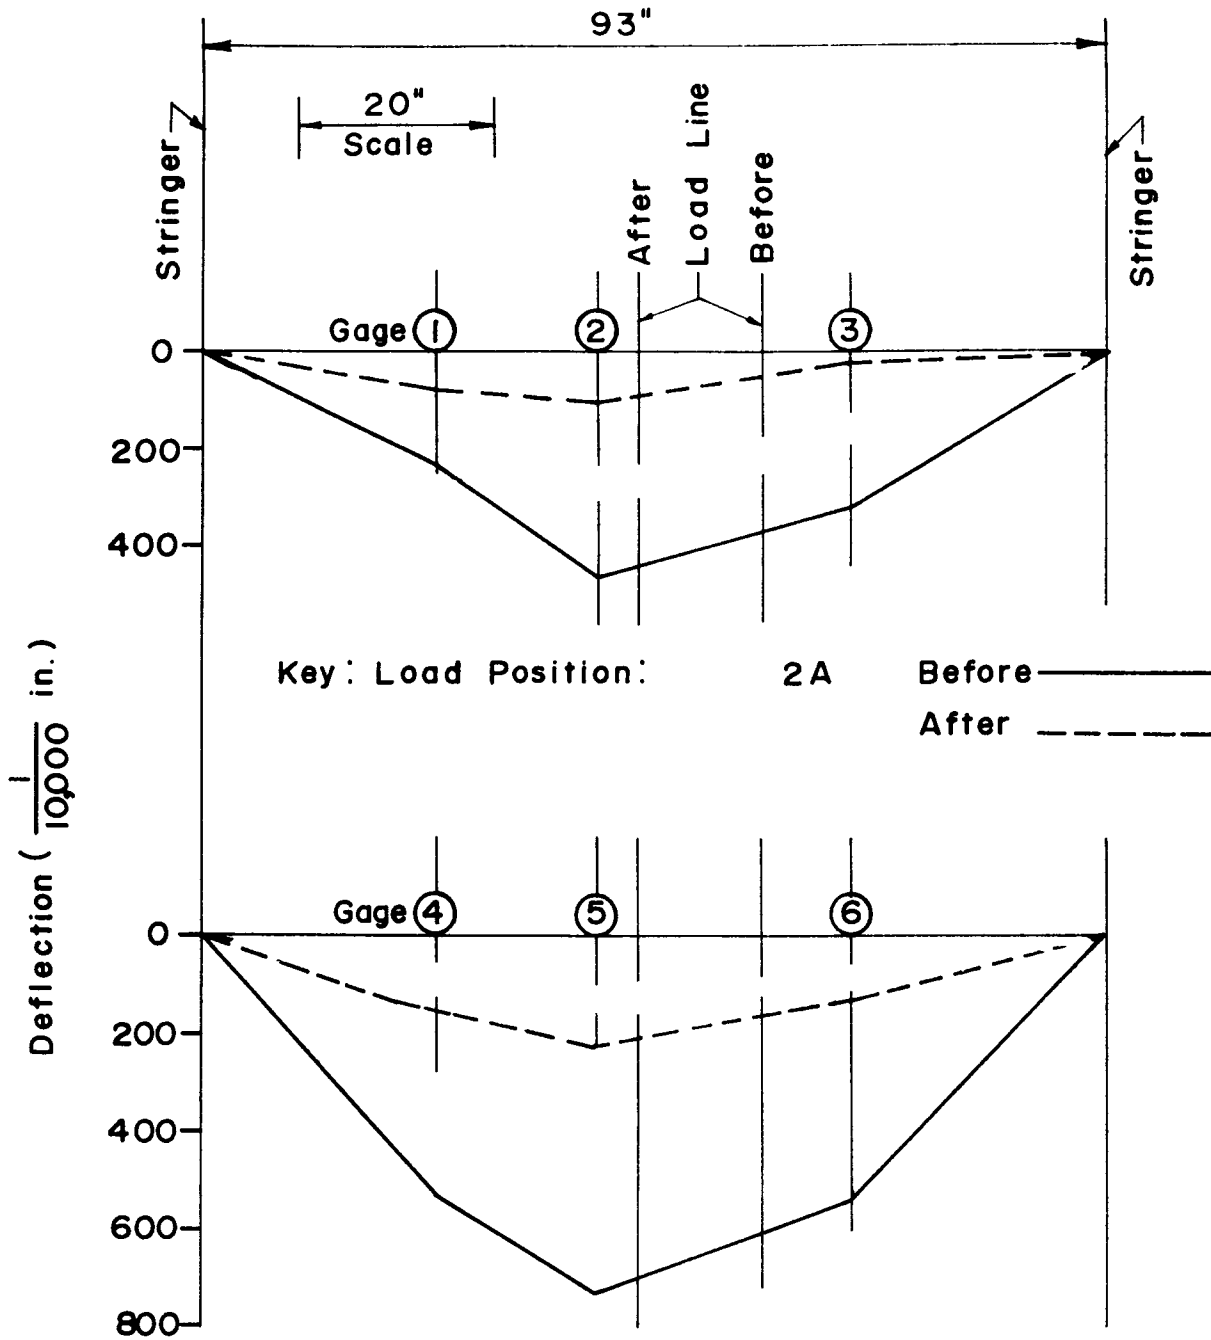
Deflections are averages from at least three load applications.

FIG. 5.II. SLAB DEFLECTIONS, PANEL  
98-2-A

The deflections shown in Figures 5.10 through 5.13 clearly show a great stiffening effect of the added beams. The individual deflections shown in tables show some scatter, but they are generally in good agreement. In Table 5.3, load position 98-1-A, gage 4 before strengthening, the value shown for deflection at second loading is one of the values so far out of line that it is very likely incorrect. This is probably due to an

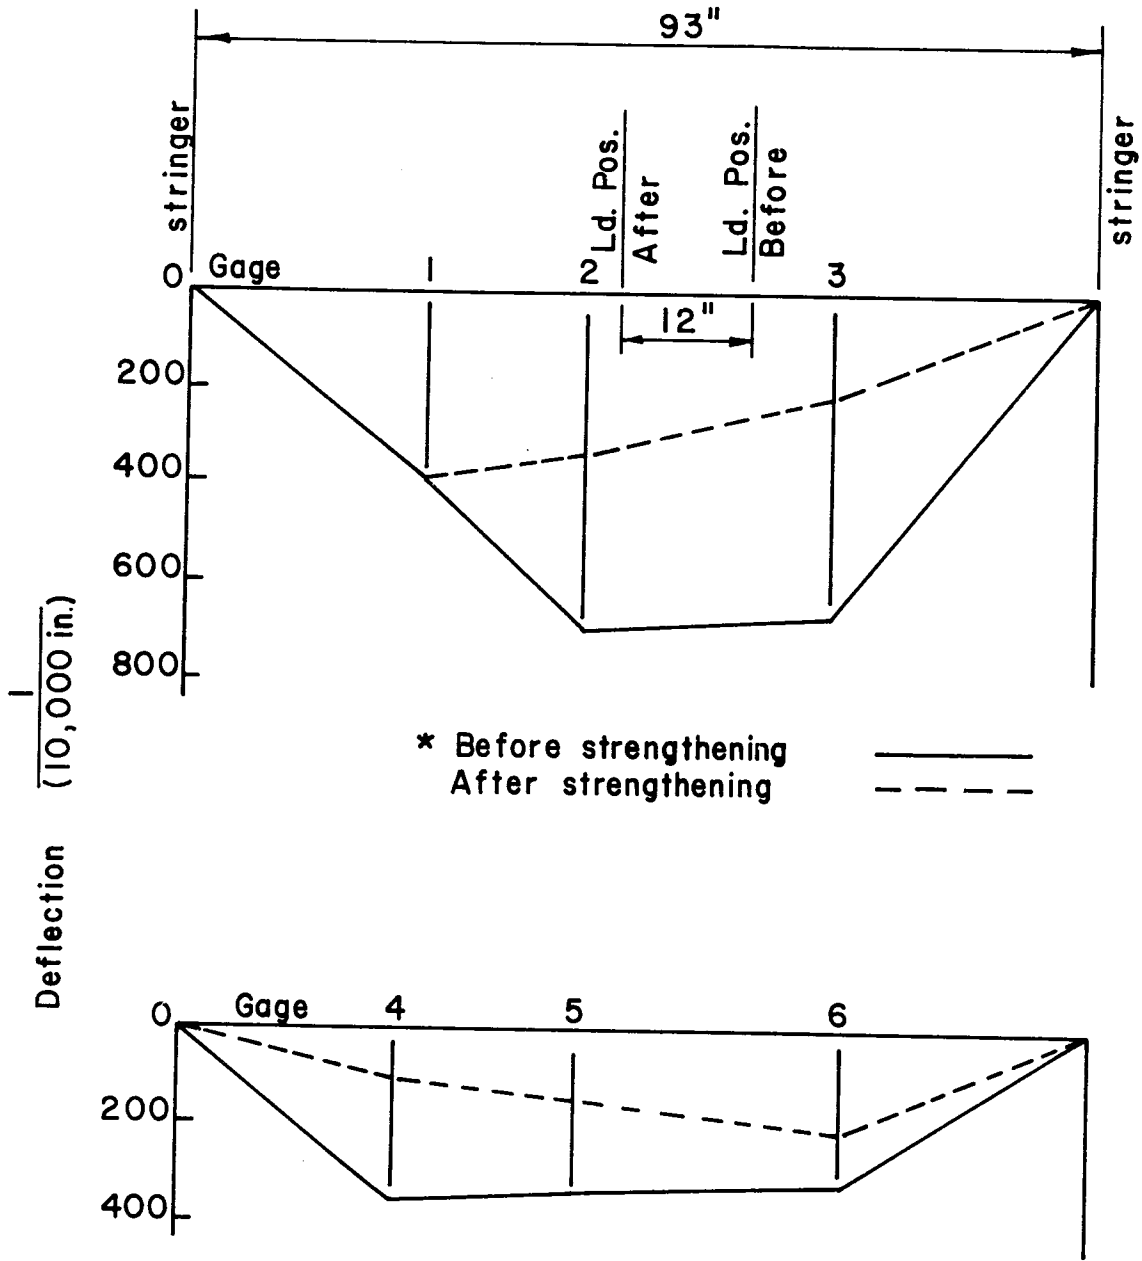
\* Before strengthening  
 After strengthening

\* Before strengthening deflections are assumed and are based on measurements made at load position 98-1-A

FIG. 5.14. SLAB DEFLECTIONS  
 PANEL 98-1-B
