1. Report No. TTI-2-10-75-223-1		2. Government Accession No.		3. Recipient's Catalog No.	
4. Title and Subtitle Crash Test and Evaluation of a Precast Concrete Median Barrier			5. Report Date October 1975		6. Performing Organization Code

CRASH TEST AND EVALUATION OF A PRECAST  
CONCRETE MEDIAN BARRIER

Research Report 223-1  
Crash Test and Evaluation of Precast  
Concrete Barrier and Remedial  
Measures for Crash Cushions

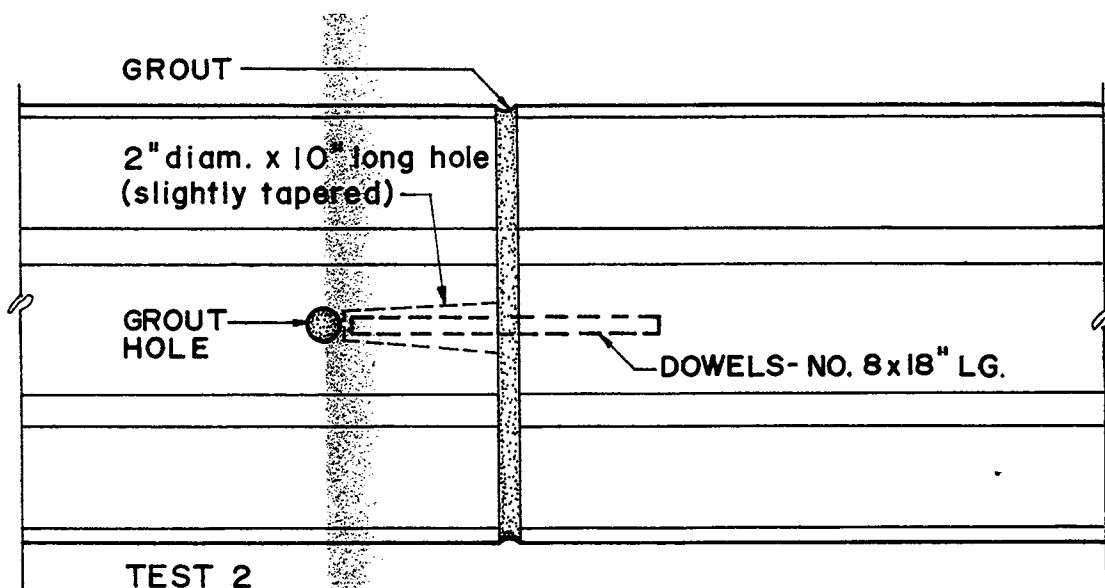
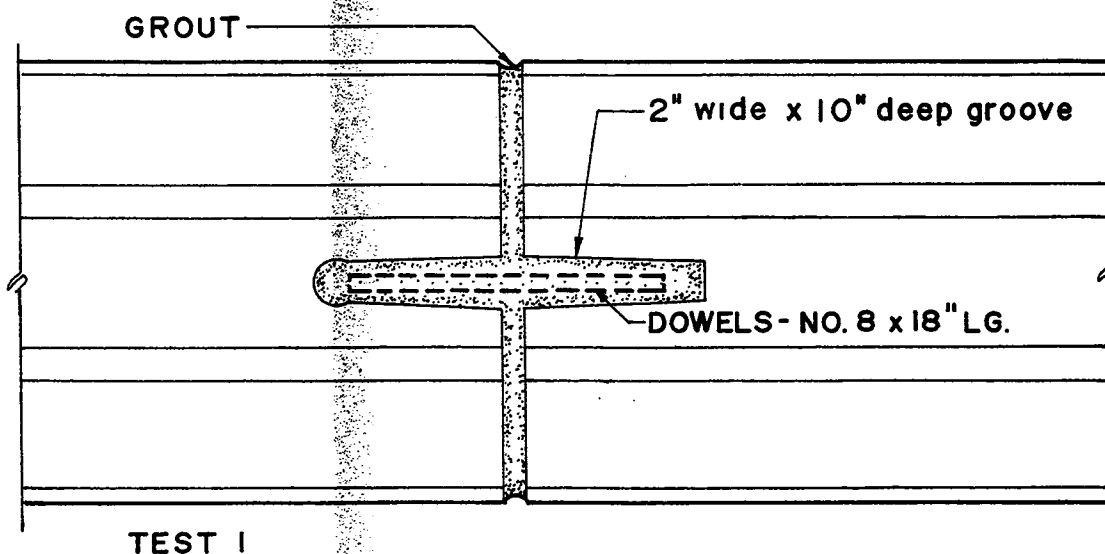
FIG. 2. PCMB TEST CONNECTION DETAILS.

Two slightly different dowel joint details were used to connect the 30 ft (9.1 m) precast sections together (See Figure 2). The Male-Female dowel connection used three No. 8 dowels (1 in. diam. or 2.54 cm) 18 in. (.46 m) long precast in one end and three mating 2 in. diam. (5.08 cm) tapered holes cast in the opposite end as shown in Figure 2. A pressure grout hole was cast vertically behind the tapered female holes. The second connection used was the Grooved Connection which also used three No. 8 dowels (1 in. diam or 2.54 cm) 18 in. (.46 m) long as shown in Figure 2. The Grooved Connection was believed to be more desirable when the precast sections would be used as a temporary barrier. It was believed that the grout and dowels could be chipped out of the grooved block outs and the precast sections more readily reused. This latter connection detail was arrived at after the precast CMB sections were cast, so these grooves were sawed instead of being precast in as would be desirable.

TEST 2  
MALE - FEMALE DOWEL CONNECTION

TEST 1  
GROOVED CONNECTION

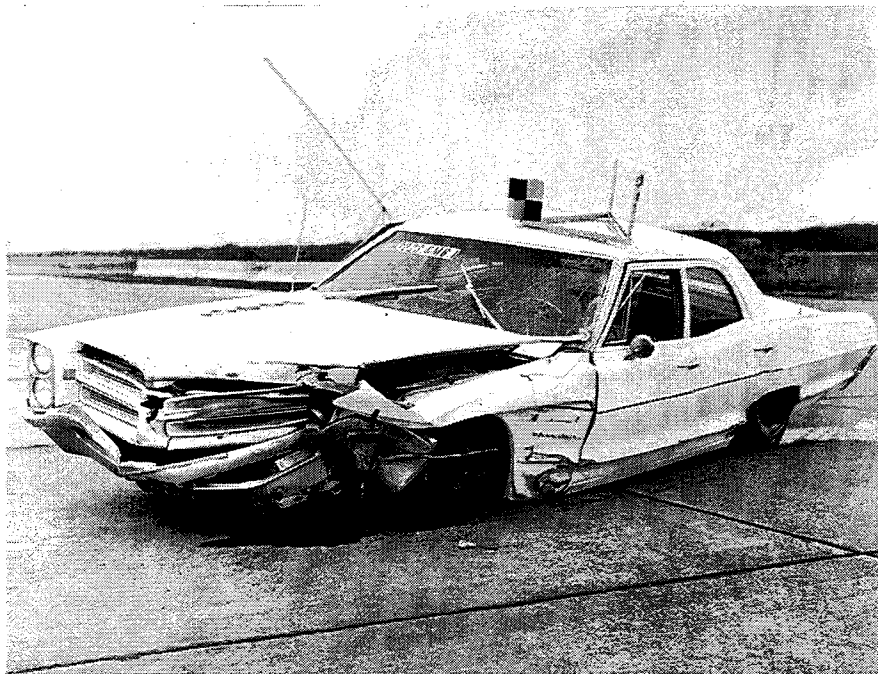
Figure 4. Test 1 Vehicle Before and After Impact.

The vehicle used for Test 1 was a 1966 Pontiac 4500 lbm (2040 kg). The impact point of the left front fender and the barrier occurred 7 ft (2.1 m) upstream from the groove joint as shown in Figure 1. The actual impact angle was 23.5 degrees and the actual impact velocity was 60.5 mph (97.3 kph). The top picture in Figure 4 shows the vehicle before impact while the lower picture shows the vehicle after impact. The vehicle was smoothly redirected and the exit angle was 7 degrees. The maximum vehicle roll angle of 18 degrees occurred while the vehicle was in contact with the barrier. The vehicle remained upright during the test. The front wheel and steering linkage were damaged and the vehicle was inoperable after the impact. Sequence photographs showing the impact are shown in Figures 5 and 6 from the overhead camera and parallel camera respectively.

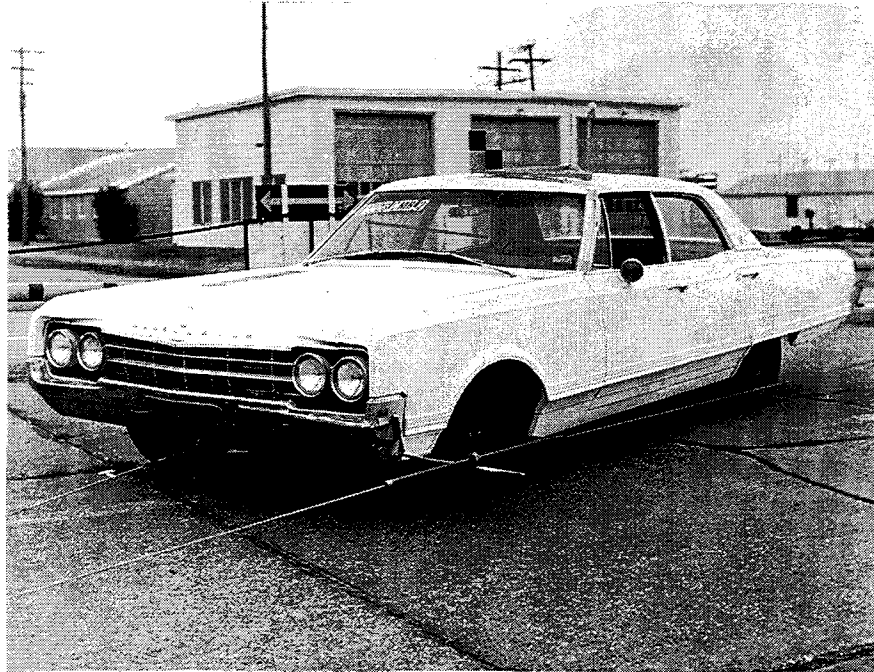
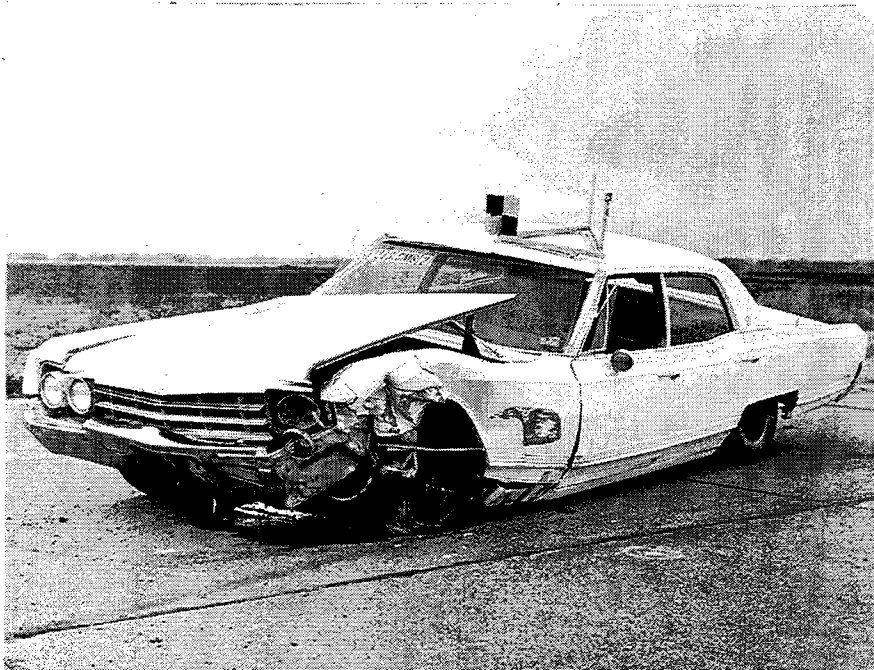
Figure 8. Test 2 Vehicle Before and After Impact

The vehicle used for Test 2 was a 1965 Oldsmobile 4540 lbm (2060 kg). The impact point of the left front fender occurred 7 ft (2.1 m) upstream from the male-female dowel joint as shown in Figure 1. The actual impact angle was 24.2 degrees and the actual impact velocity was 59.8 (96.2 kmh). The top picture in Figure 8 shows the vehicle before impact while the lower picture shows the vehicle after impact. The vehicle was smoothly redirected and the exit angle was 3 degrees. Again the maximum vehicle roll angle of approximately 18 degrees occurred while the vehicle was in contact with the barrier. The vehicle remained upright during the test. The left front wheel and steering linkage were damaged and the vehicle was inoperable after the impact. Sequence photographs showing the impact are shown in Figures 9 and 10 from the overhead camera and parallel camera respectively.
