MOVING MAINTENANCE OPERATIONS ON TEXAS URBAN FREEWAYS:
A LIMITED OVERVIEW OF CURRENT PRACTICES AND PROBLEM IDENTIFICATION

Research Report 228-4

Traffic Management During Urban Freeway
Maintenance Operations
Research Study 2-18-78-228

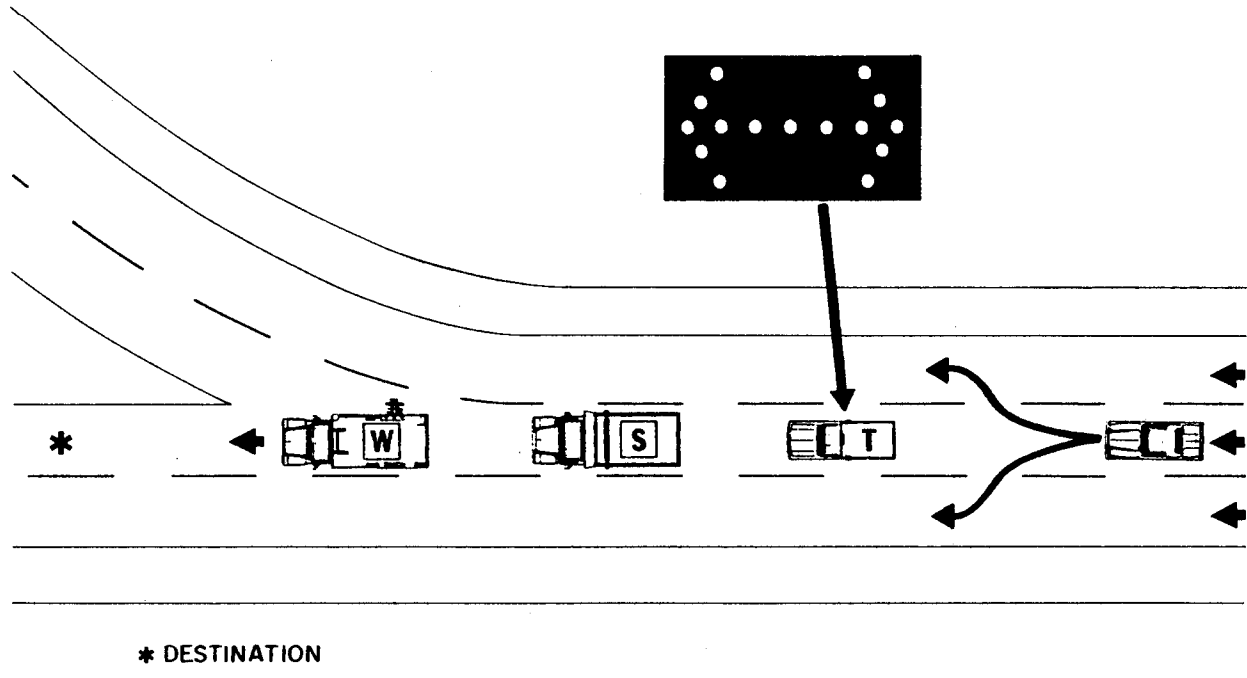
Figure 3. Freeway Design Related Problem at Major Freeway Interchange

Lane drops create the major problem at the exit ramp connector. Specifically, the problem occurs when maintenance is being performed upstream from the interchange on a middle lane that suddenly becomes the shoulder lane through the interchange because of a lane drop to the crossing freeway (see Figure 3). In the maintenance operations observed, the trailing vehicle in the caravan normally displayed a double-headed flashing arrow encouraging drivers to pass the caravan on either side. As the caravan approached the interchange, the double-headed arrow presented erroneous information to through drivers. They were incorrectly instructed to pass on the right side of the caravan. Drivers electing to do so, were suddenly found on the ramp leading to the crossing freeway.

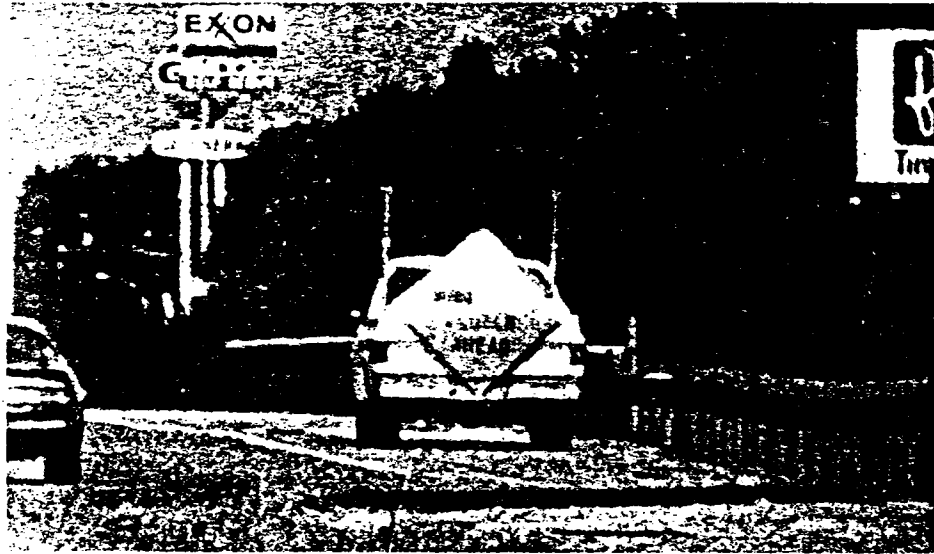
Figure 5. Advance Signing for Moving Maintenance.

and vertical curvature. Of the operations observed, only two used any advance signing (Figure 5). In both cases, vehicle-mounted warning signs and arrowboards were used upstream from the caravan to warn approaching motorists of the operation.

The signing, however, failed to identify the blocked lane. Through the application of previous study results (3), the lane occupied by the moving maintenance caravan could be identified. This can be accomplished with either a black legend on orange background static sign or a changeable message sign with a message similar to the following:
