BRIDGE RAIL TO RESTRAIN AND REDIRECT BUSES

Research Report 230-3

Research Study No. 2-5-78-230  
Bridge Rail to Contain Heavy Trucks and Buses

Texas Transportation Institute  
The Texas A&M University System  
College Station, Texas

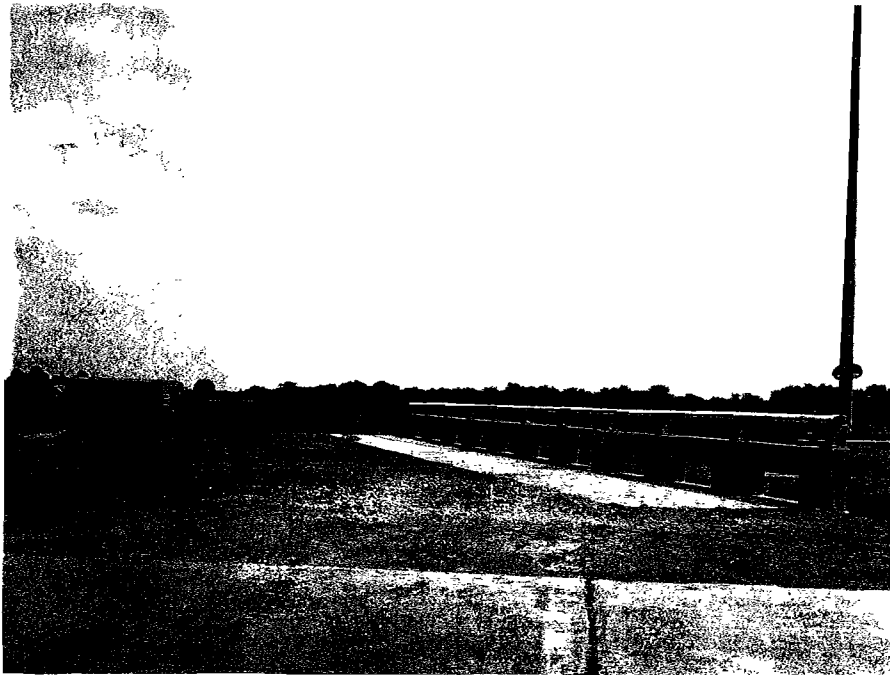
Figure 3. Front View Before and After Photographs of Bridge Rail for Test 3.

In test No. 3, a 1970 Ford, 66-passenger school bus weighing 19,690 lb (8,931 kg) impacted the bridge rail at 54.4 mph (87.6 km/hr) at 15°. The bus was smoothly redirected and departed the rail at an angle of 3.5°. The bus was very stable during the test, with a maximum roll angle of 13°. No passengers (simulated by sandbags placed unrestrained on the seats) were ejected from the bus. The light damage to the school bus is shown by Figure 7. The very light damage to the bridge rail is shown by Figures 3, 4,

5 and 6. Note the location of the school bus after the test in Figures 3 and 4. The residual deflection in the aluminum rail was only 2 in. (5.1 cm) and nil in the concrete beam or parapet. The concrete bridge deck supporting posts 4, 5, and 6 were cracked slightly as shown by Figure 6. The bridge deck was repaired prior to test No. 4 by injection of epoxy glue. Figure 8 shows the repaired concrete deck and beam at post No. 4. Total cost of the epoxy injection done by a subcontractor was \$2400.

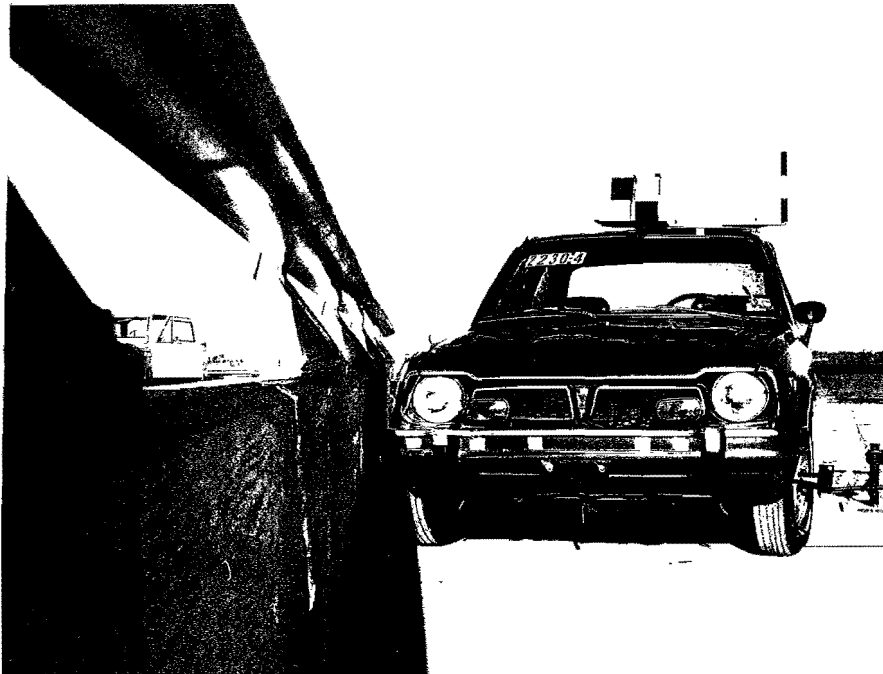
Figure 8. Bridge Rail and Honda Before Test 4.

In test No. 4 a 1974 Honda Civic weighing 1800 lb (817 kg) impacted the bridge rail at 59.4 mph (95.6 km/hr) and  $15^{\circ}$ . The precise point of impact was at midspan between posts No. 4 and 5 (see Figure 8). The purpose of this test was to see if the 13 in. (33 cm) wheel with an overall diameter of 22 in. (56 cm) would penetrate the 13 in. (33 cm) clear opening between the bridge deck and concrete beam and snag on a concrete post.

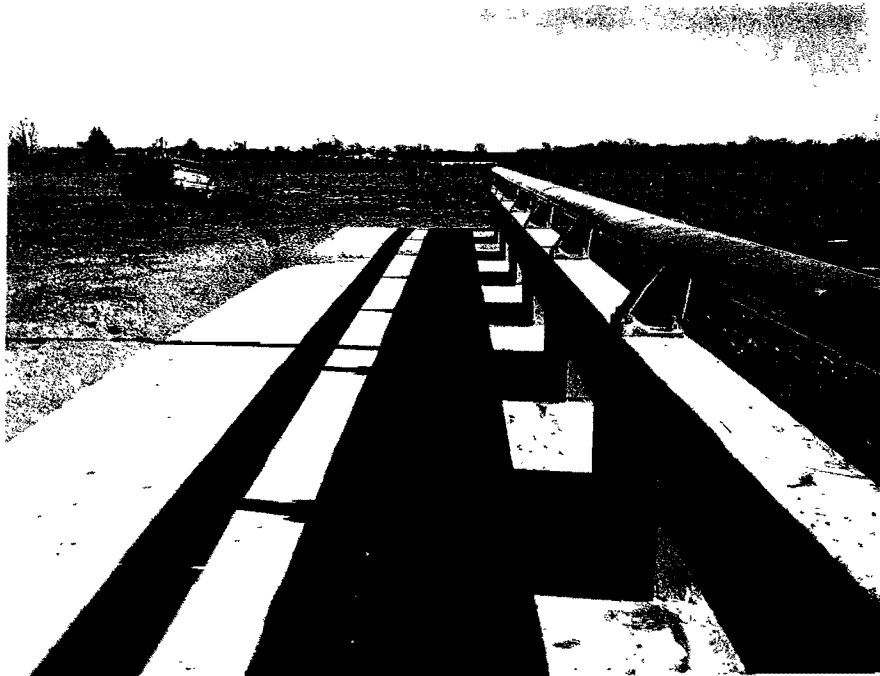
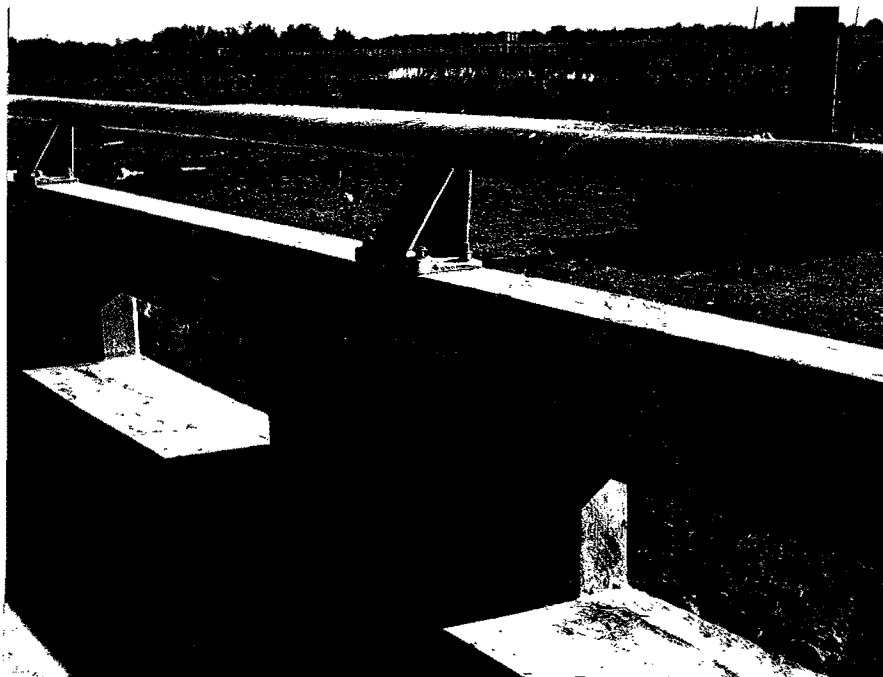
Figure 9. Bridge Rail and Post No. 5  
After Test 4.

During impact the Honda was redirected and the right front wheel did contact the concrete post. The wheel was bent back and jammed against the front passenger compartment wall as shown in Figure 10. This metal wall had a dent about 4 in. (10 cm) deep. Other damage to the vehicle was as shown in Figure 10. Damage to the bridge rail or concrete deck was nil, and no repairs were required (see Figure 9).

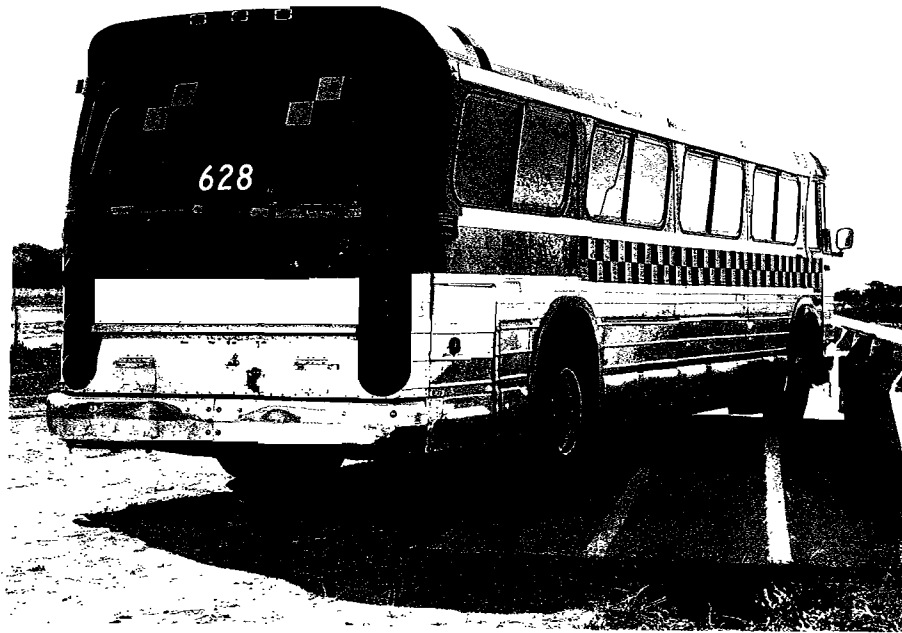
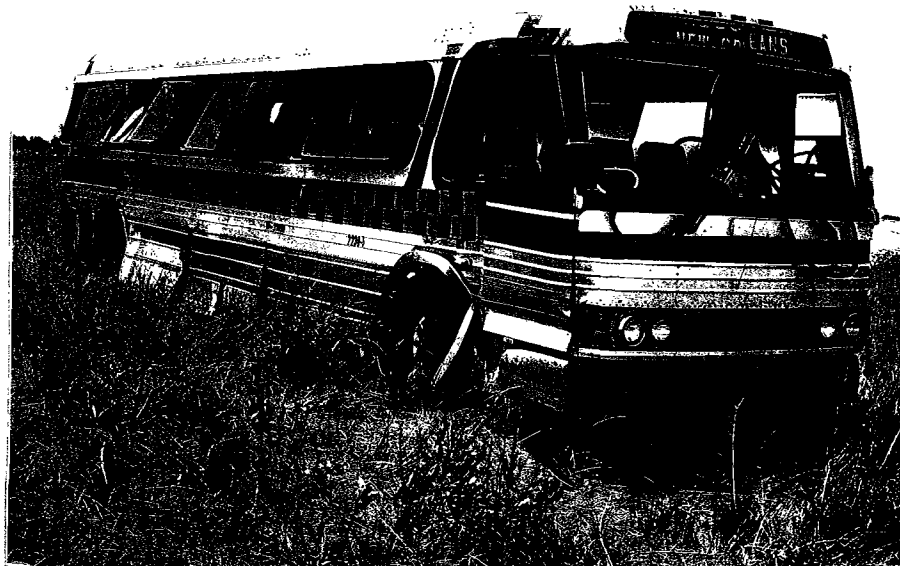
Figure 12. Vehicle Before and After Test 5.

In test No. 5 a 1962 GM coach intercity bus weighing 32,080 lb (14,562 kg) impacted the bridge rail at 61.1 mph (98.3 km/hr) and  $15^{\circ}$  angle. The intercity bus was restrained and smoothly redirected. The bus experienced a maximum roll angle of  $21^{\circ}$  and departed the rail at an  $8.5^{\circ}$  angle, remaining stable throughout the test. Damage to the bus can be seen in Figure 12.

simulated passengers (sandbags) were ejected through the bus side windows (see Figure 12). It should be remembered that this was a 1962 intercity bus and was not designed and constructed to the current Federal Motor Vehicle Safety Standards (FMVSS Standard No. 205, Jan. 1, 1968, and FMVSS Standard No. 217, Sept. 1, 1973).

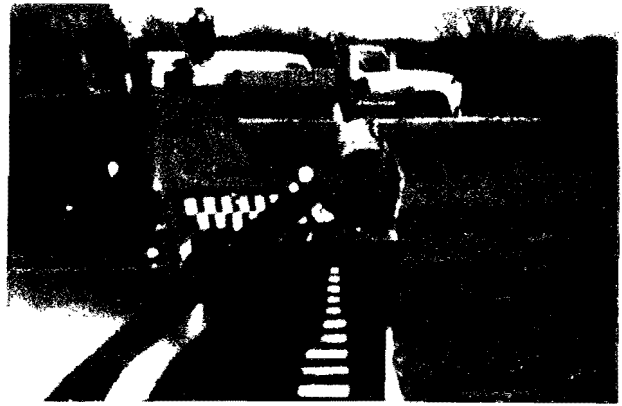
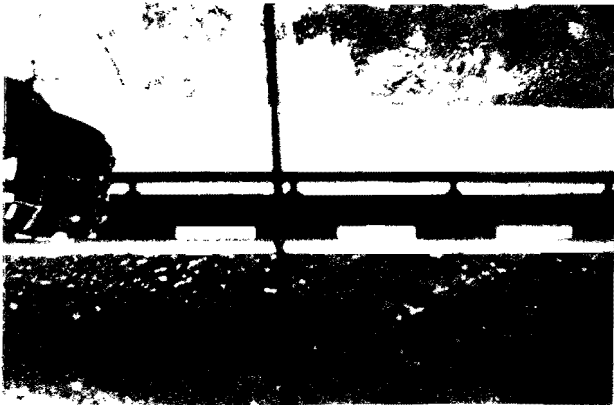
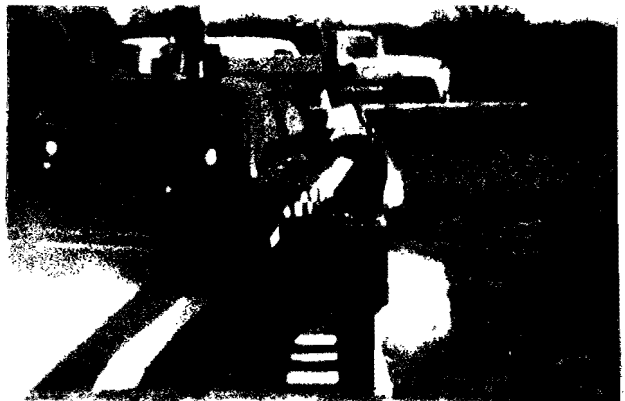
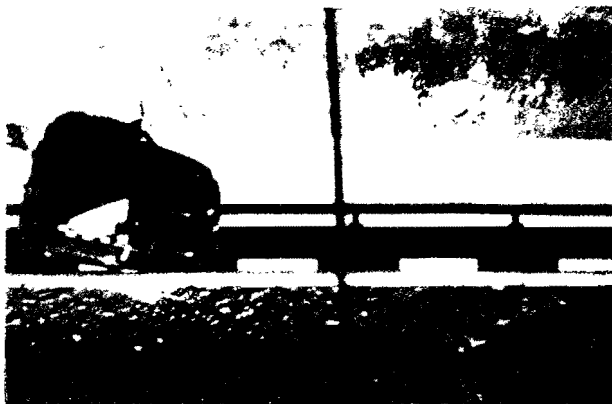
Figure C2. Sequential Photographs for Test 4.

The second test was with an 1800 lb (817 kg) minicar with front wheel drive and impacting the rail at 59.4 mph (95.6 km/hr) at a  $15^{\circ}$  angle. The vehicle was redirected but the small diameter right front wheel did penetrate under the 13 in. (.33 m) clear opening between the deck and concrete beam and snagged a concrete post. Damage to the vehicle was moderate and to the rail nil.

In crash test 4 with the Honda Civic, the hypothetical passenger impact velocity with the vehicle interior was 23 ft/sec (7 m/sec) longitudinal and 22 ft/sec (6.7 m/sec) lateral. The vehicle's highest 10 ms accelerations subsequent to passenger impact was 1 g longitudinal and 4 g's lateral. All of these values are well within the recommended guidelines from reference 11.
