1. Report No. FHWA/TX-82/52+262-3		2. Government Accession No.		3. Recipient's Catalog No.	
4. Title and Subtitle A Portable Traffic Barrier For Work Zones				5. Report Date October 1982

A PORTABLE TRAFFIC BARRIER FOR WORK ZONES

Research Report 262-3
on
Research Study No. 2-18-79-262
Safety Devices for Highway Work Zones

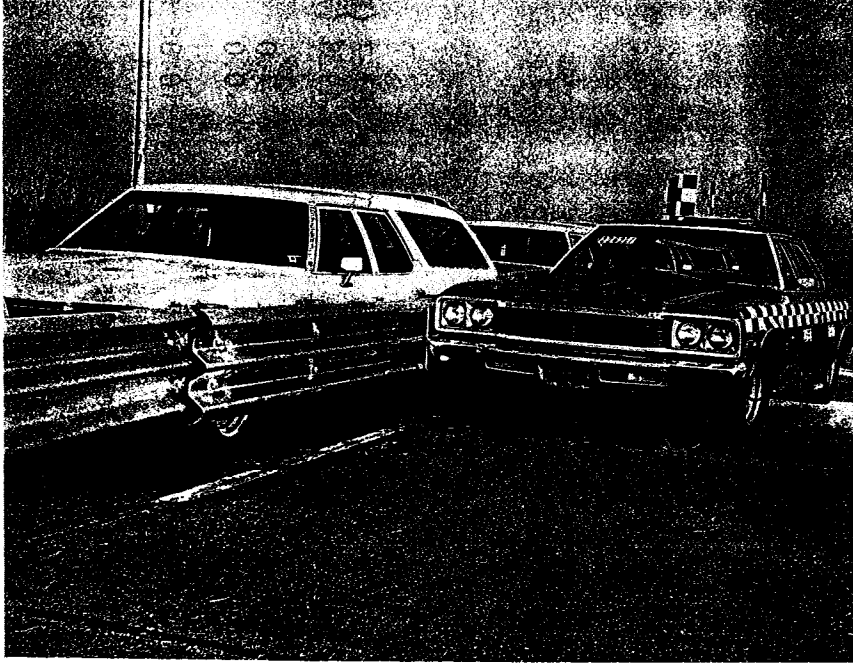
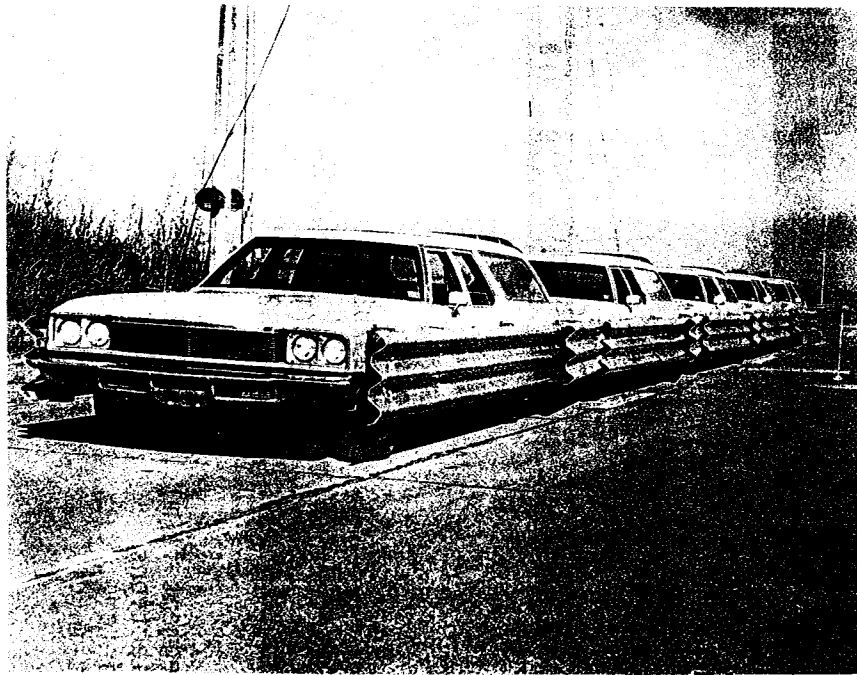
Figure 9. Test Vehicle and Barrier Before Test 7.

Figures 9 and 10 show the test vehicle and barrier before and after test 7, respectively. As shown in Figure 10, test vehicle damage was limited to sheet metal deformations. The barrier sustained no visible damage and was driven from the test site. Barrier displacement was limited to 2 in. Test 1 was considered very successful due to the light test vehicle damage and negligible barrier damage.

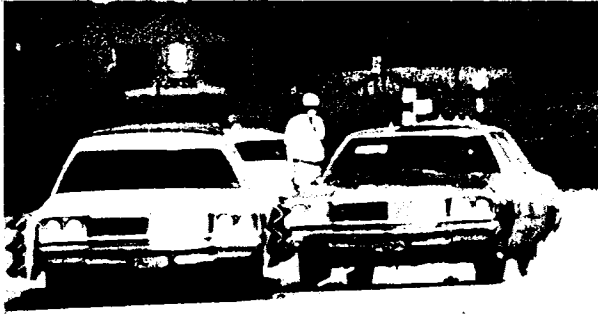
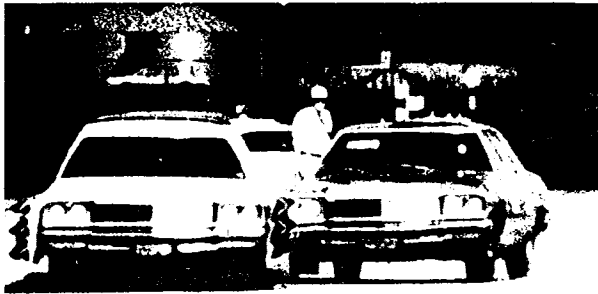
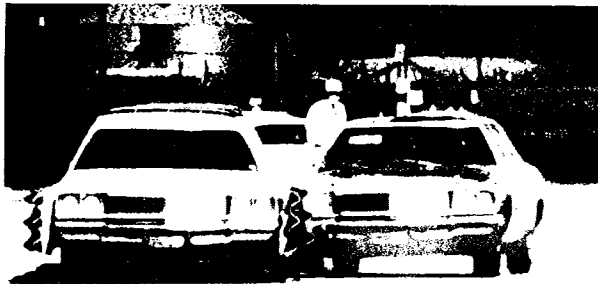
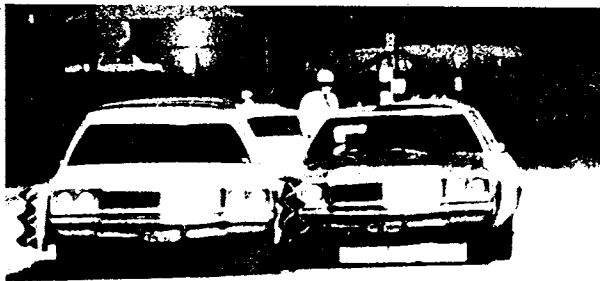
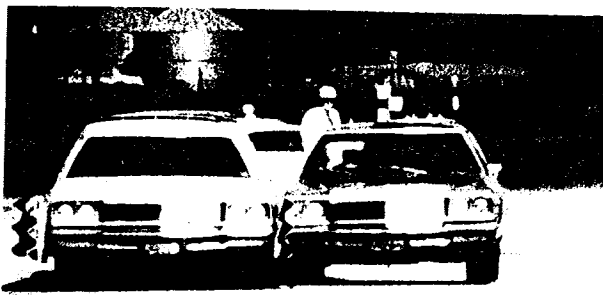
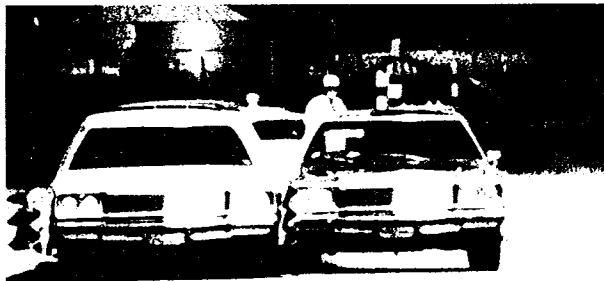
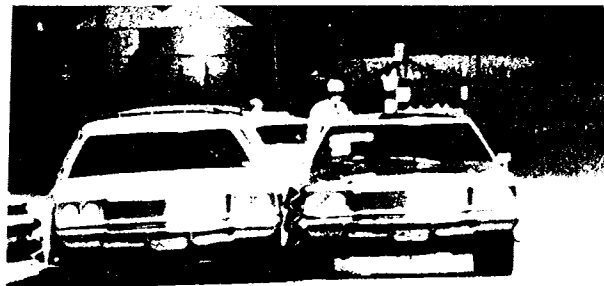
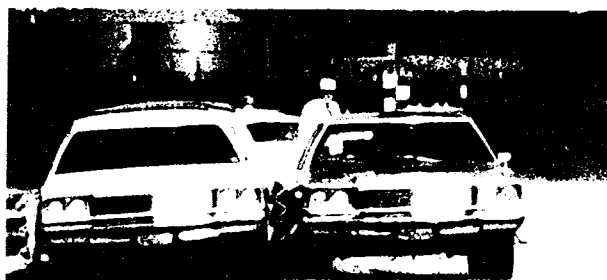
Figure 16. Sequential Photographs for Test 7.

0.000 sec

0.043 sec

0.086 sec

0.129 sec

0.171 sec

0.214 sec

0.300 sec

0.386 sec

In the first test a 4500 lb (2043 kg) vehicle impacted at 51.7 mph (83.2 km/h) and 7 deg. Figure 8 contains a summary of this test. The test vehicle was smoothly redirected and exhibited no tendency to pocket or snag on the end treatment. As shown in Table 2, all occupant risk values and the vehicle trajectory hazard were well below recommended values (2).

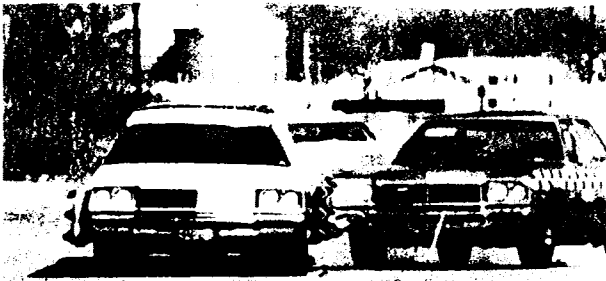
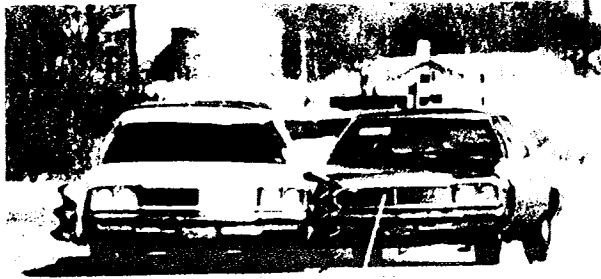
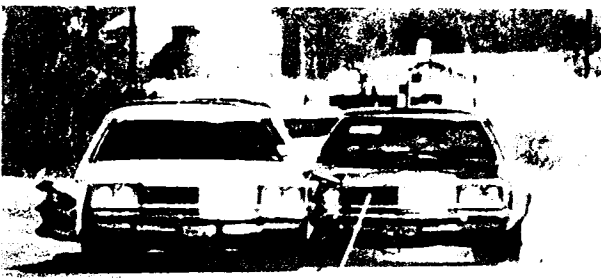
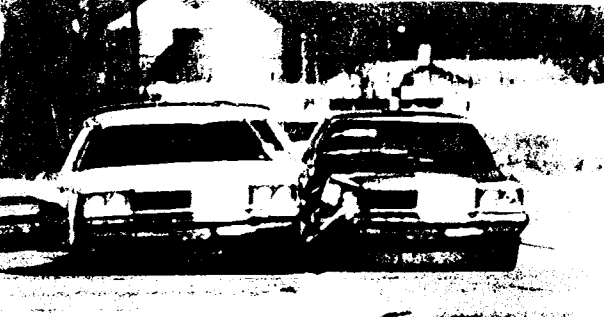
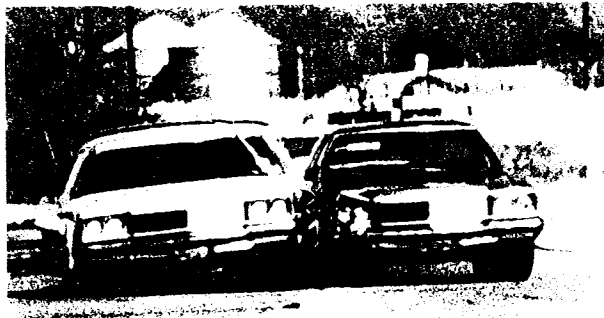
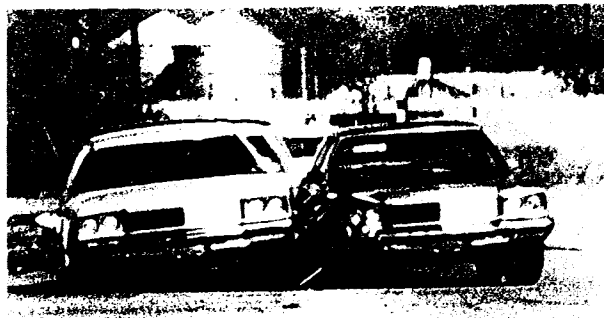
0.000 sec

0.093 sec

0.186 sec

0.326 sec

0.378 sec

0.425 sec

Test 8 involved impacting the barrier at 48.3 mph (77.7 km/h) and 15 deg. with a 4500 lb (2043 kg) vehicle. A summary of this test is shown in Figure 11. Since the vehicle damage from test 1 was very light, the same vehicle was used in test 2. The test vehicle was smoothly redirected and, as shown in Table 2, occupant risk values and the vehicle trajectory hazard were below recommended limits (2). Maximum barrier deflection was limited to 8.4 in.

The test vehicle, shown in Figure 12, was only lightly damaged. Barrier damage, shown in Figure 13, was limited to minor deformations in the thrie beam rail and the barrier vehicle sheet metal. The barrier was again driven from the test site, and no barrier repair was required. This test was also considered to be very successful.
