DEVELOPMENT OF A TRUCK-MOUNTED  
PORTABLE MAINTENANCE BARRIER

Research Report 262-5  
on  
Research Study No. 2-18-79-262  
Safety Devices for Highway Work Zones

Texas Transportation Institute  
The Texas A&M University System  
College Station, Tx

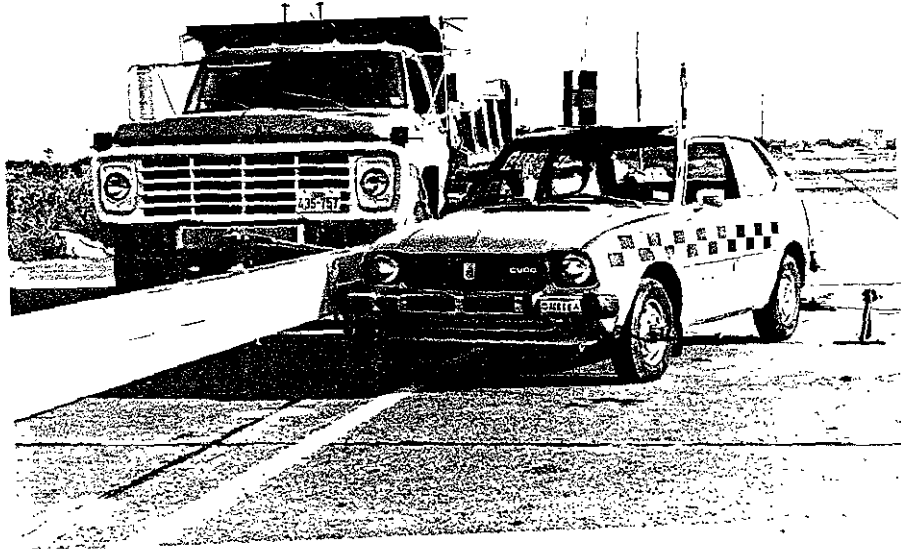
Figure 19. Barrier and Automobile  
Prior to Test 10

Figure 19 presents photographs of the barrier and the automobile prior to impact. Figure 20 presents photographs of the barrier and the automobile after impact. The barrier section experienced another 1/2 in. (1.27 cm) of permanent deflection during this test, resulting in a total of 1 in. (2.54 cm) permanent deformation. The support trucks, hitches, and support members experienced no damage. The automobile experienced damage to the right front fender and scratches down the right side, damage to the right front tire and rim, and the right front headlight.
