SAFETY TREATMENT OF ROADSIDE
CROSS-DRAINAGE STRUCTURES

Research Report 280-1
on
Research Study No. 2-8-79-280
Safe End Treatment for Roadside Culverts

Texas Transportation Institute
The Texas A&M University System
College Station, Texas

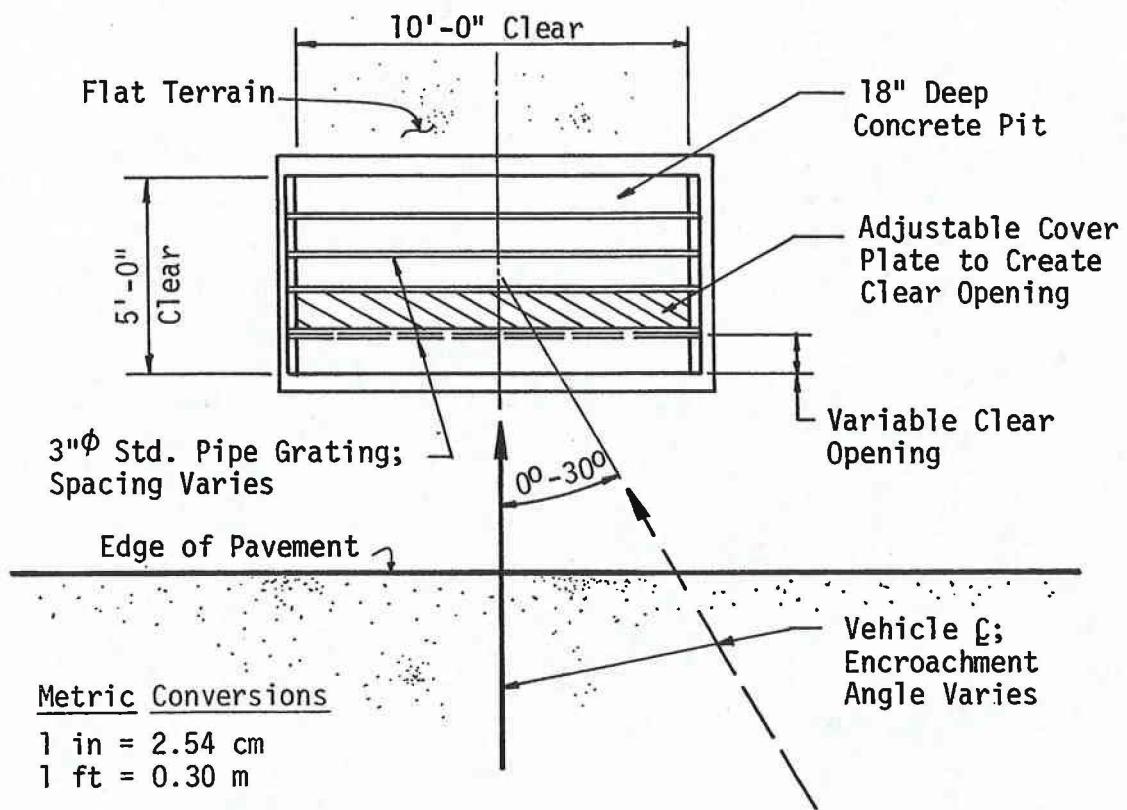
Figure 7. Plan View of Culvert Test Pit

Note: Appendix B contains a working drawing of the test pit.

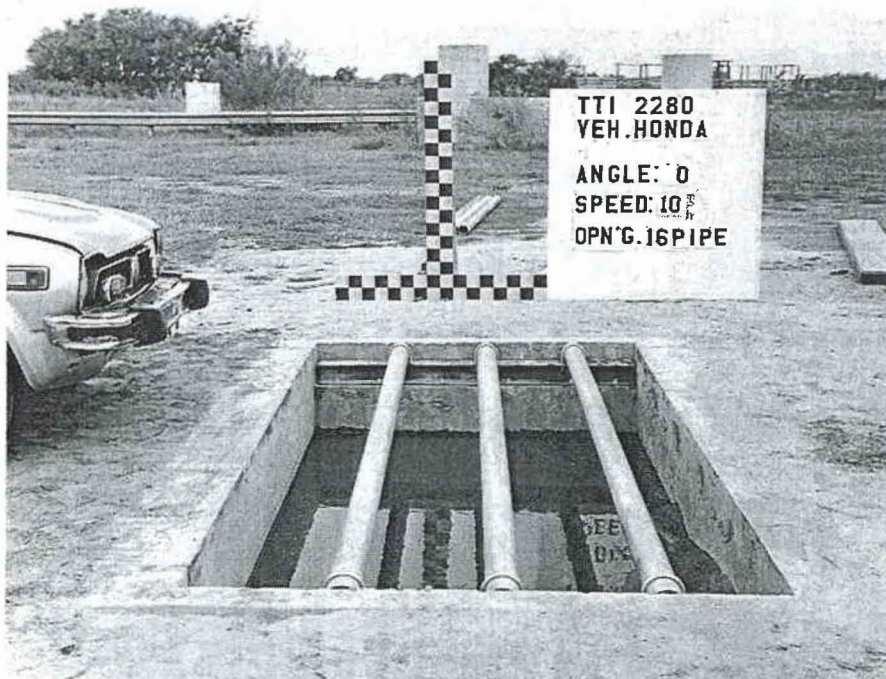
Figure 8. Culvert Test Pit

a) Nongrated Culvert Setup

b) Grated Culvert Setup

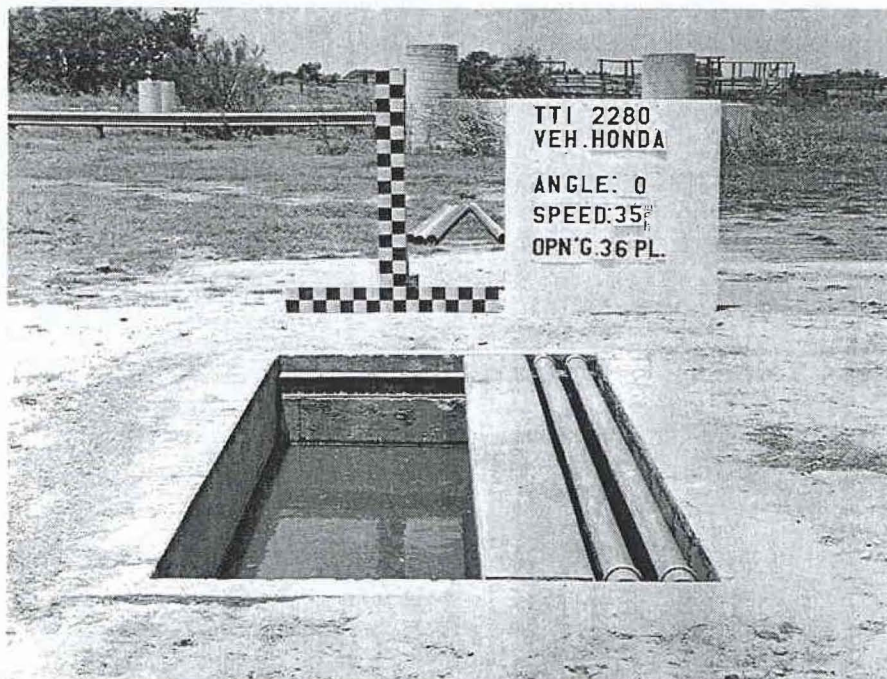
Figure 11. Test Pit Setup for Simulation of Nongrated Culvert

a) 22 in. Clear Opening

b) 36 in. Clear Opening

A total of 29 full-scale test runs were conducted on the clear opening setup. General details of the test runs are given in Table 1. Limiting values were determined by the severity of the ride as experienced by the driver in traversing each opening. In other words, the lowest speed shown for a given opening represents the lowest speed judged to be "traversable" by the driver. Sequential photos from high-speed film of two test runs are shown in Figures 13 and 14, picturing the second largest and largest clear openings tested, respectively. Figure 15 shows the amount the wheel would drop into an 18 in. (45.72 cm) clear opening under static or very low-speed traversals. Wheel hub and car displacement versus time data are plotted in Figure 16 for a 36 in. (91.44 cm) clear opening. The maximum wheel hub displacement values for the 22 in. and larger openings are shown in Table 2.

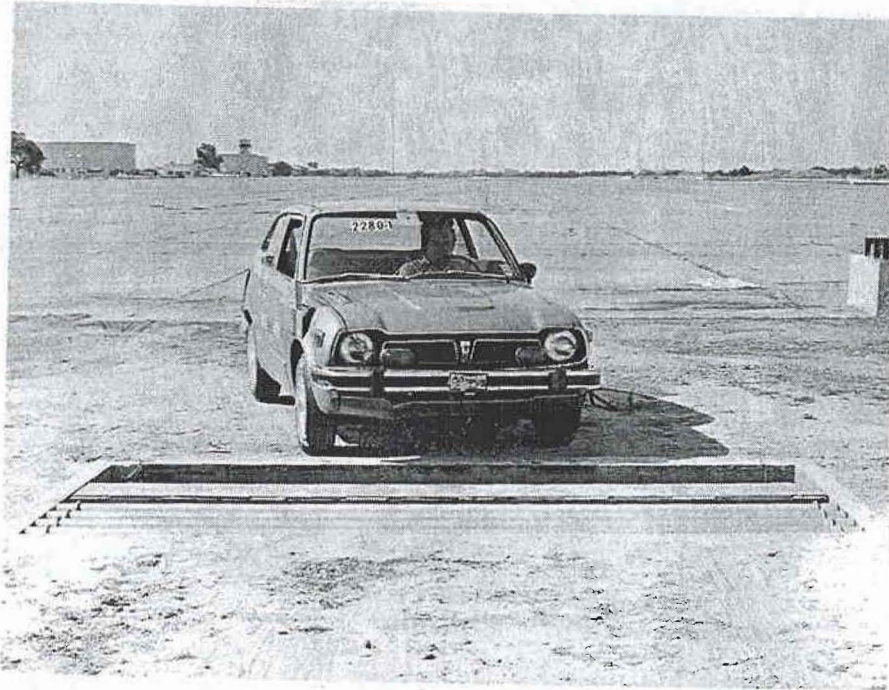
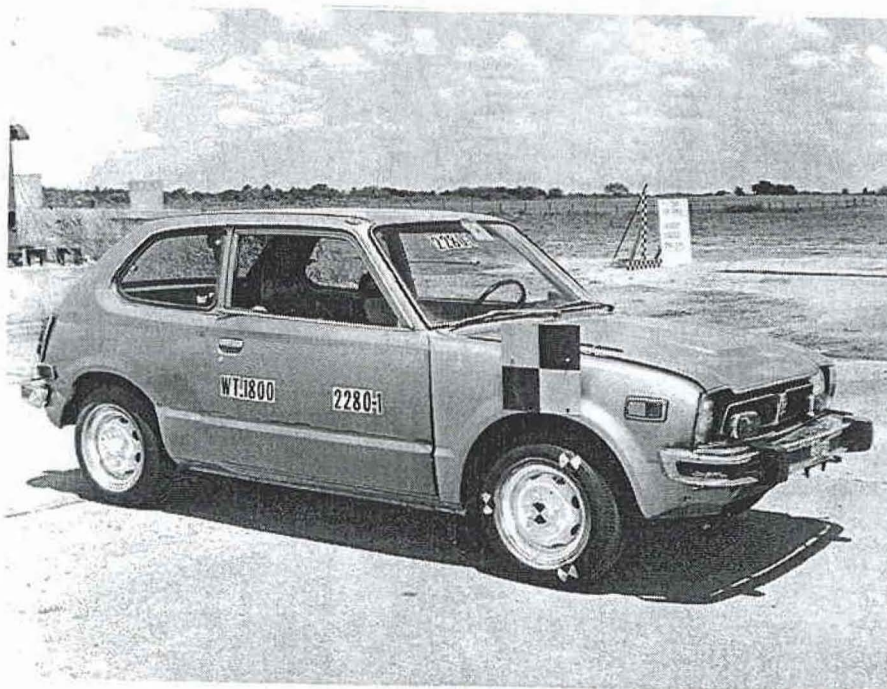
Figure 12. 1974 Honda Civic

a) Front View

b) Side View

The test vehicles for this set of runs were a 1974 Honda Civic, used previously in the nongrated culvert test (see Figure 12), and a 1975 Plymouth Fury, shown in Figure 19. Both vehicles were accelerated to test speeds and kept on line with the test pit by a driver.

The test vehicles used in the preliminary tests were also used in the full-scale tests. These vehicles are shown in Figures 12 and 19. The vehicle was accelerated to test speed with a reverse tow system, and kept on line with the test structure by a cable guidance system as shown in Figure 30.

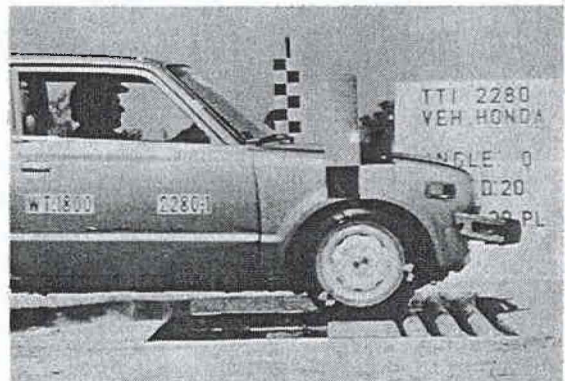
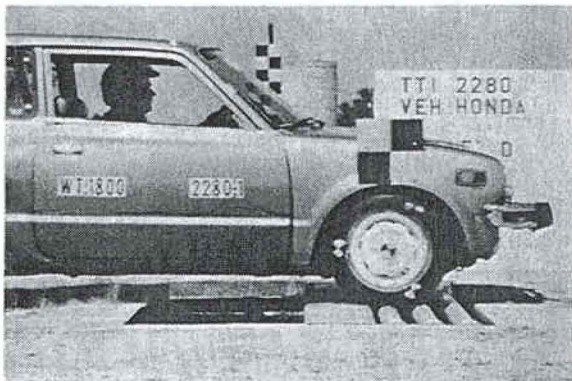
Figure 13. Sequential Photos of Nongrated Culvert Test, 30 in. (76.2 cm) Clear Opening, 1974 Honda Civic.

0.105 sec.

0.135 sec.

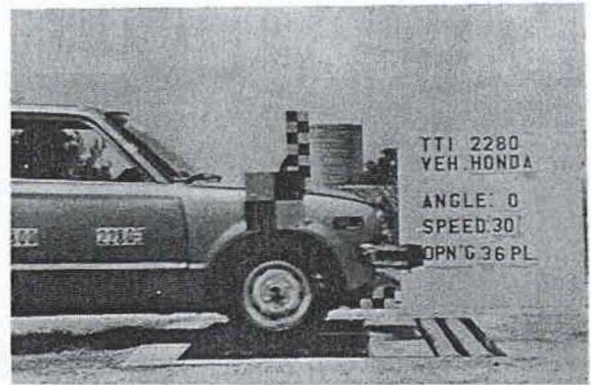
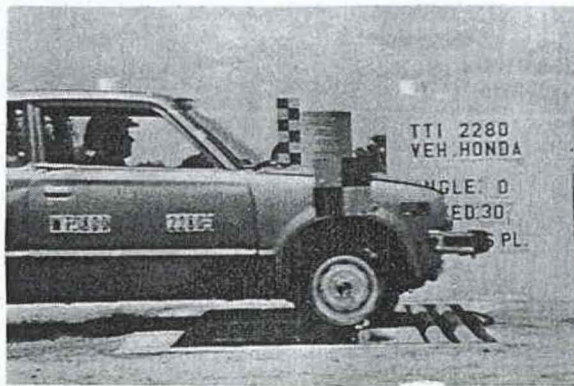
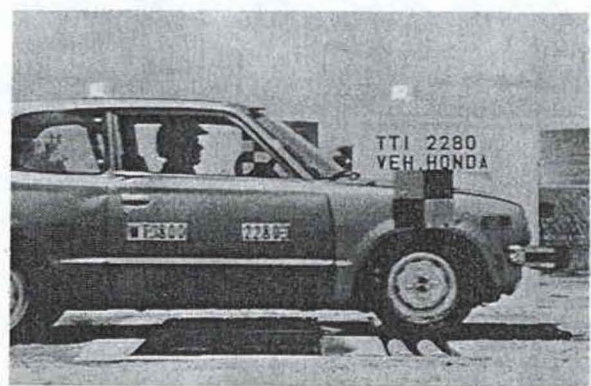
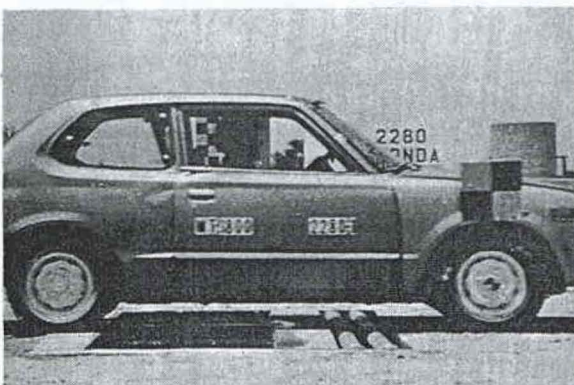
0.000 sec.

0.030 sec.

0.060 sec.

0.105 sec.

0.151 sec.

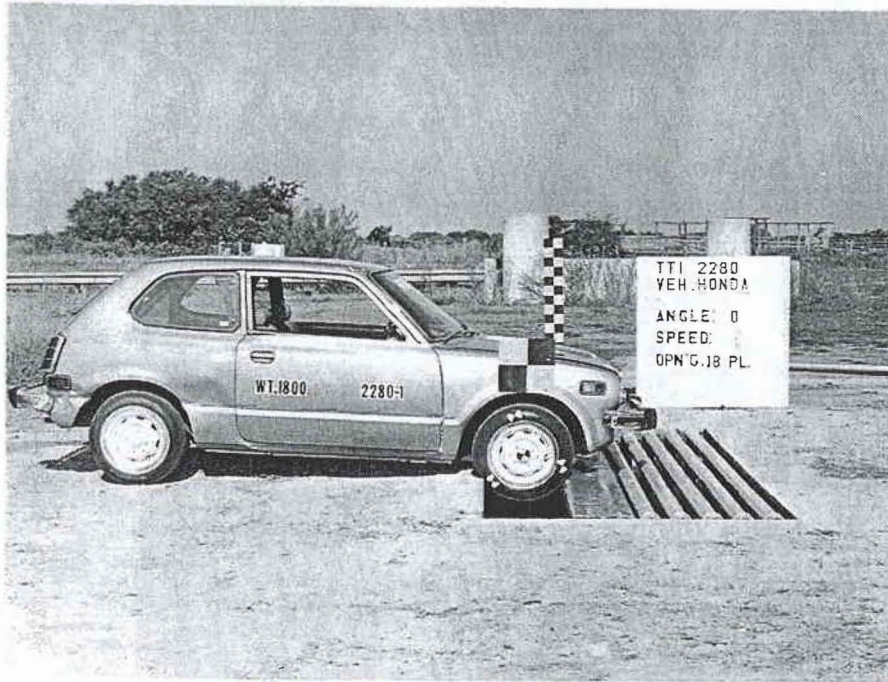
Figure 15. Wheel Drop into Clear Opening Setup

a) Front Wheel Drop

b) Closeup of Front Wheel Drop

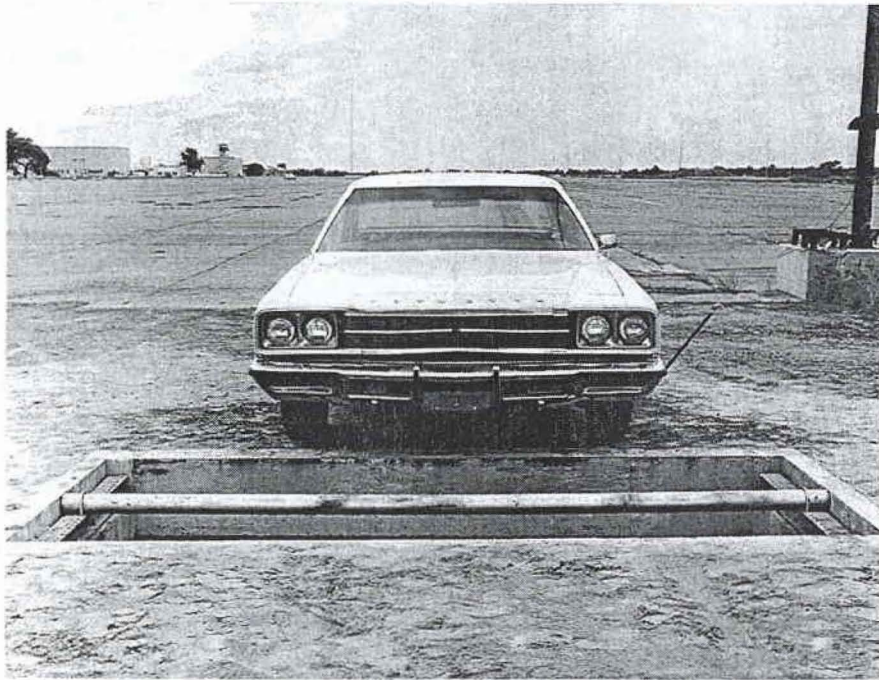
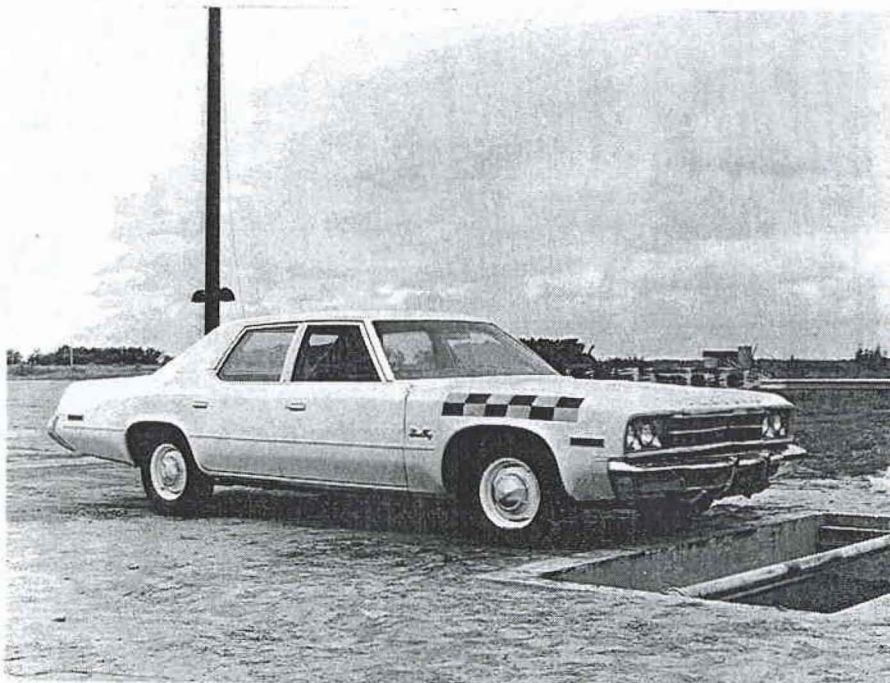
Figure 19. 1975 Plymouth Fury

a) Front View

b) Side View

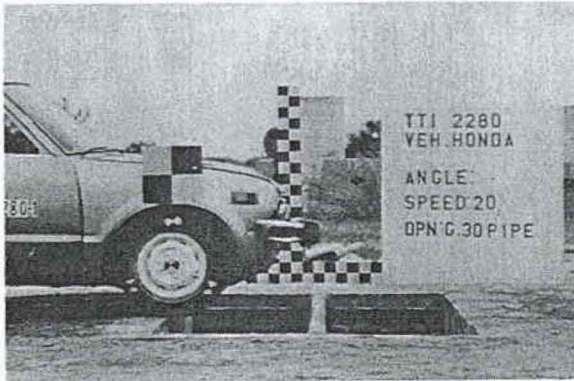
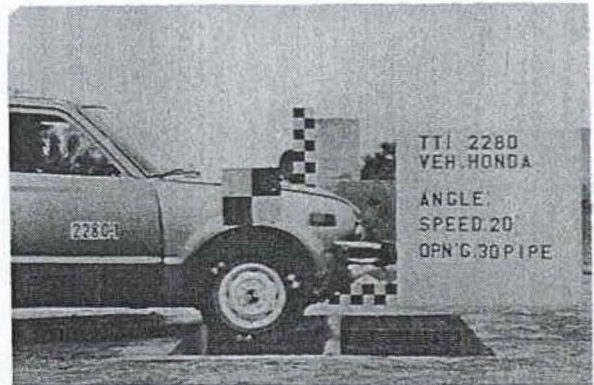
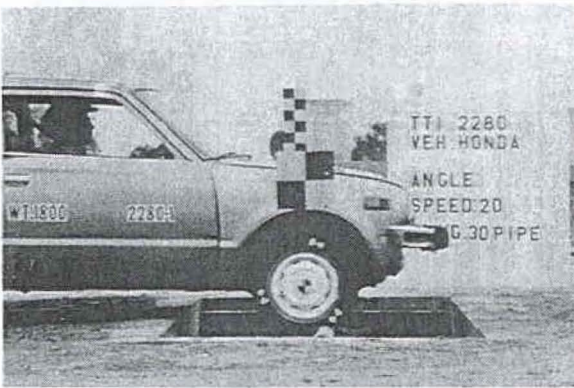
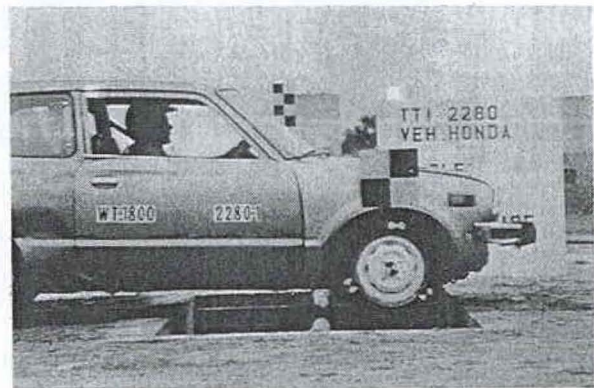
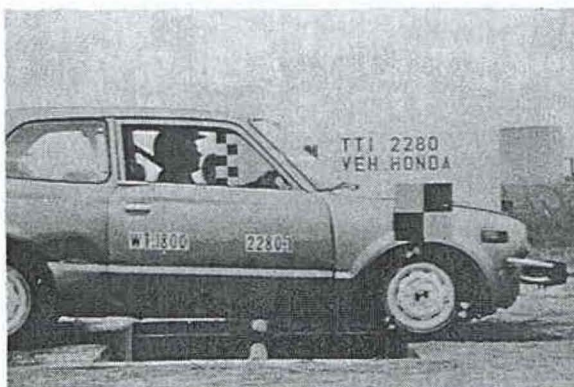
Figure 20. Sequential Photos of Grated Culvert Test, 30 in. Pipe Spacing, 1974 Honda Civic

0.000 sec.

0.040 sec.

0.079 sec.

0.139 sec.

0.198 sec.

A total of 22 full-scale test runs were conducted on the grated culvert setup. General details of the test runs are given in Table 3 with limiting values determined as previously discussed for the nongrated condition. Sequential photos from high-speed film of two test runs are shown in Figures 20 and 21, picturing the two test vehicles traversing a 30 in. (76.2 cm) grate spacing. Figure 22 shows the amount the wheel would drop into a safety grate with a 16 in. (40.64 cm) center-to-center spacing under static or very low speed traversals. Wheel hub and car displacement versus time data are plotted in Figures 23 and 24 for the two vehicles mentioned above. The maximum wheel hub displacement values for all the test runs are shown in Table 4.

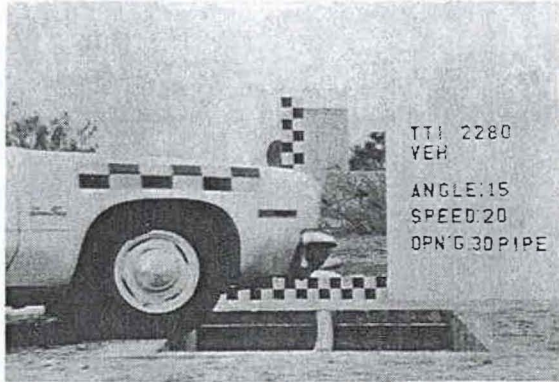
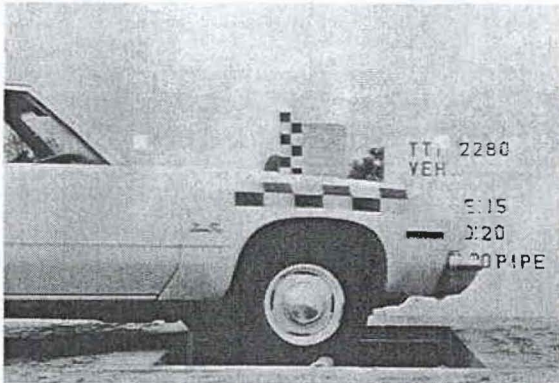
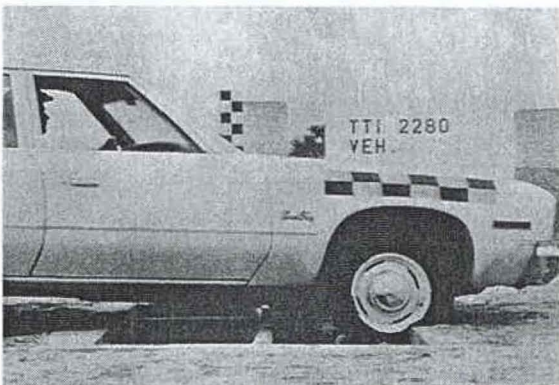
Figure 21. Sequential Photos of Grated Culvert Test, 30 in. Pipe Spacing, 1975 Plymouth Fury

0.000 sec.

0.040 sec.

0.099 sec.

The only installation damage occurred in the form of permanent deformation of the pipe at midspan for the 30 in. (76.2 cm) spacing setup. This deformation resulted from the run made with the Plymouth vehicle impacting at 25 mph and a 0° encroachment angle. This deformation can be seen in Figure 21 just prior to the 15° encroachment angle run. This deformation could be reduced or eliminated by using a larger pipe or a fixed-end type connection (rather than a pinned-end type) as was used for the final test discussed in subsequent sections.

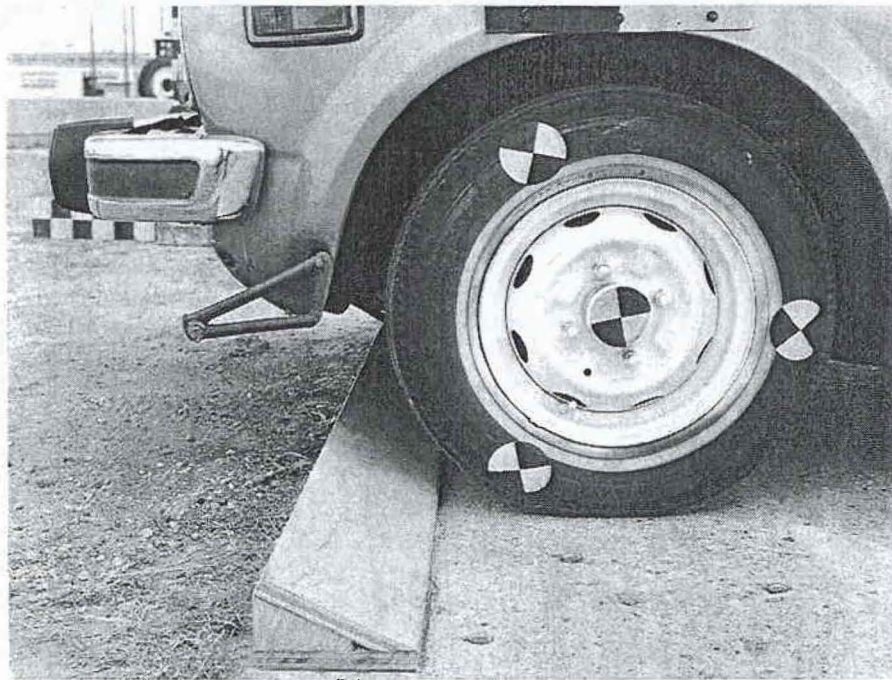
Figure 25. Ramp Installation for Curb Impact Study.

Curb Impact Study. A curb with a ramp-like cross section was constructed to further investigate the effect a curb would have on vehicle trajectory. Based on the results of the computer simulation work, a curb with a 2:1 slope helped to maintain a fairly uniform vertical position of the sprung mass cg, and thus was the one chosen for use in this curb impact study. The curb was constructed of 3/4 in. (1.905 cm) plywood as shown in Figure 25. Note that the area behind the ramp was flat earthen soil.

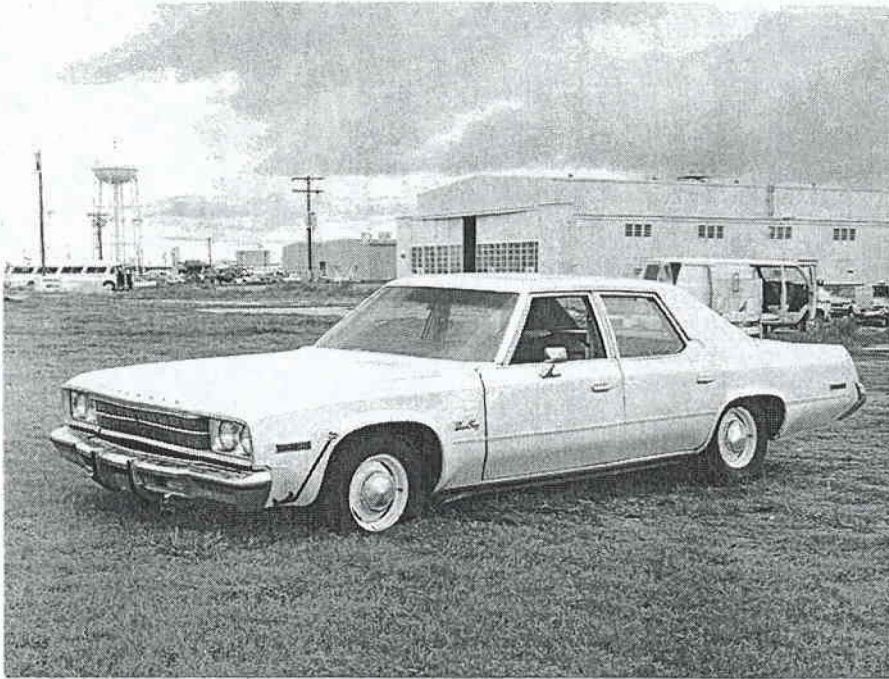
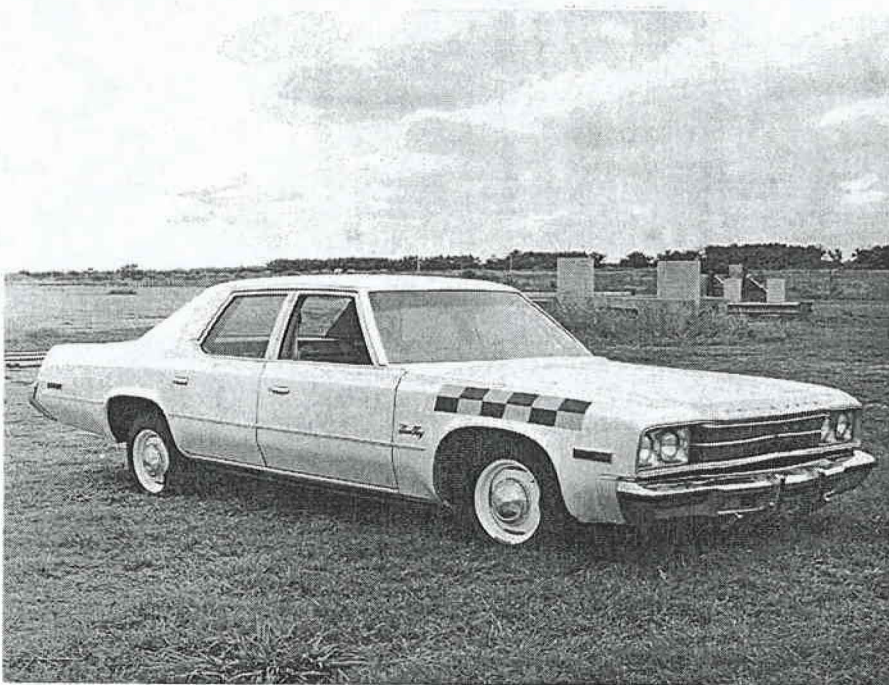
Figure 28. Vehicle Damage, Test 1

Of the two vehicles used throughout the preliminary studies only the Plymouth was damaged as indicated in Figure 28. Damage was light, and only the wheels and tires were involved. Three tires were blown out and all four wheel rims were deformed as the rear edge of the test pit was impacted at a test speed of 20 mph and 15° encroachment angle.

a) Front Tire Blown Out; Wheels Slightly Bent

b) Both Tires Blown Out; Both Wheels Bent

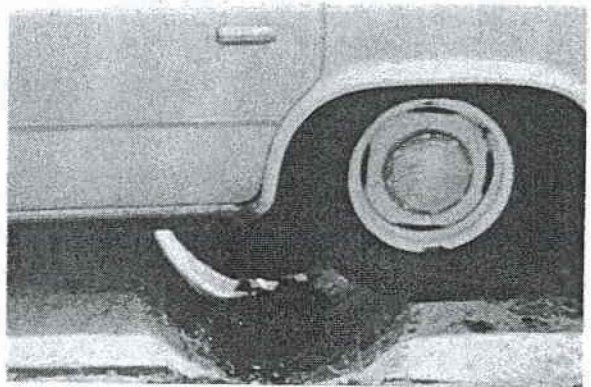
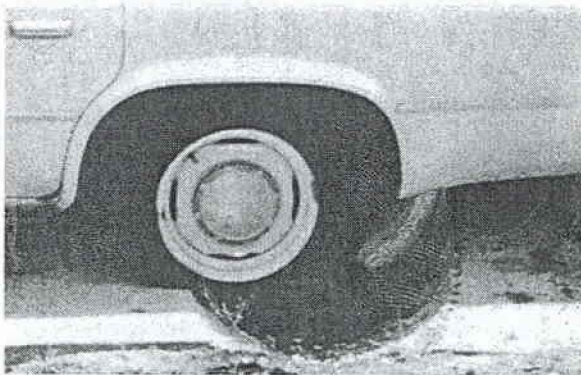
Figure 36. Sequential Photos, Test 2

0.248 sec

0.374 sec

0.450 sec

Test 2.* In test 2, the 30 in. (46.2 cm) diameter culvert was impacted at 20 mph (32.18 km/h) and easily traversed by the vehicle. Sequential photos from high-speed film of the impact are shown in Figure 36. Due to the low test speed, the vehicle tended to travel towards the ditch centerline and up the back slope where it finally came to rest as shown in Figure 37.

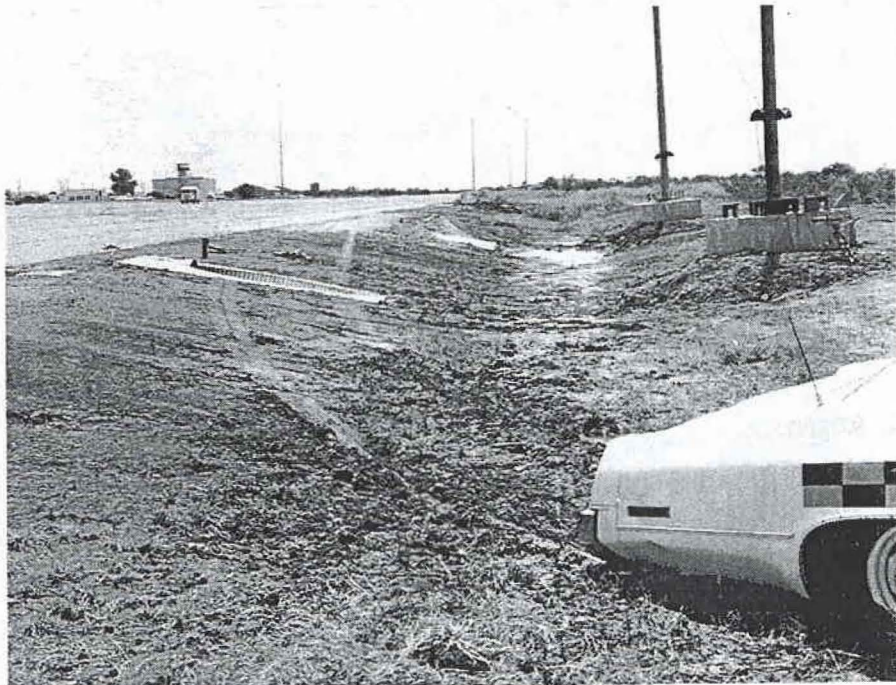
Figure 37. Resting Position of Vehicle after Traversing Pipe Culvert, Test 2

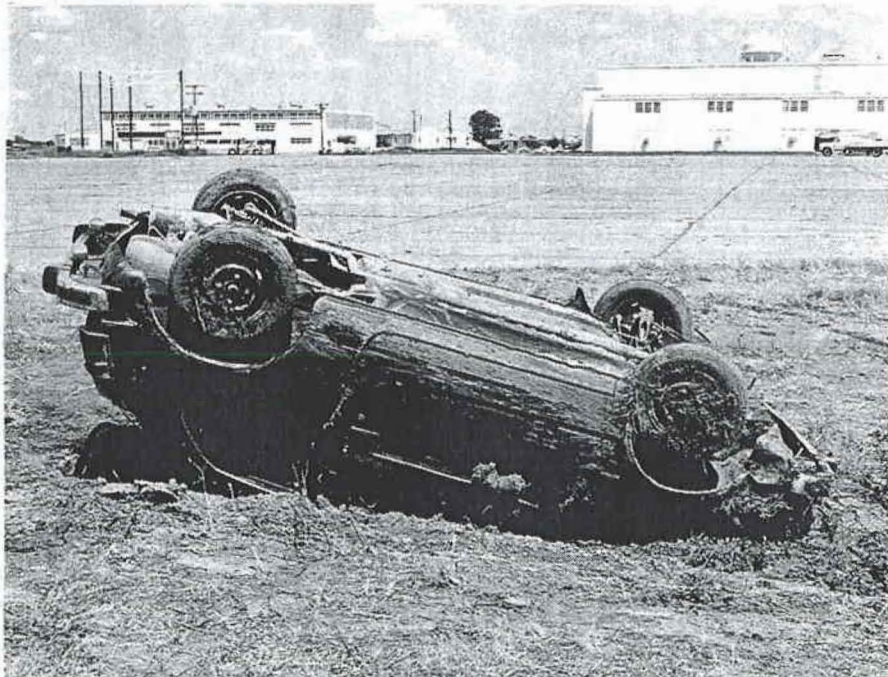
Figure 42. Resting Position of Vehicle after Impacting Box Culvert in Straddled Position, Test 6

Figure 41. Upon contact with the grate the vehicle began to roll towards the ditch centerline. As impact continued, the vehicle's left-front tire and fender dug into the ditch and caused the vehicle to roll over as shown in Figure 42. Damage to the vehicle was extensive and it was considered a total loss. The culvert installation did not receive any damage since the right side tire kept the underside of the vehicle from contact with the safety grates.

As a result of this test it was apparent that the grate members should be extended and anchored at the flow line of the culvert to eliminate the dropoff at the end of the culvert.

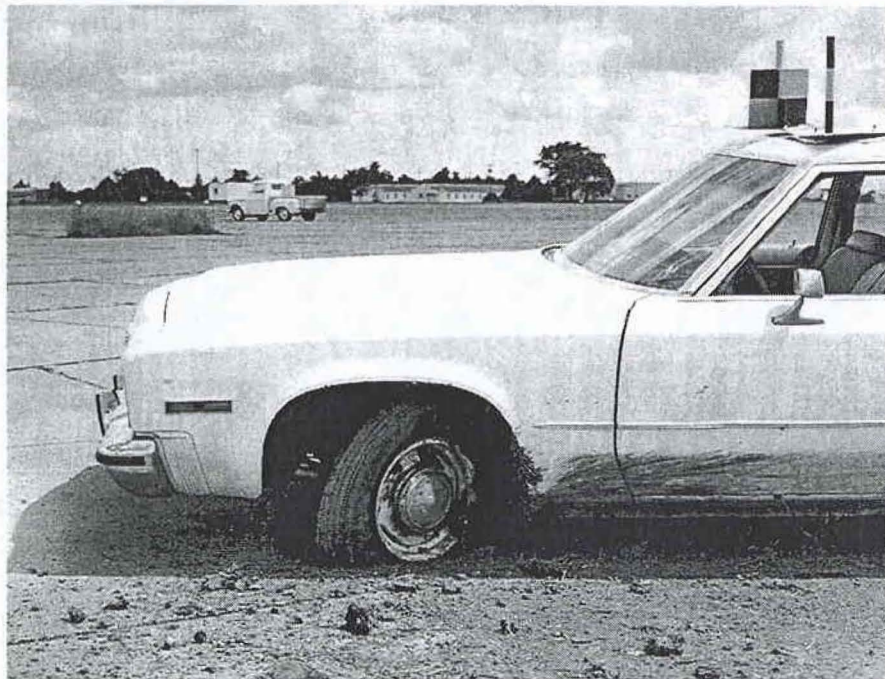
Figure 44. Resting Position and Damage to Vehicle after Traversing Box Culvert, Test 7

Test 7. This test was identical to test 5 except that the impact speed was increased from 20 mph (32.18 km/h) to 60 mph (96.54 km/h). The purpose of this test was to demonstrate that a vehicle could safely traverse the safety grate at a high speed. High-speed sequential photos are given in Figure 43. The box culvert was in fact safely traversed by the full-size vehicle. There was no damage to the culvert installation. Figure 44 pictures the resting position of the vehicle and damage to the vehicle involving the left-front tire and wheel.

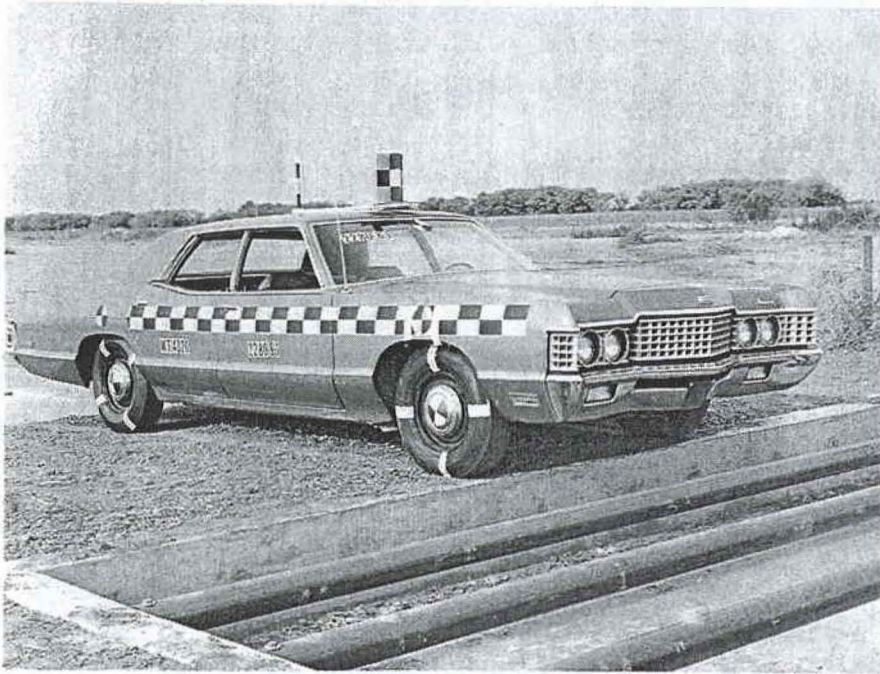
Figure 45. Test Vehicle and Installation before Test 8-1.

Shown in Figure 45 is the test pit constructed to evaluate various grate sizes across a 20 ft (6.10 m) span. Details of the pit are shown in Figure 46. The grate-to-pit attachments shown in Figure 46 were fabricated according to tentative standard SDHPT plans. Five full-scale crash tests were conducted on the test pit. All of the crash tests incorporated a 4500 lb (2043 kg) vehicle, an impact velocity of 20 mph (32 km/hr), and an impact angle of zero degrees.

For the first test, test 8-1, 5.0 in. (12.7 cm) I.D. standard schedule 40 steel pipe was installed in the test pit as shown in Figure 45. Sequential photos from high-speed film of this test, shown in Figure 47, reveal that the vehicle easily traversed the pit and there were no major permanent deformations of the pipes. Therefore this test was very successful.

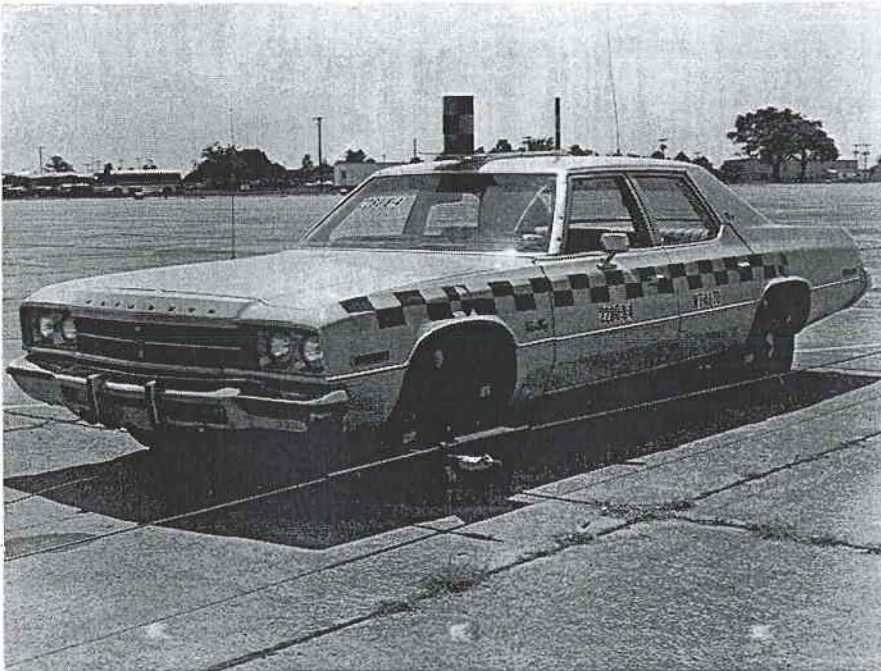
Figure 54. Test Vehicle and Installation before Test 8-4.

Figures 51 and 52 show permanent deformations of the grates were larger and the test vehicle was damaged more than in the previous tests. Figure 53 shows that the grate-to-pit attachments were damaged as well. Therefore this test was only marginally acceptable. Since Test 3 was not completely successful, it was decided to utilize midspan vertical supports for the test of 3.0 in. (7.62 cm) I.D. standard schedule 40 steel pipe grates. Analysis of grate deformations from previous tests showed that wheel impact loads for design of midspan supports should be approximately 4000 lb (17,800 N) per wheel and oriented such that maximum stresses are developed in either grate member or midspan support. For design purposes the track width of a typical standard size automobile can be assumed to be 60 in. (152.4 cm). Figure 54 shows the modified test pit and the test vehicle before impact. Details of the grate and support structure are shown in Figure 55. Sequential photos from high-speed film of test 4, shown in Figure 56, show that the vehicle traversed the test pit quite easily. Figure 57 shows light damage to the test vehicle and relatively large horizontal deformations of the grate resulting from the test. Even though the horizontal deformations are large, this test can be considered successful since the vehicle damage was light and the vertical pipe deflections were small. Permanent deformations of the grates after each test are given in Table 6.

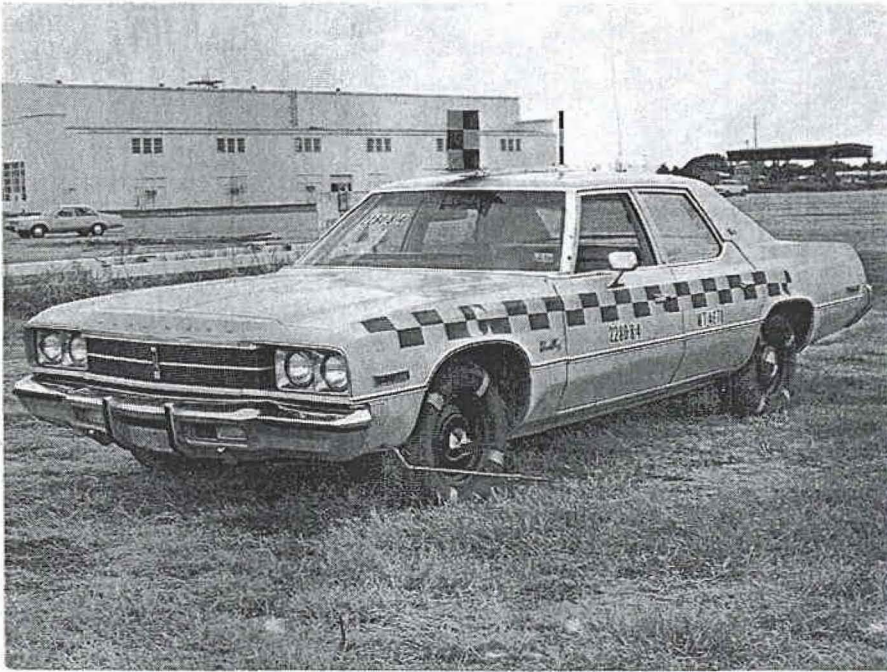
Figure 57. Test Vehicle and Installation after Test 8-4.
