1. Report No. TX-96/2919-1		2. Government Accession No.		3. Recipient's Catalog No.	
4. Title and Subtitle Evaluation of Stabilized Base Durability Using a Modified South African Wheel Tracking Device				5. Report Date October 1995

**EVALUATION OF STABILIZED BASE DURABILITY USING
A MODIFIED SOUTH AFRICAN WHEEL TRACKING DEVICE**

Research Report 2919-1
Research Study Number 7-2919
Research Study Title: Spall Repair, Base and Subgrade Stabilization,
and Non Destructive Test (NDT) Service for the Houston District, Phase II

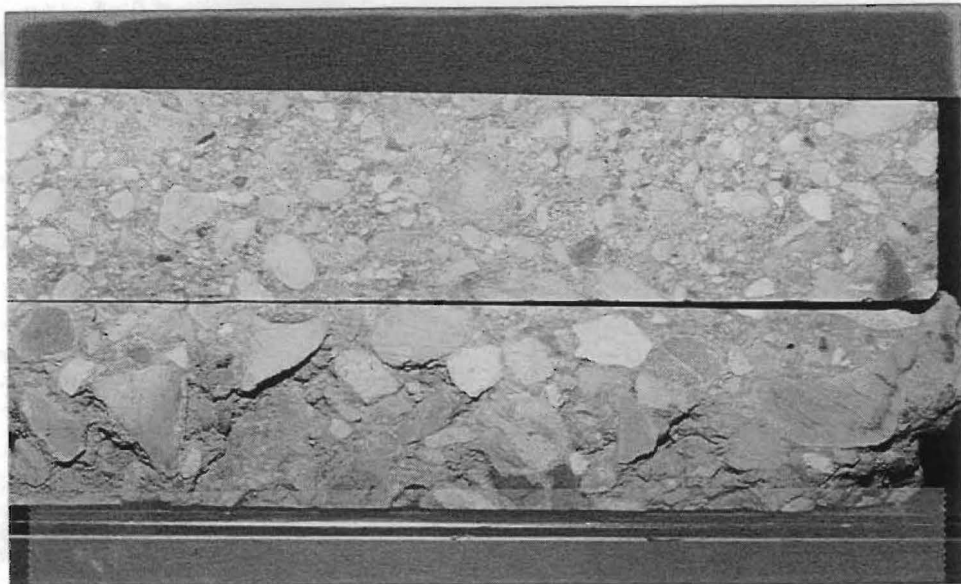
Figure 1.2. In situ Sample from SH 36 Shows the Bottom Half of the Cement Treated Base Deteriorated More Rapidly than the Top Half.

Transverse and block cracking occurred shortly after construction. It appeared that water was trapped within the stabilized layers of the pavement, which may have led to accelerated disintegration. Examination of cores taken from the distressed areas showed clean, large aggregates, with the fine material apparently pumped out, Figure 1.1 shows this. Cores taken in the undistressed areas were intact and showed no sign of fines loss. However, closer examination of insitu samples taken from the undistressed shoulder of the road showed the bottom half of the stabilized layer had deteriorated more rapidly than the top half, Figure 1.2 illustrates this.

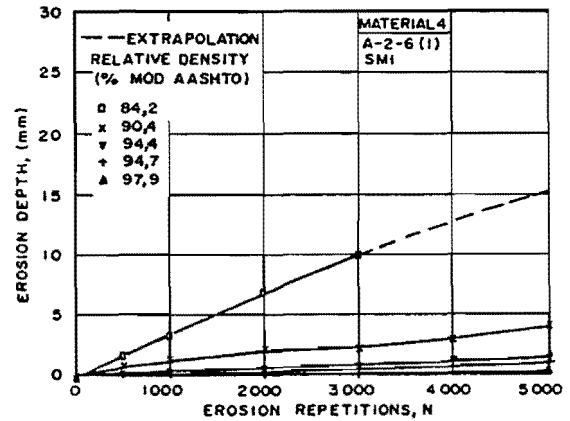
(a) MATERIAL 1: UNIFORM SAND + 4 % PBFC

(b) MATERIAL 2: VERY CLAYEY SAND (LOW PLASTICITY) + 4 % LIME

(c) MATERIAL 3: WELL GRADED SAND + 4 % PBFC

(d) MATERIAL 4: VERY SILTY SAND OF INTERMEDIATE PLASTICITY + 4 % LIME

Each individual result represents the average of three test specimens, 15 measurements per specimen.

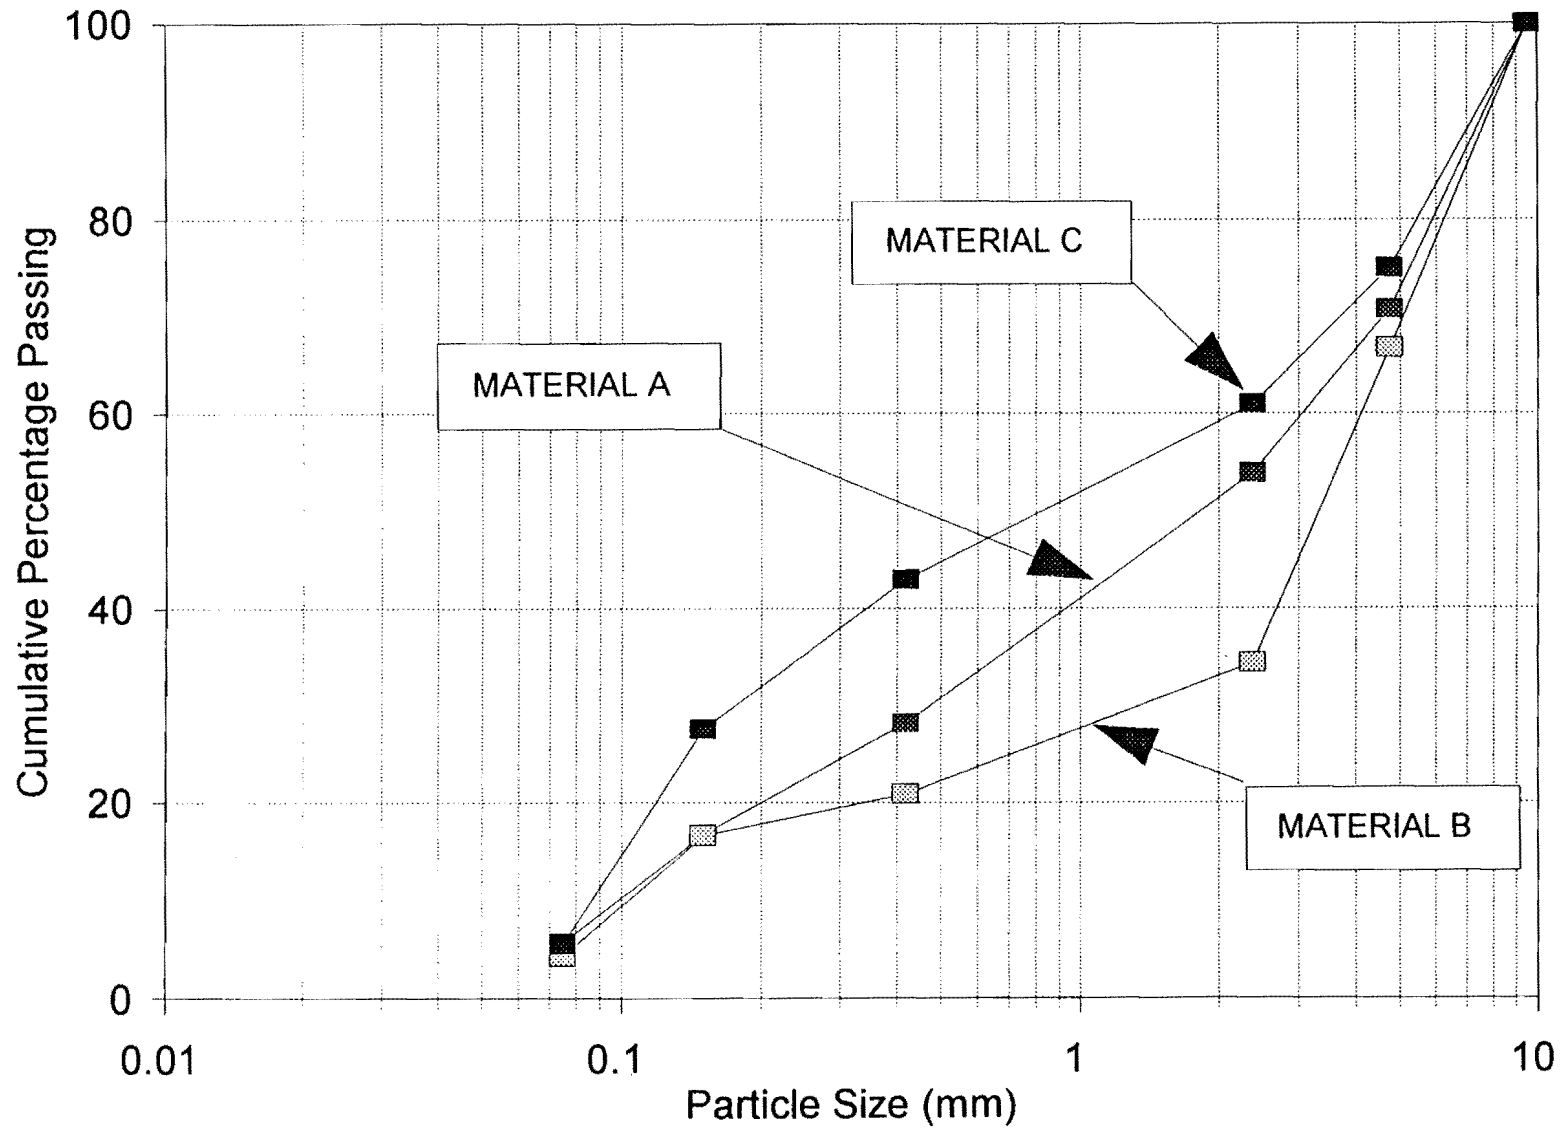
Figure 3.2. Sieve Gradings of the Three Materials Used in the Study.

Figure 3.2 shows the gradation of each of the three material types. For the purpose of this report, only the material passing the 9.4 mm sieve diameter size was used. The reason for this is that the erosion test was designed for the testing of fine grained material with a maximum diameter size of 19 mm.

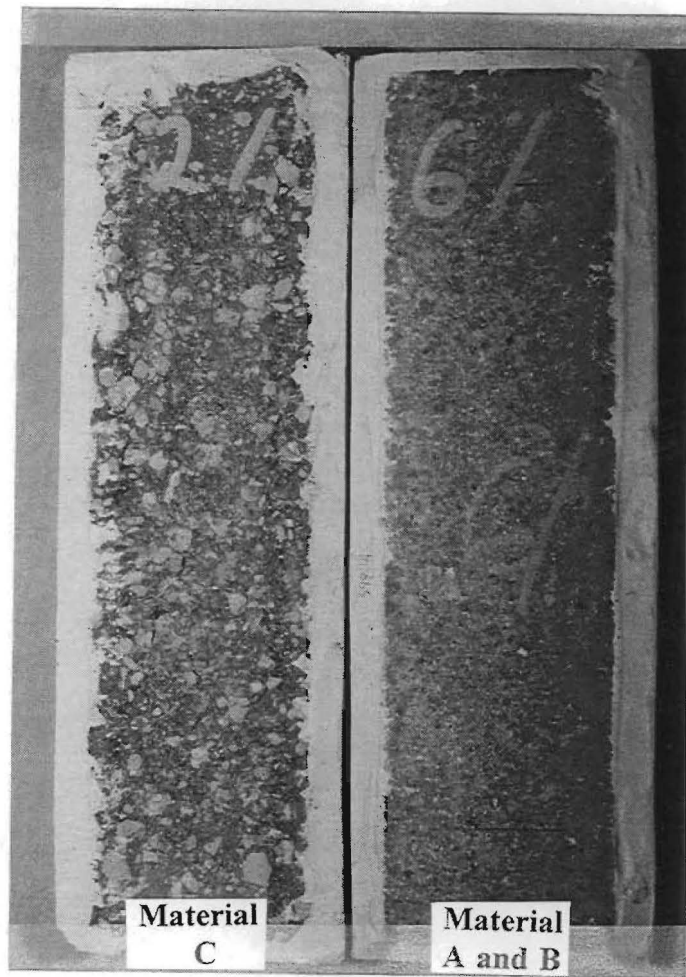
Figure 4.6. Material C with 2 Percent Cement and Materials A and B with 6 Percent Cement are Shown After Performing the Erosion Test (5,000 Cycles).

In the case of material C, the erosion wheel rolled over the larger aggregates, preventing erosion of the aggregate particles from taking place. Erosion depths of 1 to 2

mm were measured; however, with the South African classification this material would have excellent durability resistance. Figure 4.6 clearly shows the aggregates from material C more exposed than materials A and B; therefore, some amount of fines were washed out from the material C sample. This exposed the aggregates of the test sample, but the large size of the aggregates prevented any measurable erosion from taking place. These results stress the fact that it is important to determine a maximum aggregate size for the test material to ensure usable test results. Further research work is recommended in this field
