STATUS REPORT ON OPERATIONS  
OF CCTV SYSTEM USING LEASED FIBER OPTIC CABLES  
(FEBRUARY 1995–AUGUST 1995)

Gene P. Ritch  
Research Scientist  
Texas Transportation Institute

Research Report 2923-2  
Research Study Number 7-2923  
Research Study Title: Development, Implementation, and Evaluation of a  
Closed Circuit Television System for Houston Freeways and  
Arterial Streets Utilizing Leased Fiber Optic Cables

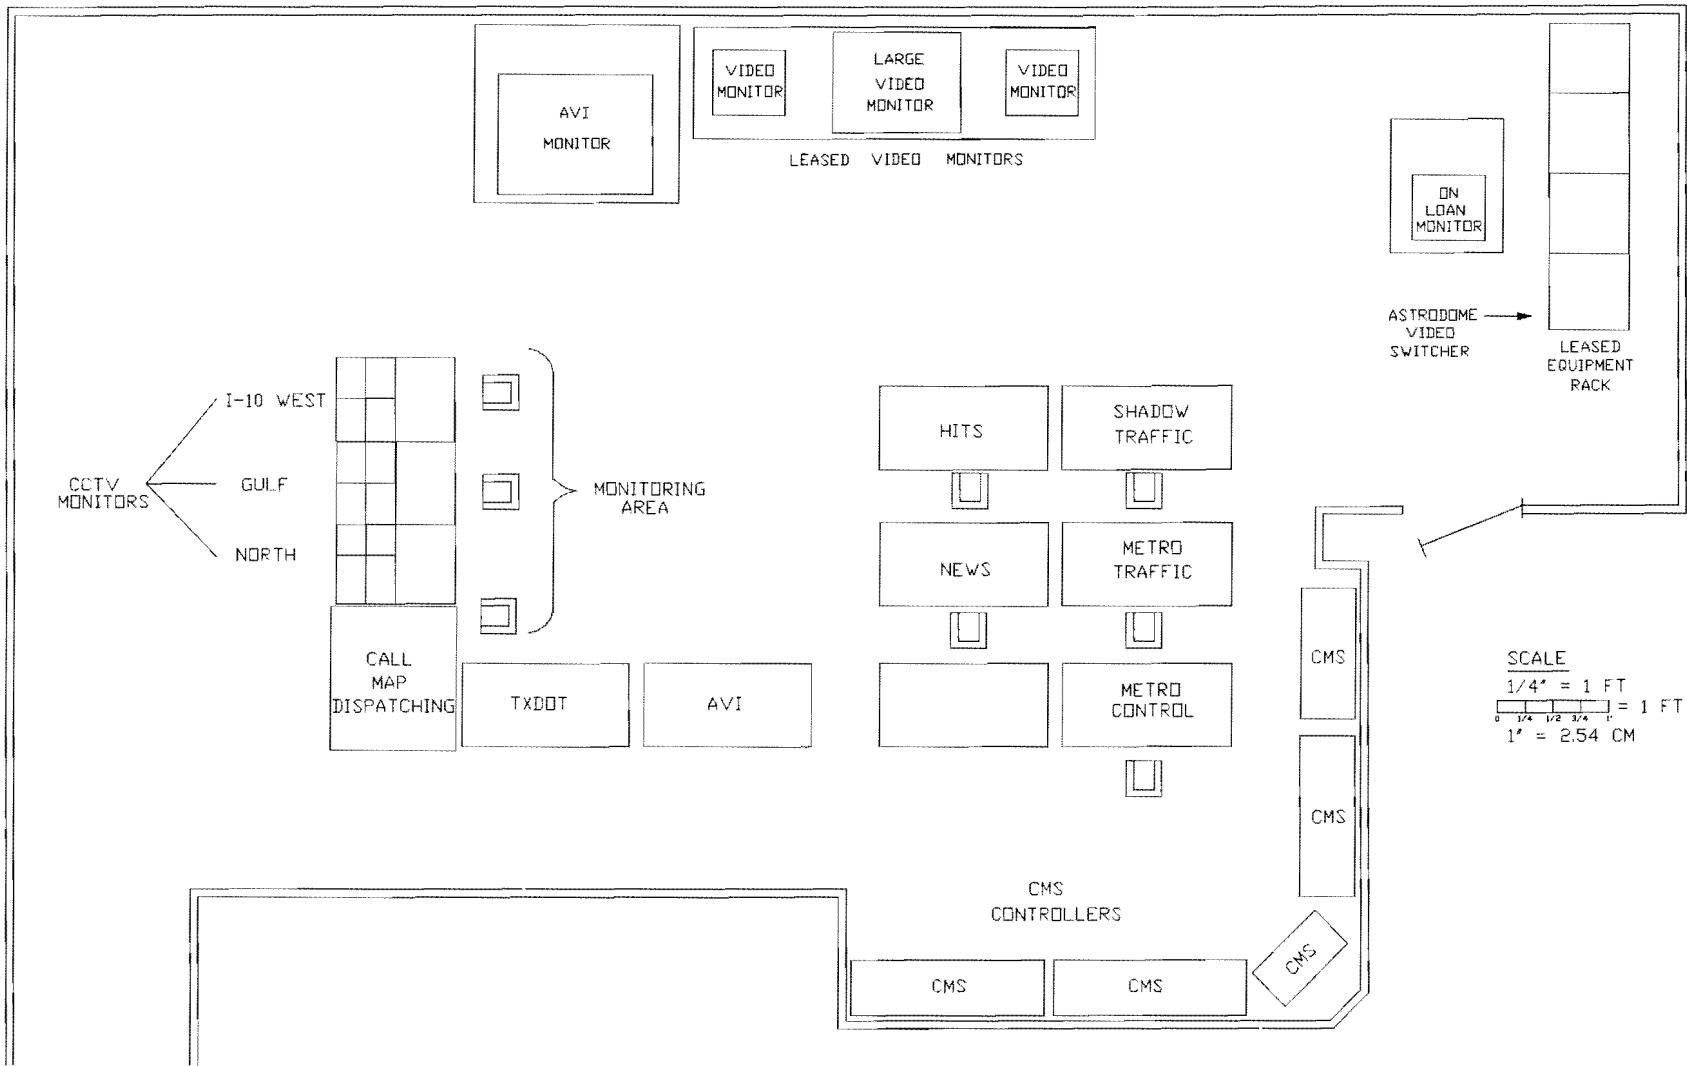
Figure 2. Leased Equipment Positioning in ITMC

- Figure 2 depicts the relative positioning of the video switcher and the location of the ITMC staff. To control a camera, the staff person must walk to the Astrodome video switcher, make the controlling options, and return to the monitoring area. To reduce overall effort requires a remote video control unit implementation. This unit can reside near the staff monitoring area and does not require the staff person to physically move in order to control the Astrodome camera(s).

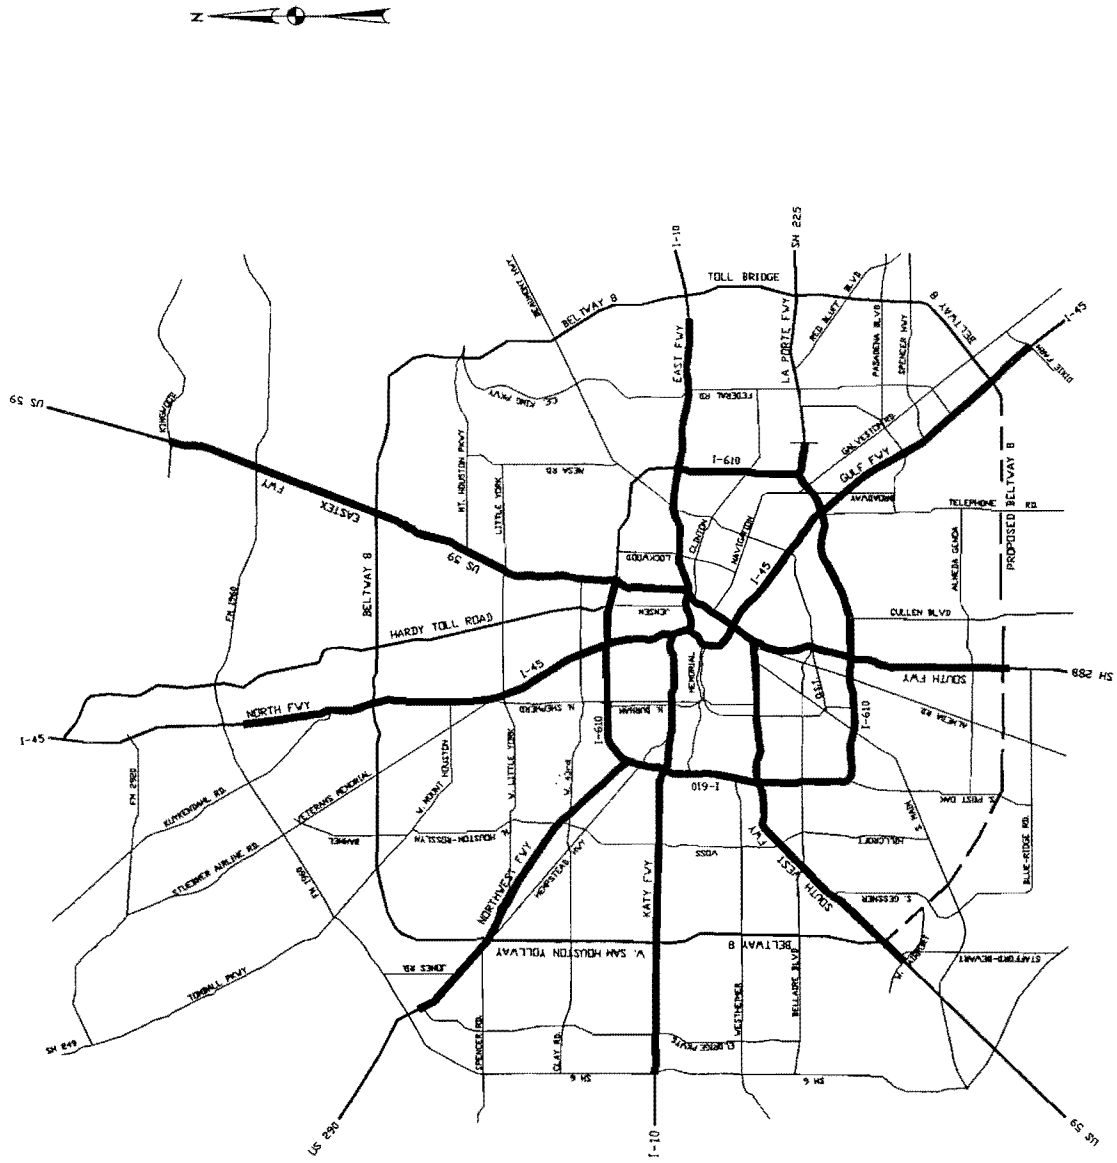
Figure 3. Limits of Houston Motorists Assistance Program Patrol Area

\* Patrol limits based upon patrol routes provided by TxDOT

The Houston Motorists Assistance Program (MAP) started in 1989 through a public/private partnership to aid stranded motorists along the major freeways within an approximate 24 kilometer (15 mile) radius of the Central Business District and along the I-610 Loop Freeway. The Metropolitan Transit Authority of Harris County (METRO), the Texas Department of Transportation (TxDOT), the Harris County Sheriff's Department (HCSD), the Houston Automobile Dealers Association (HADA), and Houston Cellular Telephone Company provide funding for the MAP program. MAP currently patrols 241 kilometers (150 miles) of freeway with nine mini-vans continuously between the hours of 6:00 a.m. and 10:00 p.m. on non-holiday weekdays (Figure 3). Each vehicle comes equipped with hand tools, gasoline, water, jumper cables, etc., as needed to assist motorists. The push-bumper equipped vehicles can also move vehicles stranded in the travel lanes to the emergency shoulder. A cellular telephone is available to motorists; motorists may use this telephone to call for additional assistance and/or to inform others of their delay. TxDOT staff in the ITMC dispatches the vans driven by HCSD deputies.
