1. Report No. <b>TX-00/2927-2</b>	2. Government Accession No.	3. Recipient's Catalog No.	
4. Title and Subtitle <b>DEVELOPMENT OF IMPROVED GUIDELINES FOR FRONTAGE ROAD DRIVEWAY ACCESS AT ENTRANCE RAMP LOCATIONS</b>		5. Report Date <b>October 1999</b>

**DEVELOPMENT OF IMPROVED GUIDELINES FOR  
FRONTAGE ROAD DRIVEWAY ACCESS AT ENTRANCE  
RAMP LOCATIONS**

Report 2927-2  
Project Number 7-2927  
Research Project Title: Development of Improved Guidelines  
for Frontage Road Driveway Access Location

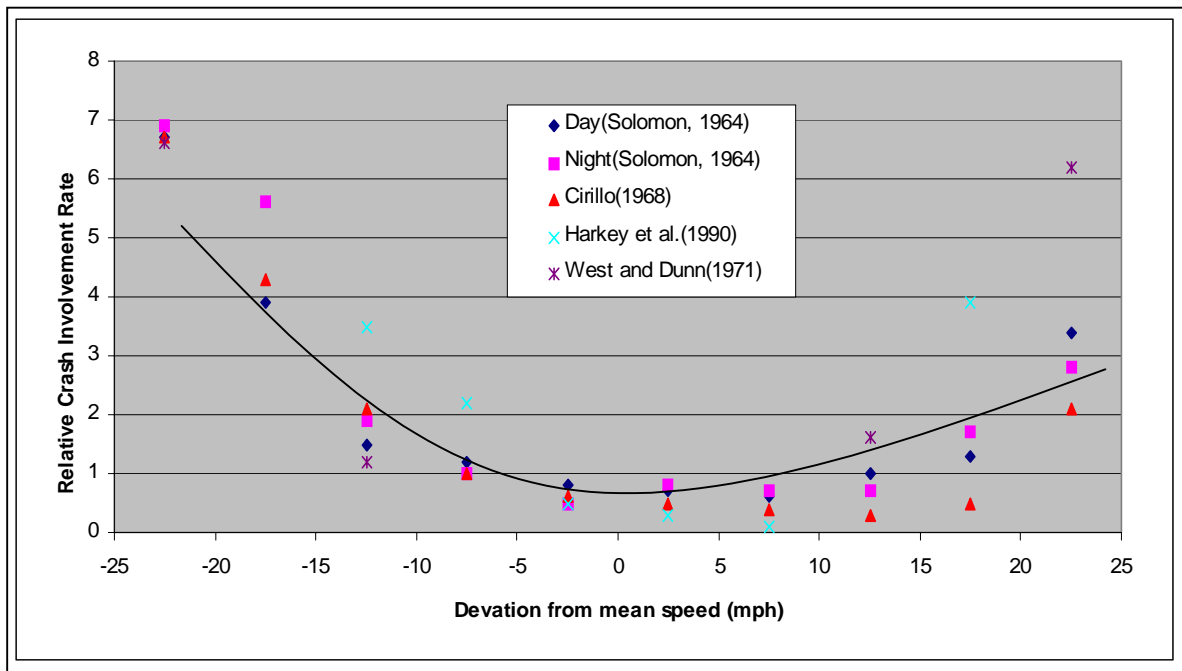
An additional noteworthy item identified in the literature review related to speed variability between vehicles. Past research has consistently indicated that speed differential between vehicles (as opposed to absolute speed) is the primary contributing factor to vehicle-to-vehicle collisions (5, 6). This phenomenon is probably best illustrated in Figure 1, which represents a conglomeration of over 30 years of research on this particular topic (5). As can be noted in Figure 1, crash-rate probability increases significantly with increasing speed differential. Crash probability becomes particularly high once speed differential between vehicles is greater than 10 miles per hour (mph).

**Figure 1. Crash Involvement and Overtaking Rates Relative to Average Rate and Speed.**

As a result of this finding, the research conducted during this study was directed at determining adequate spacing between frontage-road access points and a downstream entrance ramp based on this target value of establishing a maximum speed differential of 10 mph. Existing guidelines of the *Operations and Procedures Manual* were accepted as the benchmark to determine if modifications to current guidelines were warranted.

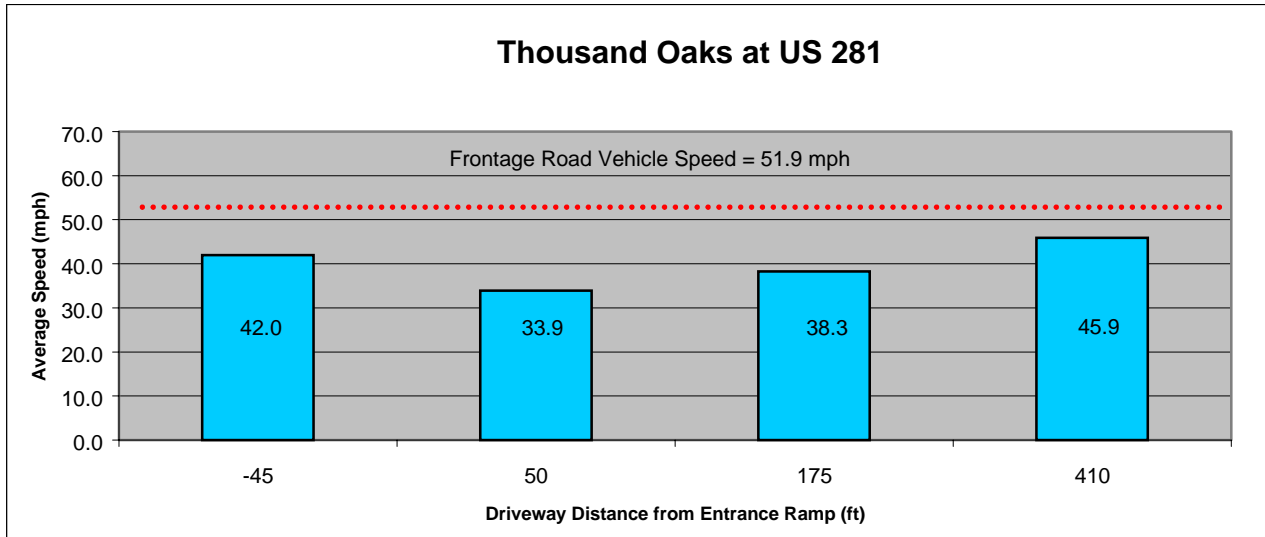
**Figure 4. Average Speed for Driveways at Thousand Oaks Study Site.**

Driveways located between the painted and physical gores were shown as negative distances. Speed and video data indicated that vehicles entering the entrance ramp through the painted gore were doing so at a higher rate of speed to compensate for distance. This is clearly visible for Driveway 1 of Figure 4. The nose of the painted gore was taken as the origin for measuring driveway distances, as demonstrated in the existing guidelines of TxDOT Design Division *Operations and Procedures Manual*.

The same table formats were used for all the study sites to understand the basic trends occurring within the frontage-road influence area. A trend between all study sites indicated a lower average differential speed as the distance between the driveway and entrance ramp increased. As [Table 2](#) shows, Driveway 2 was the first driveway upstream of the entrance ramp (painted gore) and had an average differential speed of 18 mph. As the distance between the driveway and entrance ramp increases, the average differential speed has a tendency to decrease as well. For example, vehicles using the entrance ramp and originating from Driveway 4 (a distance of 410 feet) exhibit a speed differential of only 6 mph by comparison. [Figure 4](#) shows a graph illustrating the increase in average speeds associated with the driveways upstream of the entrance ramp for this study site. The complete set of graphs for all study sites is located in the [Appendix](#) of this report.

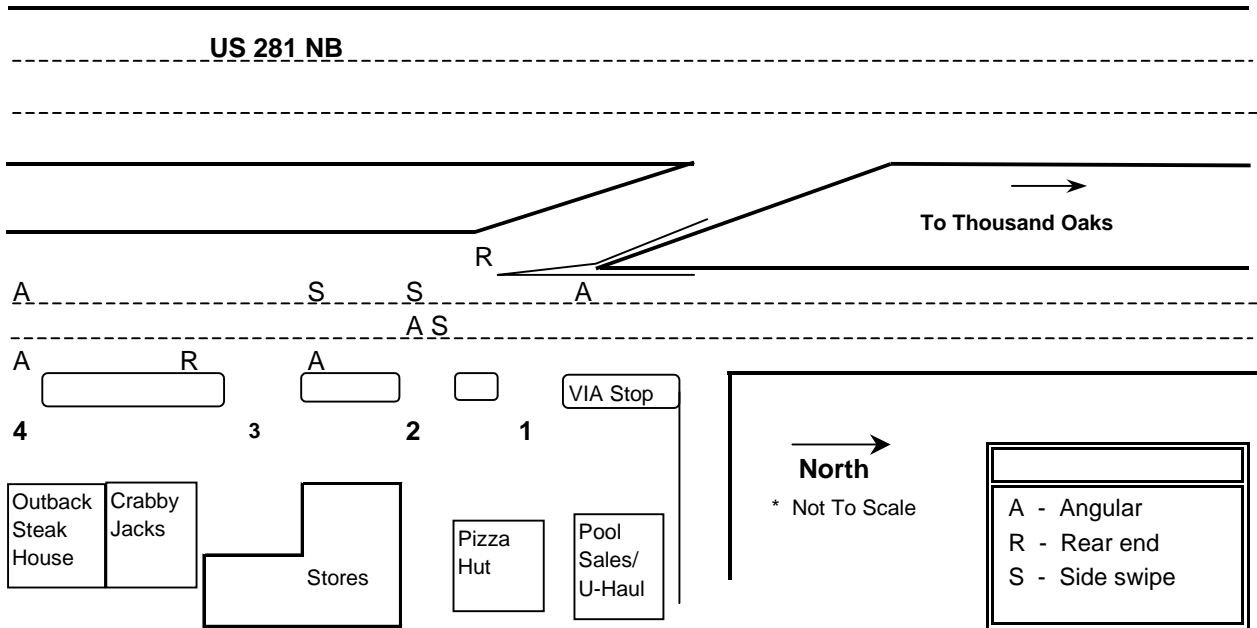
**Figure 6. Crash Diagram for the US 281 at Thousand Oaks Site within Years 1995 to 1998.**

Researchers summarized the crash data into a simplified crash diagram for determining the type and frequency of accidents occurring near the entrance-ramp and driveway vicinity. General observations from the crash diagrams indicated the following features to be prevalent:

- rear-end collisions near entrance to frontage road driveways,
- angular collisions near exit from driveways, and
- side swipe collision near approach to freeway entrance ramp.

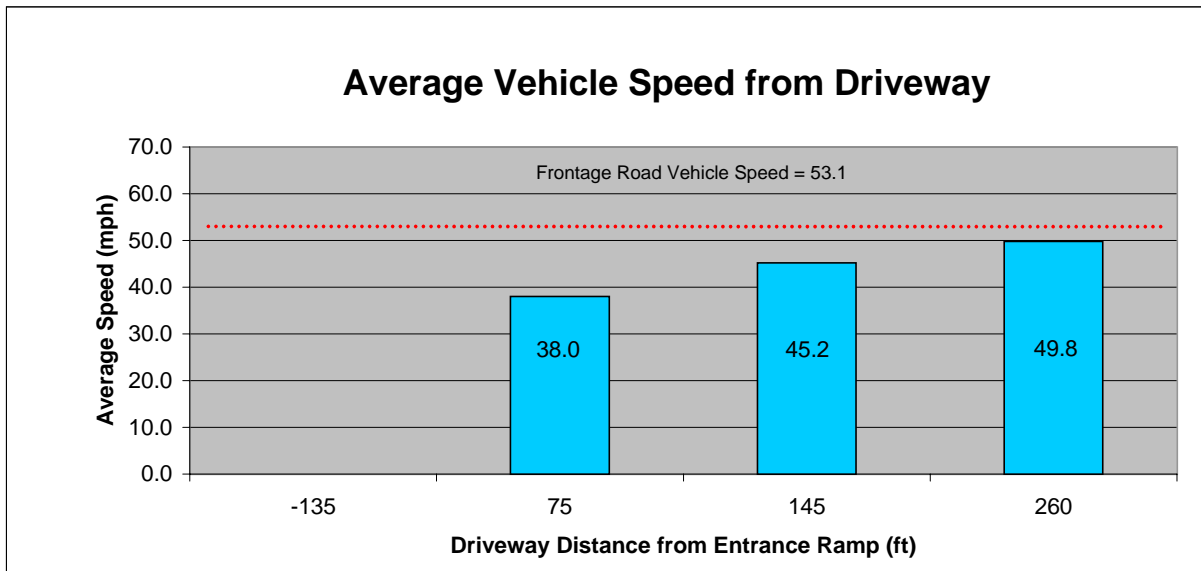
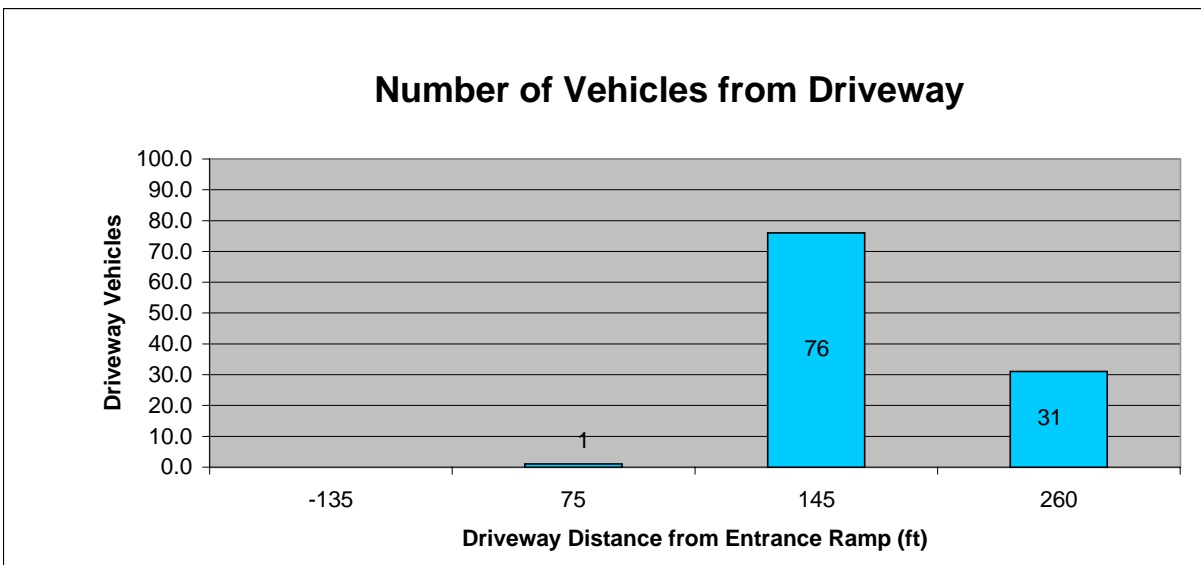
**Figure A-1. US 281 at Bitters, San Antonio, Texas.**

Location:	Bitters at US 281					
Counter:	9298					
File:	Bitters.xls, S925					
	Frontage	Driveway 1	Driveway 2	Driveway 3	Driveway 4	Total
Driveway Type	4 Lane *	Restaurant	Restaurant	Drive	Conv. Store	4
Vehicles	2509	0	1	76	31	2617
Distance (ft)	-	-135	75	145	260	
Speeds	53.05	0.00	38.00	45.20	49.77

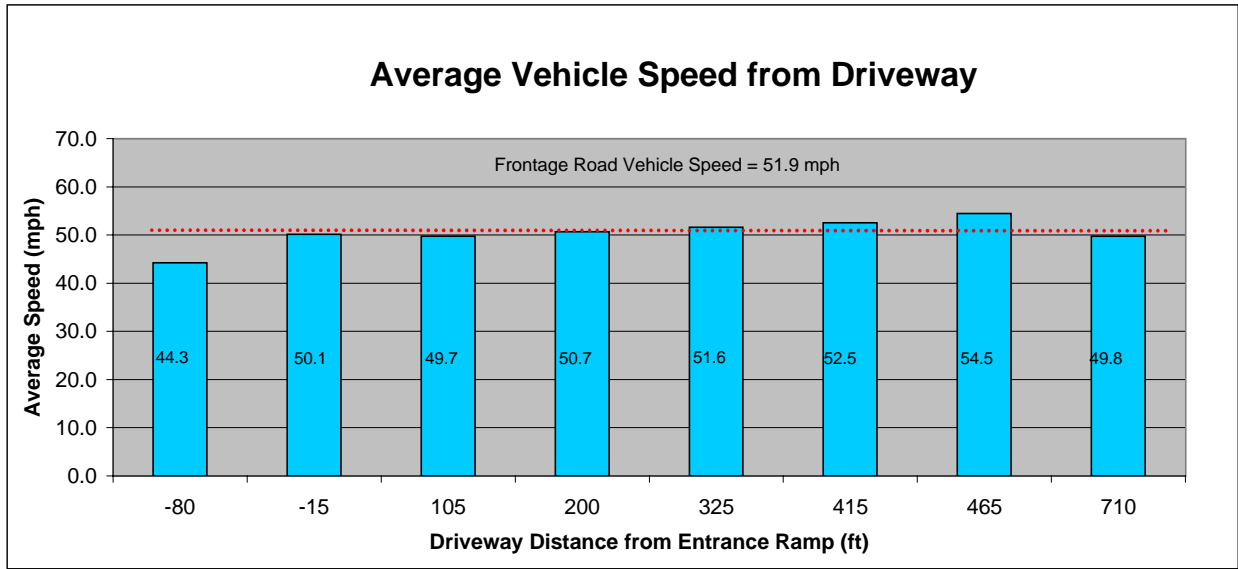
**Figure A-3. US 281 at Brook Hollow, San Antonio, Texas.**

Location:	Brook Hollow at US 281									
Counter:	659									
File:	Brookhollow.xls, S869									
	Frontage	Driveway 1	Driveway 2	Driveway 3	Driveway 4	Driveway 5	Driveway 6	Driveway 7	Driveway 8	Total
Driveway Type	4 Lane *	Strip Center	Strip Center	Strip Center	Strip Center	Strip Center	Strip Center	Strip Center	Strip Center	8
Vehicles	3682	8	137	15	225	20	13	29	69	4198
Distance (ft)	-	-80	-15	105	200	325	415	465	710	
Speeds	51.86	44.25	50.12	49.73	50.67	51.60	52.54	54.48	49.75

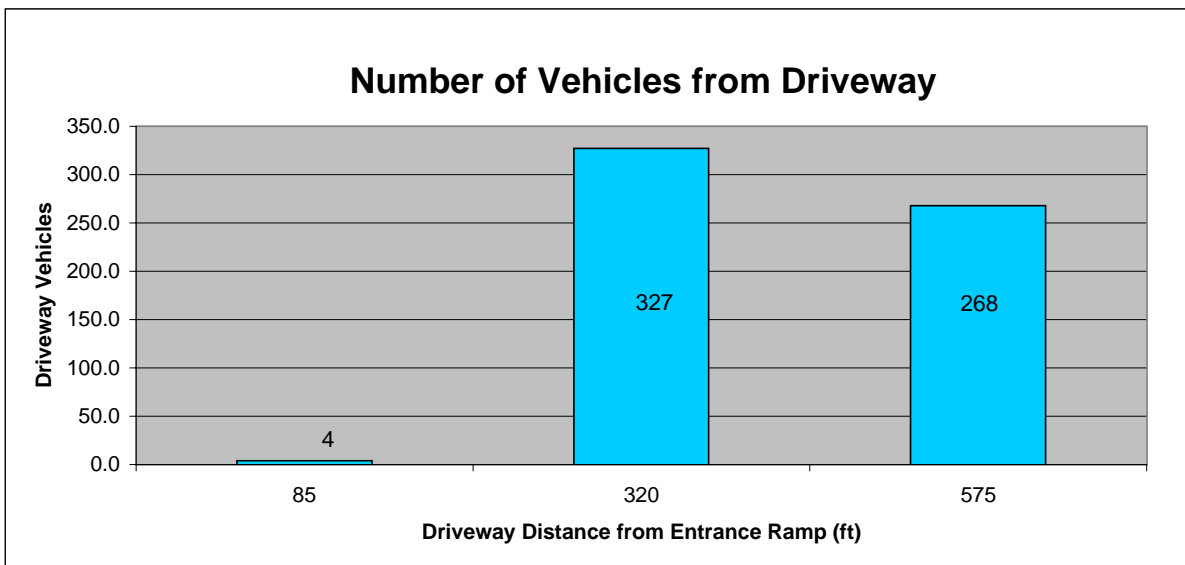
**Figure A-4. US 183 at Braker Lane, Austin, Texas.**

Location:	Braker Ln at US 183				Total
Counter:	3126				3
File:	Austinhi BrakerLn.xls, 3126				
	Frontage	Driveway 1	Driveway 2	Driveway 3	
Driveway Type	3 Lane	Restaurant	Strip Center	Strip Center	
Vehicles	3719	4	327	268	4318
Distance (ft)	-	85	320	575	
Speeds	43.76	41.75	34.44	41.34

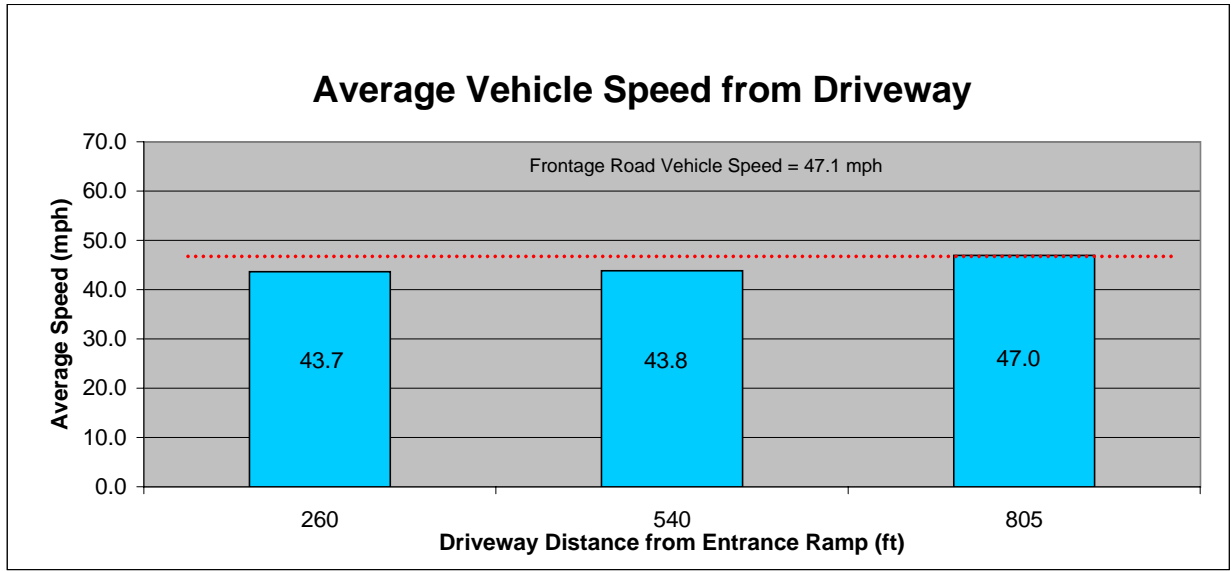
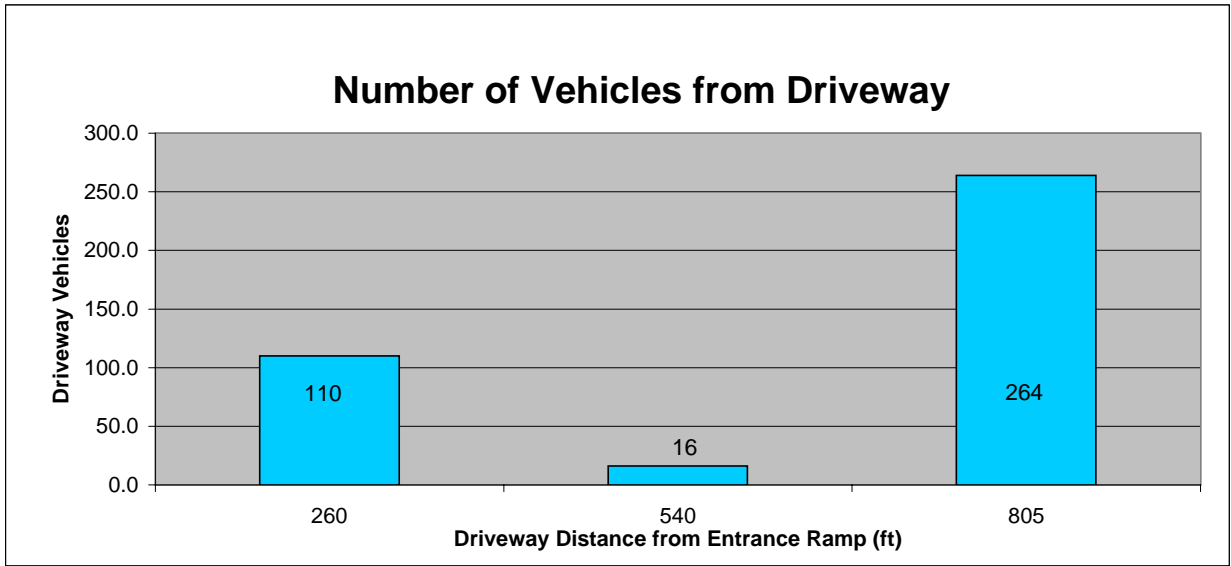
**Figure A-6. US 290 at IH 35, Austin, Texas.**

Location:	IH 35 at US 290					Total
Counter:	3125					4
File:	Austin35@290.xls, 3125					5295
Driveway Type	Frontage 4 Lane *	Driveway 1 Lodging	Driveway 2 Lodging	Driveway 3 Drive	Driveway 4 Lodging	
Vehicles	4905	110	16	264	0	
Distance (ft)	-	260	540	805	1075	
Speeds	47.12	43.66	43.83	46.95	none
