BRIDGE DECK DESIGNS FOR RAILING IMPACTS

Research Report No. 295-1F on  
Research Study 2-5-81-295  
Bridge Deck Designs for Railing Impacts

TEXAS TRANSPORTATION INSTITUTE  
The Texas A&M University System  
College Station, Texas 77843

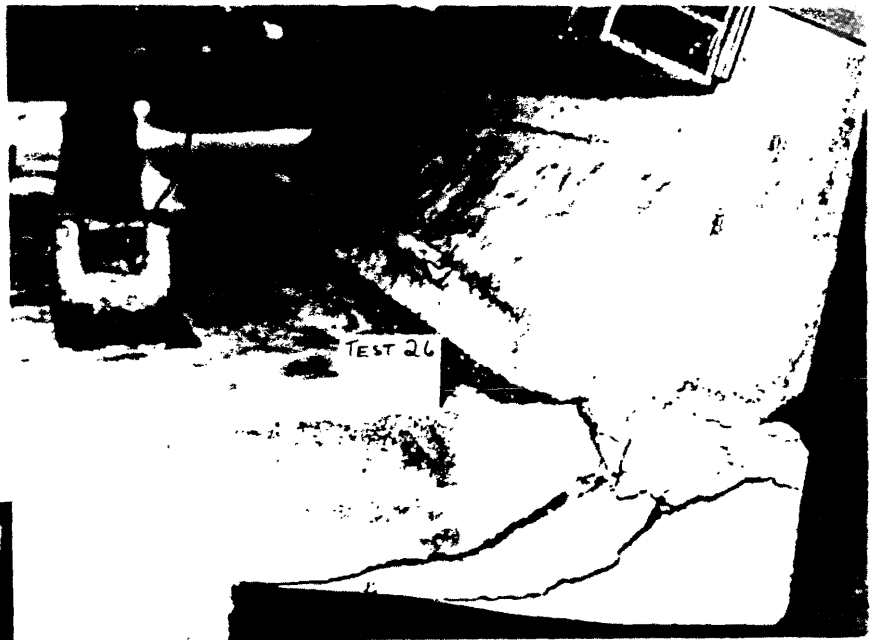
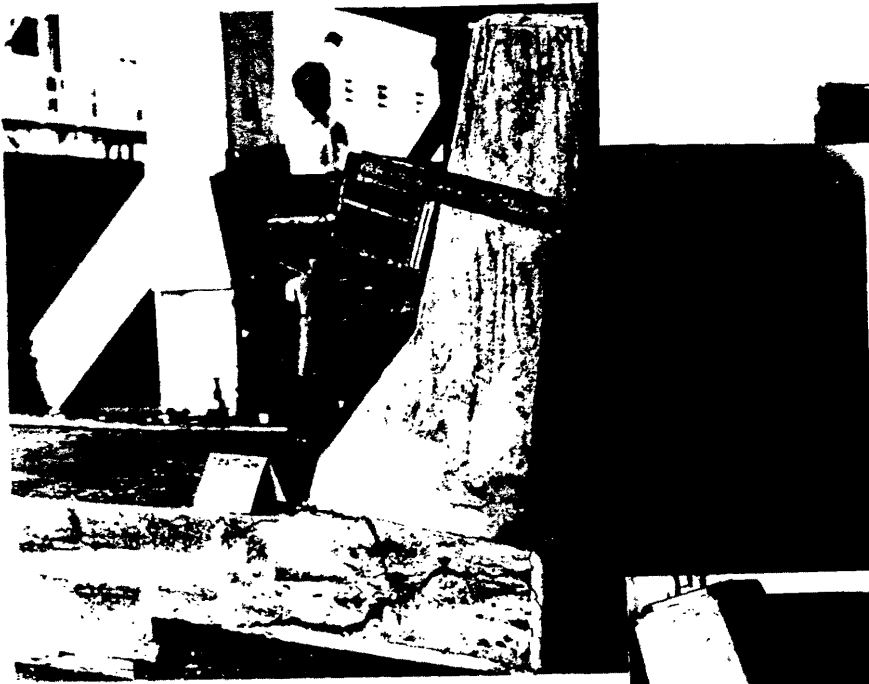
Figure 12. Typical Crack Patterns for Texas T5 Concrete Post and Bridge Deck.

Major cracks occurred in the deck along the tension leg of the "hair pin" bar except in the design with the #4 bar stirrup. In this test the related crack formed at the traffic edge of the parapet and angled 45 degrees into the deck. The 10 in. deck also had a hairline crack where the deck thickness was reduced to join the 8 in. standard deck thickness.

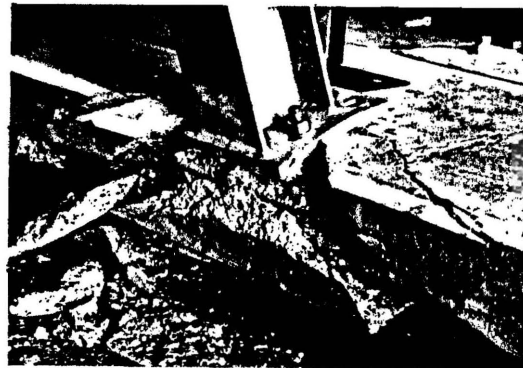
TEST # T101-5S

Cracked Deck and Bent Base Plate After Test

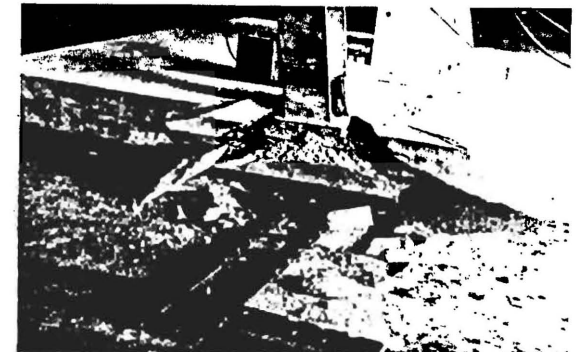
Deck After Test Shown With Anchor Bar

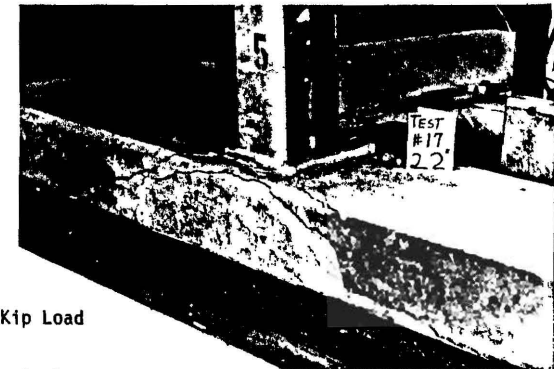
Bolt Broke

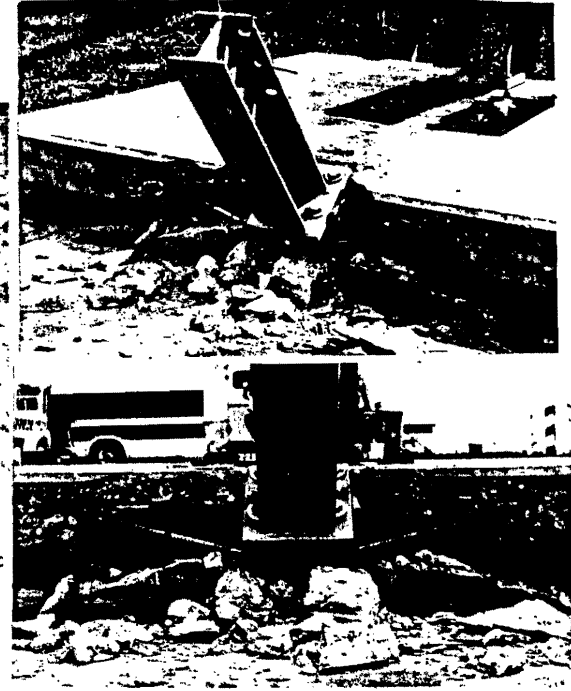
TEST # T101-1D

Deck Cracking in T101 Deck After Dynamic Test

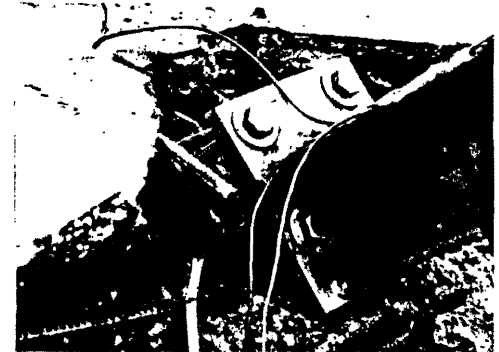
TEST # T101-2D

Deck Cracking in T101 Deck after Dynamic Test

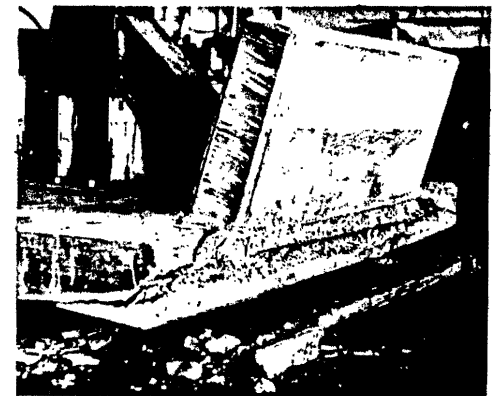
TEST # T202-2S

Modified T202 Post With 7 1/2" Deck and Welded Wire Fabric After Test

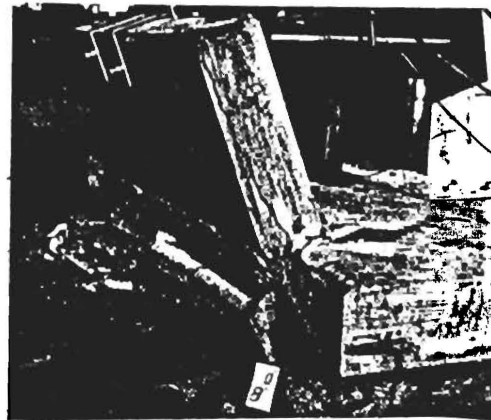
TEST # T202-5S

Cracking in Modified T202 Post and Deck After Test.

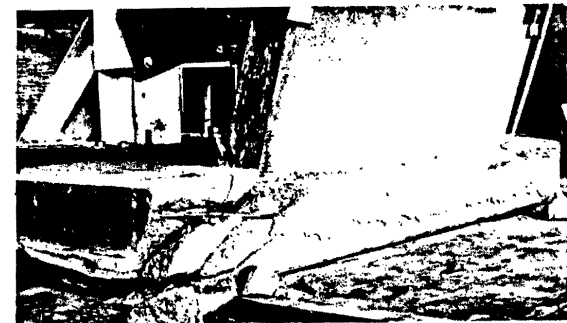
8 Kip Load - 9.0" Post Deflection
