1. Report No. TX-00/2966-3		2. Government Accession No.		3. Recipient's Catalog No.	
4. Title and Subtitle FIELD PERFORMANCE EVALUATION OF HYDRATED, FLY ASH BASES IN THE ATLANTA DISTRICT - YEAR 3				5. Report Date October 1999

**FIELD PERFORMANCE EVALUATION OF HYDRATED,  
FLY ASH BASES IN THE ATLANTA DISTRICT: YEAR 3**

Report 2966-3  
Project Number 7-2966  
Research Project Title:  
Durability of Surface Treatments as the Wearing Course  
Placed on Crushed Fly Ash and Long-Term Performance  
of Crushed Fly Ash for Flexible Base

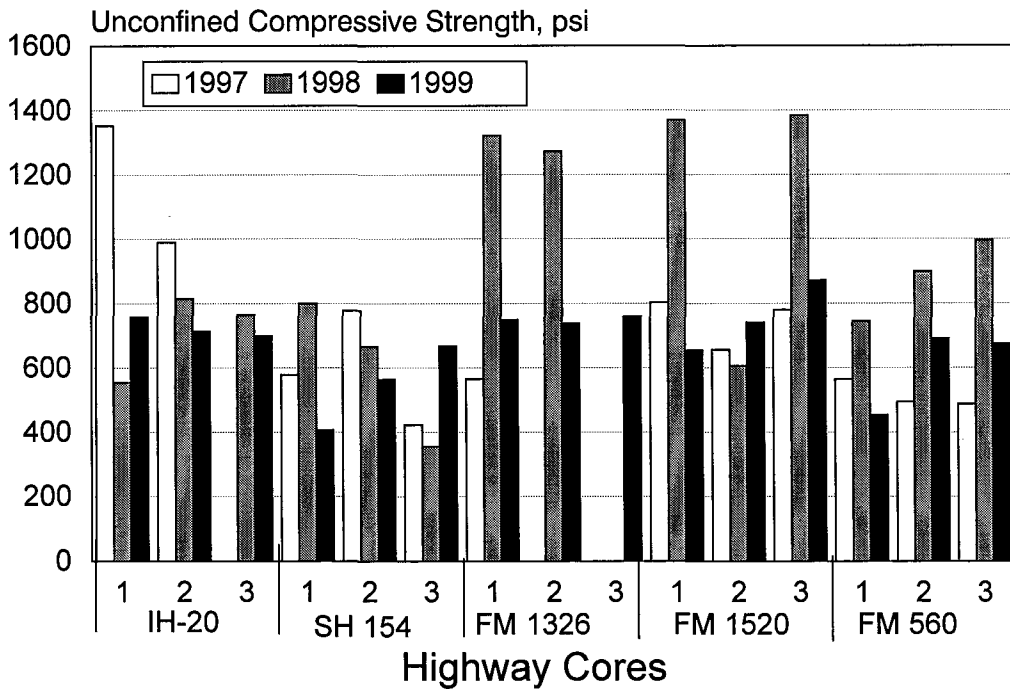
**Figure 1. Unconfined Compressive Strength of Highway Cores**

Texas Transportation Institute (TTI) performed unconfined compressive-strength testing on the field cores. Plaster was used to cap the ends of the specimens prior to testing. For unconfined compressive strength, it is desirable to have a sample length (L) to diameter (D) ratio of at least 2. However, some of the cores were very short. Adjustment factors were used to facilitate comparing cores of different thickness as described in Tex 418-A. Table 7 shows results of the field core strength tests. Figure 1 compares results with previous year's results.

Three cores were obtained from this pavement as shown in Figure 1. The pavement core strengths are similar to the core strengths measured last year. There is very little change in the FWD data exhibited in Figure 3 since 1997. Note in Figure 3 that the last data point may coincide with the beginning of a different type of pavement section..

From what appears to be shrinkage cracking, one would expect this pavement to be the stiffest of the six. This is true in terms of FWD data (Figure 4). Base moduli values along the pavement exceed 1,000,000 psi in some locations. Base moduli values in 1999 appear to be similar to values in 1998 and 1997. Compressive strengths of the cores (on the average) are also close to the values obtained the previous year (Figure 1).

Cores obtained from FM 1326 in 1999 show a significant decrease in strength over that exhibited in 1998. However, the base moduli values as calculated from FWD data (shown in Figure 5) do not indicate a significant change is occurring in the pavement.

Three cores were obtained from FM 1520 and these cores had an average strength which was lower than last year's core data. However, the strengths are about the same as that measured in 1997. FWD data (Figure 6) on this pavement indicate that there may be a general decrease in moduli values; however, most of the values still fall between 100,000 and 300,000 psi as in previous years.

All three cores obtained from FM 560 had lower compressive strengths than the cores obtained in 1998 but about two of the 1999 cores had higher strengths than the 1997 cores as shown in Figure 1. The base on this pavement has two different thicknesses along its length: 9 inches and 16 inches. Because of the difference in thicknesses, two separate FWD analyses were performed as shown in Table 13. Results from both analyses, however, were combined for Figure 7. Moduli values for this pavement are generally higher in 1999 than for the previous years.

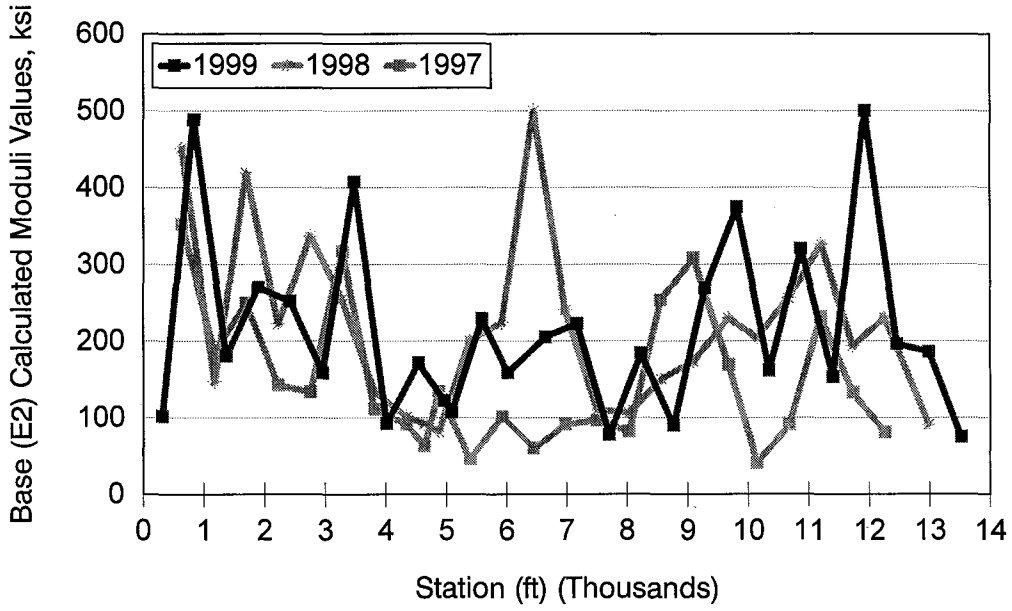
Figure 2. Base Moduli Values for Loop 390

No cores were obtained from this pavement. Unsuccessful attempts were made in 1997, 1998, and again in 1999. As shown in Figure 2, there is some variation in the moduli values since 1997; however, it doesn't appear that the base is overall exhibiting a deteriorating strength. Some locations indicate an increase in stiffness while others show a decrease.
