16. Abstract The Queen Isabella Causeway, also known as Park Road 100, is a 3.86 kilometer (2.4 mile) bridge that crosses the Intracoastal Waterway and connects Port Isabel with South Padre Island. The Queen Isabella Causeway presents several unique challenges which influence transportation operations. These challenges include an endangered species of Brown Pelican (<i>Pelicanus occidentalis carolinensis</i>) (B. Pelican) which land on the causeway and are hit and killed, and traffic incidents which have the ability to completely close down access between Port Isabel and South Padre Island. In September of 1984, the first documented B. Pelican mortality occurred on the Queen Isabella Causeway, causing considerable public concern. Since that death in 1984, the population of B. Pelicans has dramatically increased, and the number of B. Pelican mortalities has also increased but at a slower rate. Observations of the B. Pelicans in the area show that a majority of the birds forage on the south side of the bridge during the day and return to the Laguna Madre on the north side of the bridge in the evening to roost. Although the increasing population of the B. Pelican may cause the pelican

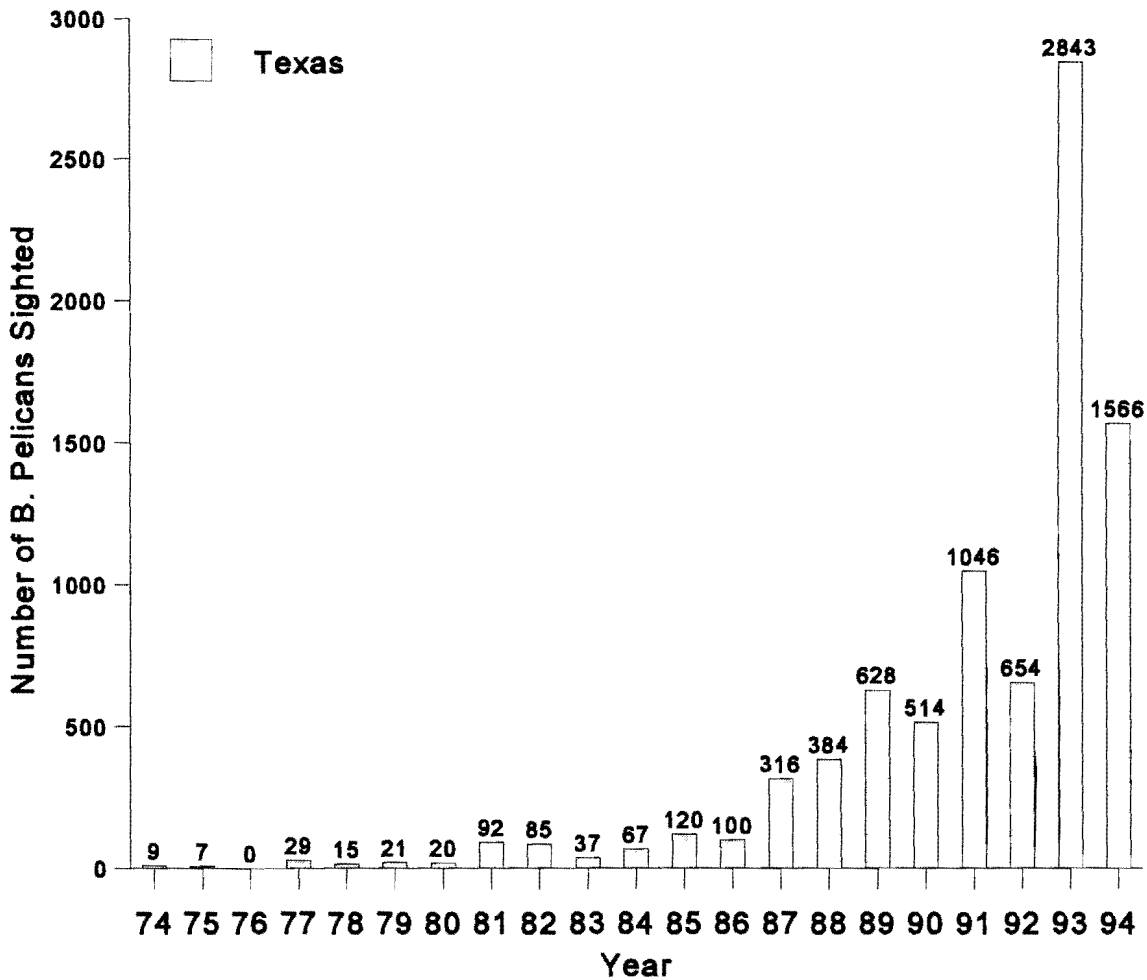
Figure 3.1 B. Pelican Sightings on Texas Coast (1974-1994)

Since 1971 the B. Pelican has made a dramatic recovery in Texas due to reduced contaminant levels. A review of the Audubon Christmas Bird Counts from 1974 to 1994 shows the recovery of the B. Pelican in the Texas as shown in Figure 3.1 (21).

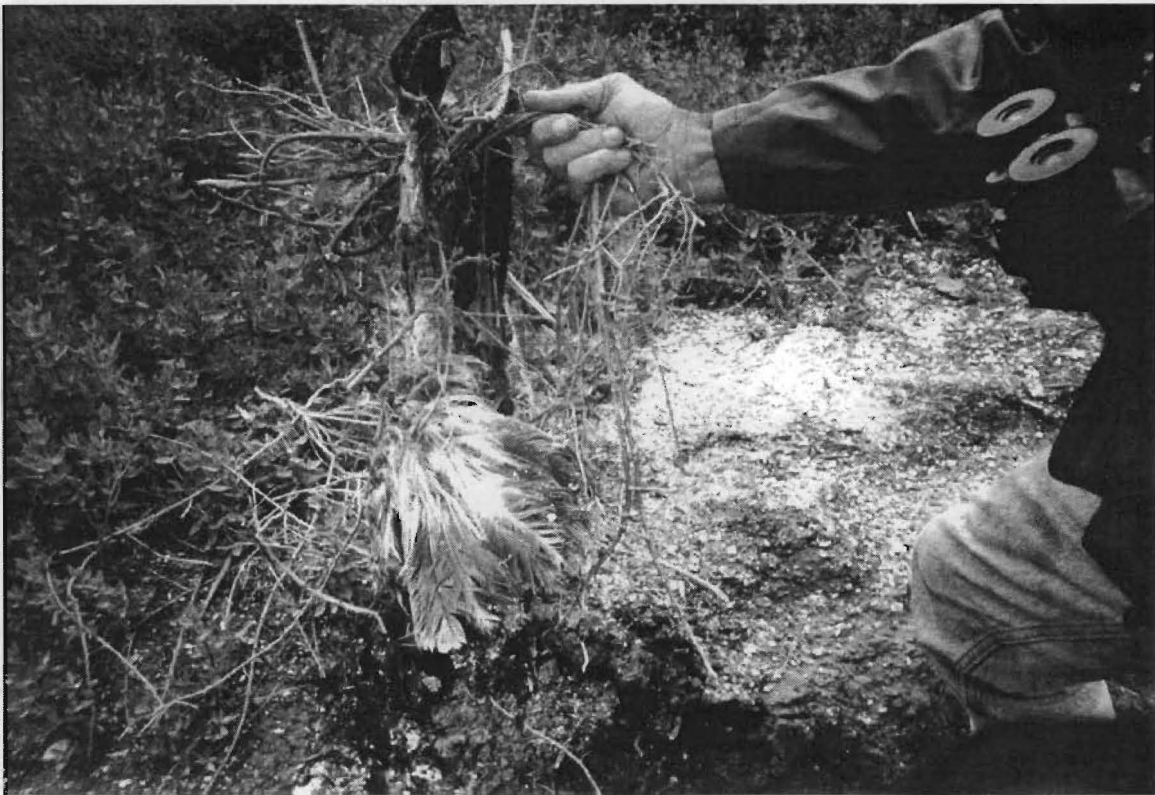
Figure 3.4 Dead B. Pelican Ensnared in Monofilament Fishing Line

The TTI research team found a dead B. Pelican on a spoil island in the Laguna Madre during the May 1997 field expedition. The pelican carcass, shown in Figure 3.4, was found with the feet entangled in a piece monofilament fishing line with weight and float, that was ensnared in vegetation. It was surmised that the pelican died of either starvation or exposure.

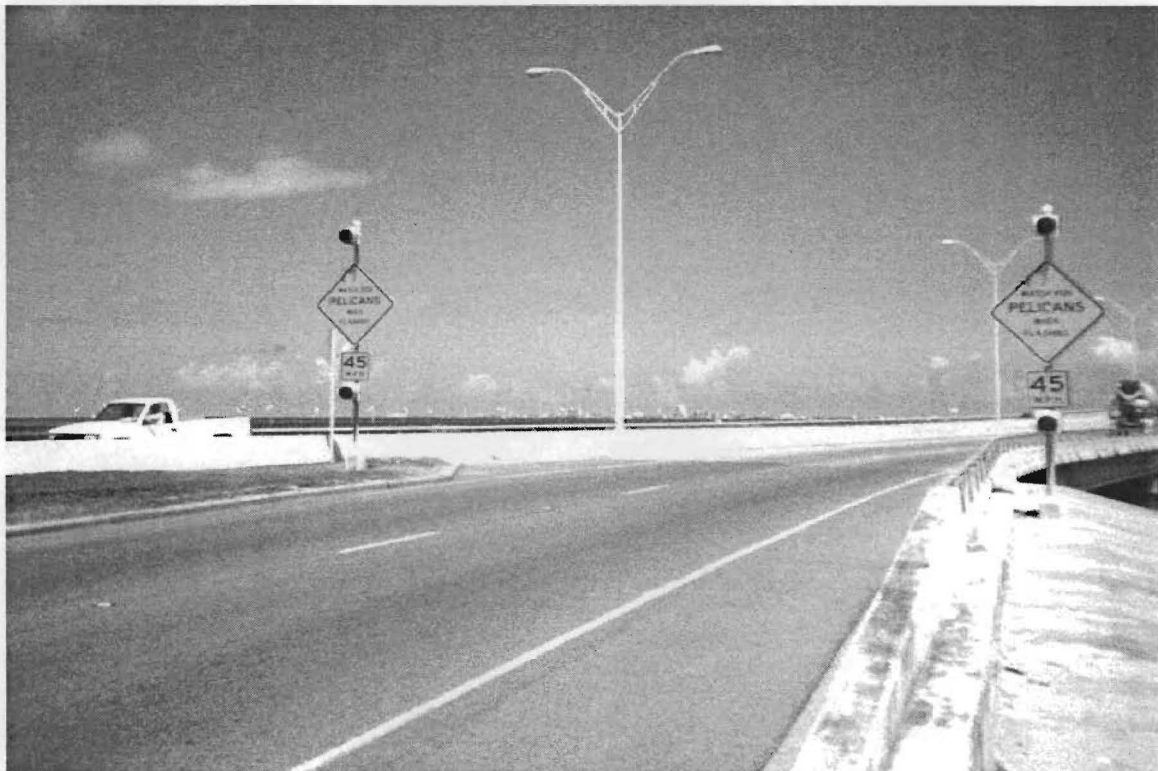
Figure 4.1 “Watch for Pelicans When Flashing” Signs

TxDOT has used several signing methods in an attempt to alert motorists to the possibility of B. Pelicans being on the deck of the Queen Isabella Causeway. First, a series of static signs that stated “Watch for Brown Pelicans - Endangered Species,” were placed on each side of the causeway. These signs were followed by a new version of signs that added two flashing beacons. These signs are depicted in Figure 4.1. The new signs removed the supplemental placard of “Endangered Species” and replaced it with a “45 mph.” placard. This placard was an attempt to reduce the speed of vehicles traveling on the section of the bridge where a majority of mortalities

were thought to occur. Additional signs were placed on the elevated section of the causeway which attempted to further slow the traffic to 48 km/h (30 mph.) Problems have occurred when signs were placed on the bridge railing. The large gusts of wind, which are common to the area, have blown several sets of these signs off the bridge.

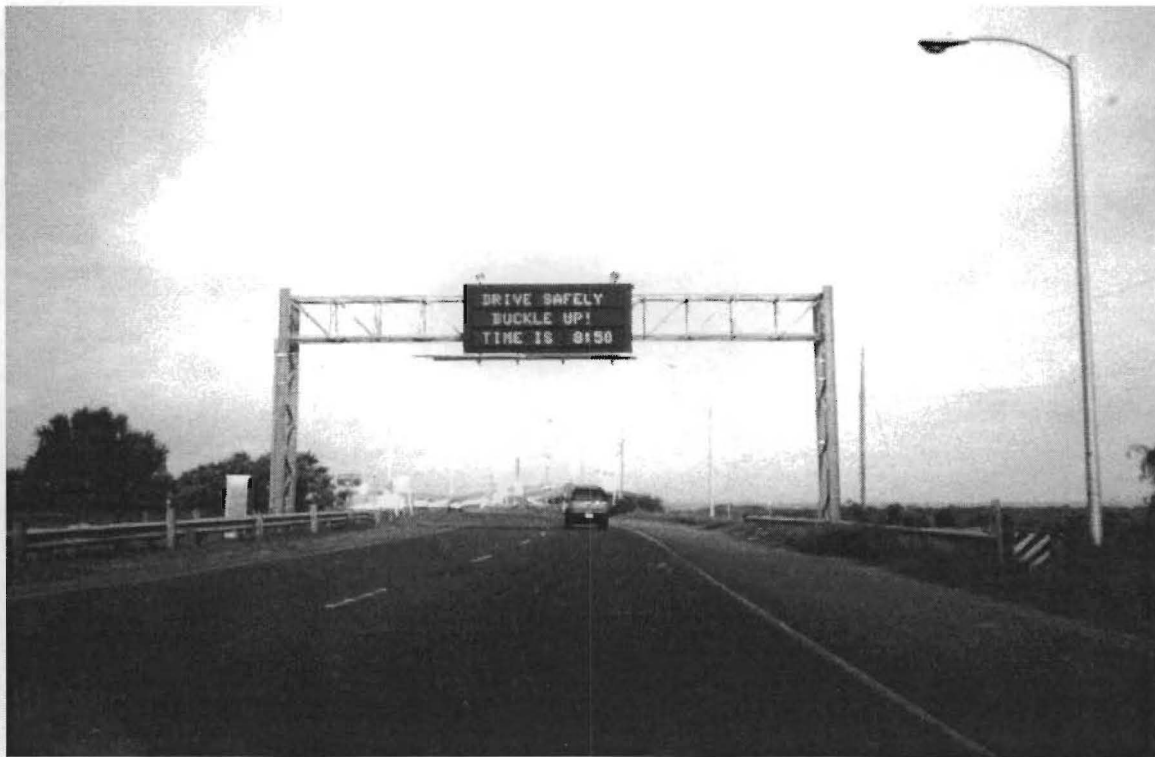
Figure 4.2 Existing Changeable Message Sign on South Padre Island

In addition to the flashing signs, overhead changeable message signs (CMS) have been constructed on each side of the Causeway. Figure 4.2 shows the CMS on the South Padre Island side of the causeway. These signs are primarily used for hurricane evacuation information, but serve other functions. One function involves alerting motorists when weather conditions are favorable for an increased possibility of B. Pelican mortalities. There are two messages used to warn motorists. The first message simply states, "WATCH FOR PELICANS - 45 MPH." The second message gives additional instruction by adding, "CAUTION!! - REDUCE SPEED" to the original message. At other times, when the sign is not being used for hurricane evacuation information or for B. Pelican warnings, it is being used to broadcast drive friendly messages along with the current time.
