1. Report No. FHWA/TX-86/10+322-1		2. Government Accession No.		3. Recipient's Catalog No.	
4. Title and Subtitle State-of-the-Art and Objectives of Reflective Raised Pavement Markers				5. Report Date October 1986

STATE-OF-THE-ART AND OBJECTIVES OF REFLECTIVE RAISED PAVEMENT MARKERS

Research Report 322-1
Study Number 2-18-322-1

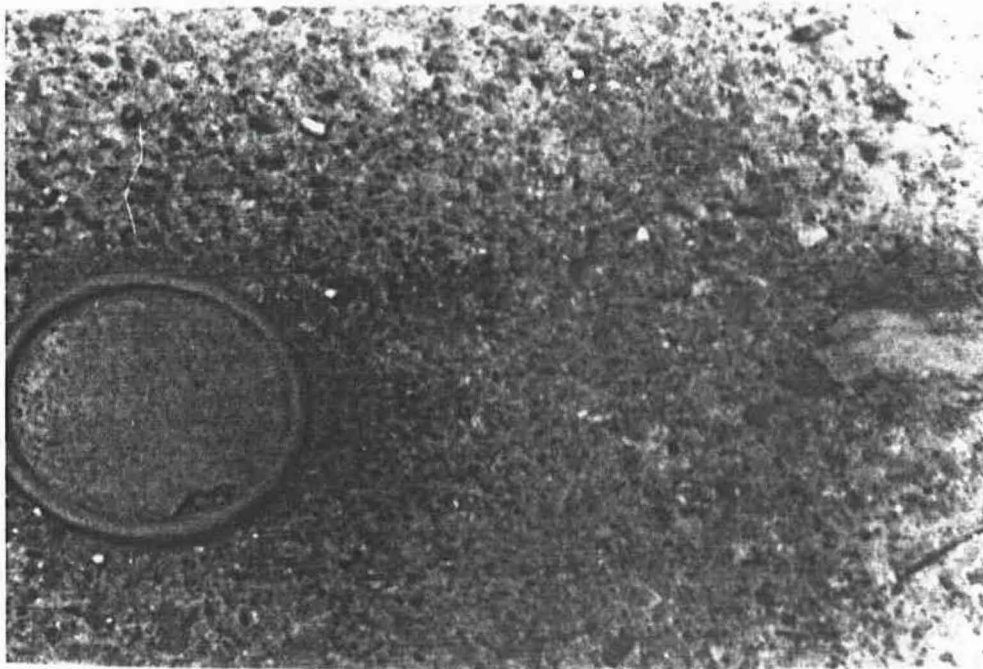
Figure 1. Two Types of Raised Pavement Marker Retention Failures. On the Left the RTB Clearly Separated from the Epoxy. On the Right a Portion of the Portland Cement Concrete Pavement was Extracted with the RPM and Epoxy.

Several factors related to the problem of marker retention were indicated. One of the problems was not directly related to the markers themselves. There were very few marker-to-epoxy failures observed where the failure was attributed to the marker itself. However, in some instances, moisture absorbed by the ceramic markers prior to installation is believed to have accelerated this type of failure. Other observed modes of failure included epoxy-to-pavement adhesion failure and failure within the pavement itself (Figure 1).

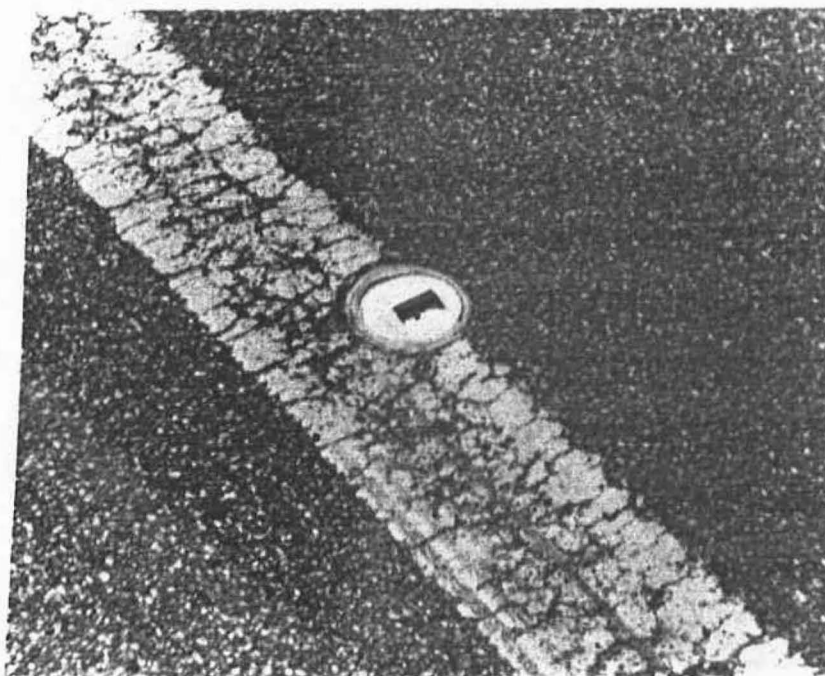
Figure 2. A RTB Bonded Over an Existing Paint Stripe.

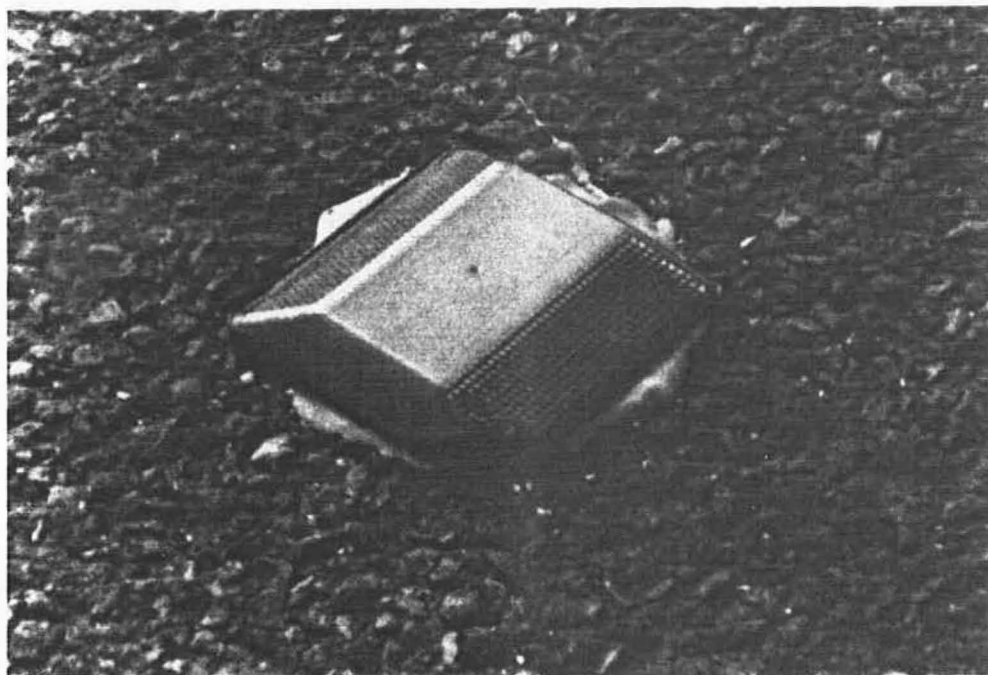
Figure 5. Improper Placement of the Epoxy Leaves the RPM Corners Unsupported and Susceptible to Failure as Shown.

Installation errors were found statewide. Personal observations of the application of RPMs on surfaces having dirt particles, excessively darkened premixed epoxy, and insufficient epoxy to completely cover the bonding surfaces were all noted. Figure 2 shows a ceramic marker bonded over an existing paint stripe, Figure 3 shows markers installed on a seam, Figure 4 shows an RPM with the bonding surface incompletely covered, indicated by a pocket knife blade inserted under a corner, and Figure 5 illustrates one type

of marker failure that results from incomplete coverage of the bonding surface.

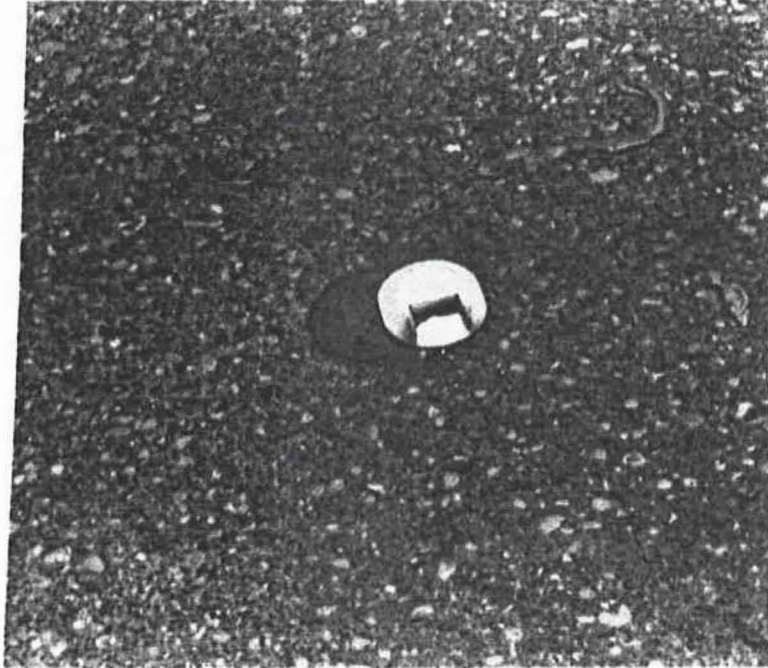
Figure 6. Photographs of a Sliding RTB Indicating the Epoxy did not Properly Cure.

Figure 6 and 7

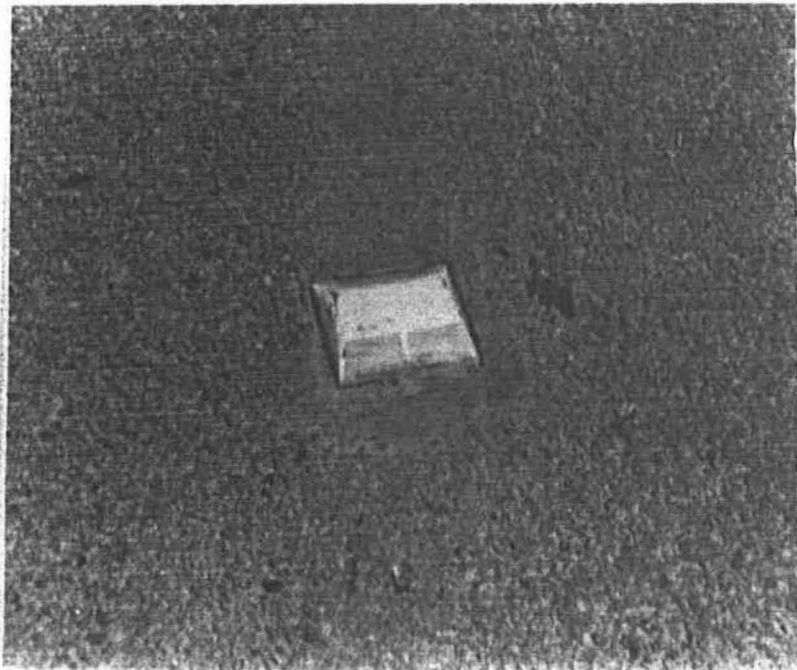
Figure 7. Photograph of a RPM Showing Excessive Flow of the Epoxy. Again Incomplete Cure is Suspected but the Cause Remains Unknown.

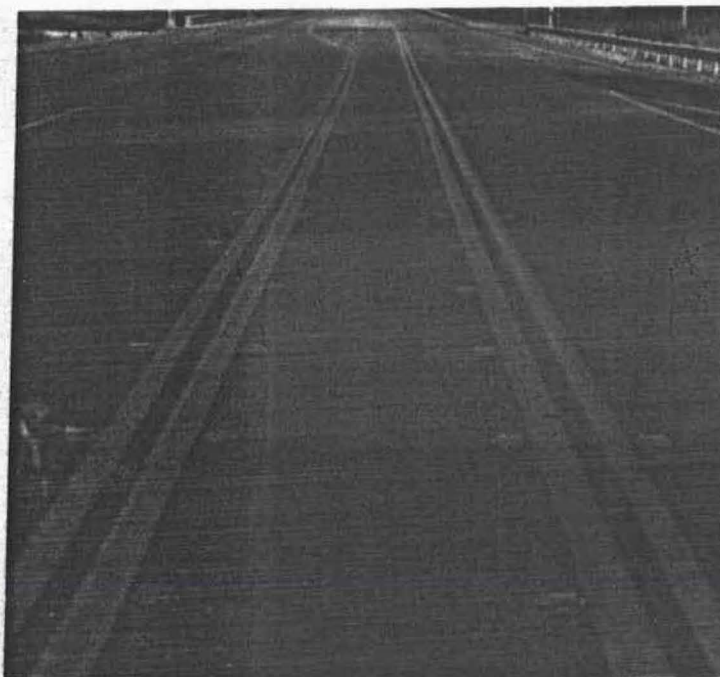
Figure 8. Photograph Showing the Influence of Traffic on Early RPM Loss. The RPMs Inside the Island and in the Turning Lane (on the left) Remain Intact While Those in the Traffic Lane (on the Right) are Missing. These RPMs have been in Place Three Months.

The most severe of these factors was the loss of the RPM due to failure within the paving material itself. While this was a problem with Portland cement concrete and chip-seal coated pavements, it appeared to be more severe on asphaltic concrete pavements. The problem was complicated by erratic behavior between locations but it seemed to be primarily a function of the material properties of the asphaltic concrete. Reports from District 11 indicated that 20% of the RPMs placed on a L-M.C. Item type 290 asphalt surface in October 1981 were retained and that nearly 100% of those placed on asphaltic concrete L-M.C. Item Type 340 had been retained. Similar observations were made on IH-10 near San Antonio where the retention of RPMs on a chip-seal pavement northwest of the city was excellent, while the retention of those east of the city was poor. These markers were installed by the same contractor, at the same time. Figure 8, a photograph taken in District 17, shows an example of these types of failures and also gives evidence that wheel loadings are the primary factor in the dislodging failures.

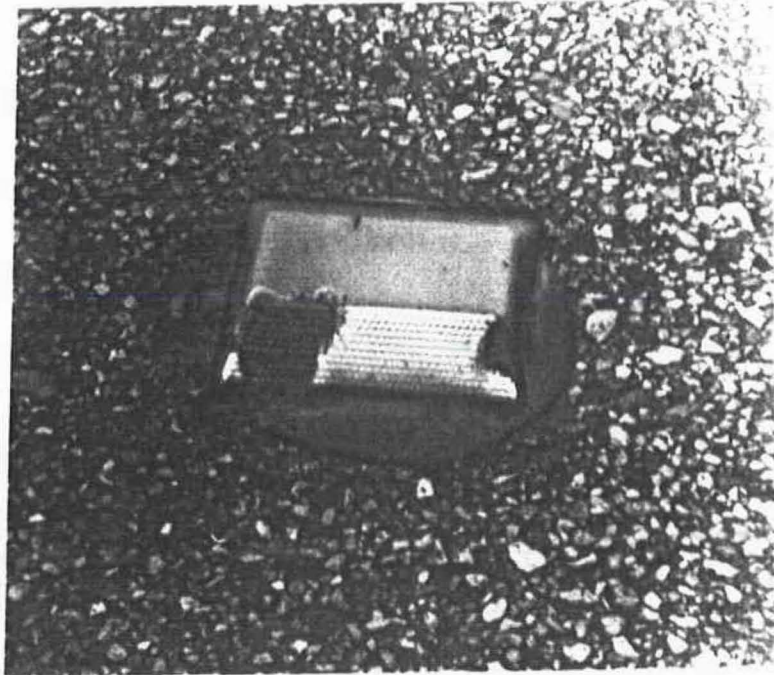
Figure 9. Badly Worn and Broken RPM, Type I-C.

Examples of diminished reflectivity due to wear and breakage were plentiful wherever RPMs had been in extended service. Worn lenses (Figure 9), missing lenses (Figure 10), cracked bodies (Figure 11), and dirt covered lenses (Figure 12) were frequent occurrences that were observed on Texas highways during the research study. Often the reflectivity was degraded when the marker was pounded vertically into the pavement, as shown in Figures 13 and 14. Large rolls of extruded epoxy in front of a marker similarly tended to degrade their reflectivity.

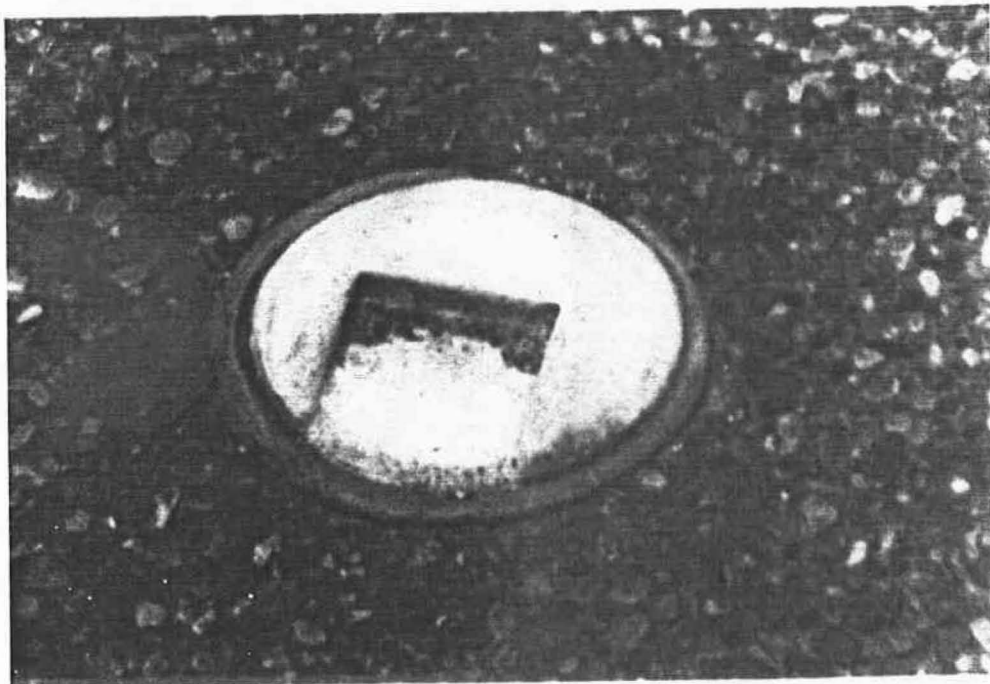
Figure 10. A RTB with the Reflective Lens Completely Missing.

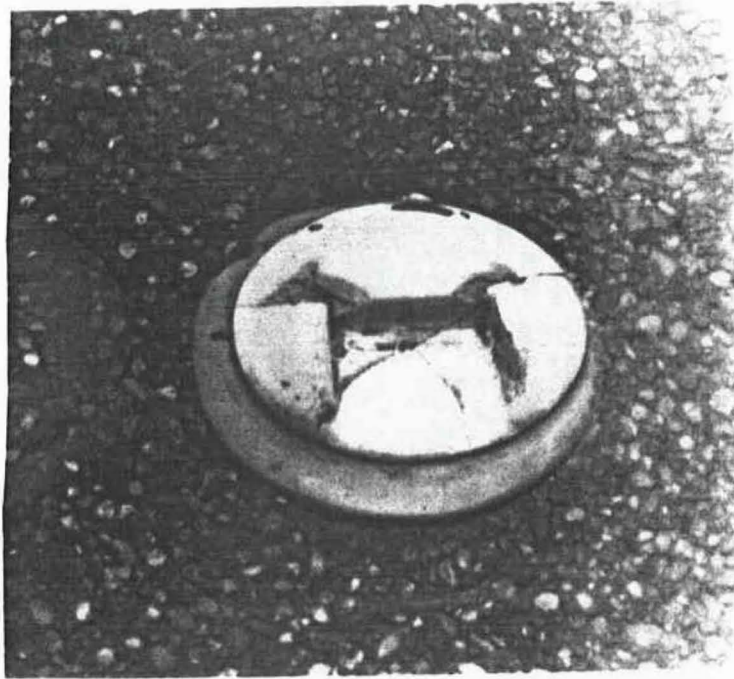
Figure 11. RTB, Type I-C, Badly Broken and Worn. Lens is Completely Missing.

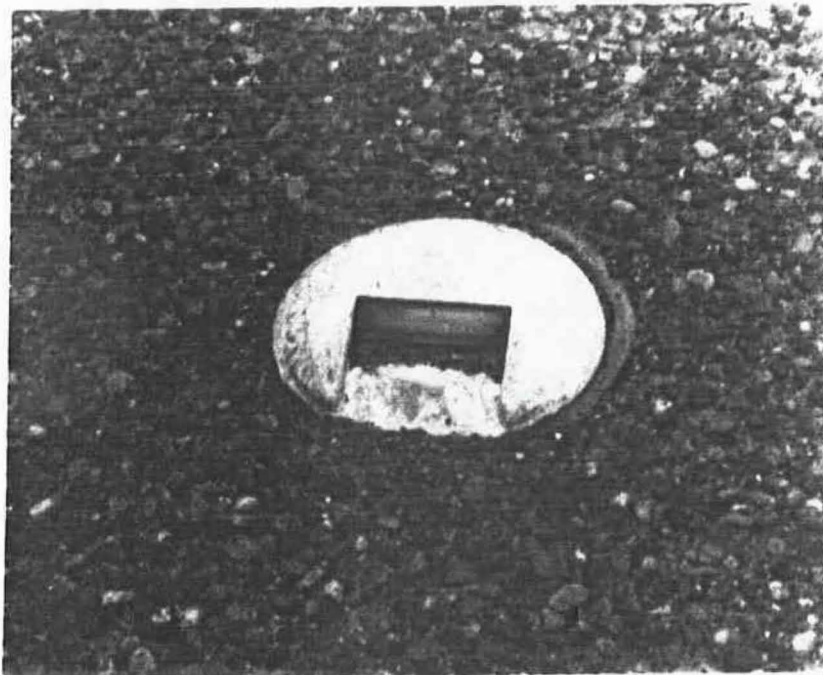
Figure 12. A RTB with the Lens Partially Obscured by Dirt.

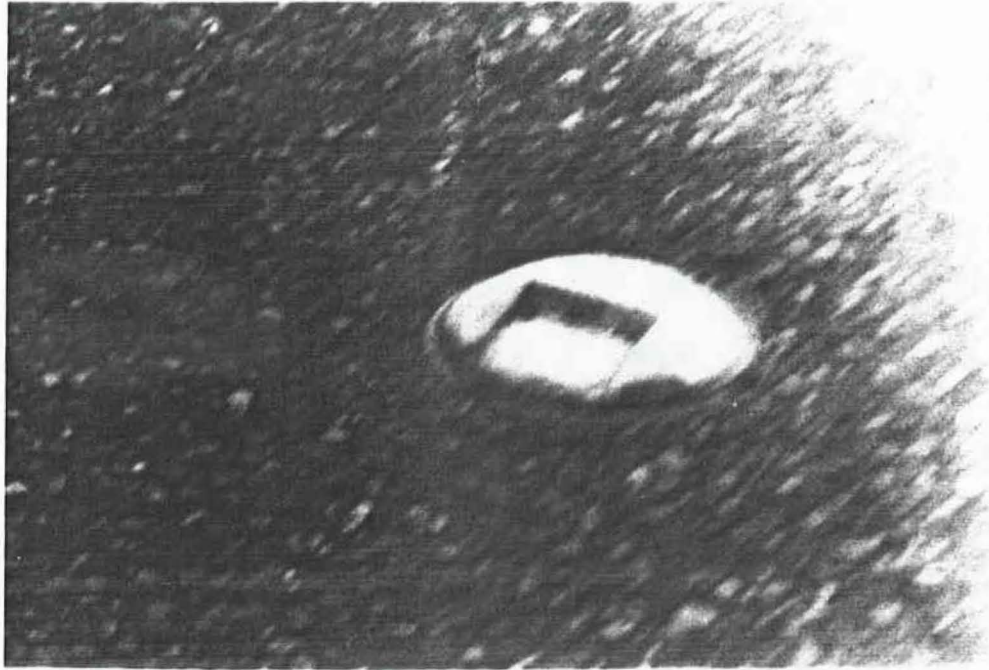
Figure 13. A RTB Submerged Into the Asphalt Pavement.

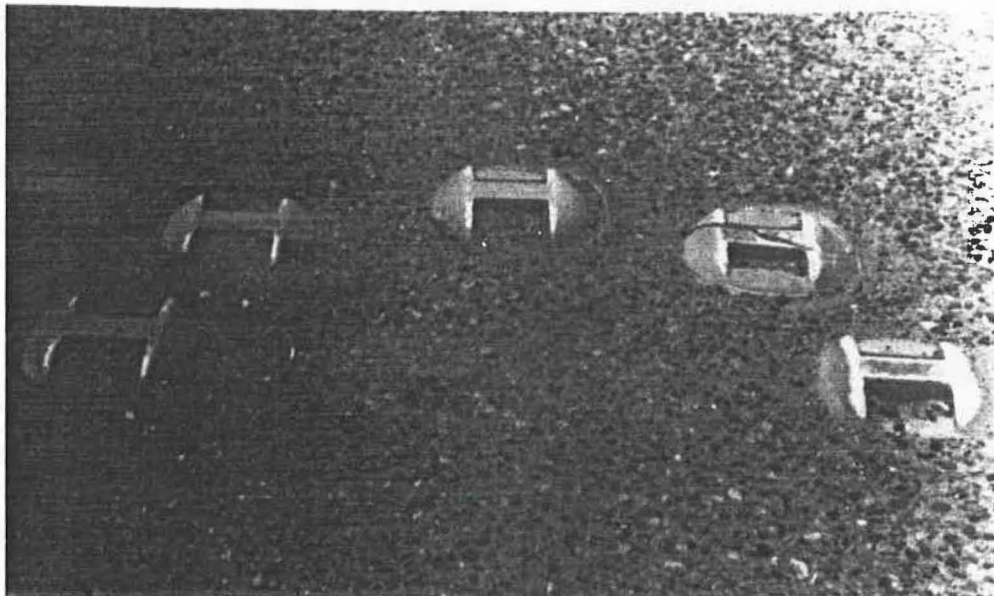
Figure 14. A Photograph of Five RTBs with Different Problems. Note the Amber Glaze Has Rapidly Worn Away, Probably Because of Lowered Lead Content. Also Note the Dirt Covered Lenses and the Tendency for the Markers to Sink Into the Asphalt.

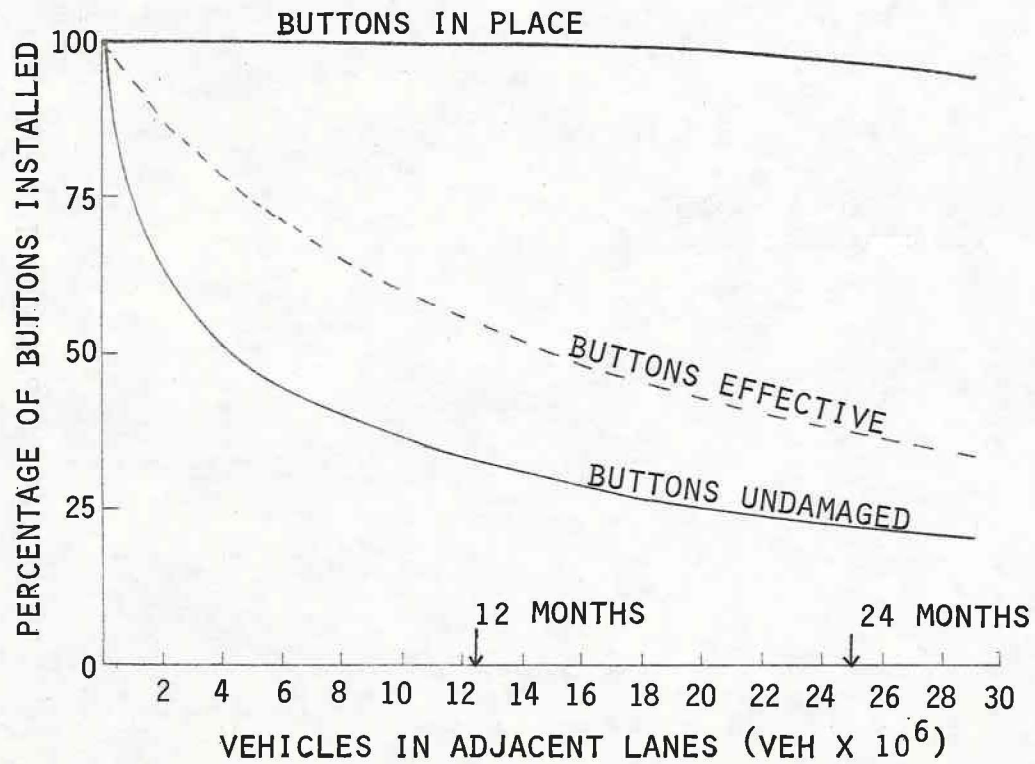
Figure 17. Curves Showing the Deterioration of RTBs (Permark P-17 and P-117) Observed in the 1977 Dallas - San Antonio Test. The Average Daily Traffic in the Two Lanes Adjacent to the Buttons was 33,300 vpd.

The performance of the RPMs (both Stimsonite and Ray-0-Lite) and of the RTBs (Permark P-17 and P-117) were plotted as a function of the number of vehicles passing in the adjacent two lanes (Figures 16 and 17, respectively). The ADT at each test site was different, therefore a weighted ADT was calculated. Table 2 illustrates how this calculation was made. The average traffic in the two adjacent lanes at all the test sites was found to be 33,000 vpd (or 12.15×10^6 vehicles/year).

The results were plotted as the average traffic in the adjacent two lanes. They included (1) the percent of RPMs remaining in place, (2) the percent of RPMs undamaged, and (3) the percent of RPMs effective. The definition of numbers (1) and (2) is straightforward, and it reflects actual numbers counted on the roadway. The percent of the original RPMs remaining in place is shown by the topmost heavy solid curve, and the percent of the markers still undamaged is shown by the lower (and lighter) solid curve. The number of RPMs effective, is a much more subjective term. The effective marker systems take into account (1) the number of missing markers and (2) the reduction in reflectivity of the remaining markers. The reflectivity is evaluated across all markers and not reduction in reflectivity for individual markers. These results are plotted on the graphs as a broken line. A review of Figures 16 and 17 indicates that the retention of RTBs is better than that of the RPMs, however, RPMs behaved much better in terms of reflective effectiveness and resistance to damage.

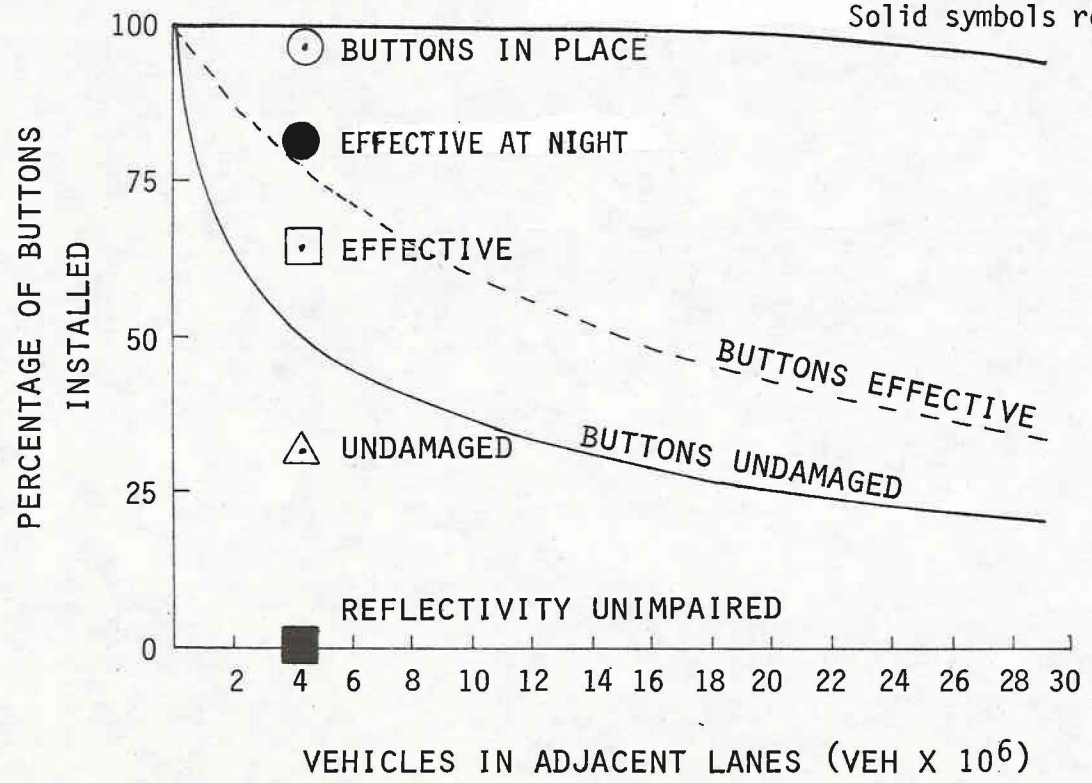
Figure 20. Observed Condition of RTBs on IH 10 East of San Antonio (Both Directions) Compared to RTB Performance Reported in the 1977 Dallas - San Antonio Study.

The results of these observations are shown plotted against the summary curves from the Dallas - San Antonio study in Figure 18 for the 947s, Figure 19 for the 88s, and Figure 20 for the P-117s. It is apparent that this section of highway does not have good retention properties. While only 2% of the P-117s were gone (all epoxy failures), 13% of the 88s and 79% of the 947s had disappeared! This confirmed by other observations, that the RTBs are retained better than the RPMs.

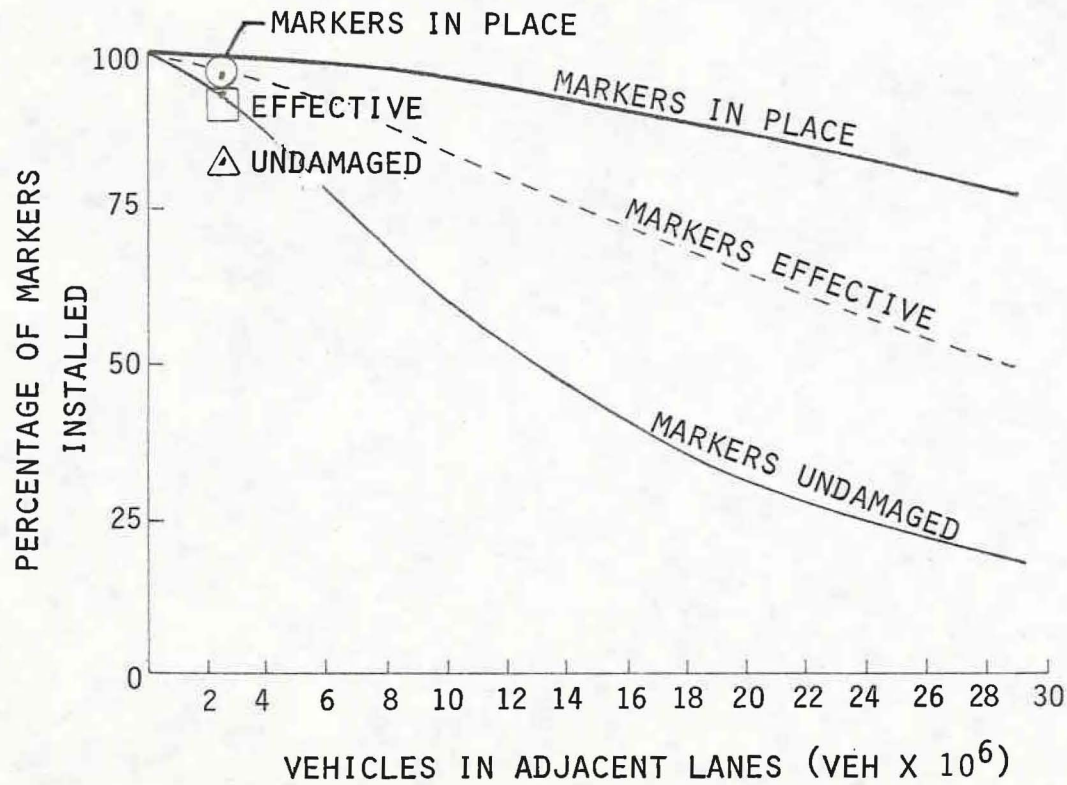
Installation Date: April, 1981
 Pavement: Hot mix asphalt concrete
 Tradename: Stimsonite 88 (Type II-CR)
 ADT (two adjacent lanes only): 6,000
 Total Markers: 700
 Note: Open symbols represent daytime data

Figure 21. Observed Condition of RPMs on IH 10 Northwest of San Antonio (Eastbound) Compared to RPM Performance Reported in Dallas - San Antonio Study.

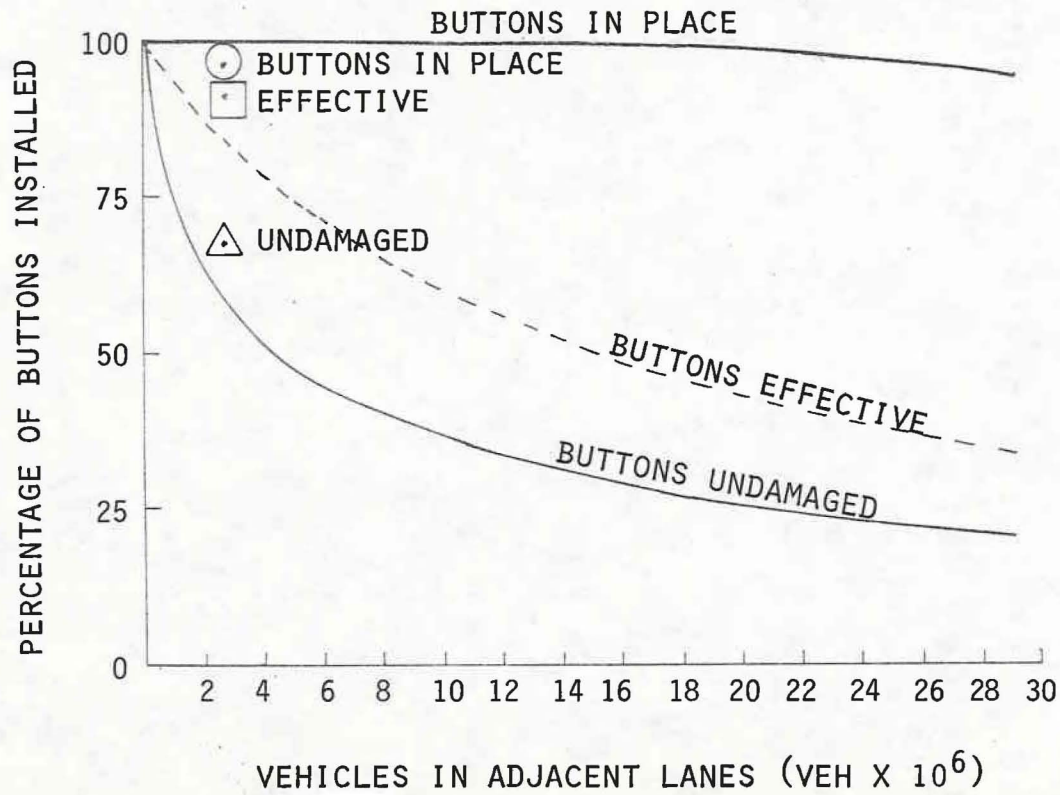
Installation Date: April, 1981
 Pavement: Hot mix asphalt concrete
 Tradename: Permark P117 (Type II-CR)
 ADT (two adjacent lanes only): 6,000
 Total Buttons: 736
 Note: Open symbols represent daytime data

Figure 22. Observed Condition of RTBs on IH 10 Northwest of San Antonio (Westbound) Compared to RTB Performance Reported in Dallas - San Antonio Study.

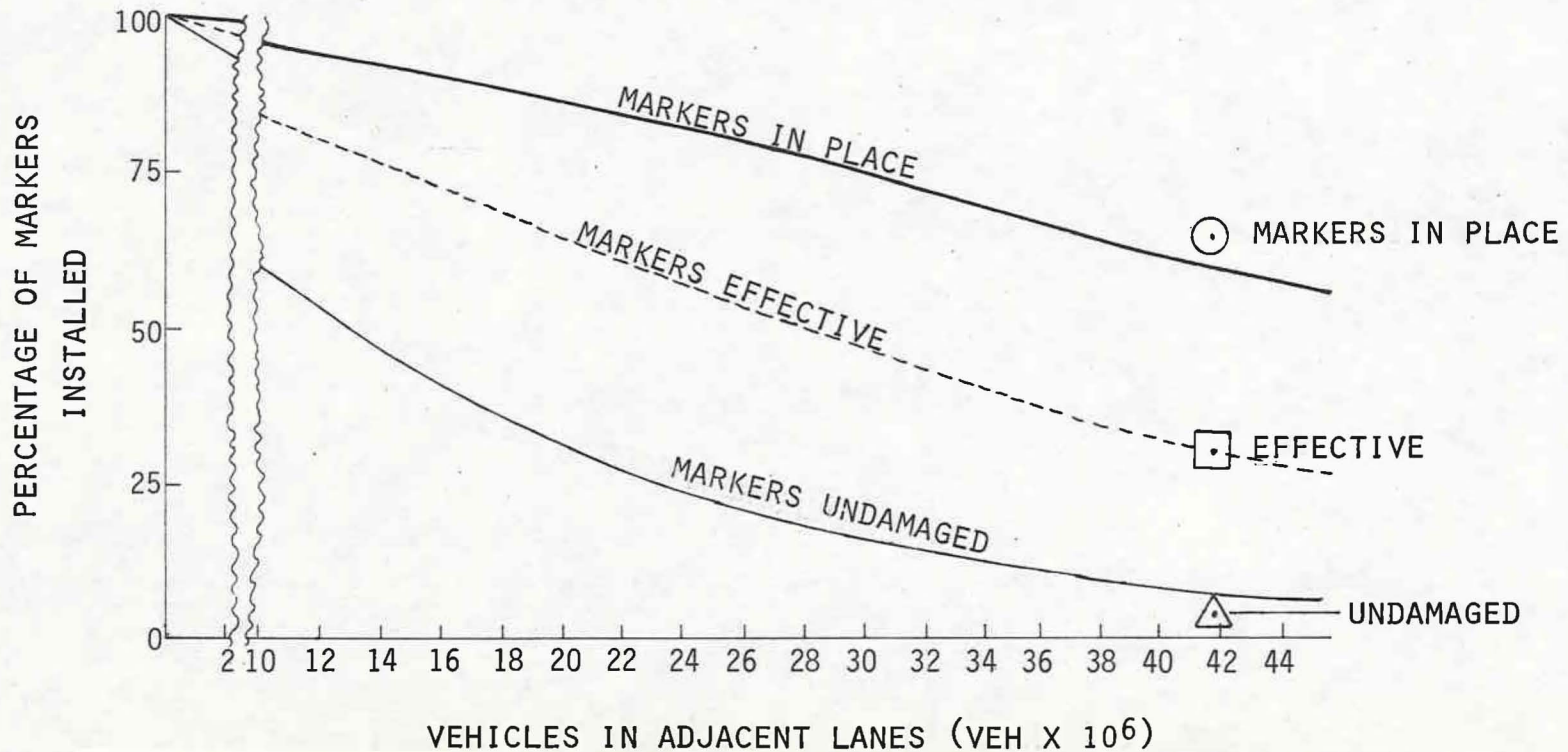
Installation Date: July, 1977
 Pavement: Portland Cement Concrete
 Tradename: Stimsonite 88 (Type II-CR)
 ADT (both directions): 69,000
 Total Markers: 403
 Note: Open symbols represent daytime data

Figure 27. Observed Condition of RPMs on IH 10 West of Houston (Both Directions) Compared to RPM Performance Reported in the 1977 Dallas - San Antonio Study.

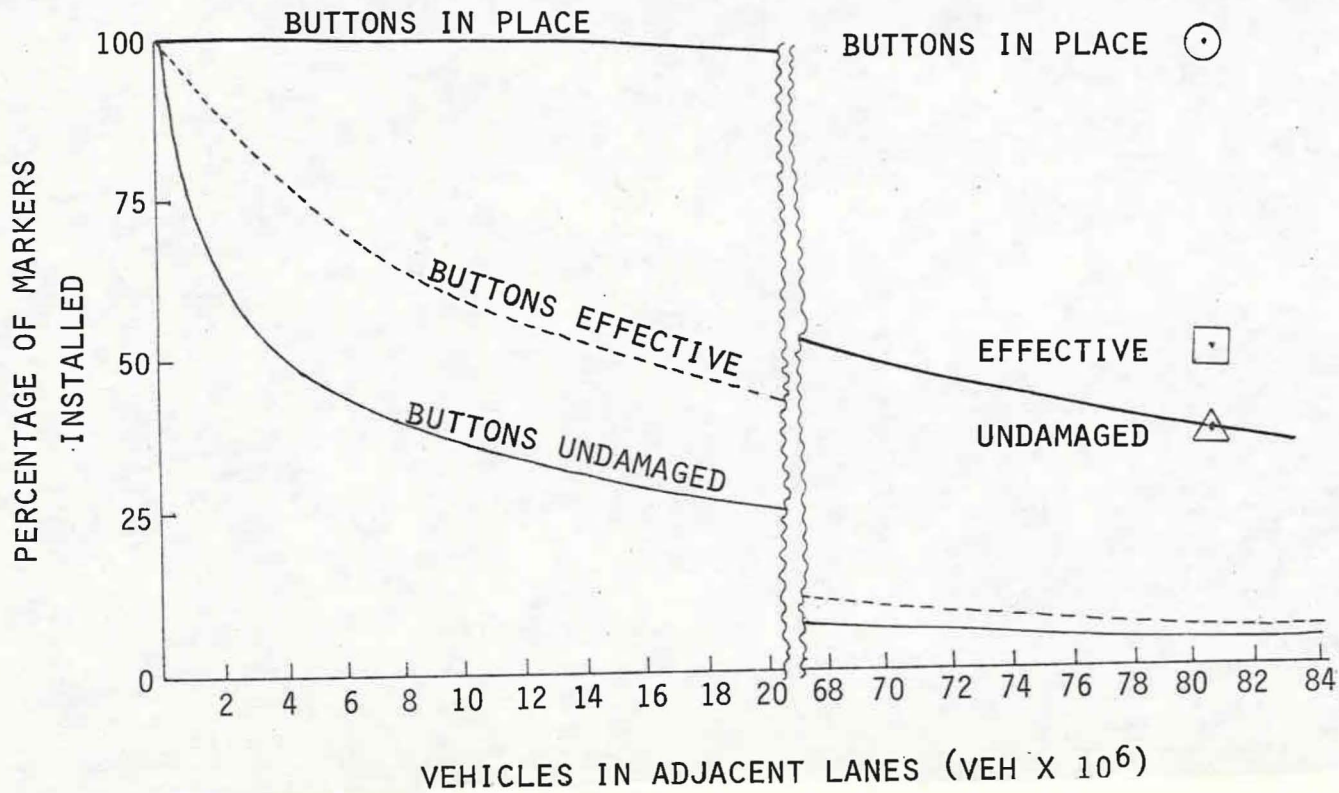
Installation Date: February, 1974
 Pavement: Portland Cement Concrete
 Tradename: Permark P117 (Type II-CR)
 ADT (two adjacent lanes only): 27,450
 Total Markers: 132
 Note: Open symbols represent daytime data

Figure 28. Observed Condition of RTBs on IH 35 Upper Level in Austin (Northbound) Compared to RTB Performance Reported in the 1977 Dallas - San Antonio Study.

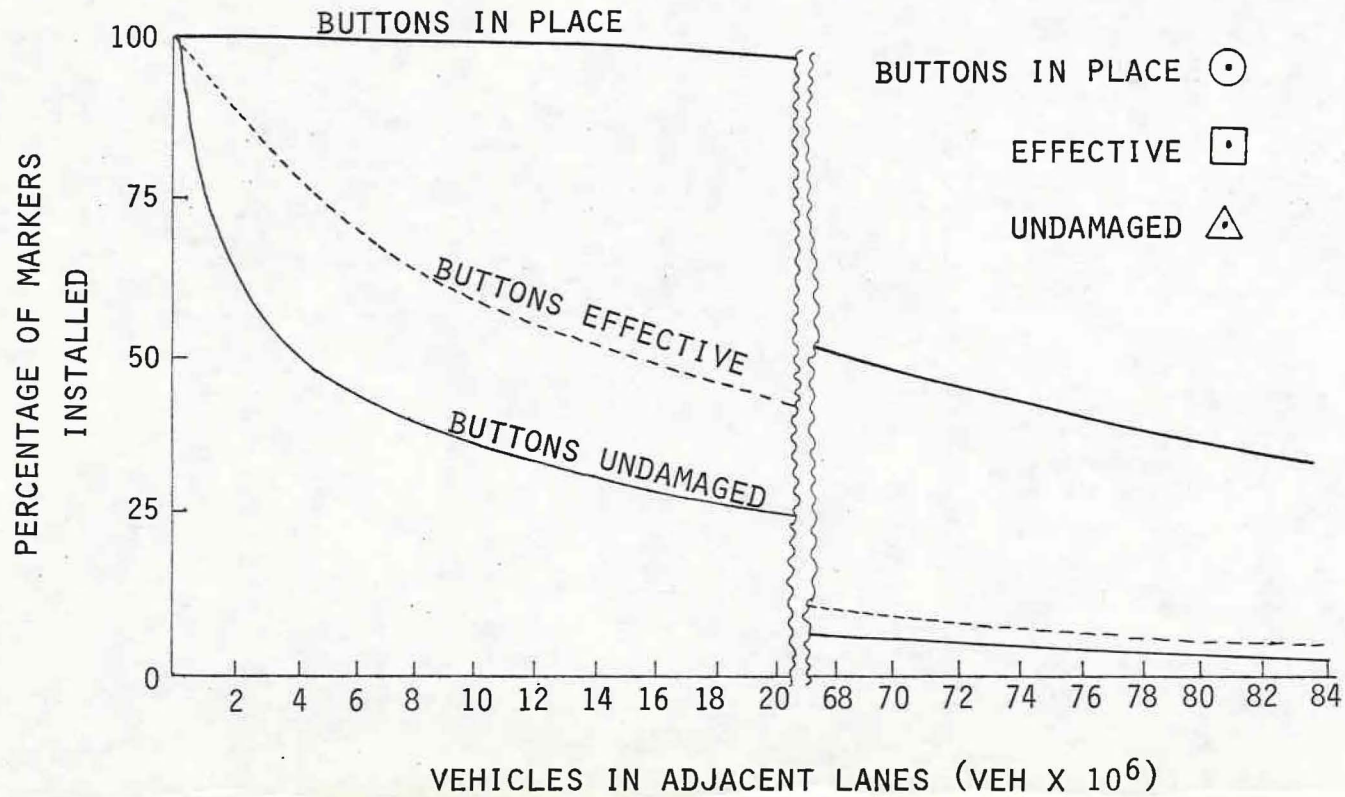
Installation Date: February, 1974
 Pavement: Portland Cement Concrete
 Tradename: Permark P117 (Type I-C)
 ADT (two adjacent lanes only): 27,450
 Total Buttons: 396
 Note: Open symbols represent daytime data

Figure 29. Observed Conditions of RTBs on IH 35 Upper Level, in Austin (Northbound) Compared to RTB Performance Reported in the 1977 Dallas - San Antonio Study.

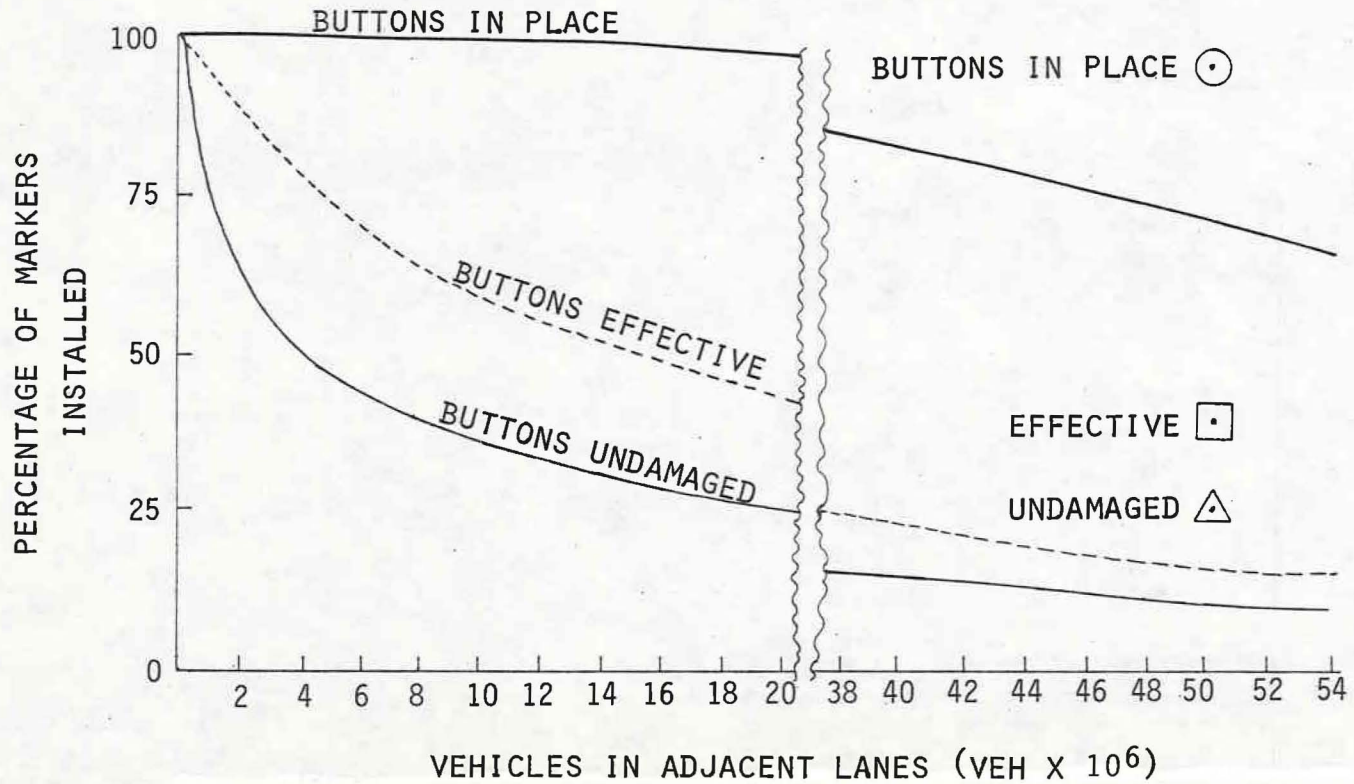
Installation Date: May, 1976
 Pavement: Asphalt Concrete
 Tradename: Permark P-117 (Type II-CR)
 ADT (two adjacent lanes only): 22,500
 Total Buttons: 70
 Note: Open symbols represent daytime data

Figure 30. Observed Conditions of RTBs on IH 35 Lower Level, in Austin, (Southbound) Compared to RTB Performance Reported in the 1977 Dallas - San Antonio Study.

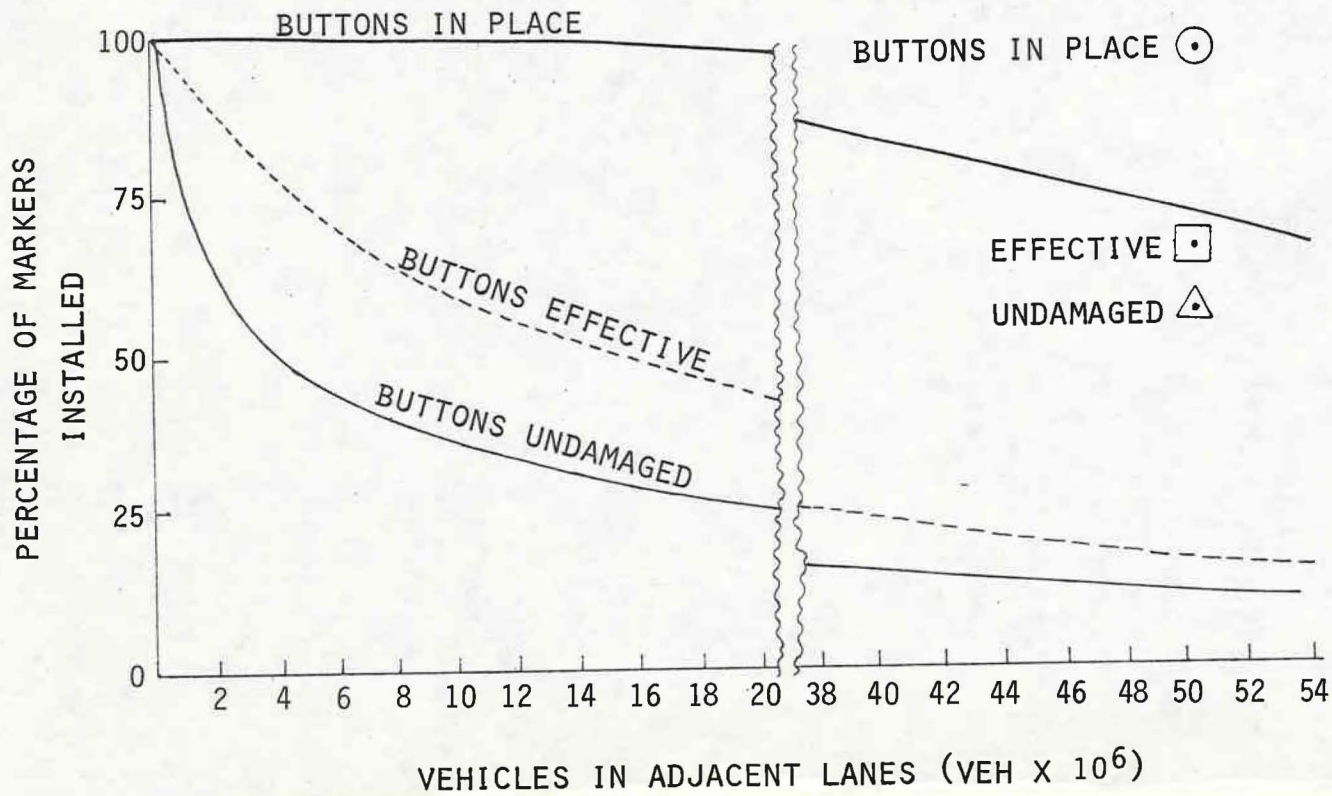
Installation Date: May, 1976
 Pavement: Asphalt concrete
 Tradename: Permark P-15 (Type I-C)
 ADT (two adjacent lanes only): 22,500
 Total Buttons: 396
 Note: Open symbols represent daytime data

Figure 31. Observed Condition of RTBs on IH 35 Lower Level, in Austin (Southbound) Compared to RTB Performance Reported in the 1977 Dallas - San Antonio Study.

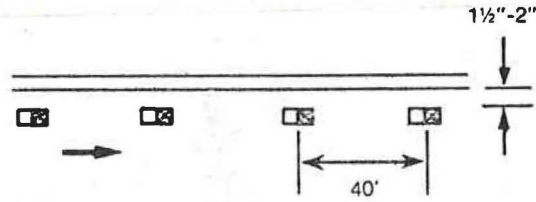
a) Combination RPM/Stripe for Left Edge Line (RPMs not recommended for right edge line)

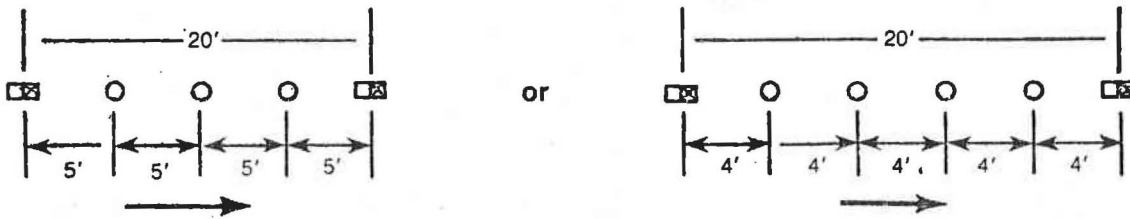
b) RPM System for No Passing Barrier

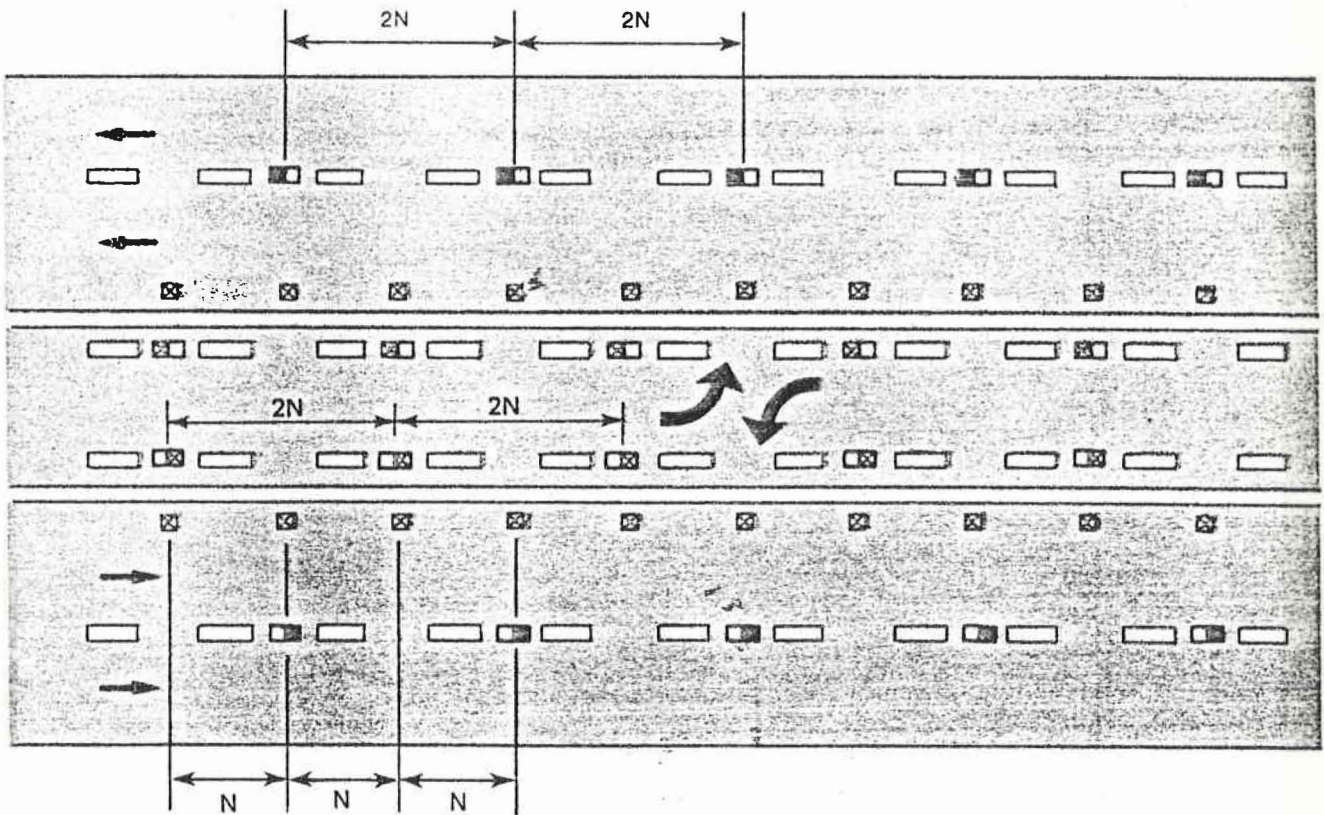
b) Center Lane of Five-Lane Roadway

Figure 45. Marking Patterns for Left-Turn Lanes.

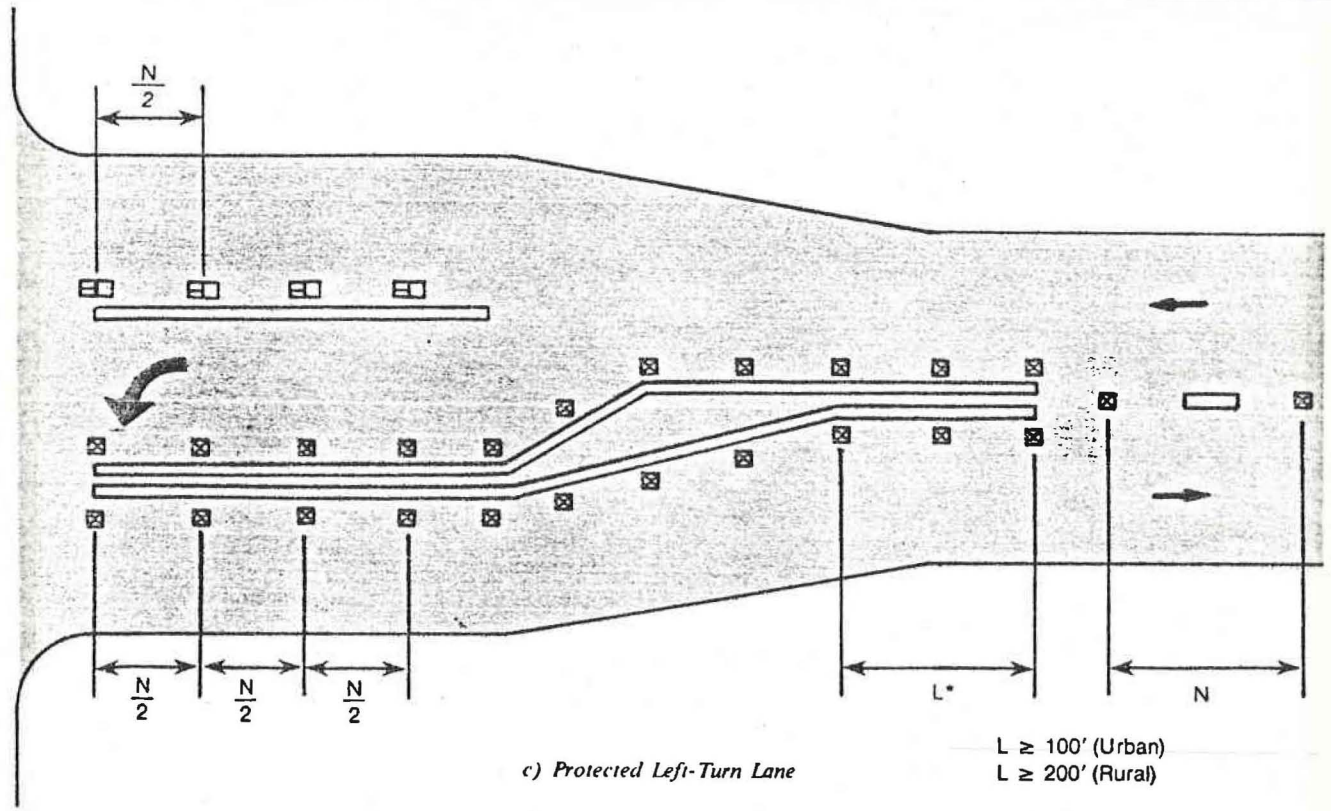
Figure 46. Marking Patterns for Left-Turn Lanes (continued).
