1. Report No. FHWA/TX-86/10+322-1		2. Government Accession No.		3. Recipient's Catalog No.	
4. Title and Subtitle State-of-the-Art and Objectives of Reflective Raised Pavement Markers				5. Report Date October 1986

STATE-OF-THE-ART AND OBJECTIVES OF REFLECTIVE RAISED PAVEMENT MARKERS

Research Report 322-1
Study Number 2-18-322-1

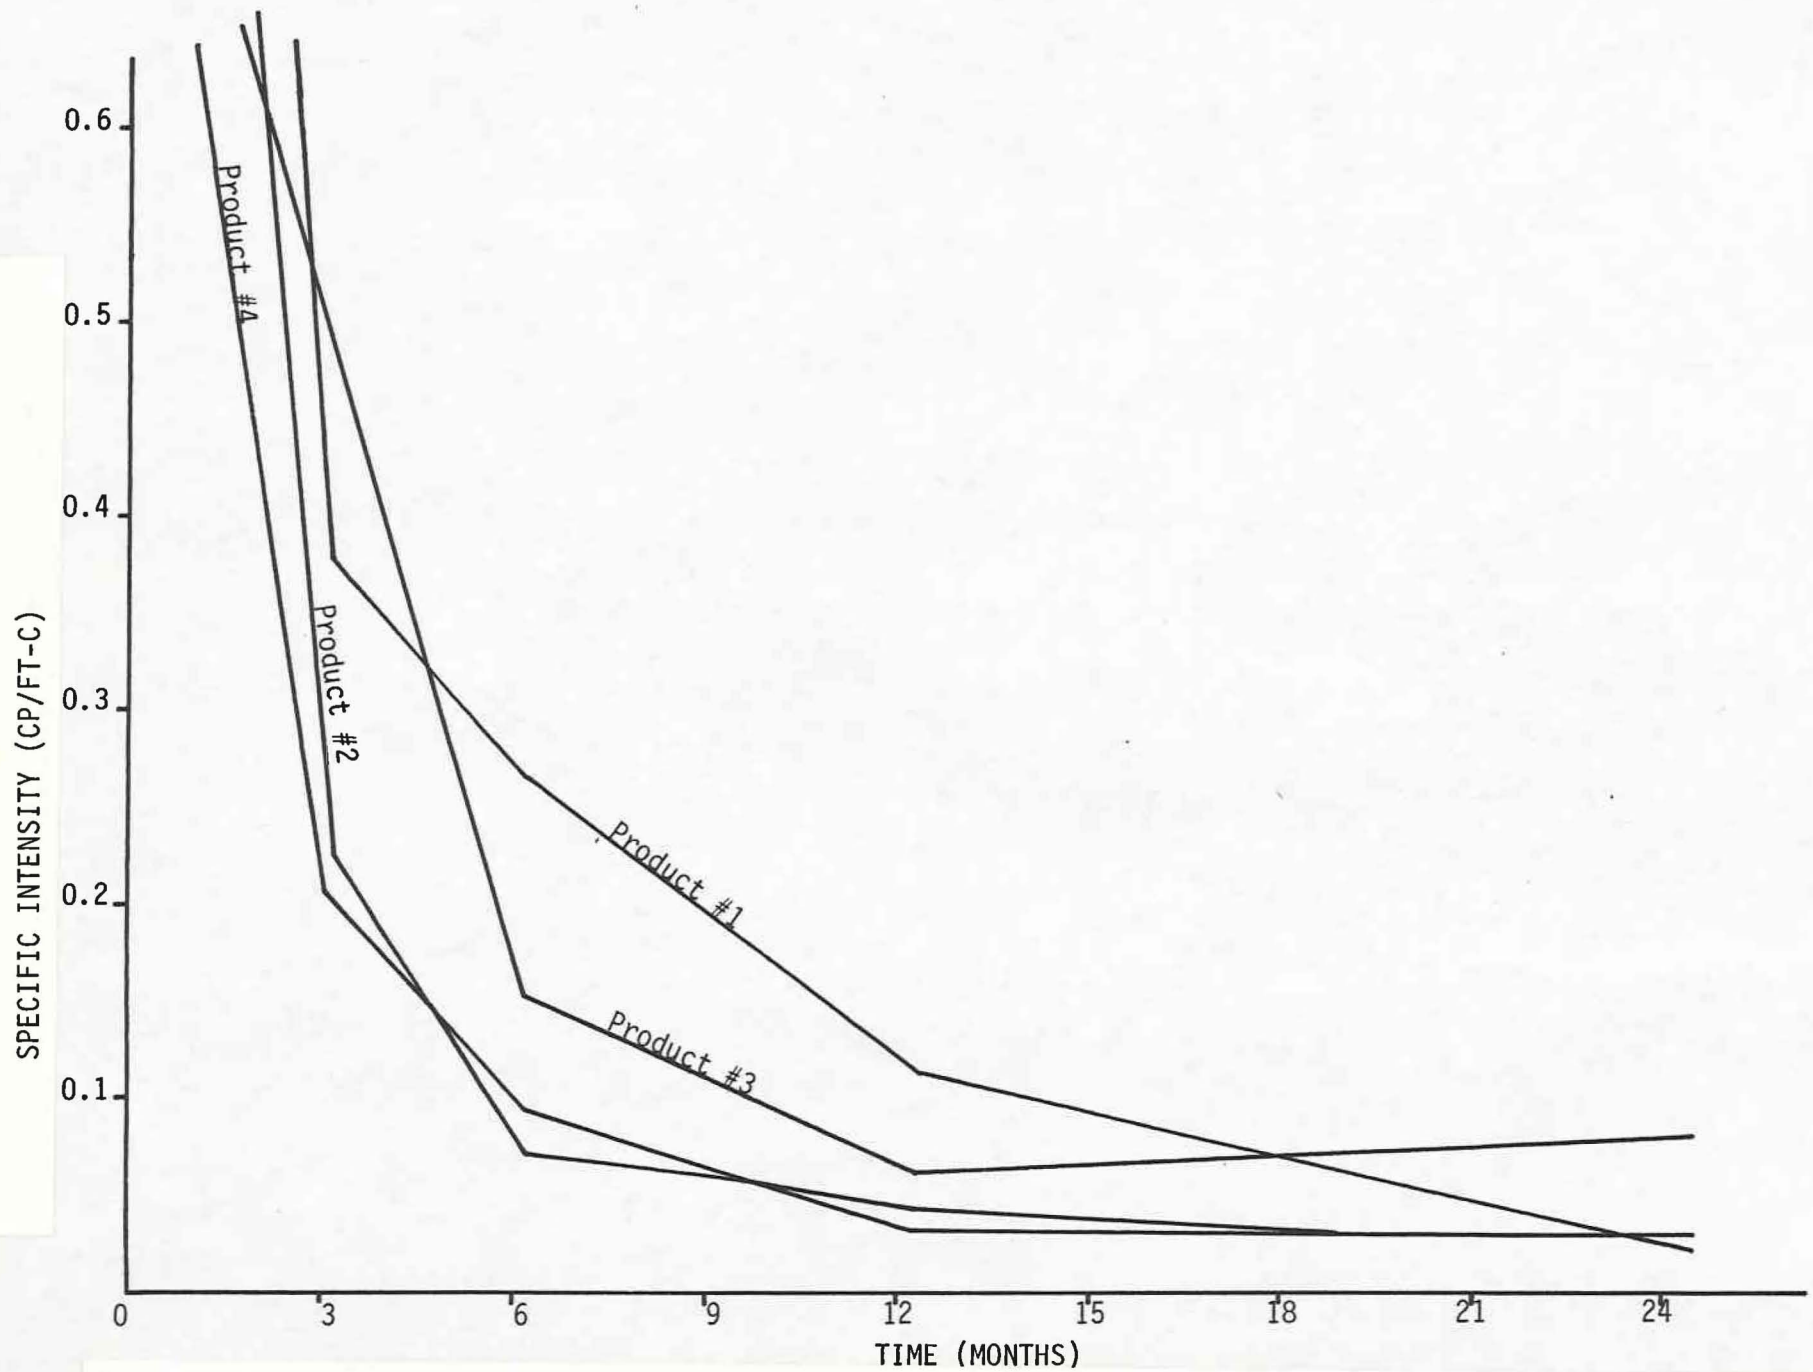
Figure 48. Specific Intensity Levels, Less Than 1.0 CP/FT-C, for the Four Major Types of Rural Pavement Markers by Length of Time From Dallas Test Sites.

While the number of impacts have an effect on the brightness levels of the markers, other factors also affect brightness. Impact affects brightness in two ways. First, the number of impacts determine the degree to which the lense is scratched. This scratching has a significant impact on the brightness level of the marker. Second, the number of impacts significantly determines the number of markers missing at any location. The number of

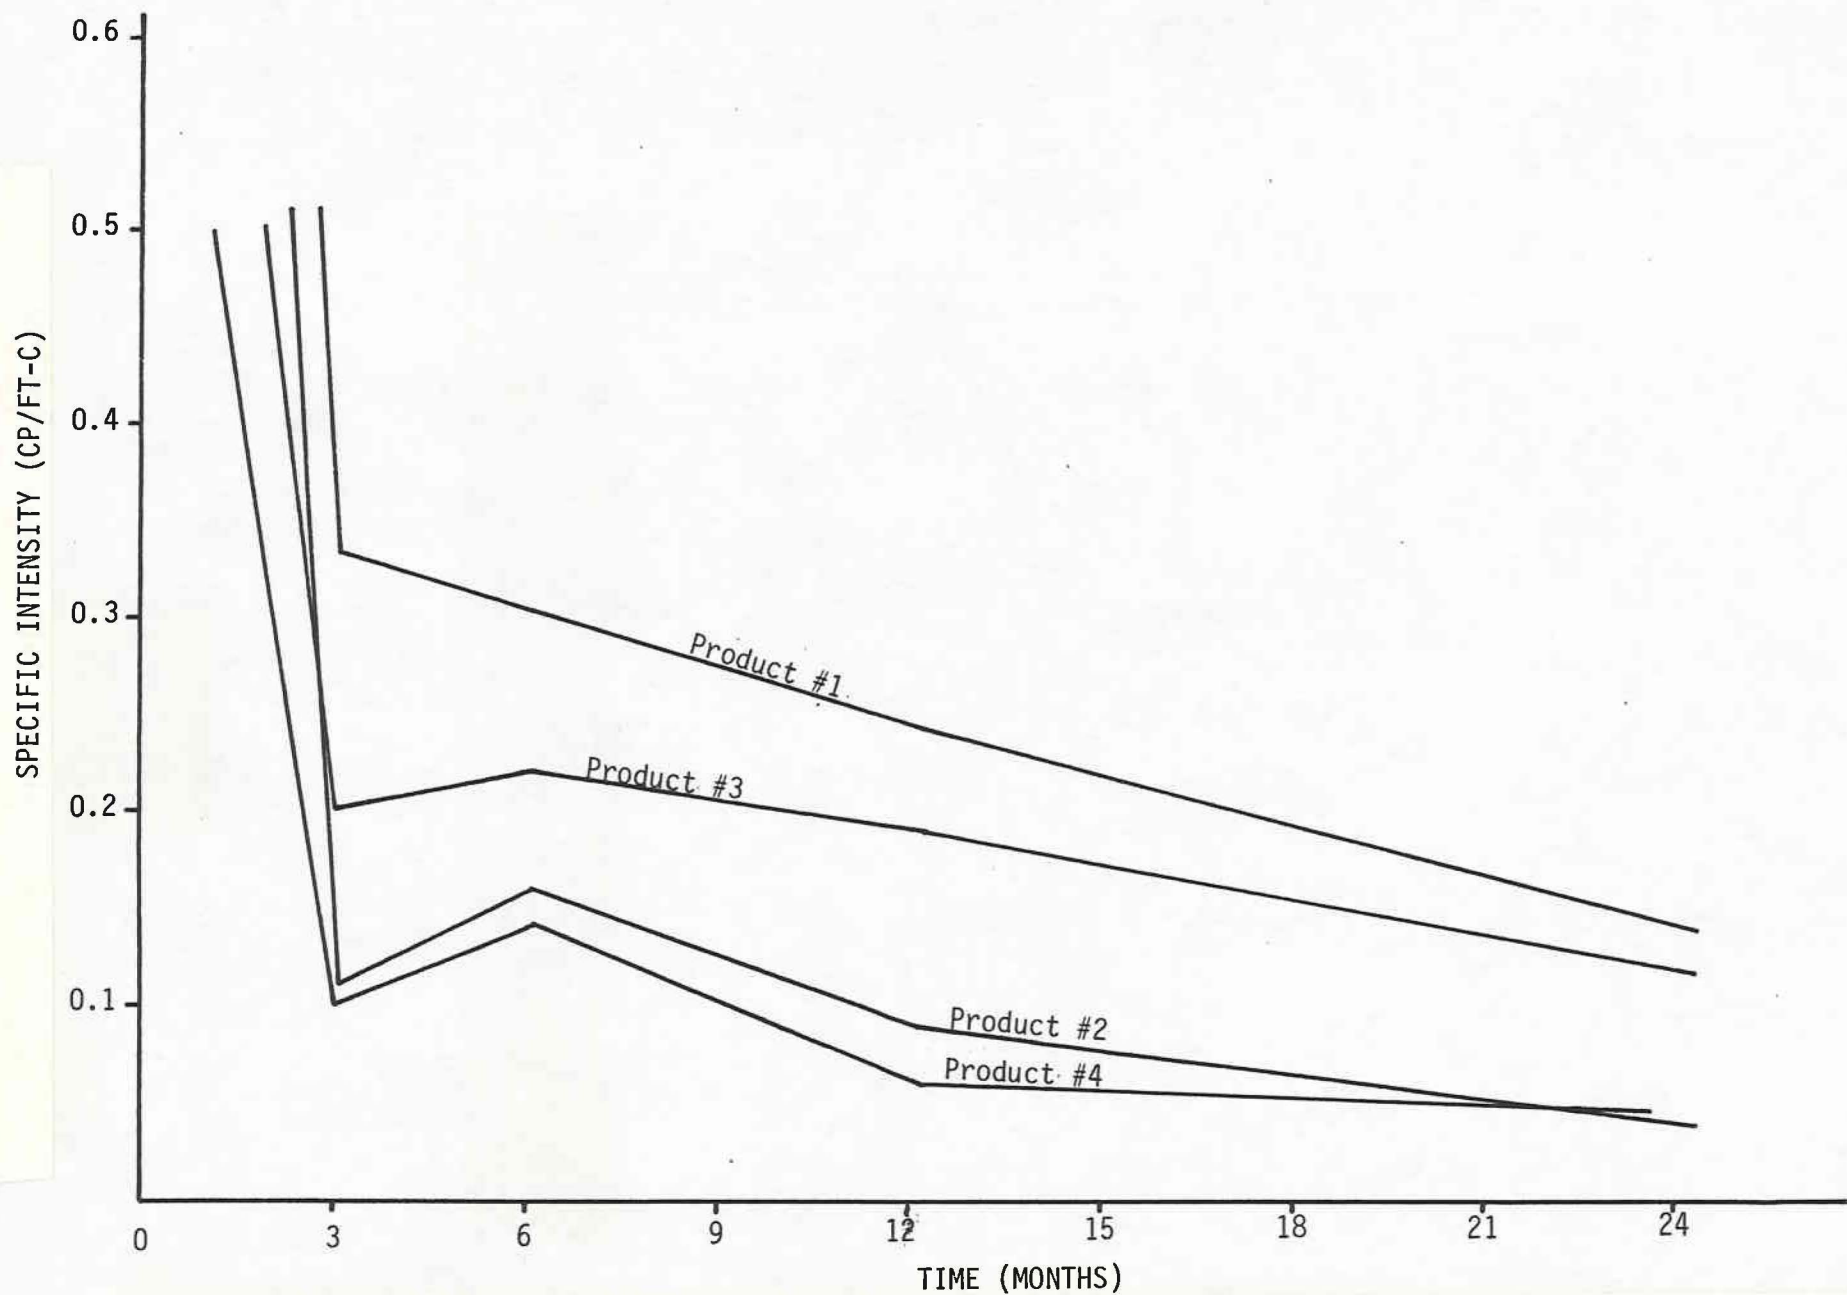
Figure 49. Specific Intensity Levels, Less Than 1.0 CP/FT-C, For the Four Major Types of Raised Pavement Markers by Length of Time on Roadway From San Antonio Test Sites.

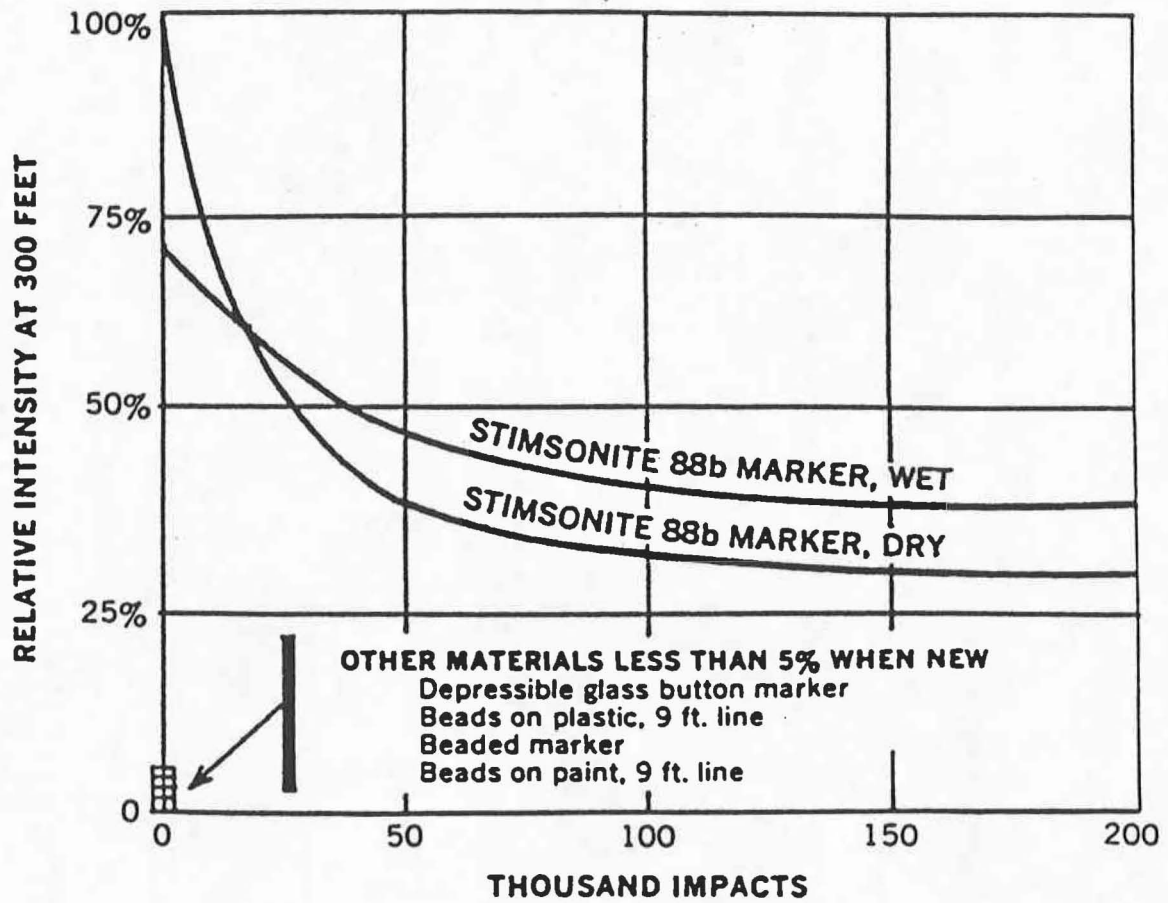
Figure 50. Accelerated Wear Test Results.

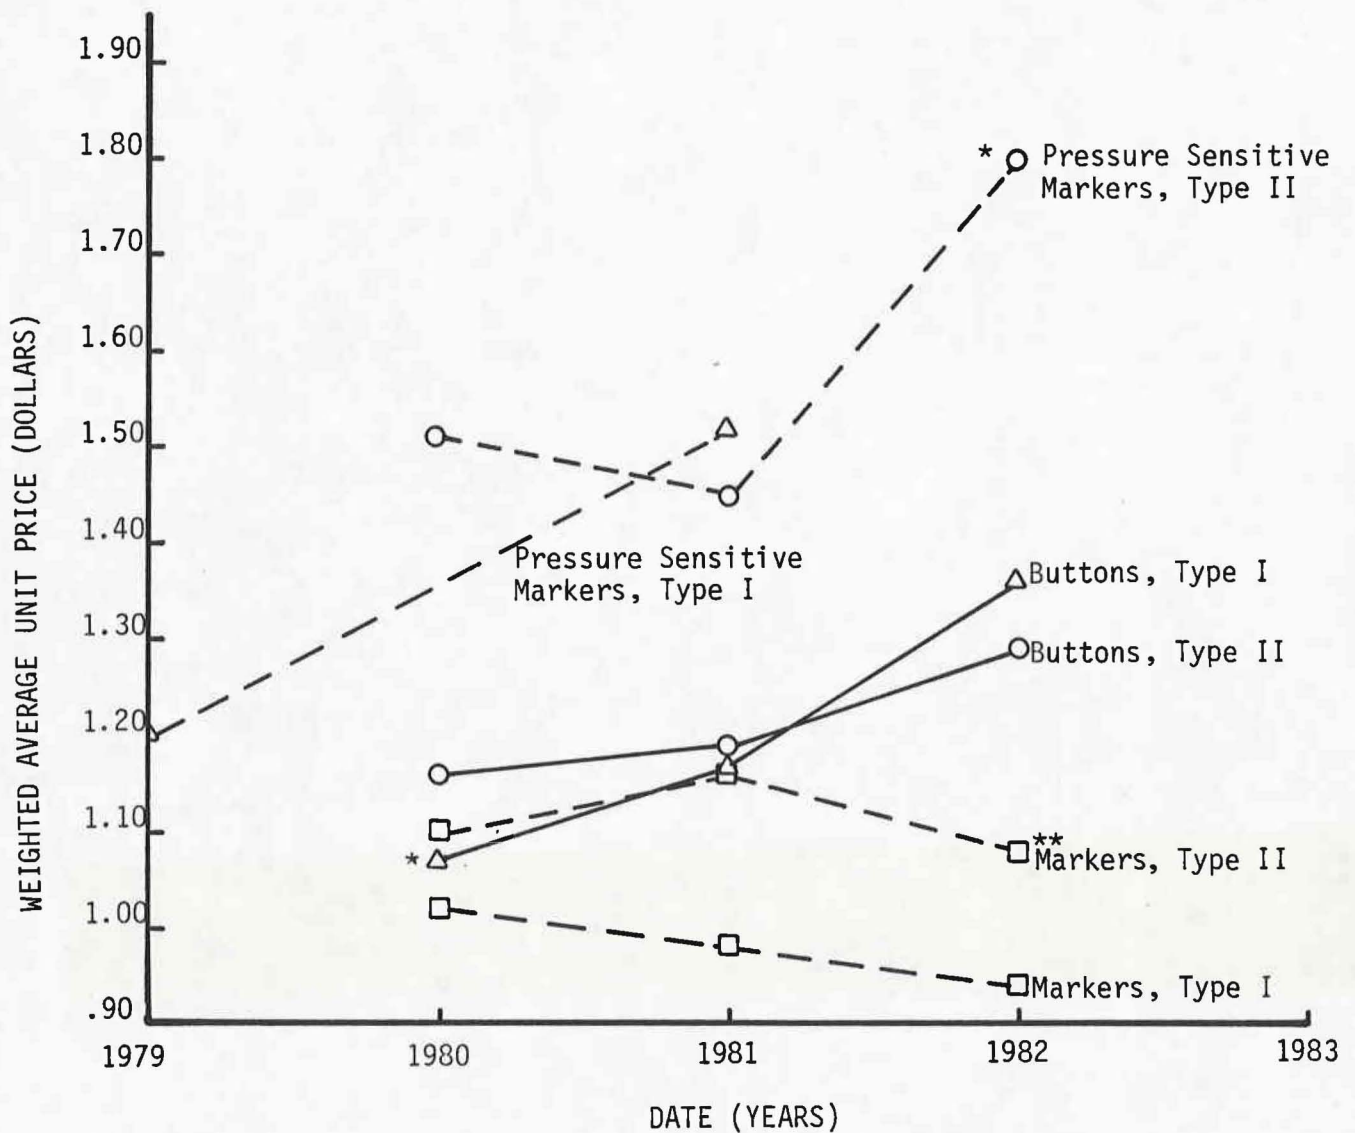
Note: No purchases of Type I, pressure sensitive markers were made in 1980.

Figure 51. Weighted Average Unit Price.

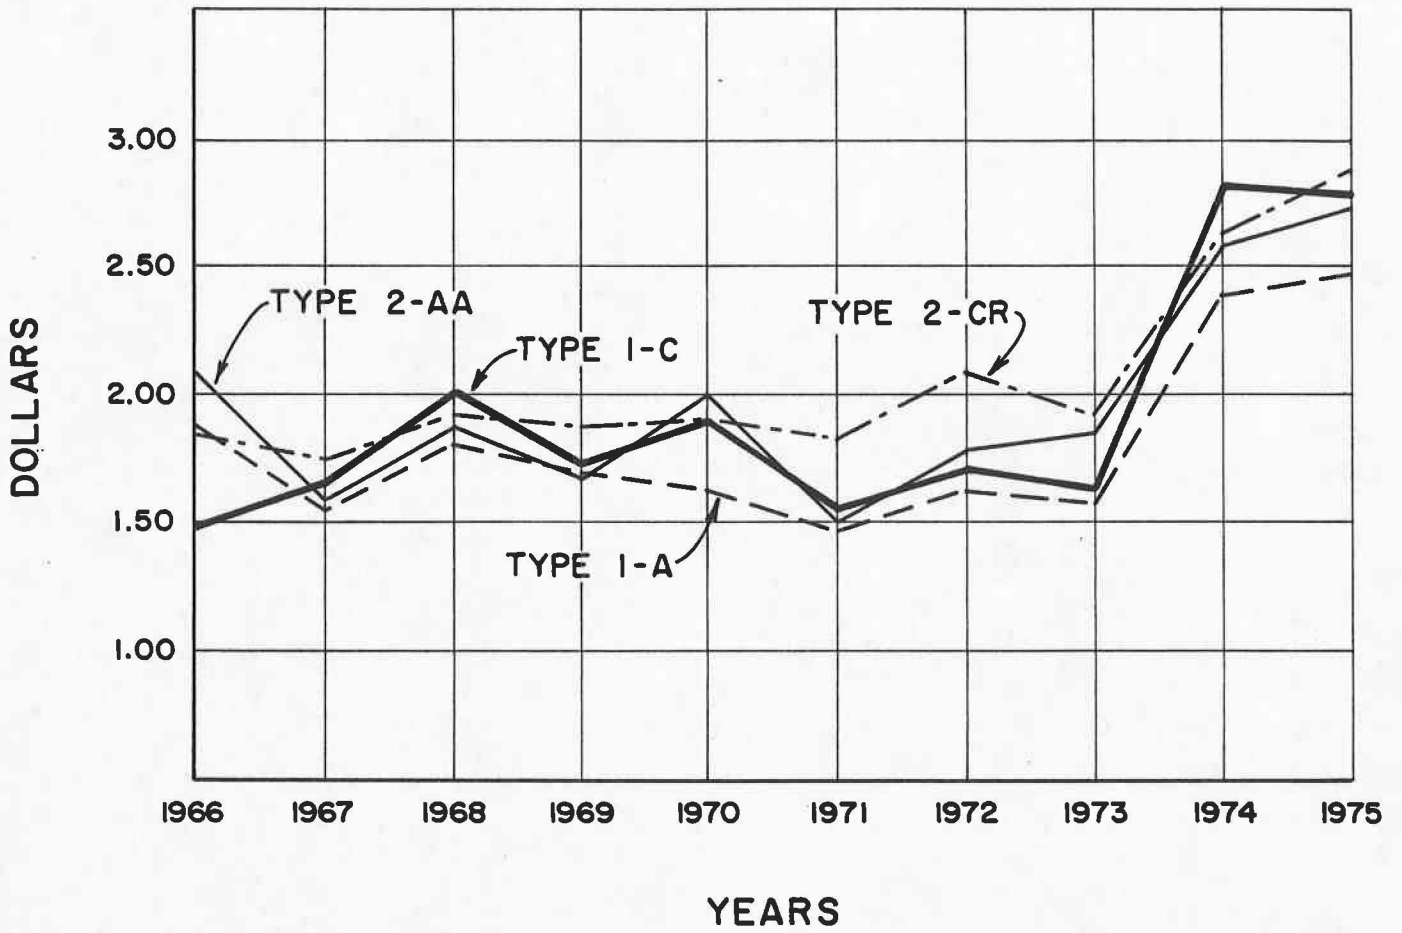
Figure 52. California Experience with Pavement Marker Costs - Installed.

Figure 52, adapted from a Caltrans Report (4), reflects bid prices for the installation of RPMs in California between 1966 and 1975. The increase in cost is due entirely to the cost of installation. The cost of RPM's remained practically unchanged.
